OPEN FILE 2004–18

A regional characterization of landslides in the Alaska Highway corridor, Yukon

C.A. Huscroft, P.S. Lipovsky and J.D. Bond

Huscroft, C.A., Lipovsky, P.S. and Bond, J.D., 2004. A regional characterization of landslides in the Alaska Highway corridor, Yukon. Yukon Geological Survey, Open File 2004-18, 65 p., report and CD-ROM.

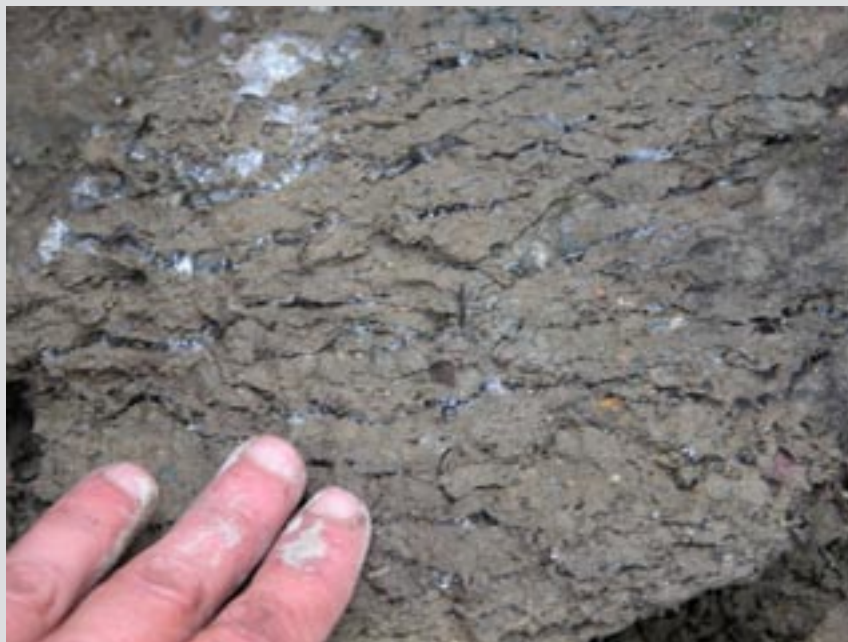
Figure XVI. Soil from beneath the permafrost table from unburned forest site displaying stratified visible ice. Thawing of ice-rich soil causes a significant loss of soil strength.

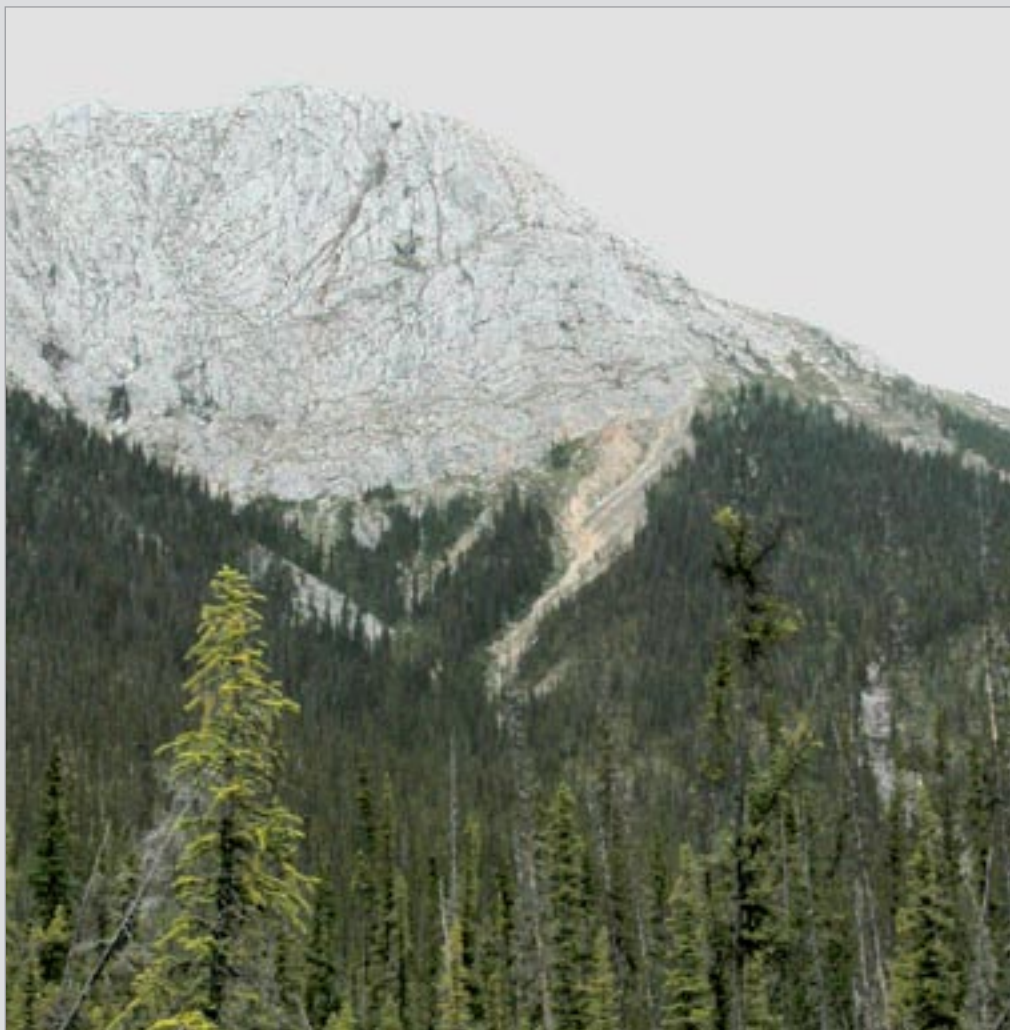
Figure XIX. Catchment area of White Mountain debris flows originating from north-facing slopes of White Mountain. Permafrost was encountered within 1 m of the surface within forested slopes adjacent to the catchment. Photograph taken looking south from Alaska Highway.

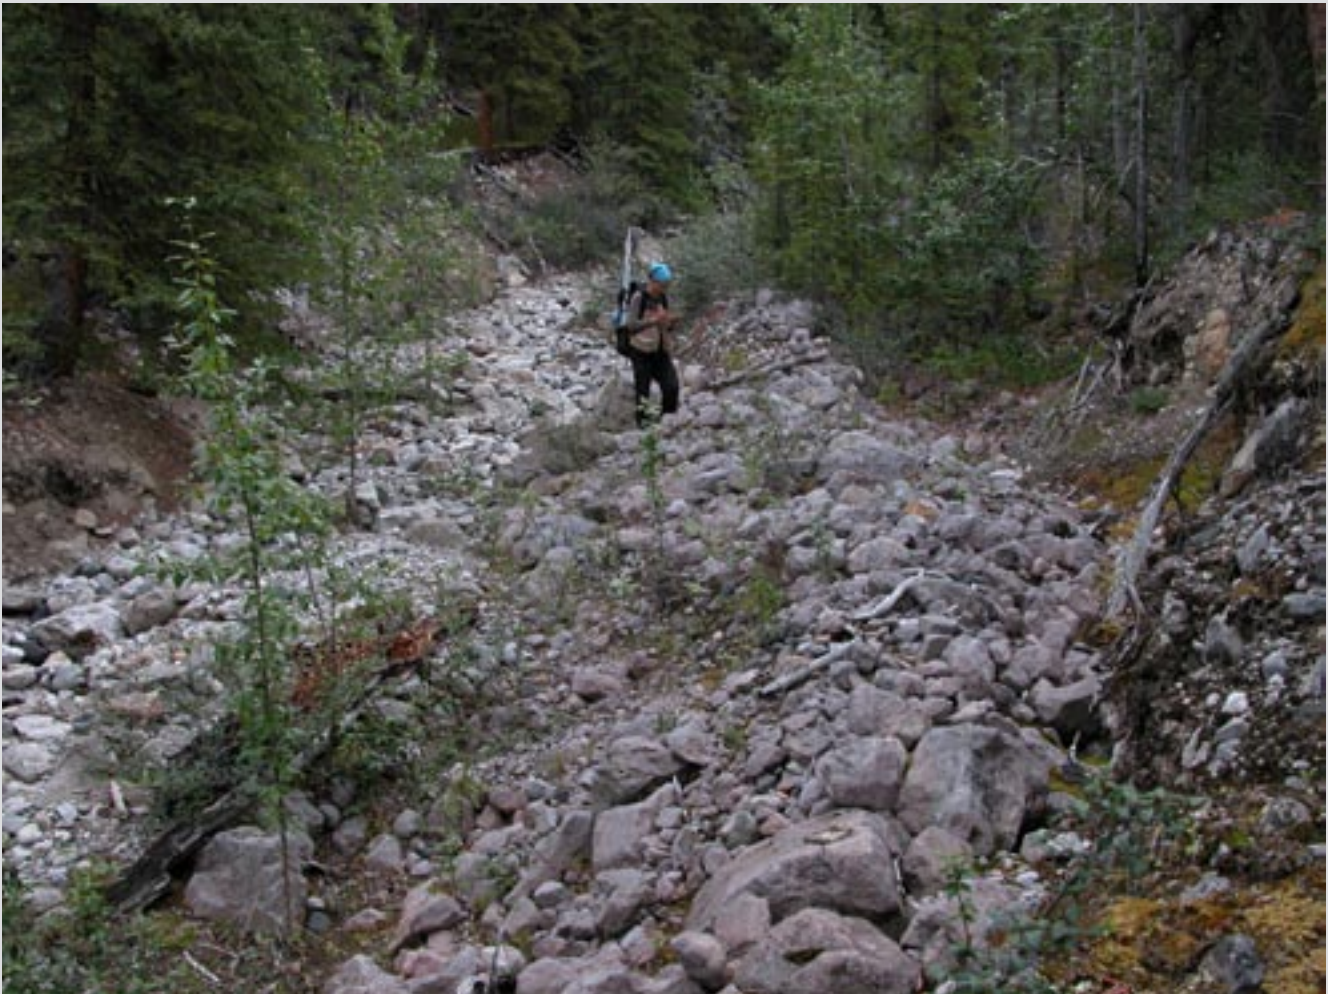
Figure XX. Deposits from two youngest debris flows (occurred between 1980-1991 and 1952-1980, based on dendrochronology).

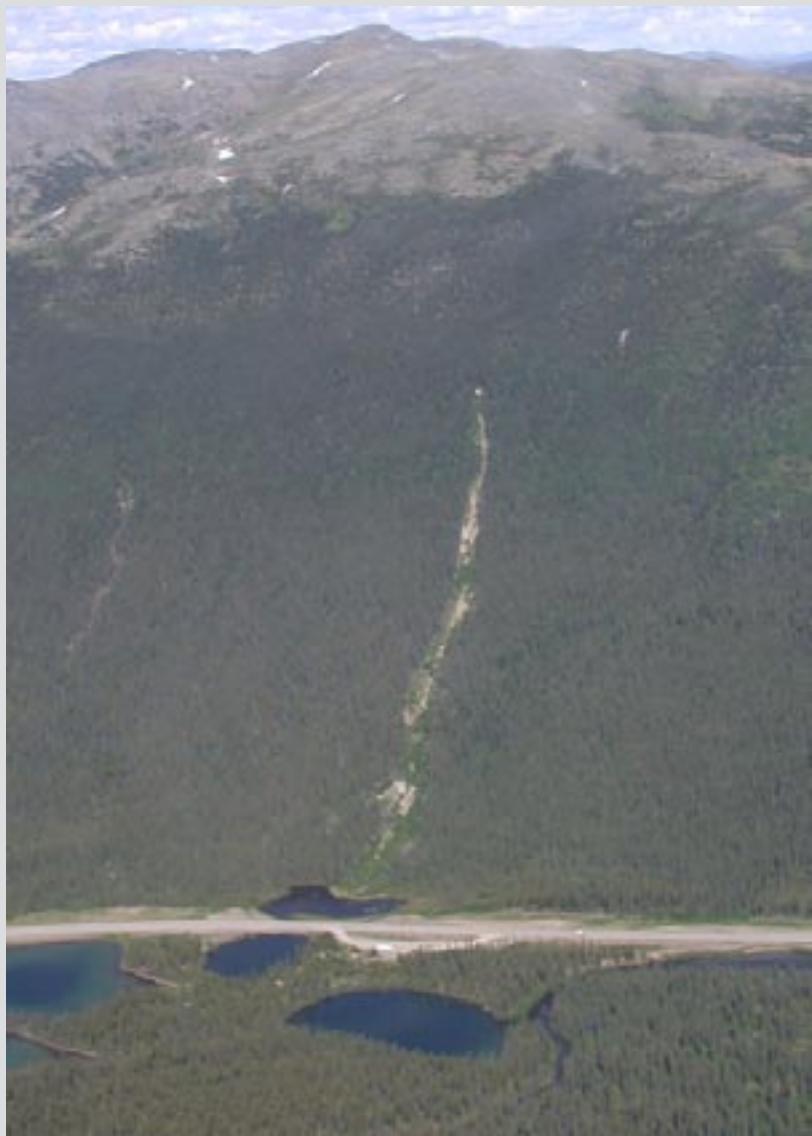
Figure XXII. Debris flow induced by intense rainstorm in 1988 on south-facing slope near Rancheria Message Post. Alaska Highway in foreground.

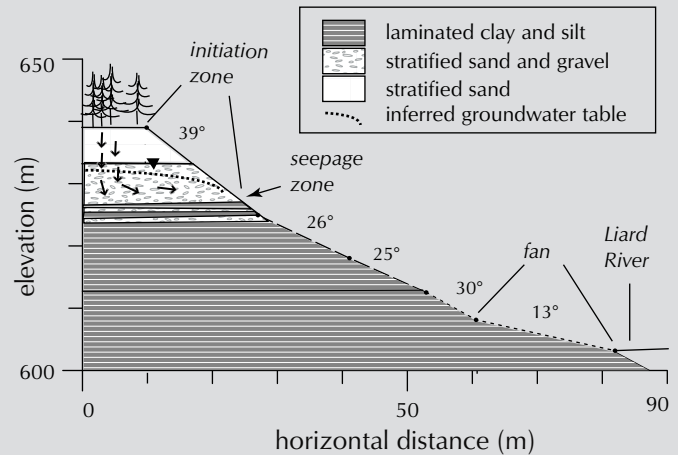
Figure XXV. Surveyed long profile of Liard River debris slide with inferred sub-surface conditions which contributed to failure.
