# Geophysical and borehole investigations of permafrost conditions associated with compromised infrastructure in Dawson and Ross River, Yukon

Laxton, S. and Coates, J., 2011. Geophysical and borehole investigations of permafrost conditions associated with compromised infrastructure in Dawson and Ross River, Yukon. *In: Yukon Exploration and Geology 2010*, K.E. MacFarlane, L.H. Weston and C. Relf (eds.), Yukon Geological Survey, p. 135-148.

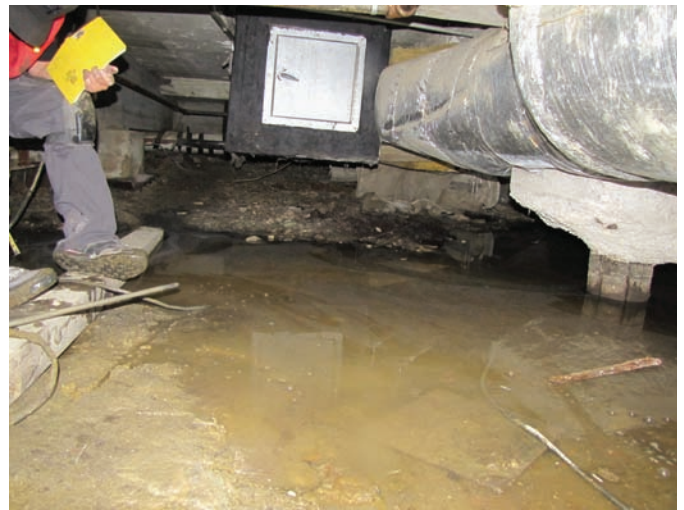
At the time of inspection on July 20, 2010, the crawlspace had 5 to 10 cm of water in a depressed area near the centre of the building (Fig. 5). The floor of the crawlspace appears to have subsided almost 40 cm since the piles were poured, as evidenced by suspended concrete slabs which originally rested on grade. The piles do not appear to be settling and the building appears to have remained level.

**Figure 5.** Water in crawl space beneath Palace Grand Theatre, July 25, 2010; note the exposed piling below concrete pad indicating the presence of ground surface subsidence.

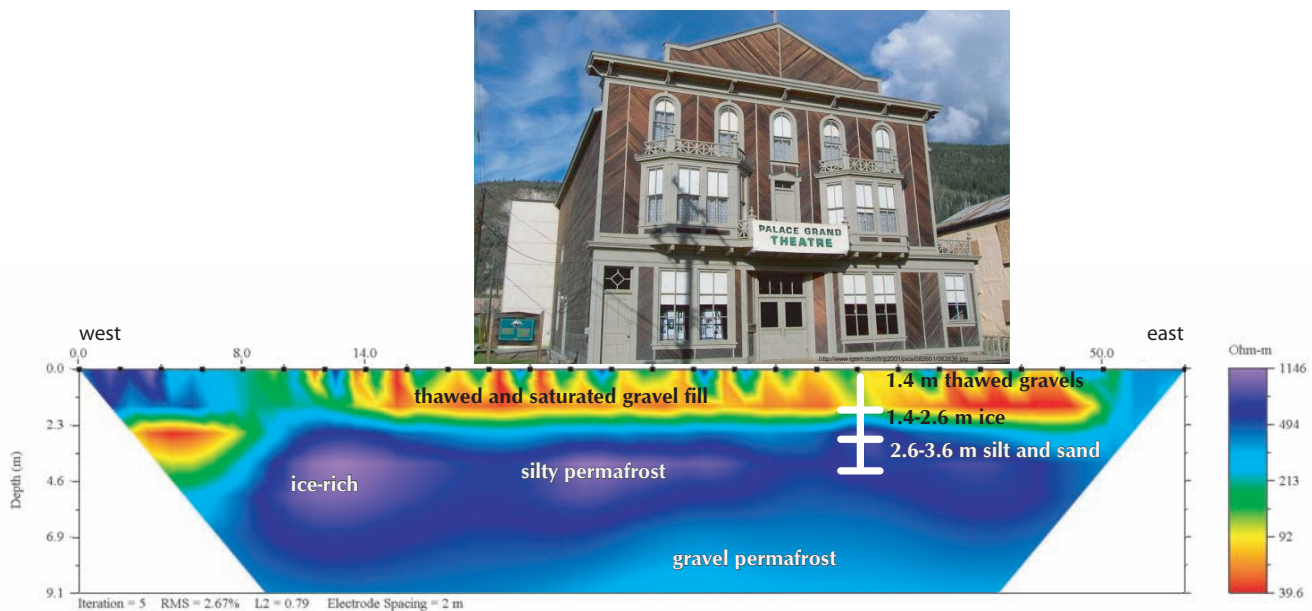
Drilling and resistivity showed a relatively consistent active layer approximately 1.5 m thick (Fig. 6). Deeper thaw was observed beneath a drainage ditch in a parking lot to the west of the structure (Fig. 6). Several ice-rich or pure ice lenses were detected by the resistivity and drilling at depths from 1.4 to 5.0 m. These were characterized by high resistivities of 800-1200 Ωm. This roughly corresponds with the depth of the silt unit. Frozen gravel layers beneath the ice-rich silt have lower resistivities due to lower ice contents (200-300 Ωm). The thawed active layer, which is largely composed of White Channel gravel fill, has a very low resistivity (40-50 Ωm). This indicates high groundwater content between the highly resistive quartz cobbles. Standing water was observed in the crawlspace below the building. The source of this water is likely groundwater moving through the permeable active layer.

Figure 6. The Palace Grand Theatre resistivity tomogram run on the north side of the building, and borehole data.

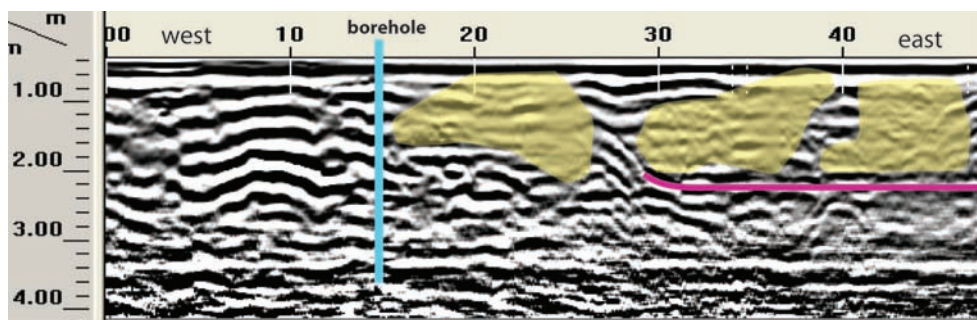
The GPR output indicates an active layer which is approximately 2 m thick (Fig. 7). Above this level, the signal is attenuated and blurry, indicating groundwater presence. Several regions of chaotic GPR signals may indicate massive ice or very ice-rich conditions.

Figure 7. GPR image along same path as resistivity transect located on the north side of the Palace Grand Theatre. Yellow areas demark zones with higher groundwater content; the blue line indicates the location of the borehole; and the pink line is the interpreted upper contact of the silty sand unit.

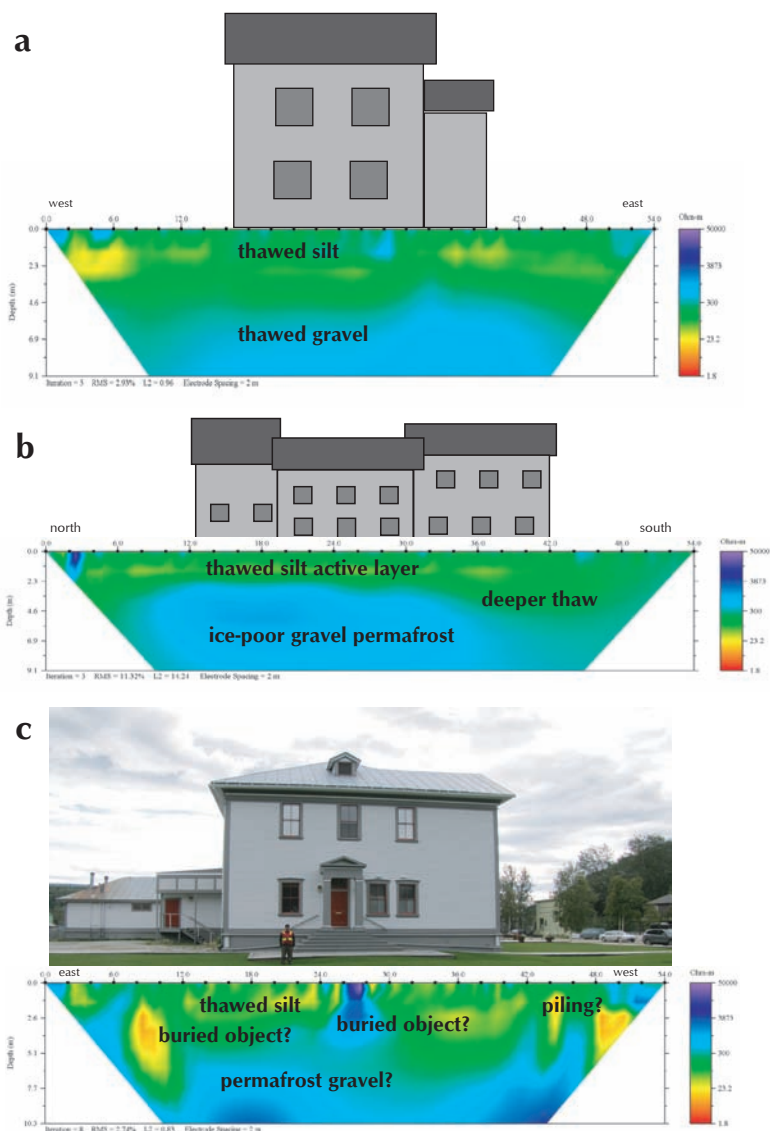
No permafrost was detected within the top 10 m of the subsurface on the south side of the building (Fig. 8a). While higher resistivities were present near the base of the image, there is no sharp boundary which is generally found at the top of the permafrost table. Thawed silt were encountered in the upper 2 to 5 m (100-200  $\Omega$ m). Gravel is likely found below 5 m. Low resistivities within the gravel indicate that they are probably thawed (200-350  $\Omega$ m). Borehole BH01 was drilled to a depth of 1.3 m; sticky unfrozen clay bound the Bosch drill auger stem and prevented further drilling.

The transect on the east side of the building was run along the east side of the parking lot adjacent to the foundation excavation for the new hospital construction site (Fig. 8b). Possible permafrost was encountered at the north end of the transect within local alluvial gravel (300-500  $\Omega$ m). The hospital foundation excavation allowed for observation of materials to a depth of 4 m, which consisted of 2 to 3 m of silt (50-200  $\Omega$ m) overlaying gravel. No permafrost was found by equipment operators during excavation for the new hospital's foundation; however, the resistivity showed a strong contrast between high and low resistance materials. This is likely ice-poor gravel permafrost which equipment operators may not have recognized. As the ice content in the sediments are low, thaw and subsidence are not expected at this site.

The transect on the north side of the building ran parallel to the structure at the edge of the Fifth Ave. entrance boardwalk (Fig. 8c). Several regions of very low resistivity may be groundwater channels, rotting wooden pilings or buried metallic debris (10-30  $\Omega$ m). Low resistivities near the surface are likely thawed silt (25-200  $\Omega$ m). A high resistance buried object (2000-8000  $\Omega$ m) was found beneath the centre of the porch. Permafrost appears to be present at depths below 7 m with high resistivities (1000-3000  $\Omega$ m), likely in alluvial gravel. This area may have been subject to permafrost thaw and surface subsidence in the past; however, with such a deep active layer and ice-poor gravel, further subsidence is unlikely.

**Figure 8.** Resistivity tomograms at the Old Territorial building: (a) run on the south side; (b) run on the east side; and (c) run on the north side.

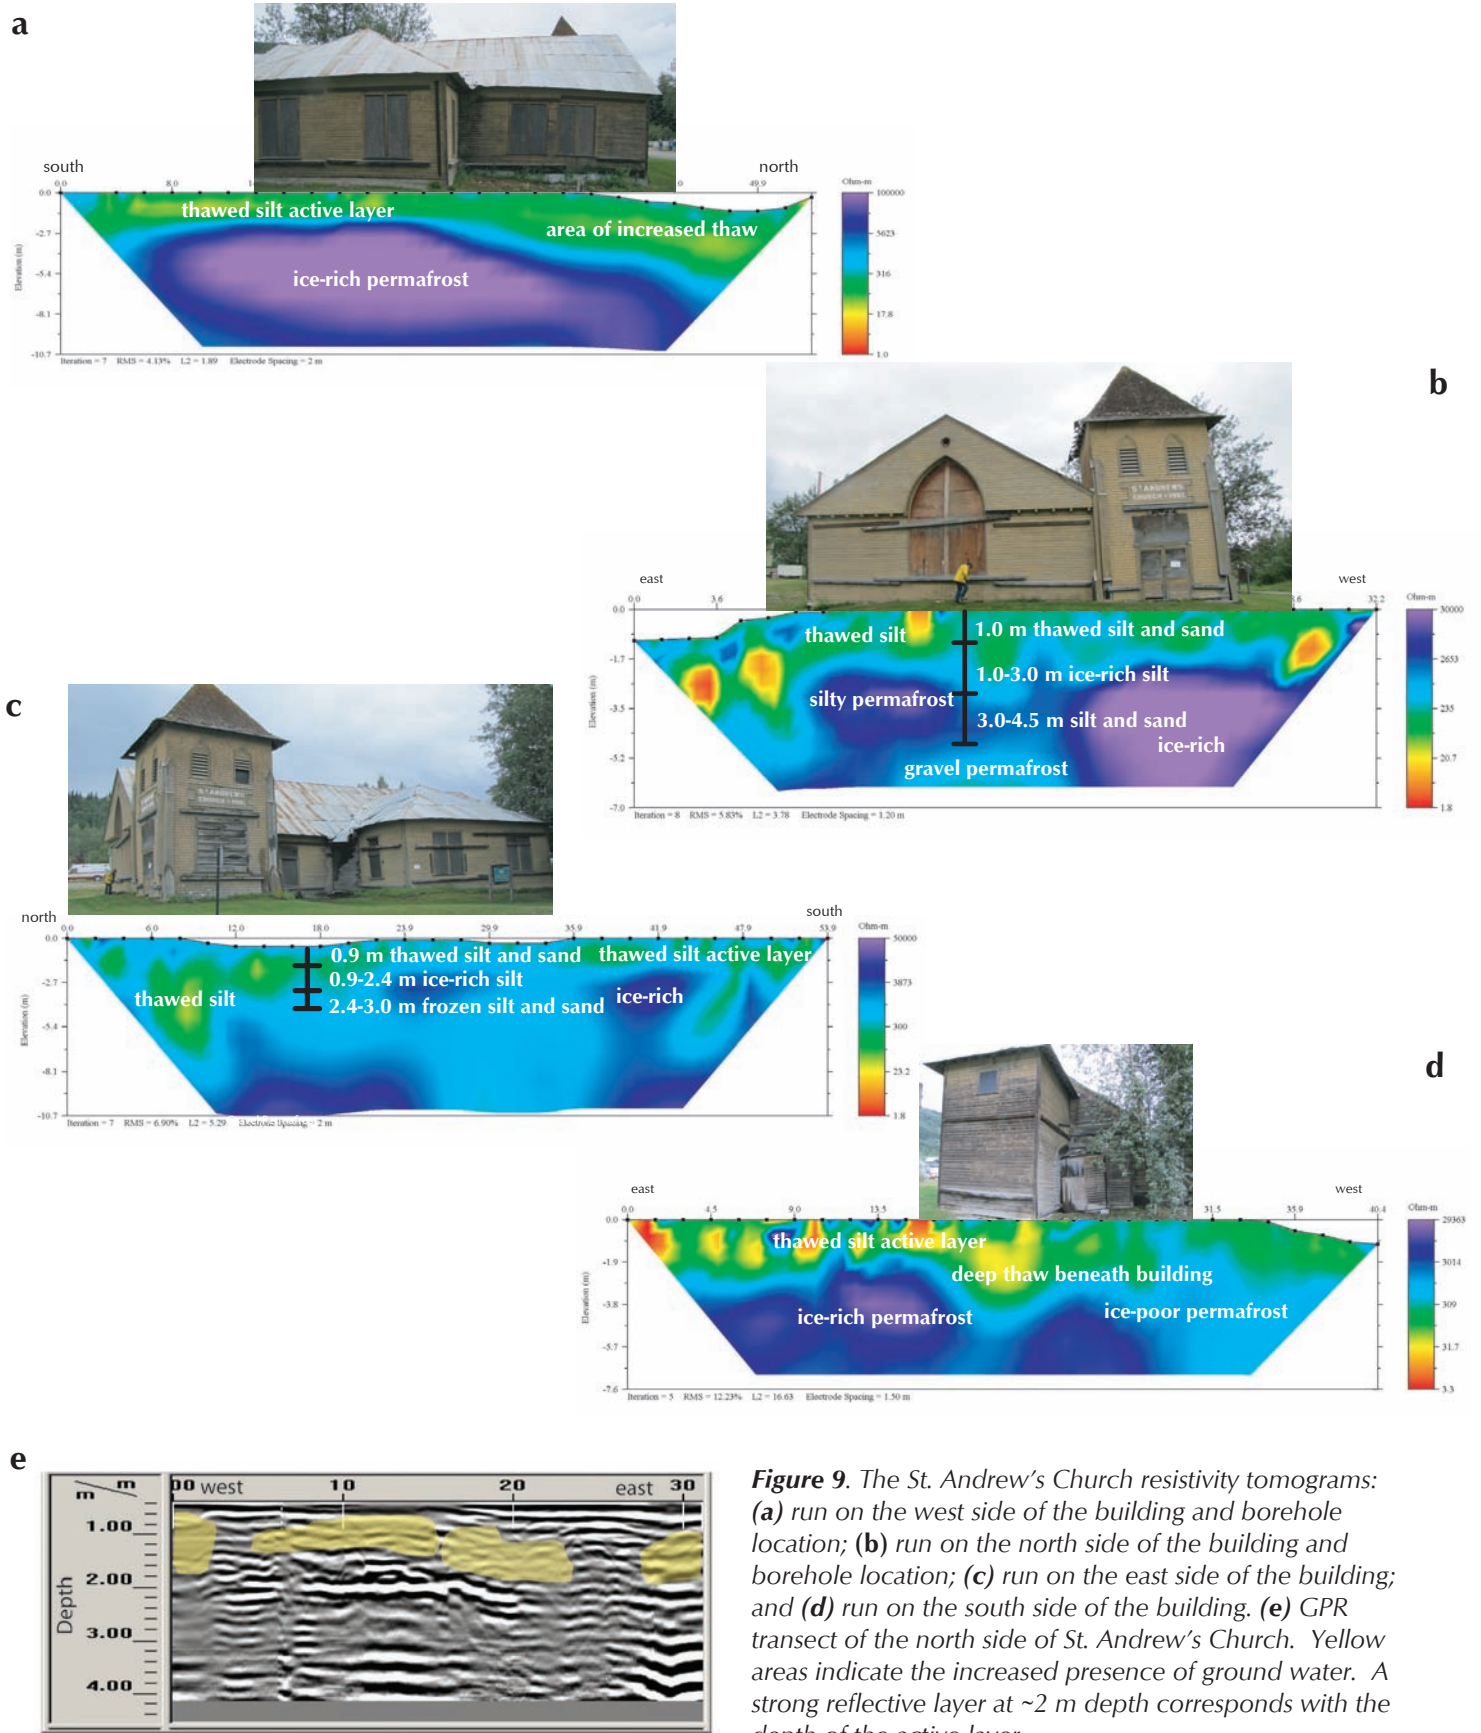
The west side of the church appears to be underlain by permafrost within alluvial silt (300-4000  $\Omega\text{m}$ ; Fig. 9a). Permafrost degradation has taken place, as evidenced by tilting of the structure. The permafrost on this side of the church has the lowest resistivity in the building area, indicating low ice contents or high unfrozen water content. Several isolated bodies of high-resistivity material (4000-30000  $\Omega\text{m}$ ) were surrounded by low-resistivities (300-500  $\Omega\text{m}$ ), suggesting that there are relict patches of ice-rich silt surrounded by ice-poor degraded permafrost. Deep thaw depths of >6 m beneath the south face of the bell tower may account for some of the lean evident in the structure. This side of the church may experience more thaw due to its westerly aspect, which receives increased summer evening insolation.

A large region of ice-rich silt underlies the west end of the transect, beneath the bell tower (~30 000  $\Omega\text{m}$ ) (Fig. 9b). Degraded permafrost is found towards the east end of the structure, where surface subsidence is visible (100-200  $\Omega\text{m}$ ). Regions of low resistivity found in the thaw depression at the left end of the image are likely due to saturated silt (<20  $\Omega\text{m}$ ). However, they may also be interpreted as buried metallic debris. Borehole STA02 was drilled to a depth of 4.5 m through ice-rich silt before refusal was encountered on frozen gravel.

Along the east side of the structure, permafrost has a relatively consistent depth of thaw to 2.5 m along the south end of the transect (<300  $\Omega\text{m}$ ; Fig. 9c). Towards the thaw depression at the north side of the building, the active layer becomes much deeper as indicated by the area of increased thaw (<200  $\Omega\text{m}$ ; Fig. 9c). This is an area where surface water pools. This will trap heat and transfer it to the underlying permafrost causing continued thaw. Much of the damage to the structure appears to be as a result of the building 'leaning' into this thaw depression. Permafrost appears to be colder and/or more ice-rich than at other locations beneath the structure as is evidenced by the high resistivities (80 000 to 100 000  $\Omega\text{m}$ ).

The permafrost table is deep and uneven across the south side of the structure; it ranges in depth from 2 m in an adjacent lawn area to 4.0 m directly in front of the structure on 4<sup>th</sup> Ave. (Fig. 9d). Deep thaw in front of the building (30-100  $\Omega\text{m}$ ) is likely due to the south-facing wall absorbing solar energy and re-emitting that energy into the ground. Ice-rich permafrost is present in the shaded area to the east (3000-30 000  $\Omega\text{m}$ ) of the church, but ice-poor or high water content permafrost with an uneven active layer surface and low resistivities (300-400  $\Omega\text{m}$ ) was found on the west side.

GPR was run along the same path as the resistivity array on the north side of the church. Results from the GPR survey yielded data which support the resistivity results that suggest the presence of a thawed active layer (Figs. 9b,e). Zones with a higher ground water content are identified by a decrease in the GPR signal strength and are highlighted by the yellow areas in Figure 9e. The active layer is also visible on the GPR image as a strong horizontal linear layer at a depth of ~ 2 m below the ground surface.

**Figure 9.** The St. Andrew's Church resistivity tomograms: (a) run on the west side of the building and borehole location; (b) run on the north side of the building and borehole location; (c) run on the east side of the building; and (d) run on the south side of the building. (e) GPR transect of the north side of St. Andrew's Church. Yellow areas indicate the increased presence of ground water. A strong reflective layer at ~2 m depth corresponds with the depth of the active layer.

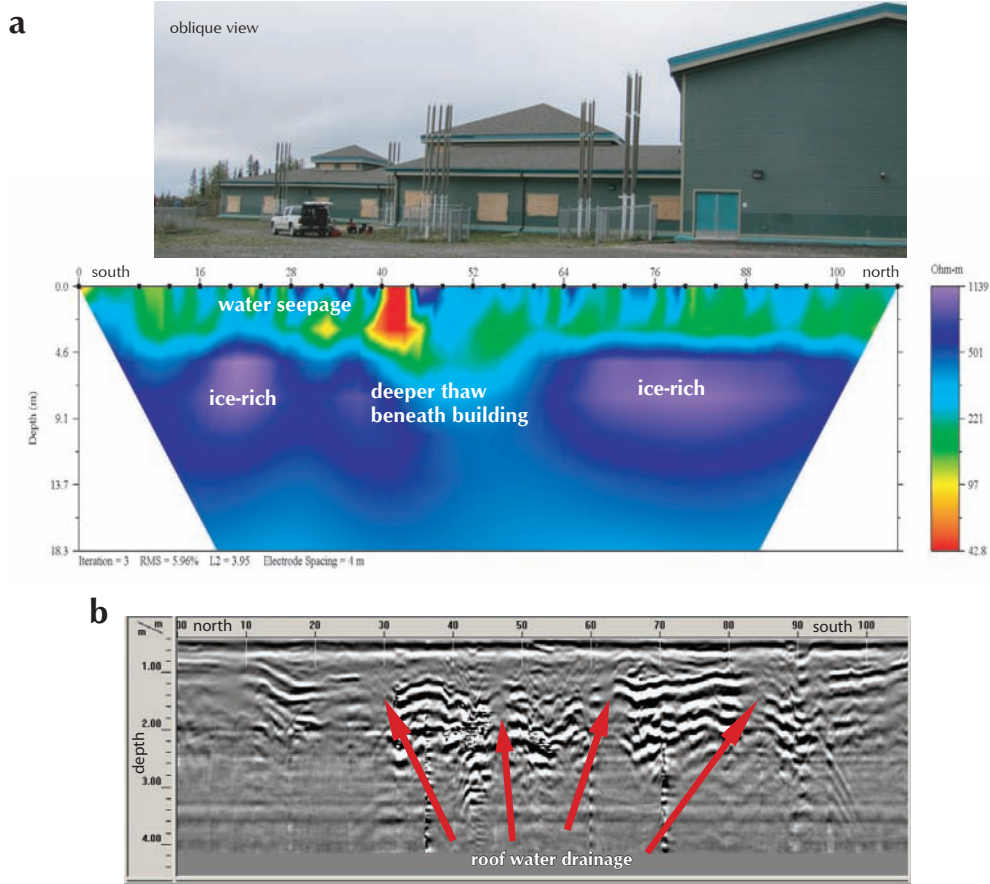
The Ross River School has experienced damage relating to foundation settlement for over 10 years (Fig. 2b). An insulated crawlspace and thermosiphons are being used to prevent thaw of the underlying ice-rich permafrost; however, continued thaw and settlement is occurring (Fig. 10a).

The two high-resistance regions labeled as ice-rich (500-1000 Ωm) are separated by a lower resistance region (200-300 Ωm) that is likely the same temperature as the surrounding permafrost, but may have much higher unfrozen water content (Fig. 10a). In this case, future thaw and subsidence may take place in this region, which

lies beneath an area of already deep thaw. A region of very low resistivity (40-100 Ωm) near the centre of the image may indicate the presence of a large buried metal object or an area of groundwater infiltration. Groundwater infiltration is the more likely explanation, as a drain pipe from the roof eaves trough discharges in this area. GPR was used along the same transect and revealed an area of increased signal attenuation over the resistivity anomaly, an indication of groundwater presence (Fig. 10b).

Interpretations of the geophysical data indicate that water drainage from the roof may be a contributing factor for the deep thaw in the very warm permafrost adjacent to the west side of the school.

**Figure 10.** (a) Ross River School resistivity profile on the west side of the building; (b) GPR transect following the same path as the resistivity profile. The red arrows indicate regions where water runoff from the roof of the school has infiltrated into the ground.
