February 28, 2011

2010 Annual Geotechnical Dam Inspection, Faro Mine Complex, Faro, Yukon

Submitted to: Denison Environmental Services Faro Care and Maintenance Project P.O. Box 280 Faro, YT Y0B 1K0

Report Number: Document Number: Distribution: 10-1427-0032

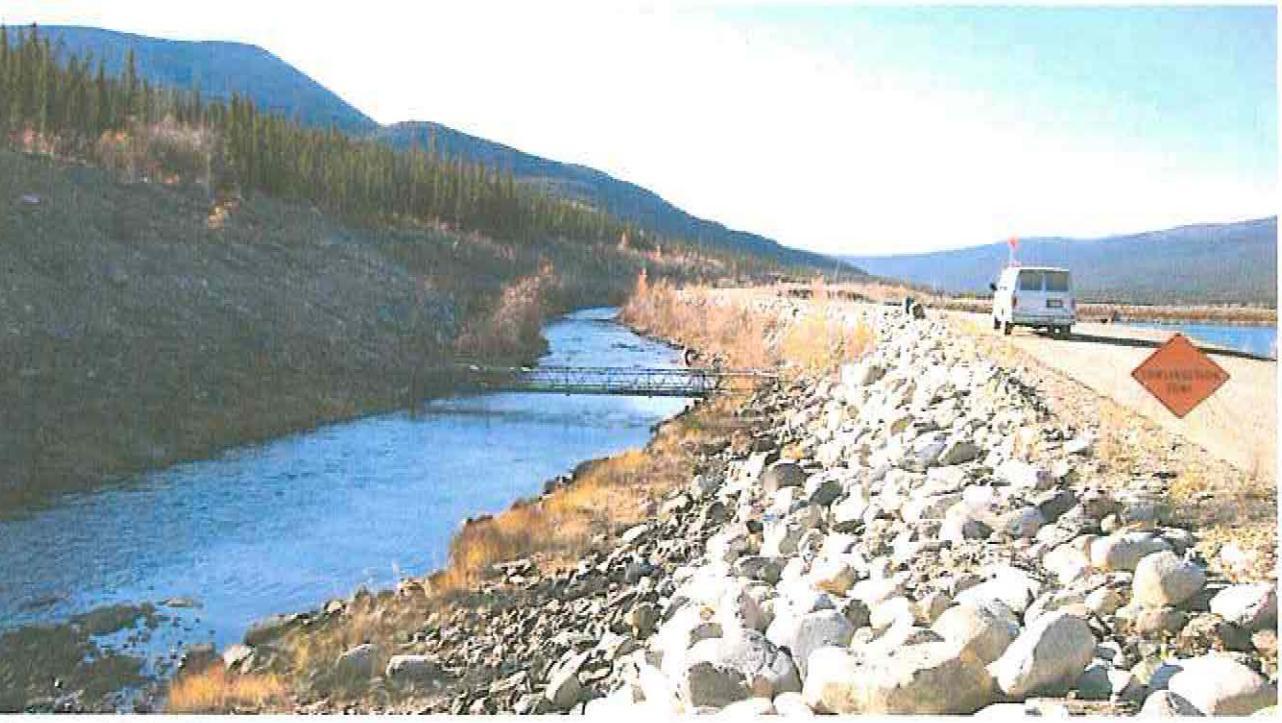
At about Stn. 2+700, the RCDC transitions to a steeper gradient with more rapid flow and the channel is founded primarily in fractured to intact bedrock (Photo B-01). The channel incorporates rock weirs comprising large blast rock placed across the channel width at regular intervals to help dissipate the rapid flow conditions in the steeper gradients. The rock weirs appear stable and the channel returns to slow flow conditions at the end of the RCDC.

DES is proceeding to remove vegetation from the diversion channel side slopes along the length of the RCDC to improve channel flow conditions. Channel vegetation removal operations were in progress at about Stn. 2+250 and appear satisfactory.

Photograph B-01: Vegetation removal progress near Stn. 2+500 of Rose Creek Diversion Channel

- In general, the rock armour and lined channel conditions observed in the Rose Creek and the Faro Creek Diversion Channels appear stable and are performing satisfactorily. It is recommended that visual monitoring for any change in rip rap and / or seepage loss conditions are recorded and instrumentation monitoring activities are continued.

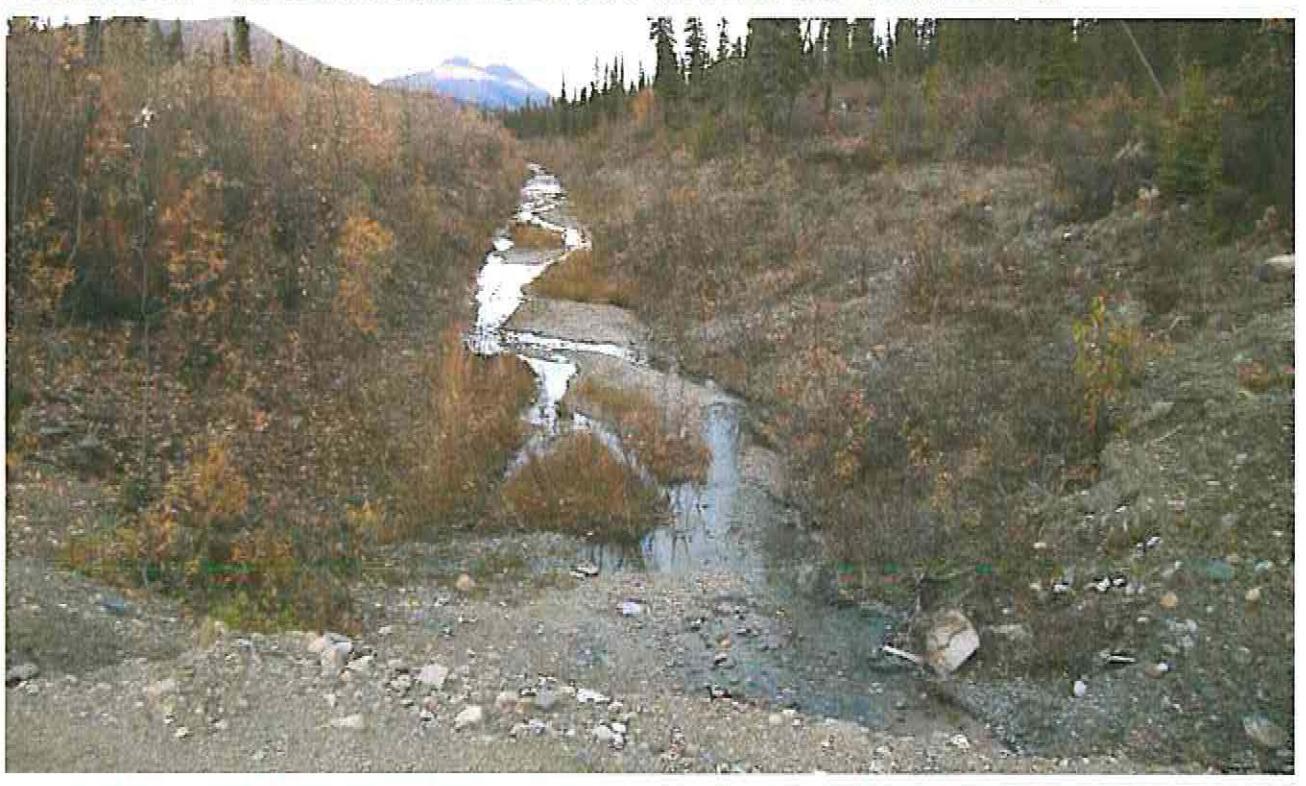
The channel gradient varies from relatively flat to moderate conditions, with ponded water developing in areas where the channel bottom undulates or is obstructed. Sedimentation is developing down gradient of the new water supply well access road crossing due to uncontrolled sediment erosion (Photo B-02). Consideration should be given to address the erosion conditions that are developing along the new fresh water supply access road which crosses the NWID, as defined in Section 4.

Photograph B-02: Sedimentation downstream of well access crossing of North Valley Wall Interceptor Ditch

- The sedimentation and ponded channel conditions observed in the upper portion of the North Wall Interceptor Ditch should continue to be monitored. Consideration should be given to address the erosion conditions that are developing along the new fresh water supply access road which crosses the NWID, such as ditch lining and/or rip rap protection to limit further sedimentation degradation of the diversion channel. Furthermore, the observed ponded water conditions should be monitored as there is evidence of toe erosion occurring along the channel side slopes, which may require regrading of the drainage channel gradient in the upper channel portion.

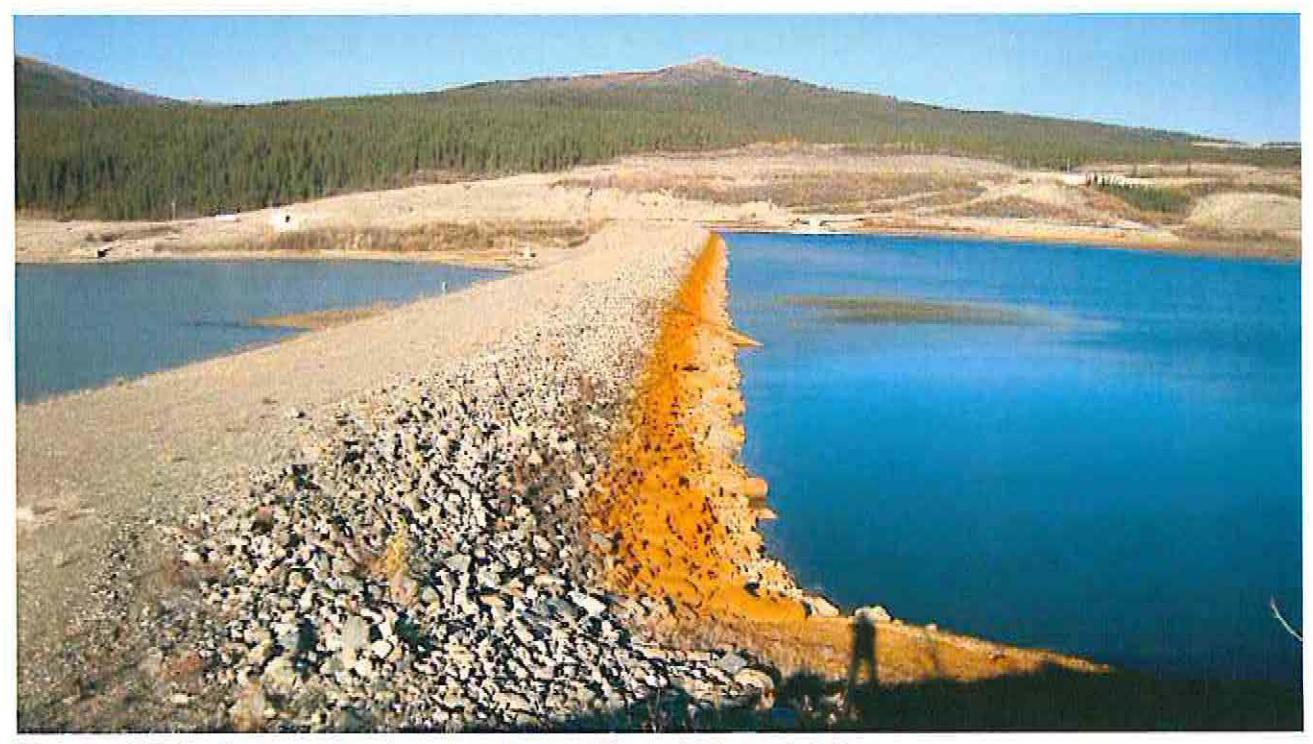
The Intermediate Dam (ID) is an internal tailings dam designed to retain tailings, supernatant water and run-off water within the tailings facility. At the time of inspection, the impoundment water level was operating below the rip rap protection provided on the upstream slope. There was at the time of the inspection no apparent evidence of upstream slope instability of the underlying sand and gravel shell material or rip rap degradation (Photo B-03).

Photograph B-03: Upstream drawdown operating conditions at Intermediate Dam

- The current operating impoundment water level conditions upstream of the Intermediate Dam and Cross Valley Dam should be monitored for potential soil erosion of the upstream shell material below rip rap surface and rip rap degradation if the new operating water levels are to be maintained.

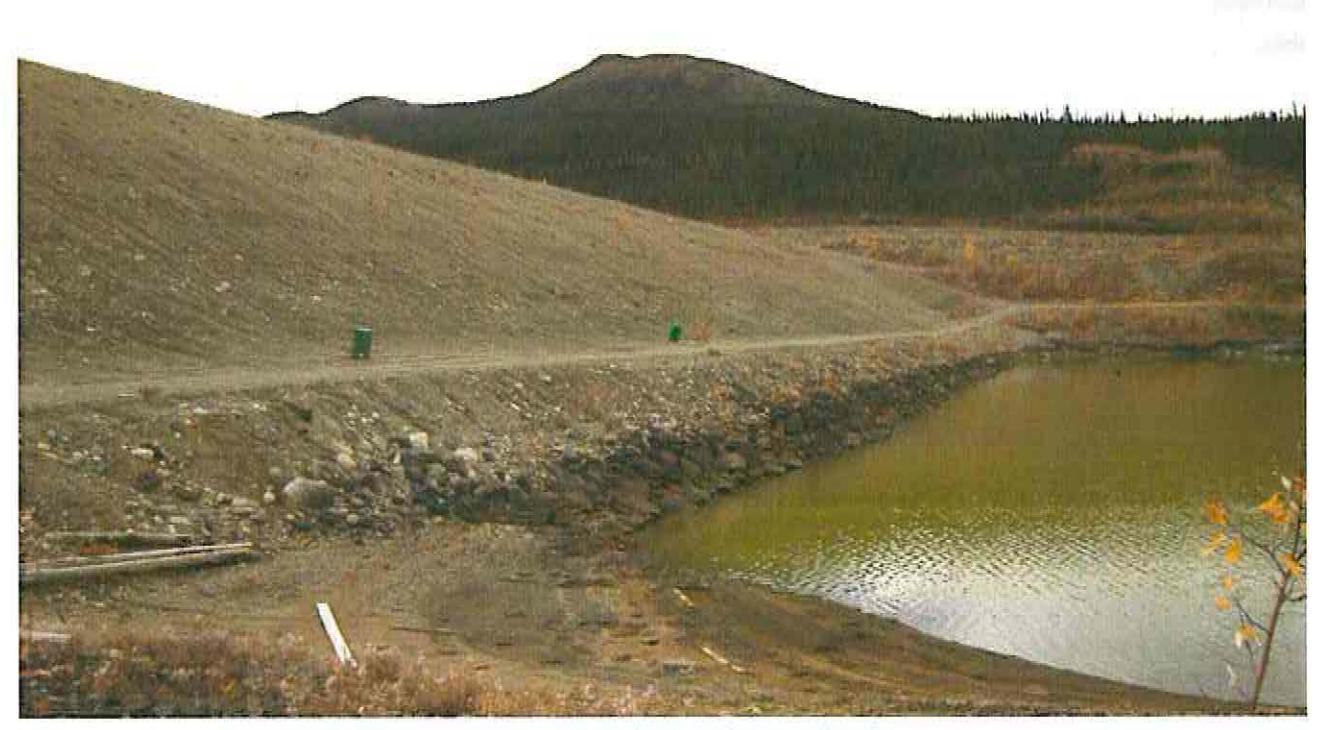
The downstream slope is experiencing extensive surficial soil erosion, with no apparent movements of underlying downstream shell material (Photo B-04). The surficial soil erosion conditions comprises a series of shallow soil rills across the entire dam width from the base of slope up to at least two-thirds of the dam's downstream slope height. In addition, there are shallow soil scarps developing on the lower dam slope across the southern portion of the dam length. The shallow soil scarps extend from the base of slope up to at least half of the dam slope height across the southern two-thirds of the dam length. The shallow soil rills and shallow scarps have eroded the downstream surface to a depth of less than 0.3 m and the deeper soil scarps range between about 0.3 m and 1 m deep.

The back scarp and eroded soil conditions appear to comprise silty sand and gravel. The eroded soil has been transported down slope and deposited at the toe of slope on the downstream bench. Evidence of the underlying drainage blanket was not observed.

Photograph B-04: Downstream drawdown operating conditions at Intermediate Dam

Further geotechnical evaluation of the downstream slope conditions should be considered to address the observed soil erosion slope conditions. Short and long term recommendations are summarized in Section 4.

- It is recommended that the soil erosion conditions observed on the downstream slope of the Intermediate Dam should be assessed by an experienced geotechnical engineer. The soil erosion conditions should continue to be monitored for potential further erosion, slope creep and/or possible slope instability. The work to regrade the observed unstable soil conditions on the downstream slope of the Intermediate Dam should be reviewed by the Engineer of Record and consideration should be given to addressing the observed instability conditions within the next few years. As part of the geotechnical review of the Intermediate Dam conditions, it is recommended that short term and long term dam remediation measures are identified. As input for further geotechnical evaluation of the Intermediate Dam downstream slope conditions, the following items should be considered:

- In the short term, consideration should be given to delineate the extent of the existing soil erosion conditions now and monitor the downstream slope for any potential change in slope conditions through next spring and summer.

- DES should continue to monitor the collection of unstable sediment deposition conditions overlying the existing drainage measures on the lower bench of the Intermediate Dam.

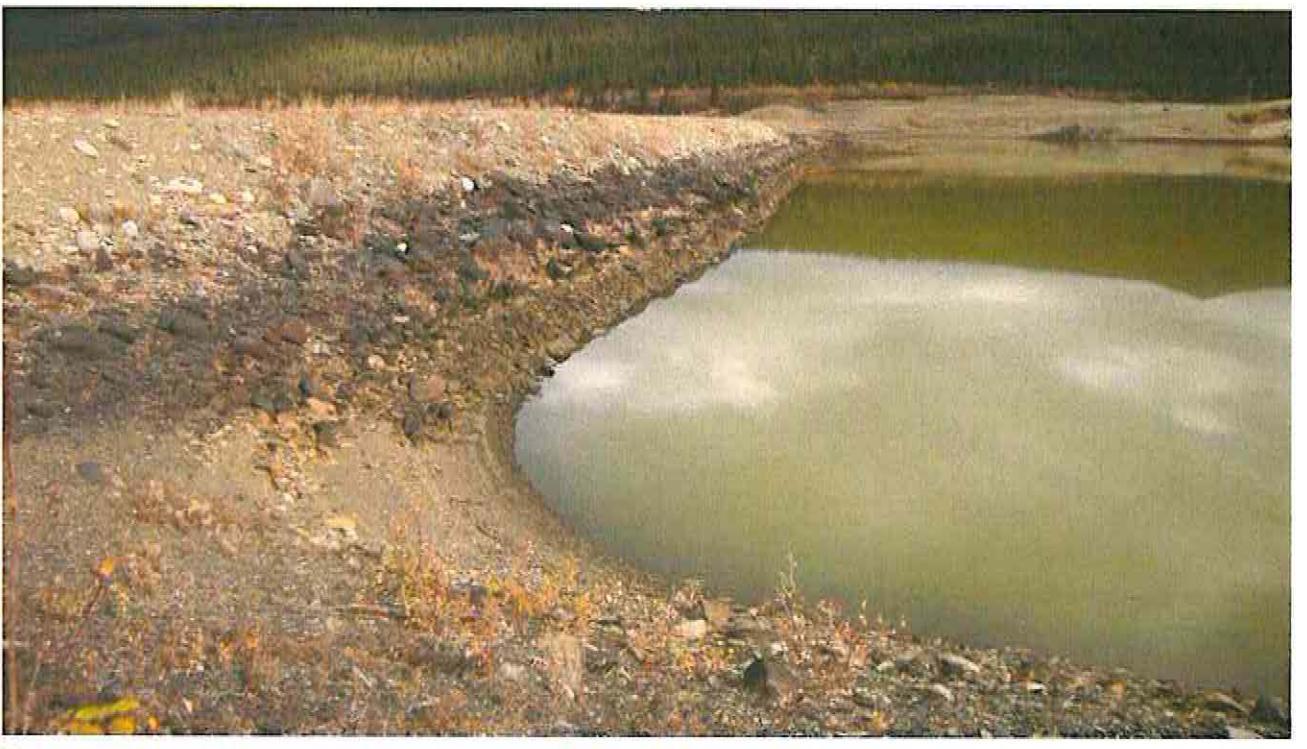
The Cross Valley Dam (CVD) is designed for a 60-day retention capacity polishing pond comprising seepage and discharge water from the tailings storage facility. Similar to the operating water level in the pond of the Intermediate Dam, the polishing pond water level was operating below the CVD rip rap surface at the time of the fall inspection. There was no apparent evidence at the time of the inspection of upstream slope instability of the underlying sand and gravel shell material or rip rap degradation (Photo B-05).

Photograph B-05: Upstream drawdown operating conditions at Cross Valley Dam

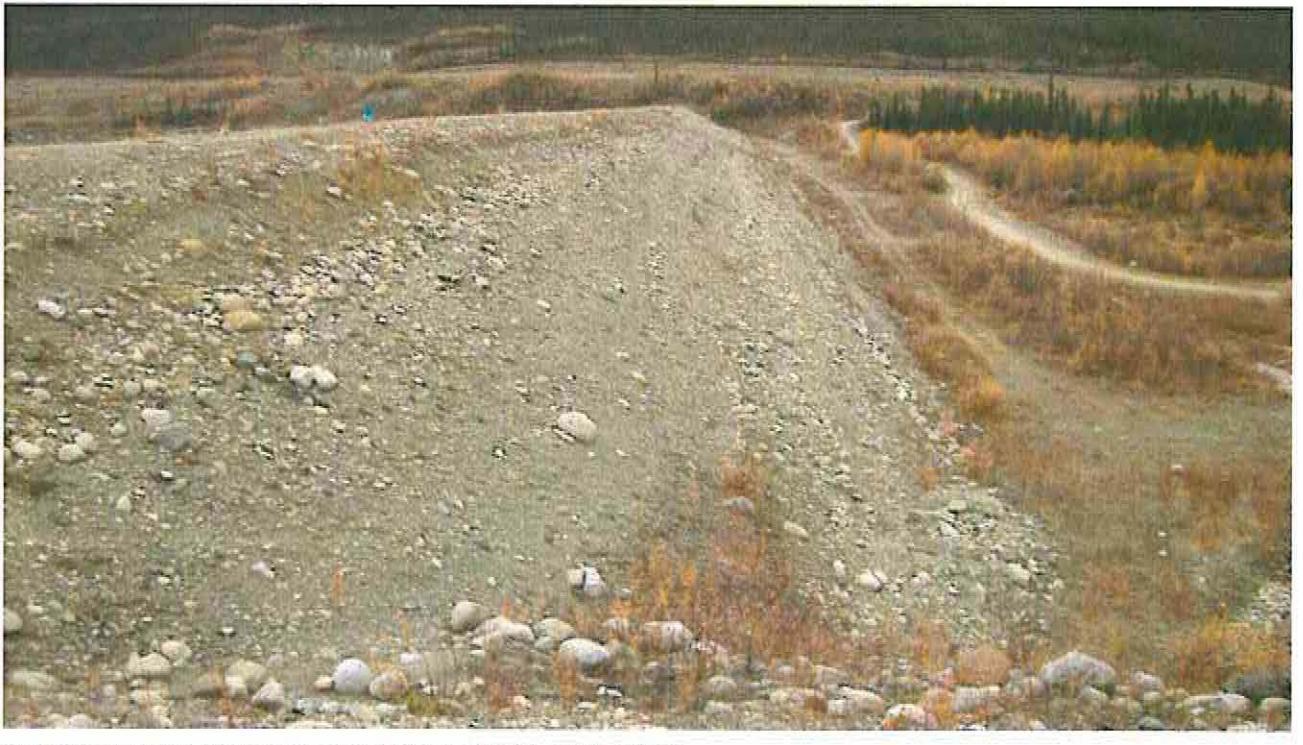
The dam crest is in satisfactory condition. However, three longitudinal tension cracks were observed along the southern portion of the dam crest, indicative of differential movement of the underlying soil conditions resulting from the zoned dam construction. The downstream slope appears stable and in satisfactory condition (Photo B-06).

Photograph B-06: Downstream conditions at Cross Valley Dam

- It is recommended that the longitudinal tension cracks observed on the crest of the Cross Valley Dam should continue to be monitored and re-grading of the granular surface is carried out during seasonably warm conditions to minimize surface water infiltration.

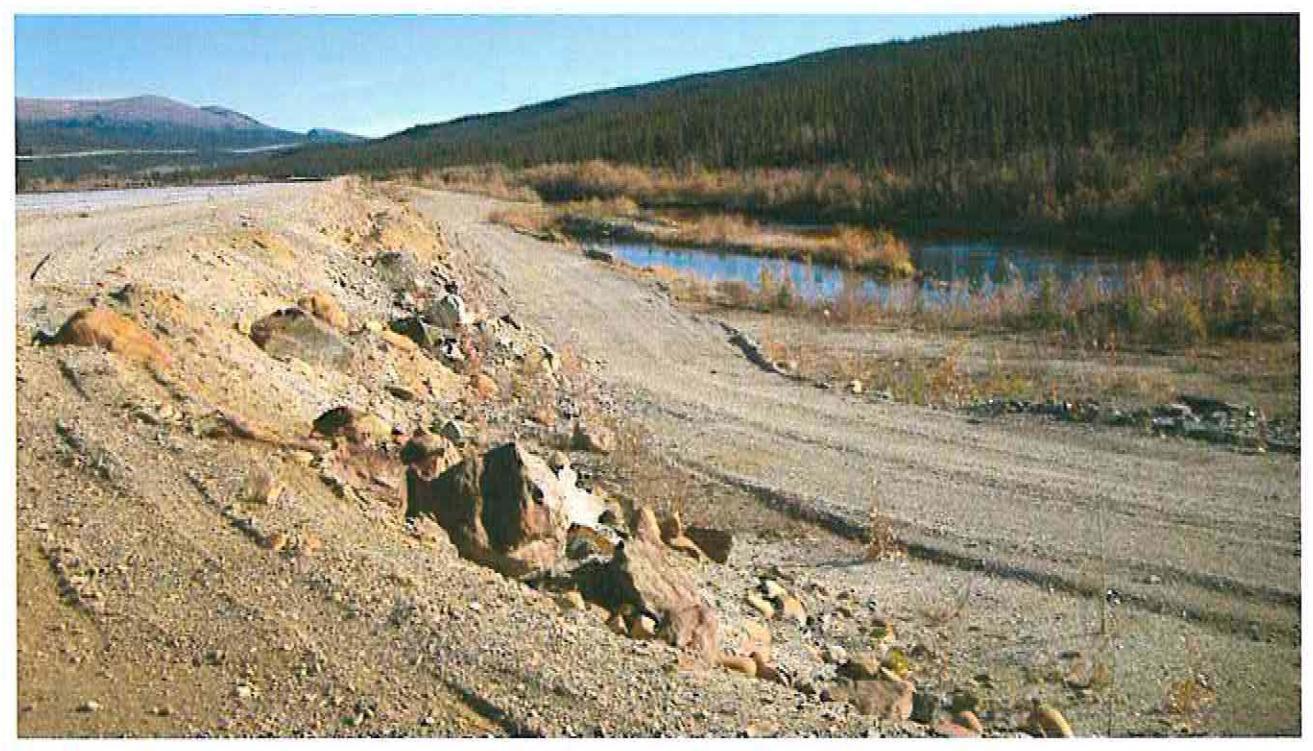
The Secondary Tailings Impoundment (STI) area was inspected. The dam crest, upstream and downstream slopes conditions appear stable at the time of inspection. The lower road conditions appear satisfactory. There was no evidence of seepage along the Secondary Dam downstream toe towards the RCDC (Photo B-07).

Photograph B-07: Downstream conditions at Secondary Tailings Impoundment at Diversion Dam

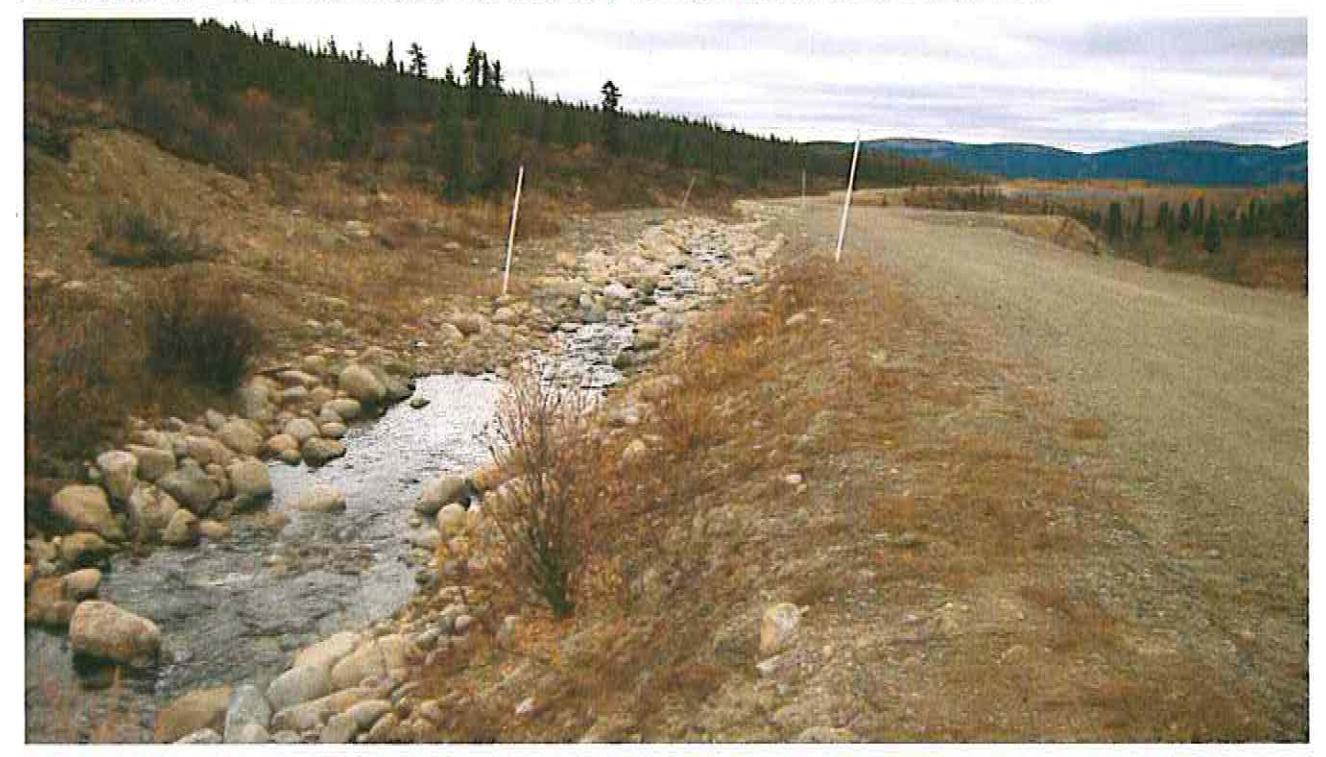
The Faro Creek Diversion Channel (FCDC) diverts creek channel flow from head waters north of the Faro Pit around the east side of the mine site. At the time of the site inspection, the seasonally, low flow conditions enable good access to view the diversion channel bottom and side slope conditions. In general, the side slopes are armoured with rip rap material comprising rounded cobble and boulder field stone. A portion of the rip rap channel near the head water diversion is underlain by a layer of synthetic liner and appears intact to limit seepage flow from the diversion channel, which is marked by white poles (Photo B-08).

Photograph B-08: Downstream view of lined channel conditions of Faro Creek Diversion Channel

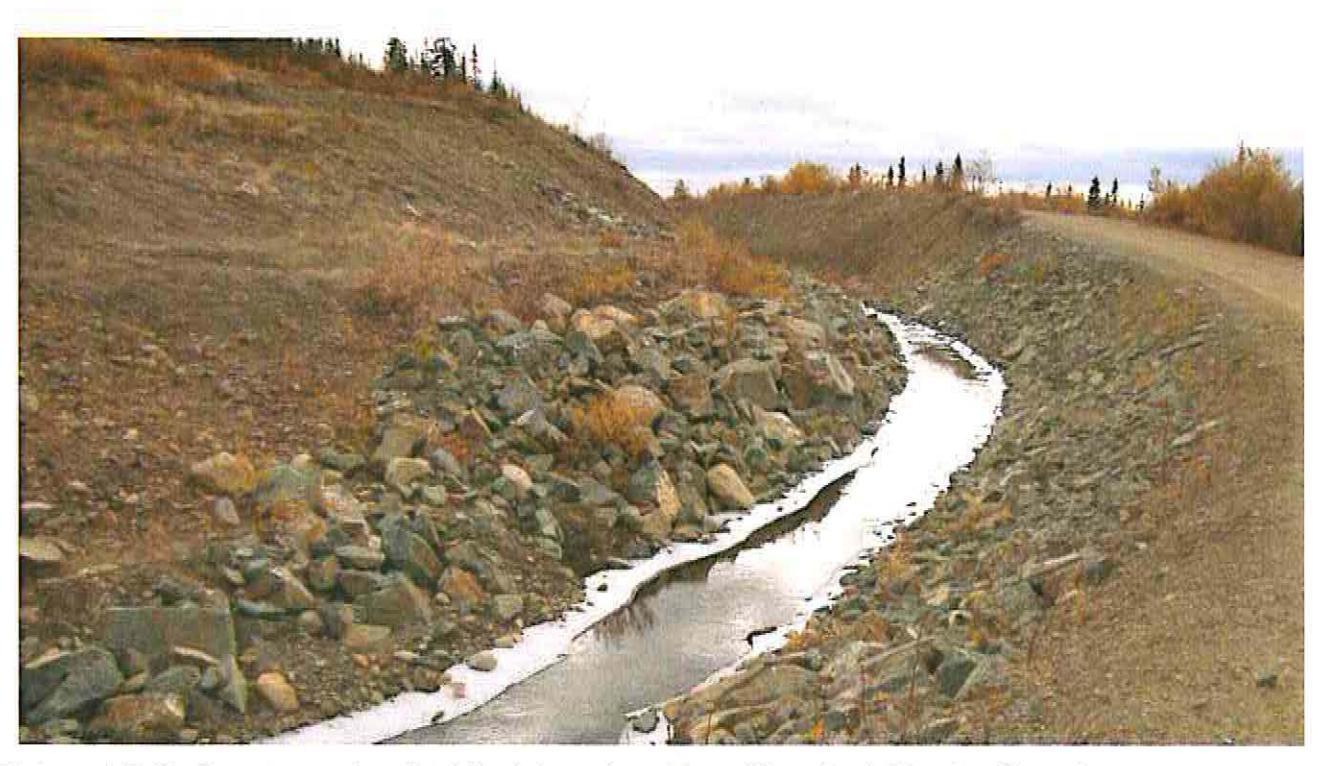
There is evidence along the length of the diversion channel that the soil back slope has experienced unstable conditions and repaired with blast rock to maintain stable channel side slope conditions (Photo B-09).

In general, the existing rock armour and lined channel conditions observed along the length of the FCDC are satisfactory.

Photograph B-09: Downstream view of stabilized channel conditions of Faro Creek Diversion Channel

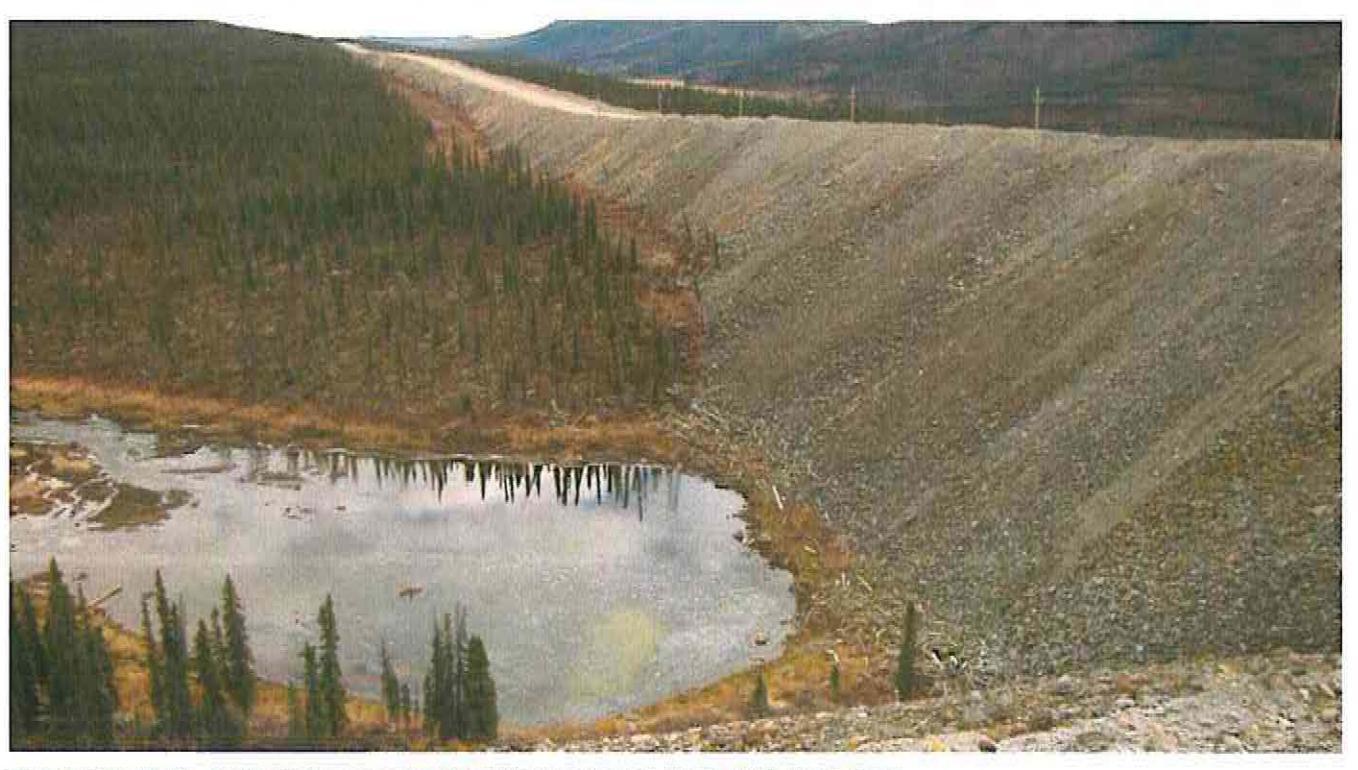
The North Fork Rock Drain (NFRD) was inspected and the head pond water level condition was found to be well below the wood debris on slope (Photo B-10). The embankment crest and side slope conditions appeared stable at time of inspection. The downstream drainage conditions comprised three drainage channels which braided into one channel downstream at the water monitor and sample location. The head pond conditions and rock drain performance appeared satisfactory at time of inspection.

Photograph B-10: Upstream view of head pond conditions at North Fork Rock Drain

- It is recommended that the upstream slope, head pond and downstream drainage conditions are monitored at the Faro Creek and K8 Creek Rock Drains locations for potential change in embankment slope erosion, blocked and/or changed drainage conditions are observed.
