# **2011 S-wells Performance Review FINAL**

## **Yukon Government**

SRK Consulting (Canada) Inc. 1CY001.050 August 2011

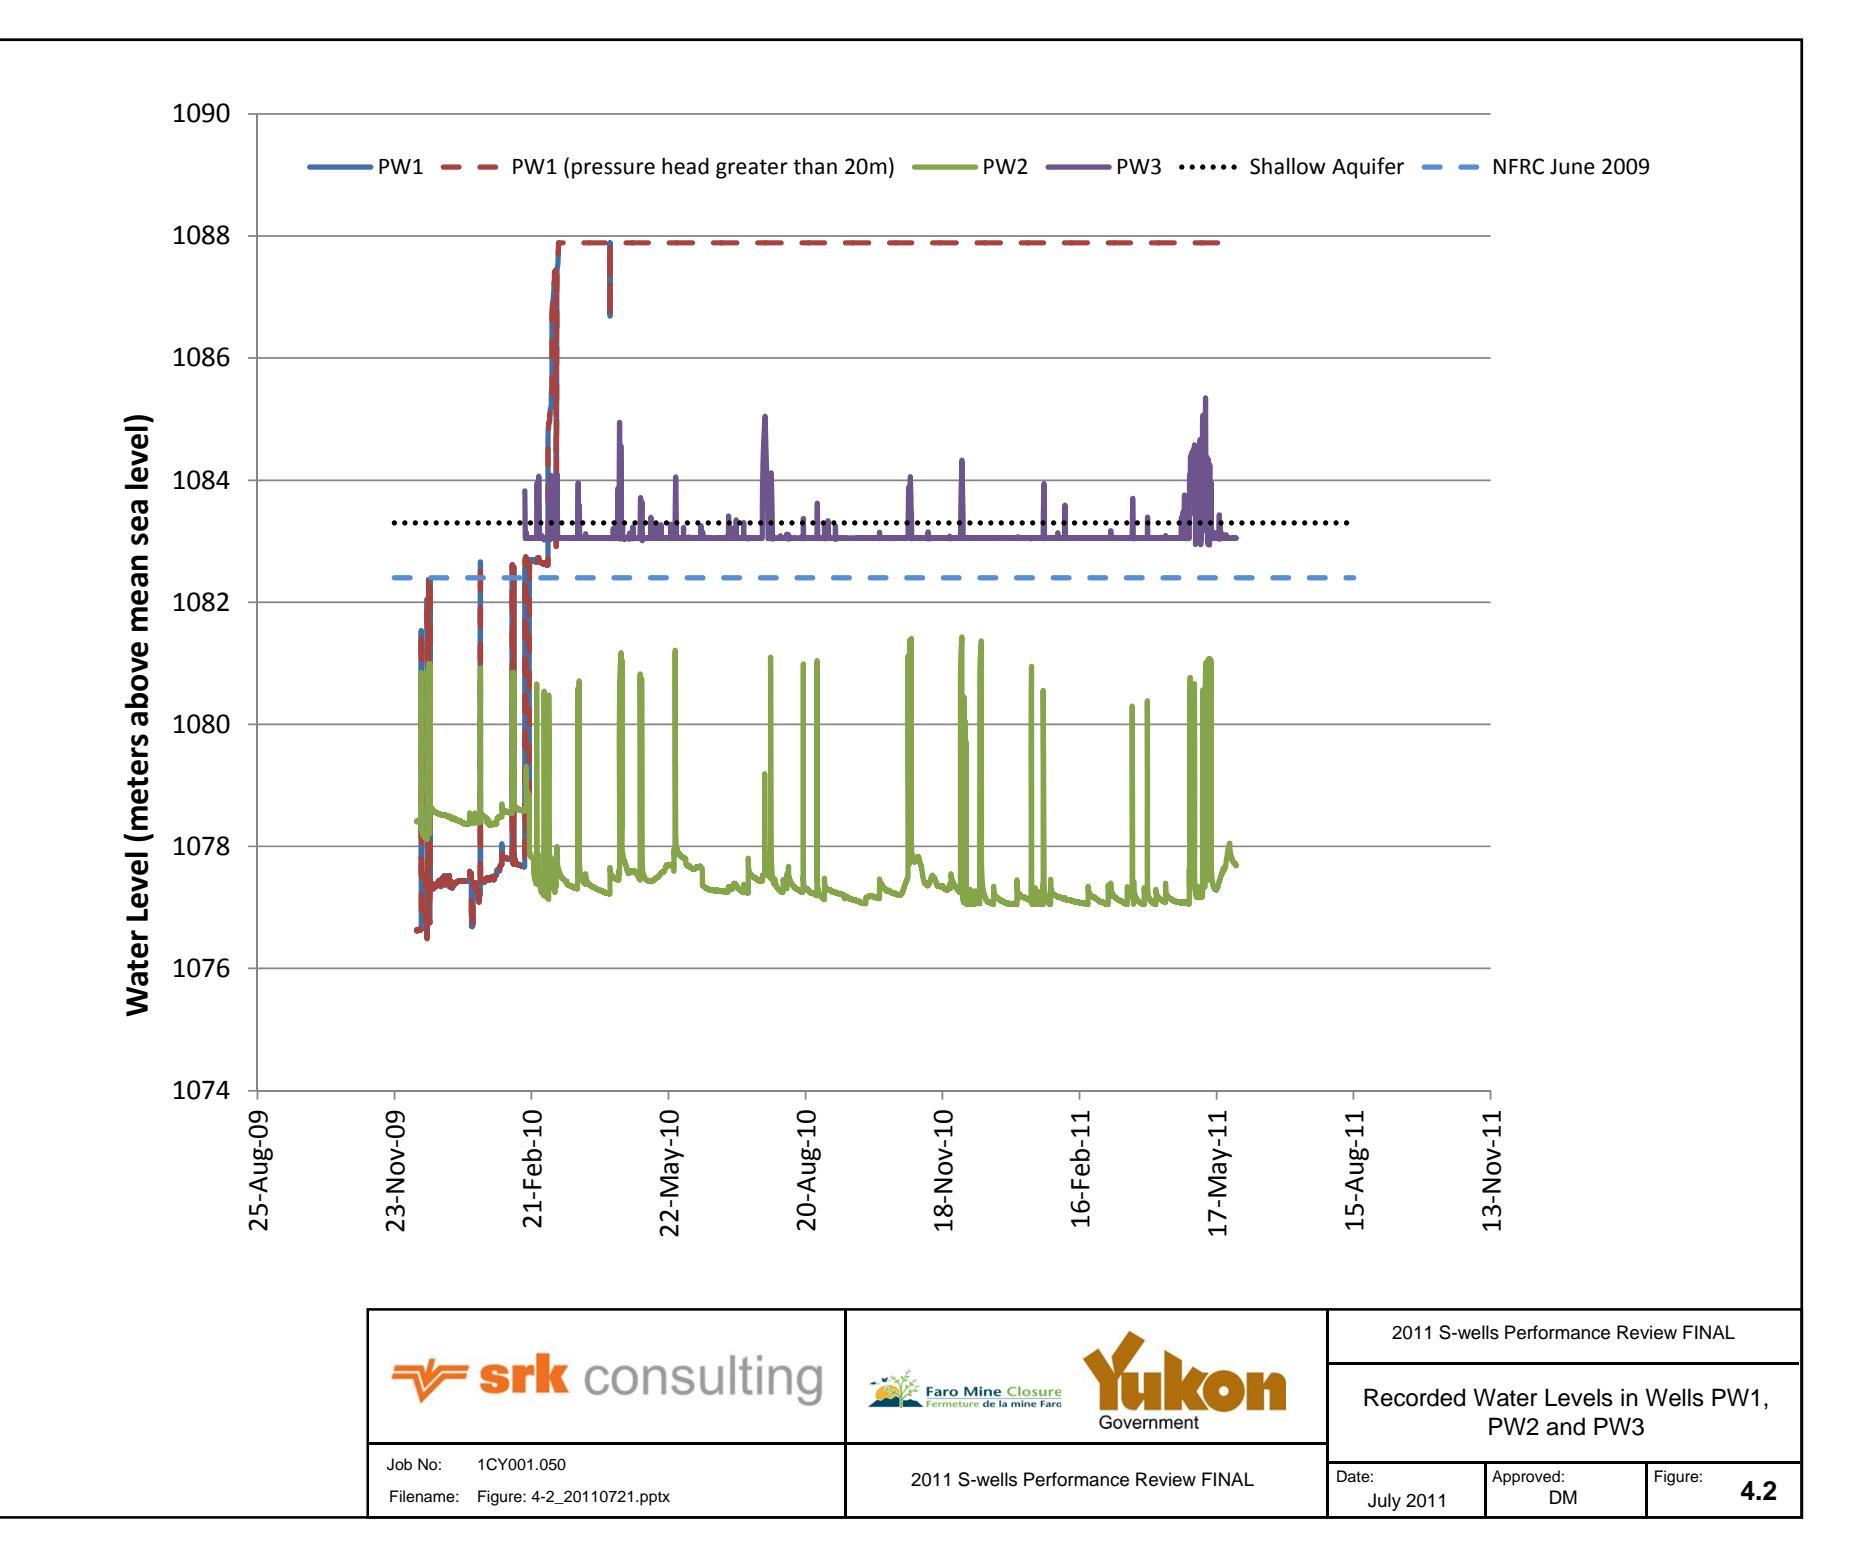
Figure 4-2 shows water levels for the three pumping wells. The water level within the PW3 sump has remained steady at approximately 1083 masl, consistent with the level observed following deepening of the sump and re-setting of the pump to a greater depth. The level remains slightly higher than the NFRC (1082.4 as measured in June 2009) but below the base of the Shallow Aquifer (1083.3 masl).

The composition of water in PW1 is evidently distinctly different from water collected in PW2 and PW3. This indicates poor connectivity between PW1 and PW2/PW3, which is corroborated by the lack of draw-down of PW1 by the dewatering of PW2 (Figure 4-2).

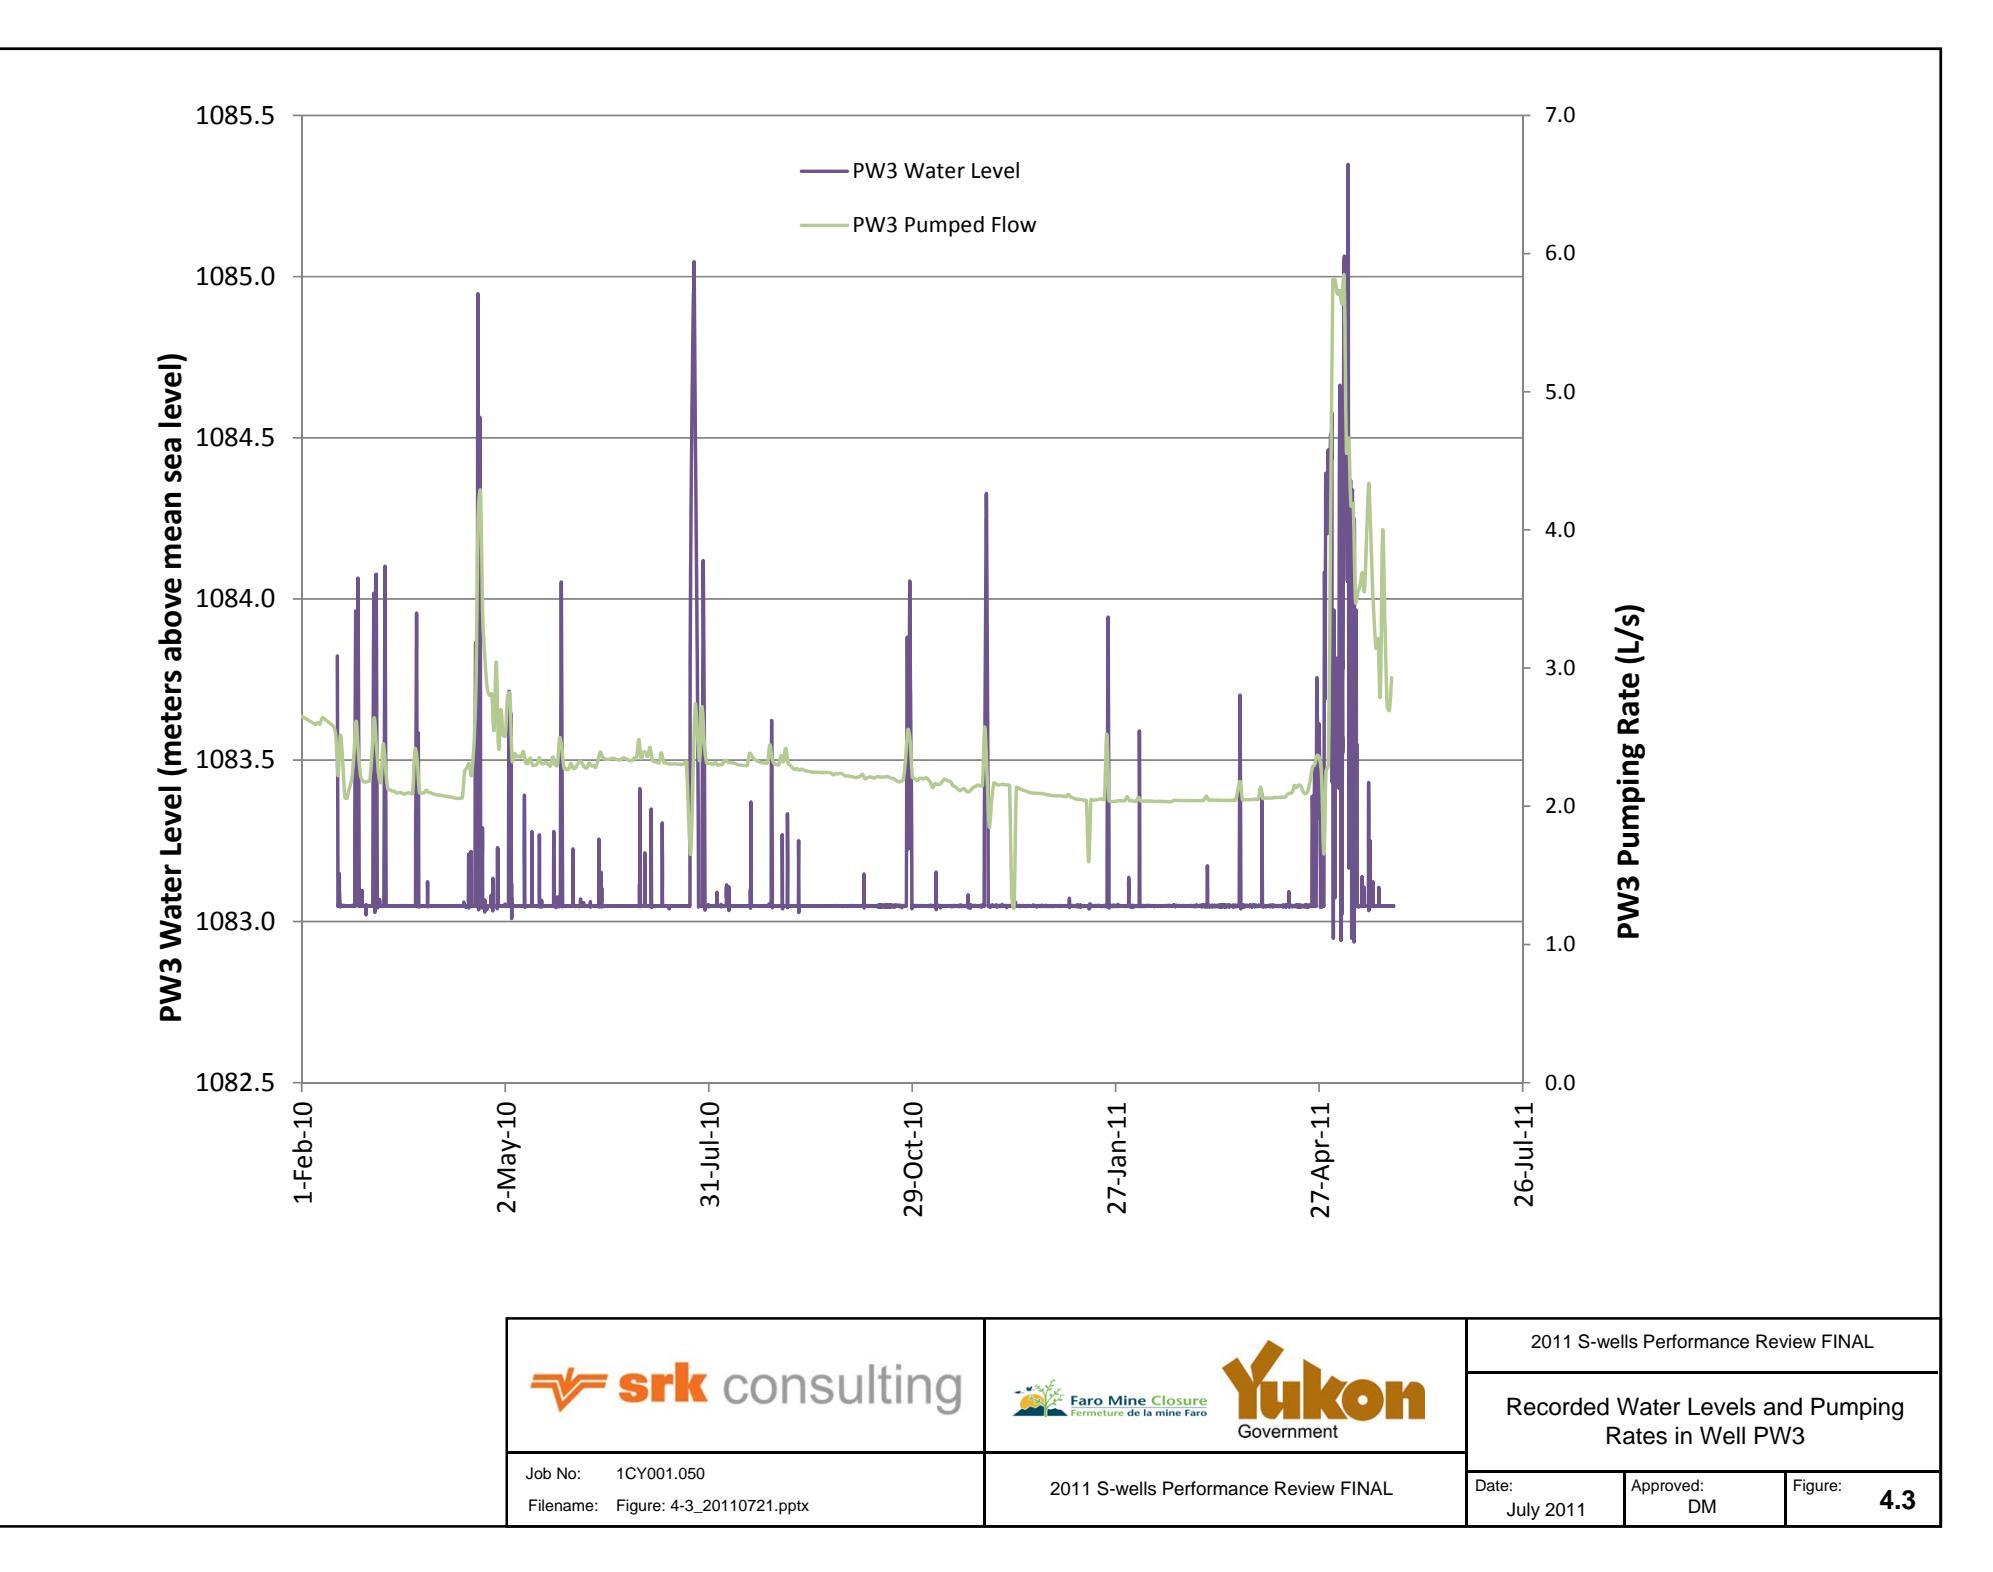
Higher sump water levels were observed over short periods. Figure 4-3 shows that the majority of the high water level events in PW3 are associated with an increase in the pumping rate and hence an increase in inflow to PW3 as a result of precipitation or snowmelt events. During the high water level events the pump in PW3 ramps up in response to the increasing water level. The maximum flow rate delivered by the PW3 pump was between 2.5 and 2.7 L/s during the winter, summer and fall seasons when the 2 inch pipeline was in use. During spring freshet, the un-insulated 4 inch pipeline was used, which allowed flows of up to 5.7 L/s.

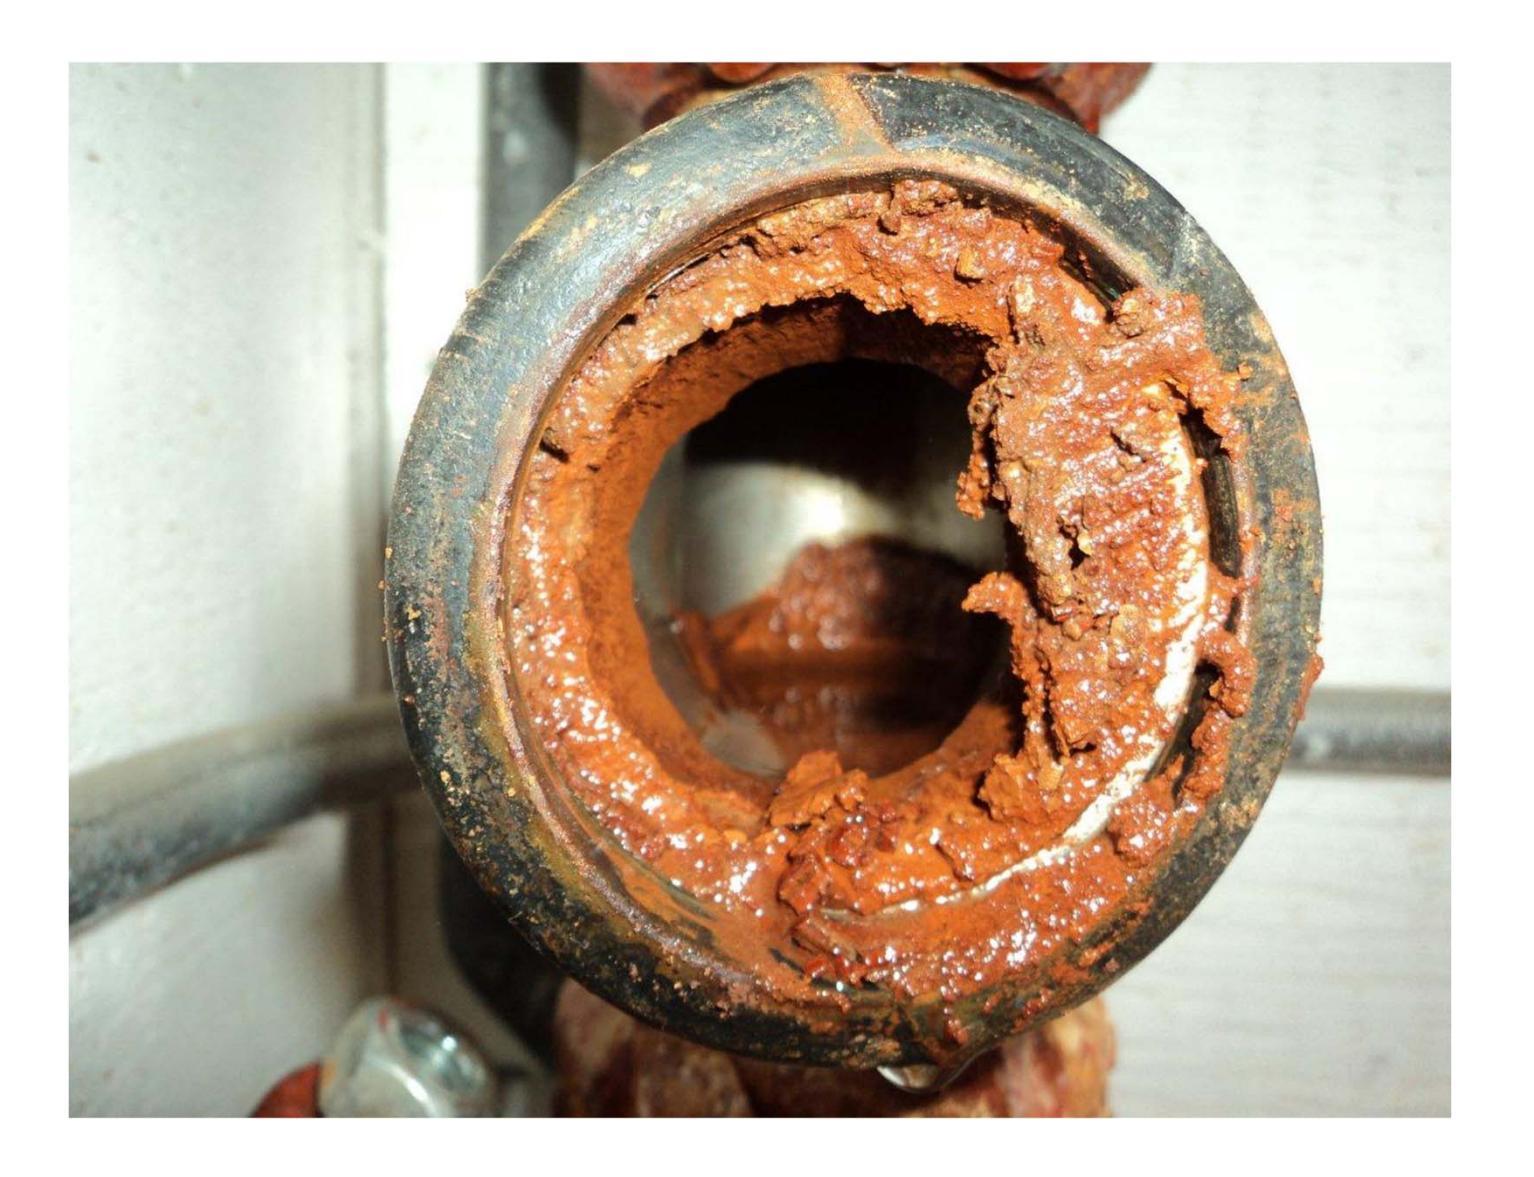
2011 S-wells Performance Review FINAL			
<b>Srk</b> consulting	Ferneture de la mine Faro Ferneture de la mine Faro Government	Example of I	Pipe Scaling, S System	IS Pumping	
Job No: 1CY001.050 Filename: Figure: 4-27_20110721.pptx	2011 S-wells Performance Review FINAL	Date: Approved: Figure: 4.27

In 2009, severe scaling was observed in the pipes from the S-well pumping system. The cause of the scaling was thought to be dissolved iron in the water extracted from PW1. On February 28, 2010 pumping from PW1 was stopped in an attempt to reduce the formation of iron scale in the SIS. The well remained inactive for the remainder of 2010. Pipe scaling is discussed further in Section 4.3.

speed; data collected during freshet when the 4 inch pipe was in use are not shown on the figure. An increase in discharge pressure and a decrease in flow rates – typical indicators of pipe scaling – were noted between December 2009 and February 2010. In July 2010 pressures and flows appear to have stabilized. It is not known if maintenance was carried out on the 2 inch pipeline in the preceding months. Between July 2010 and January 2011 the PW3 discharge pressure increased from approximately 200 to 208 psi, while flow rates decreased from 2.5 to 2.1 L/s. It should be noted that the VFD did not reach 100% capacity between late December 2010 and late April 2011, presumably because PW1 was inactive.

- Easily accessible pipe fittings should be disassembled and cleaned.
- If required, the 2 inch pipeline should be jetted or 'pigged'.
- If feasible, the 4 inch pipeline should be used whenever possible (during non-freezing conditions) to reduce exposure of the 2 inch line to ferric precipitation. THIS SHOULD BE STARTED IMMEDIATELY TO ALLOW ASSESSMENT OF THE 2-INCH LINE.

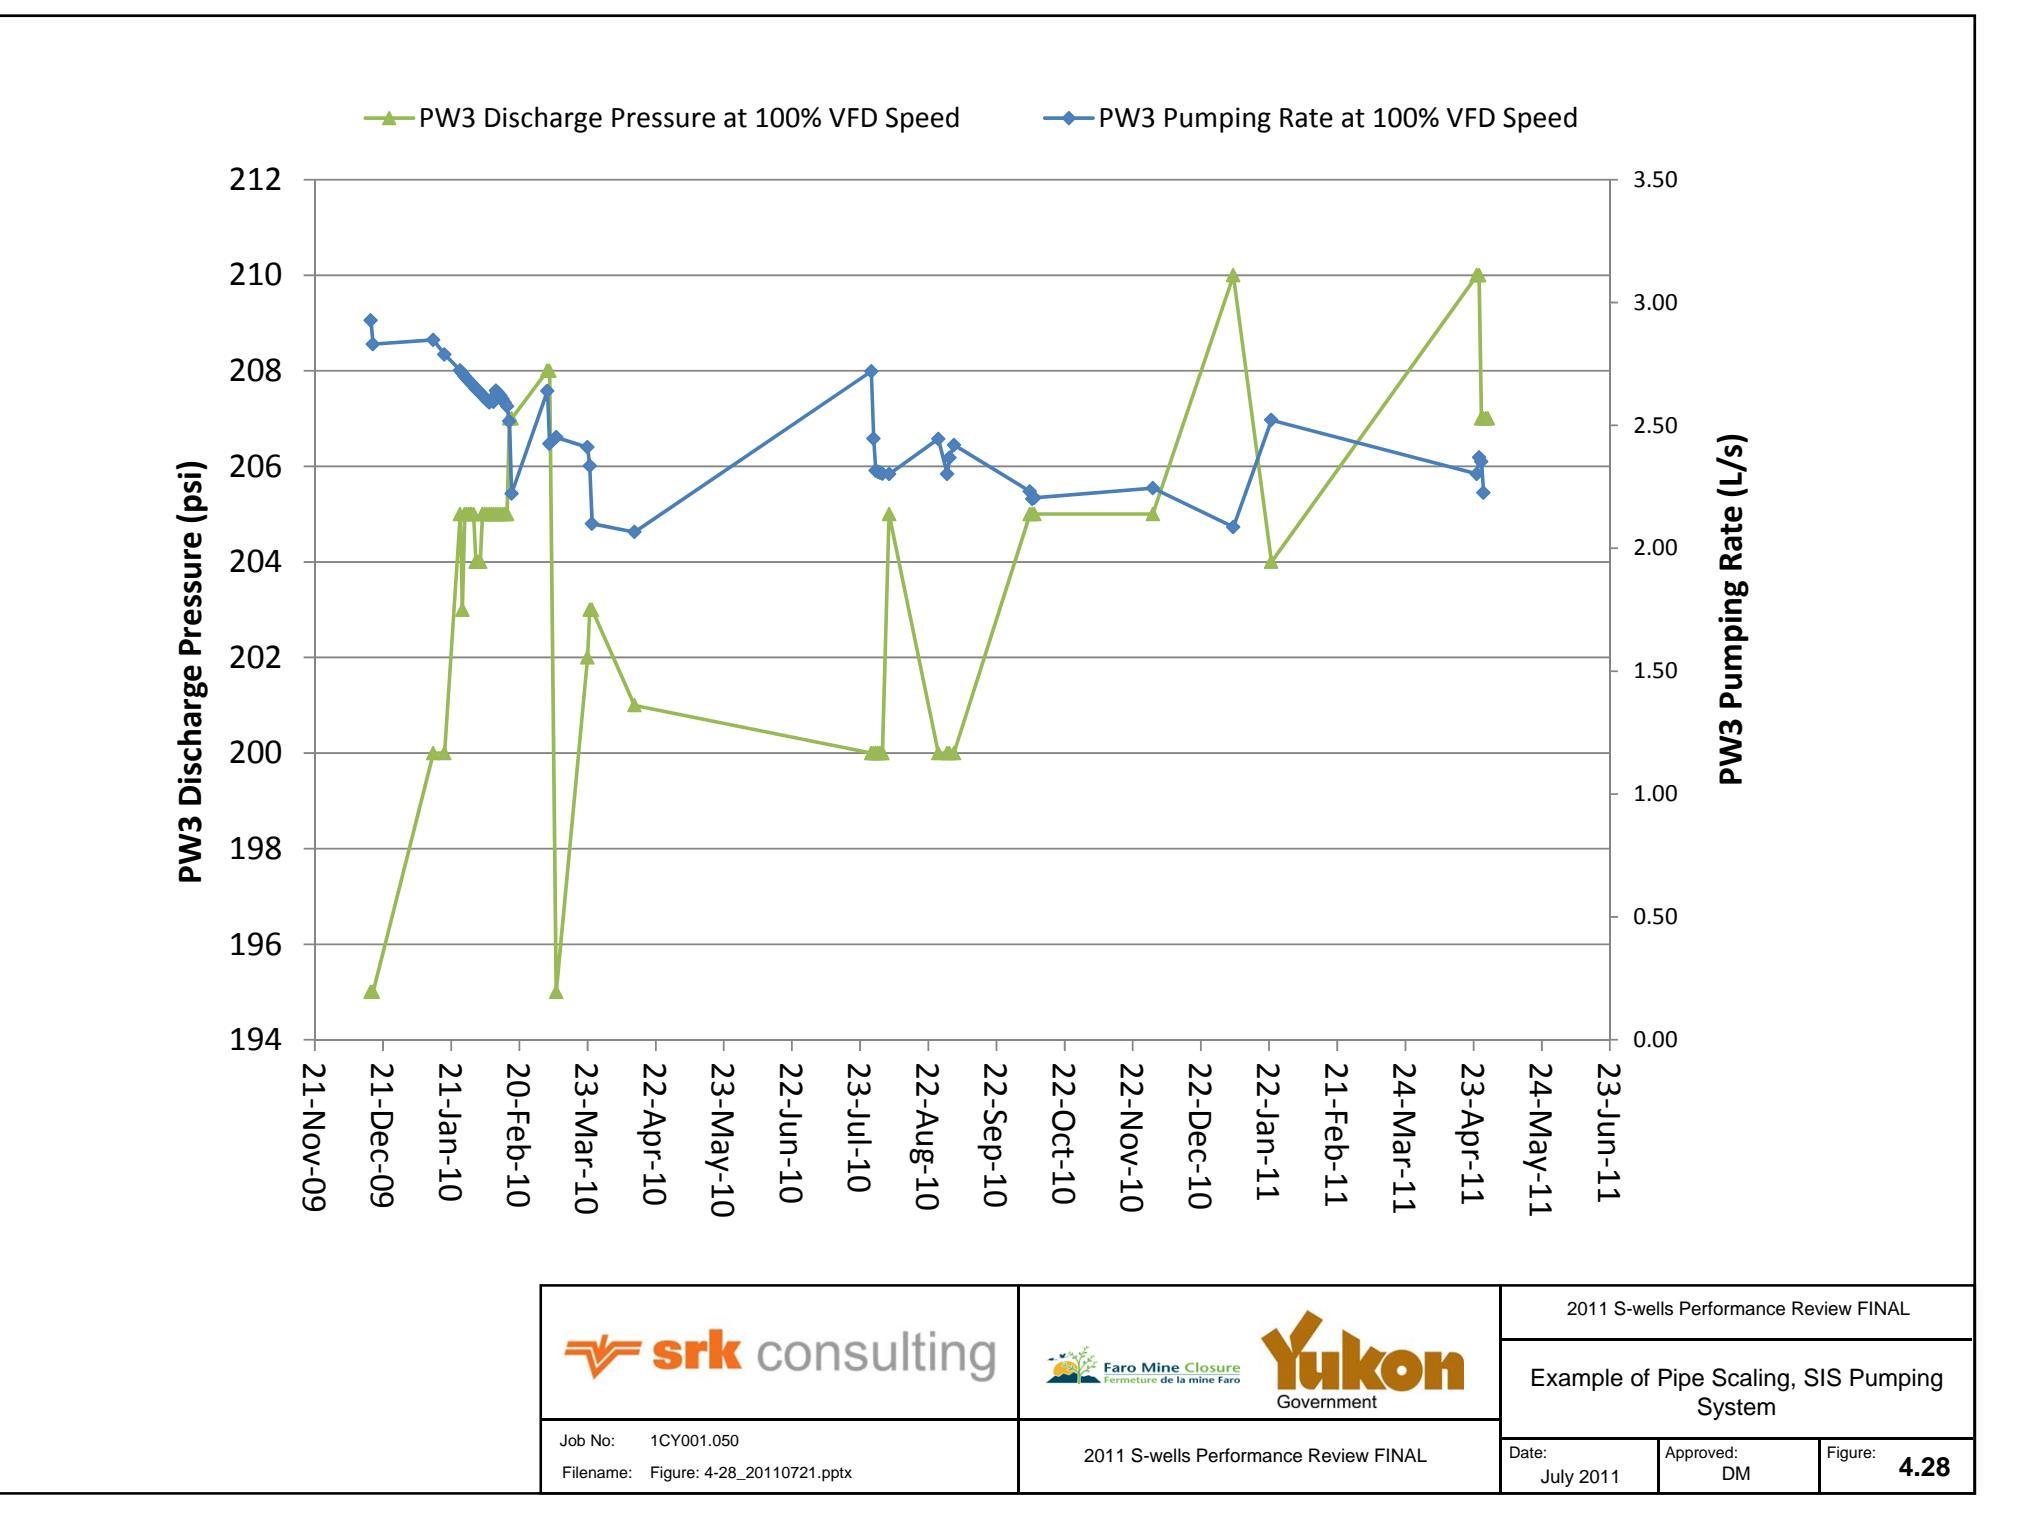
• PW3 discharge pressure and flow data (at 100% VFD speed) indicate that the 2 inch pipeline may gradually be accumulating ferric scale.

- Pipeline pressure appears to be slowly increasing maximum pump speed (VFD = 100%). Further scaling will result in further pipeline pressure increase and, consequently, reduced pumping rate. CAUTION: the pipeline pressure relief valve should be checked regularly to confirm that it functions properly. As the pipeline pressure increases, the proper operation of that valve becomes more important.
- If feasible, the 4 inch pipeline should be used whenever possible (during non-freezing conditions) to reduce exposure of the 2 inch line to ferric precipitation. THIS SHOULD BE STARTED IMMEDIATELY TO ALLOW ASSESSMENT OF THE 2-INCH LINE.
- Easily accessible pipe fittings should be disassembled and cleaned.
- If feasible, the 2 inch pipeline should be jetted or 'pigged'.
