Government of Yukon

# Former Clinton Creek Asbestos Mine 2010 Site Inspection

**Project Number:** 60160515 (402.3.1)

Date: March, 2011

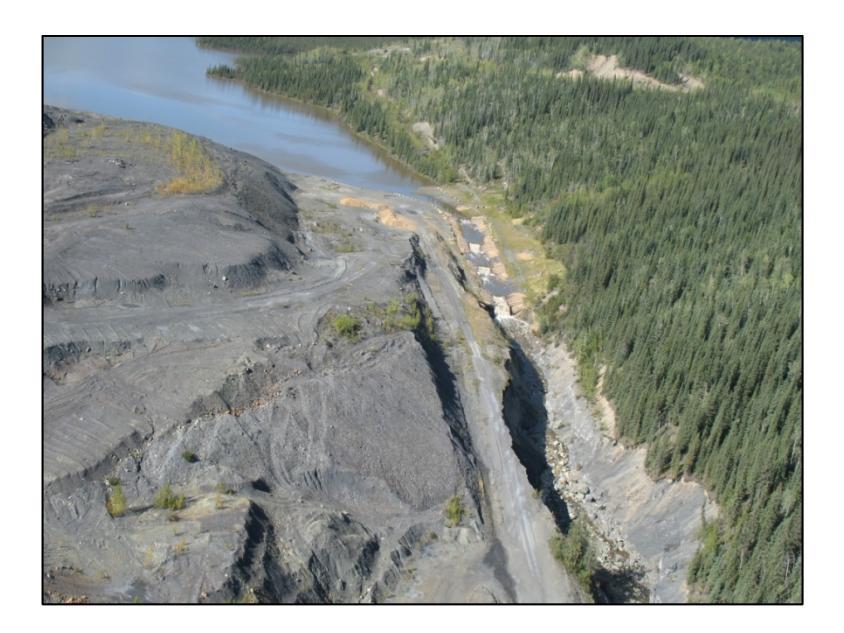
Figure 41 Clinton Creek Channel on August 23, 2010

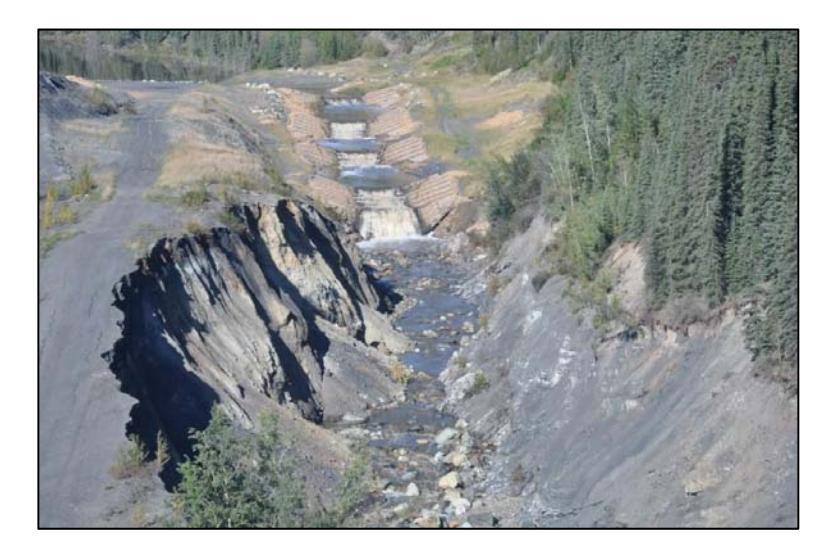
Figure 42 Clinton Creek Channel D/S of DS#4 on August 23, 2010

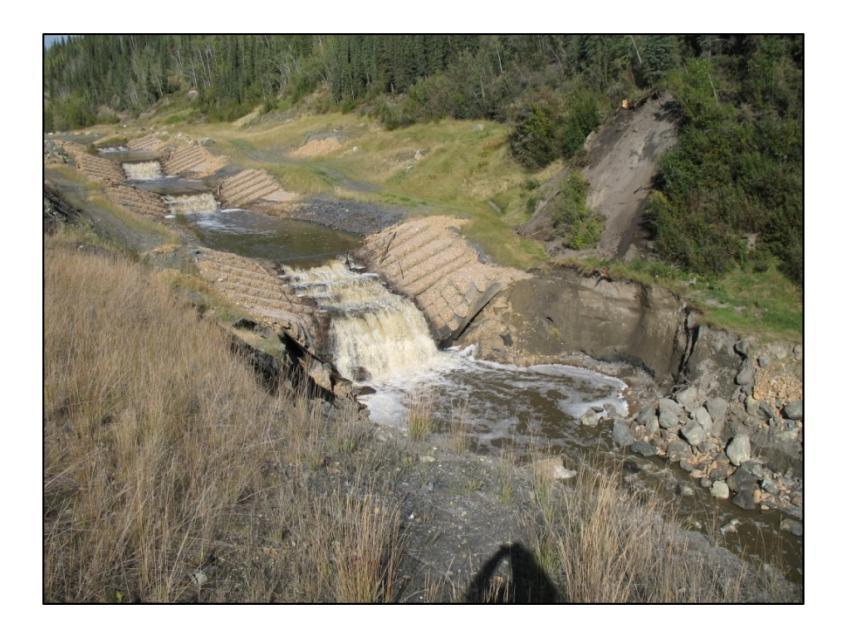
Figure 43 Clinton Creek Channel – DS#4 on August 23, 2010

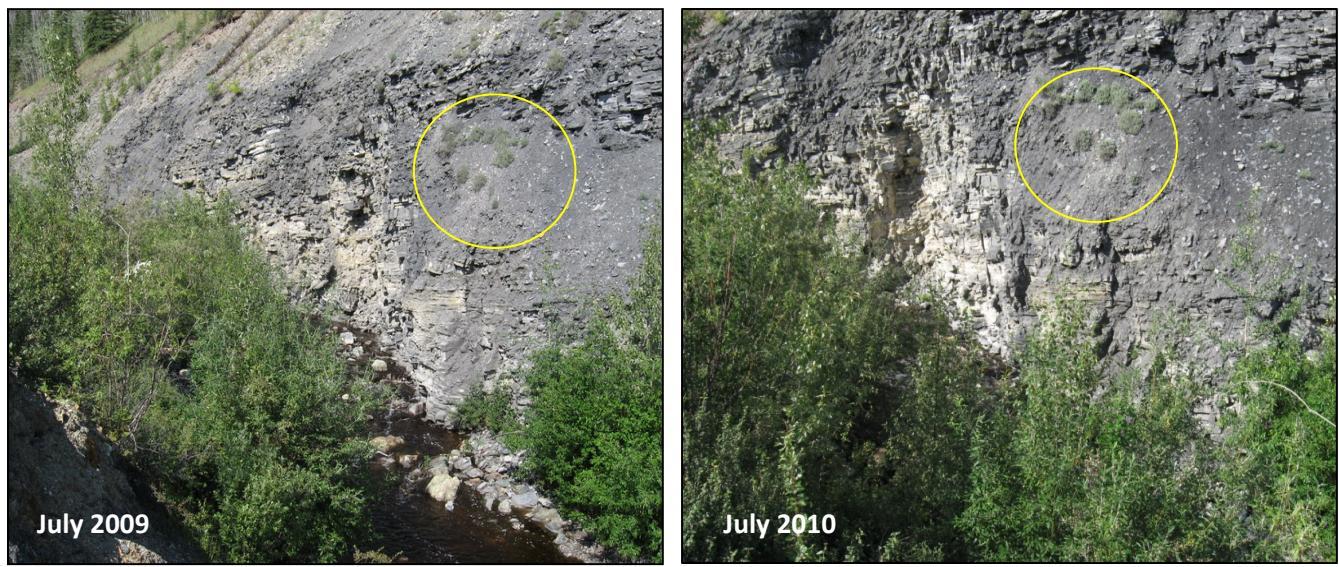
The bedrock channel bottom and outcrop visible on the LHS of the channel from approximately Station 0+600 (Drawing 01) compare well with what was observed in 2009 from Waypoints 339 and 340 (Figures 03 and 04, respectively).

Figure 03 Station 0+600 at WP 339 in 2009 and 2010, U/S view

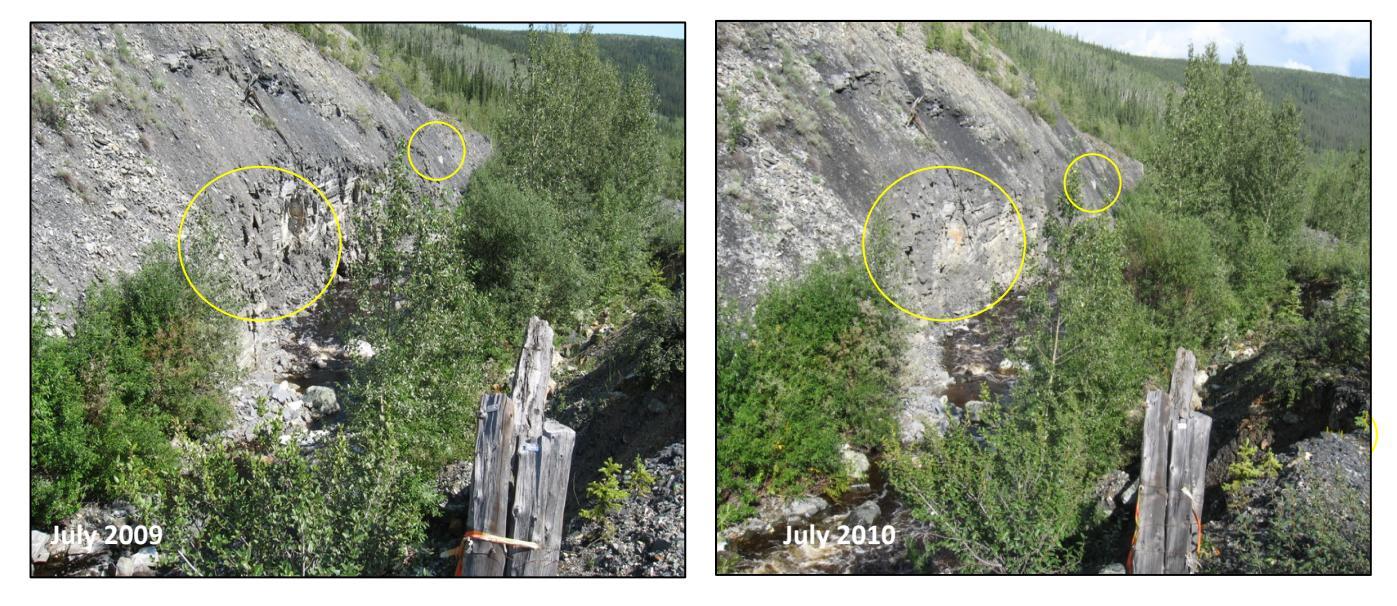
Figure 04 Station 0+600 at WP 340 in 2009 and 2010, D/S view

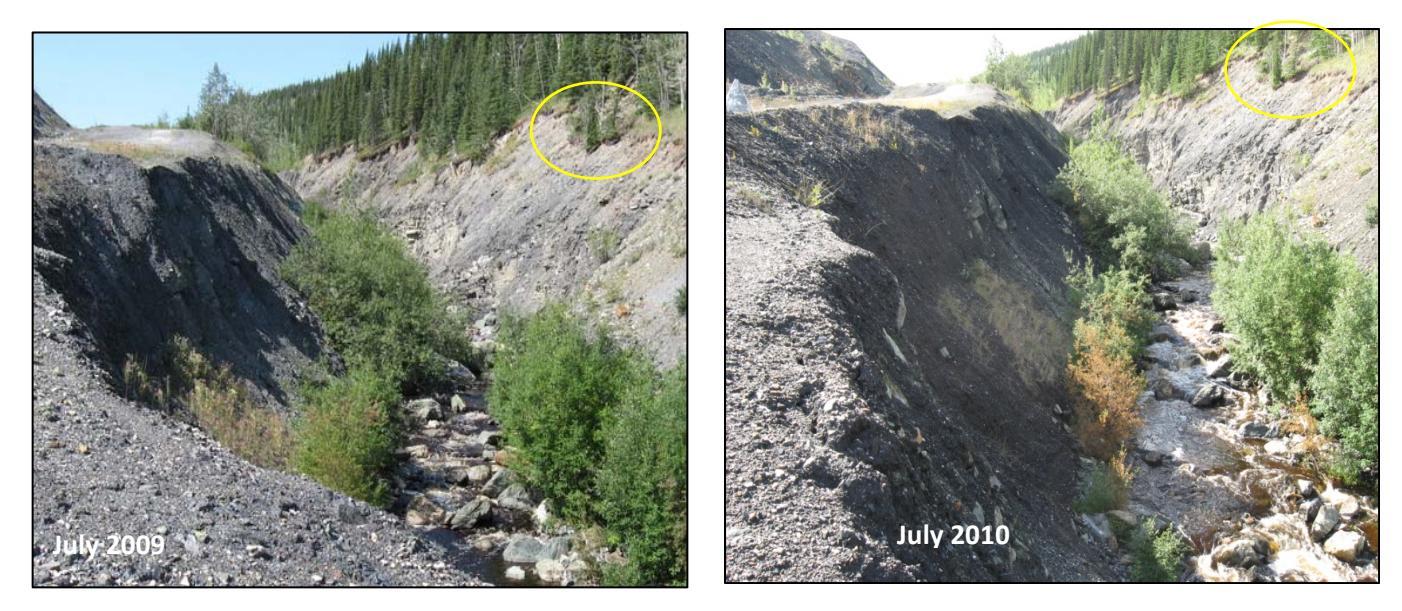
Farther upstream, at approximately Station 0+560, the physical features and vegetation along the LHS and RHS of the channel, as well as the channel bottom do not appear to have significantly changed from 2009 as seen on Figures 05, 06 and 07 taken from WP 341. A similar set of photos were taken at WP 342, located at approximately Station 0+470 in an upstream direction (Figure 08), cross-channel (Figure 09) and downstream (Figure 10); No significant changes in the condition of the channel over the one year period from July 2009 to July 2010 were noted.

Figure 05 Station 0+560 at WP 341 in 2009 and 2010, U/S view

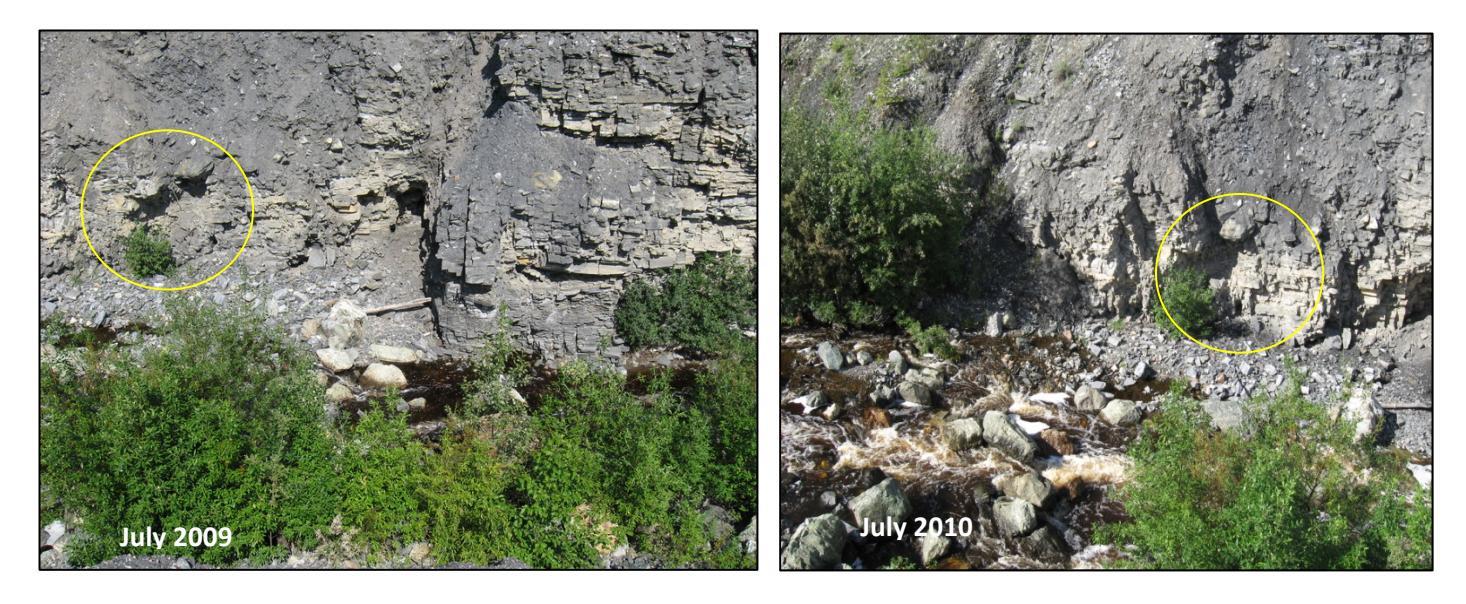
Figure 06 Station 0+560 at WP 341 in 2009 and 2010, cross-channel view (north)

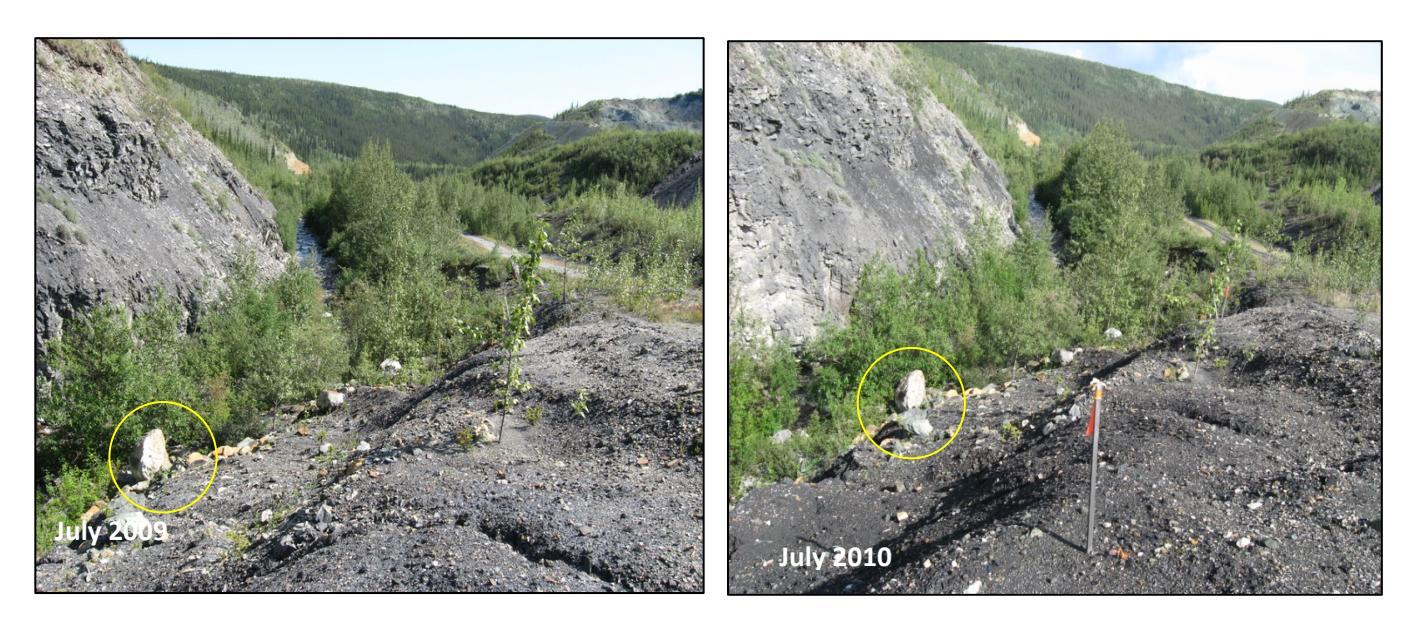
Figure 07 Station 0+560 at WP 341 in 2009 and 2010, view D/S

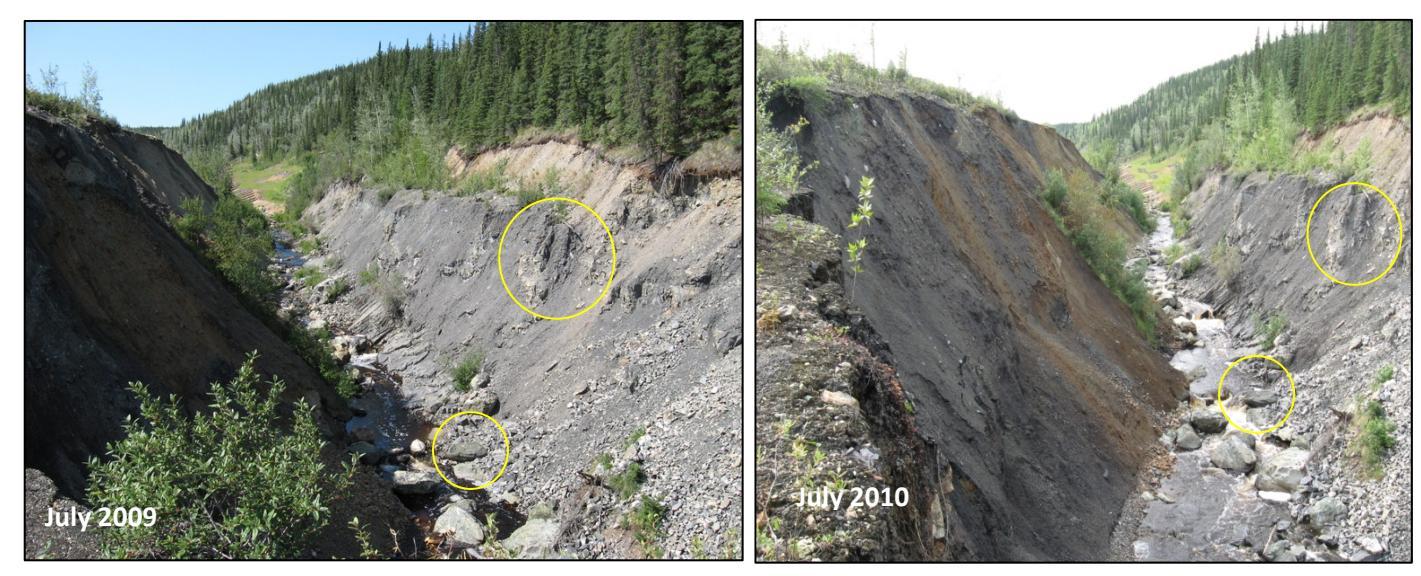
Figures 11 and 12 illustrate the channel condition at Station 0+370 m, 170 m downstream of the gabion drop structures. The photos in these two figures were taken from the same location (WP 344) but at a different magnification. This is the portion of the channel where down-cutting could impact on the stabilization works (drop structures) and is therefore considered a critical area to review during site inspections and when reviewing the creek profile for the performance monitoring program. Comparison of the 2009 and 2010 photos does not suggest any significant changes in the channel over this time period which is consistent with the 2010 creek channel profile survey (AECOM, 2011a). Several boulders and other channel features do not appear to have changed.

Figure 11 Station 0+360 at WP 344 in 2009 and 2010, U/S view

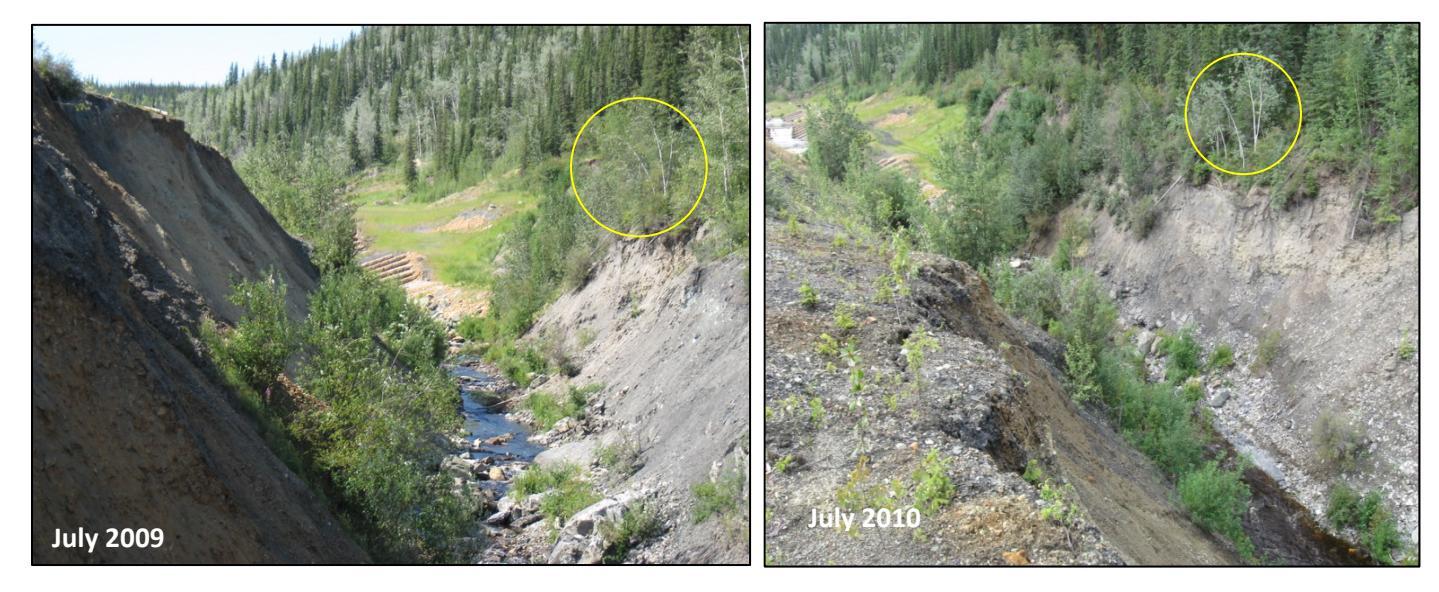
Figure 12 Clinton Creek Channel at WP 344 in 2009 and 2010, view U/S to drop structures

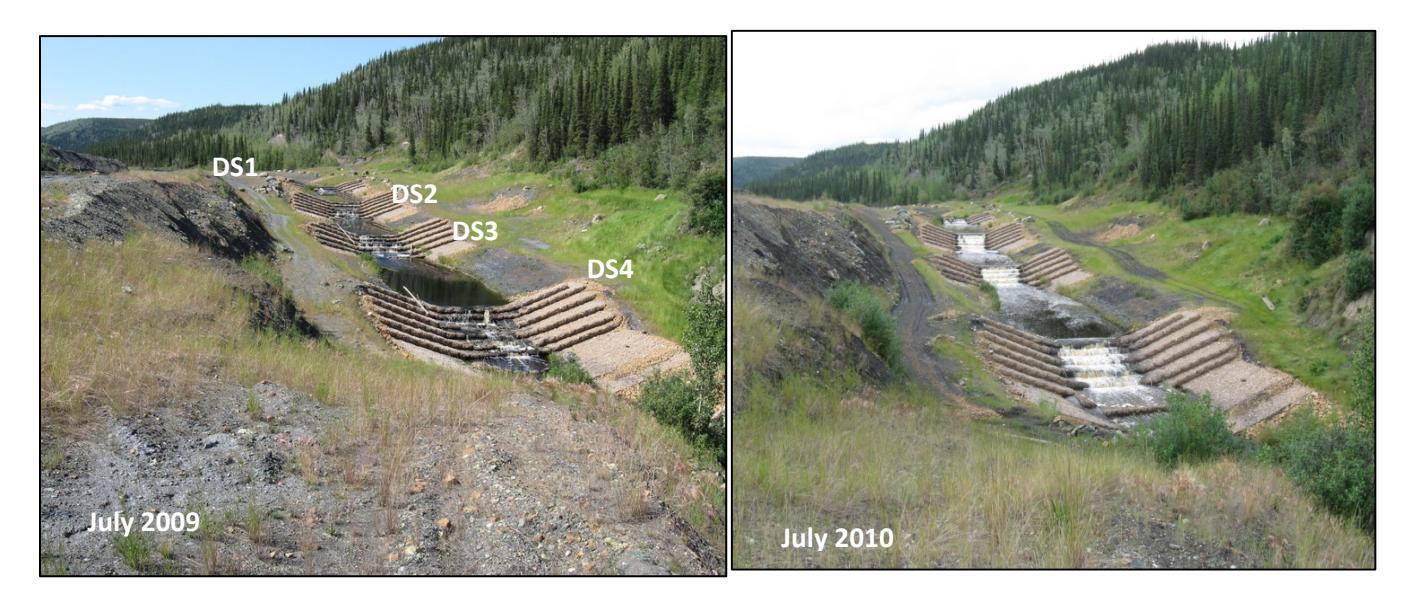
The gabion drop structures downstream of the Hudgeon lake outlet were photographed in 2009 and 2010 from WP 346 at approximately Station 0+230. From this vantage point, no significant change in the overall condition of the channel or structures located between the lake outlet (Station 0+000) and Station 0+184 was observed (Figure 14). In 2009, the structures were damaged during the 2009 spring freshet (AECOM 2010) and repaired in the fall of 2009 (AECOM 2011). While the damage was severe enough to warrant repair before the next spring freshet, it was concluded that overall, the structures were performing as intended because they continued to provide erosion protection immediately downstream of the lake outlet and mitigate the risk of a breach and rapid lowering of Hudgeon Lake.

Figure 14 Gabion Drop Structures from WP 346 in 2009 and 2010, U/S view

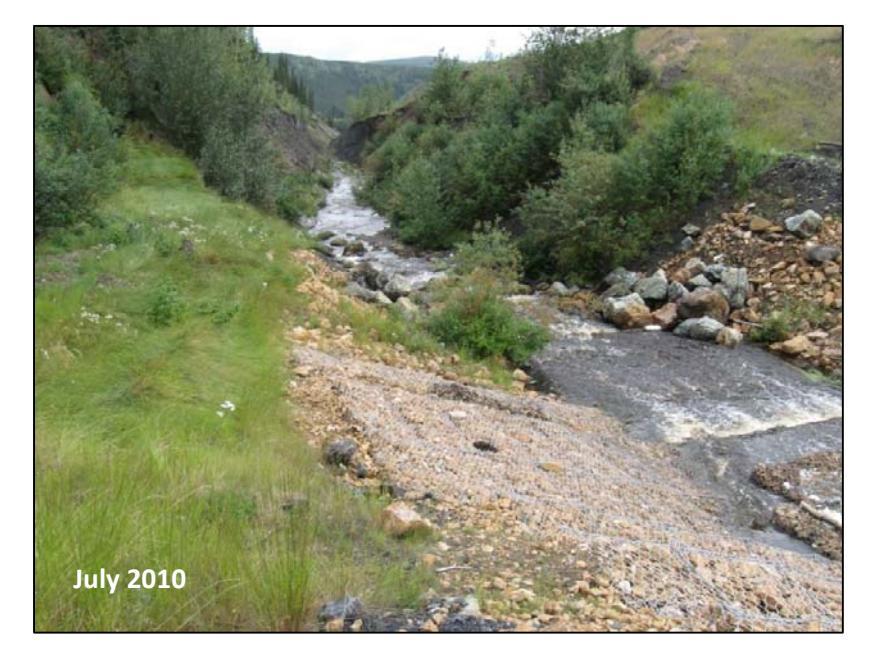
Drop Structure #4 consists of a drawdown weir with 6 tiers that provide a 2.5 m drop in channel grade and an end sill on the bottom tier. The transition from the drop structures to the natural channel is illustrated on Figure 15. Figure 16 compares the overall condition of the structure in 2009 and 2010. Of the overall damage from 2009, the most significant damage occurred to Drop Structure #4. Several of the wire baskets at the top of the structure including the drawdown weir and tiers 4, 5 and 6 were deformed and some of the baskets were torn open with the rock fill partially or completely missing (Figures 16 to 18). The lower tier of the structure was repaired by placing another layer of gabion baskets on the floor of the structure, as noted on Figure 16. The remainder of the damage was repaired by infilling the gabion baskets as required, re-fastening the lids and patching the wire mesh. The damaged end sill was not replaced.

Figure 15 Channel directly D/S of DS#4 in 2010

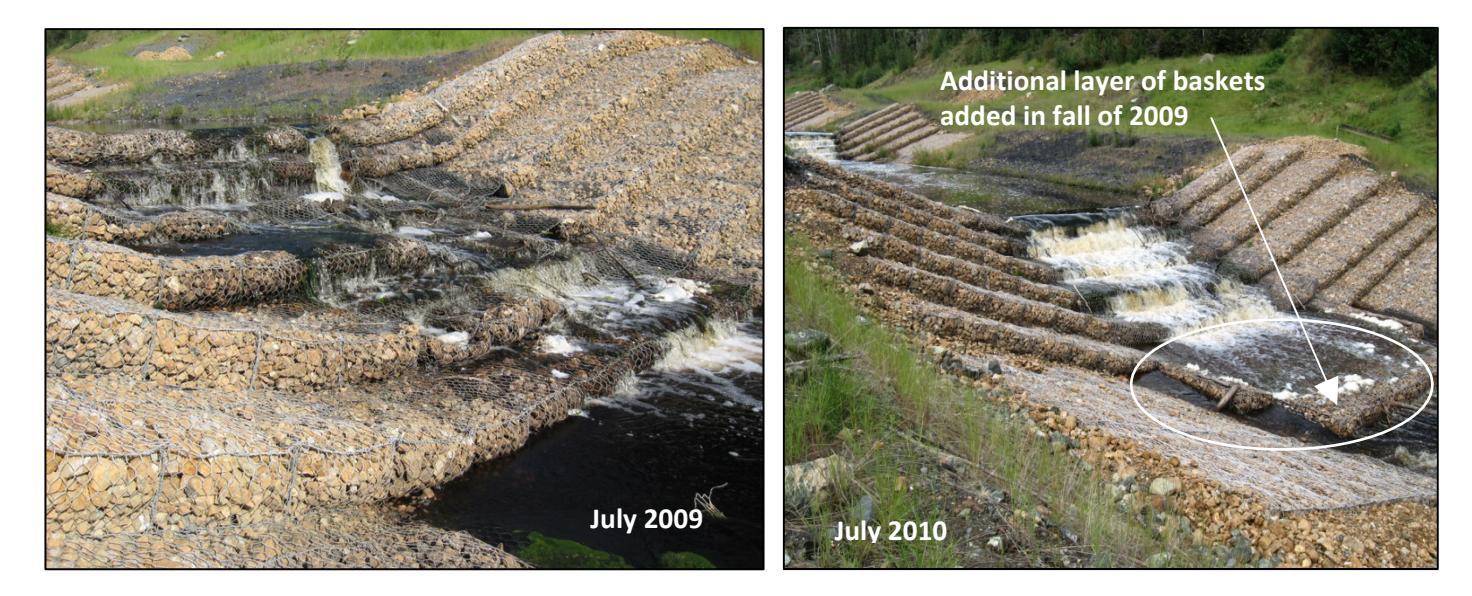
Figure 16 DS #4 in 2009 and 2010, U/S view

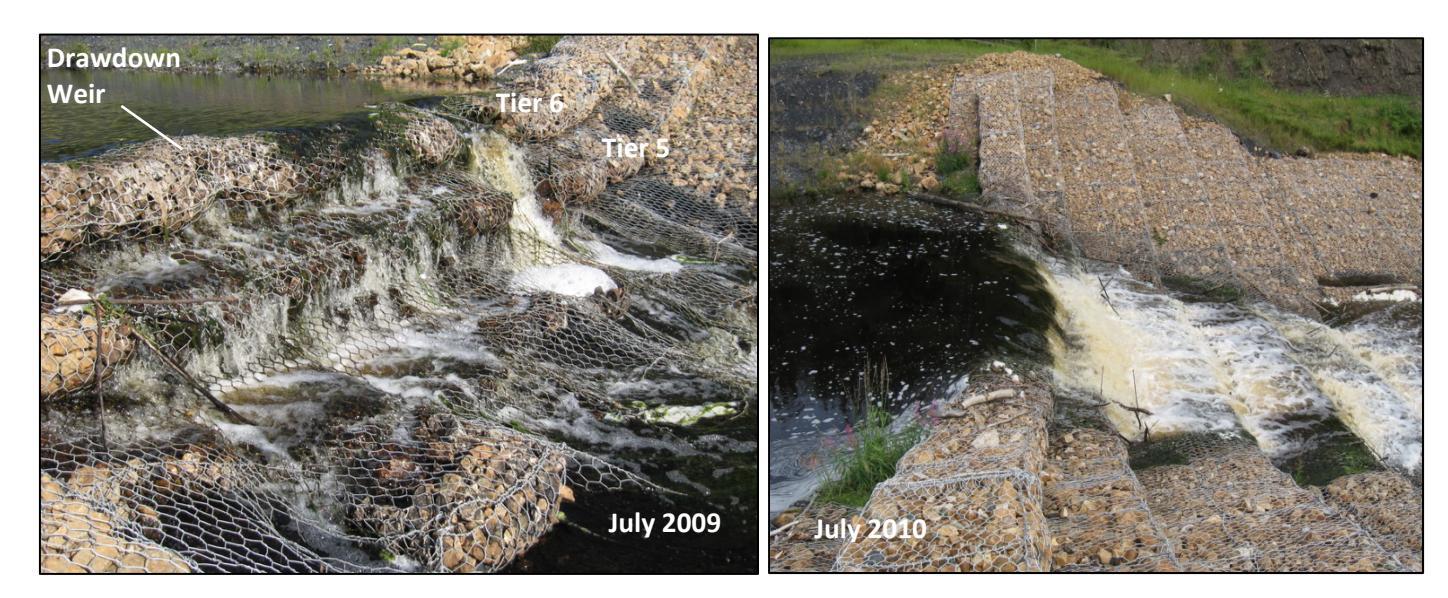
The repaired structure did not appear to have suffered any damage in the 2010 spring freshet. The upper most tier (Tier #6) and the overlying draw down weir are tilted in the upstream direction (Figure 17). The tilting may have occurred during the 2009 spring freshet. Other than the tilting observed, the structure and the creek channel directly downstream appeared to be in good condition.

Figure 17 DS #4 Tier 5 and Tier 6 in 2009 and 2010, view North

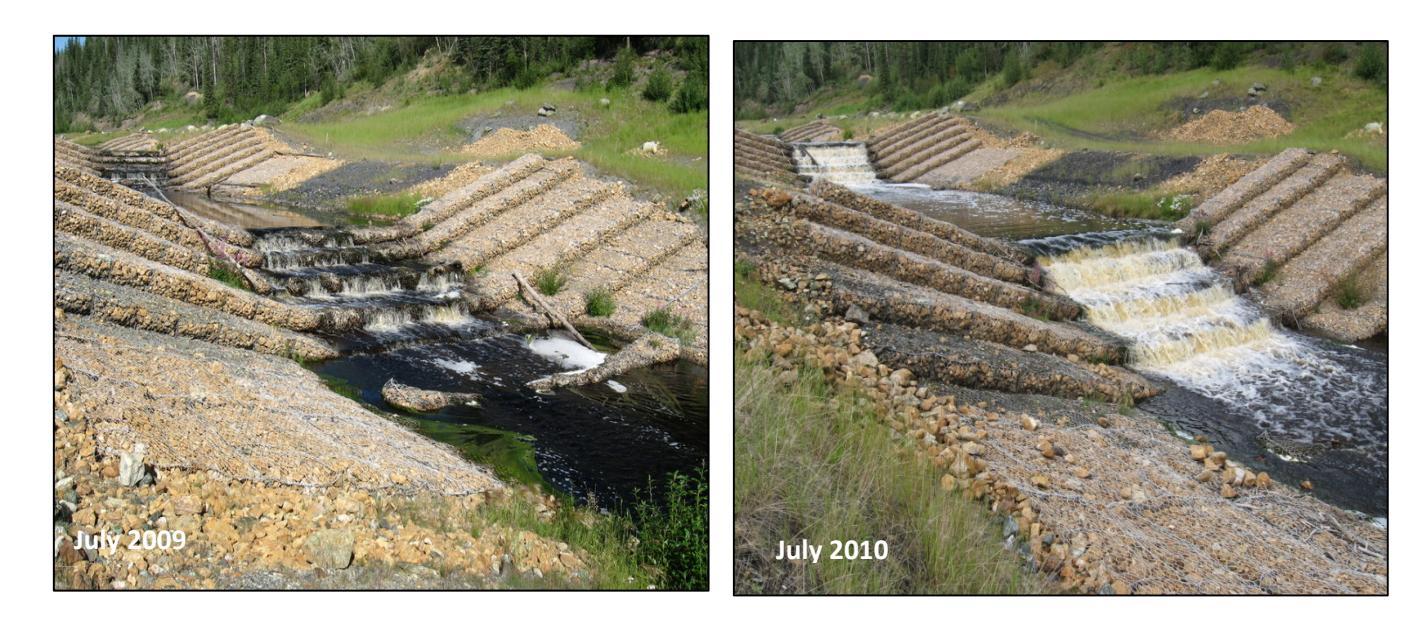
Drop Structure #3 consists of a drawdown weir with 5 tiers that provide a 2 m drop in channel grade and an end sill on the bottom tier. Figure 19 illustrates the overall condition of the structure in 2009 and 2010. Cross-channel views of the structure are shown on Figure 20. The damage to Drop Structure #3 observed in 2009 included deformation of baskets, some small holes in the tops or downstream sides of individual baskets and the end sill was badly deformed but intact.

Figure 19 DS #3 in 2009 and 2010, U/S view

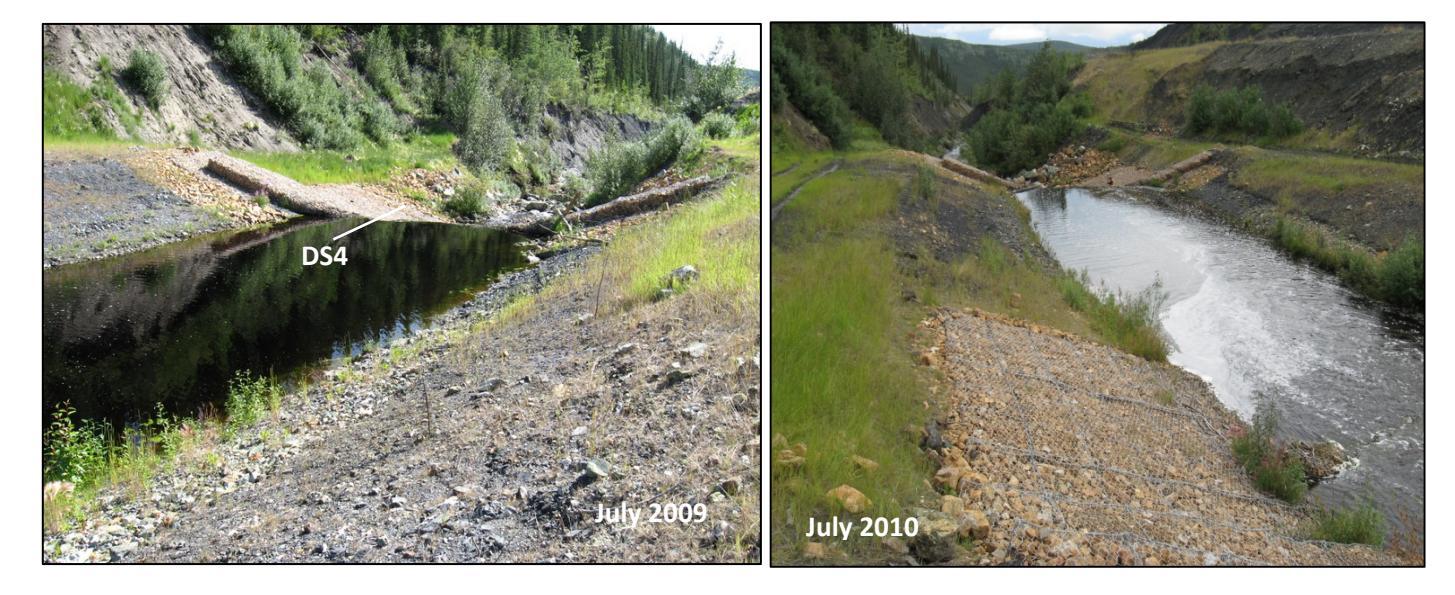
The repairs completed in 2009 held up well during the 2010 spring freshet and the structure appears to be in very good condition. The water flow over the weir was slightly uneven suggesting that RHS of the upper most tier may have settled a small amount relative to the LHS. The channel slopes between DS #3 and DS#4 (Figure 21) are in good condition with no signs of erosion other than high water marks.

Figure 21 Pond Between DS #3 & #4 in 2009 and 2010, view D/S

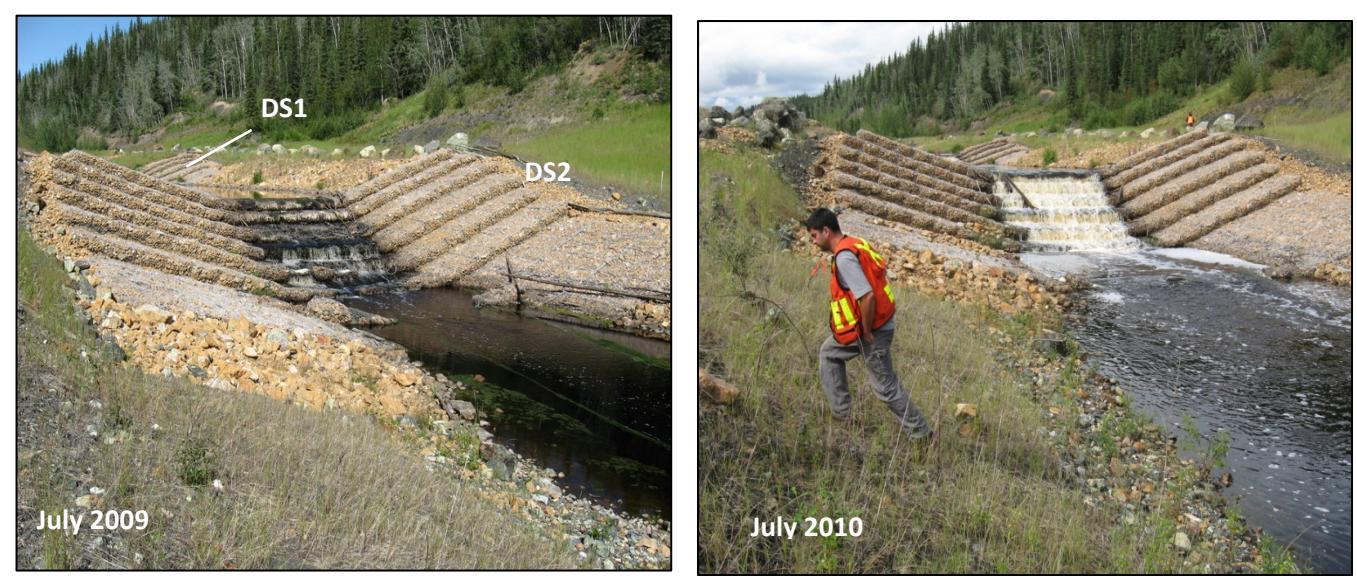
Drop Structure #2 consists of a drawdown weir with 6 tiers that provide a 2.5 m drop in channel grade and an end sill on the bottom tier. A comparison of the structure in 2009 and 2010 is illustrated on Figures 22 and 23. The damage observed in 2009 included the drawdown weir which was leaning downstream, loss of gabion fill from the end sill and several of the baskets on Tiers 2, 3 and 5. The end sill was also deformed.

The repairs completed in 2009 held up well during the 2010 spring freshet and the structure appears to be in very good condition. The channel slopes between DS #2 and DS#3 are in good condition with no signs of erosion other than high water marks.

Figure 22 DS #2 in 2009 and 2010, view U/S

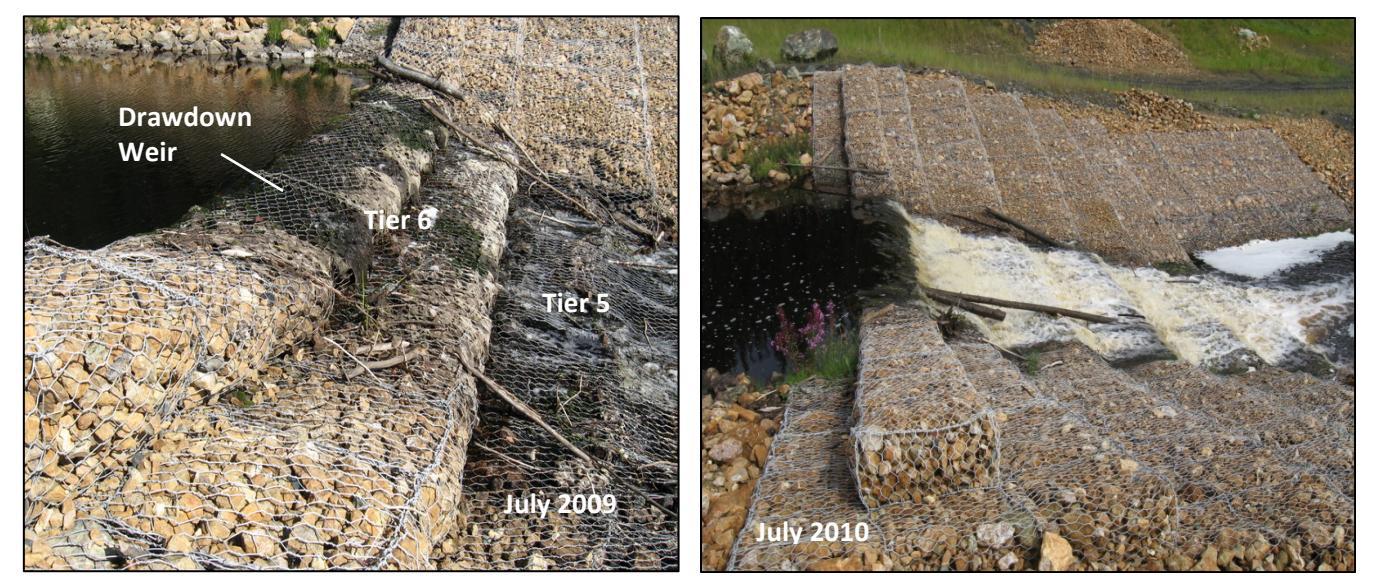
Figure 23 DS #2 Weir, Tier 5 and 6 in 2009 and cross channel view in 2010, view North

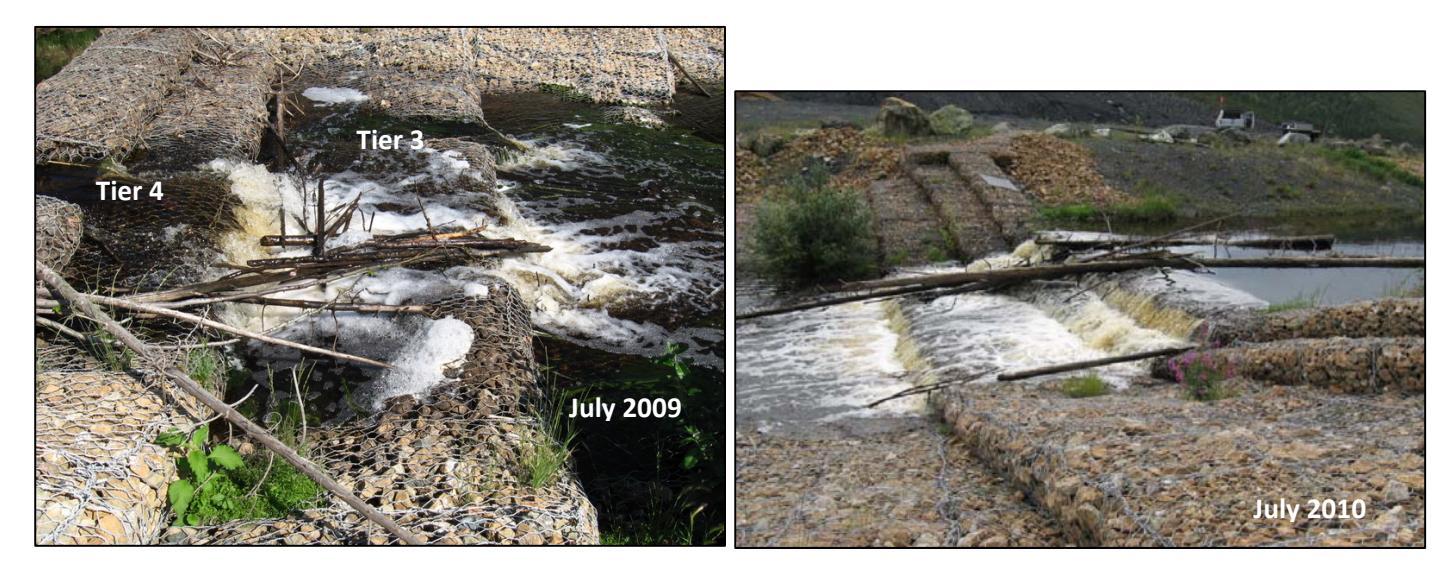
damage observed in 2009 included the drawdown weir leaning downstream, loss of gabion fill from several of the baskets in the end sill and Tiers 2, 3 and 4 (Figure 25a) and deformation of the end sill. The 0.5m wide opening in the drawdown weir was completed in 2007 to allow the elevation in Hudgeon Lake to drop during low flow periods and prior to freeze-up. This drop structure has undergone some settlement since construction in the fall of 2002.

Figure 25a DS #1 2009 and 2010 cross-channel views to north and south, respectively

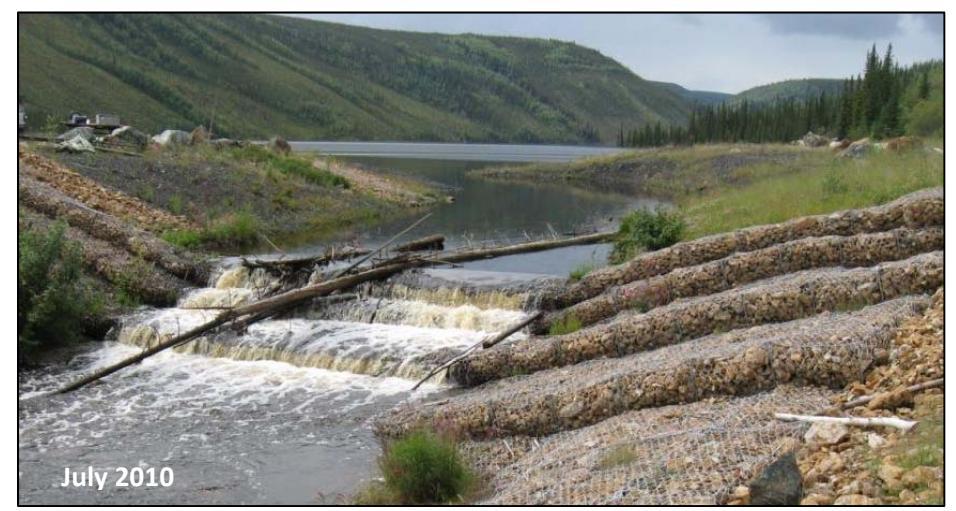
Figure 26 illustrates the general condition of the lake outlet channel upstream of DS 1 in 2010. No signs of bank erosion or instability were observed.

Figure 26 Lake outlet channel U/S of DS #1 in 2010

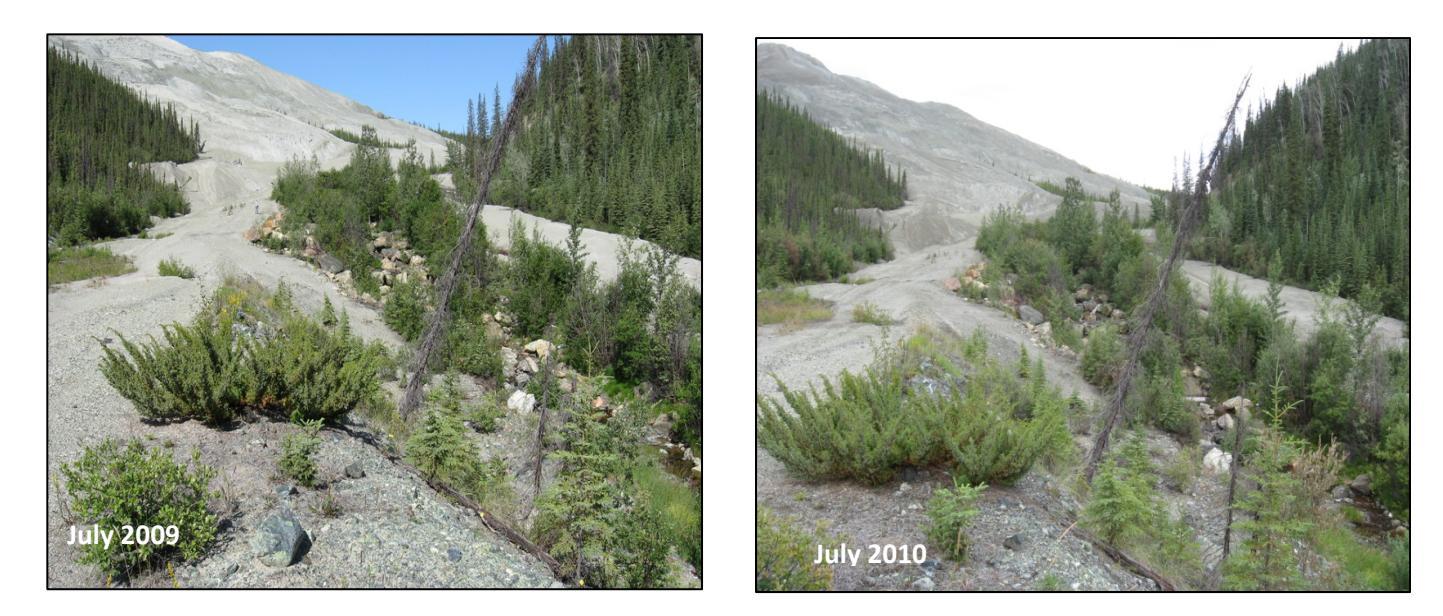
A comparison of the channel in 2009 and 2010 is shown on Figures 27 and 28 at Waypoints 75 (UGL Tag 482) and 335. No significant changes in the condition of the channel from 2009 to 2010 werre observed. As noted in the 2009 Inspection Report (AECOM 2010) vegetation, including trees, is gradually re-growing in the channel after brush removal work was carried out in 2007. The brush clearing work was limited to the removal of the trees and brush from the bottom of the channel only and not the channel banks. The rock weirs are in good condition and there is minimal erosion along the bottom and sides of the channel. Some of the rocks in the weirs have shifted around over the years but the weirs are still clearly visible. It is anticipated that some maintenance of the rock weirs will be required at some point in the future.

Figure 27 View U/S at Rock Lined Channel in 2009 and 2010, from WP 75 (UGL Tag #482)

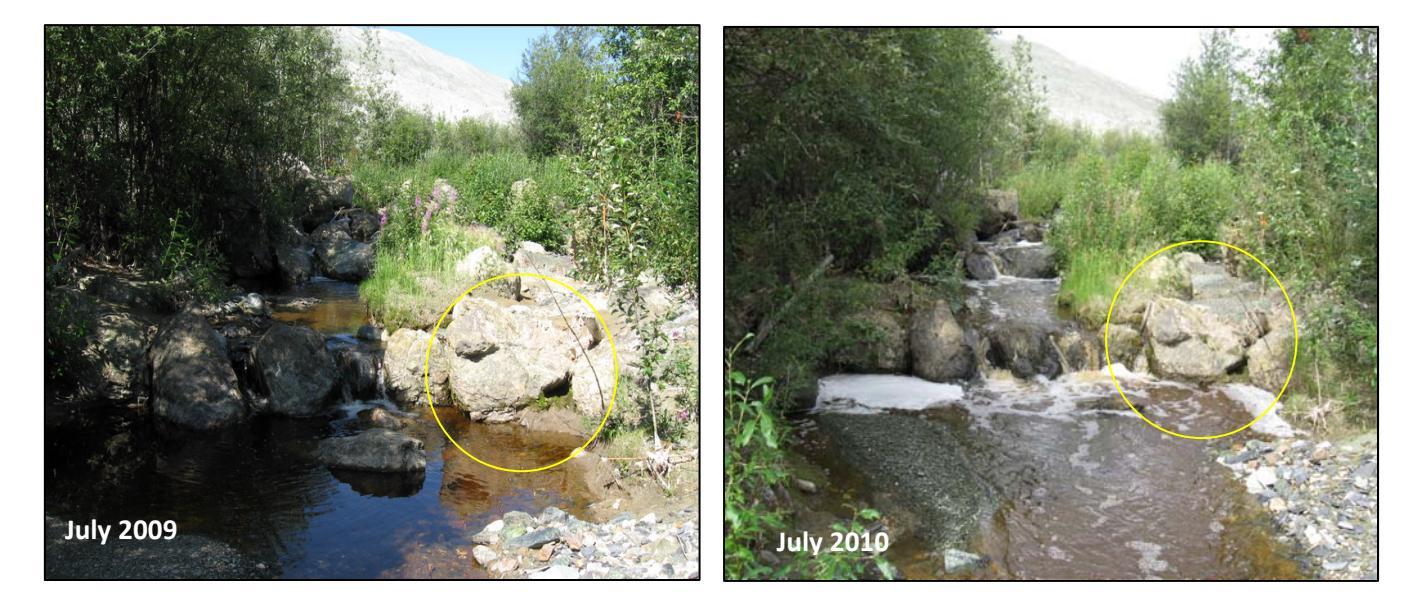
Figure 28 View U/S Along Rock Lined Channel in Wolverine Creek at WP 335 in 2009 and 2010

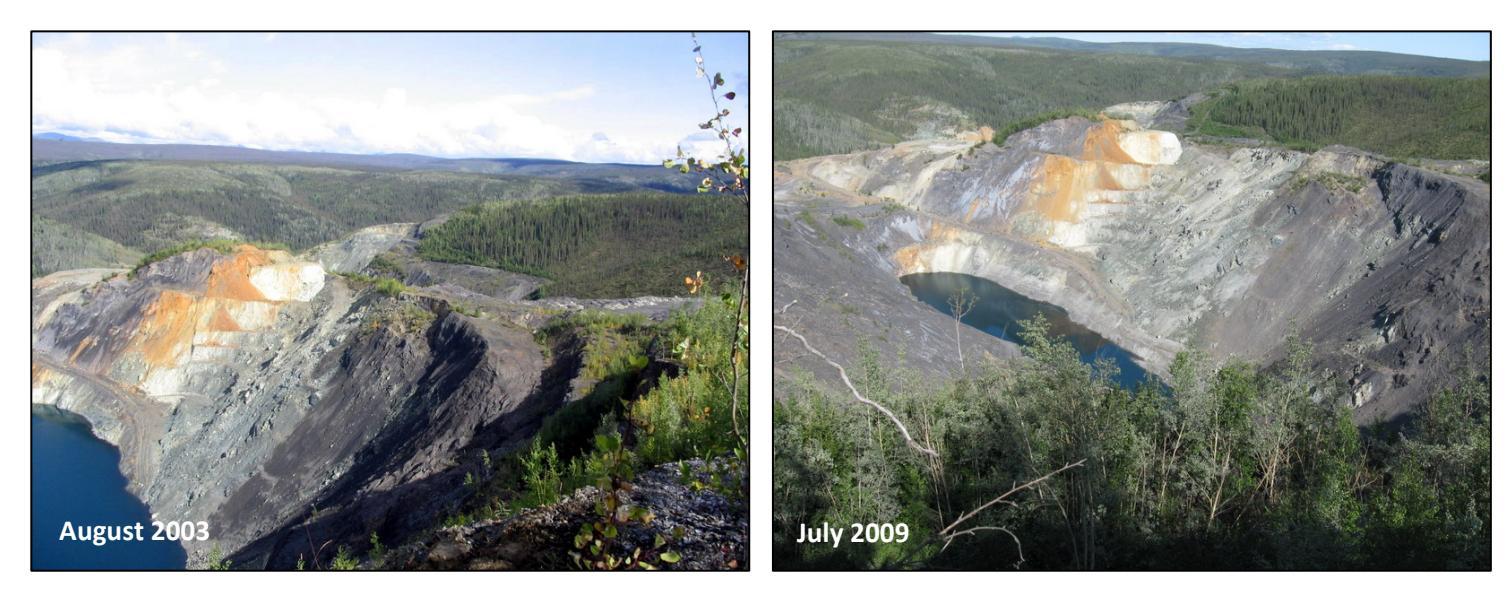
A series of photographs taken in 2003 and 2009 illustrate the overall condition of the open pit (Figures 33 and 34). Figure 35 shows the open pit from the east side and Figure 36 illustrates the condition of the pit from the north side in 2010. Waypoint (WP) locations for the photographs are shown on Drawing 02. A ditch has been excavated around the south and west sides of the Porcupine pit to restrict access. The approximate alignment of the ditch is shown on Drawing 02. Excavated material from the ditch has been placed as a berm and warning signs have been posted.

Figure 33 View NE Across Porcupine Pit in August 2003 and from WP 358 in July 2009

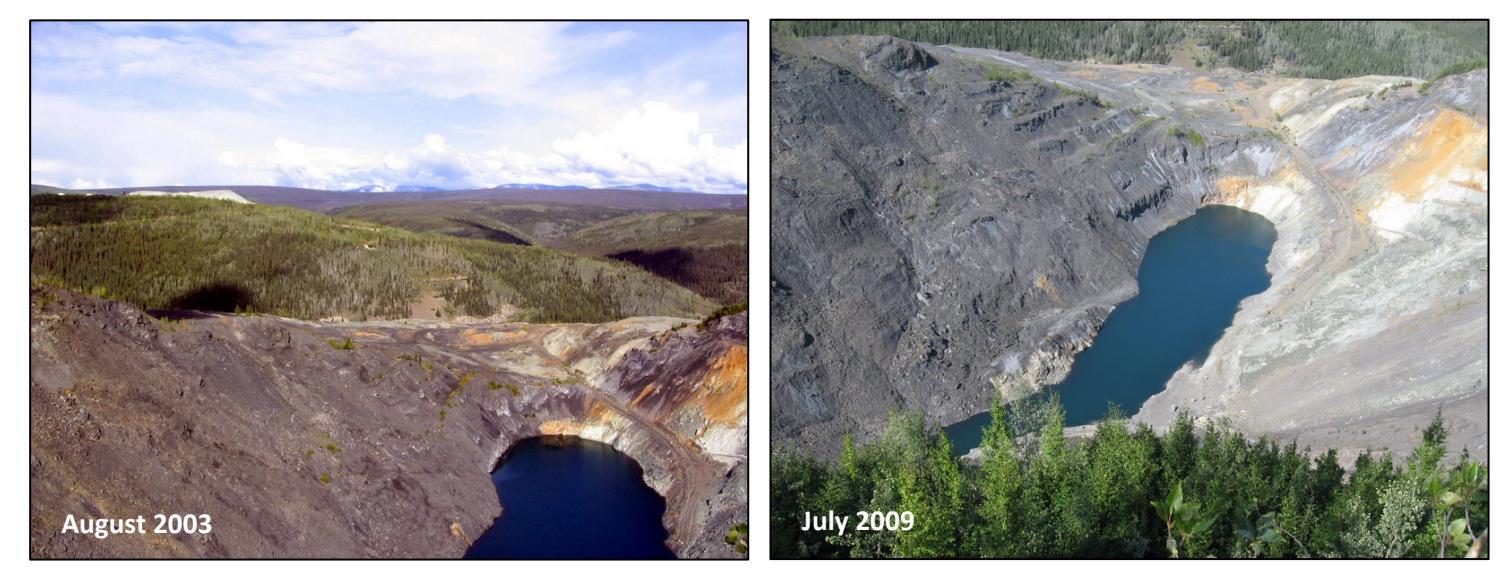
Figure 34 View N Across Porcupine Pit in August 2003 and From WP 357 in July 2009

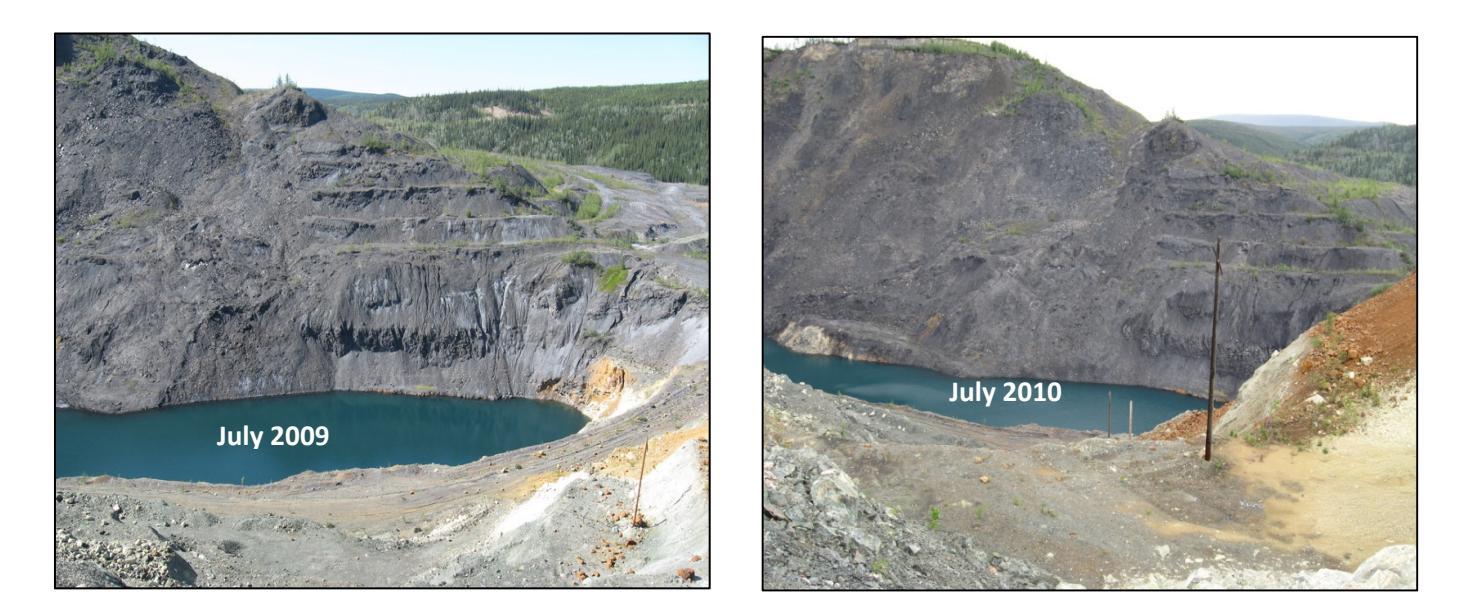
Figure 35 View W Across Porcupine Pit from WP 353 in 2009 and 2010

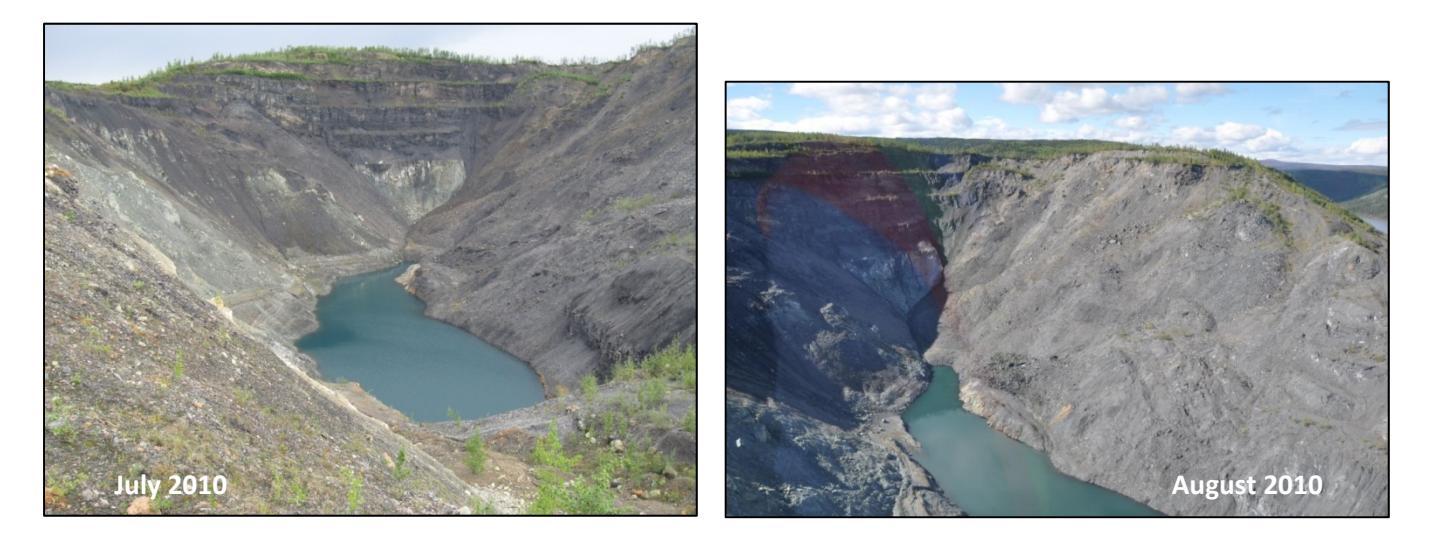
Figure 36 View W Across Porcupine Pit from WP 93 in July 2010 and a helicopter in August 2010
