Government of Yukon

# Former Clinton Creek Asbestos Mine 2010 Site Inspection

**Project Number:** 60160515 (402.3.1)

Date: March, 2011

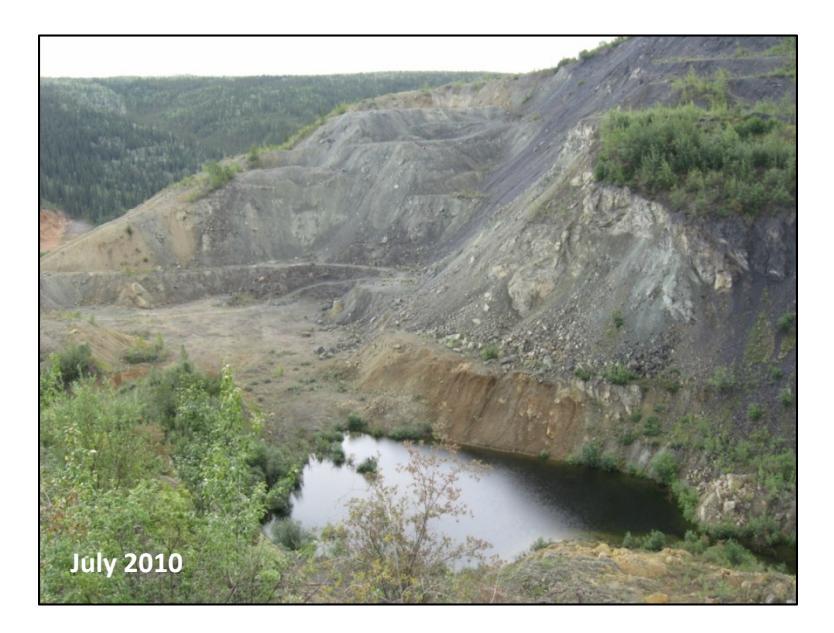
Figure 37 illustrates the general condition of this open pit in 2010 from WP 87. Photos should be taken from this Waypoint in future inspections.

Figure 37 View of Snow Shoe Pit from WP 87 in July 2010, view North East

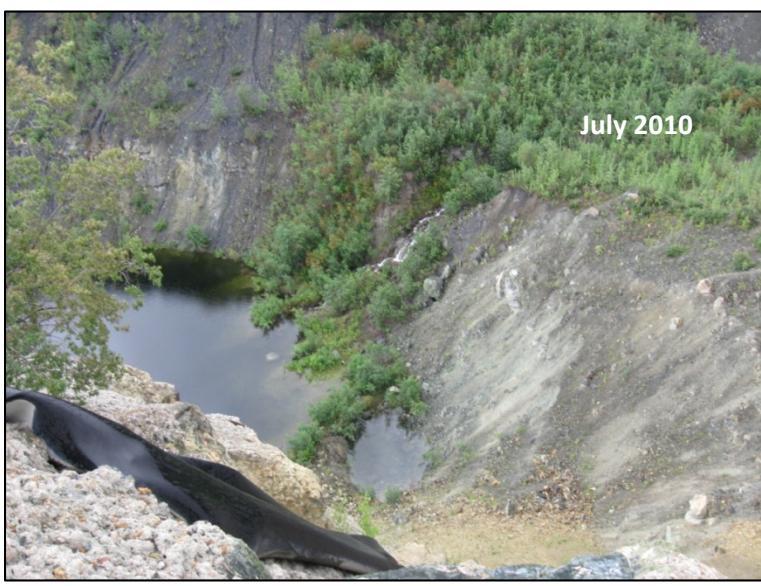
Figure 38, taken from WP 89, illustrates the general condition of this open pit in 2010. Note the level of water in the pond and the flow from the Porcupine Waste Rock Dump, which is located directly upstream of the pit. Some sloughing of the west wall of the Creek Pit was observed in 2010 as shown on Figure 39 taken from Waypoint 90. Photos should be taken from this Waypoint in future inspections.

Figure 38 View of Creek Pit from WP 89 in July 2010, view East
