ABANDONED CLINTON CREEK ASBESTOS MINE

RISK ASSESSMENT REPORT

UMA Engineering Ltd. Engineers and Planners

APRIL, 2000

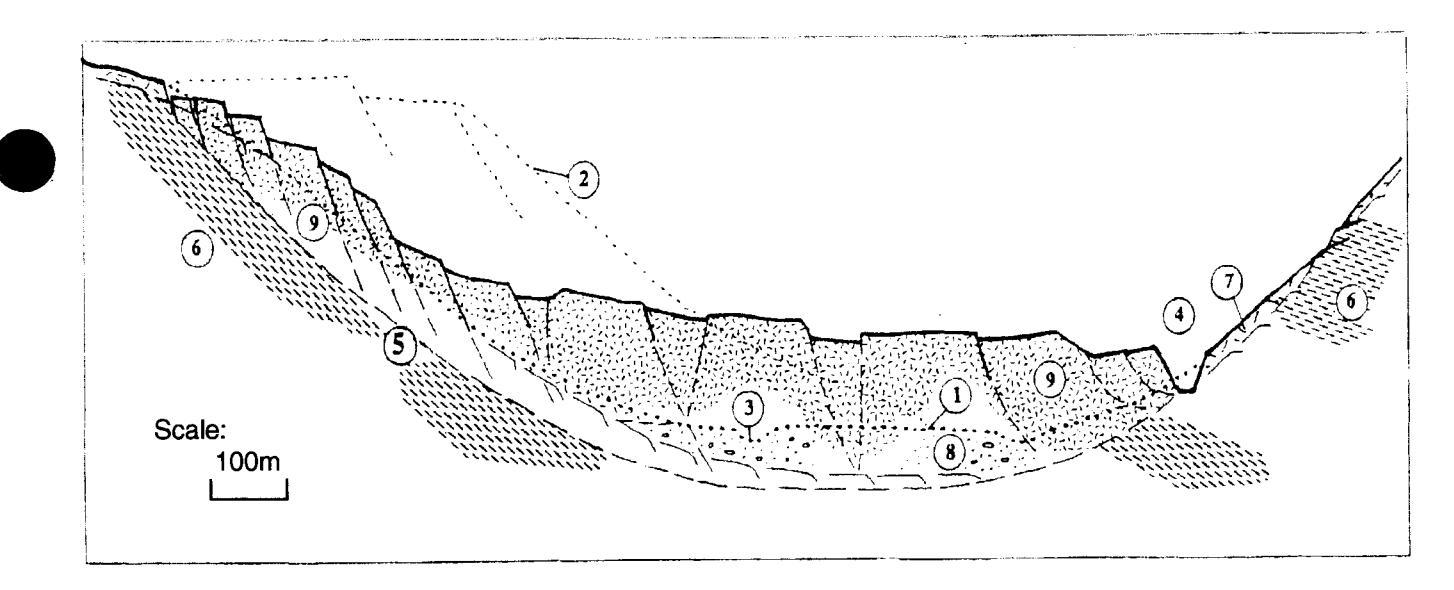
A significant slope failure of the waste rock dump into the Clinton Creek valley occurred in 1974 (Figure 2-2). The resulting landslide dam blocked natural drainage through the valley creating a 74 ha lake (Hudgeon Lake) as shown in Photo 2 (Klohn, 1986). A new creek channel (UMA Photo 7-17) was subsequently formed along the interface between the landslide material and north valley slope, some 25 metres above the original valley bottom at the Hudgeon Lake outlet. Within the area now occupied by the waste rock dump, the creek channel is approximately 700 m long with a gradient ranging from 3 to 5.5 percent compared to its natural gradient of approximately 0.075 percent.

Figure 2-2 Waste Rock Slide Looking Upstream 1-Original Ground Surface, 2-Initial Waste Rock Configuration,
3-Original Creek Channel, 4-Present Creek Channel,
5-Probable Slip Plane, 6-Bedrock, 7-Colluvium, 8-Alluvium,
9-Slide Debris

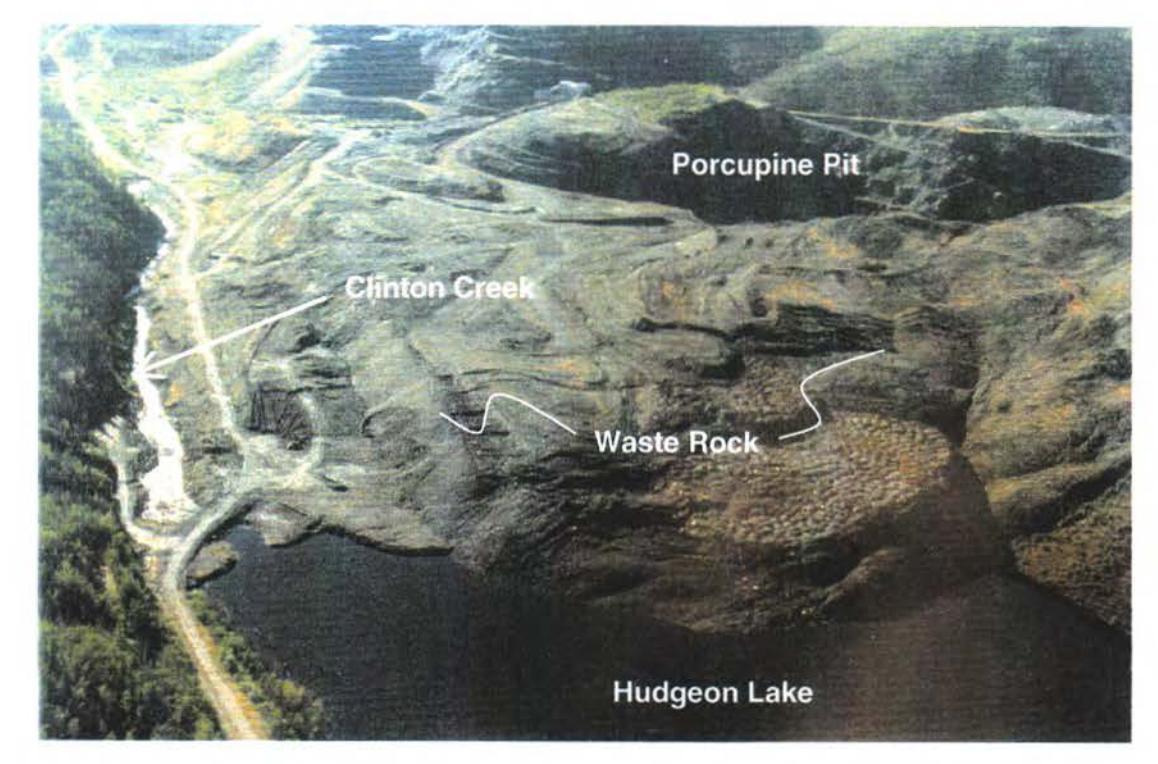
Photo 2 Clinton Creek Waste Rock Dump (1986)

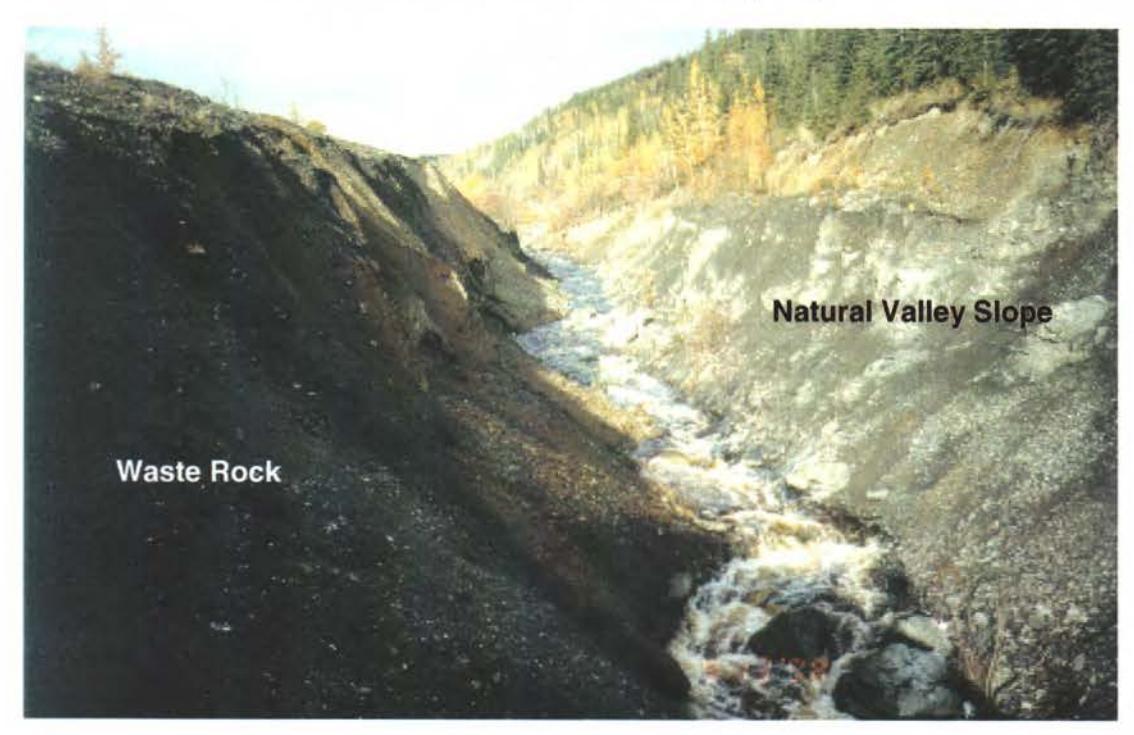
UMA Photo 7-17 Clinton Creek Channel Downstream of Hudgeon Lake Outlet

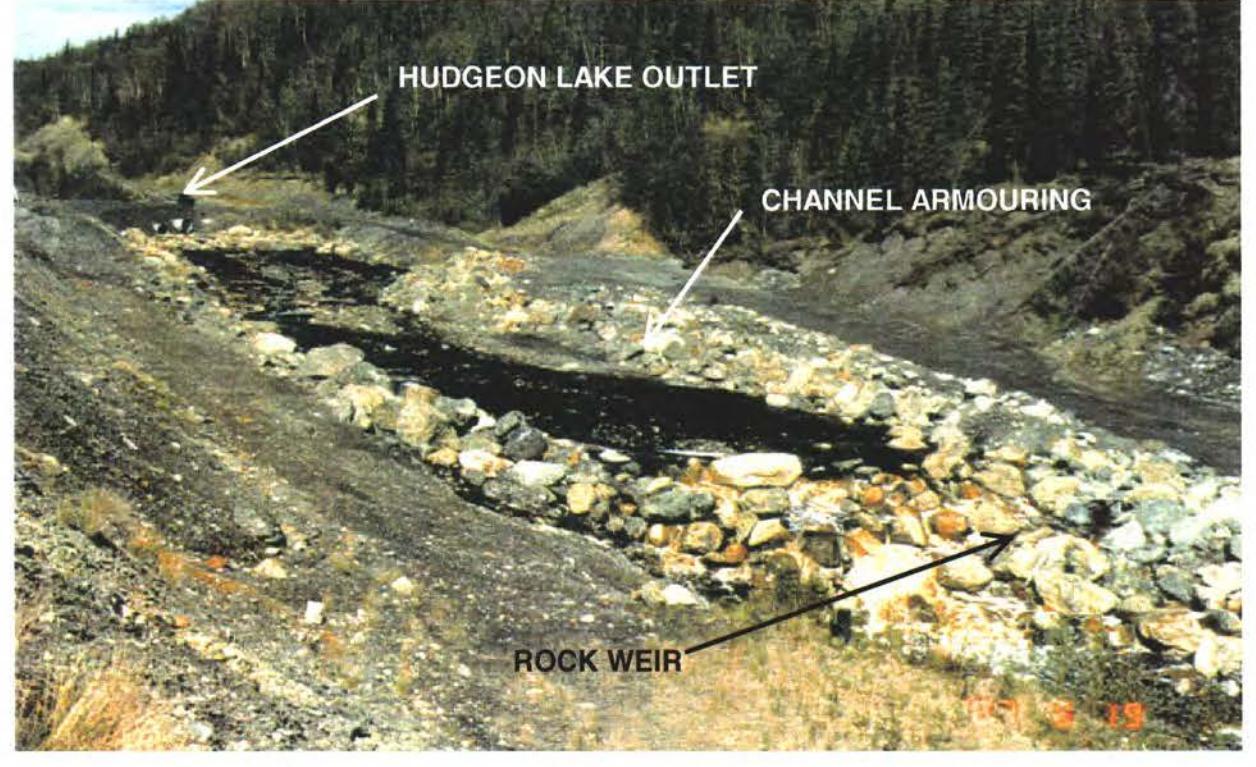
Channel erosion protection measures were constructed between 1979 and 1984, including a rock weir and channel armouring just downstream of the Hudgeon Lake outlet (Photo 5, Geo Eng., 1987). These erosion control works have since proven to be largely unsuccessful and were almost completely destroyed in the spring of 1997. Since that time, significant erosion of the channel, in particular, down-cutting near the Hudgeon Lake outlet has occurred (UMA photo 8-13). The extent of the downcutting is evident when comparing the channel profile in 1999 with the profiles generated in 1983, 1984 and 1986 (Drawing 04). Up to 2 to 3 metres of incising has occurred immediately downstream of the outlet where the channel bed is bounded to the south by waste rock and to the north by natural colluvial soils overlying bedrock on the valley slope. Farther downstream, less down-cutting is evident, likely because of the less erodible exposed bedrock bounding the channel at lower elevations and/or downstream sediment transportation and deposition.

Photo 5 Rock Weir and Channel Armouring

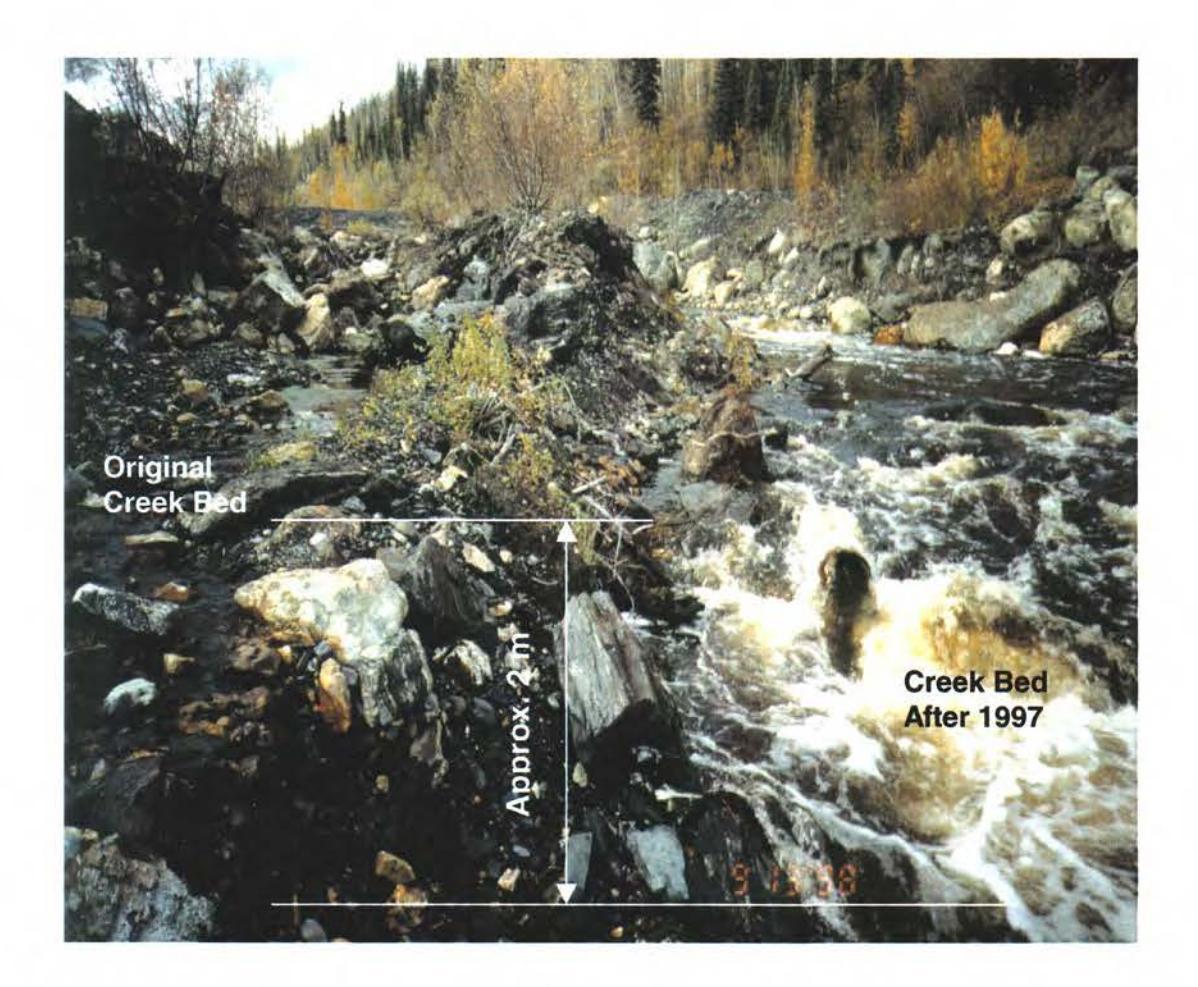
UMA Photo 8-13 Channel Down-cutting Immediately Downstream of Hudgeon Lake Outlet

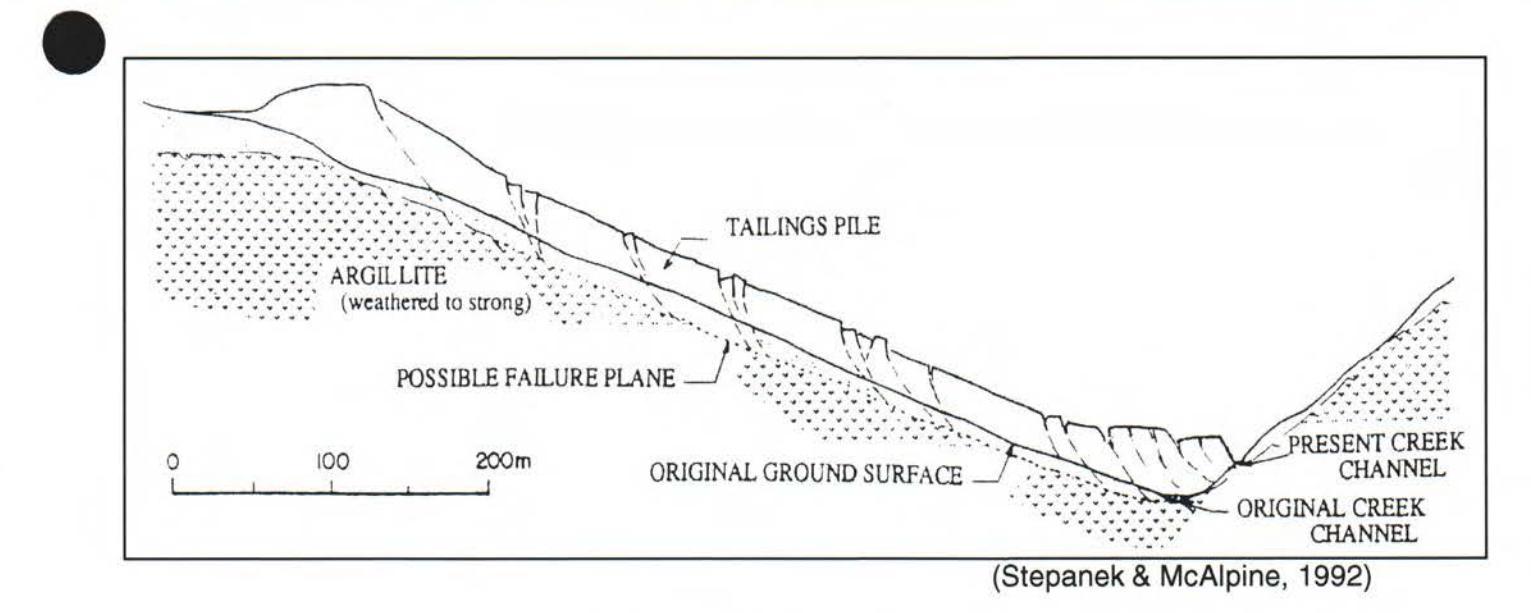
The southerly portion of the tailings pile (south lobe) failed suddenly in 1974, completely blocking the existing Wolverine Creek channel (Figure 2-3). Upon formation of a small upstream lake, the blockage was breached releasing a significant amount of water borne tailings downstream of the tailings piles. Following the 1974 event, the north tailings lobe failed (UMA Photo 3-5). A series of rock weirs were subsequently constructed downstream of the tailings piles to minimize erosion, and to date, these measures remain intact. Remedial measures to stabilize the tailings lobes, including slope flattening and terracing were unsuccessful. Downslope movements of the tailings pile lobes are still occurring, resulting in continued erosion of landslide material at the downslope toe.

Figure 2-3 Section Through South Tailings Lobe

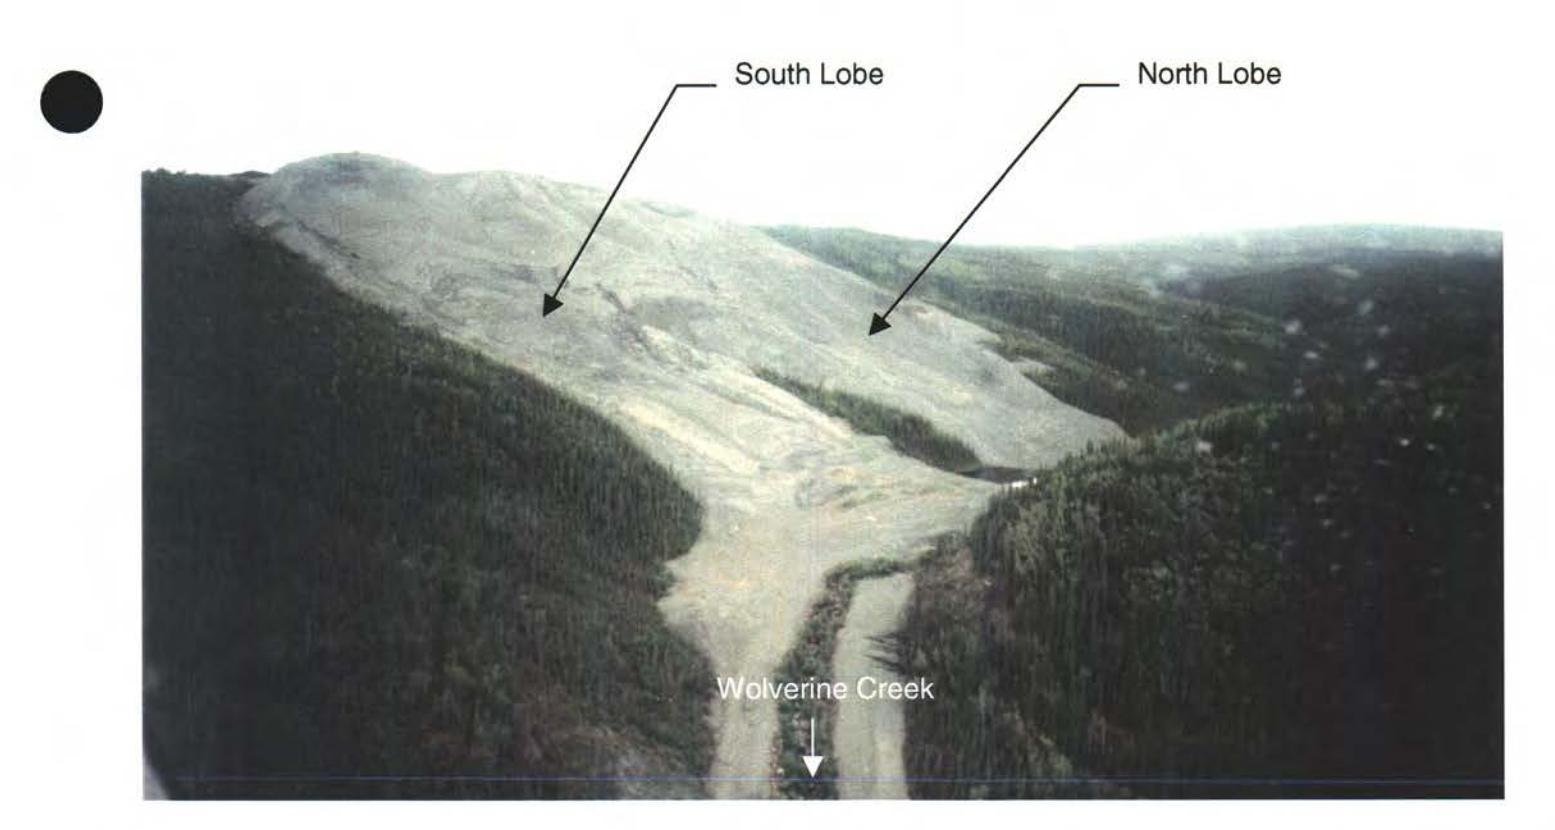
UMA Photo 3-5 Asbestos Tailings Pile

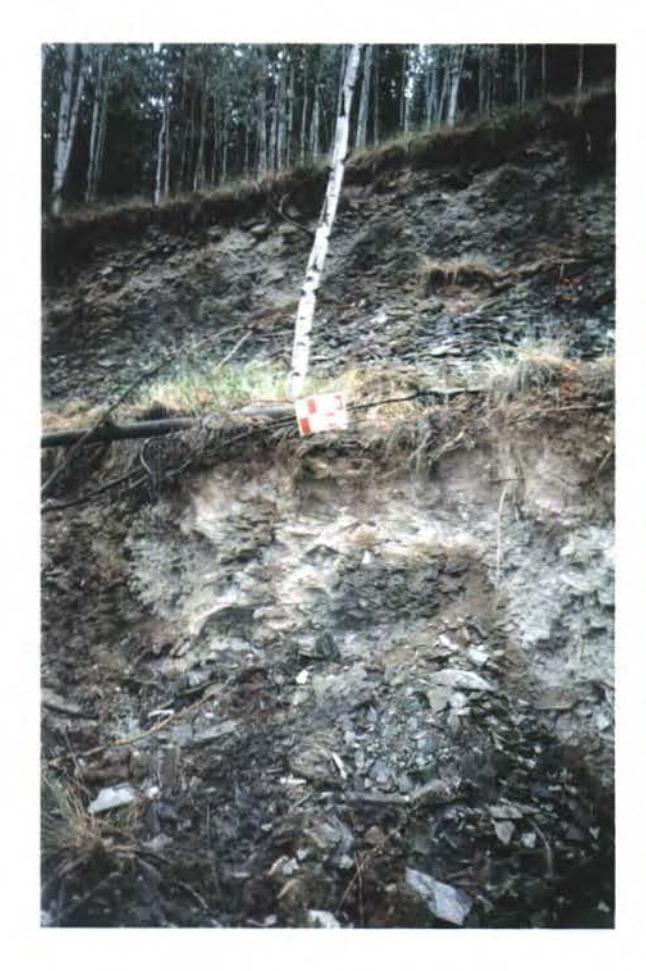
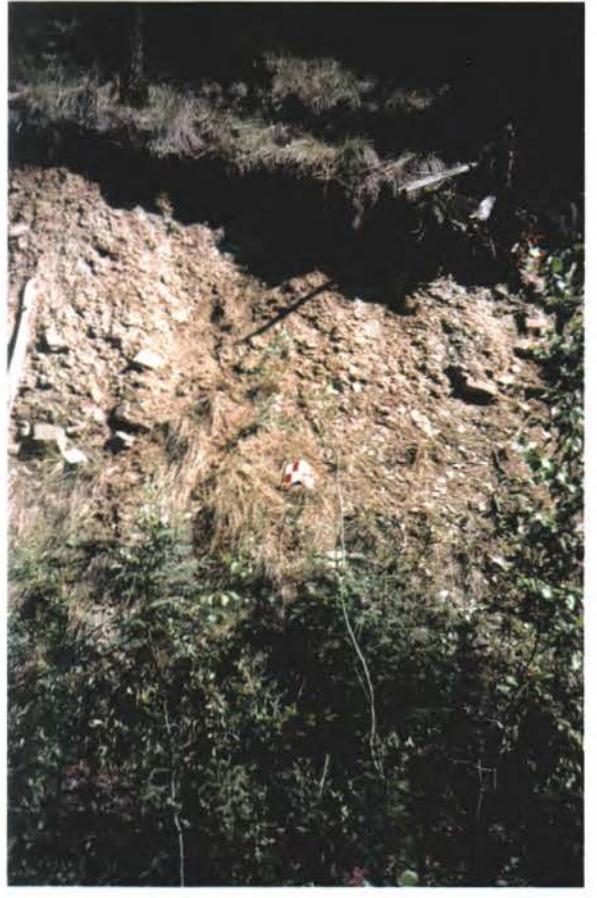
UMA Photo 14-2A

Slumping of the north valley slope within the immediate vicinity of the creek channel is evident, in particular along the lower half of the reach through the waste rock. Retrogressive slump blocks 2 to 3 metres high have developed about 500m downstream of the lake outlet exposing the weathered argillite bedrock along the backscarps (UMA Photo 14-2A). Significant slumping has also occurred about 350m downstream of the outlet where a 5 m backscarp and vegetated lower bench are clearly visible (UMA Photo 14-12A). Photo locations are indicated on Drawing 03.

UMA Photo 14-12A Valley Slope 20m W of Piezometer P4 Valley Slope 30m Upstream of Section A-AA

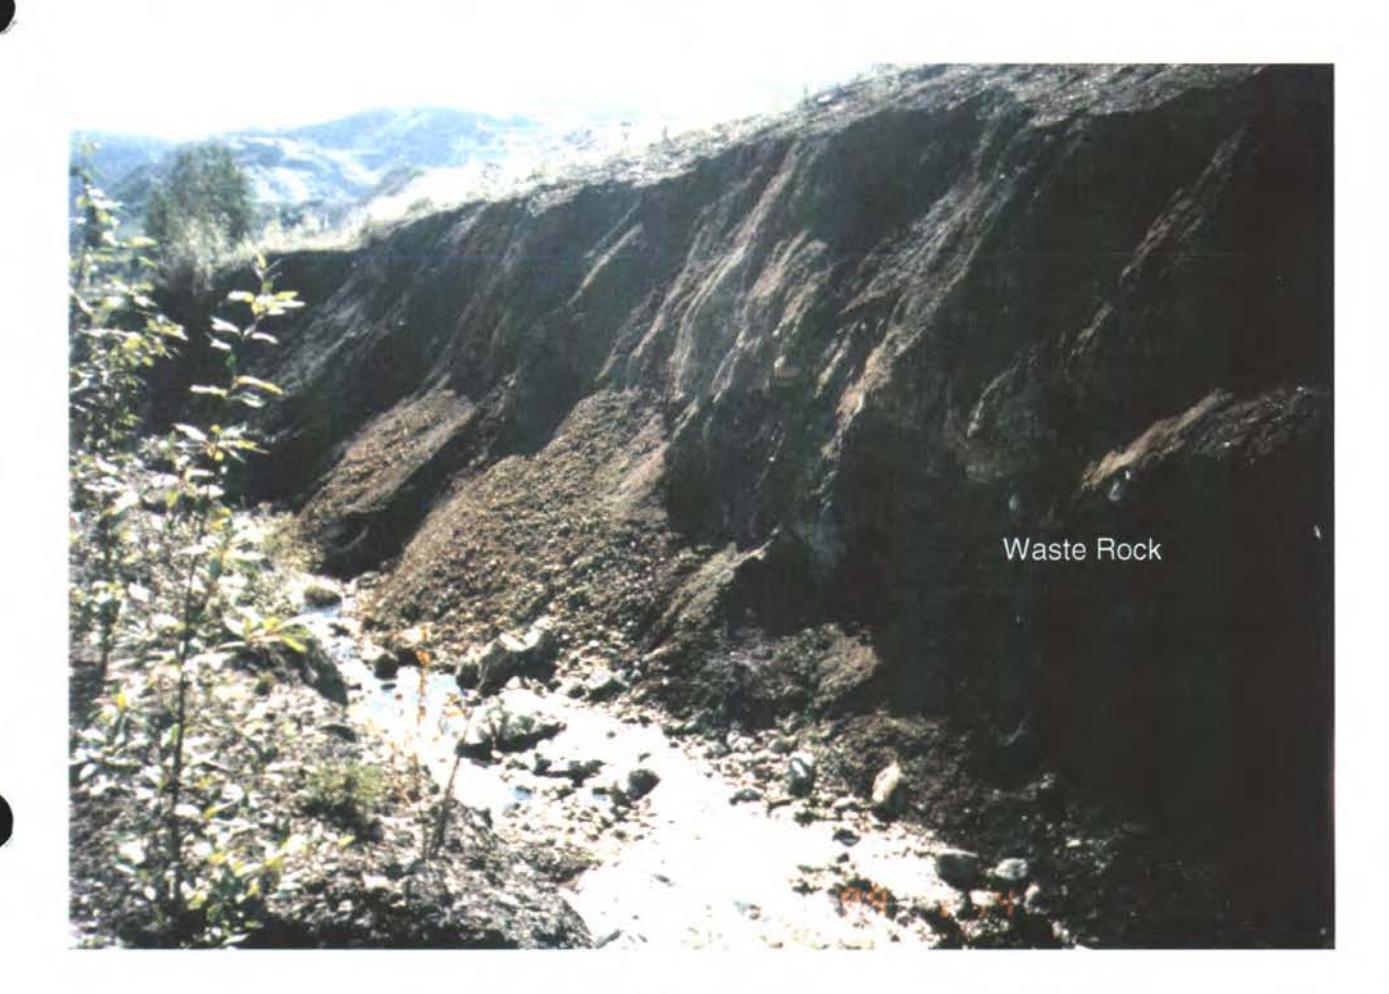
Recent slumping of the oversteepened waste rock slope can be seen from the north side of the creek channel, in particular in the vicinity of cross-channel reference line A-AA (UMA Photos 14-11A). The localized slides typically block about one half of the creek channel bottom and active erosion is evident at the toe of the slide debris in the channel.

UMA Photo 14-11A Waste Rock Slumping at Sec A-AA

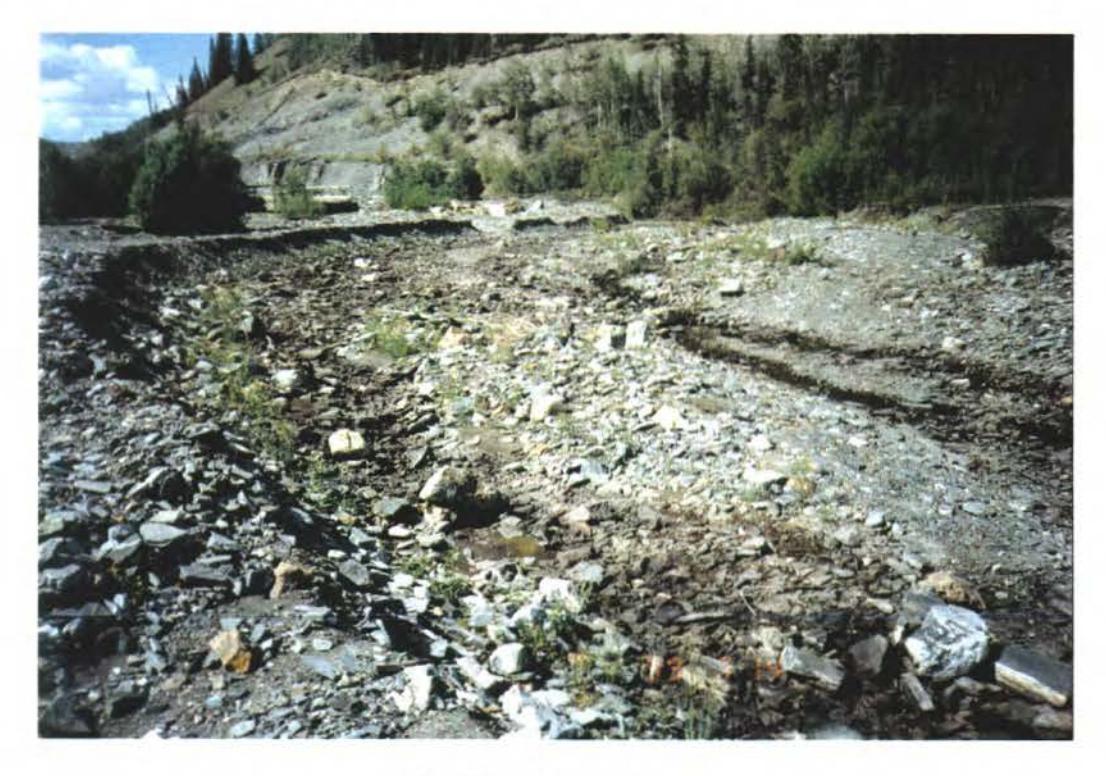
- The creek channel was dry at the Hudgeon Lake outlet with flow occurring through the 2m diameter culvert which is badly out of round. The channel remnant (which was flowing during our 1998 reconnaissance) is about 18-20m wide.
- Open channel flow in Clinton Creek terminated at the east end of the waste rock dump just before reaching the washed out bridge. The channel is dry from this point to about 100m downstream of the bridge (UMA Photo 15-4A). The water in the channel at this location (the old bridge) was at least 0.5 to 1m deep in 1998 during our site reconnaissance (UMA Photo 11-10).

UMA Photo 15-4A Clinton Creek Channel Downstream of Bridge

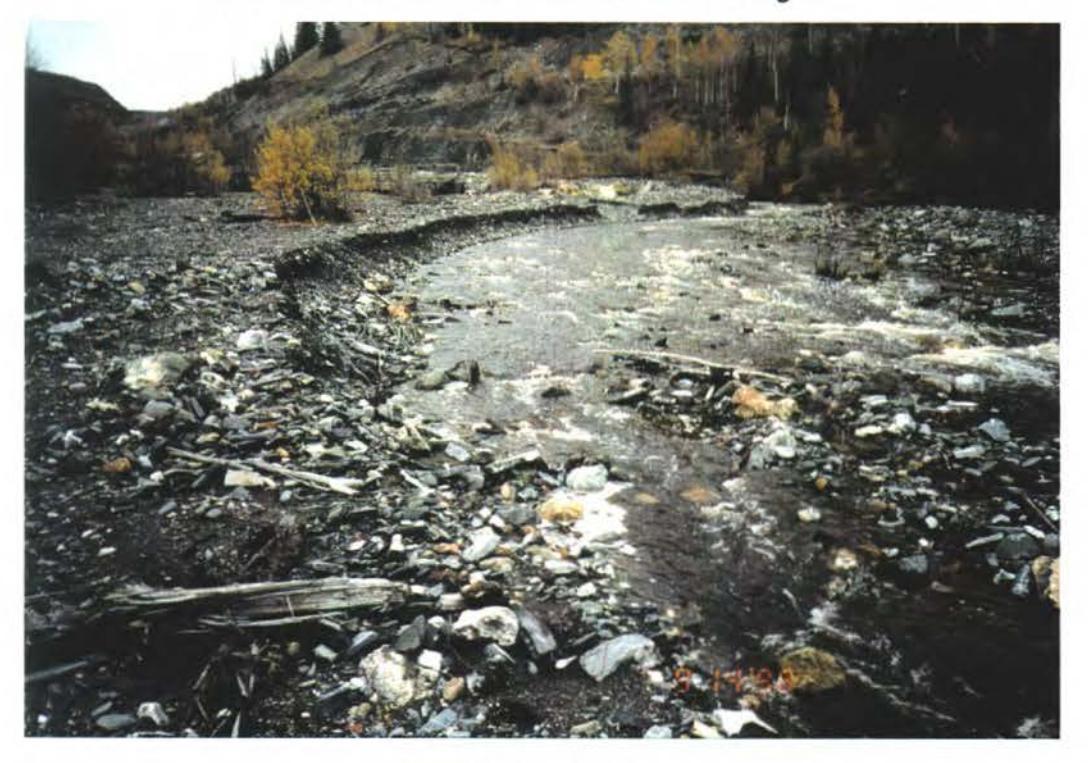
UMA Photo 11-10 Creek Channel in September 1998

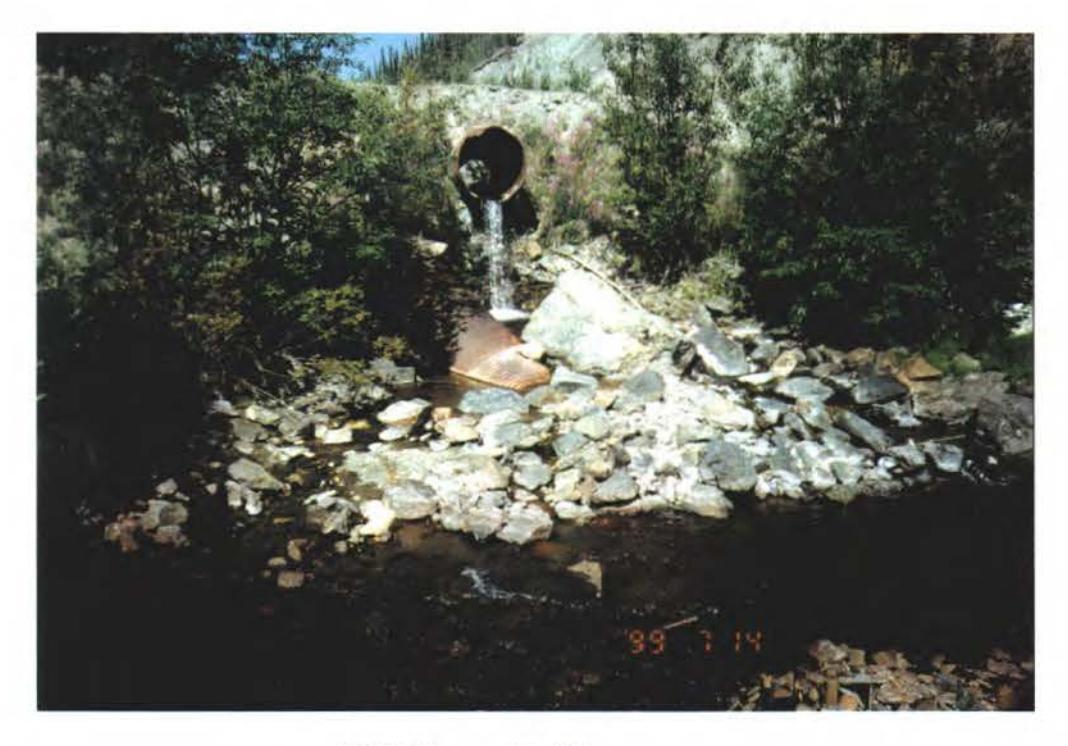
Flow from Wolverine Creek normally discharges into Clinton Creek through a 1200mm diameter steel plate (19mm thick) culvert elevated about 2m above the channel bottom (UMA Photo 15-10A). The culvert is in good condition. No flow was visible through a corrugated metal culvert which was partially embedded into the channel bed, nor was any flow occurring through the 1200mm culvert set at a higher elevation. Interestingly there was a significant flow in Clinton Creek just upstream of Wolverine Creek in comparison with little to no flow observed just downstream of the old bridge.

UMA Photo 15-10A Wolverine Creek Outlet Culvert

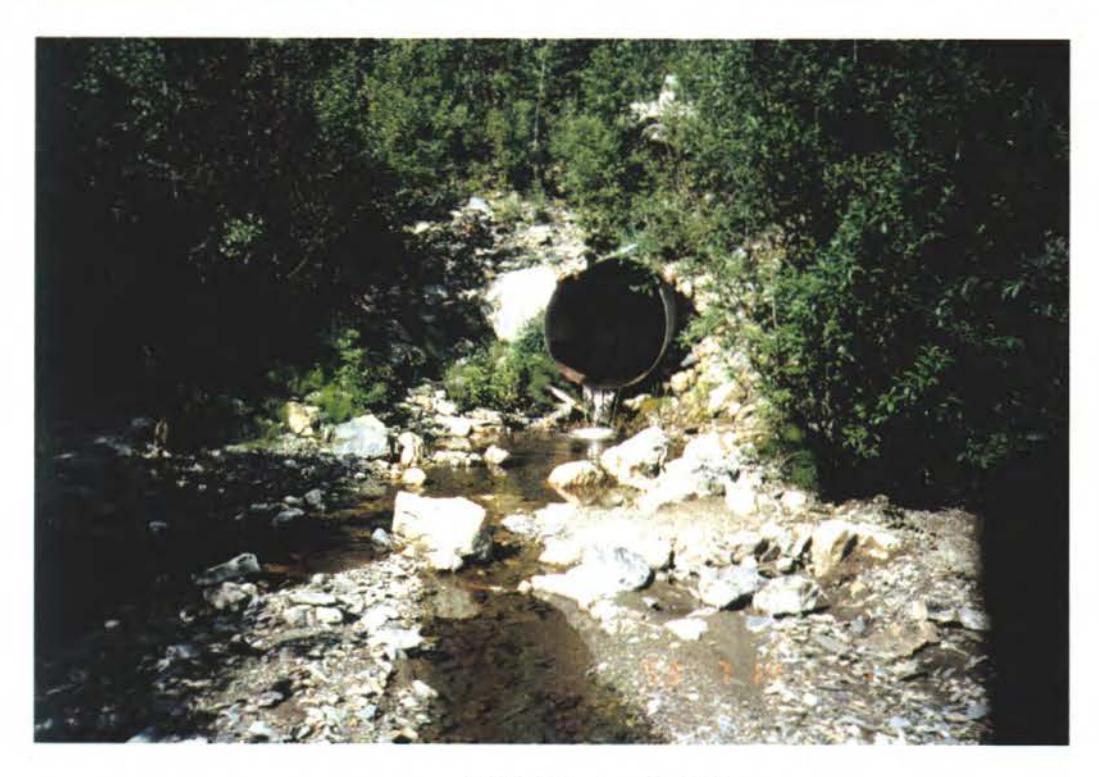
Eagle Creek drains into Clinton Creek through a 1600mm diameter corrugated metal pipe about 3 km downstream of the mine as shown on Drawing 01 (UMA Photo 15-15A). Discharge from the culvert at the time was estimated to be 7 l/sec. The culvert has been vertically deformed by about 300mm beneath the roadway. An old timber bridge is located about 20m upstream of the culvert, likely along a previous access road alignment (UMA Photo 15-16A). The timber bridge is in poor condition.

UMA Photo 15-15A Eagle Creek Culvert

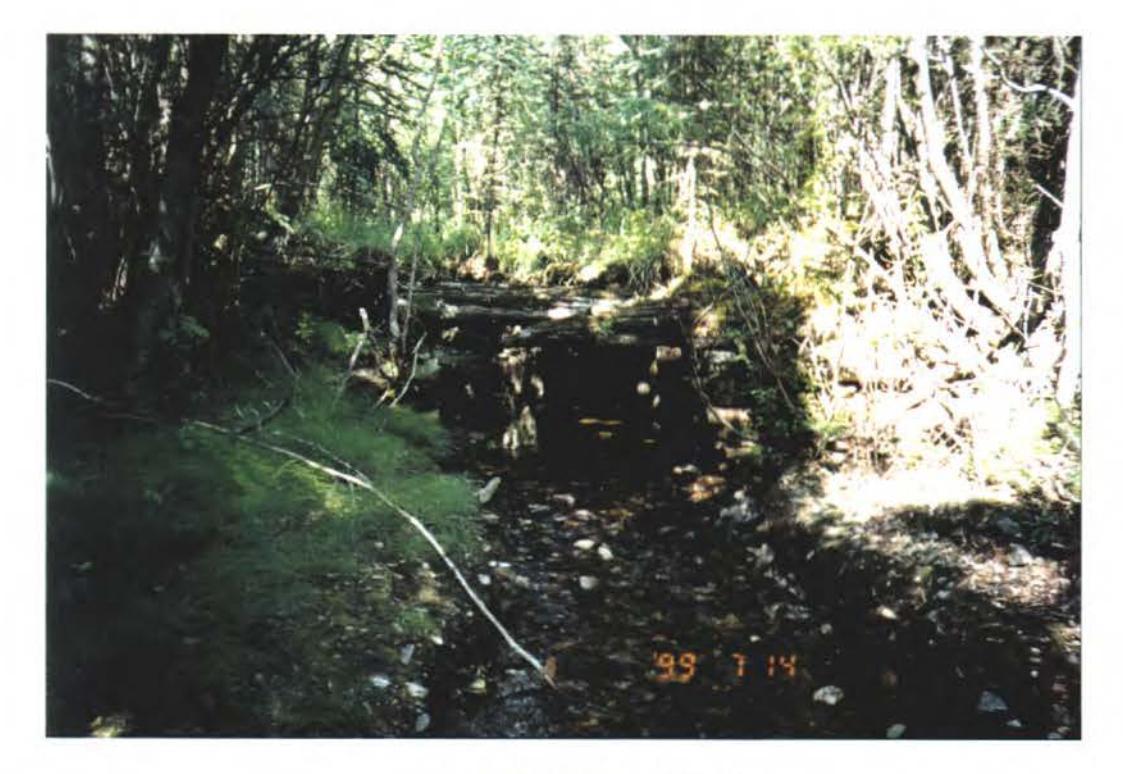
UMA Photo 15-16A Eagle Creek Timber Bridge

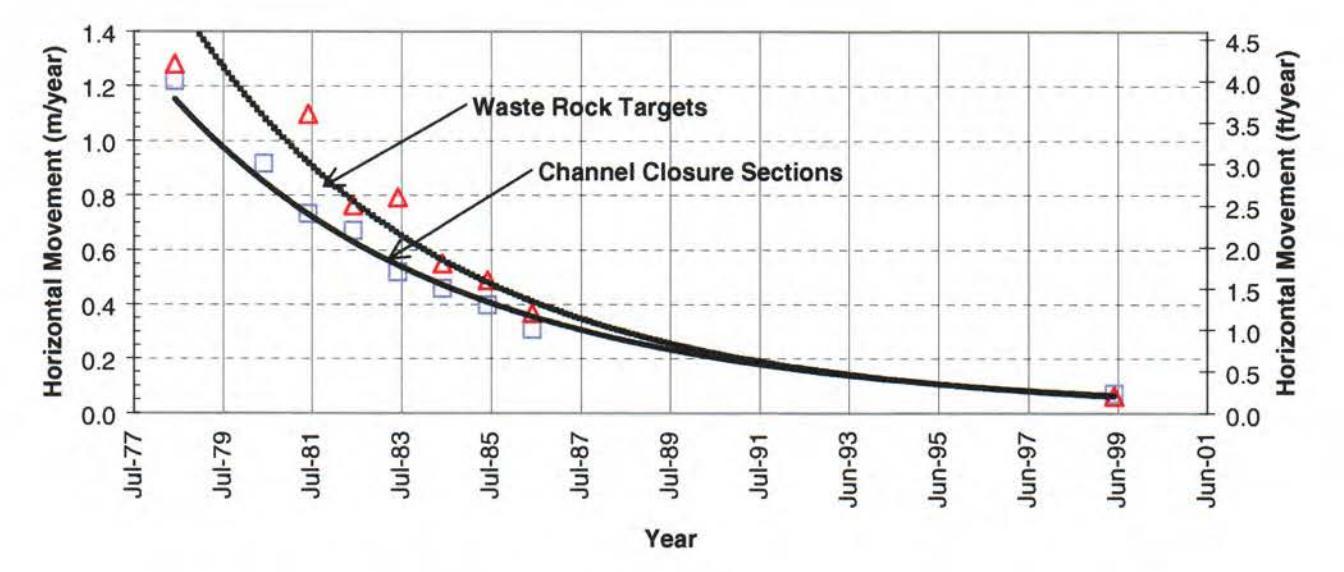
Figure 7-4 Average Annual Movement Rates
The 1999 survey appears to confirm the observations made by Klohn in 1986, that is, the movement rates are decreasing over time. With a reduced rate of waste rock movement, the supply of material from the waste rock dump to feed the creek channel erosion process is diminishing. As down-cutting of the channel continues however, sideslopes on both sides of the channel will become oversteepened resulting in localized instabilities which will deposit material into the stream course. It is likely that intermittent channel blockages at this time are much more likely to occur as a result of these instabilities rather than from larger scale waste dump movements, an observation which is borne out by recent site inspections by Geo Engineering and UMA Engineering. Given the limited volume of water which could be impounded in the confines of the channel upstream of localized failures, the resulting breach would not likely produce a significant downstream flow increase. It should be recognized however, that continued downcutting of the channel may eventually cause an acceleration in horizontal movement of the waste dump as a result of a reduction in overall slope stability.

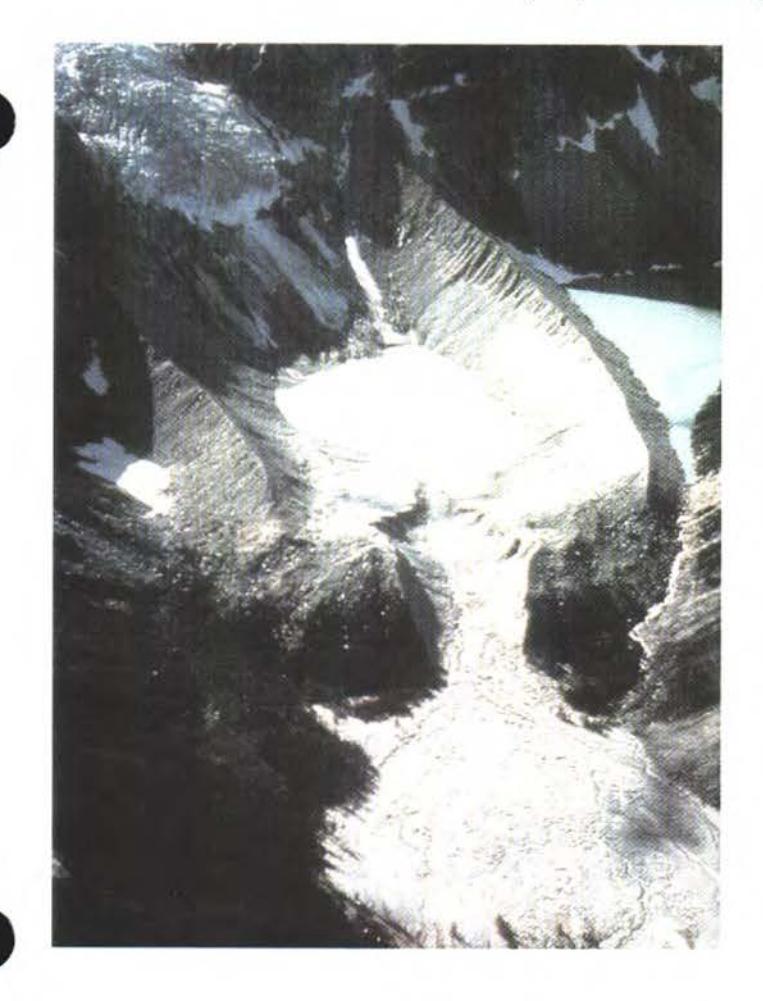
Nostetuko Lake drained through a steep channel cut through a 40 m high landslide moraine on a gradient of 0.19, floored by large boulders derived from the moraine (Photo 7-1). The frequency of boulders, however, was too small to permit re-armouring before erosion became catastrophic. When the moraine breached, almost the entire lake drained into the downstream valley in 5 horrs. Very rapid down-cutting and the draining resulted from sudden channel erosion. Once down-cutting commenced, lowering of the outlet permitted increased flow from the lake, increasing erosion. The moraine breach volume was $1.2 \times 10^{6} \text{ m}^{3}$. The volume of water released was $6.5 \times 10^{6} \text{ m}^{3}$. A similar breach failure occurred in a moraine dam on the Klattasine Creek in the early 1970's (Blown and Church, 1985, Clague et al, 1985).

Photo 7-1 Nostetuko Moraine Dam After Breach Failure (Photo From Geological Survey of Can., Bulletin 464)
