# Community Liaison Committee Meeting

July 7, 2004

# 2004 Care and Maintenance Program

**Subject:** Meeting Minutes - July 7, 2004

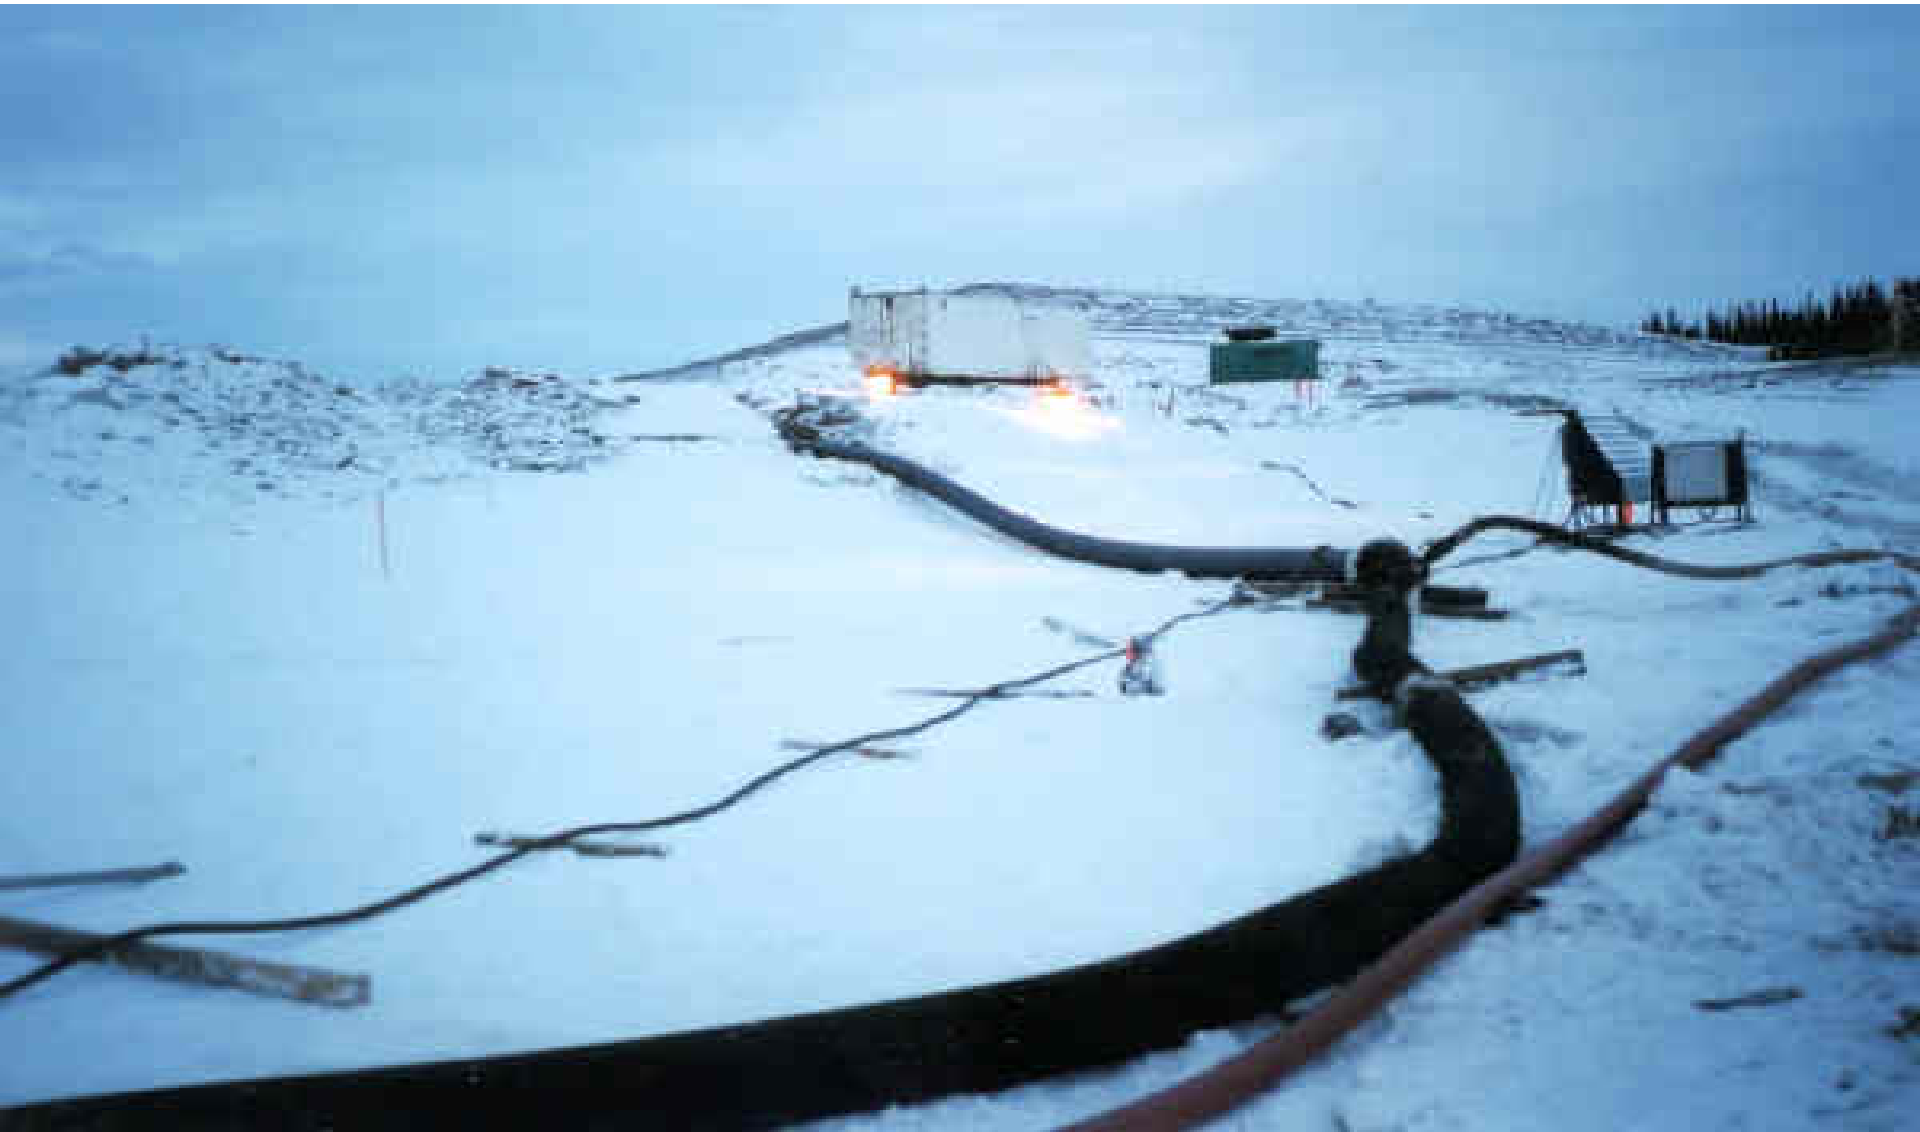
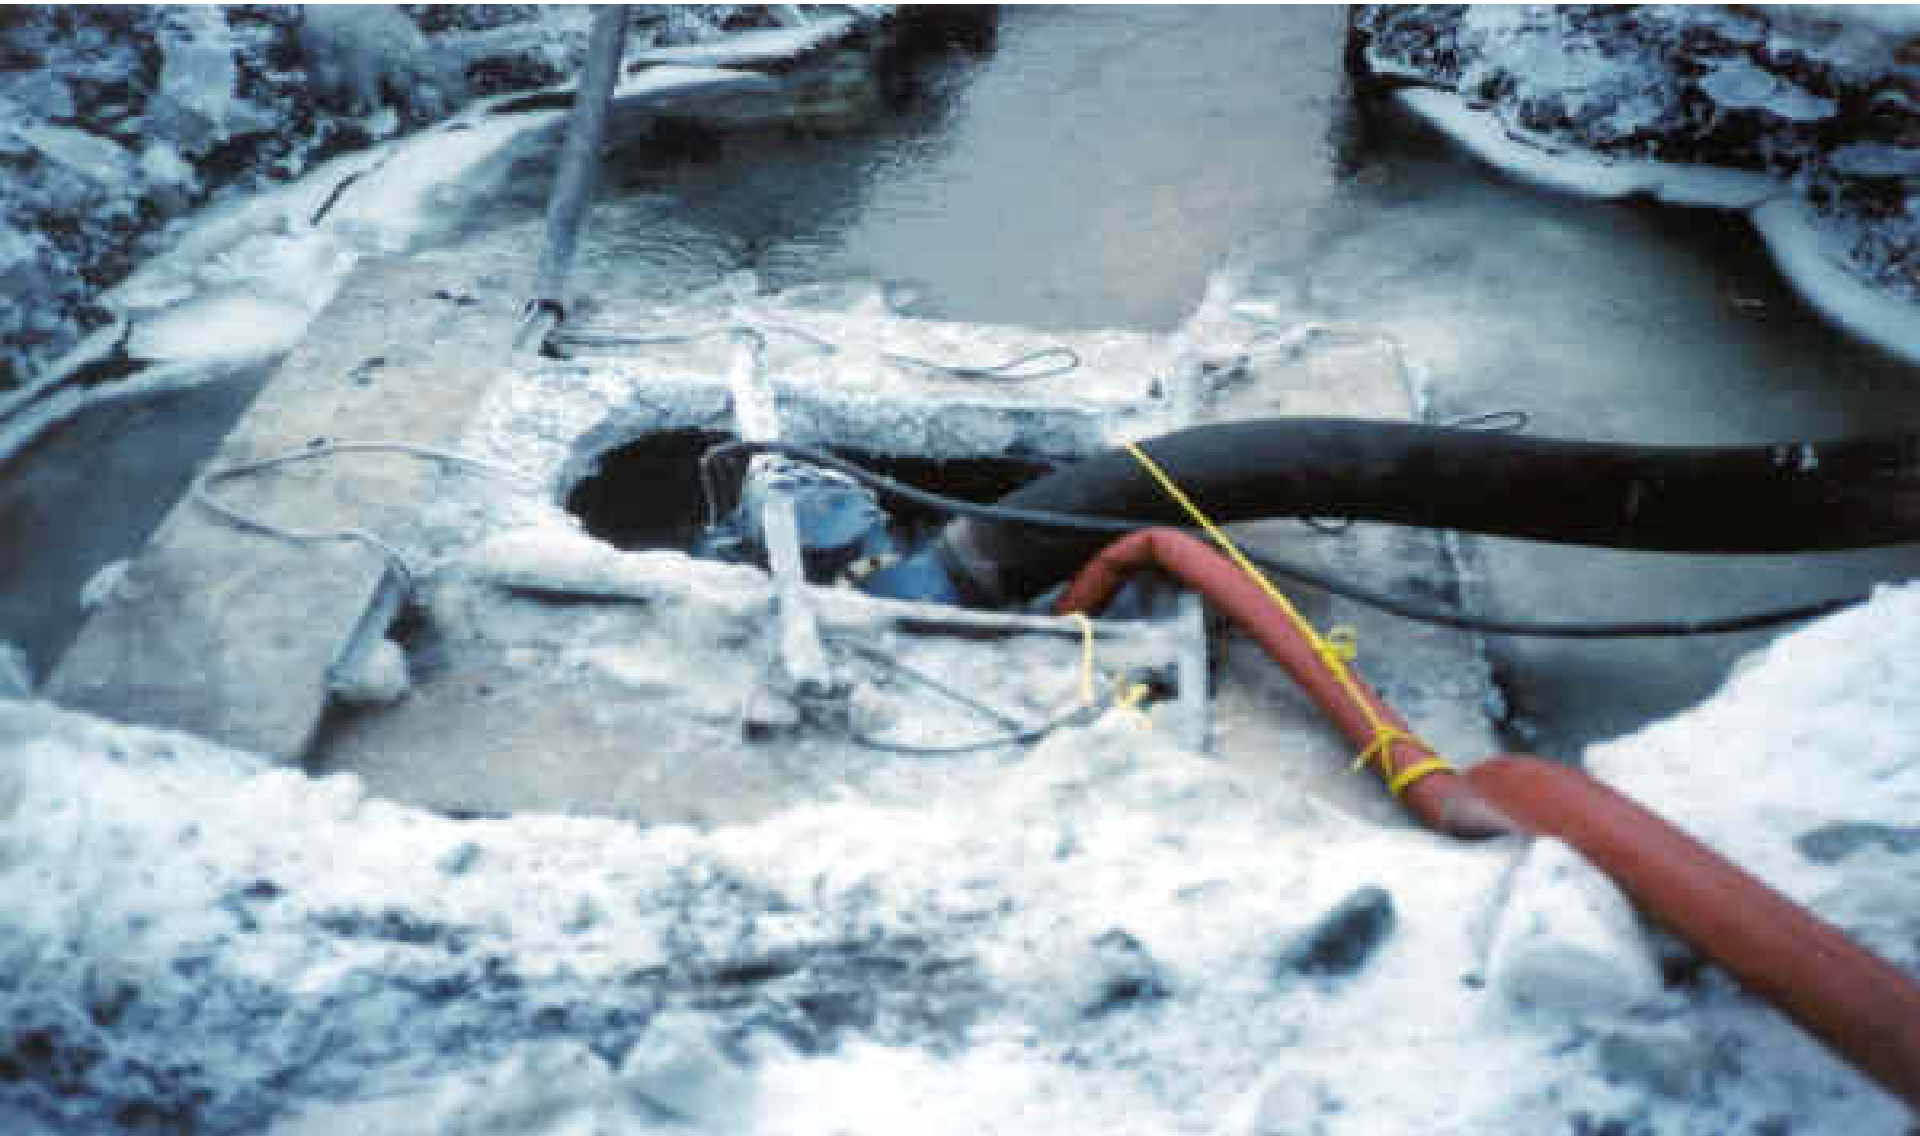
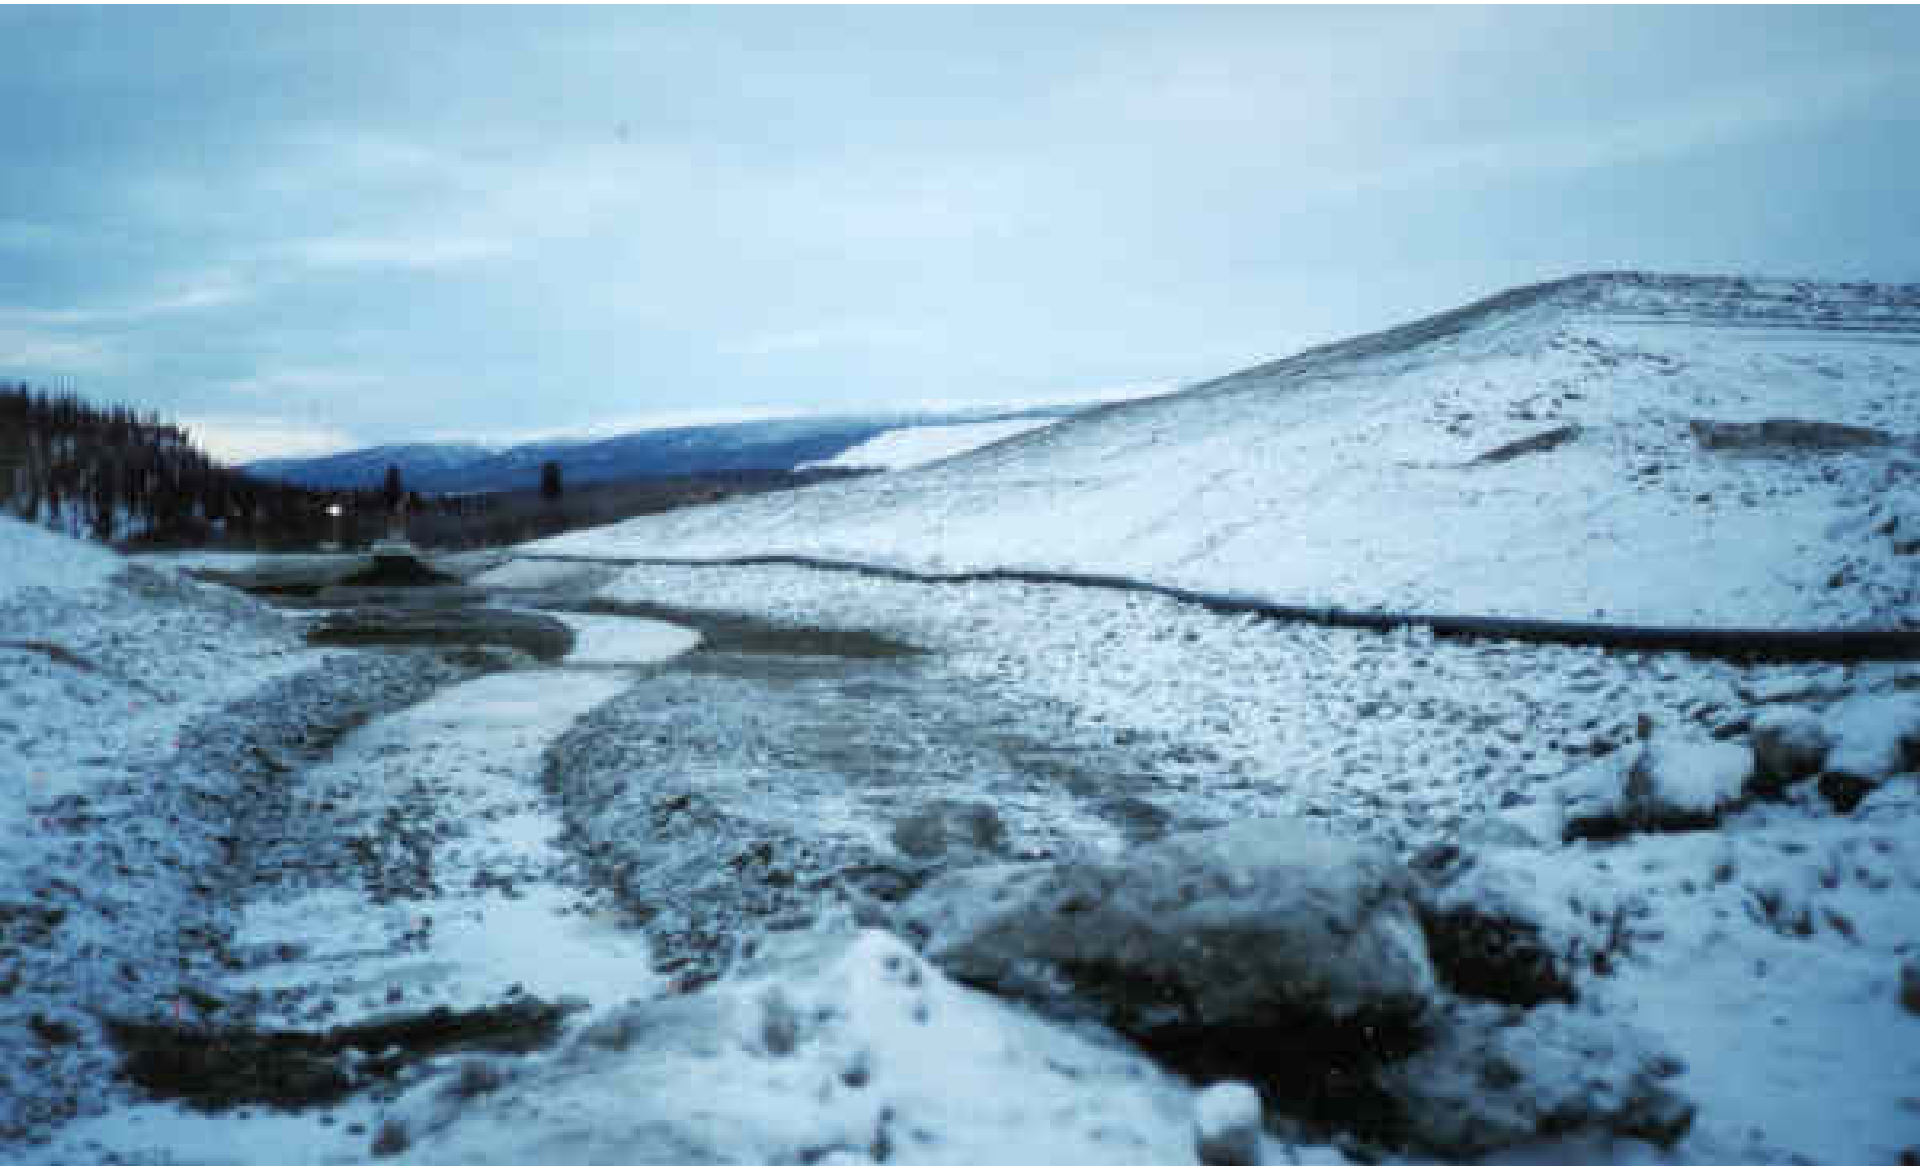
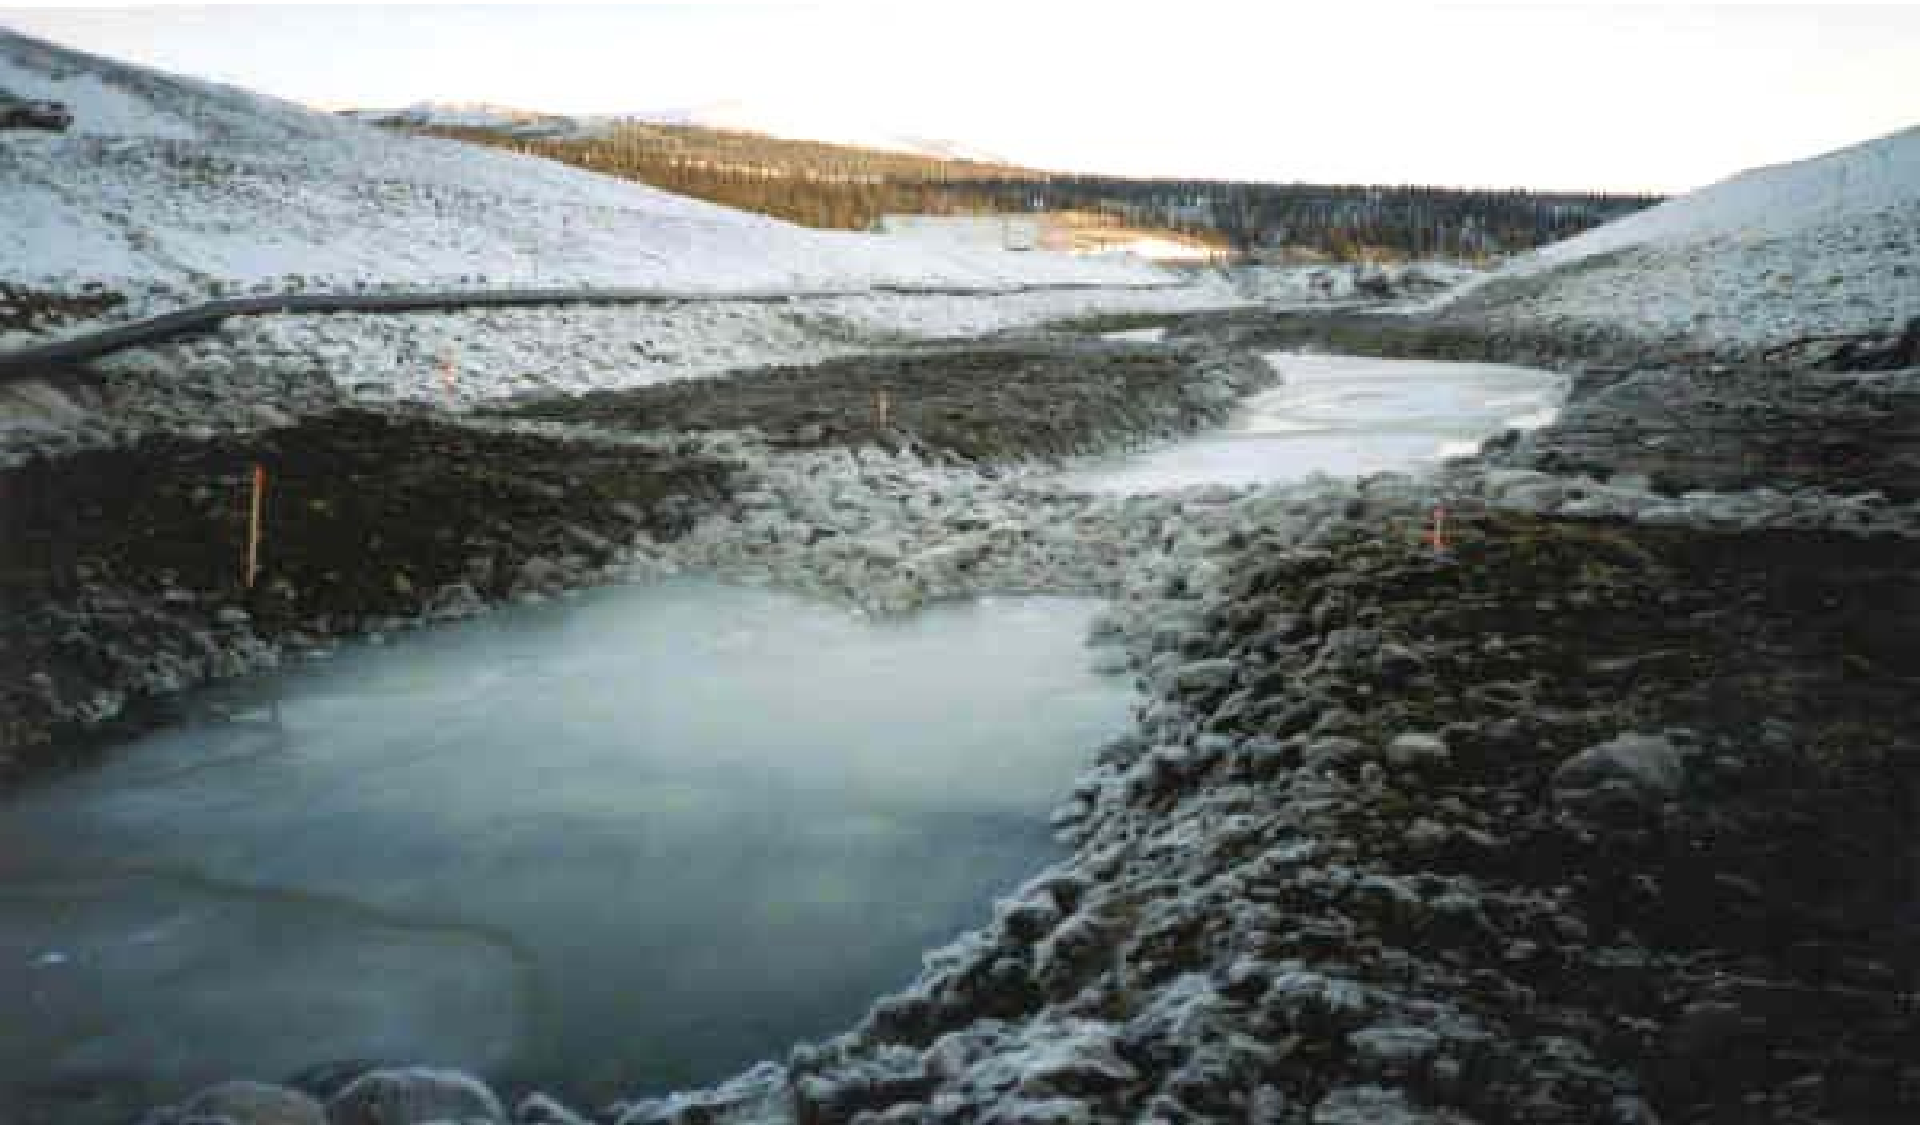
# Fresh Water Supply Dam – Breach Project December 2003

Picture 10, Mr. Treleaven pointed out where the actual breach took place noting that the valve house had been removed.

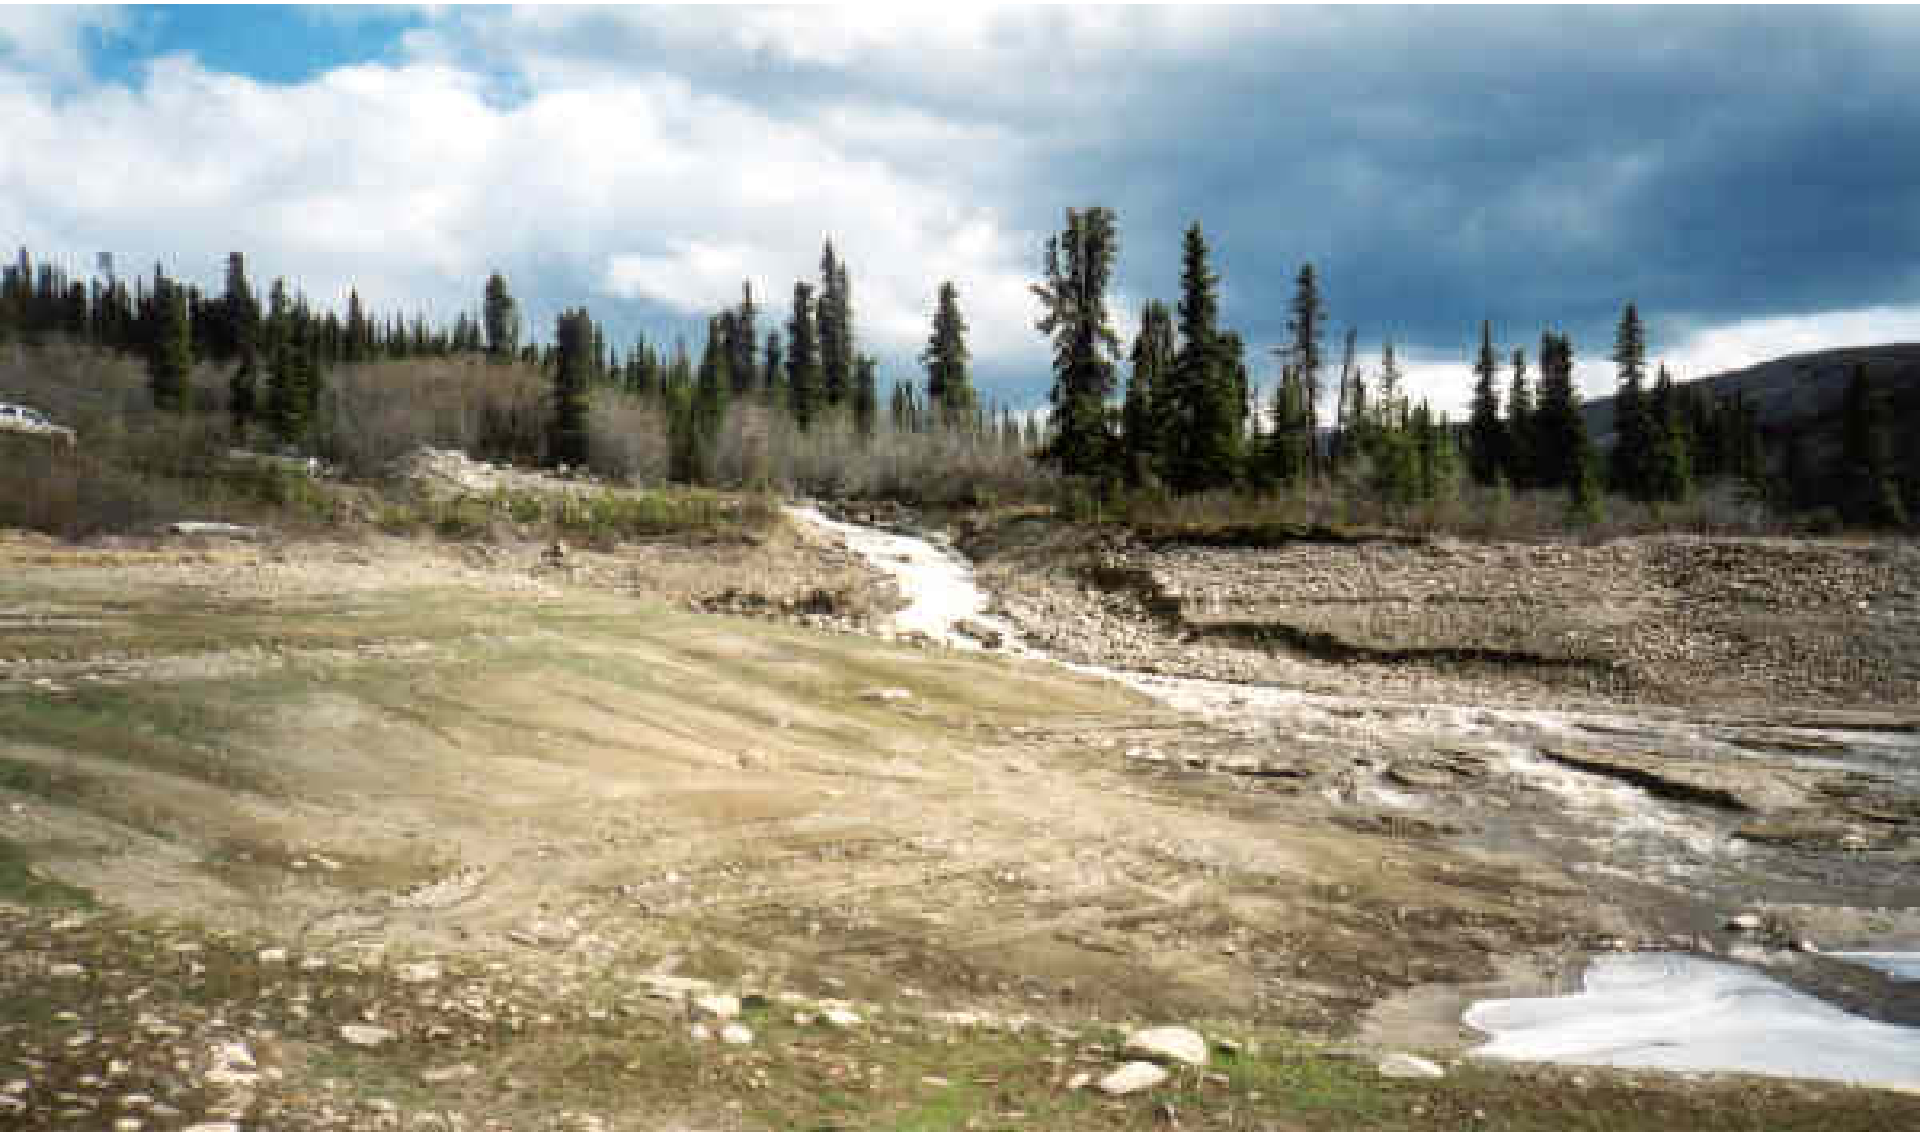
# Fresh Water Reservoir K8 – May 2004

Picture 17 shows one of the tributaries flowing into the FWS Reservoir known as K8. This is one location of two, where regular water monthly samples are taken, the results of which are provided to the community of Ross River as required under the new Water Use Licence. Repairs to this particular area were completed in early spring to limit further erosion of the channel.
