# Community Liaison Committee Meeting

July 7, 2004

# 2004 Care and Maintenance Program

**Subject:** Meeting Minutes - July 7, 2004

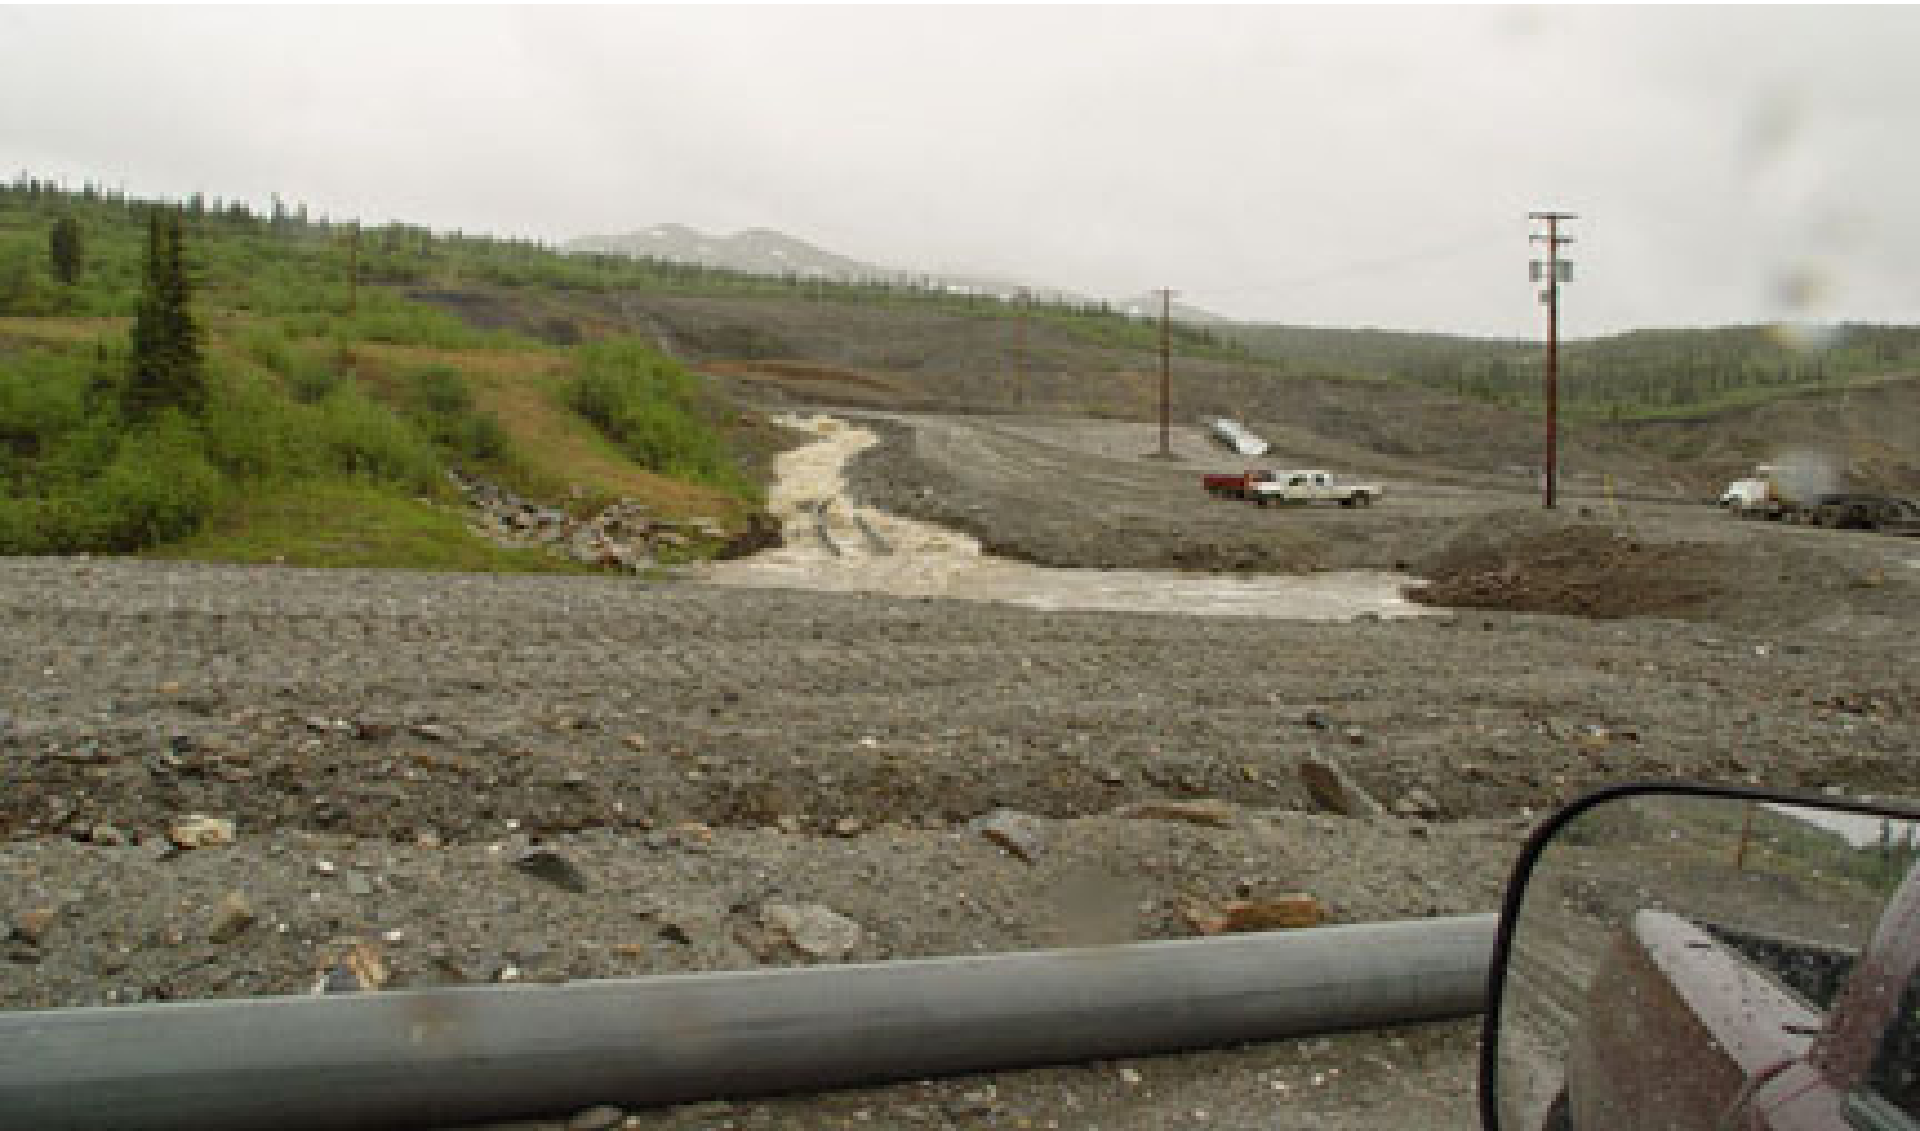
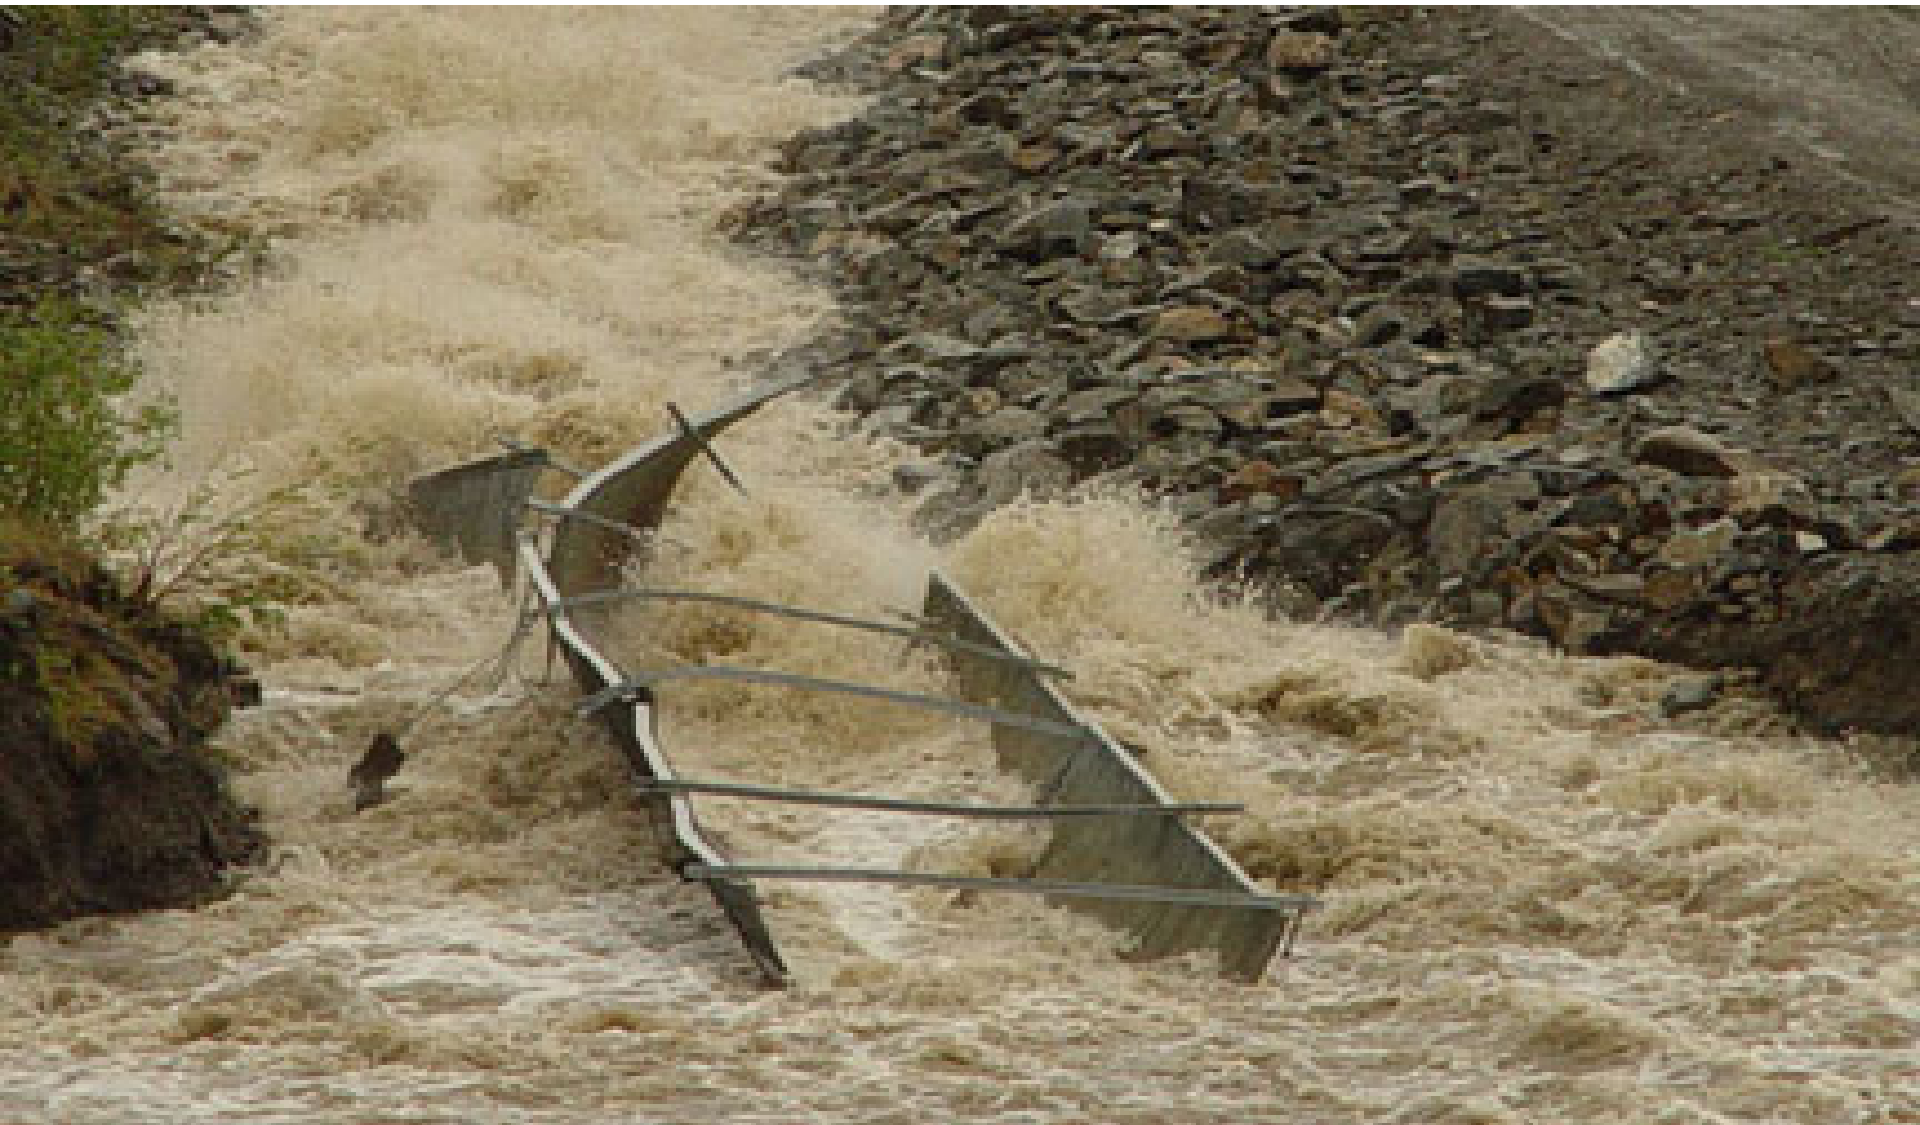
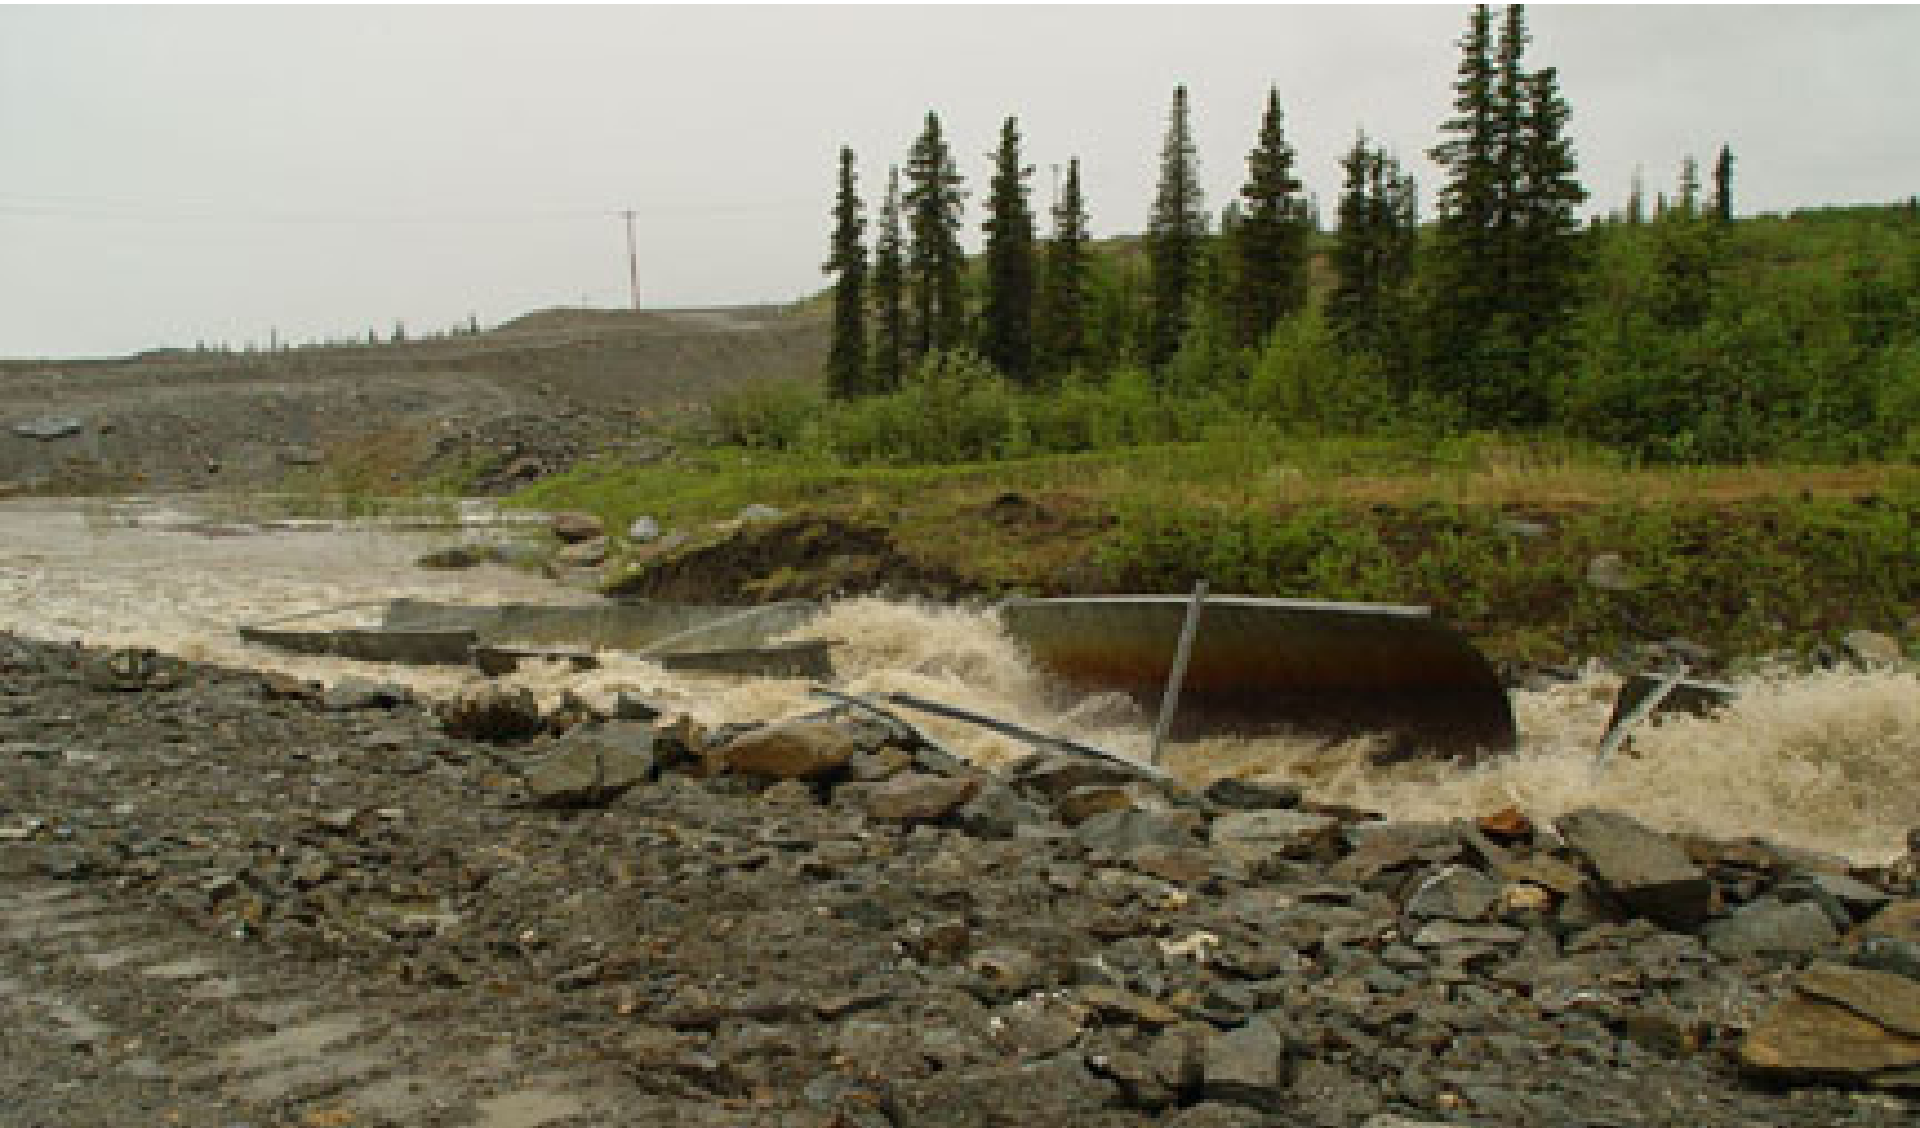
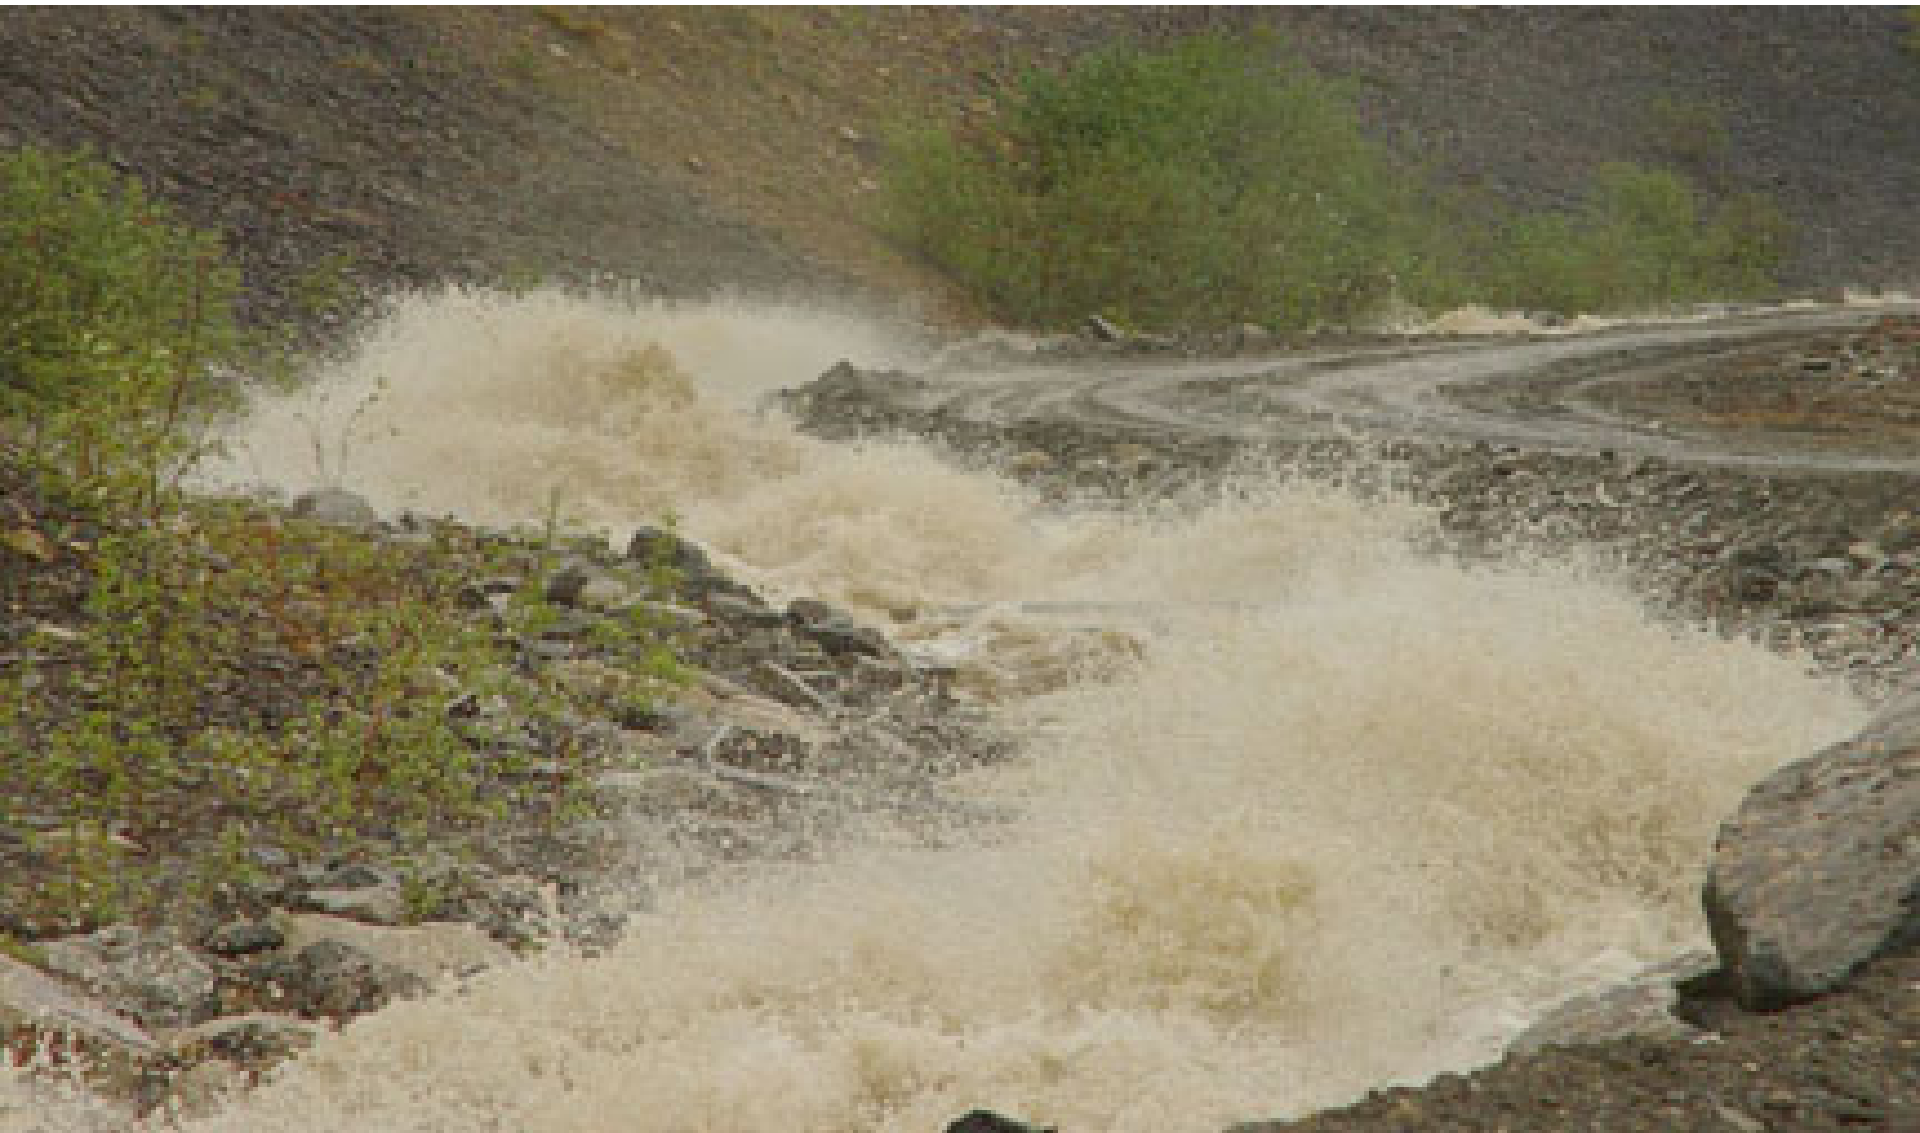
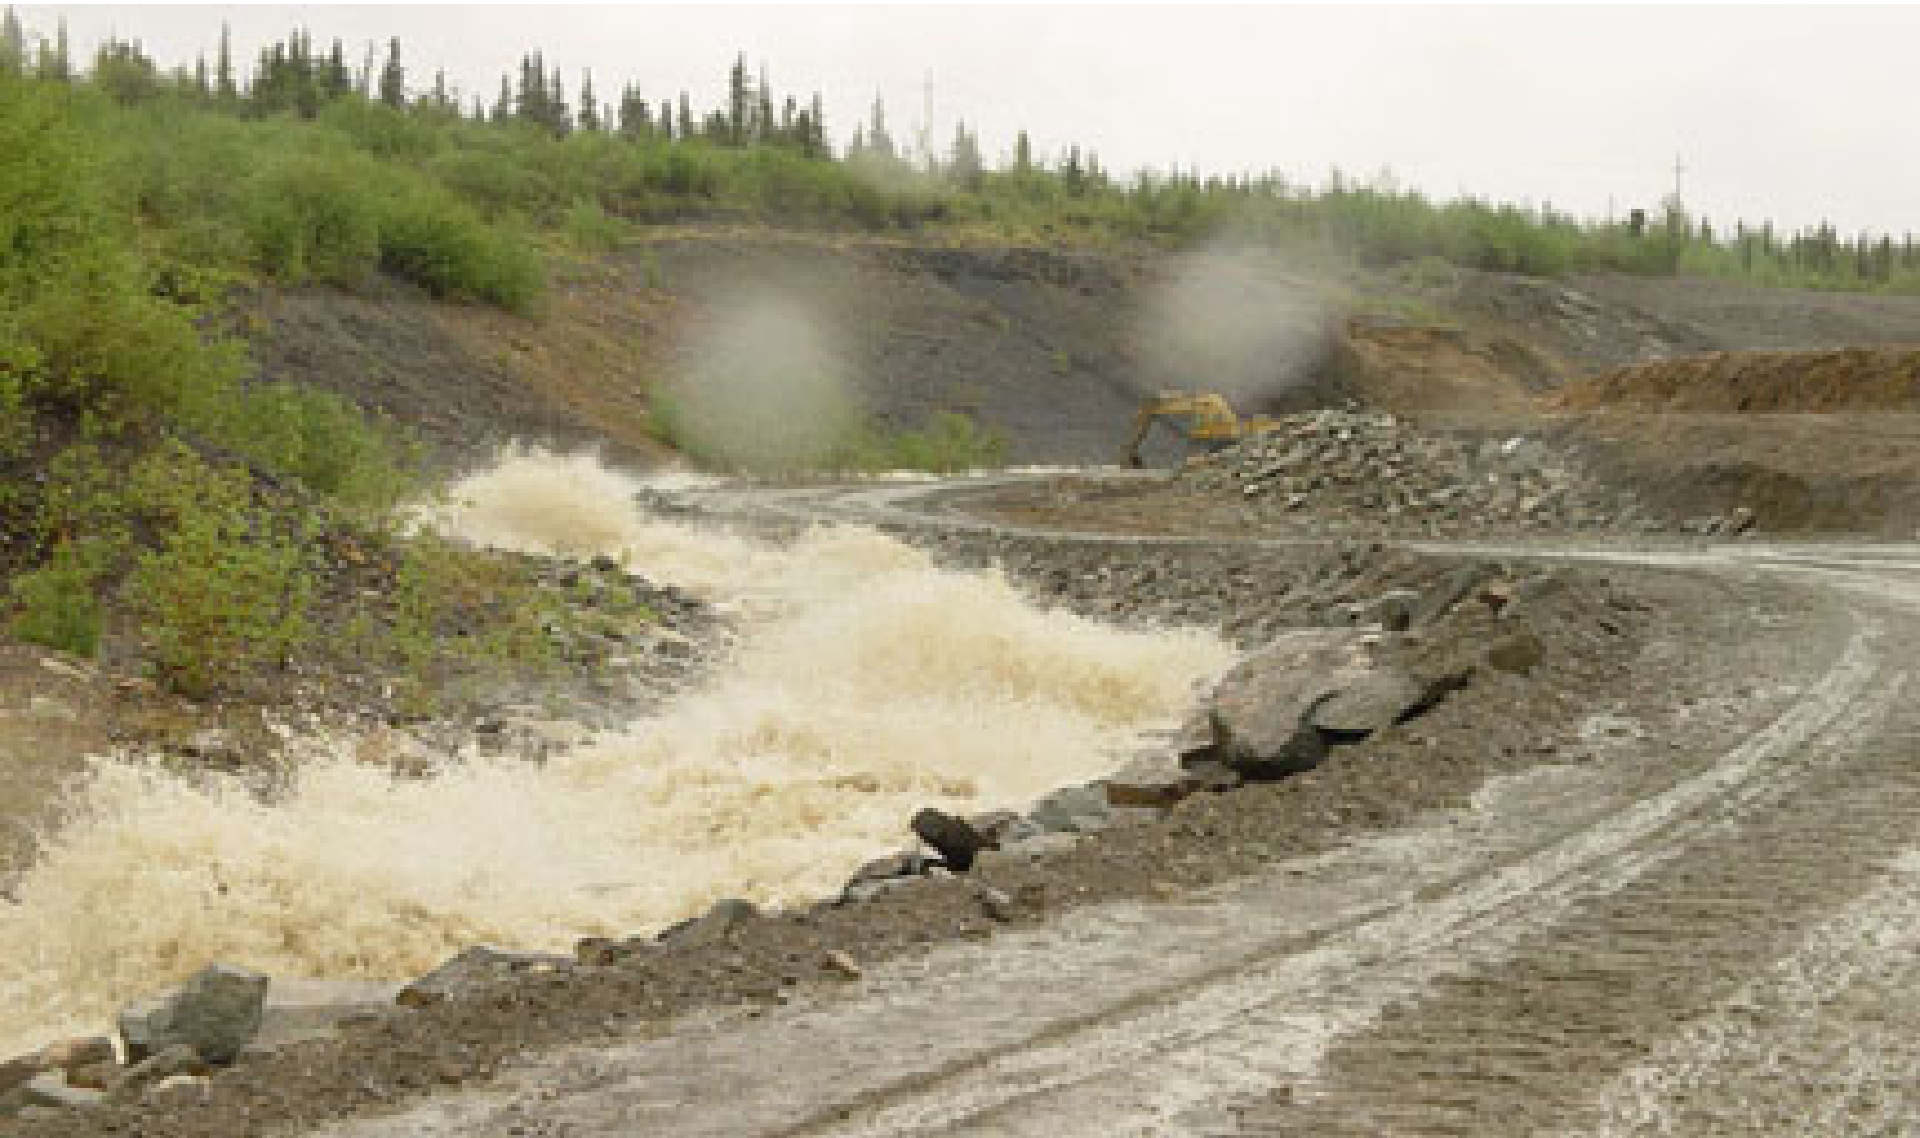
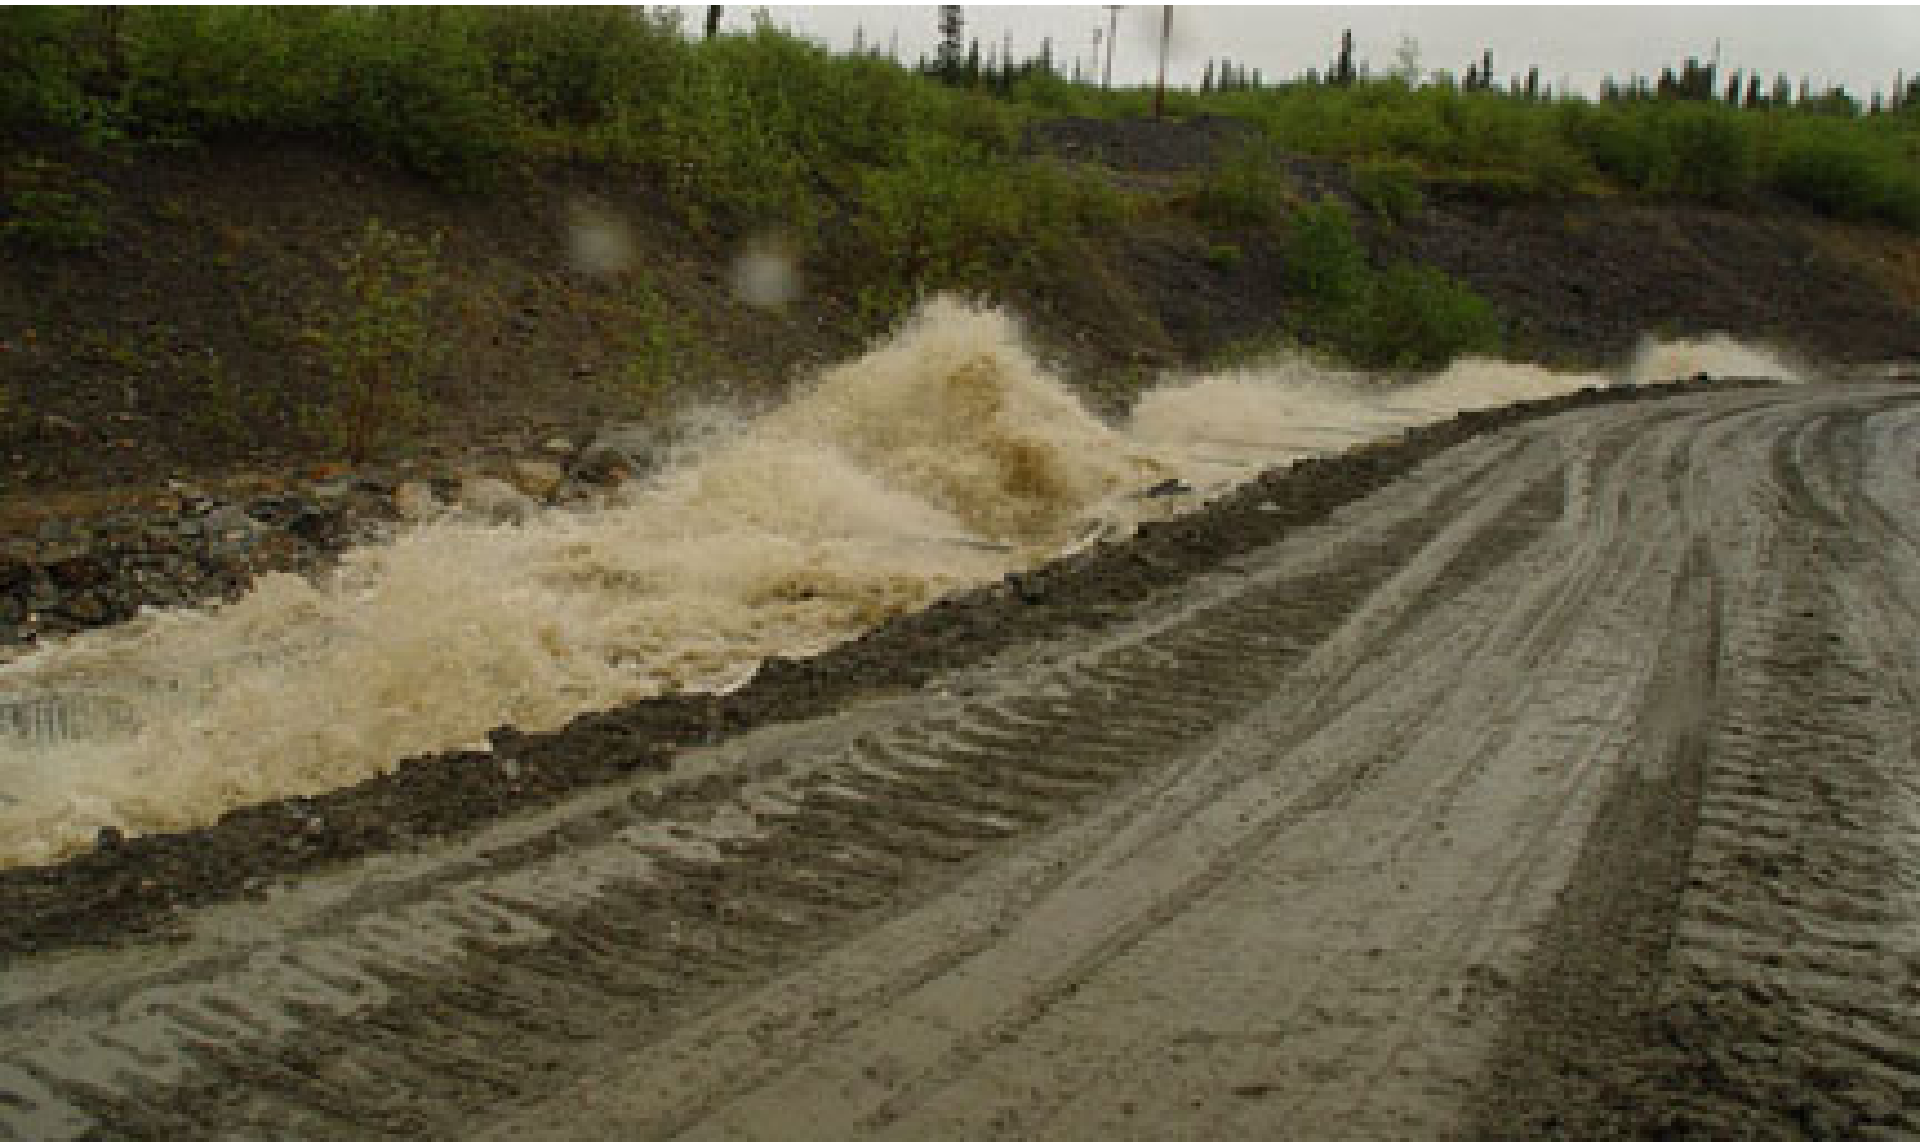
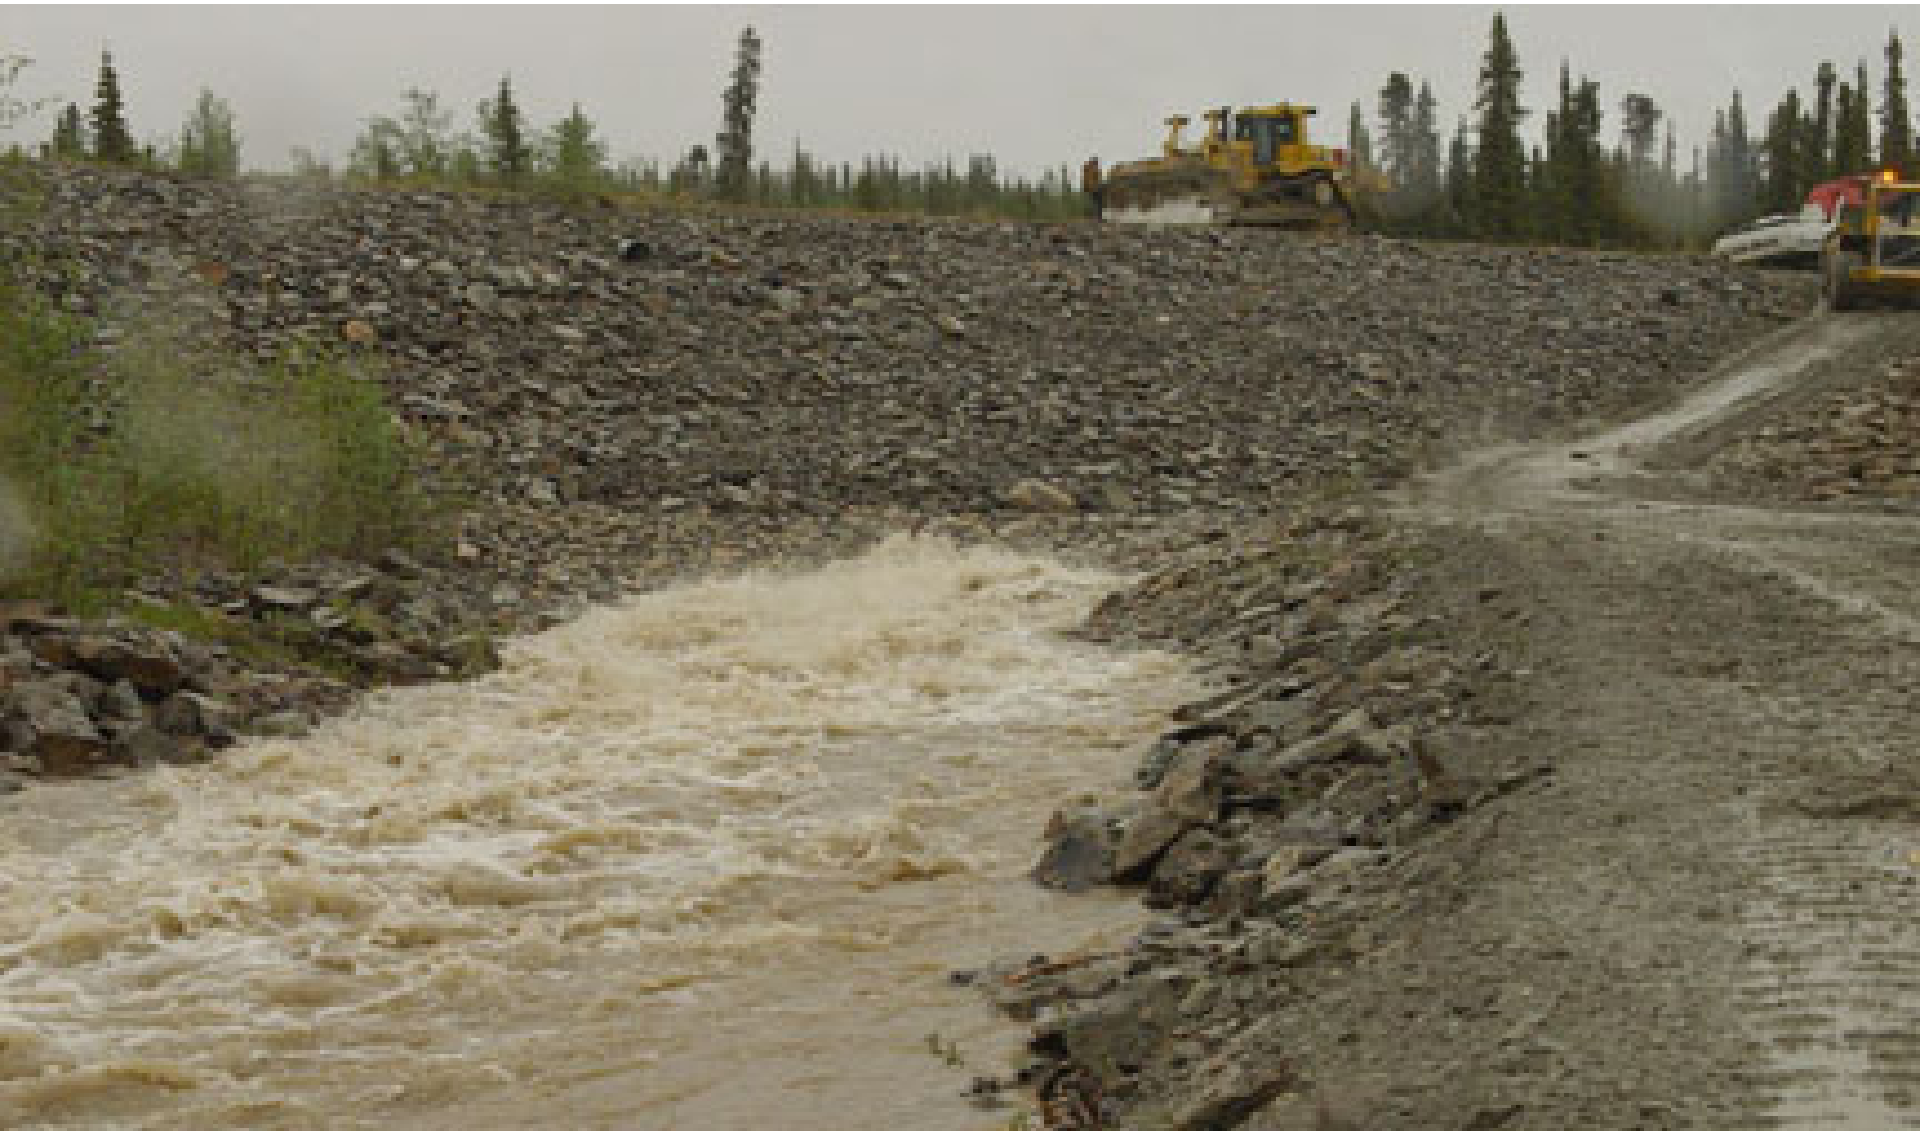
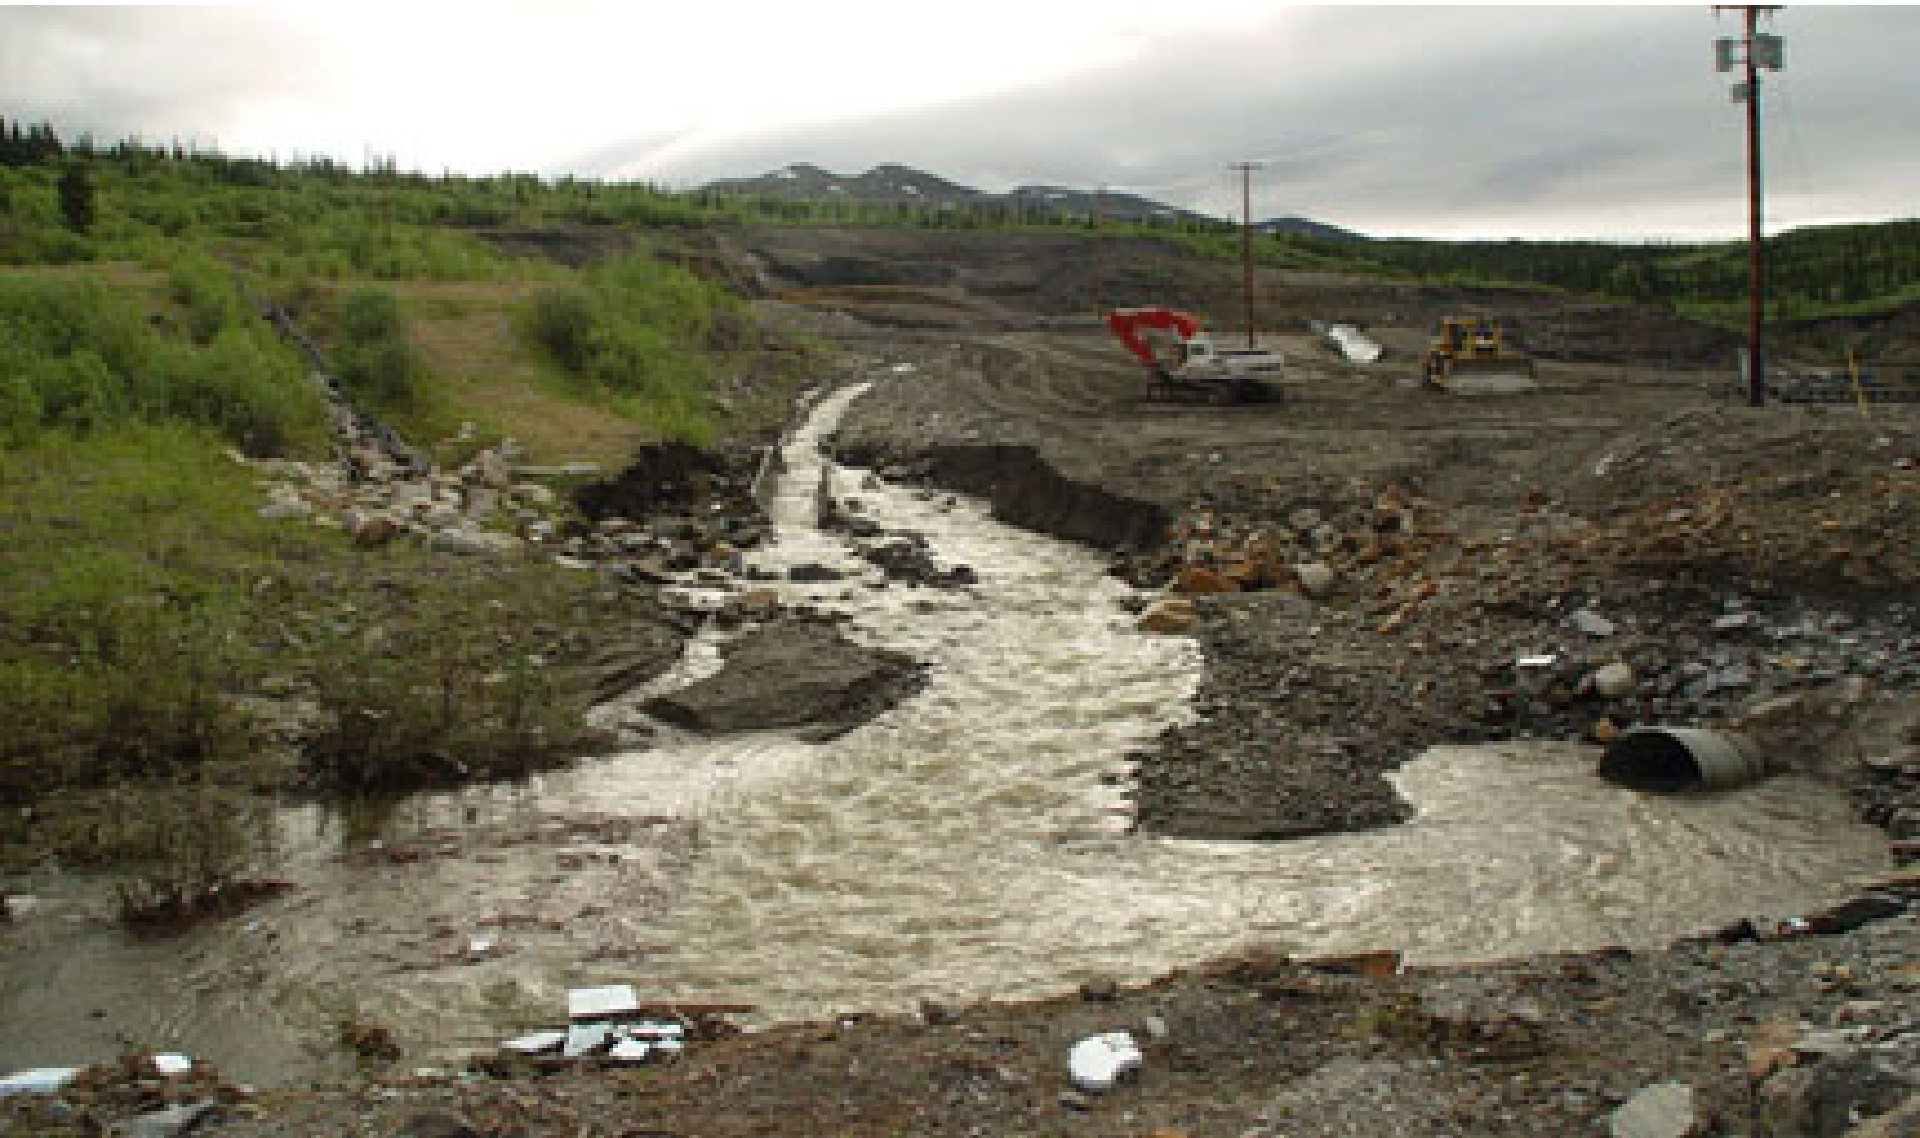
## Vangorda Flume – June 8, 2004

Pictures 69 to 86 - Mr. Treleaven advised that a storm event had occurred on the Vangorda side of the property and the result was illustrated in a series of pictures showing the flood conditions that ran through and badly damaged the Vangorda Flume. During the evening of June 7<sup>th</sup>, rain started to fall within the town of Faro and over the mine property, however, it was very concentrated within the Vangorda Valley area. The evening inspection showed that the Vangorda flume was flowing at three quarters of its capacity. During the early morning inspection which took place at 5:45 a.m. on June 8<sup>th</sup>, site personnel found that water was flowing outside of the actual flume and that a small amount of water had started to back up behind the headworks (a dam at the top of the Vangorda Flume which provides road access to the Vangorda Water Treatment Plant). An emergency response program was immediately initiated and equipment was mobilized to this side of the property including a bulldozer and backhoe. Within an hour, conditions worsened and a backhoe was used to hold portions of the flume sections in place. The latter were being lifted as a result of the significant amount of water flowing under the flume sections (pictures 73). Water behind the headworks was rapidly rising and equipment was put in place to build a breach of the roadway and relieve the pressure. By 10:00 a.m., water was nearing the top of the dam. Picture 77 shows the location of the breach and Picture 78 shows the level of water behind this eight metre dam. The result of

this storm event, which the engineers now believe was greater than a 1:100 year event , has extensively damaged the Vangorda Flume.

Pictures 80 to 86 - These pictures show the sizable amount of erosion that occurred at the lower end of the flume including the damaged flume sections (Picture 81). Mr. Treleaven indicated that within one day the water had receded and repair work had been commenced to ensure that the flume was stable.

A: The chances of this type of event occurring again next year are dependent on the timing and magnitude of the event and the capacity of the Vangorda Flume. The Vangorda Flume was designed to handle a 1:100 year storm event. An analysis to assess the magnitude of the June 8<sup>th</sup> event was performed and it was found that the localized or 'cell' event exceeded the 1:100 year storm rating. The chance of this occurring are then related to the likelihood that a storm event greater than a 1:100 year storm event will occur. The damages to the Vangorda Flume have been assessed and funds have been authorized by the Department of Indian and Northern Affairs to complete the repairs over the course of the summer and fall.
