# Community Liaison Committee Meeting

July 7, 2004

# 2004 Care and Maintenance Program

**Subject:** Meeting Minutes - July 7, 2004

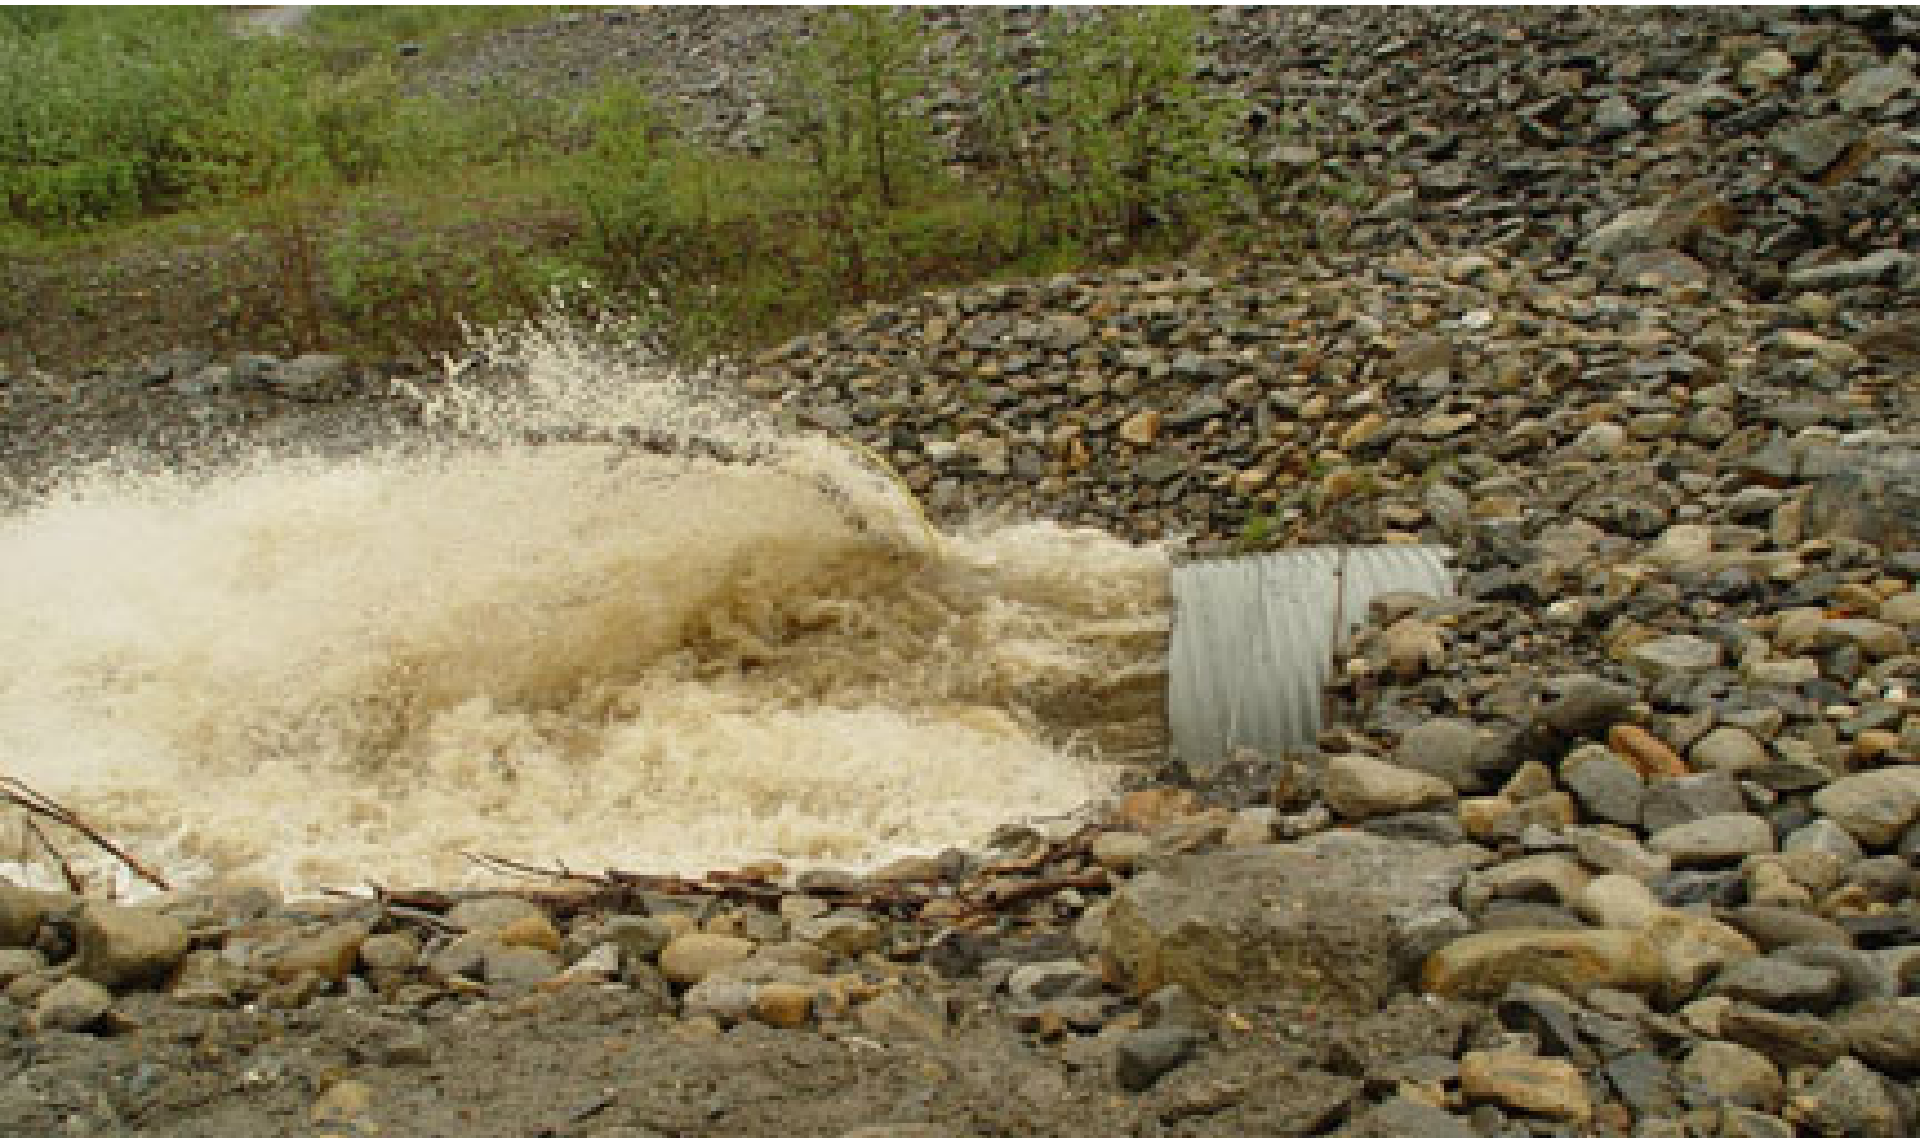
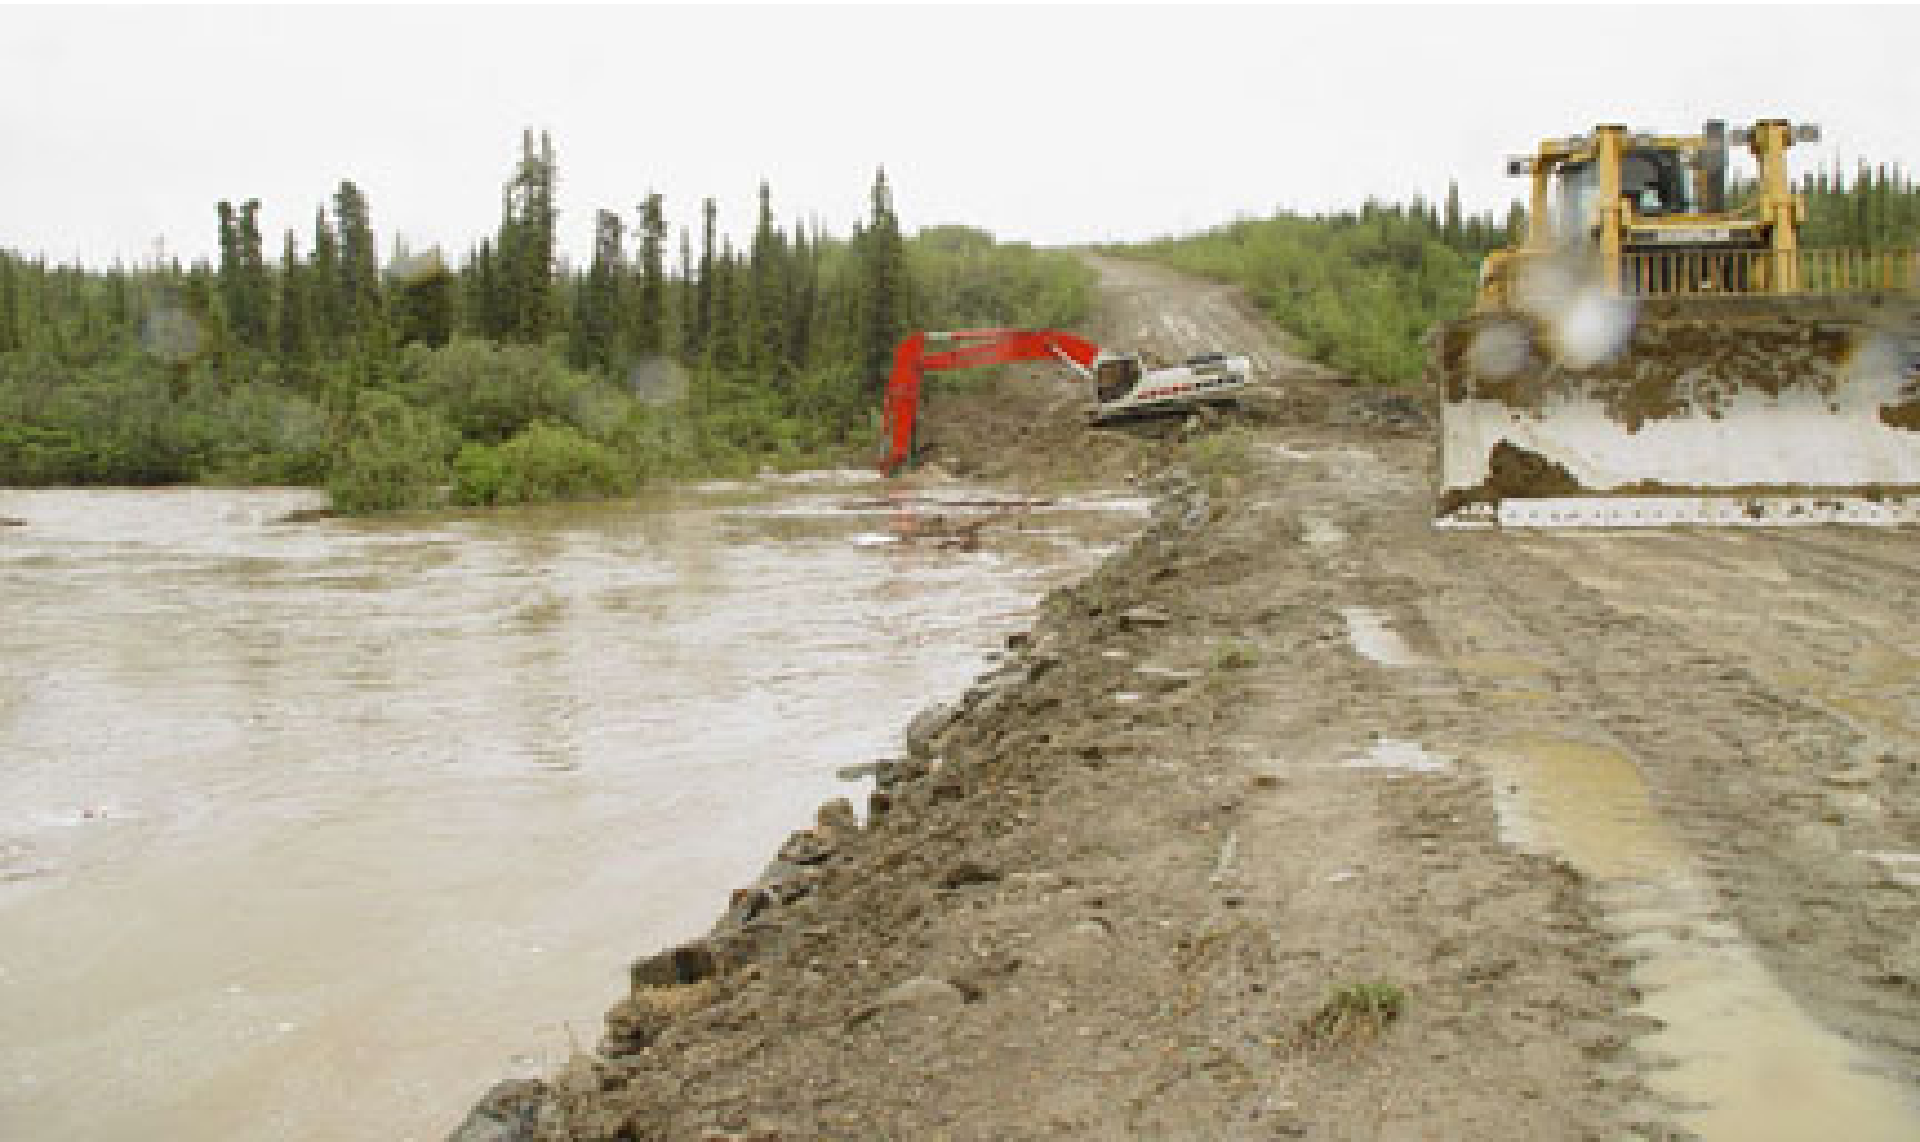
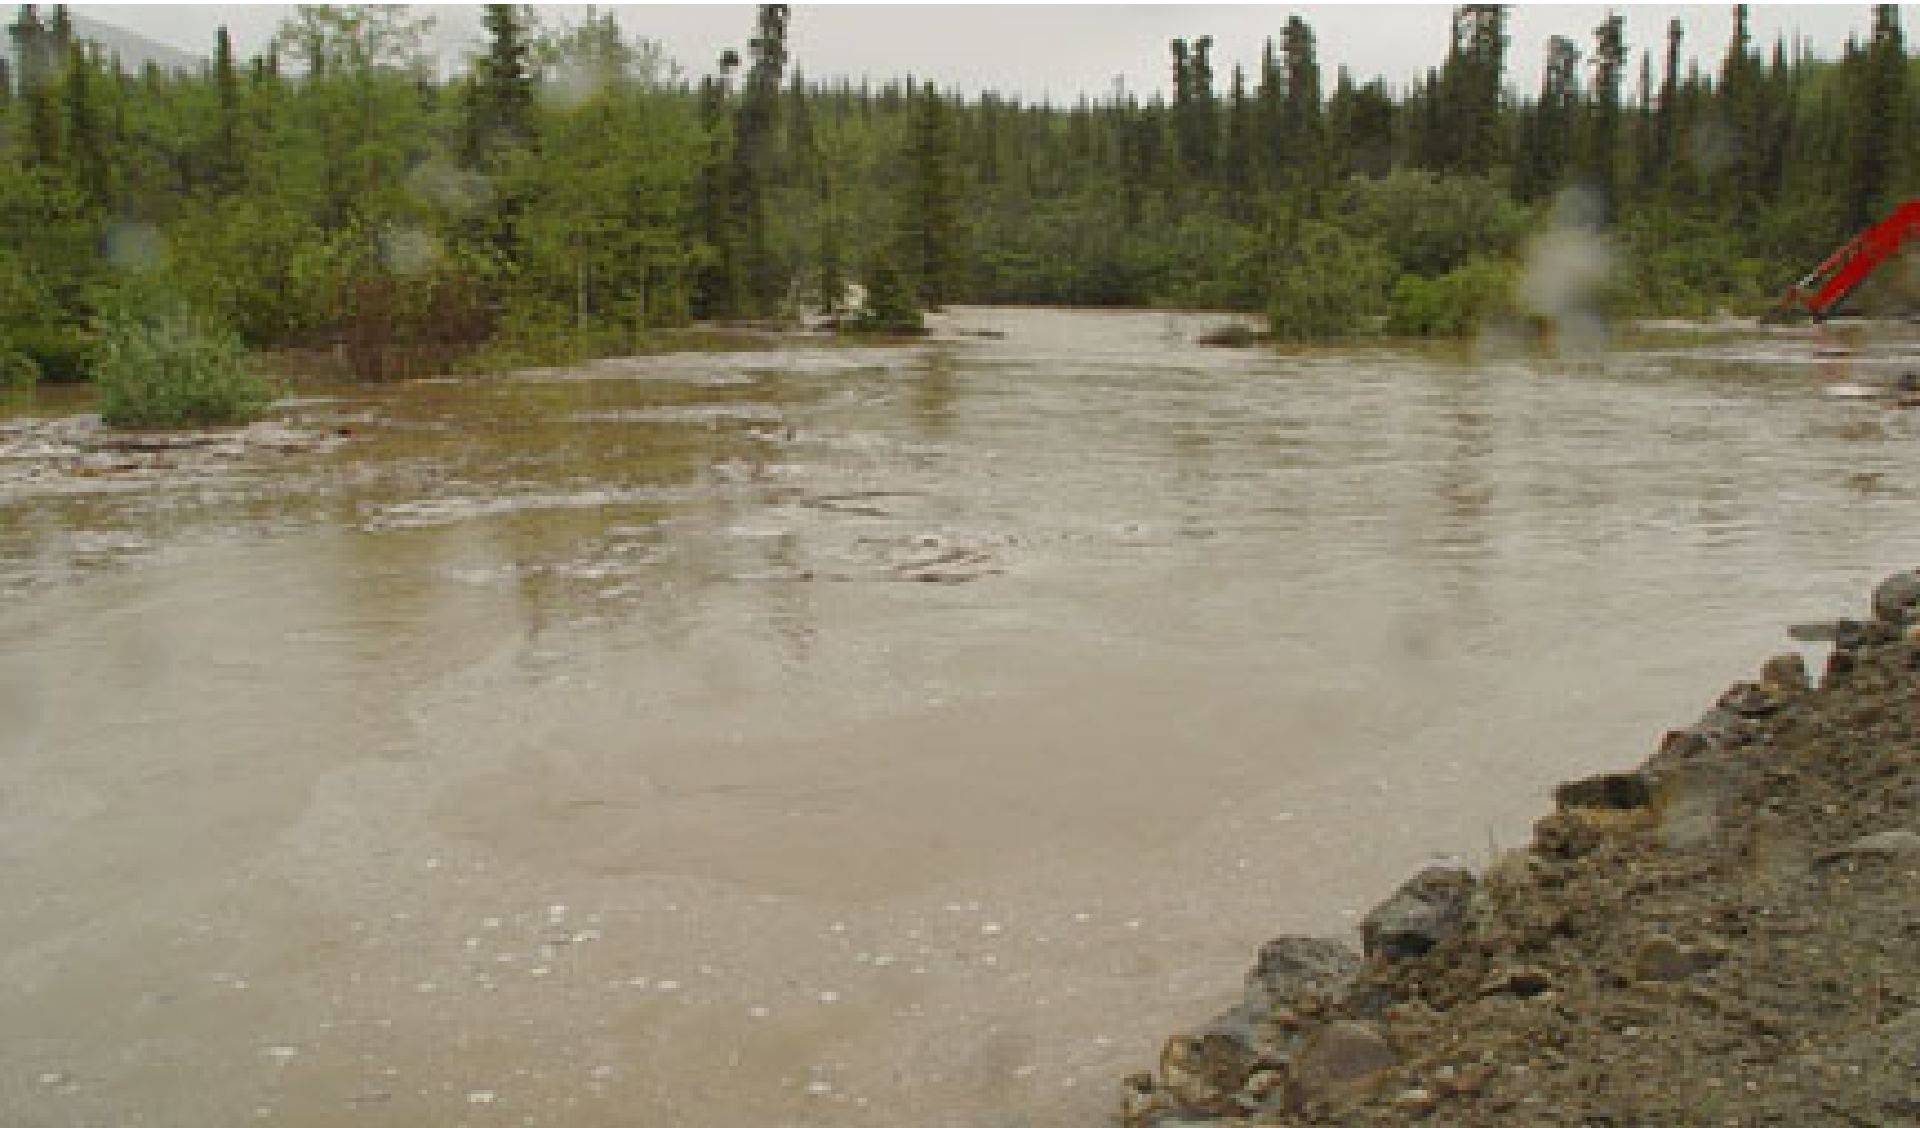
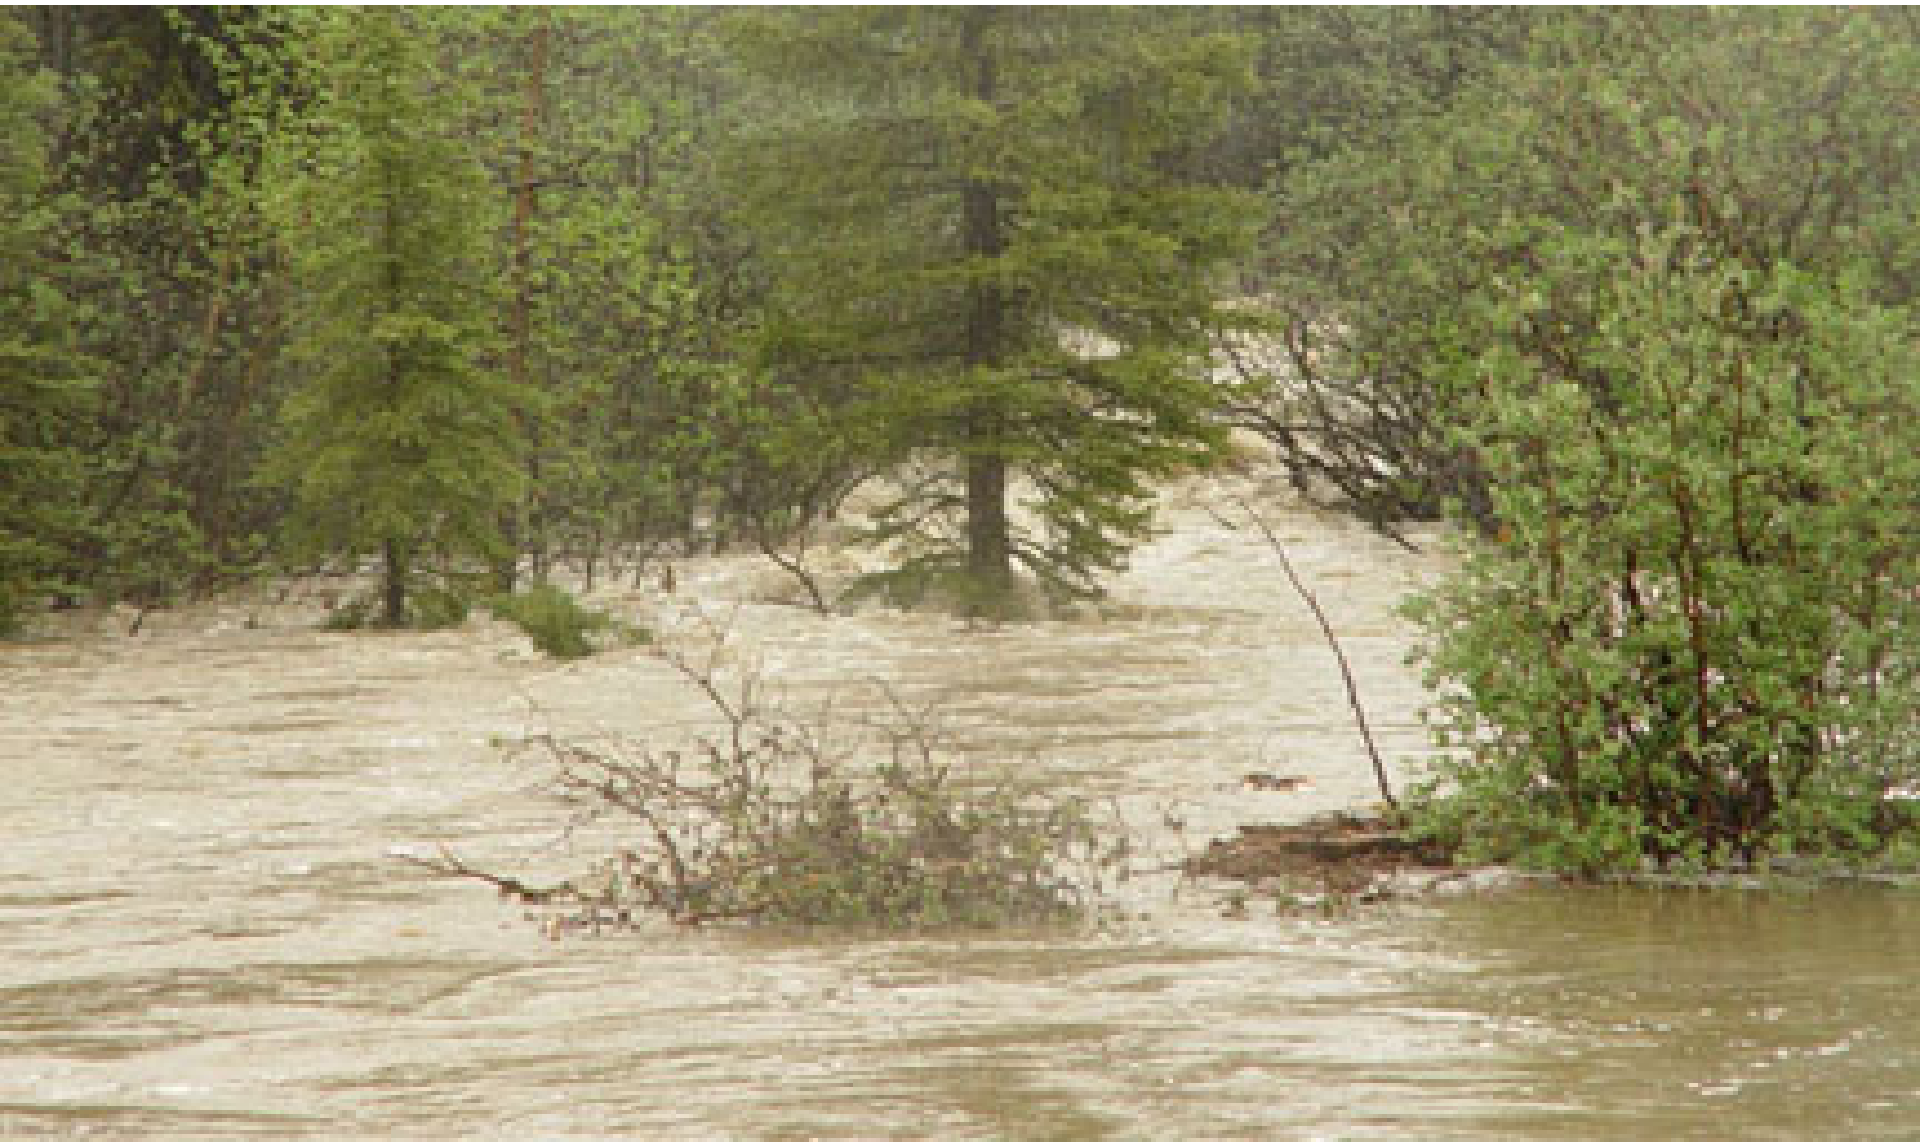
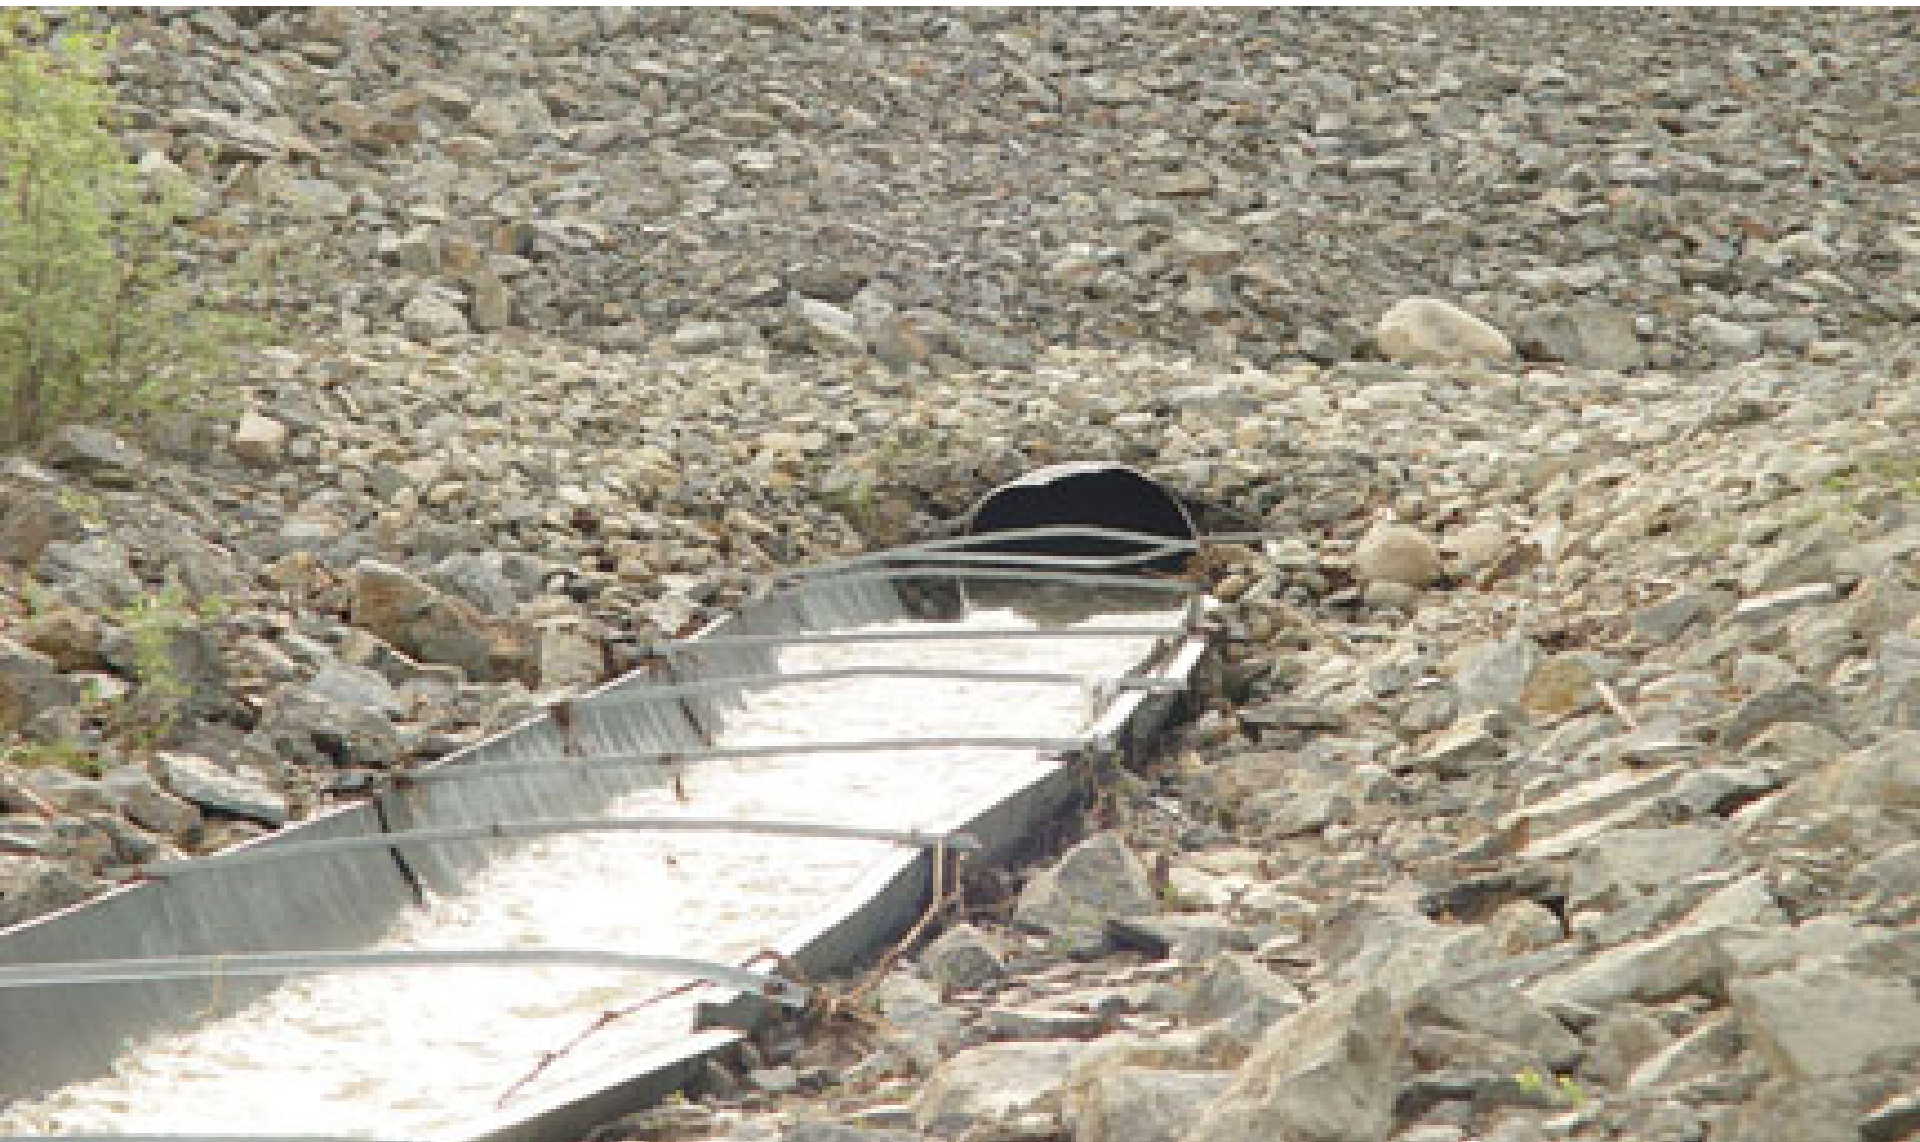
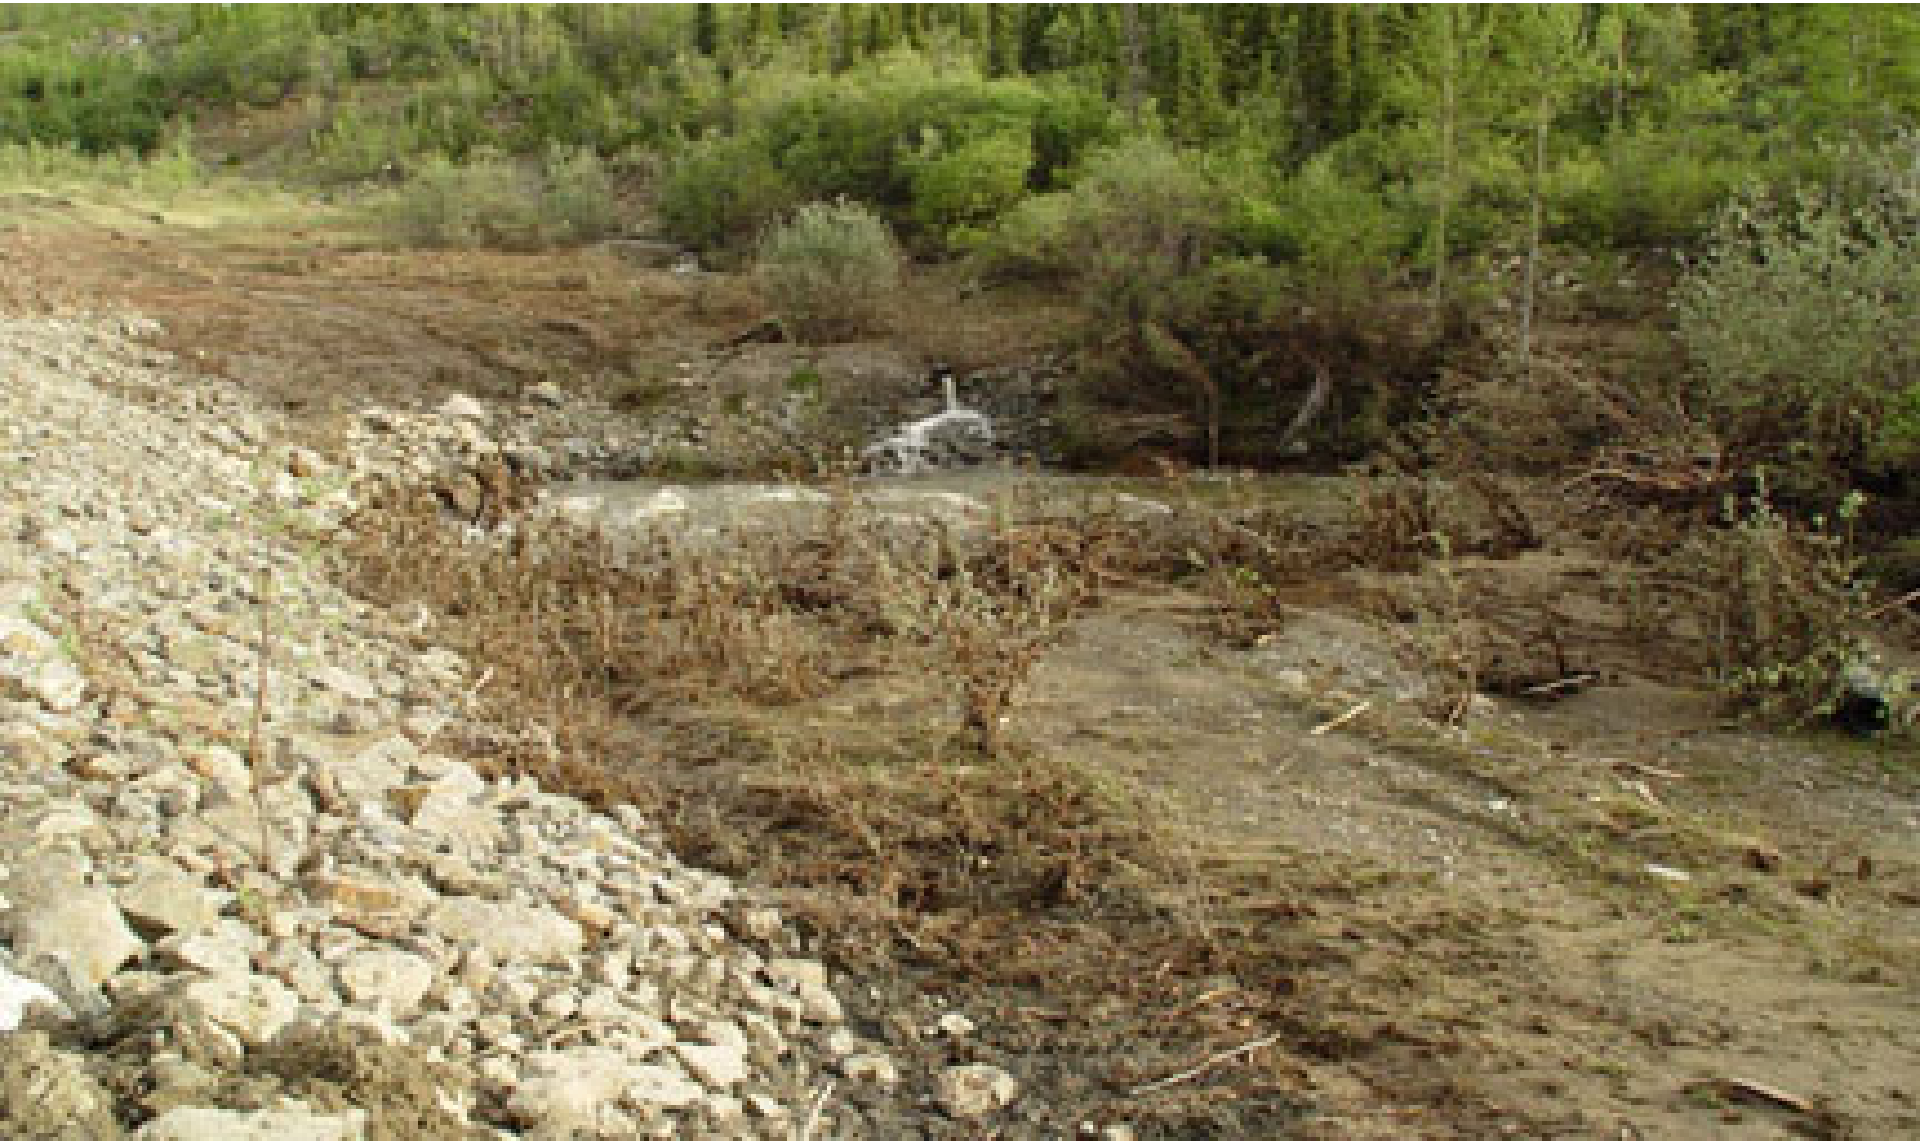
## Headworks Calvert – June 8, 2004

## Vangorda Headwork – June 8, 2004
