# Draft Baseline Environmental Report United Keno Hill Mines Property

Project Reference Number SRK 1CA009.000

January 2007

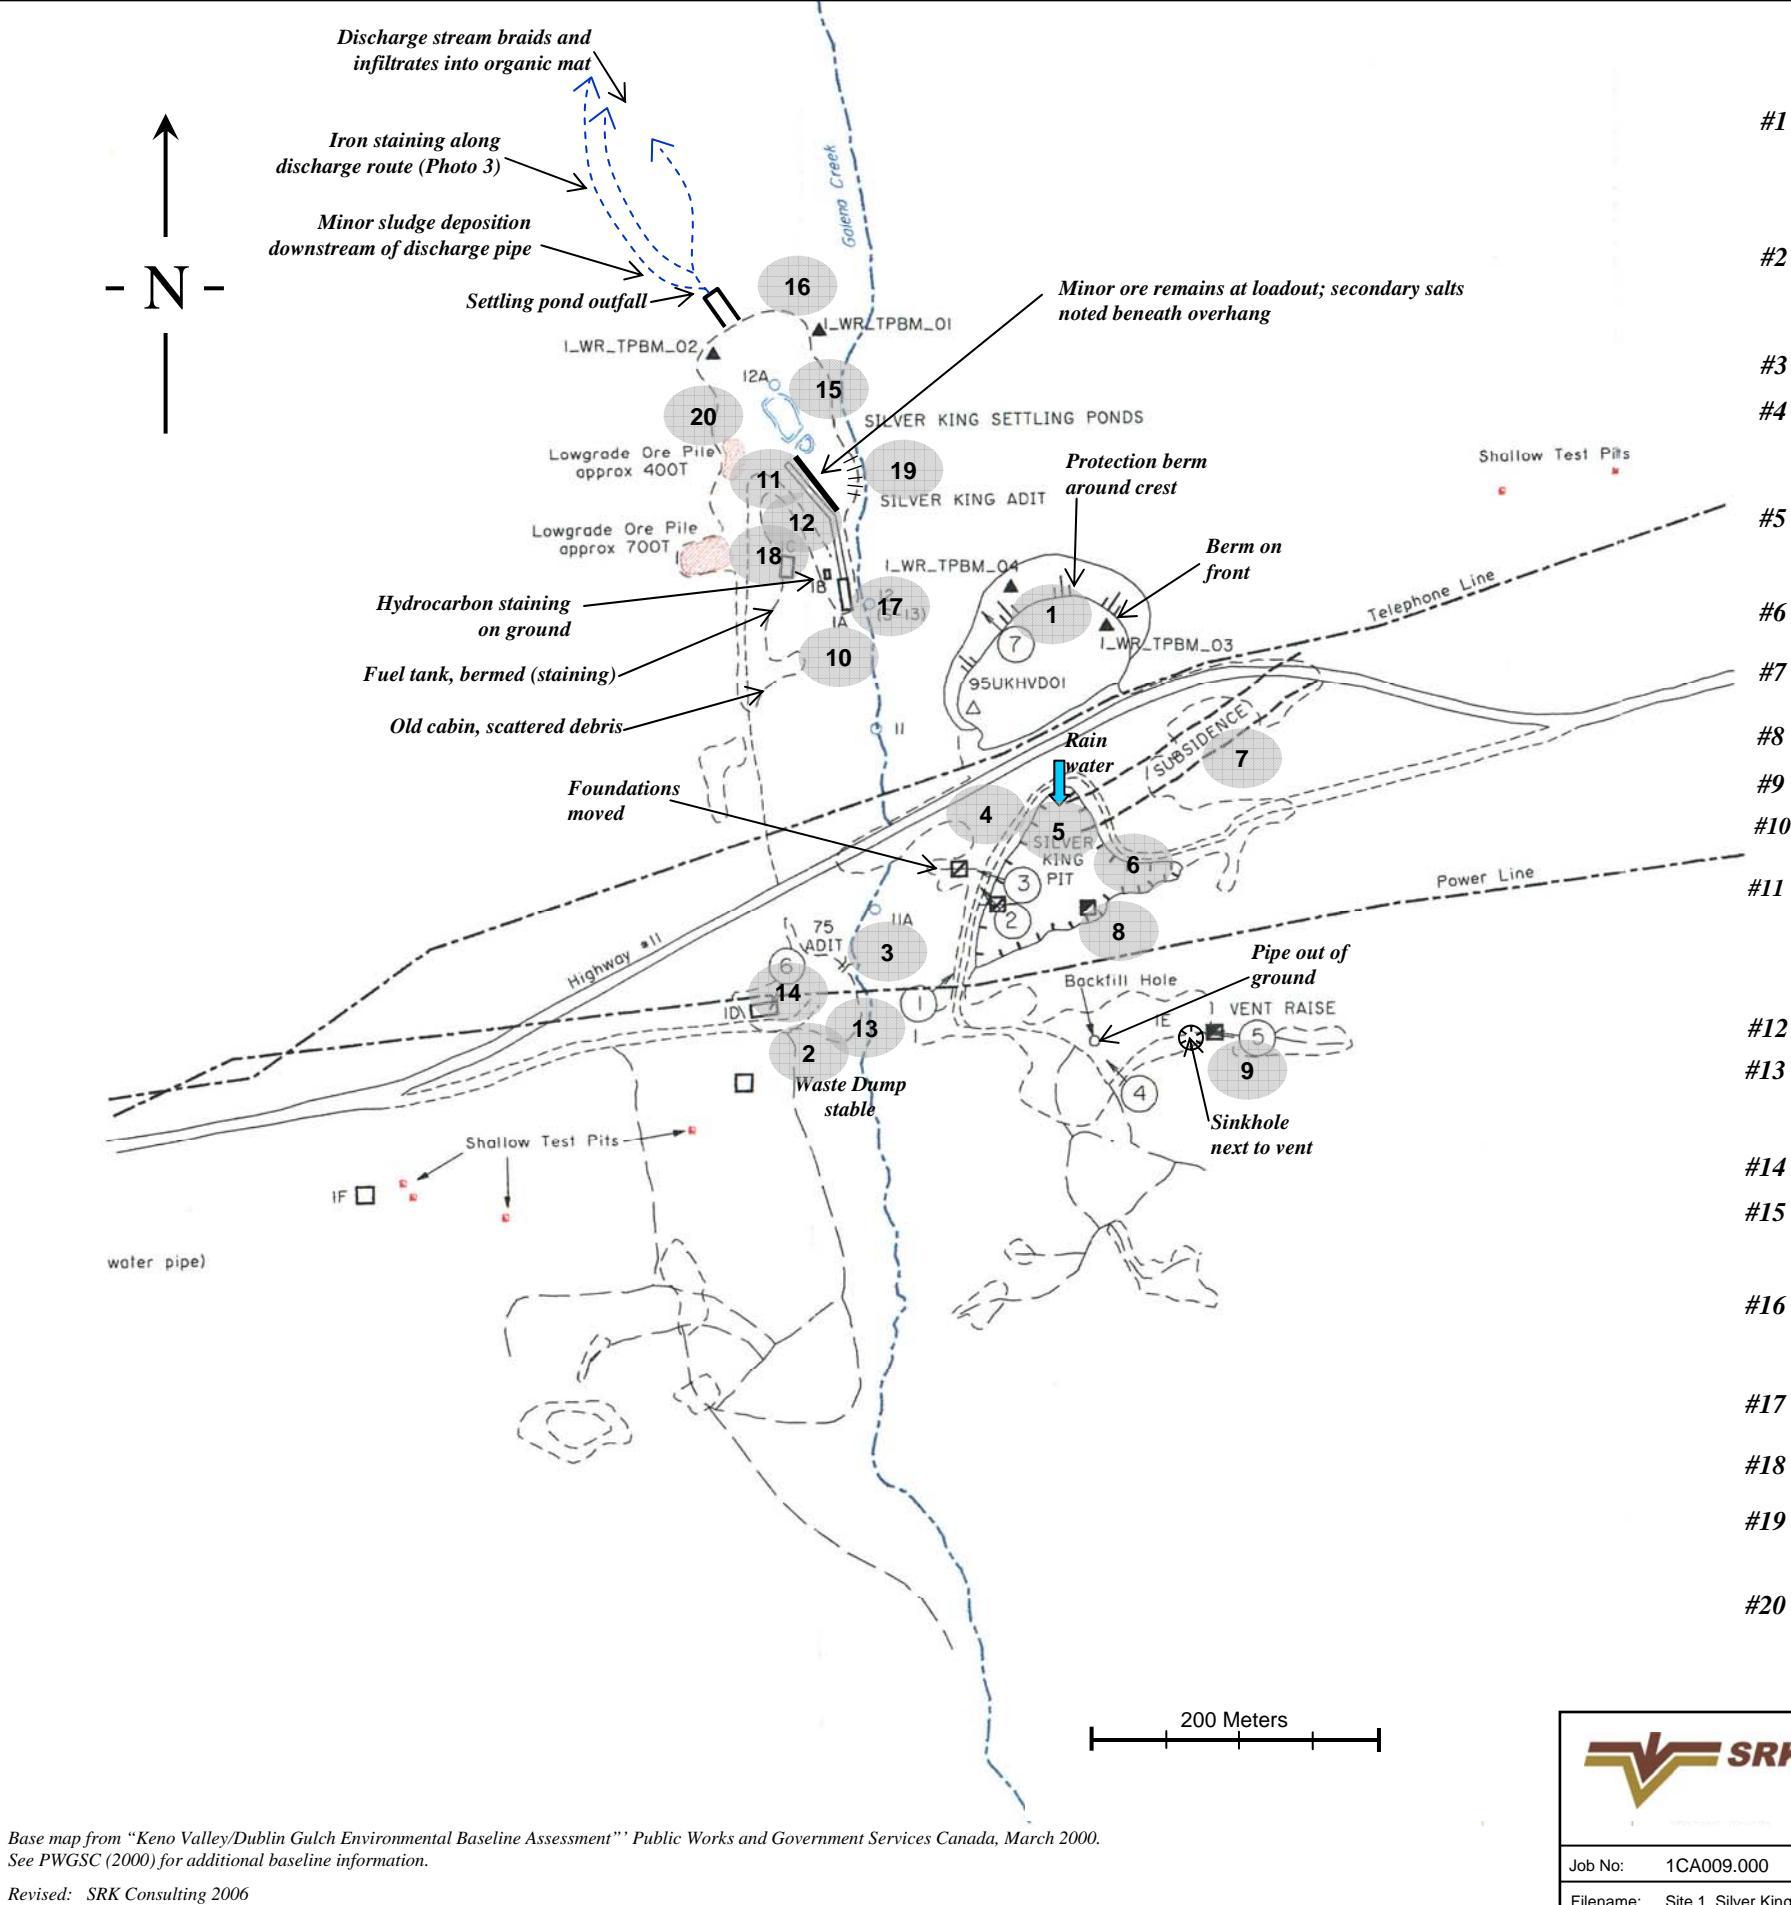
Site #1 – Silver King

- Subsidence on the top of the dump is an old feature. - The dump has a protection berm around the crest.
- Some limited creep cracks and desiccation cracks are noted on the top of the dump.

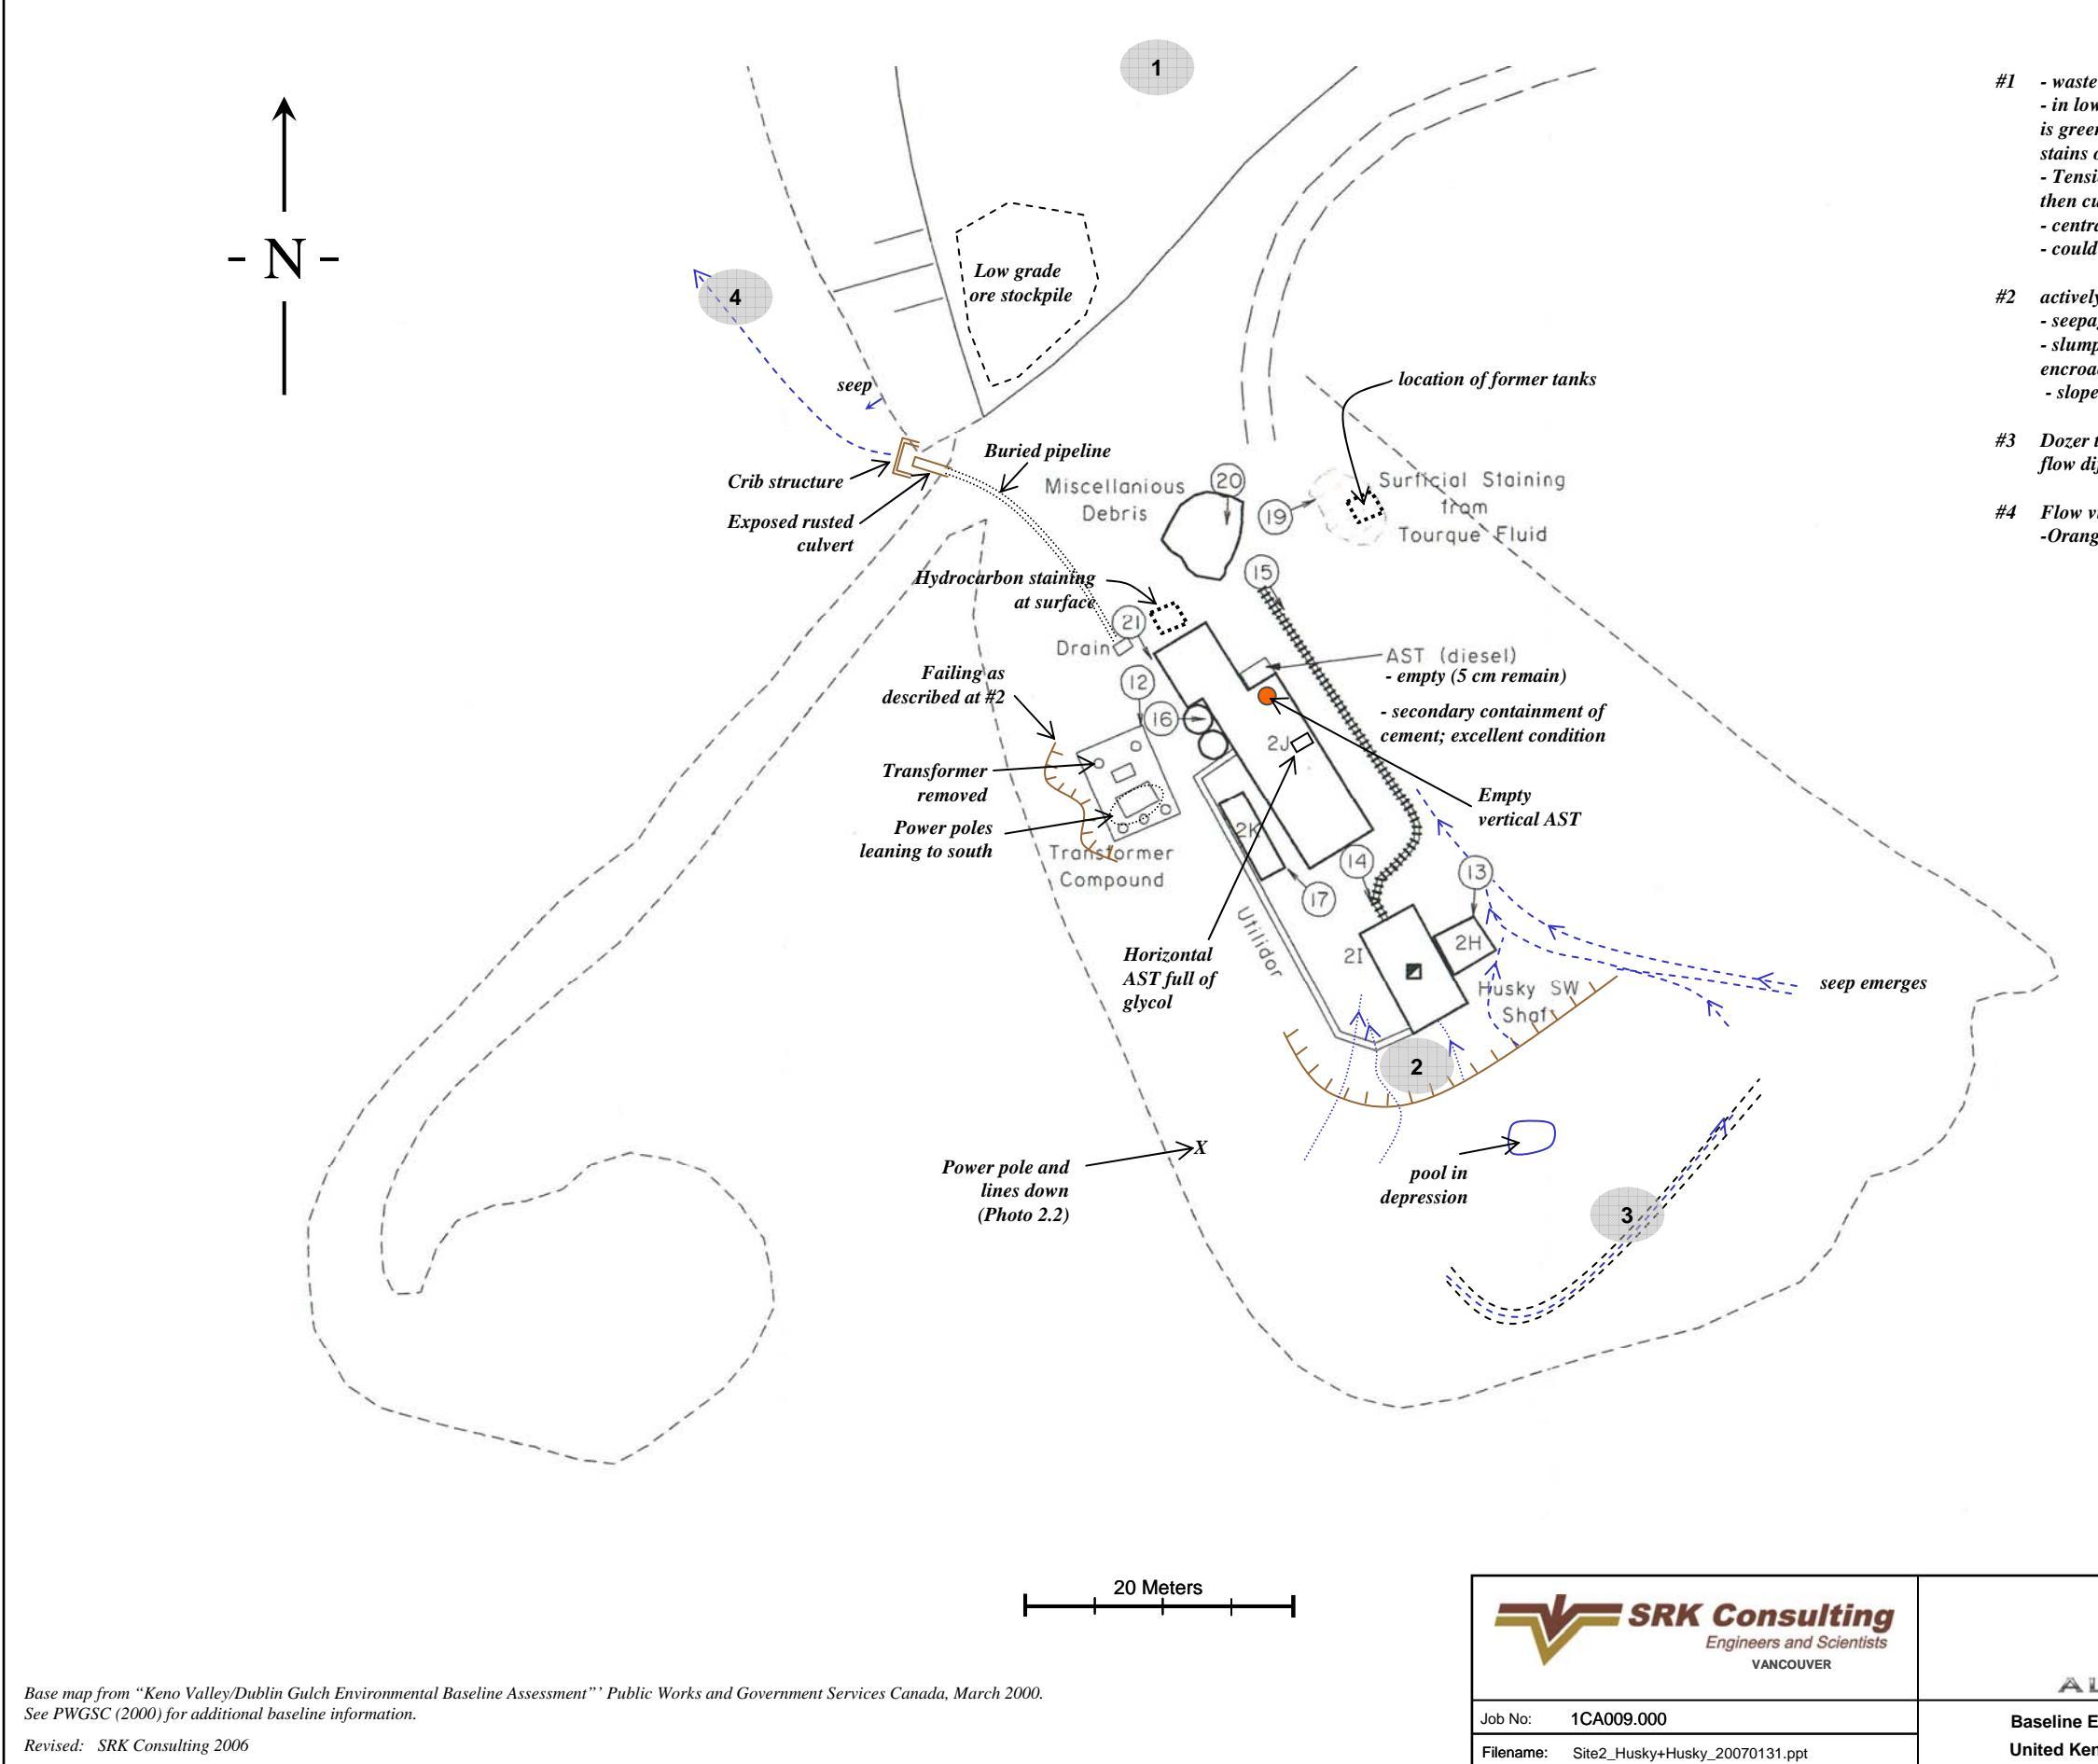
Site #2 – Husky & Husky SW

#1 - waste dump has tension cracks up to 15 cm wide
- in lowest bench, material contains rounded clasts (overburden?), but colour is greenish brown to greenish gray, with pale yellow to orange dark brown stains on clasts
- Tension cracks (12 m back from crest) parallels dump crest (Photo 2.3), then curves to intersect dump crest at NE end

- central part of zone of cracking has subsided by ~0.5 m

#2 actively failing till bank

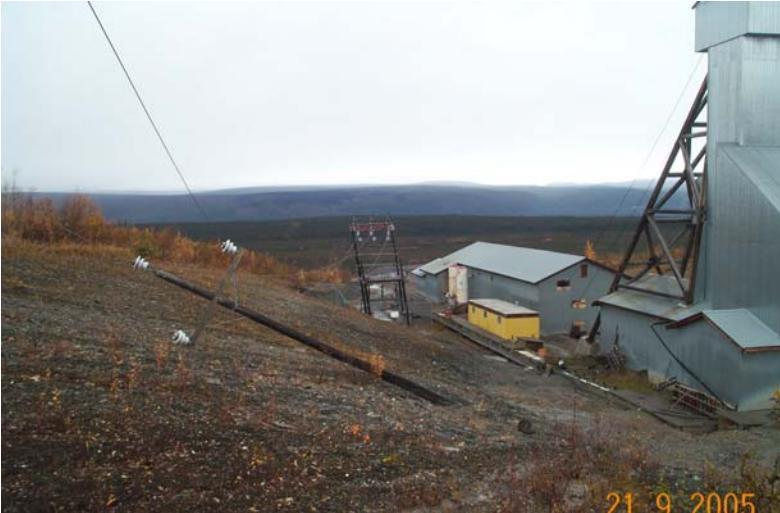
Photo 2.2\_Husky SW\_Down power pole and lines west of headframe

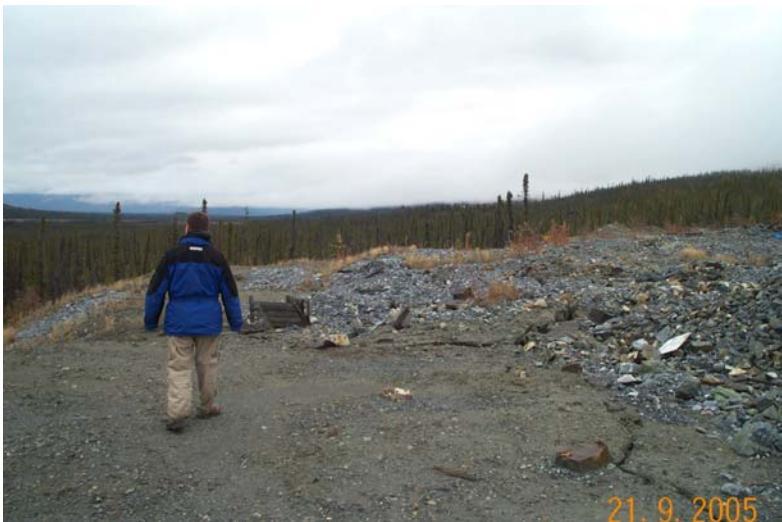
Photo 2.3\_Husky SW\_Tension crack 12 m from crest of waste dump

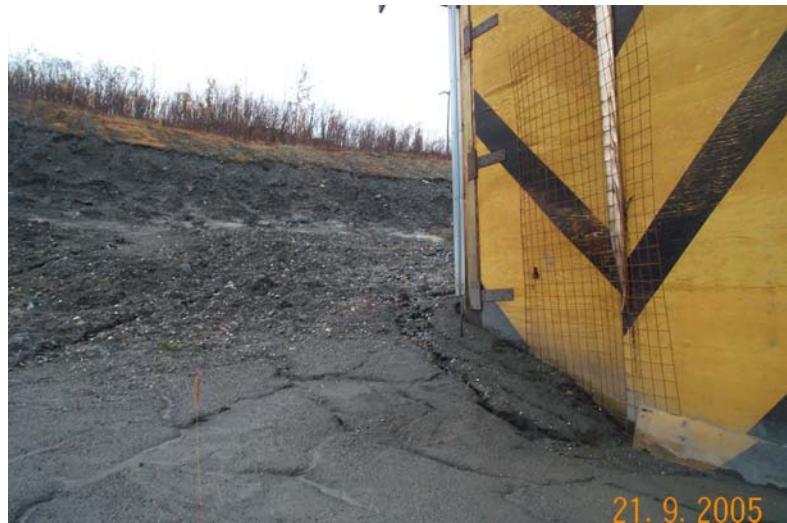
Photo 2.1\_Husky SW\_Failing till embankment encroaching on headframe

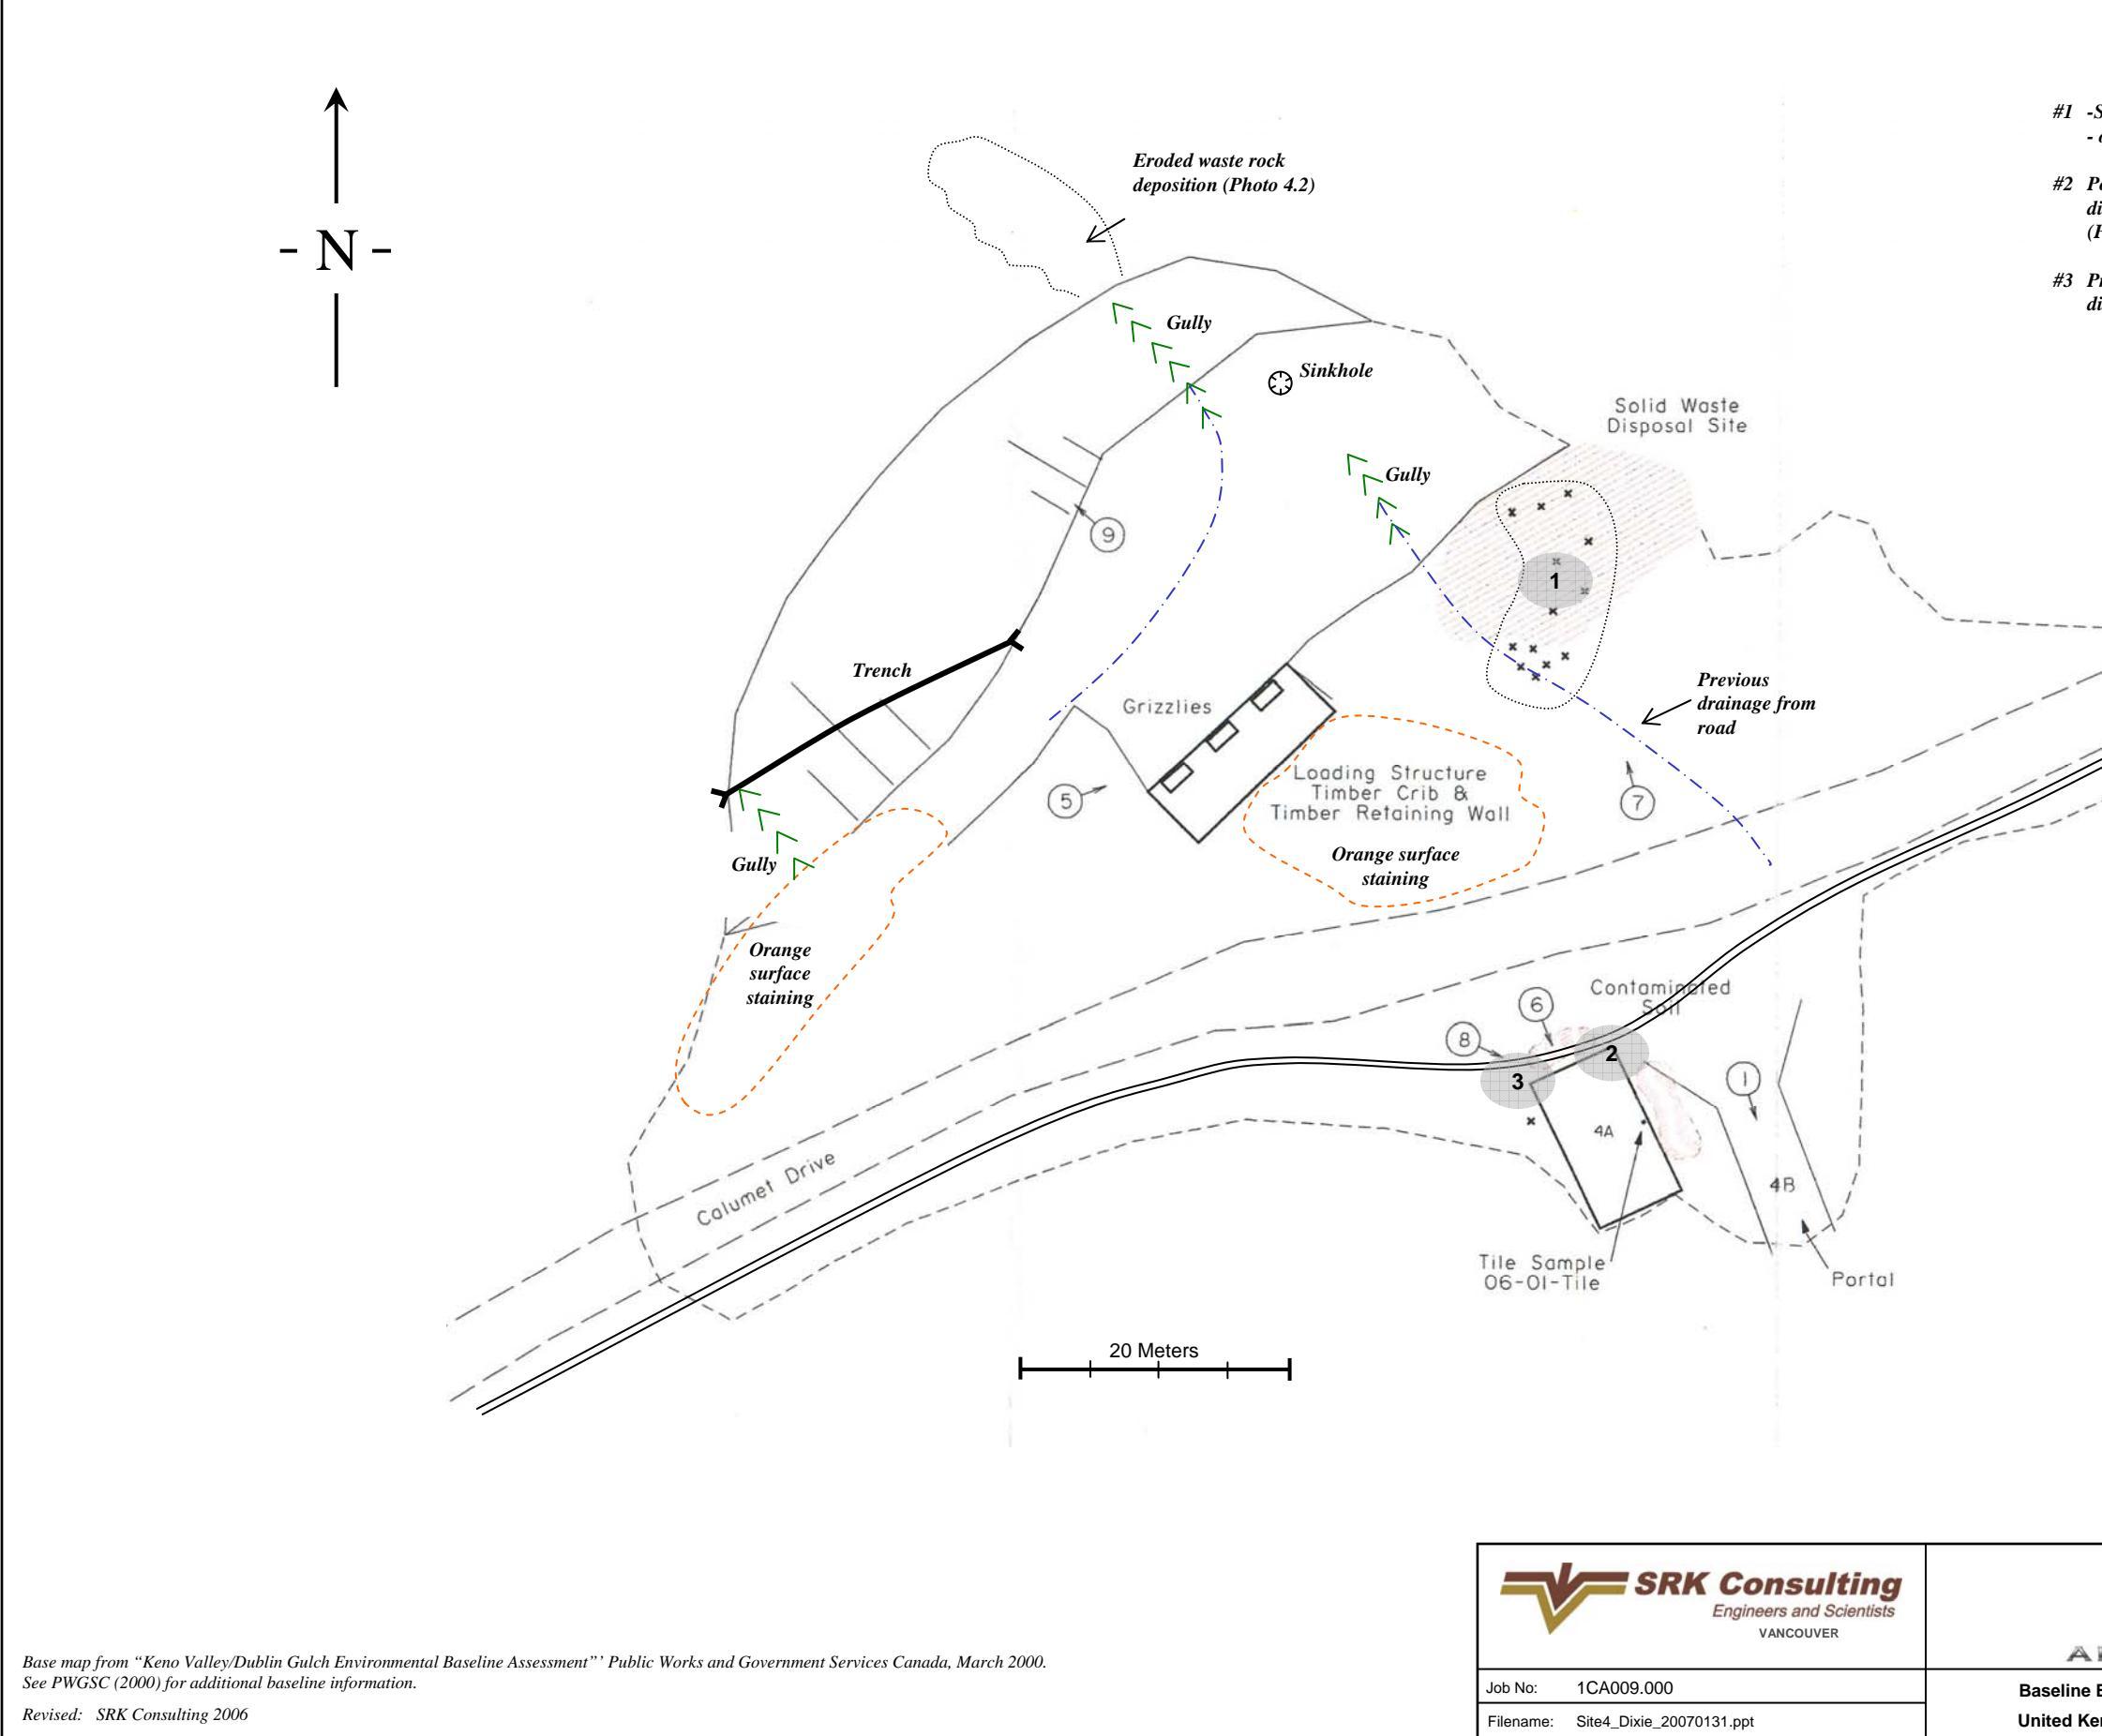
Site #4 – Dixie

#1 -Several barrels removed - only empty rusty barrels remain

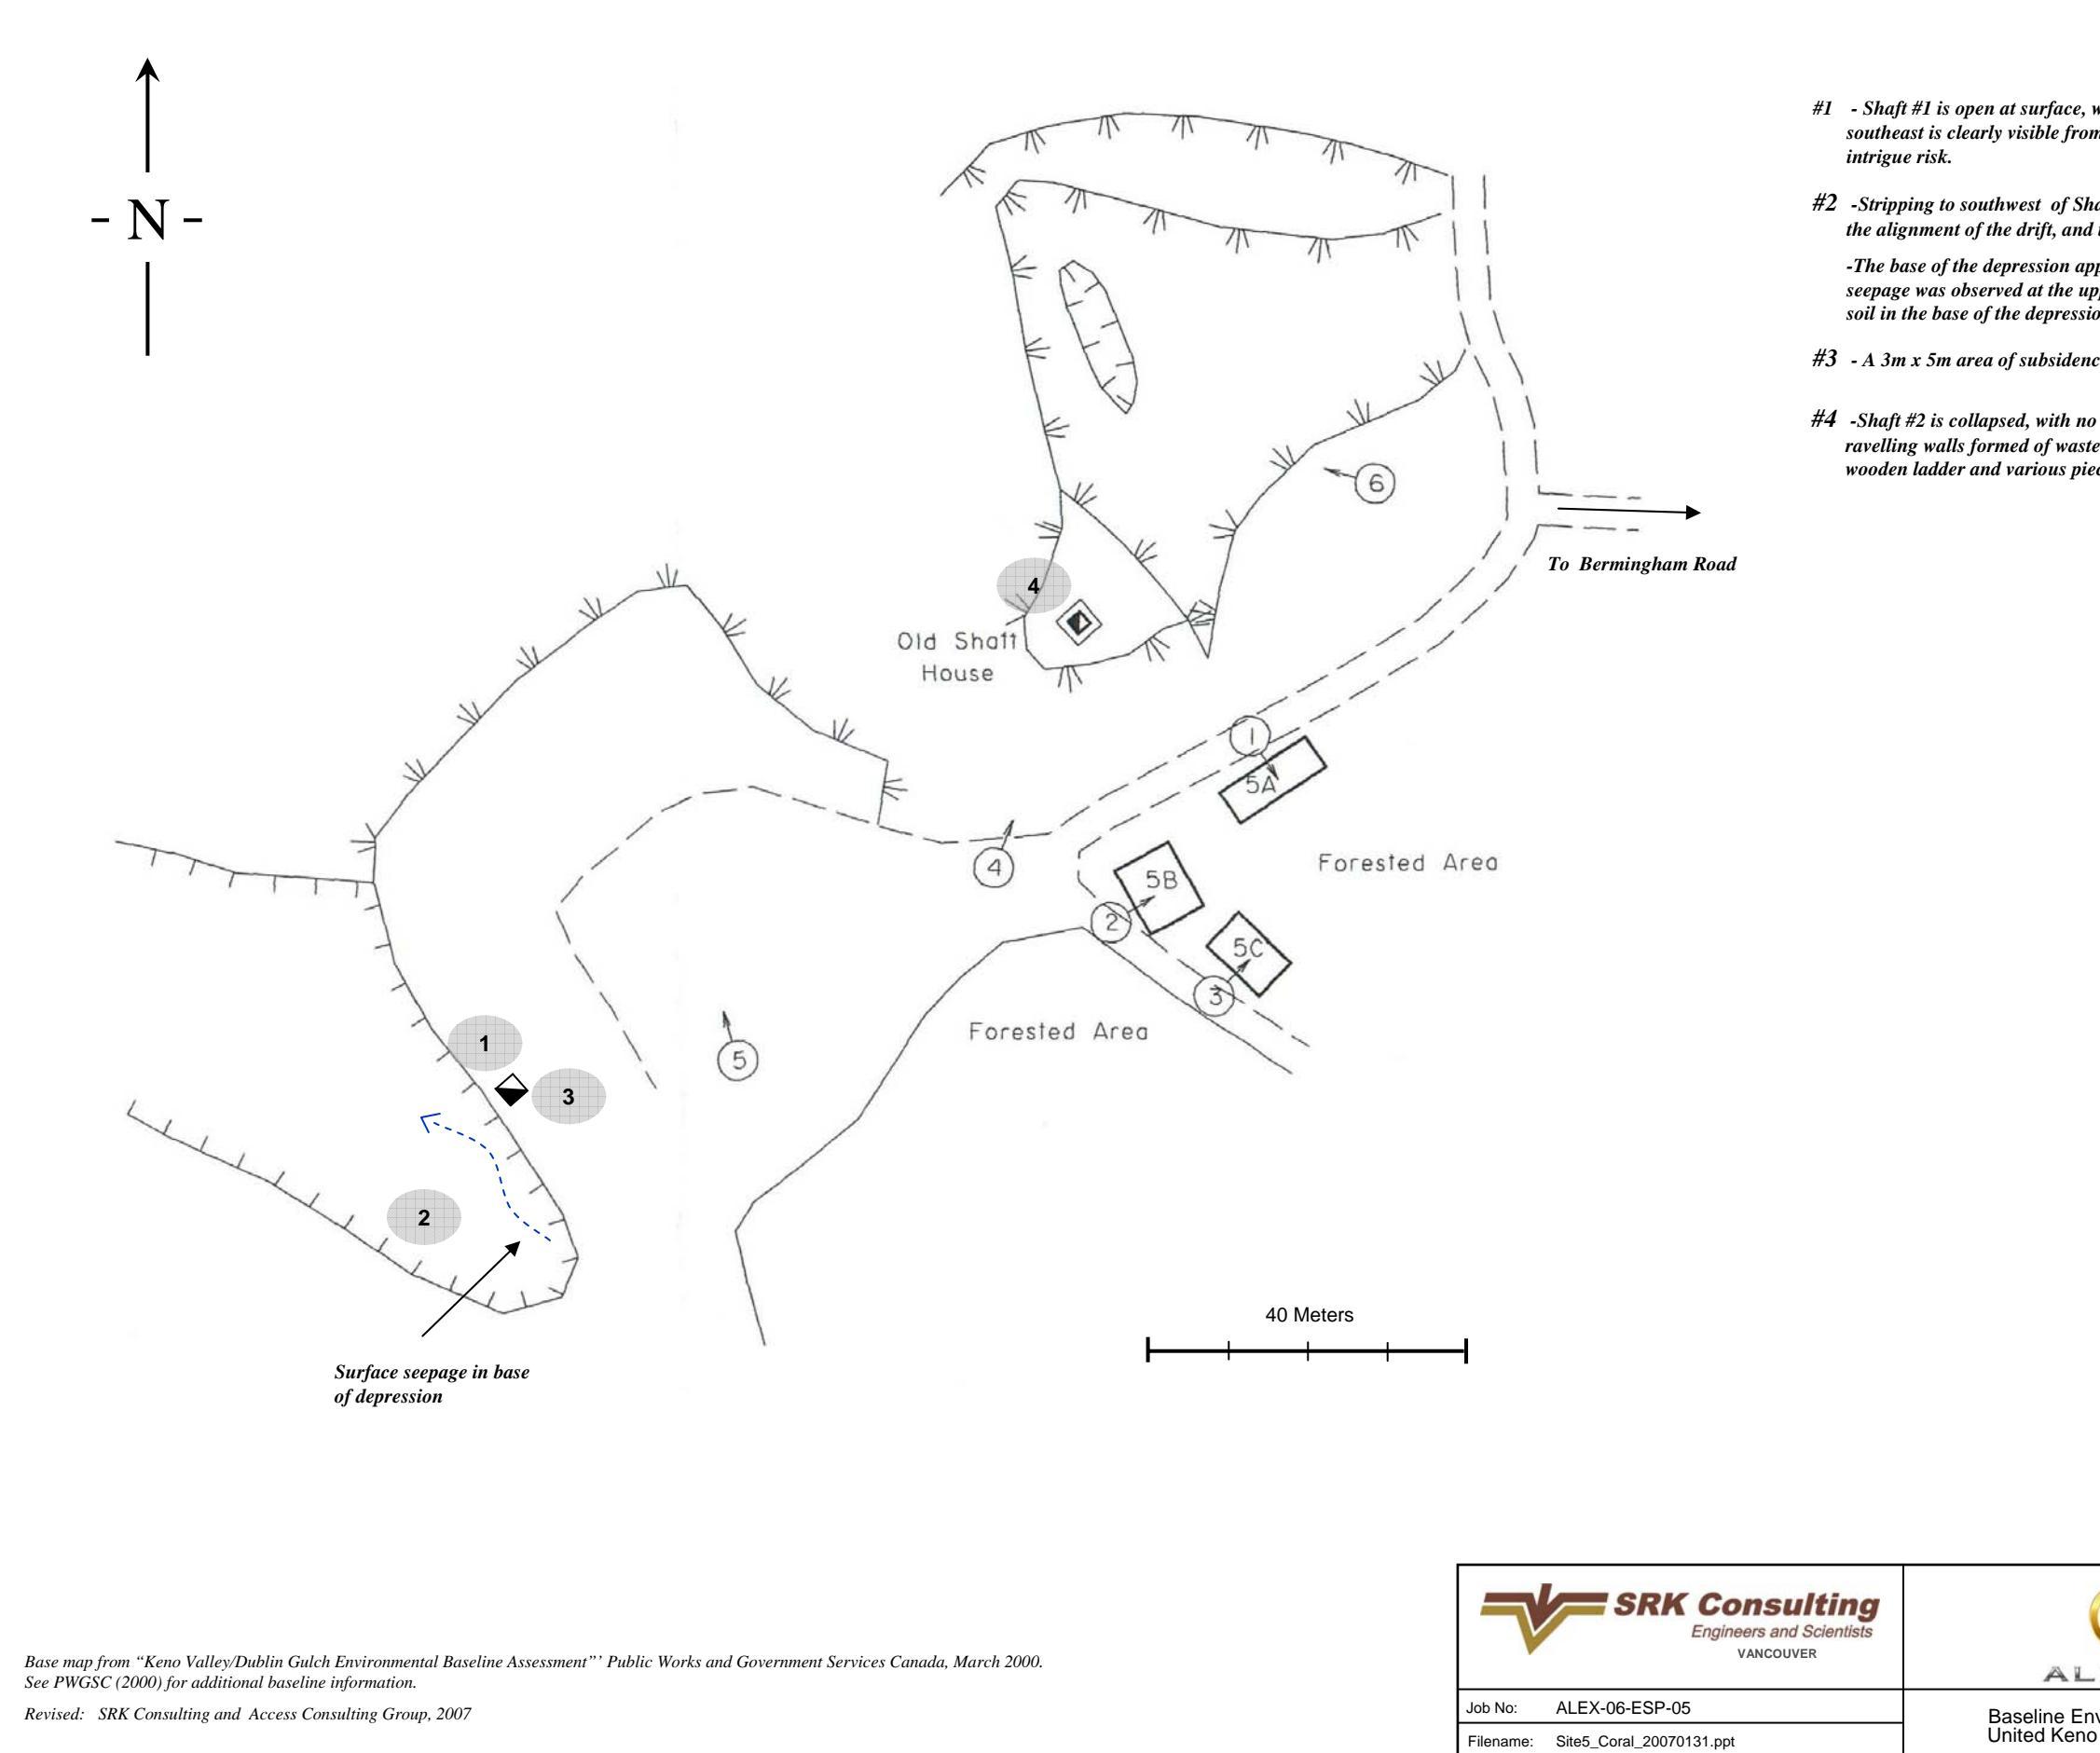
Site #5 – Coral & Wigwam

#1 - Shaft #1 is open at surface, with no barrier to access. Timber cribbing is in good condition, and drift to southeast is clearly visible from top of shaft (Photo 1) and appears to be open. This feature represents a high

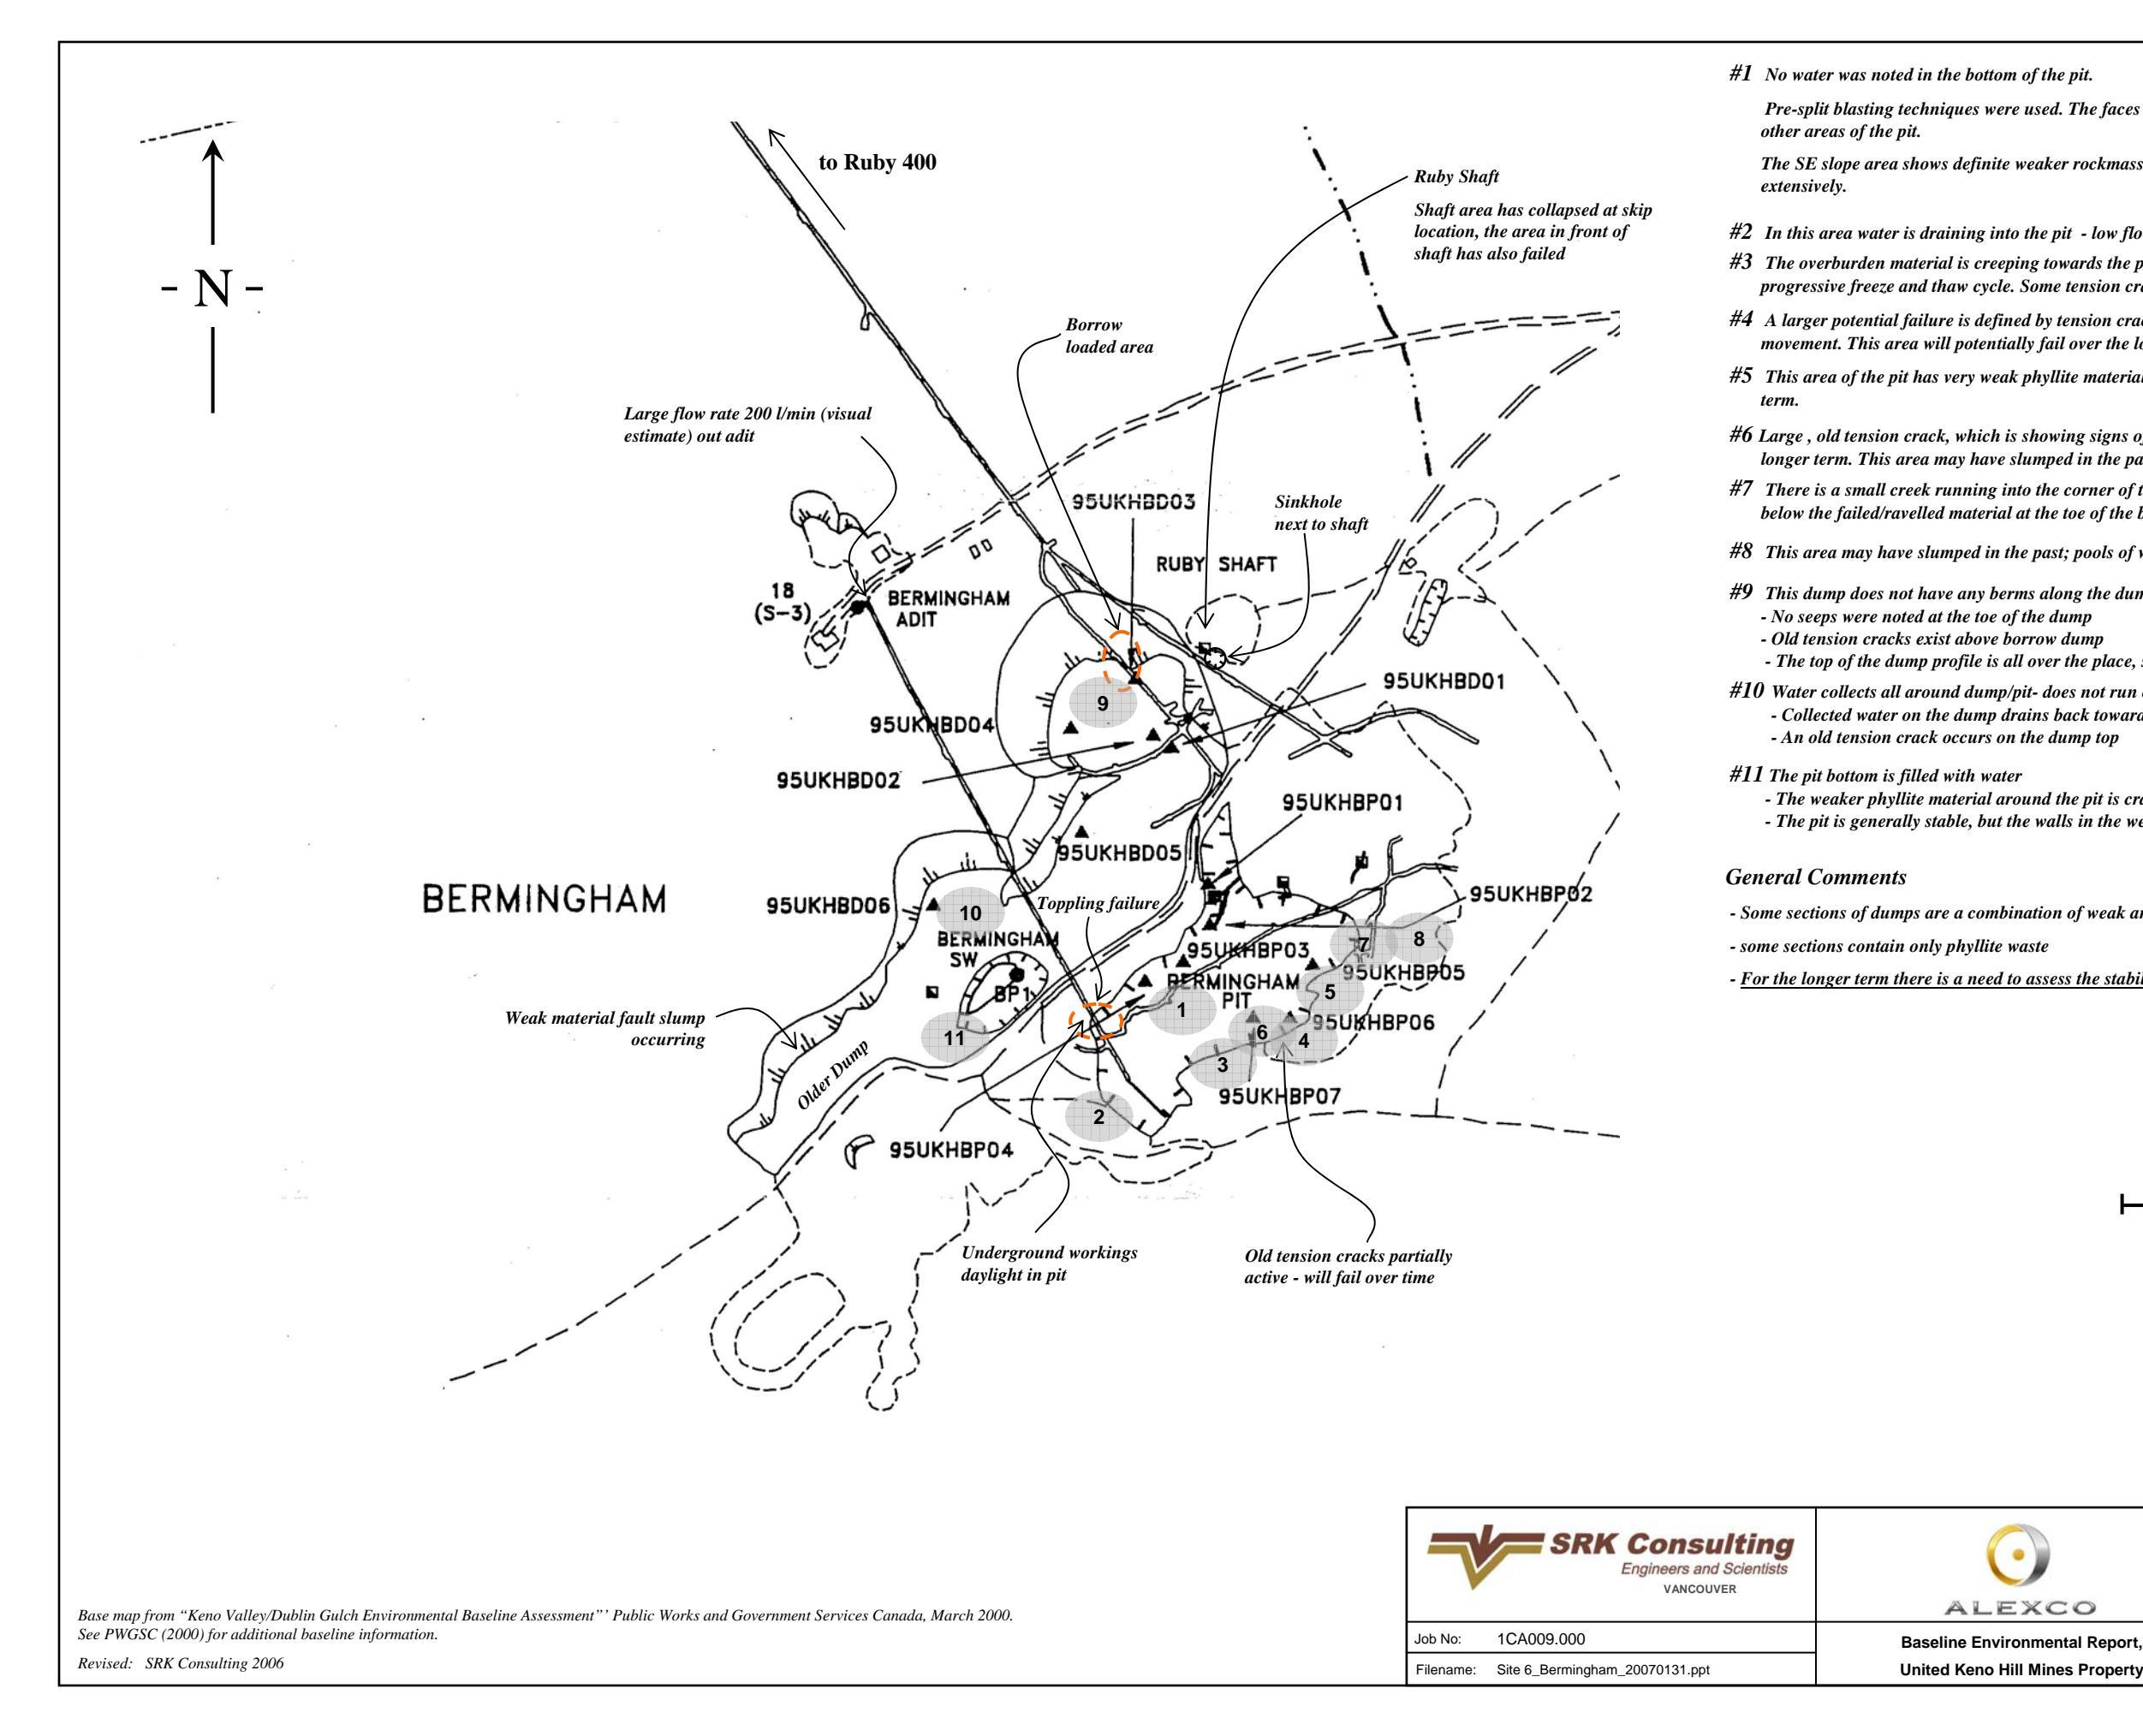
Site #6– Bermingham

ottom of the pit.	
were used. The faces look good i	in the southeast corner, but less so in
inite weaker rockmass conditions	, the slope in this area is unravelling
g into the pit - low flow rate obse creeping towards the pit. This will cycle. Some tension cracks are occ	rved. I continue to creep slowly with each curring.
defined by tension cracks. This ar rentially fail over the long term.	rea is currently showing no signs of
weak phyllite material. This mate	erial is expected to fail over the medium
ich is showing signs of re-activati ave slumped in the past	ion. This area will fail over the medium to
ng into the corner of the pit. The erial at the toe of the bench face.	flow is fairly low. This water disappears
l in the past; pools of water obser	ved on surface at time of inspection.
y berms along the dump crest toe of the dump ove borrow dump e is all over the place, sloped to bo	th the north and the northeast

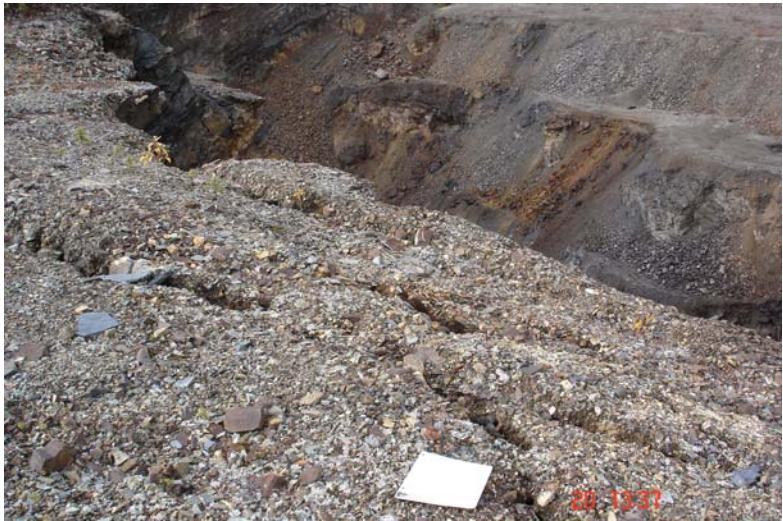
Photo 6.8\_Pt.3\_Bermingham\_Pit\_Creep- toppling crack detail

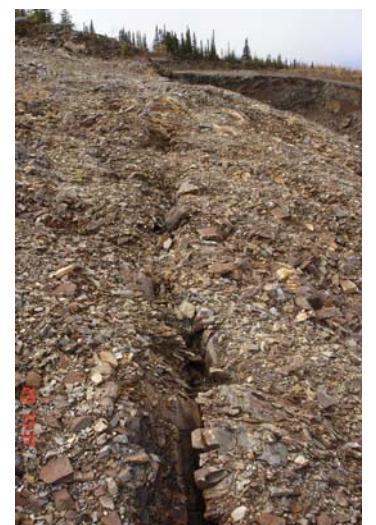
Photos 6.10\_Pt.4\_Bermingham\_Pit\_Fairly large failure delineated- dormant
