# Draft Baseline Environmental Report United Keno Hill Mines Property

Project Reference Number SRK 1CA009.000

January 2007

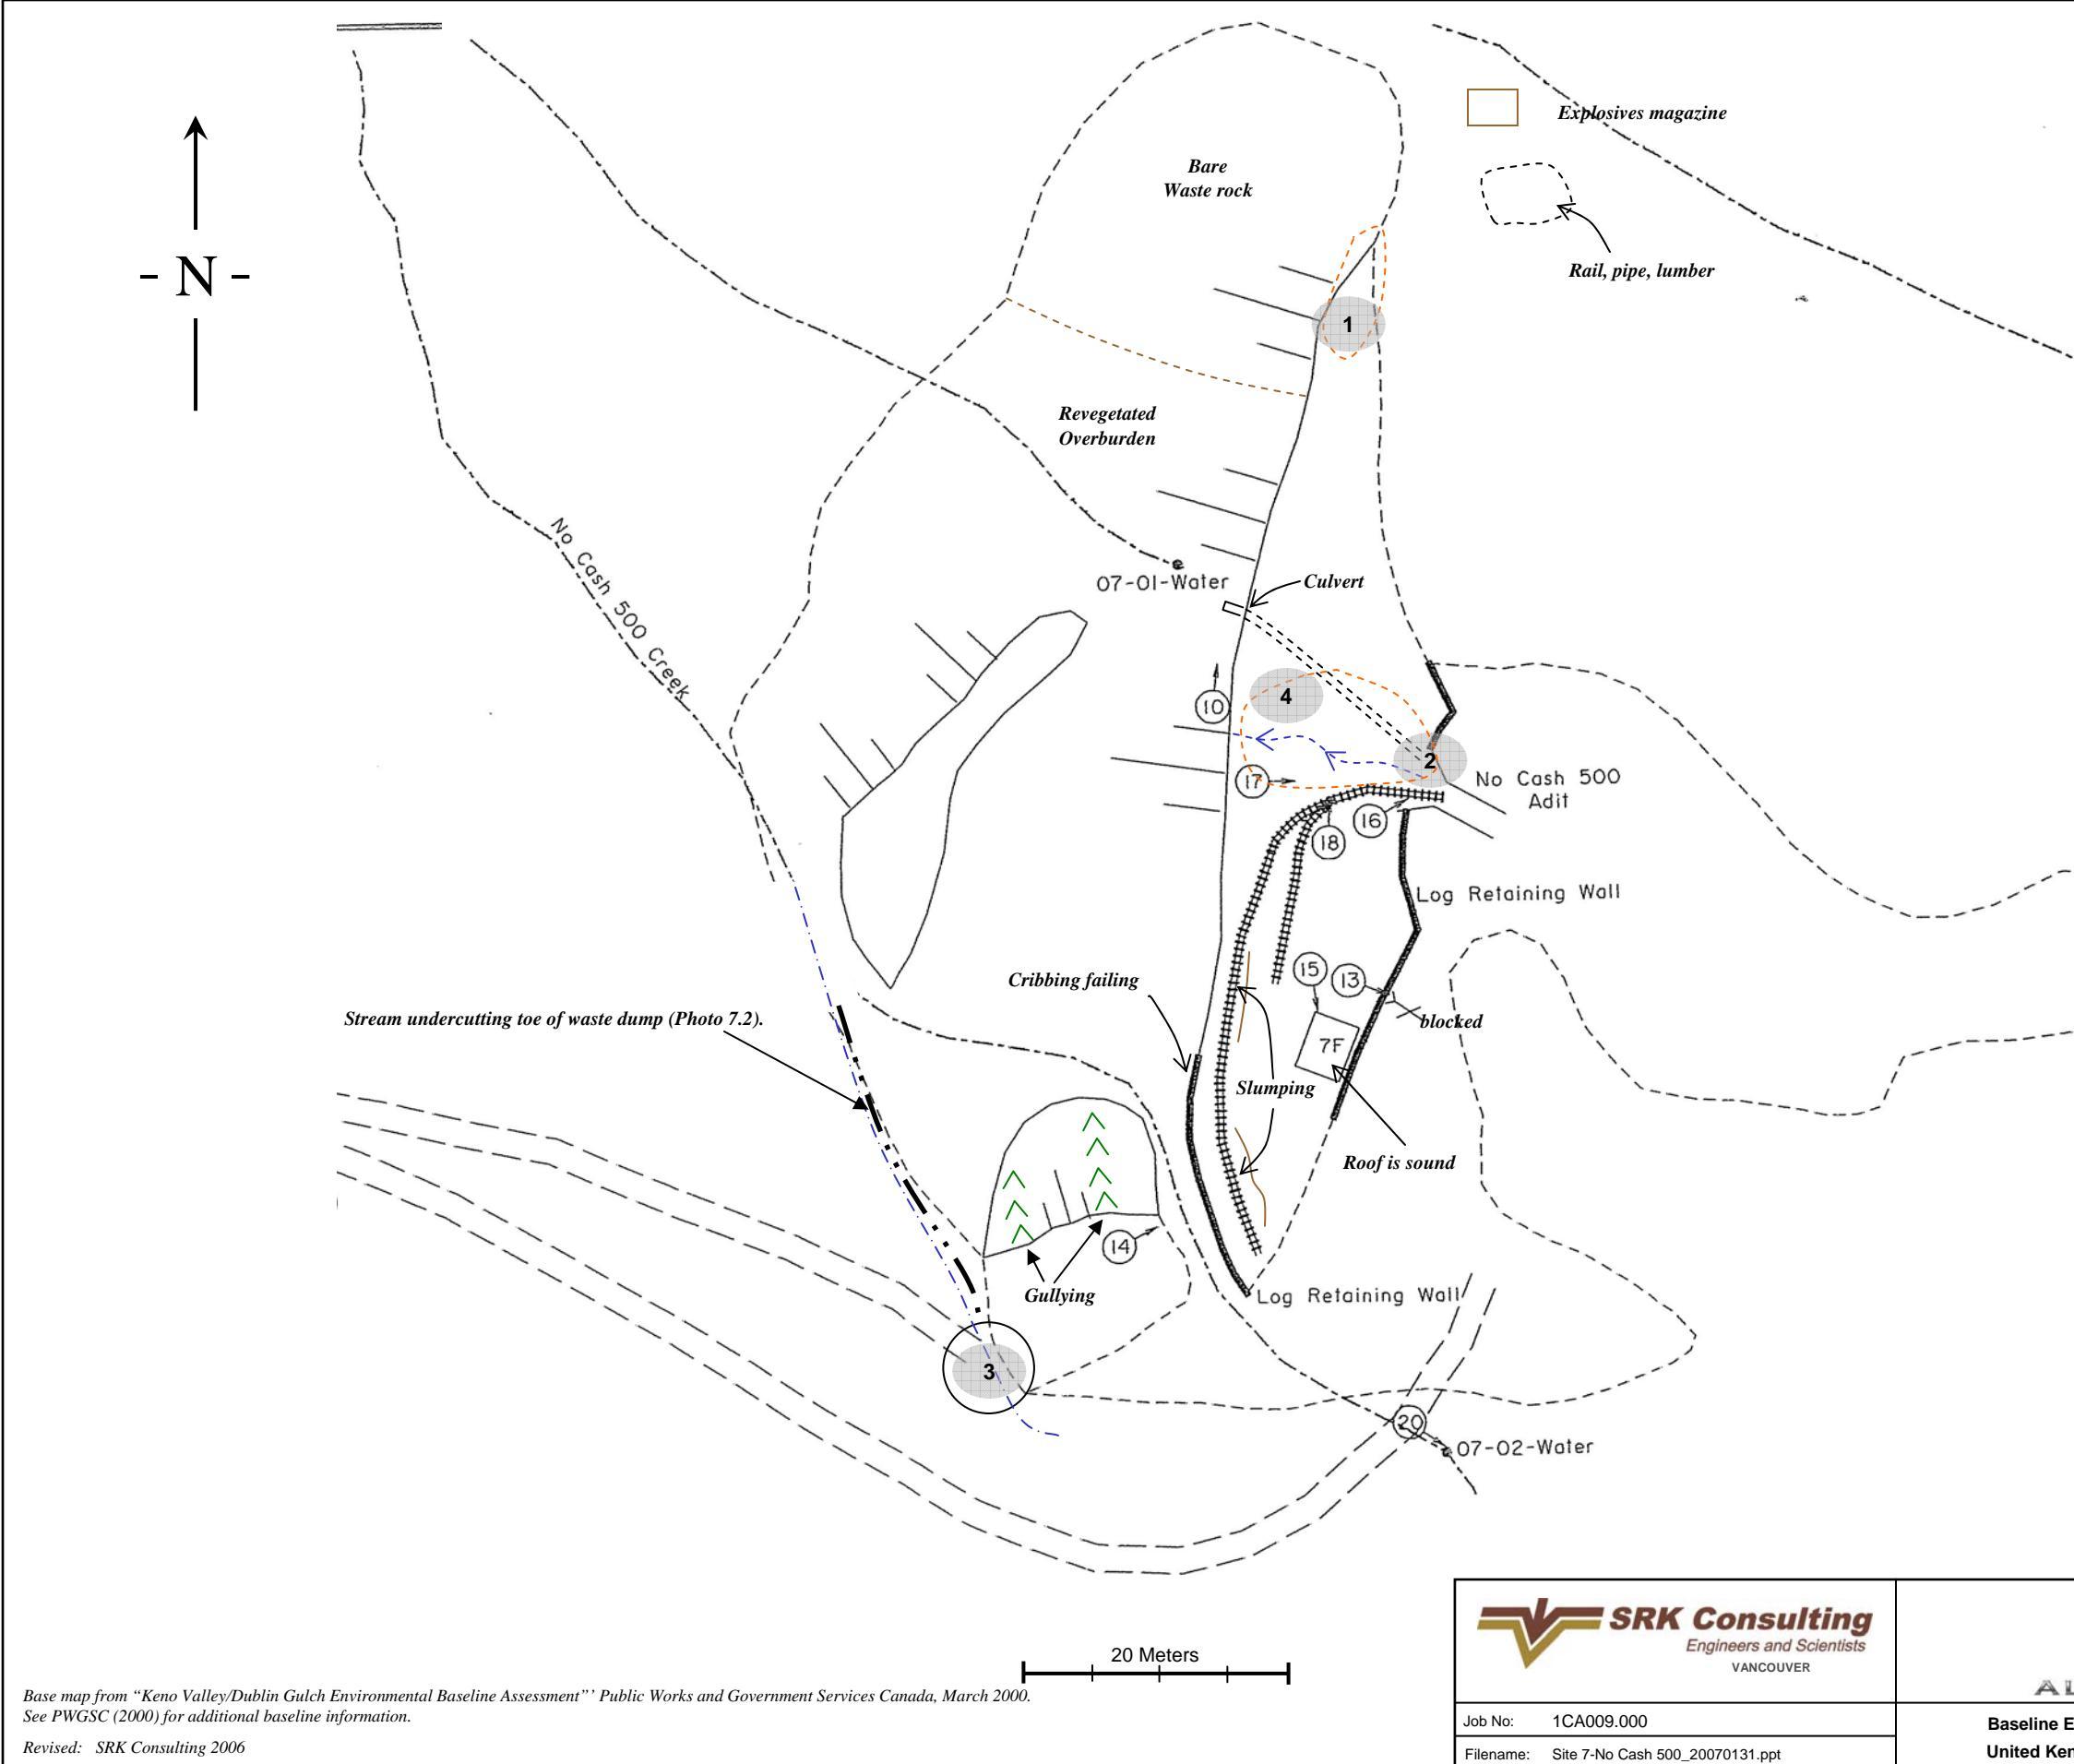
Site #7 – No Cash

- #1 Pale yellowish and orangey dark brown staining isolated clasts
  Flow path (dry) marked by pale yellow stain
- #2 Blockage inside of adit is causing part of flow to direct away from culvert and flow over crest of dump
- #3 Square timber culvert is partially collapsed, and adjacent mine waste has been partially eroded, leading to reduced lateral support (Photo 7.1).
- #4 Area of orange staining on dump surface along current and former flowpaths of adit discharge

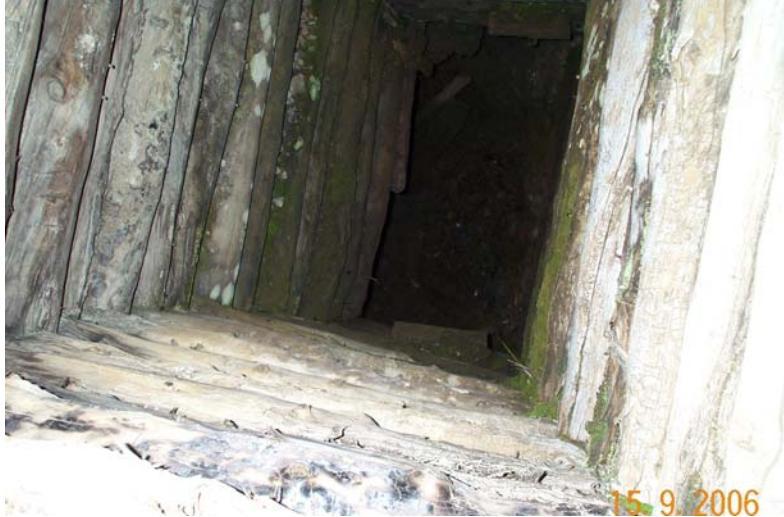
Photo.5.1\_Open timber-cribbed shaft, with drifting to SE

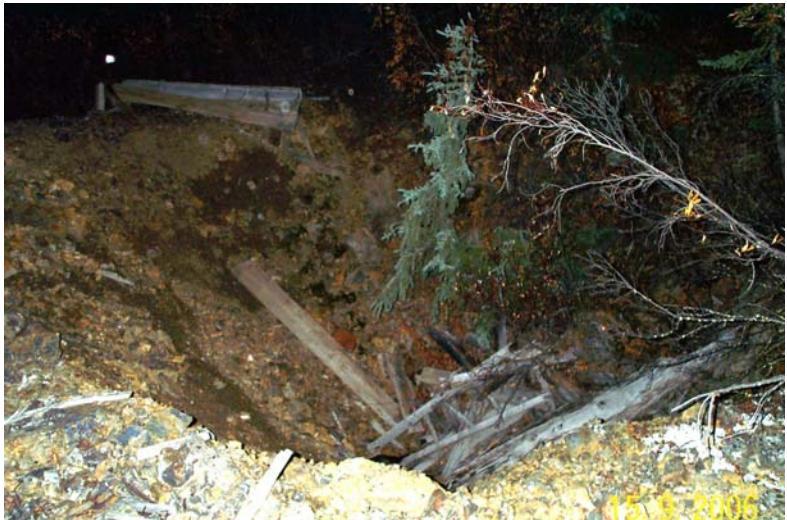
Photo.5.2\_Depression in waste rock at collar of collapsed Shaft #2

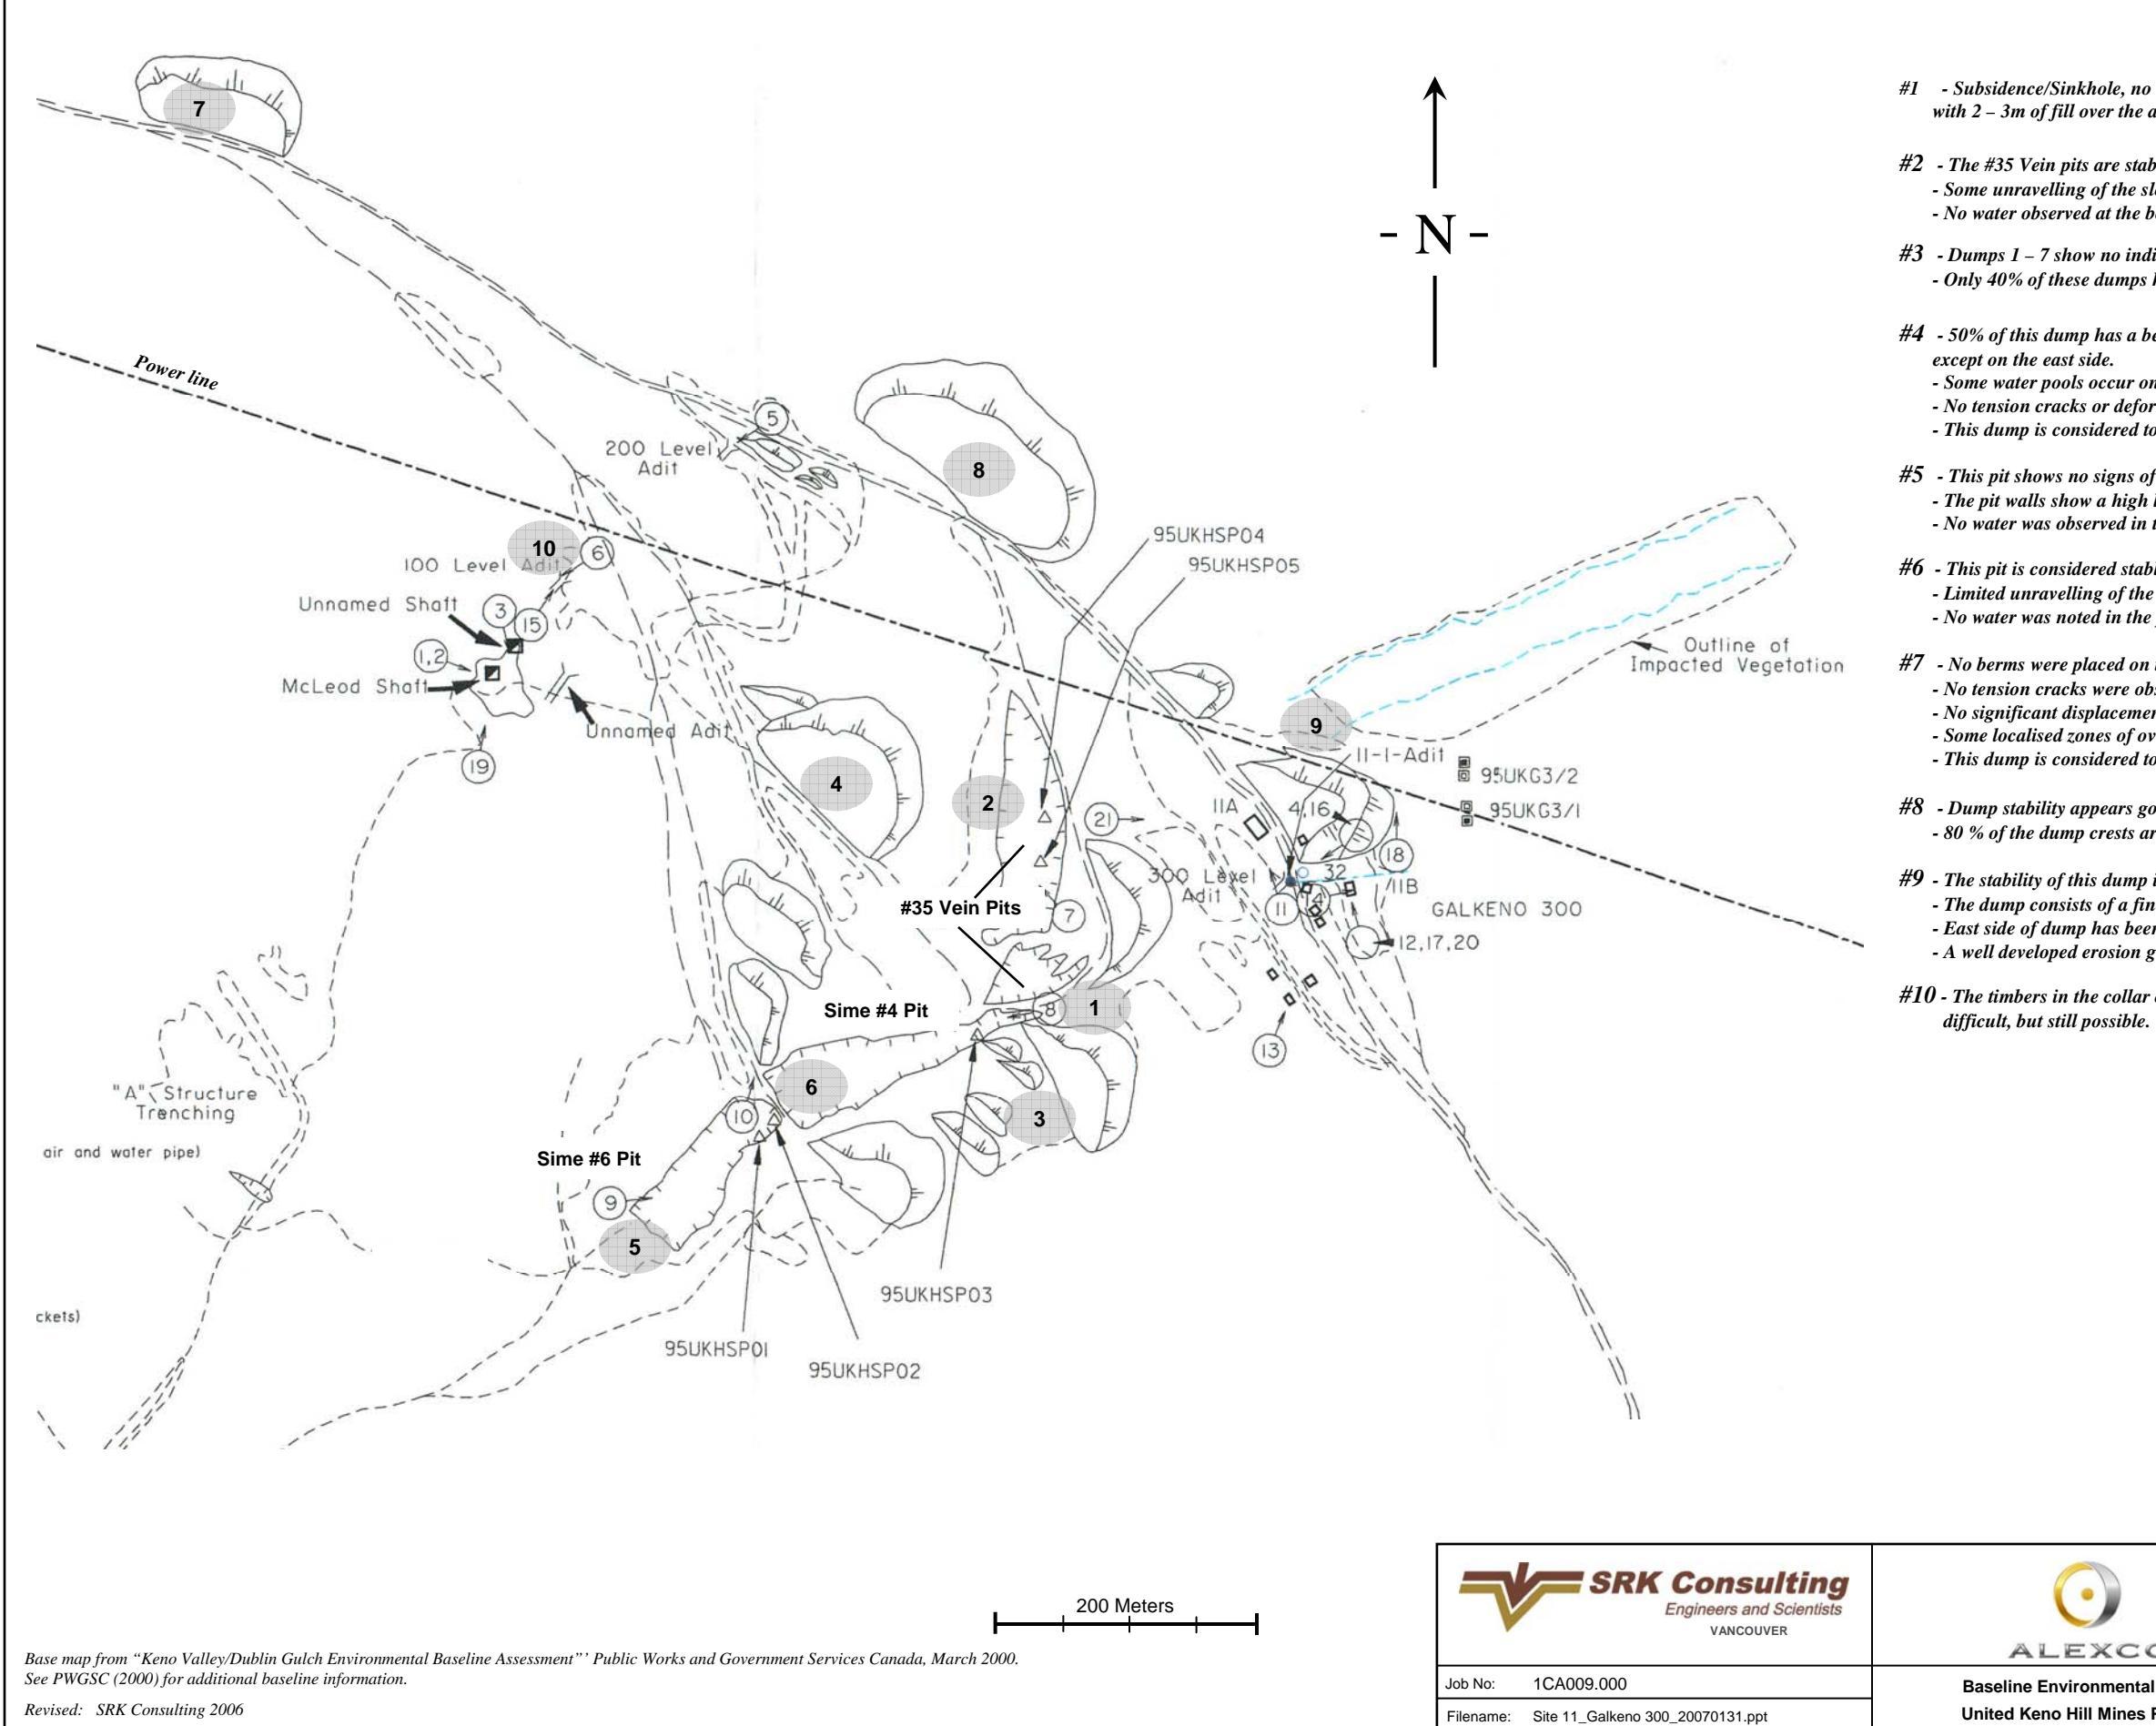
Site #11 – Galkeno 300

#1 - Subsidence/Sinkhole, no timber was noted within the hole. This is a previously-unidentified hole, with 2 – 3m of fill over the area

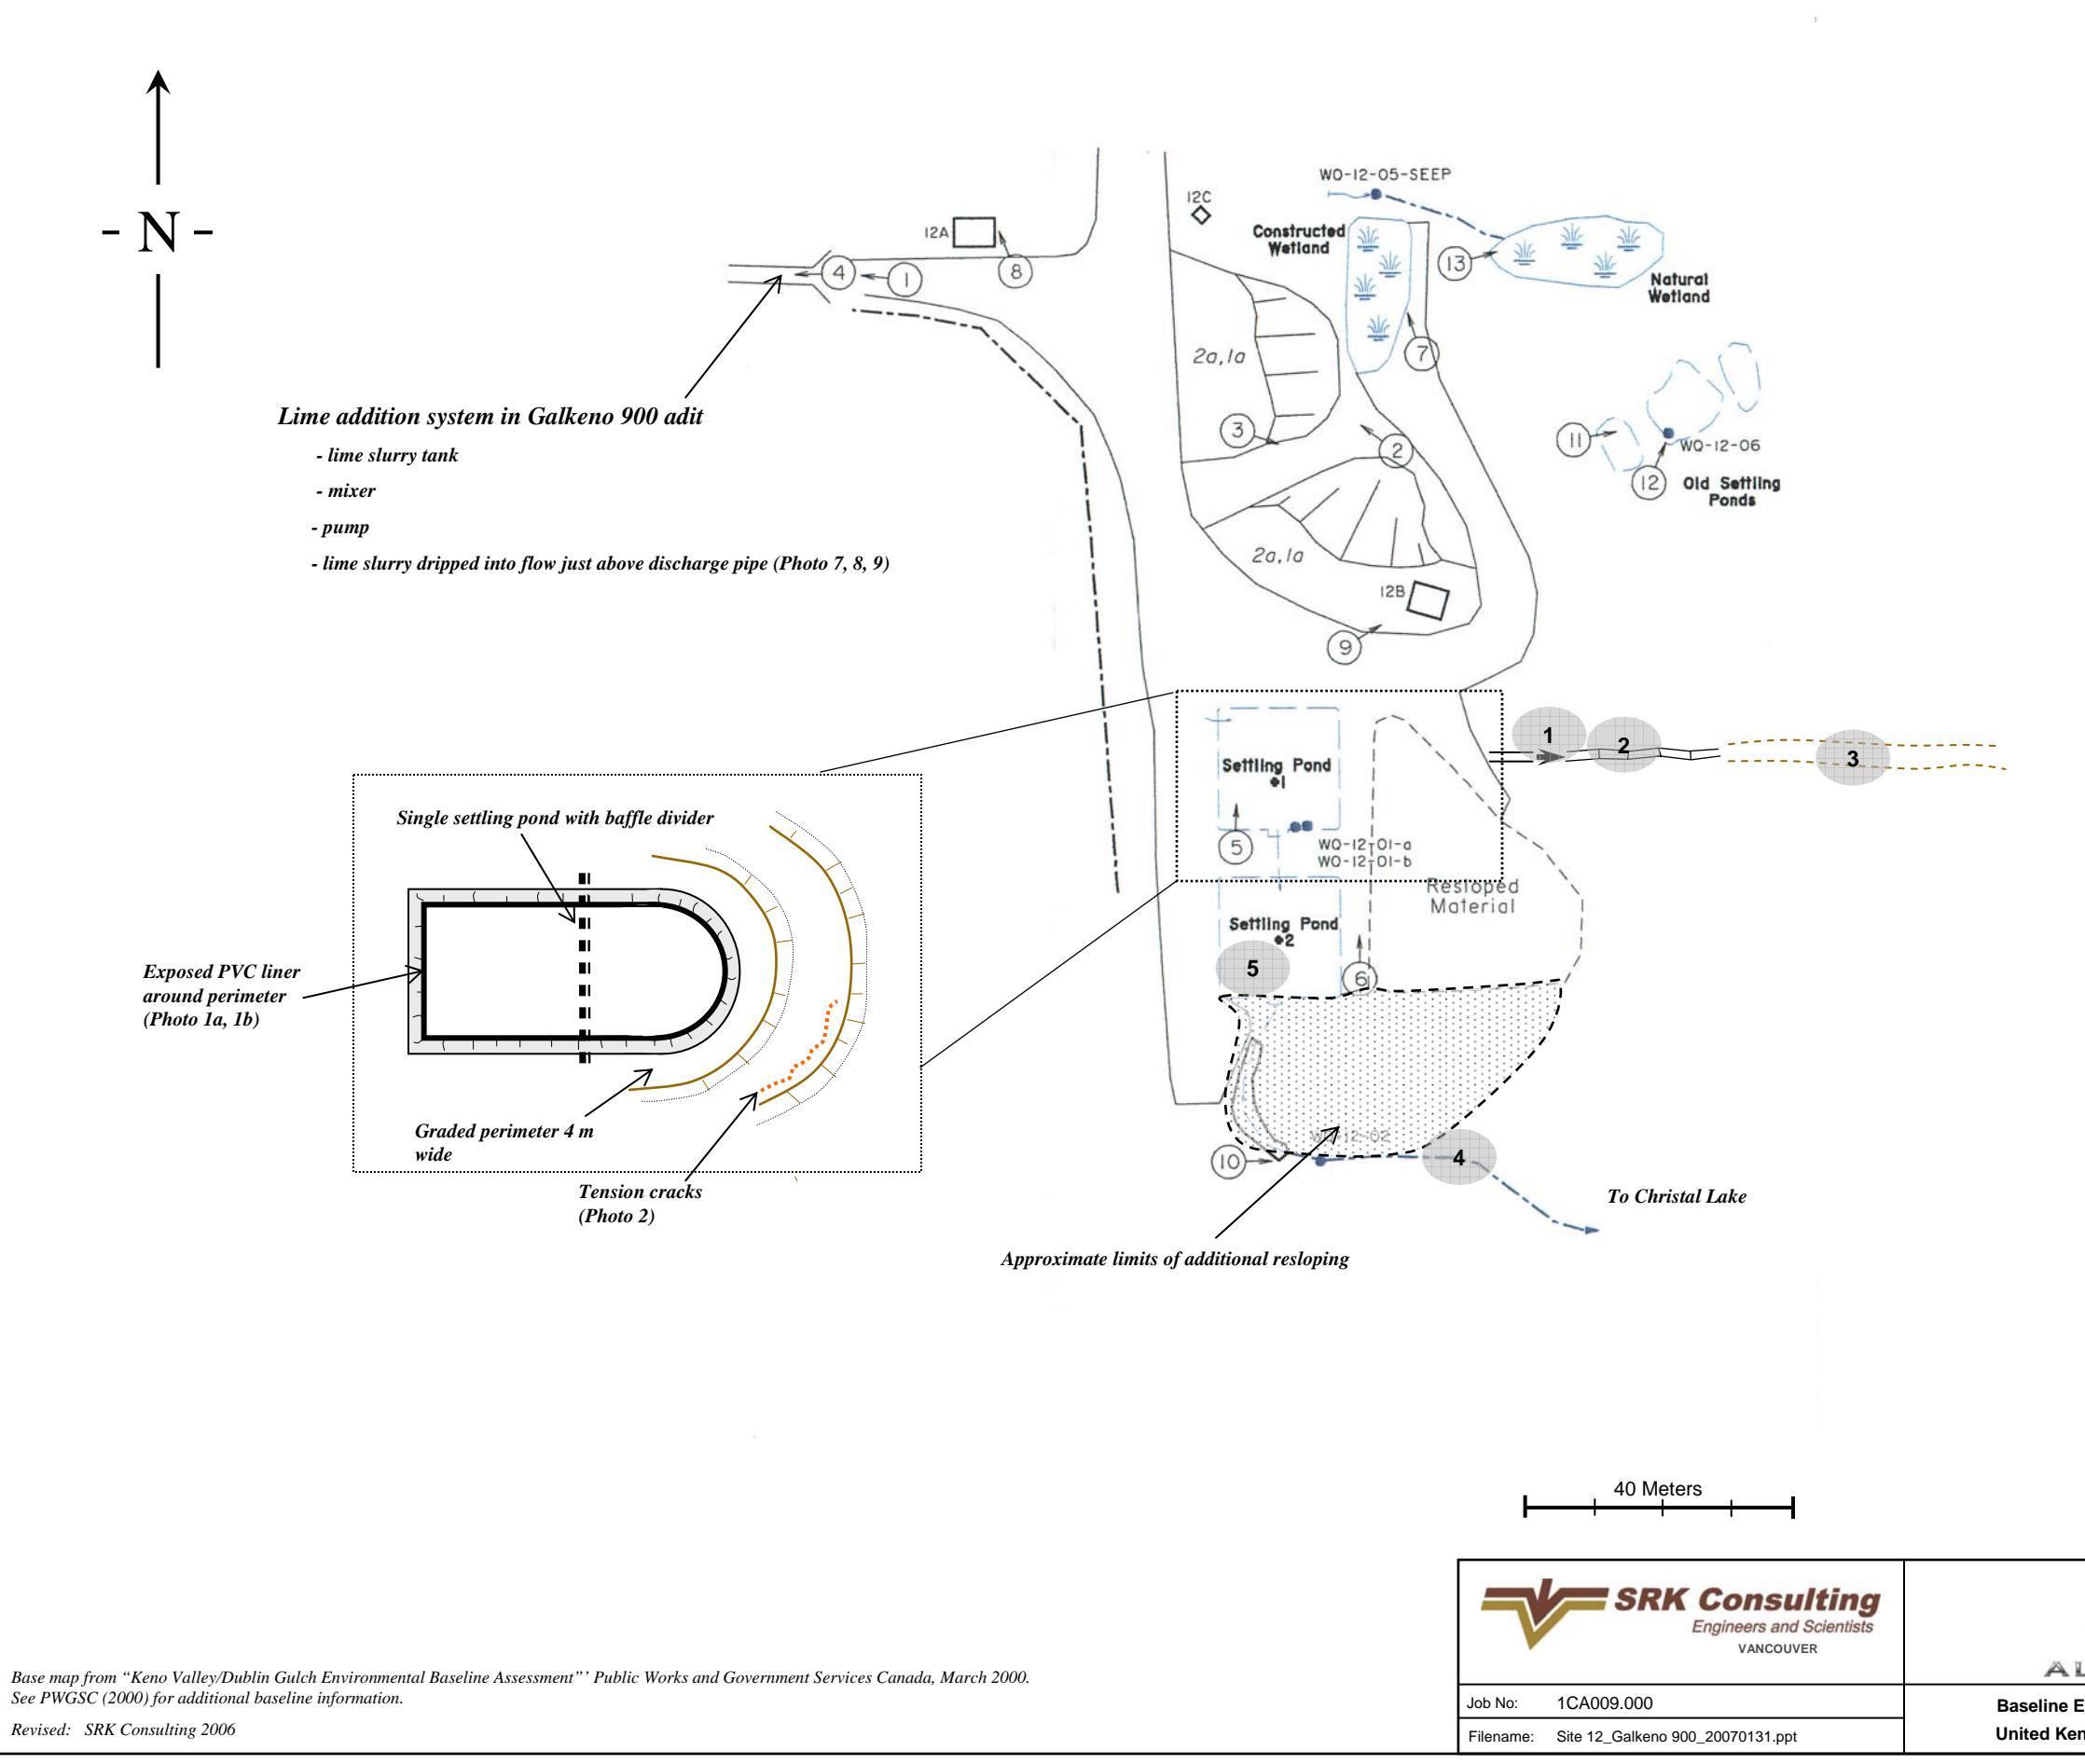
Site #12 – Galkeno 900

- #1 Discharge from pipe into unbraced corrugated sections (Photo3)
- #2 Corrugated sections are twisted and flow escapes over side (Photo 4) and under lower sections
- #3 Discharge path shows whitish precipitates, heavy iron-staining and permafrost thaw features (Photo 5)
- #4 Permafrost degradation and erosion along former discharge channel
- #5 Settling Pond #2 decommissioned and recontoured

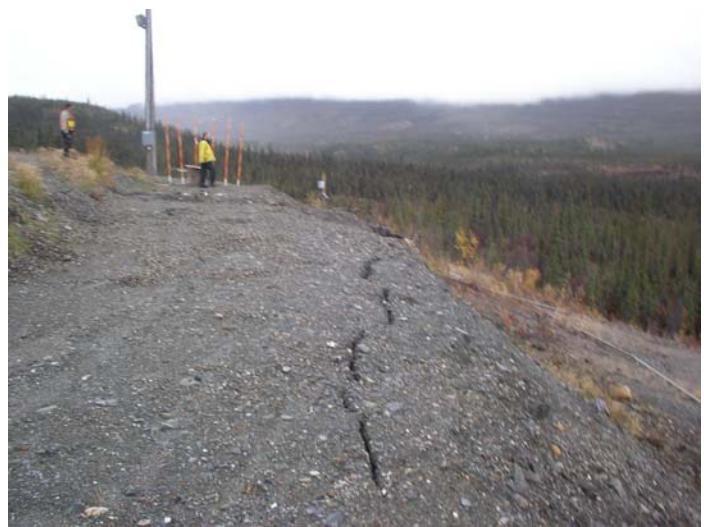
Photo\_12.2\_ SE corner tension cracks

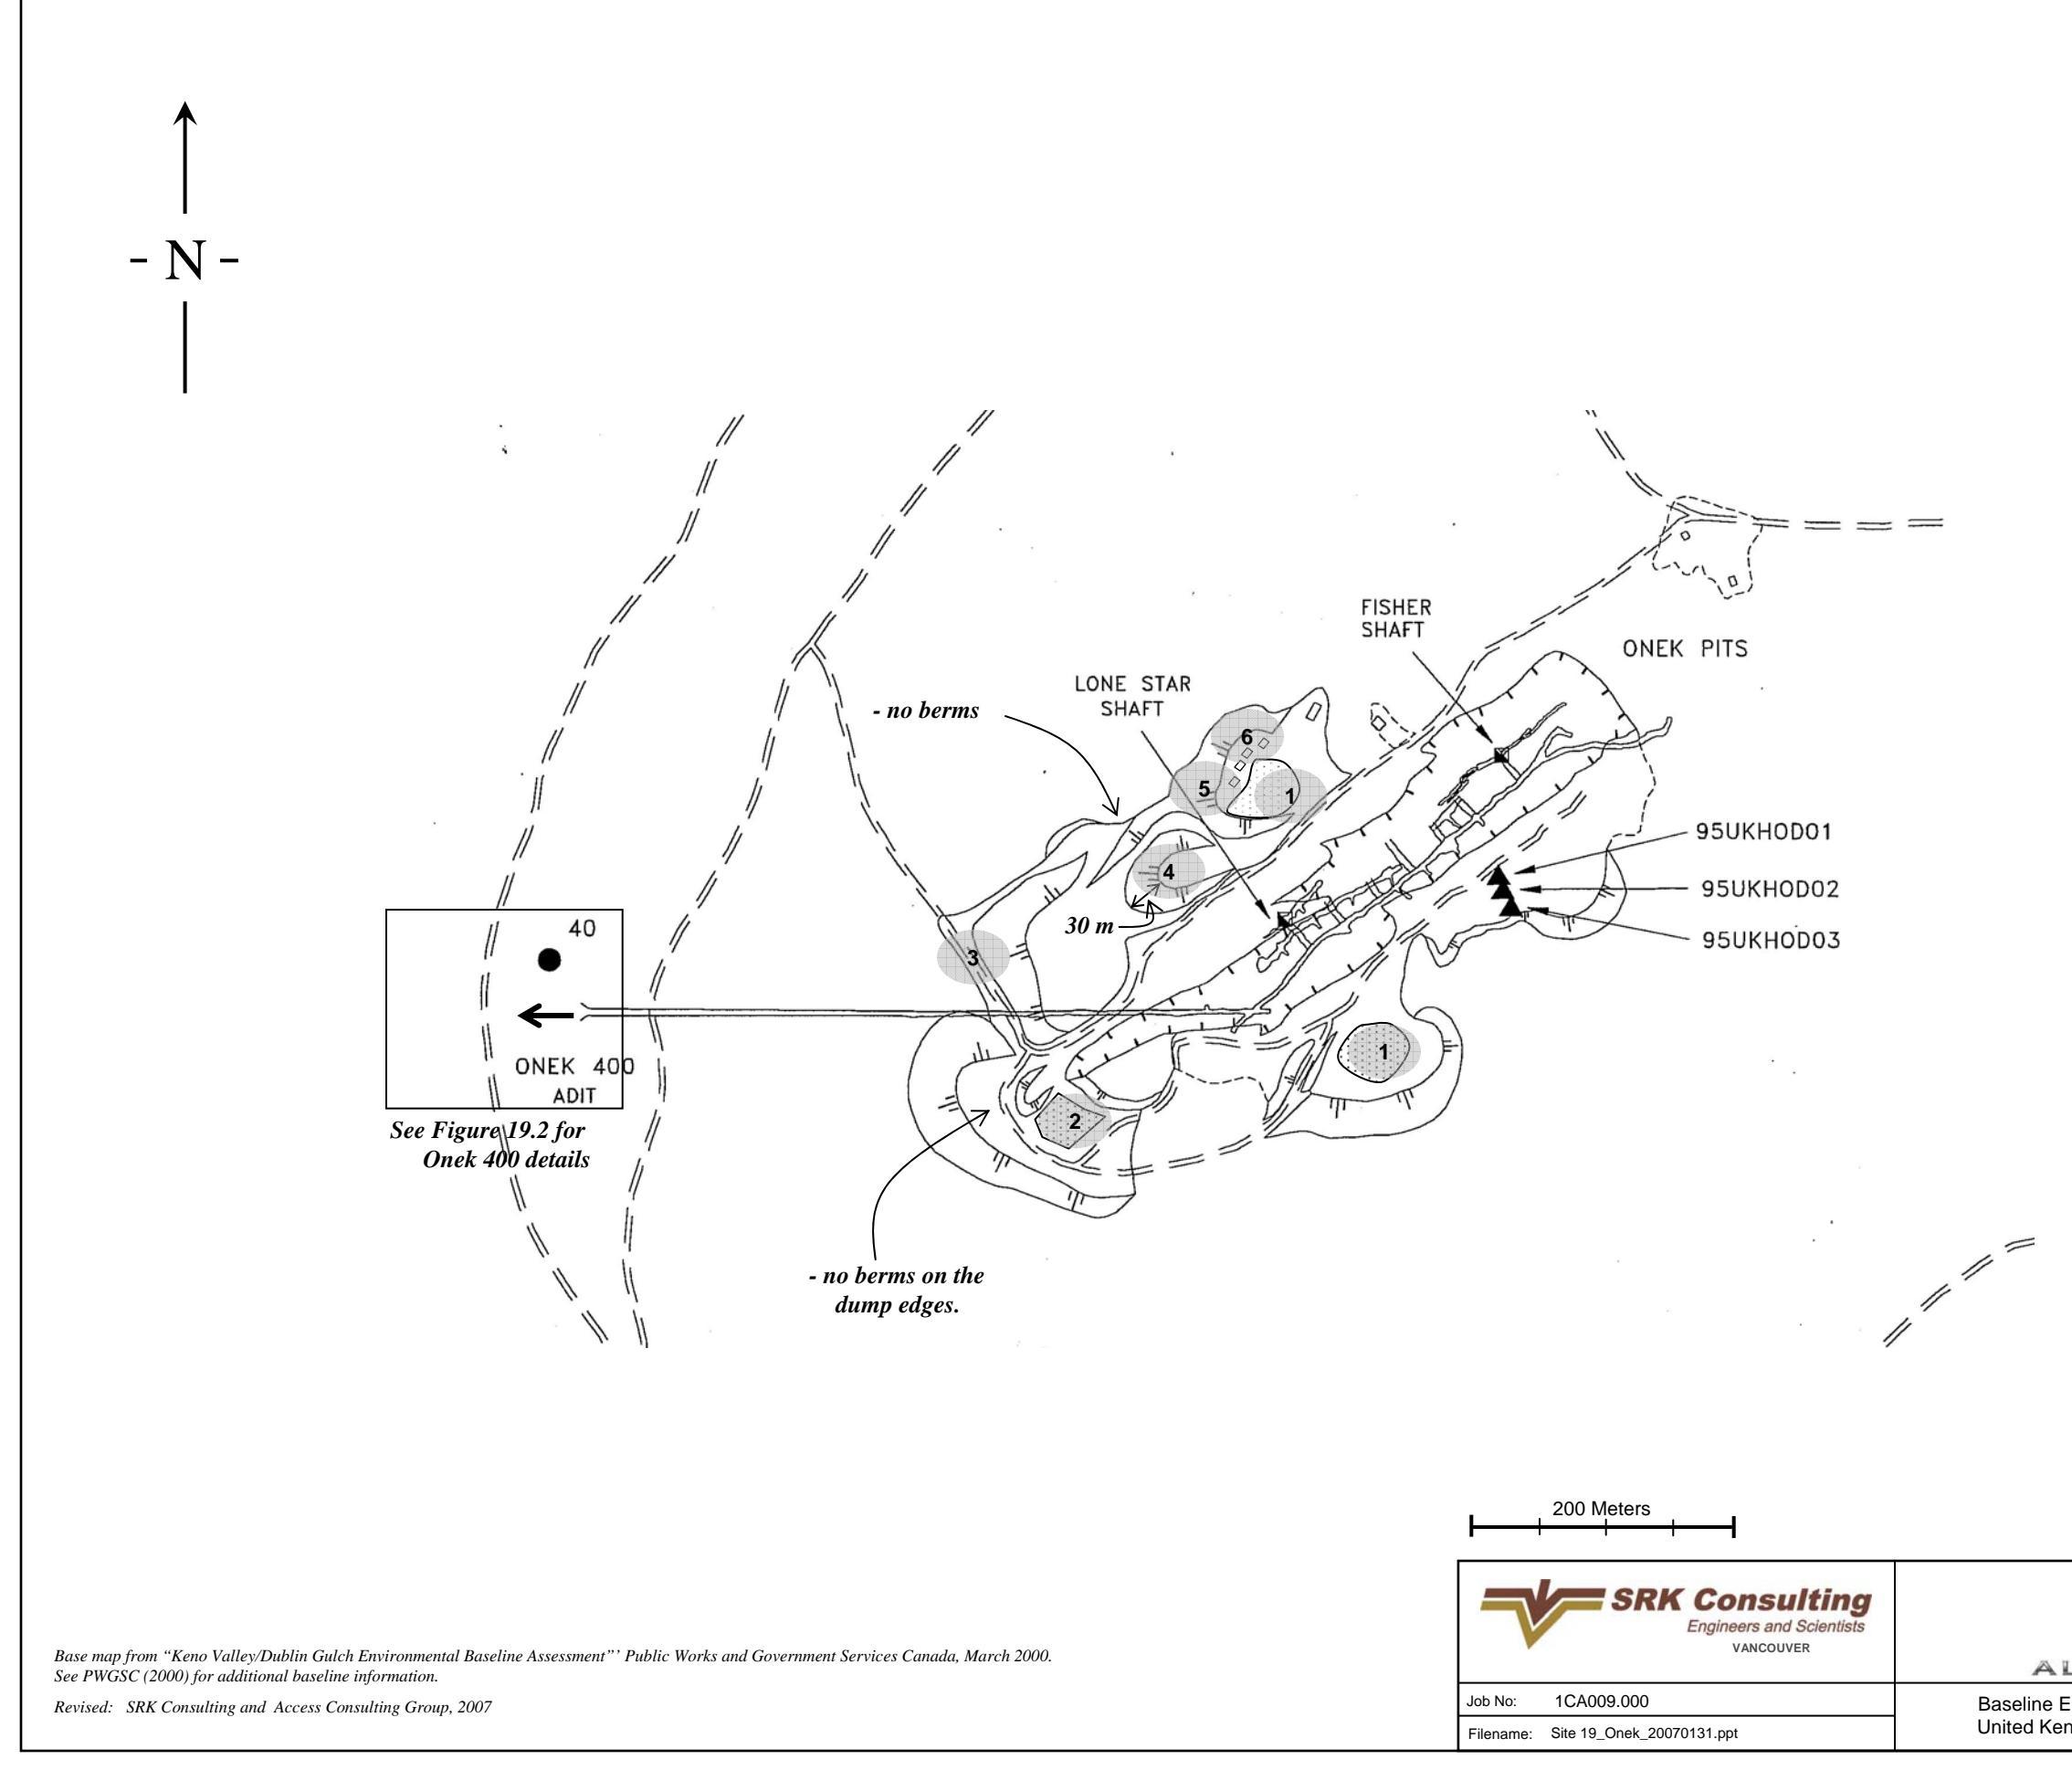
Site #19 – Onek

- #1 Free dumps and traffic surfaces of oxidized dark orangey brown to black ore
- #2 Free dumps of oxidized dark orangey brown to black ore
  Approximately 40 dump loads, each 2 m x 4.5 m x 4.5 m
- #3 North & west areas have bermsSouth area high, no berms and very steep
- #4 East slope berm 30 m wide - Berms smaller
- #5 No berms along the crest of the waste dumps
- #6 -Minor hydrocarbon staining near buildings. Buildings in poor repair. One lead/ acid battery noted.

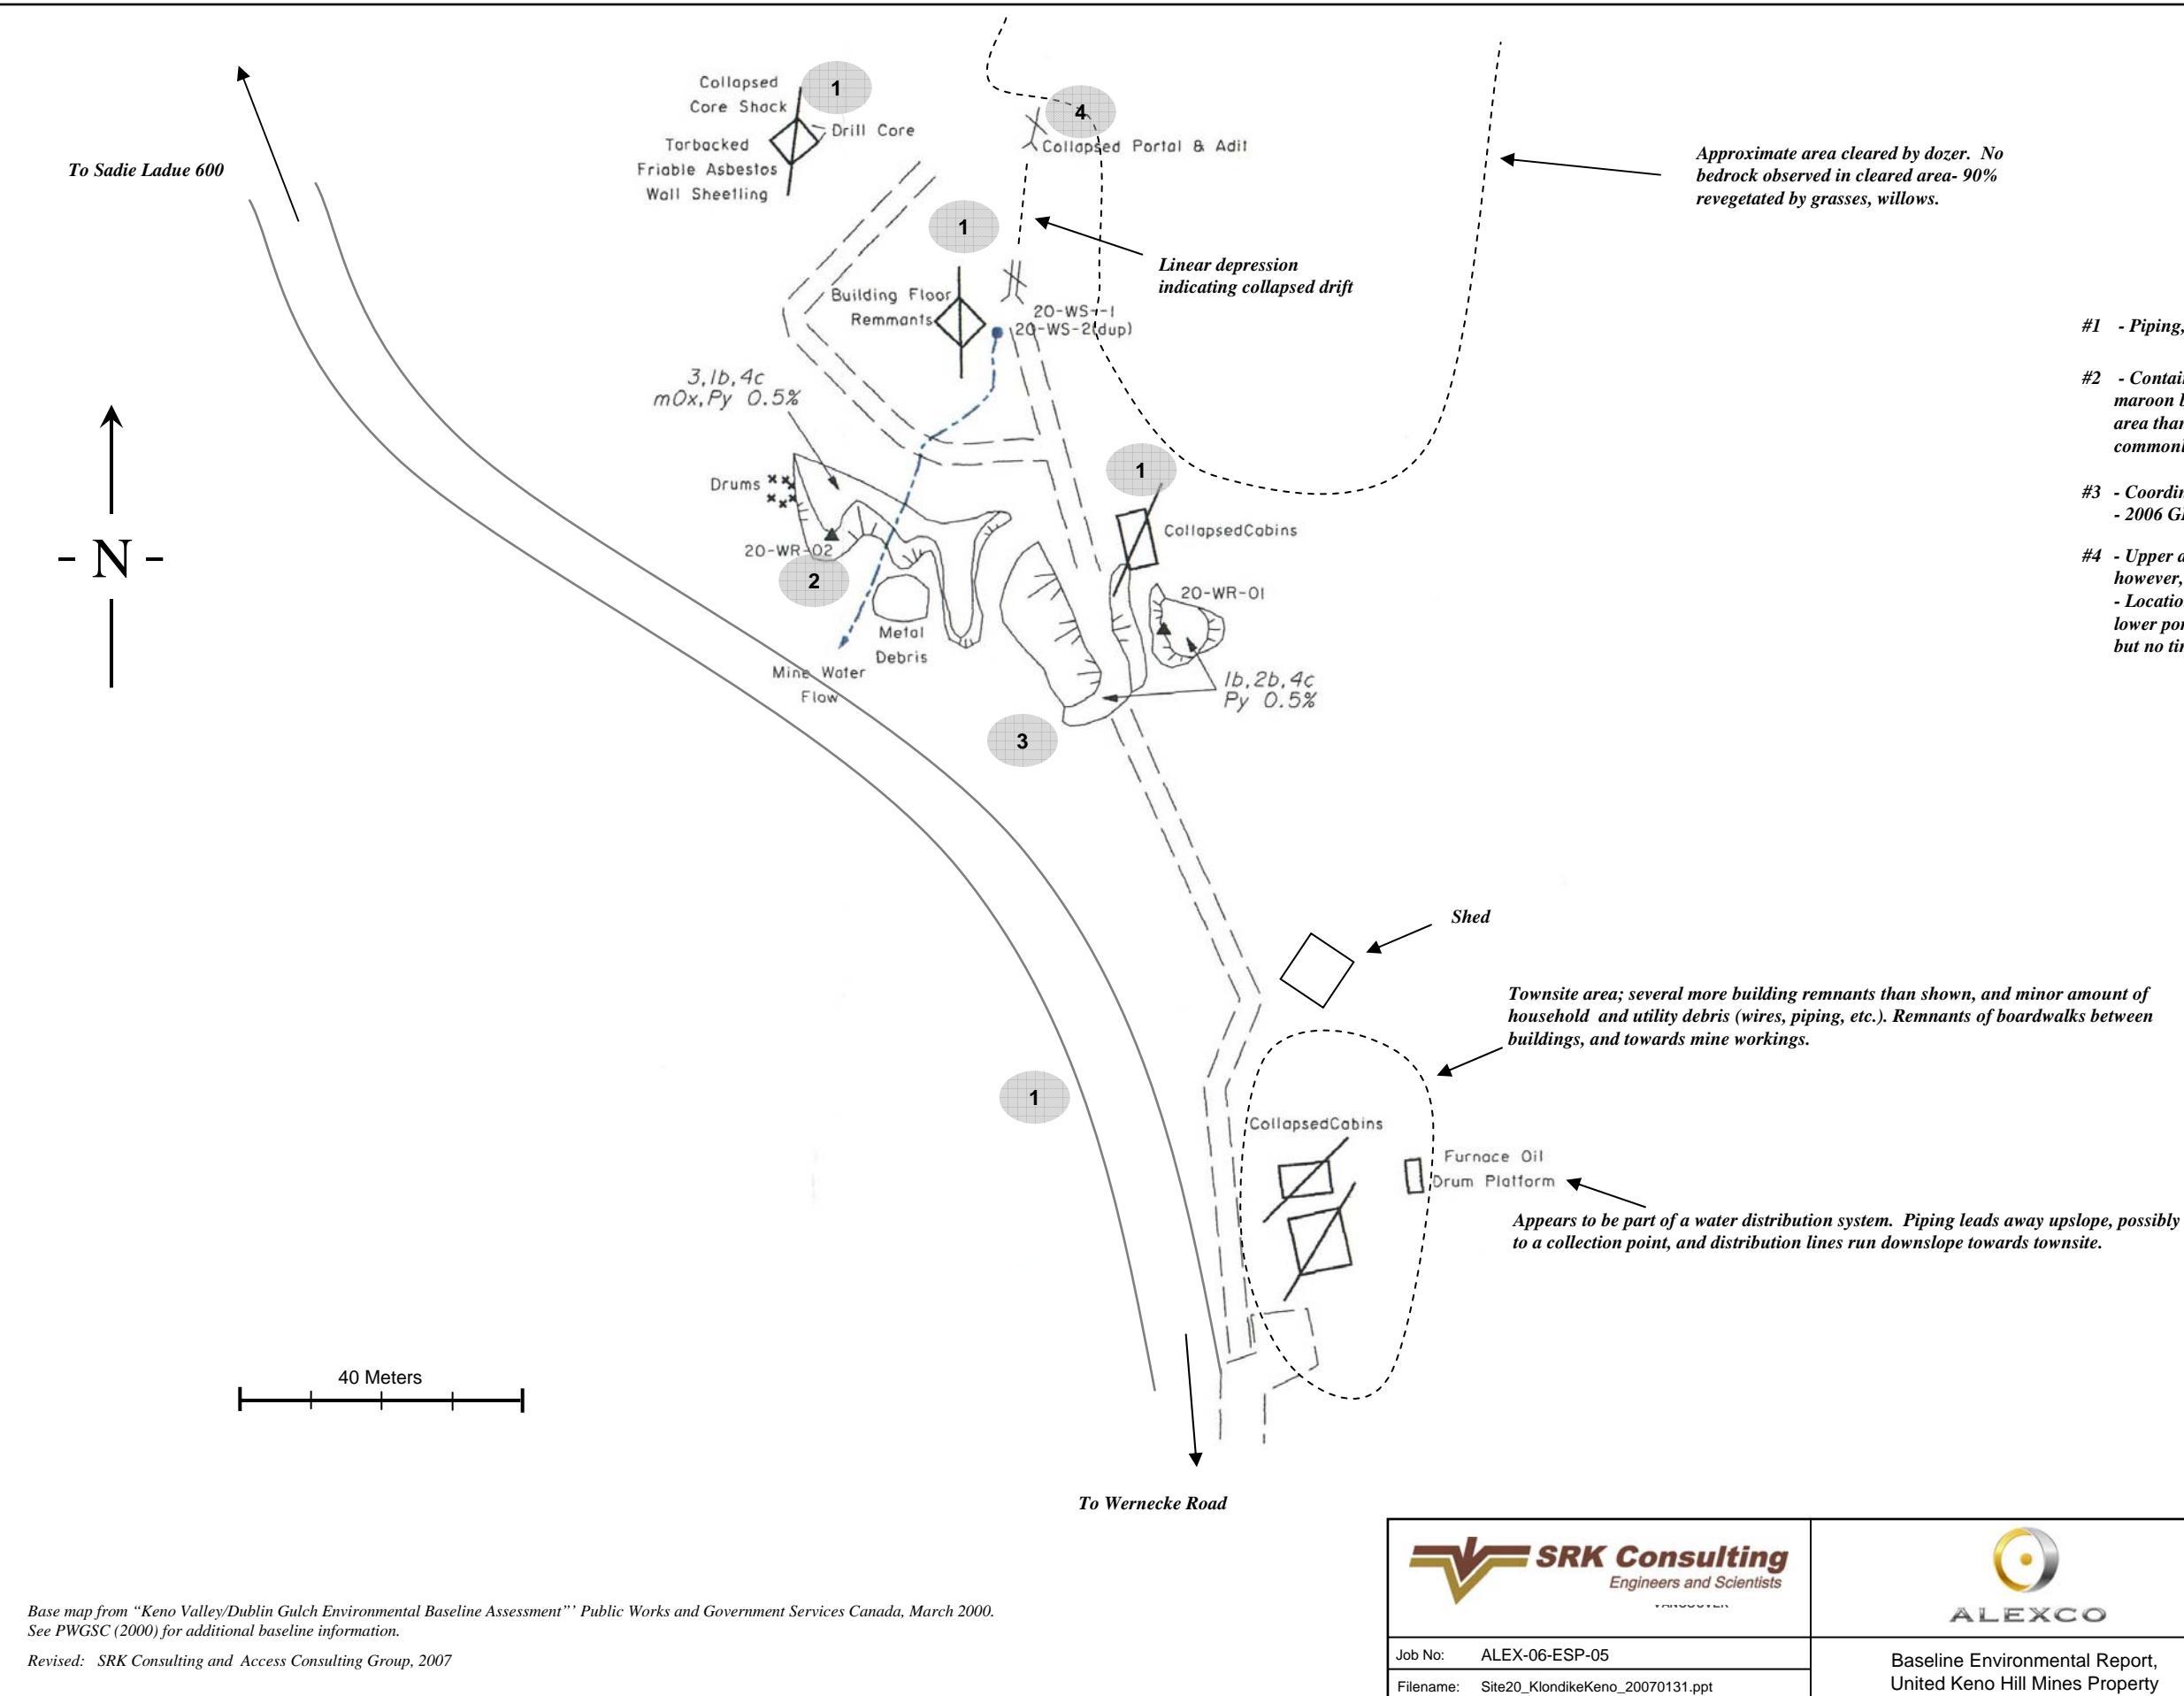
Site #20 – Klondike Keno

- #1 Piping, wood, and metal debris spread across site
- #2 Contains zones of 90% quartz siderite waste, weathering maroon brown. More orange-stained clasts (<1%) in this area than in other waste at this site; orange staining mostly commonly occurs on carbonaceous phyllite.
- #3 Coordinates and elevation in PWGSC 2000 are not correct. - 2006 GPS position: NAD 83 UTM position 485597 E 7090841 N.
- #4 Upper adit not located. Reported to be 225 m from lower adit; however, map indicates approximately 20 m. - Location as shown on map at upper limit of collapse drift of lower portal; service pipe was noted in collapsed rubble and soil, but no timbers were observed.
