# Draft Baseline Environmental Report United Keno Hill Mines Property

Project Reference Number SRK 1CA009.000

January 2007

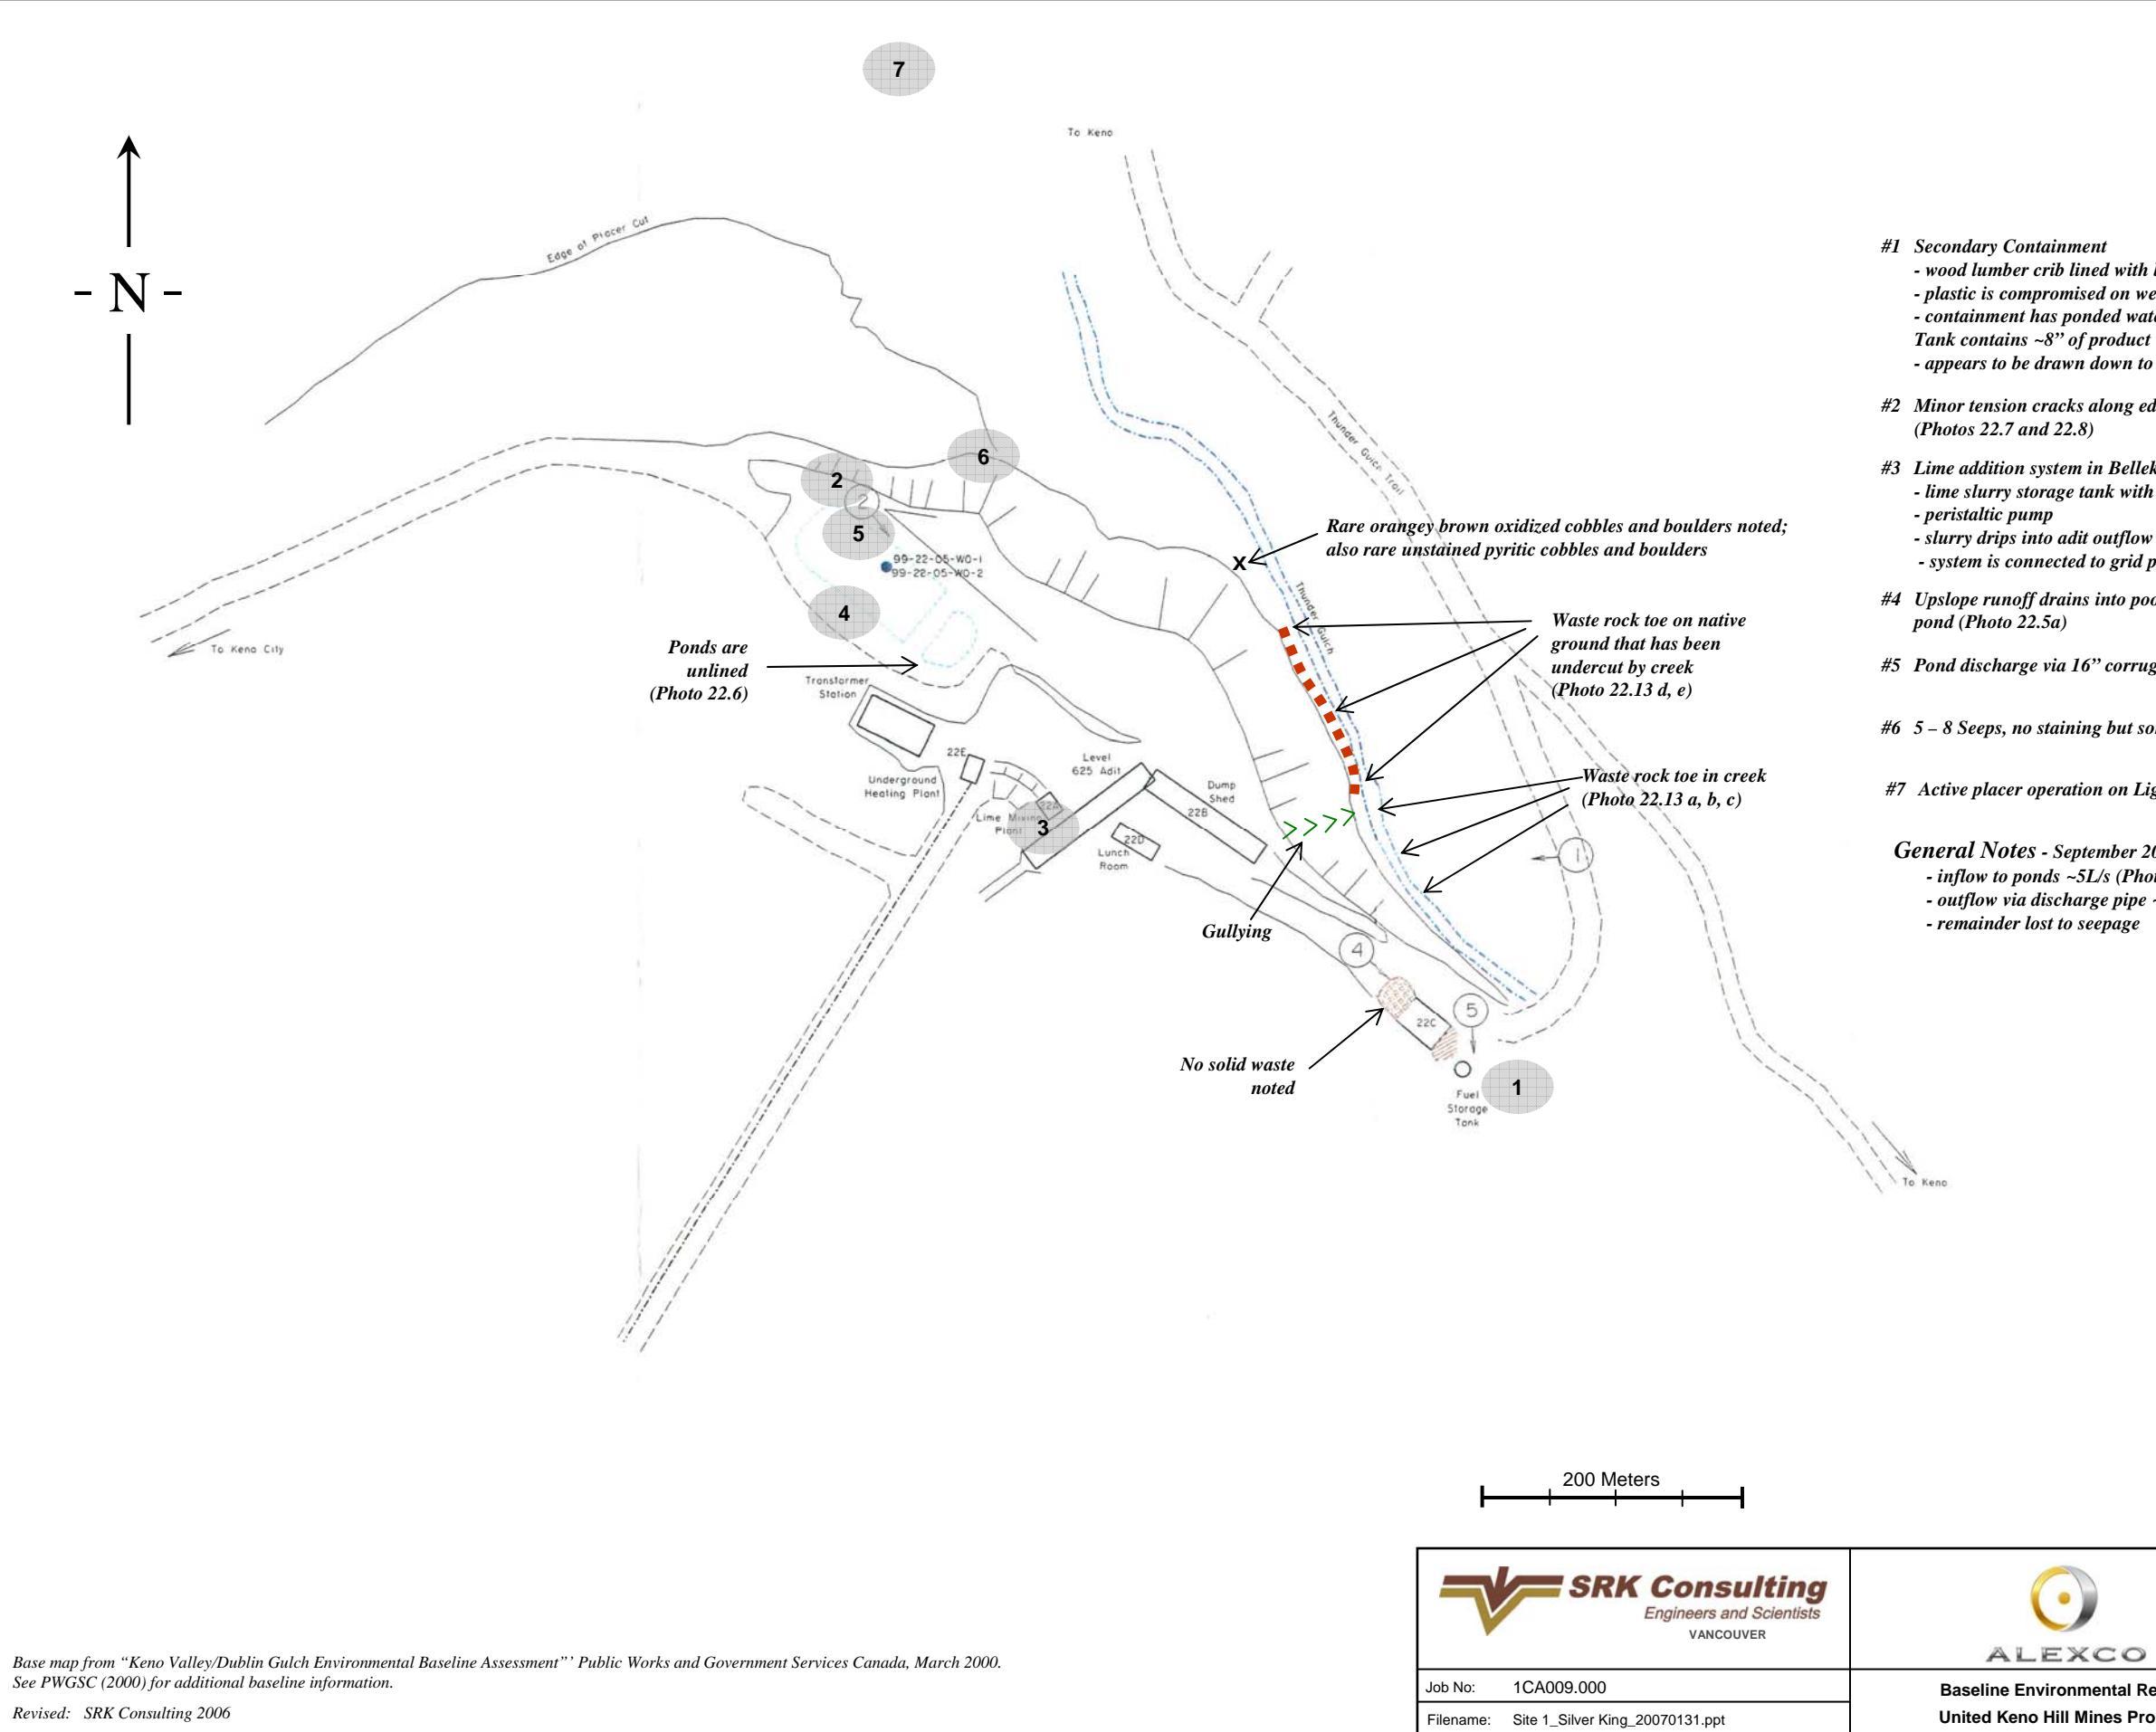
Site #22 – Bellekeno

- wood lumber crib lined with black plastic - plastic is compromised on west side, i.e. a spill would not be contained - containment has ponded water and algae inside to depth of 5 cm - appears to be drawn down to level of outlet pipe and valve

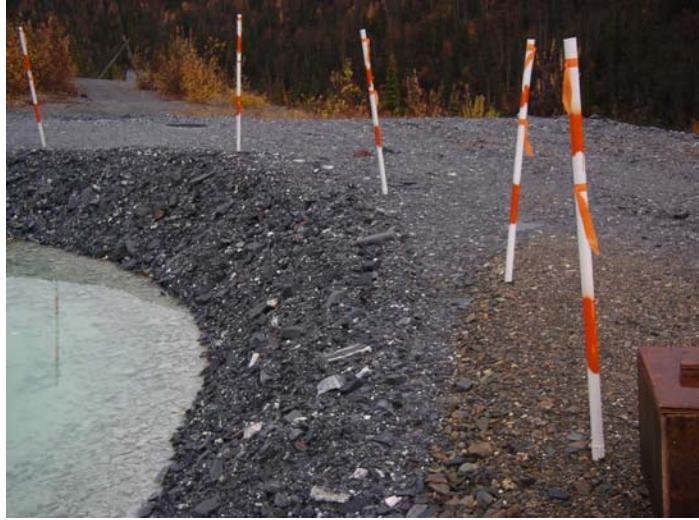
Photo 22.7\_Bellekeno tension cracks on upstream crest

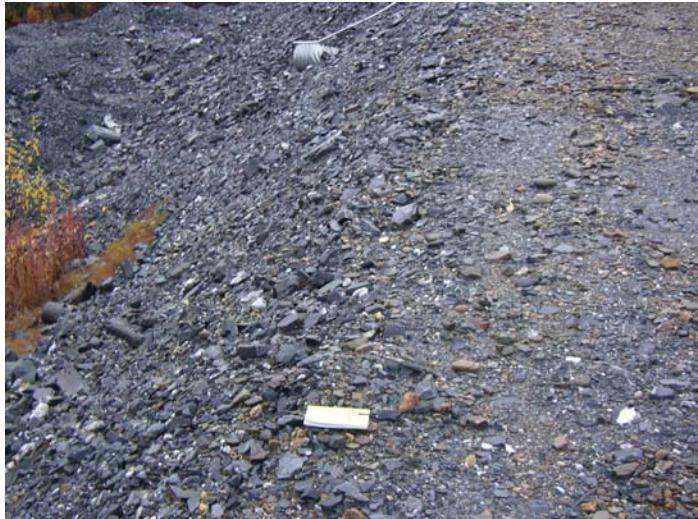
Photo 22.8\_Bellekeno tension cracks on downstream crest

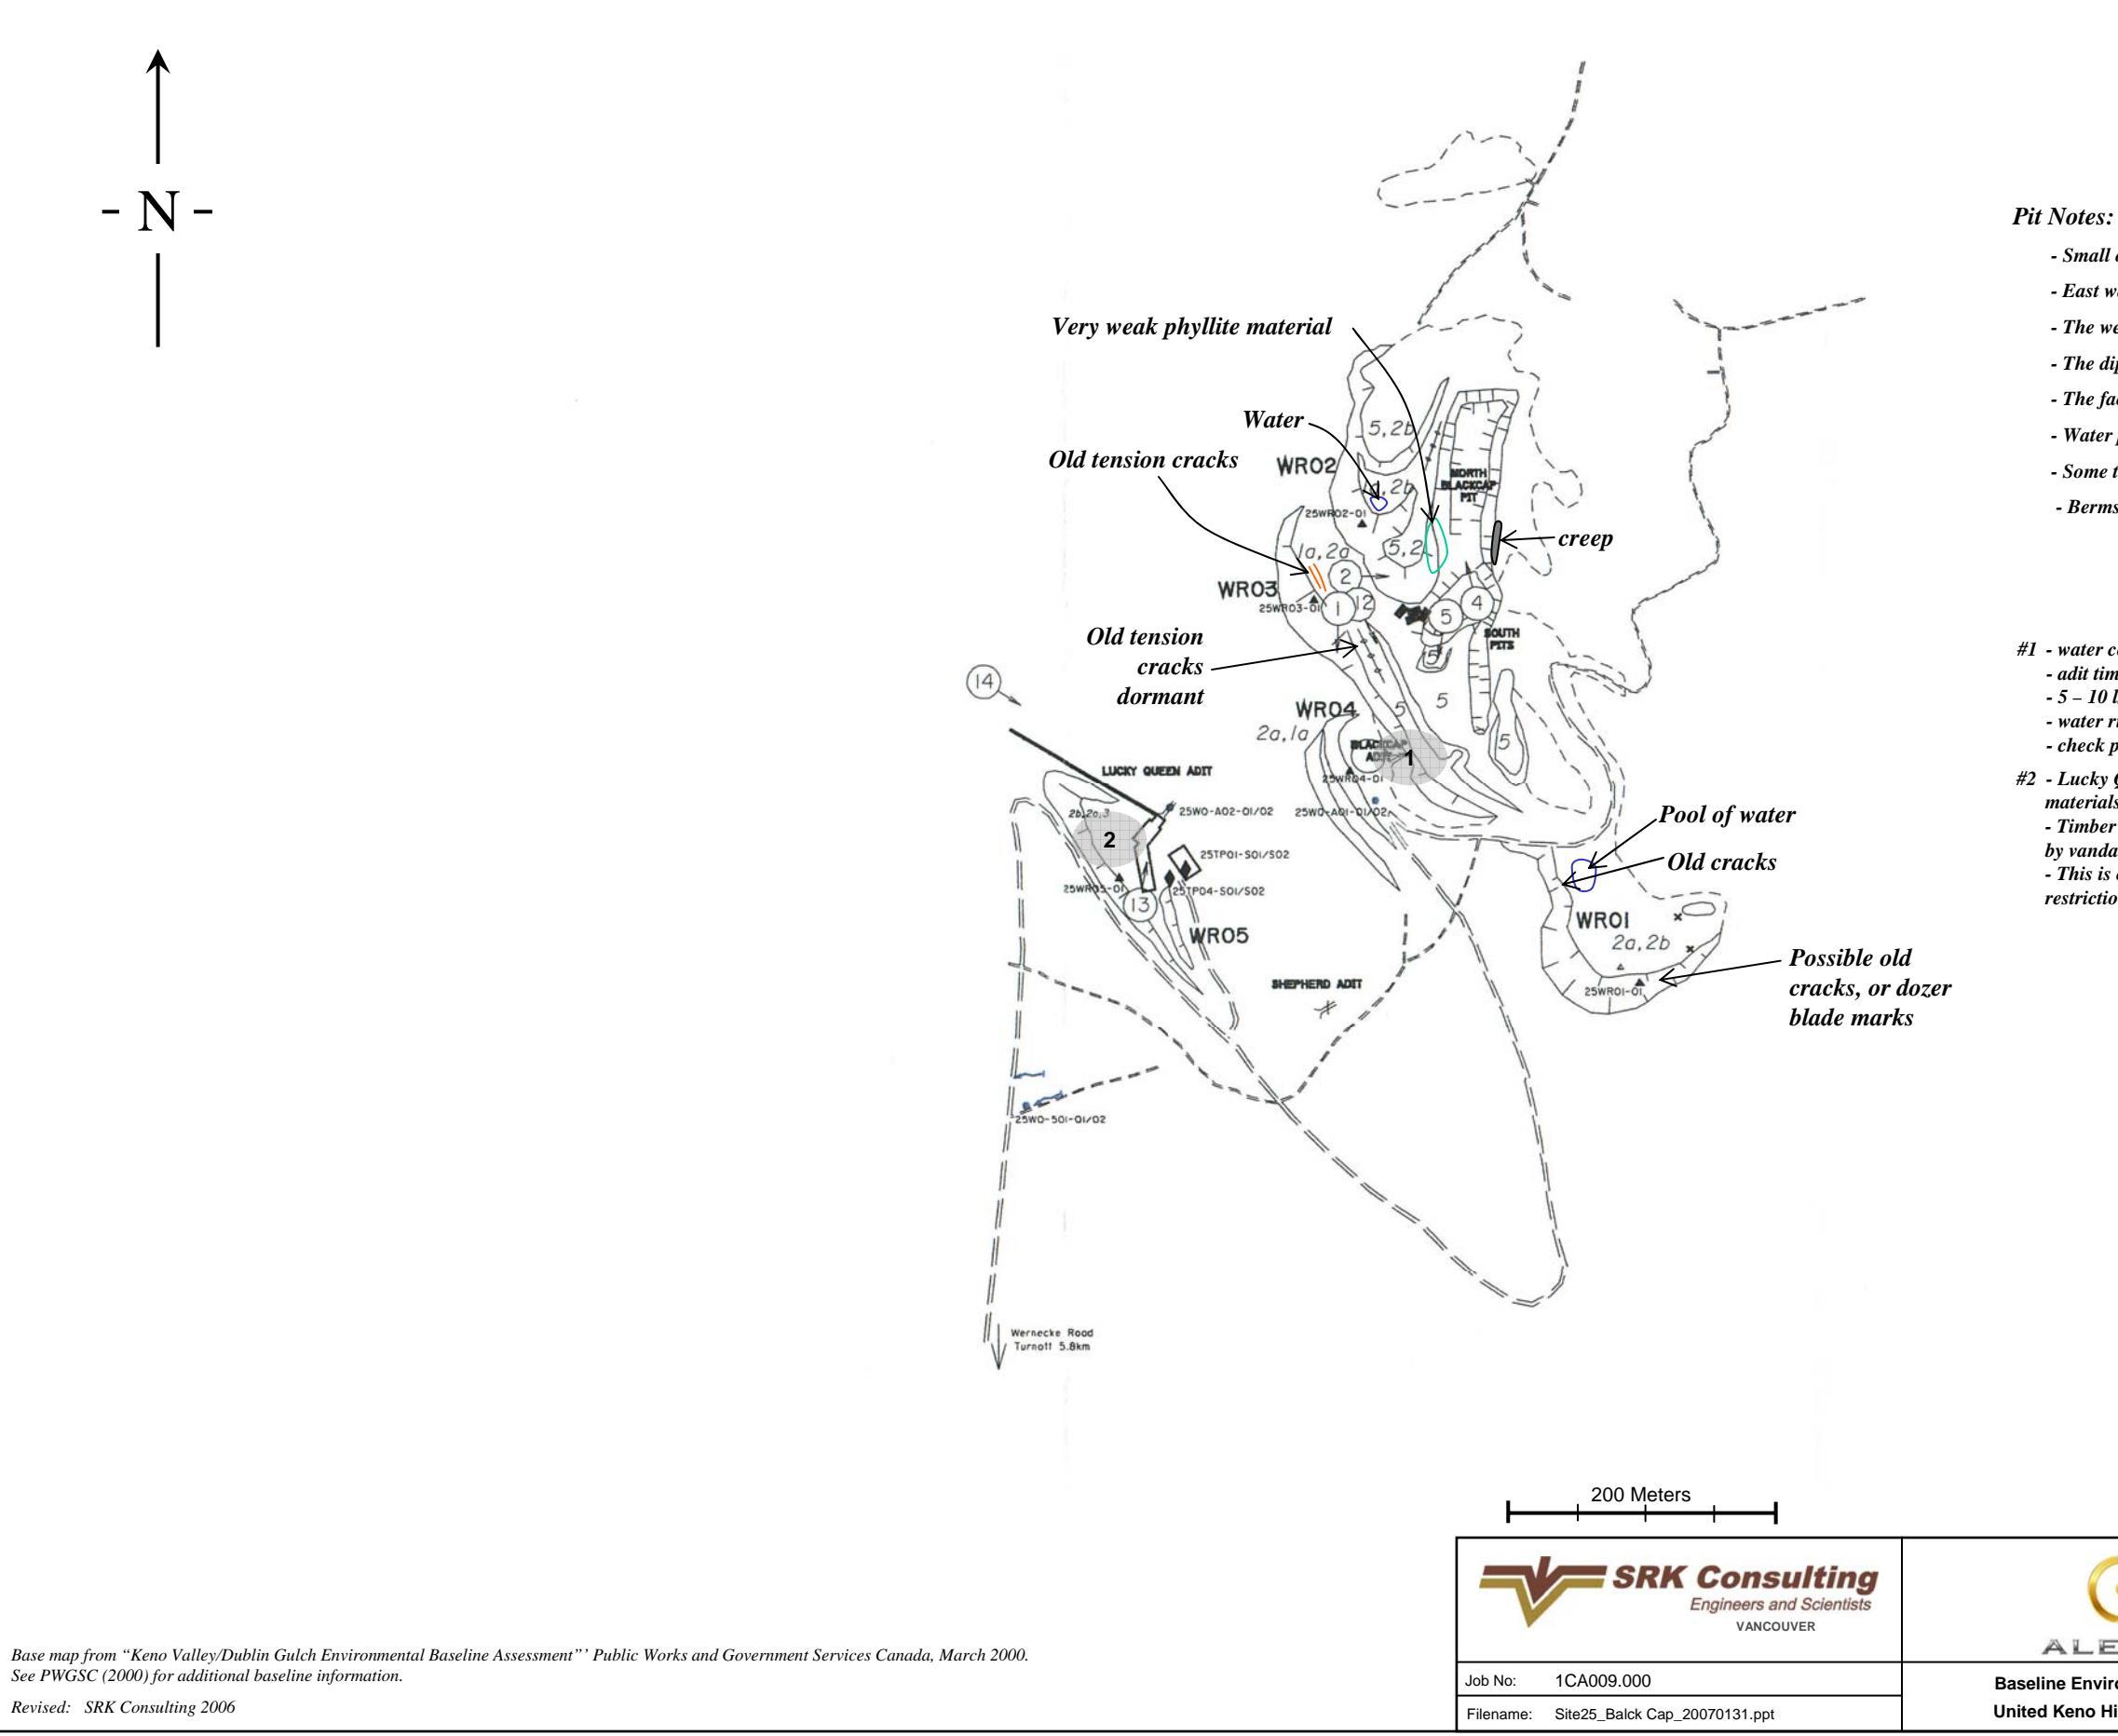
Site #25 – Black Cap

- Small operation with some poor blasting practices - East wall is benched on a 10 ft lifts; slope angle is low - The west wall was mined with no benches, very ragged appearance - The dip of ore body is at a low angle to the east. - The faces are unravelling substantially on the western entrance - Water pooling on the dump on the west side - Some tension cracks exist on the west dump; these appear dormant - Berms are placed on approximately 50% of the waste dumps

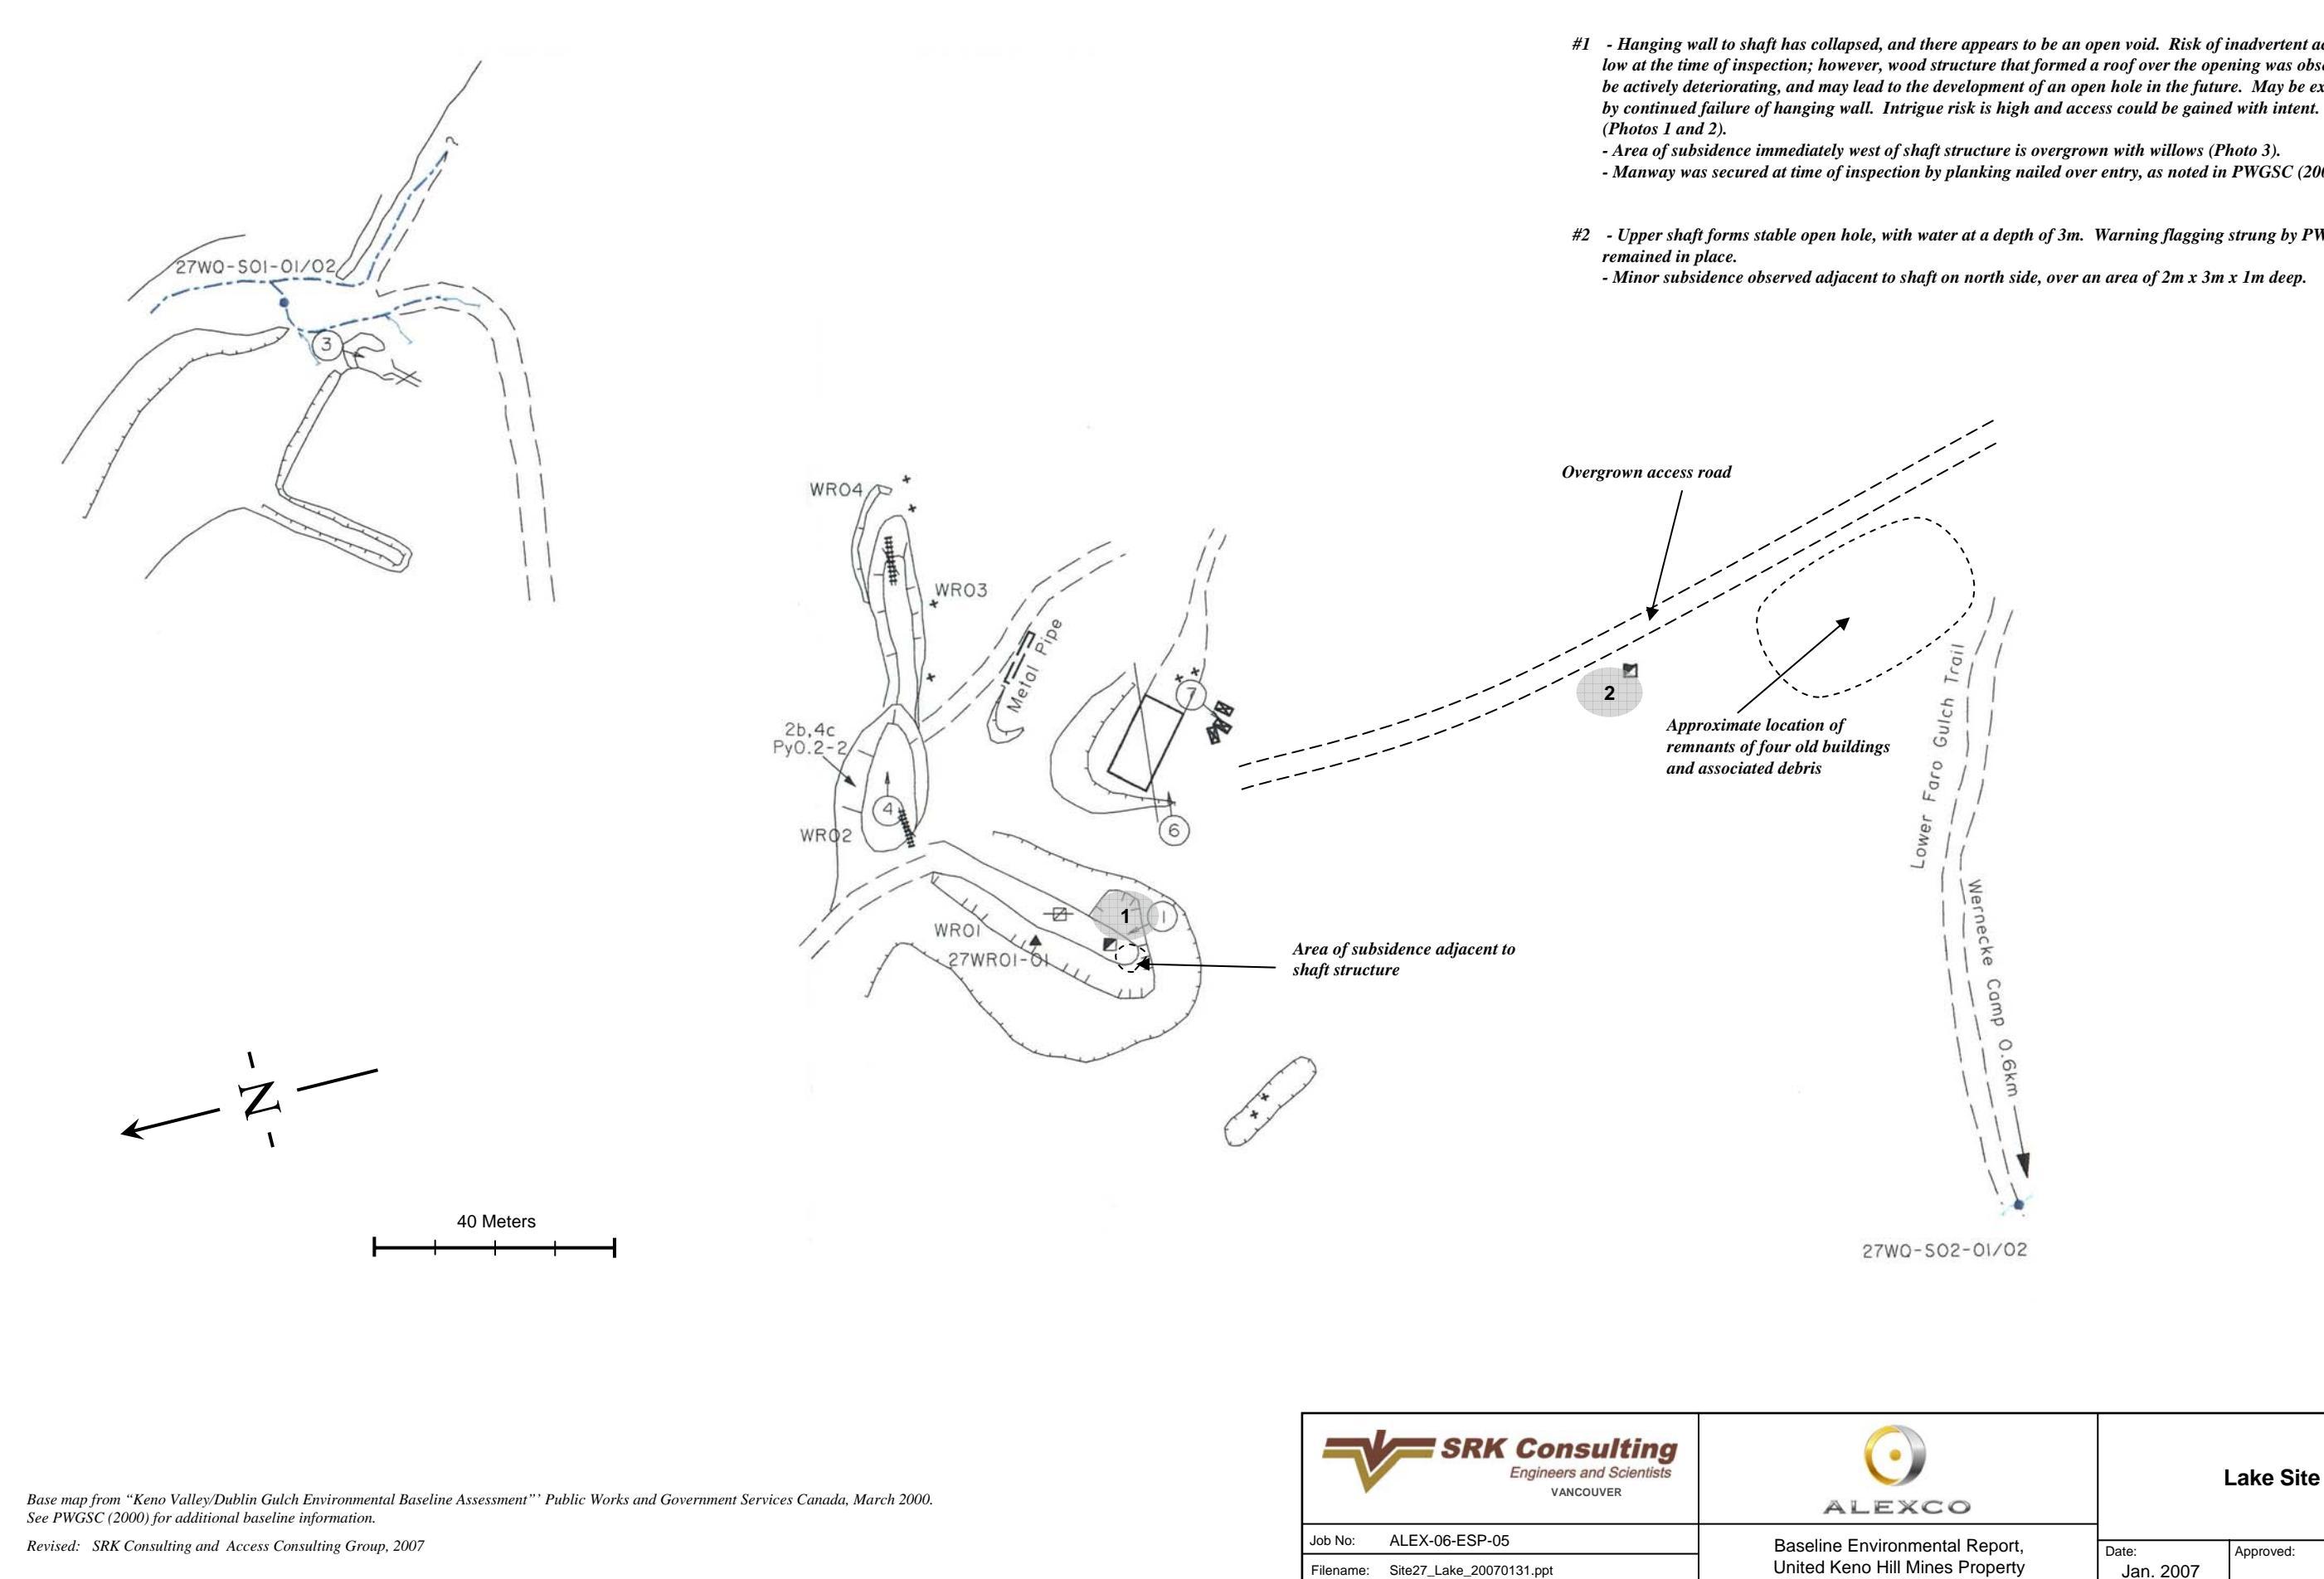
Site #27 – Lake

#1 - Hanging wall to shaft has collapsed, and there appears to be an open void. Risk of inadvertent access was low at the time of inspection; however, wood structure that formed a roof over the opening was observed to be actively deteriorating, and may lead to the development of an open hole in the future. May be exacerbated

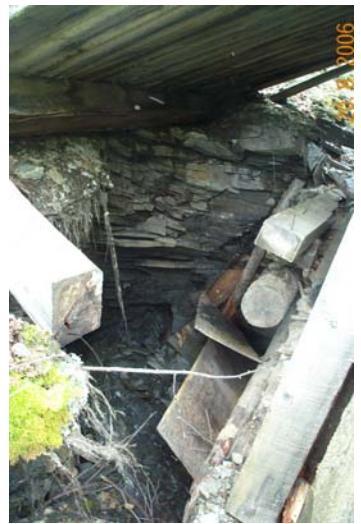
Photo 27.2\_Detail- failed hanging wall

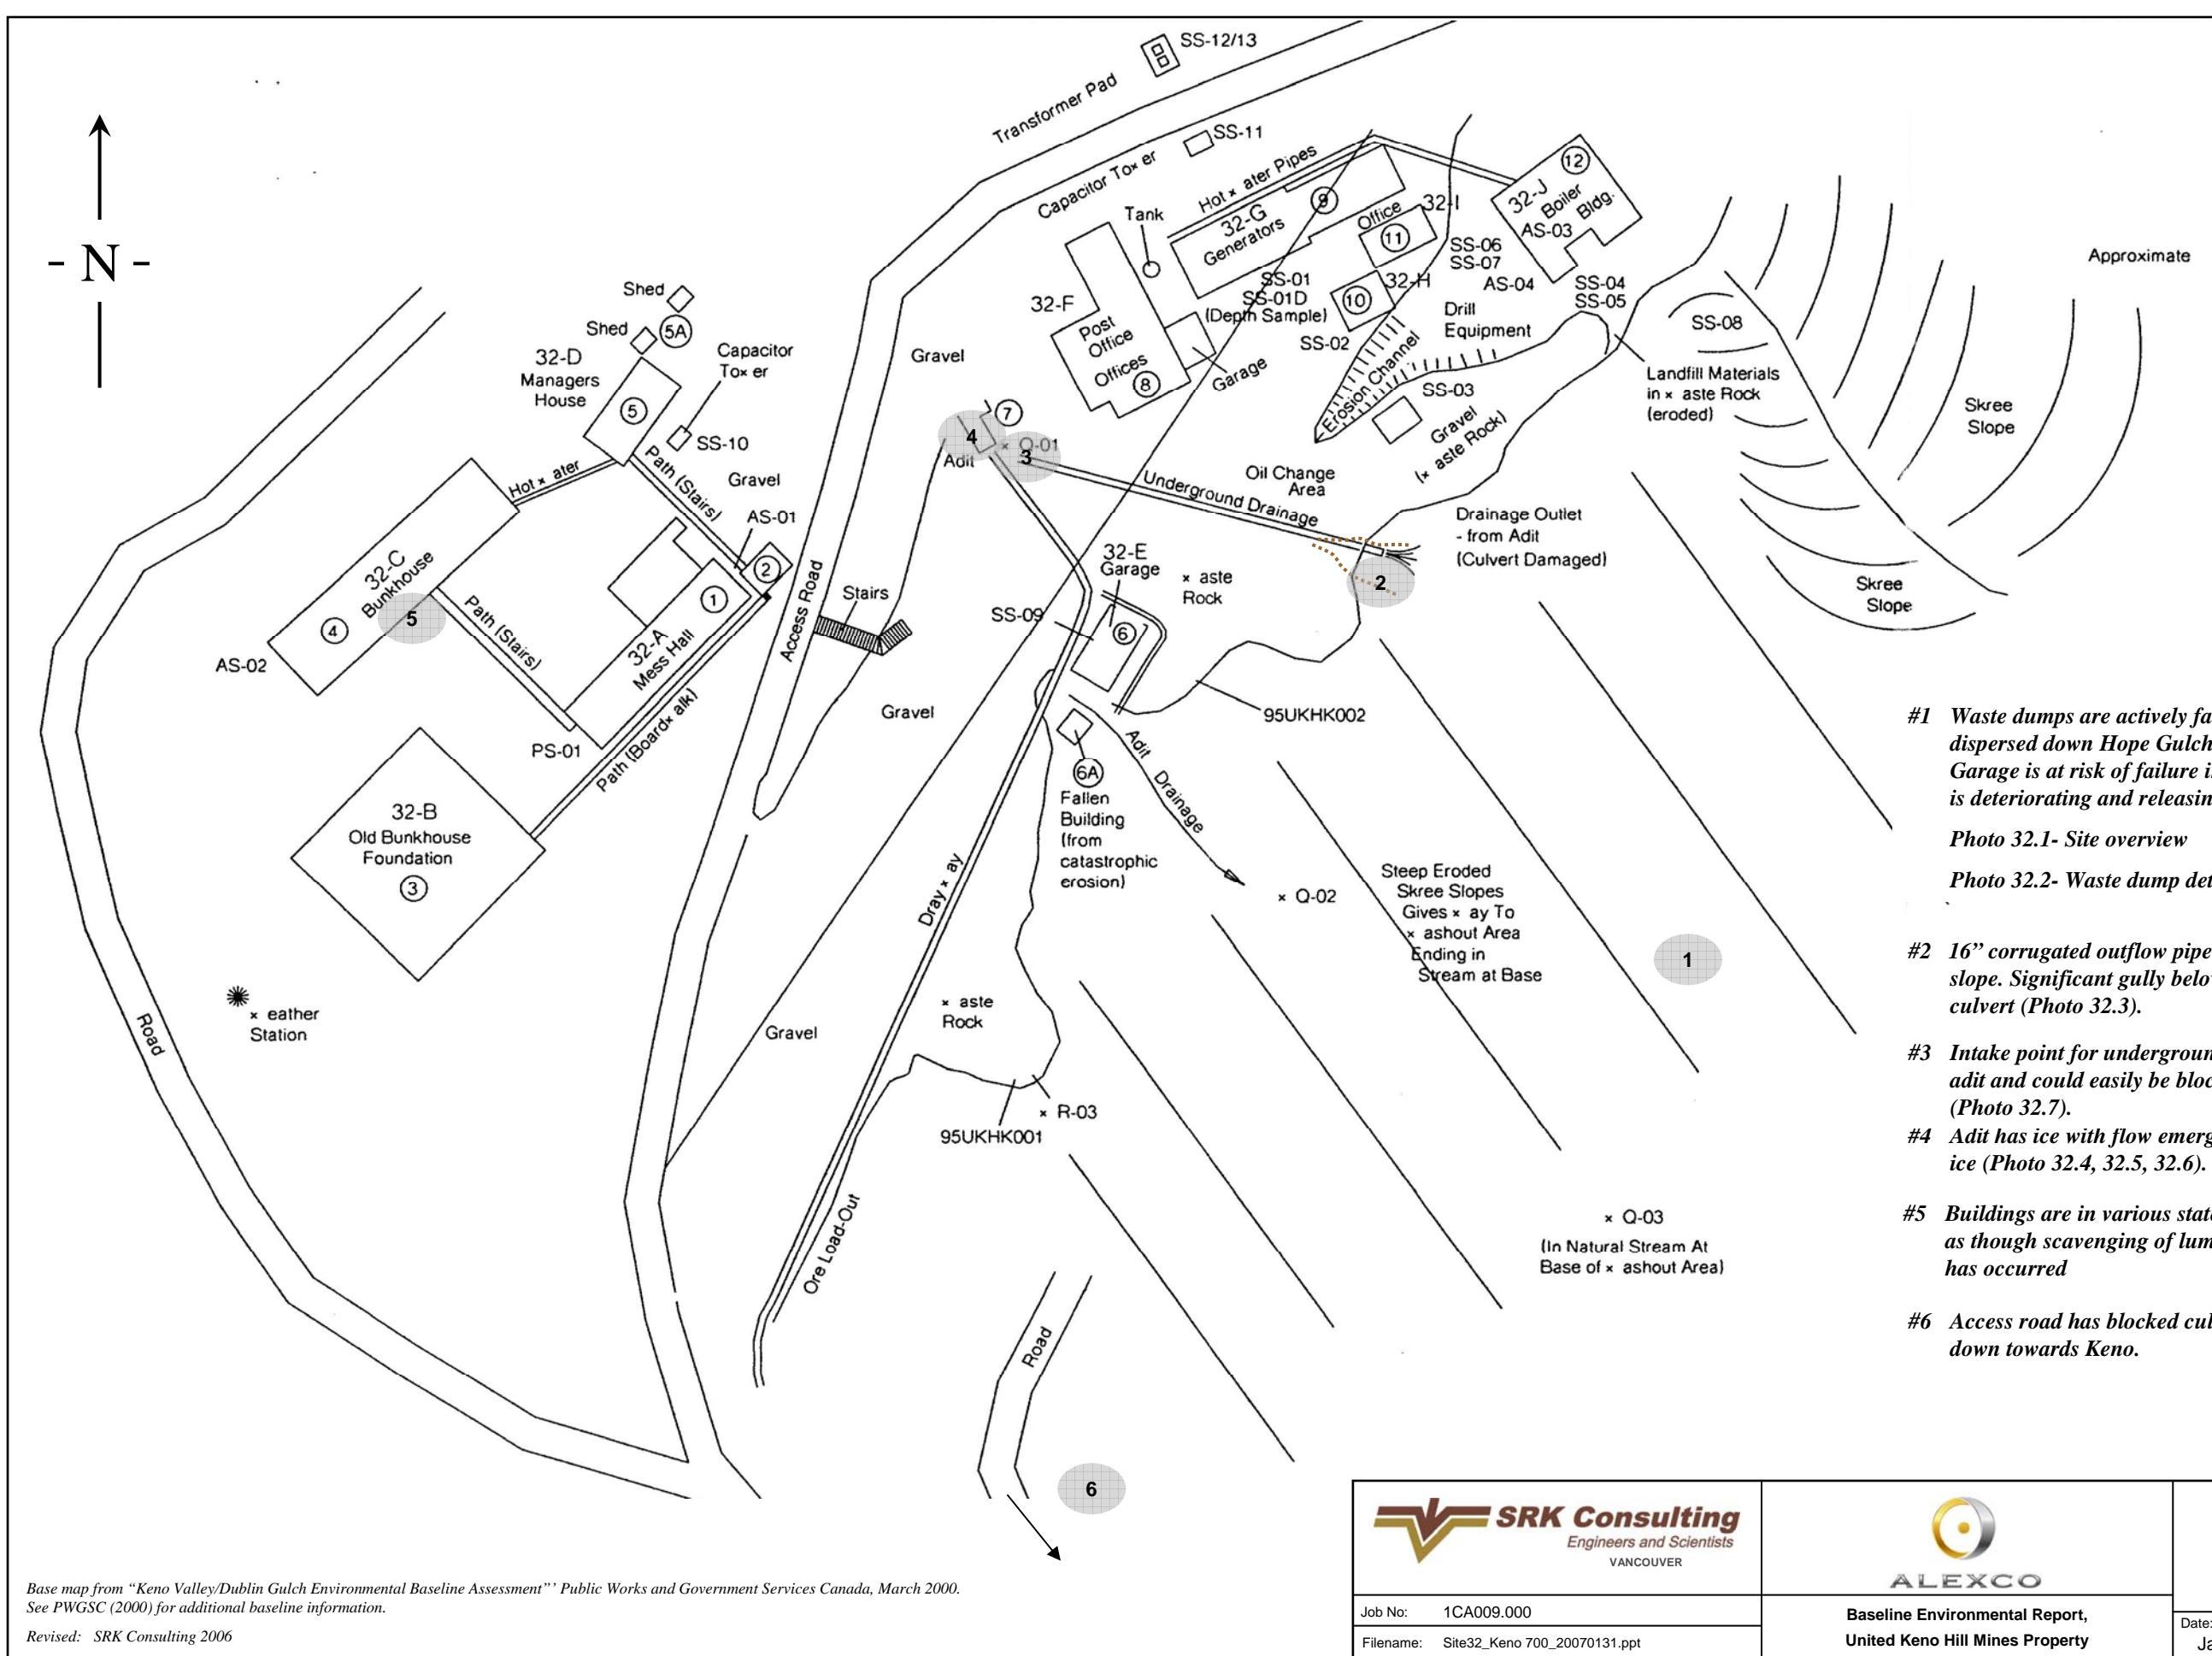
#1 Waste dumps are actively failing and waste material is being dispersed down Hope Gulch. Waste that forms foundation of Garage is at risk of failure in the short term. Timber cribbing is deteriorating and releasing retained waste material.

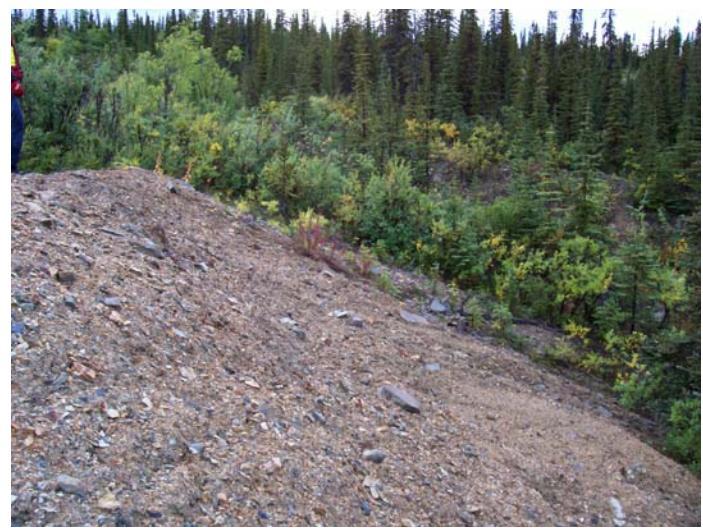
Photo 59.06\_Flow lobe and oversteepened toe at base of waste pile, steep source zone

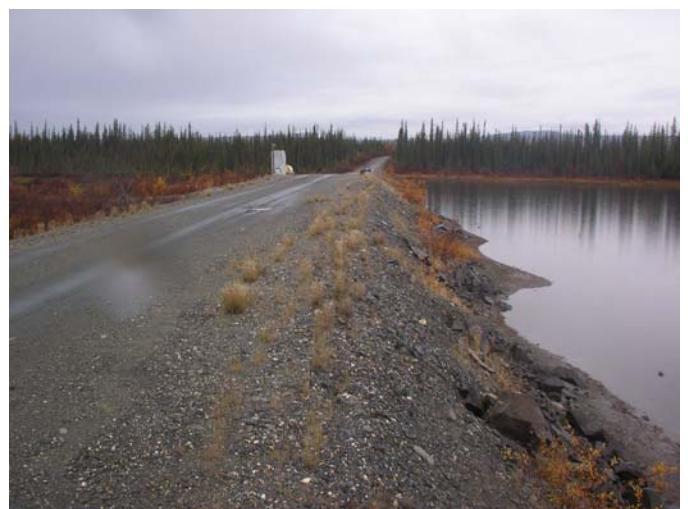
Photo 79.14\_17\_Elsa\_Tailings\_17 Dam 2 tension cracks in upstream crest

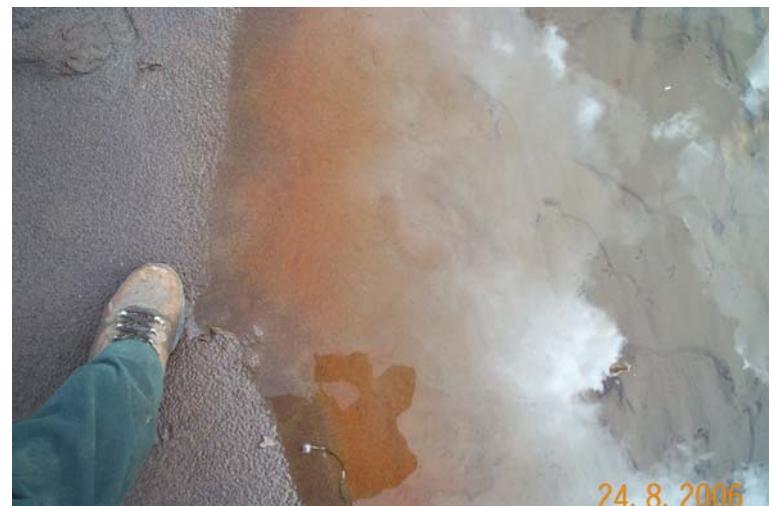
Photo 81.08\_Orange staining in seepage from wethered tailings at edge of Christal Creek
