Faro Mine Hydraulic Capacity Analysis

Final Report June 2006

northwest hydraulic consultants ltd.

June 2006

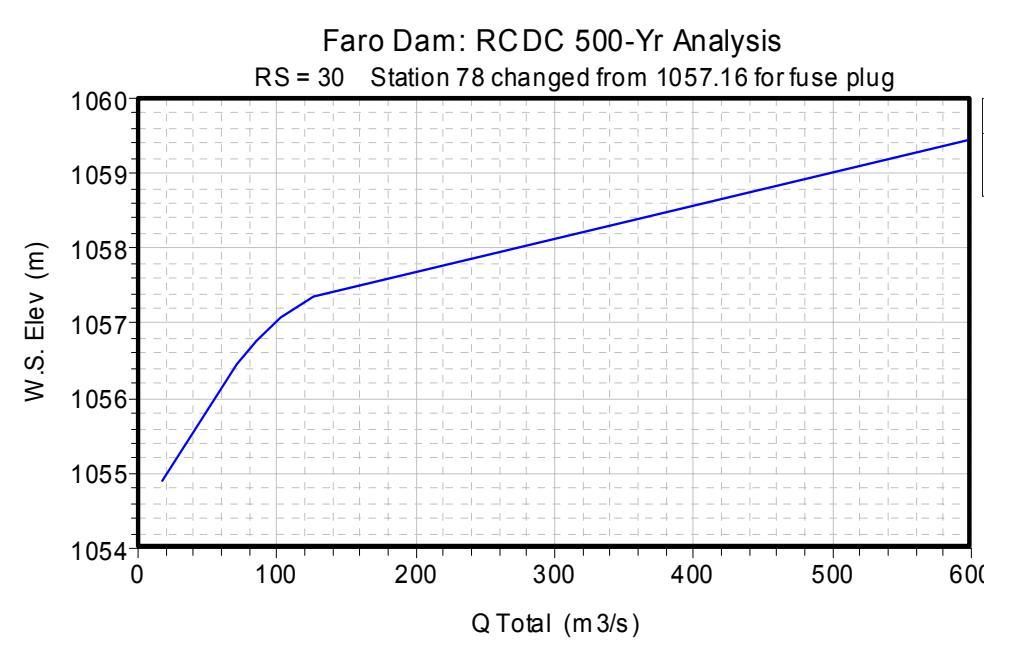
Figure 3 RCDC Rating Curve at Fuse Plug

The results of the model testing show that at the IDF the RCDC spills 6.2 m^3 /s over the fuse-plug with the existing geometry and up to 16.7 m^3 /s with $1/3^{\text{rd}}$ of the channel blocked. Upstream of the fuse-plug there is 3 to 5 m of freeboard from the IDF water level to the top of the north levee. From the fuse-plug downstream to the steep rock weir reach there is typically less than 0.5 m of freeboard. Along the steep rock weir reach the freeboard is greater or equal to 1 m.

Note: The fuse-plug was modelled at 1057.2 m El. as estimated from as-built drawings and survey.

Flow over the fuse-plug is imminent during the IDF. The available as-built drawings (Hydrocon, 1982) show an as-built slope of 20% and a median riprap size of 800 mm immediately downstream of the crest of the fuse-plug weir and a coble transition zone at 6% slope between the structure and the impound tailings. Hydraulic analysis suggests that the structure should remain stable during the IDF. However, it would be prudent to investigate the entire spillway armouring material to ensure no changes have been made to the structure since the as-built drawings were completed, and hence the fuse-plug is capable of withstanding overtopping during flow events up to and exceeding the IDF.

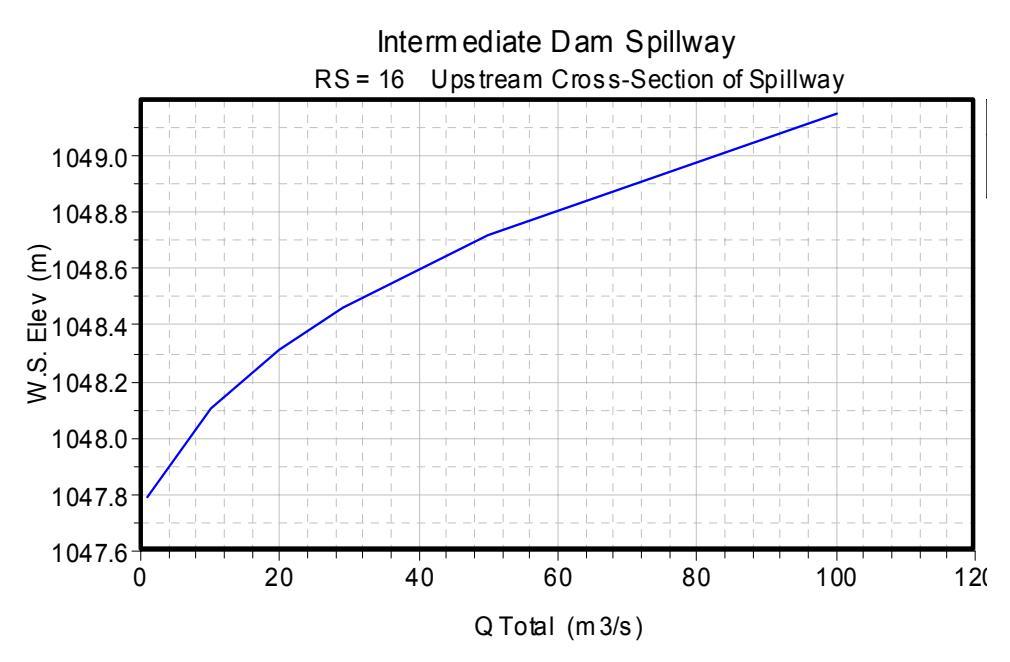
Figure 4 Intermediate Dam Rating Curve

The resulting upstream water surface elevation from modelling the IDF is 1048.2 m El. which provides 0.7 m of freeboard above the lowest point along the Intermediate Dam (BGC 2003 Survey Data). If RCDC suffers from potential channel blockage the water surface elevation may increase to 1048.4 m El. providing 0.5 m of freeboard.

Note: Bank height is roughly 1050.0 m El. and Intermediate Dam Crest is 1048.8 m El.

The Intermediate Dam spillway has enough capacity to convey the IDF. The existing channel is expected to be constructed of 200 mm diameter cobble. High velocities are expected for the downstream 70 m of the channel which may cause instability and local scouring throughout the sporadic boulder placement and the boulder weir section. A site inspection is recommended to confirm existing channel conditions and further assess stability. It is likely that the sporadically placed boulders should be salvaged and the rock weirs be flattened to form a uniform bed in order to ensure stability during the 500-year IDF.

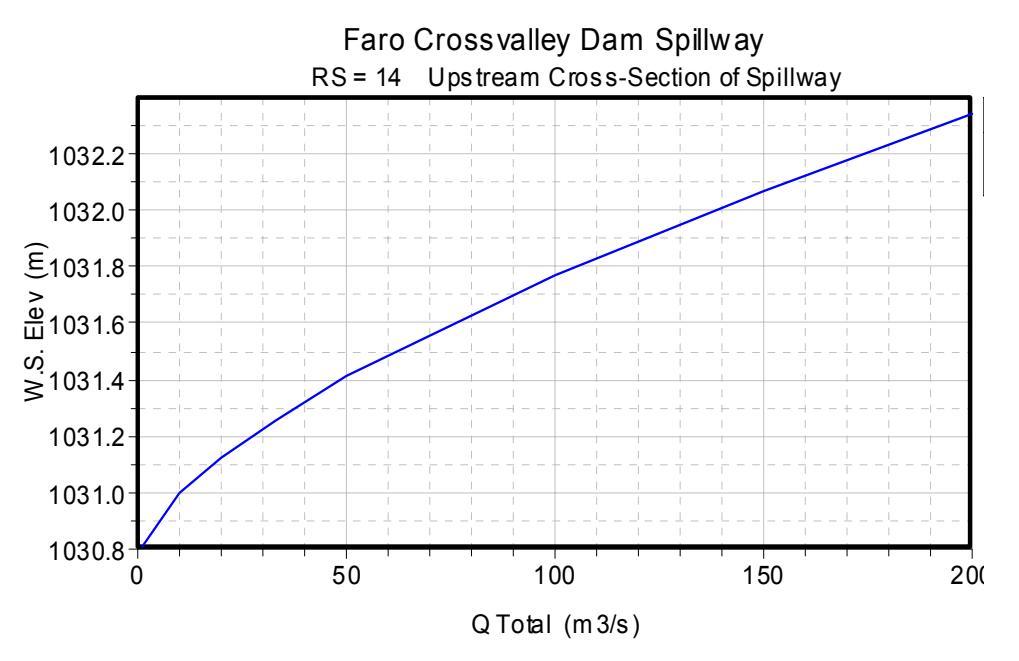
Figure 5 Cross Valley Dam Rating Curve

provides 1.6 m of freeboard above the lowest point along the Cross Valley Dam (2003 Survey). If RCDC suffers from potential channel blockage the water surface elevation may increase to 1031.17 m El. providing 1.5 m of freeboard.

Note: Bank height is roughly 1033.2 m El. and Cross Valley Dam crest is 1032.7 m El.

The Cross Valley Dam spillway has enough capacity to convey the IDF. The existing channel according to historic reports appears to generally be unarmoured. High velocities down the channel are expected to result in instability. A site inspection is recommended to confirm existing channel conditions and further assess stability. It is likely that the channel will require armouring with 300 mm to 1000 mm and larger riprap to ensure stability during the 500-year IDF.

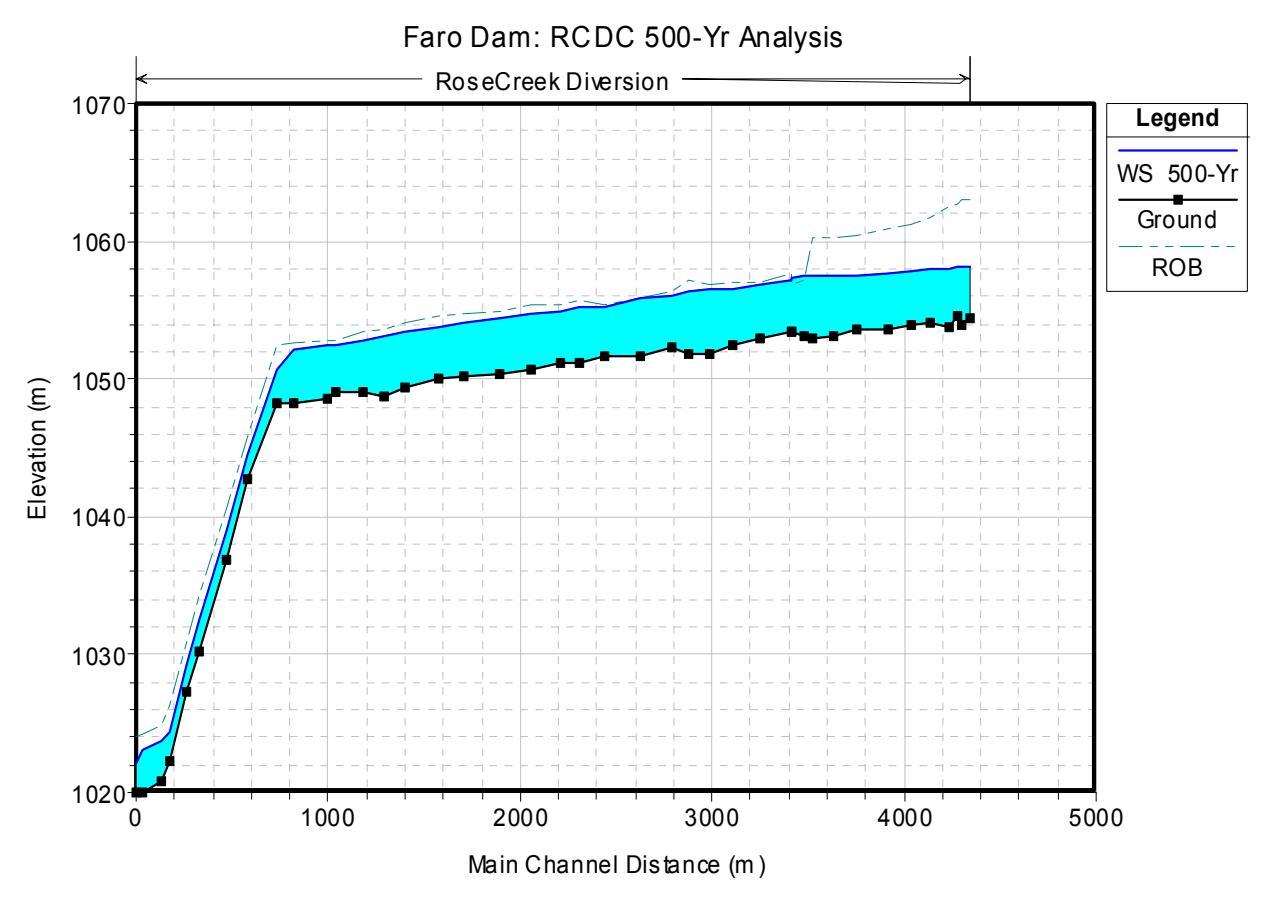
9.1 RCDC Model Results

Hydraulic modelling of the RCDC suggests the freeboard is at some locations is less than 0.5 m (see Appendix A). Typically, we would recommend that these sites be inspected and any low spots along the RCDC north levee crest be raised to ensure adequate IDF freeboard in the event of channel blockage or bank settlement. However, due to the low risk of such an event this analysis could be postponed and incorporated with the ongoing Faro Mine site closure plan. The original RCDC design IDF was the 50-year Rose Creek flood with contingency capacity for a 500-year flood (Golder, 1980). The typical RCDC section was therefore designed such that 1 m of freeboard was provided above the 50-year flood level and no freeboard was provided above the 50-year flood level for any additional factor of safety or to account for extraneous flood scenarios.
