Geotechnical Evaluation Borrow Source Assessment – Clinton Creek Area Dawson, Yukon – 2015

Yukon Government Energy, Mines & Resources Assessment and Abandoned Mines

January 8, 2016

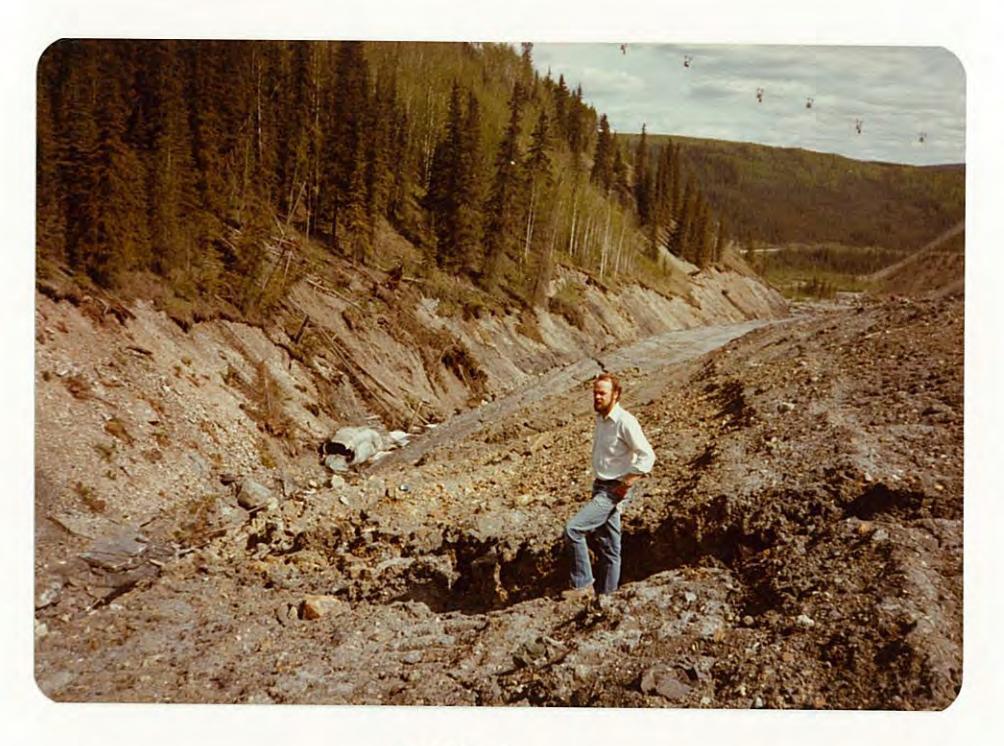
РНОТО 2

Tension cracks on surface of Clinton Dump as a result of horizontal movements due to shear of the dump on its base.

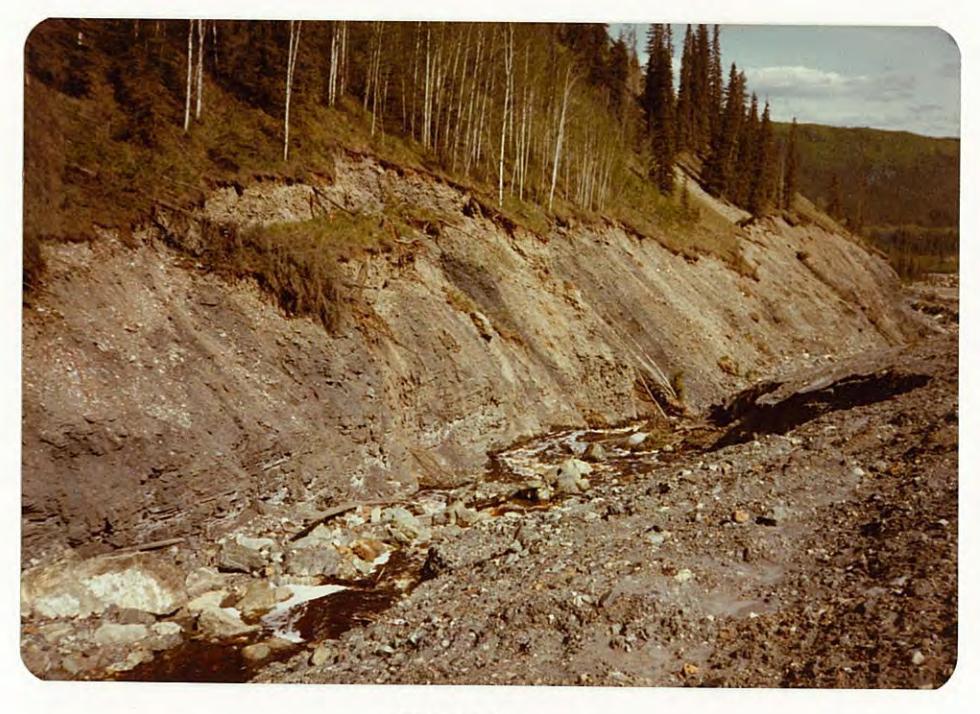
РНОТО З

Tension crack aligned approximately perpendicular to Clinton Channel.

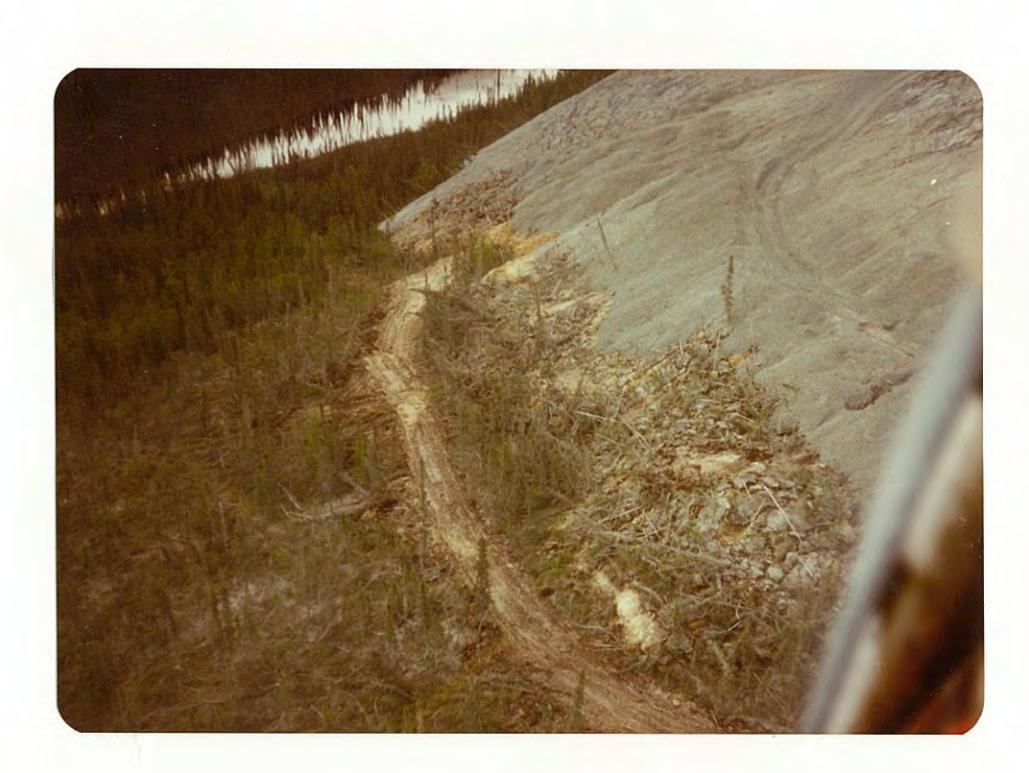
Aerial views of the 1974 failure lobe. Note the crack pattern at the toe of the failure.

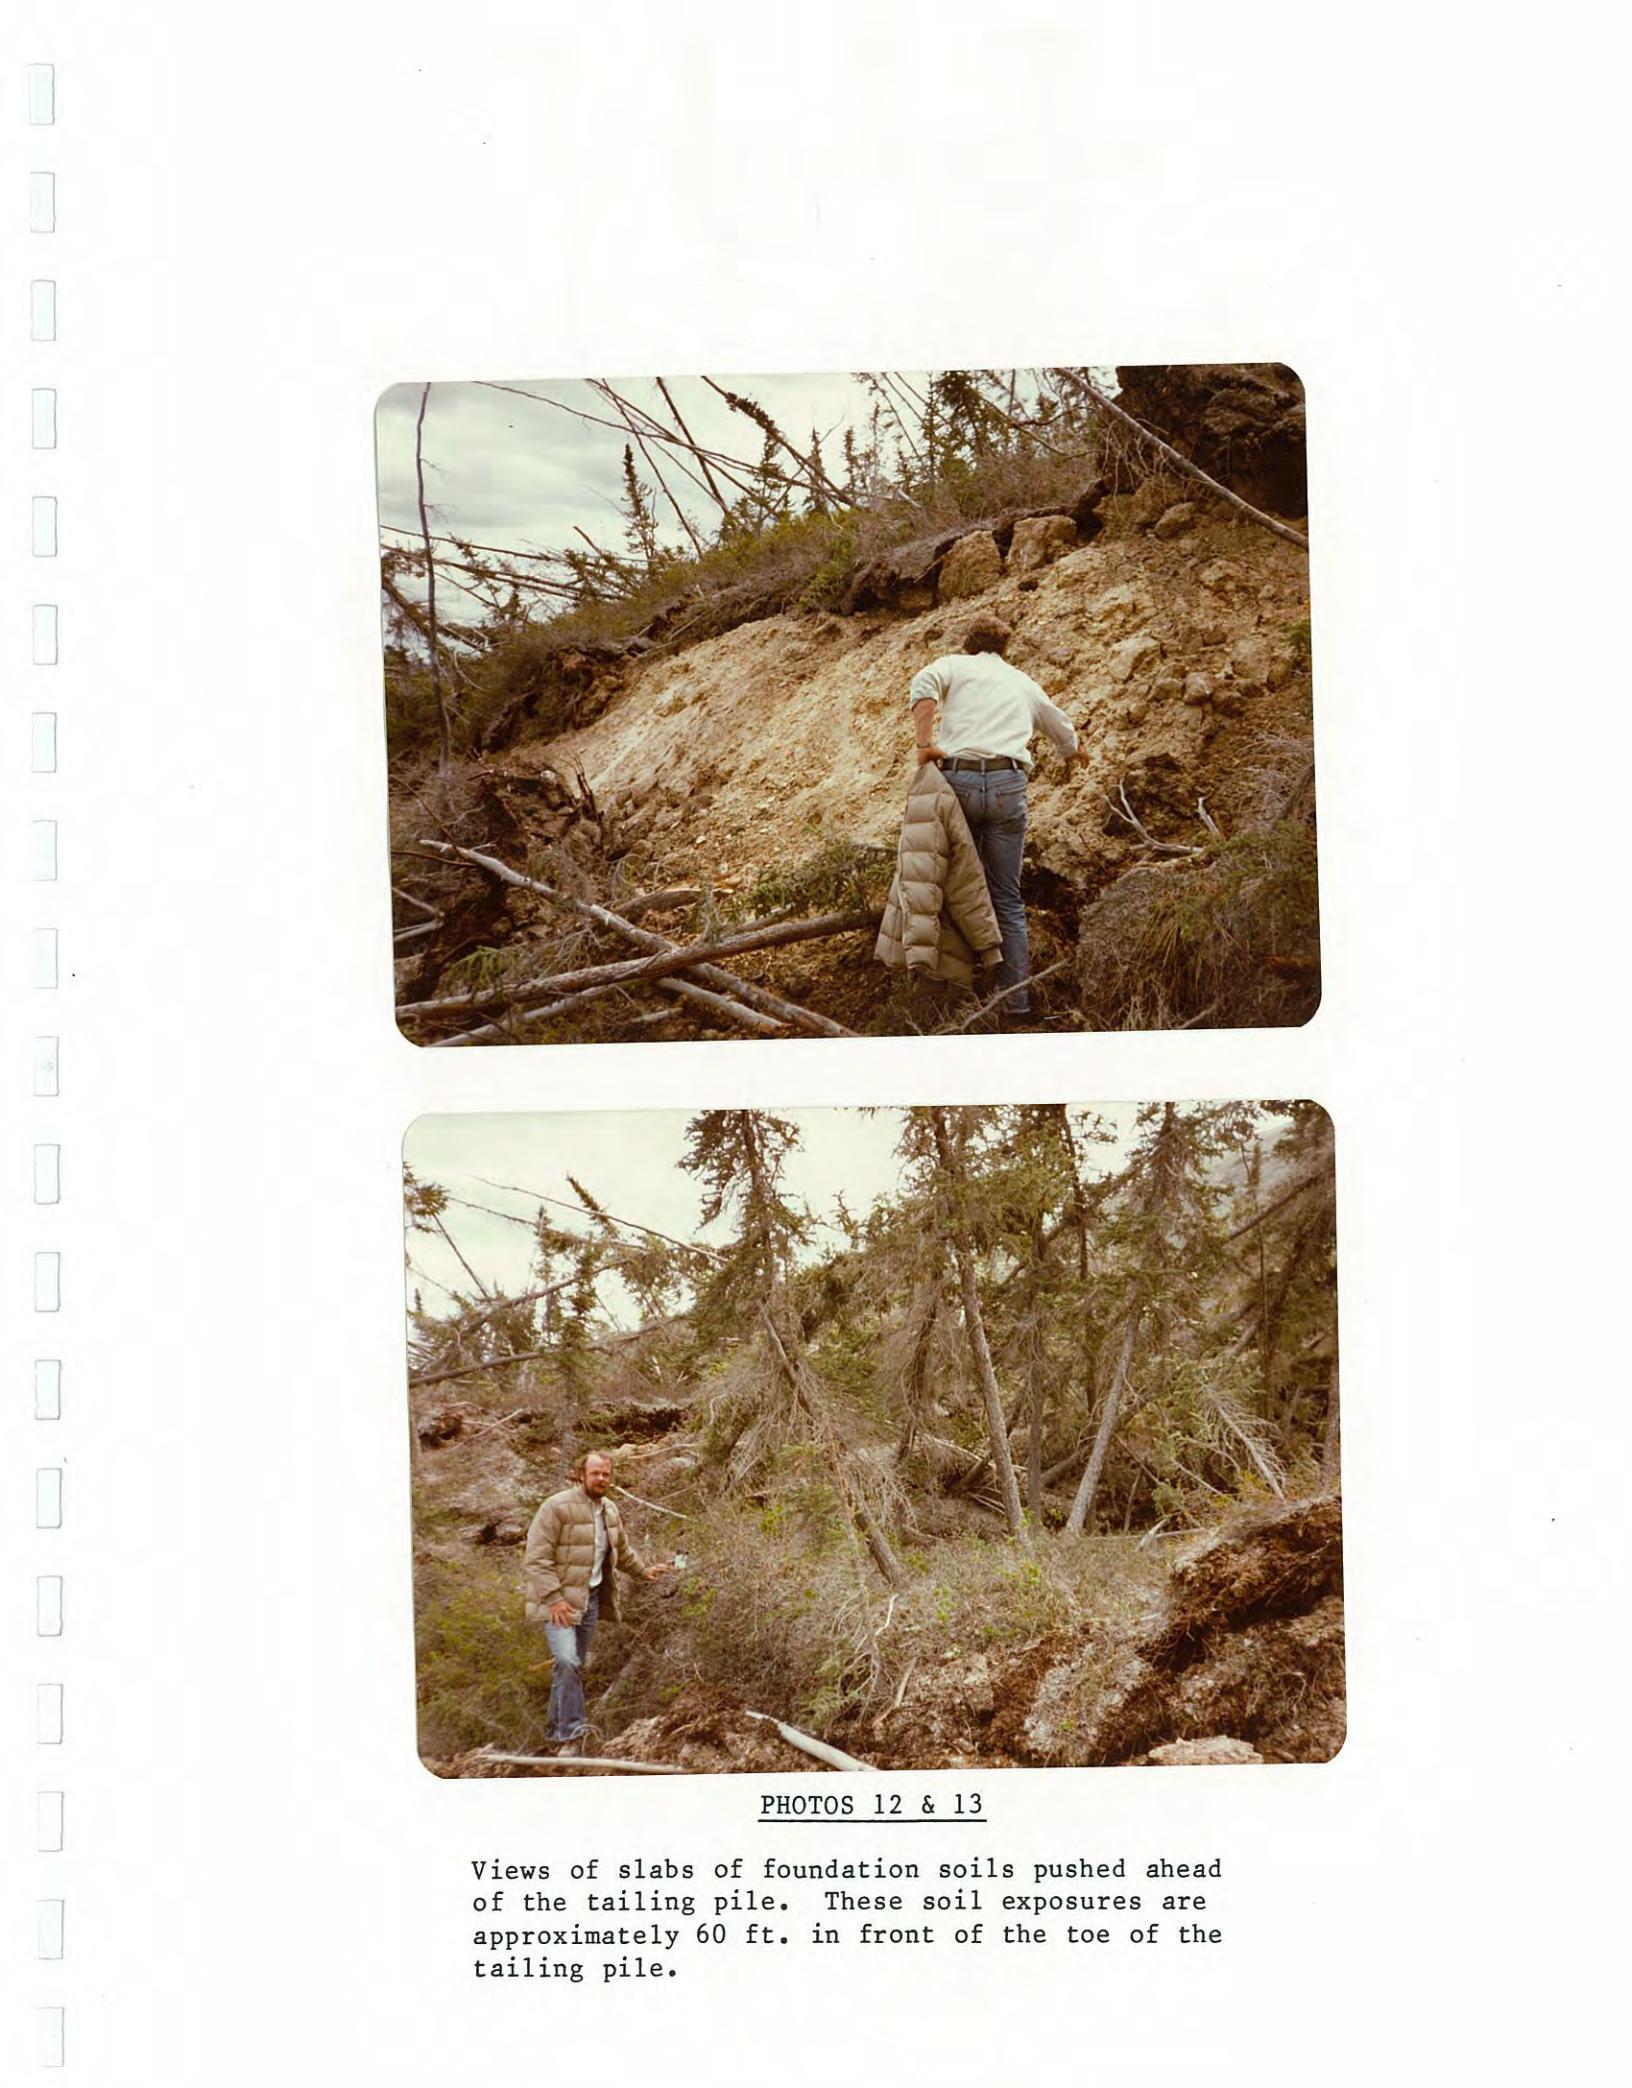
Toe of north lobe of tailing pile showing foundation soils bulldozed ahead of the pile.

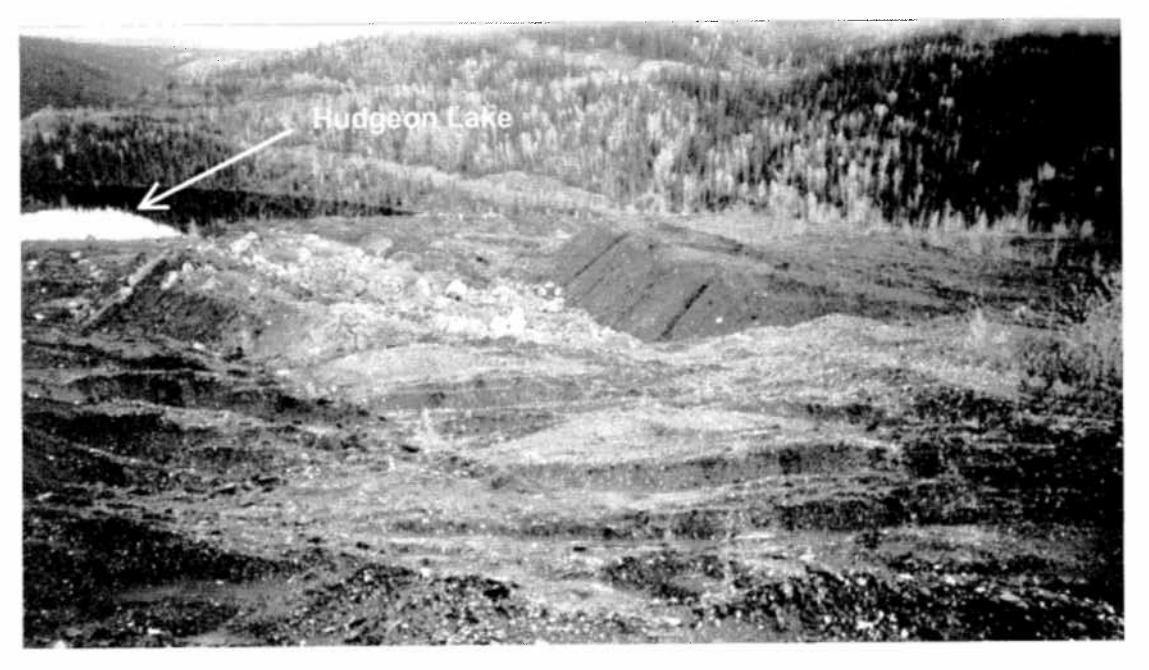
The surface of the waste rock dump is hummocky with a series of benches, slump blocks and tension cracks resulting from the on-going displacements (Photo UMA 9-9 and 9-4). Ground vegetation in the areas of the waste rock dump is extremely scarce and plant diversity very low. Ground vegetation species at the waste rock site was similar to that found at the tailings site. Nevertheless, the re-establishment of trees and vegetation in general has been much greater at the waste rock site than on the tailings lobes.

Photo UMA 9-9 Slumping of Waste Rock Dump (1998)

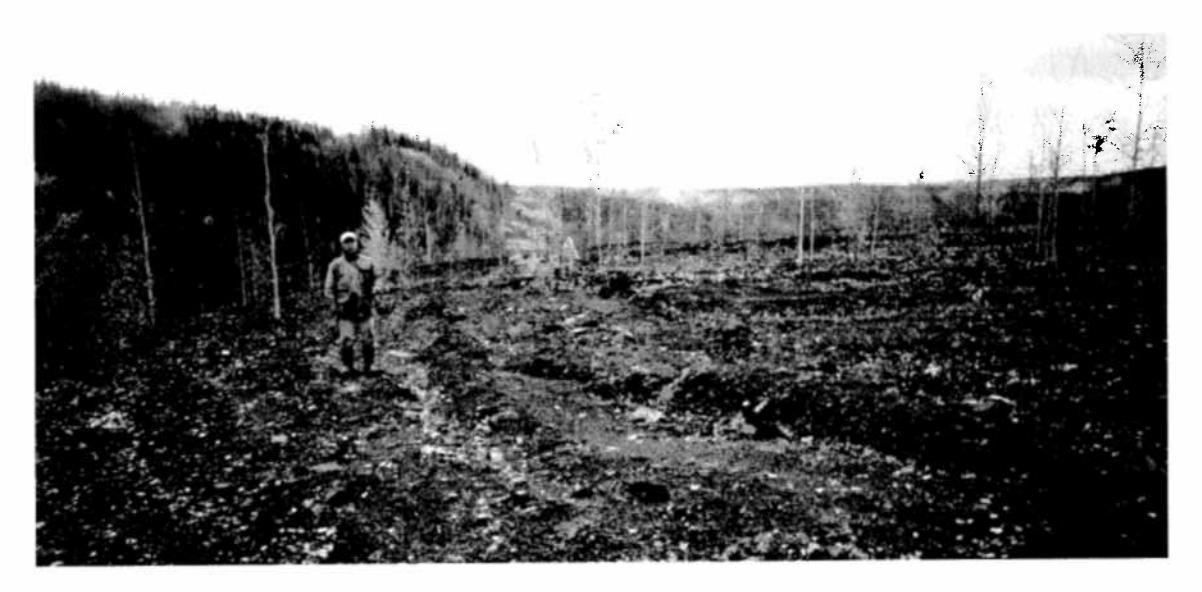
Photo UMA 9-4 Tension Cracks West End of Waste Rock Dump (1998)

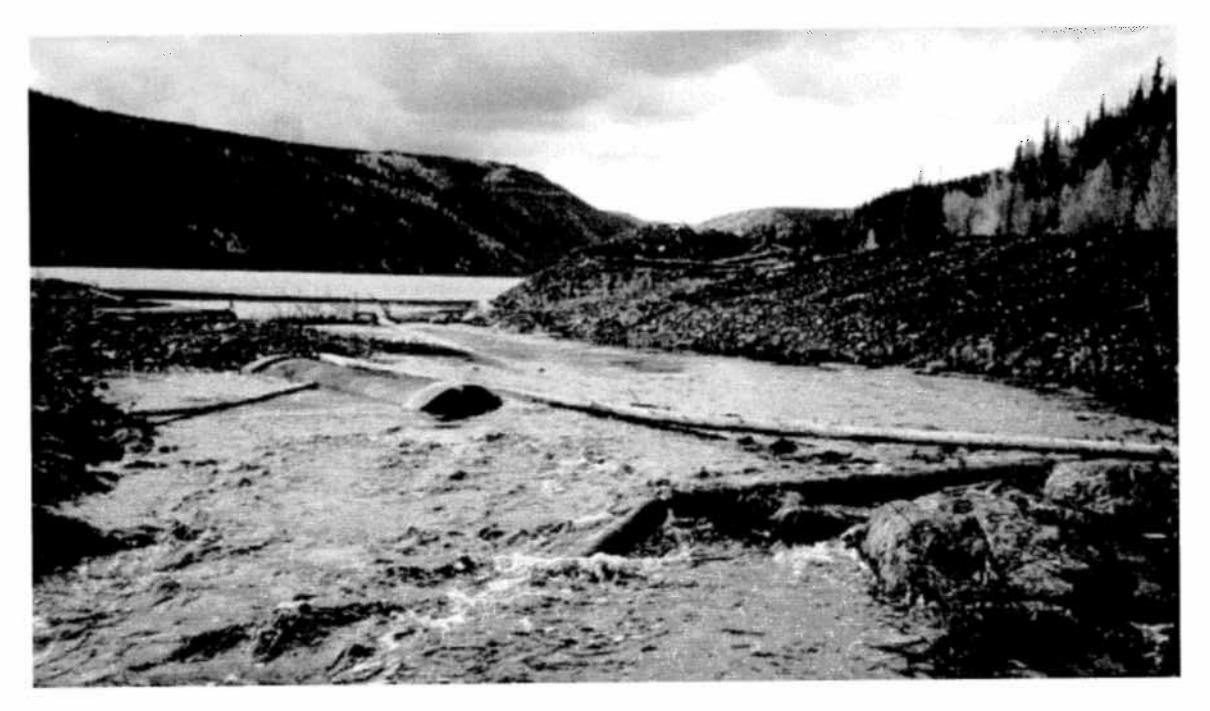
channel were estimated at 0.5 metres in September 1998 and 0.1 metres in July 1999 (Photo UMA 15-0/1). The north culvert is badly out of round. A CMP section visible in the channel through the waste rock dump a considerable distance downstream is believed to be a missing section of this culvert.

Photo UMA 8-9 Hudgeon Lake Outlet and Access Road Culverts (1998)

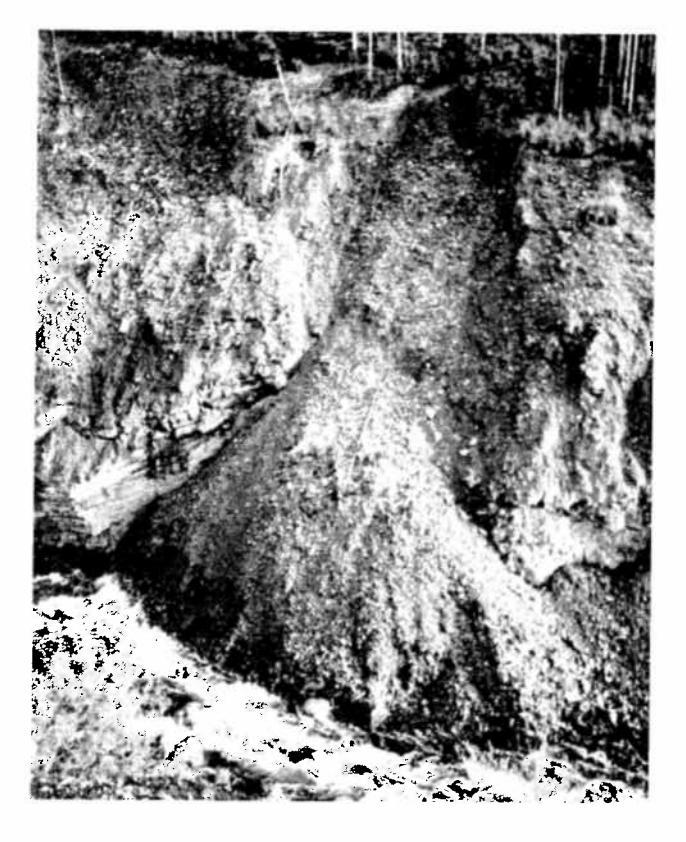
Numerous slumps and localized slope failures are occurring on both the waste rock and valley slopes (Photo UMA 7-6) as a result of channel erosion and incising. These localized instabilities have lead to meandering of the stream bed which has impacted the integrity of the access road along the waste rock dump. Tension cracks are visible along the north shoulder of the access road (Photo UMA 7-14) and narrowing of one section of the access road has occurred as a result of a slope failure into the channel (Photos UMA 14-18/19 and UMA 2-8).

Photo UMA 7-6 Slumping of Valley Slope(1998)

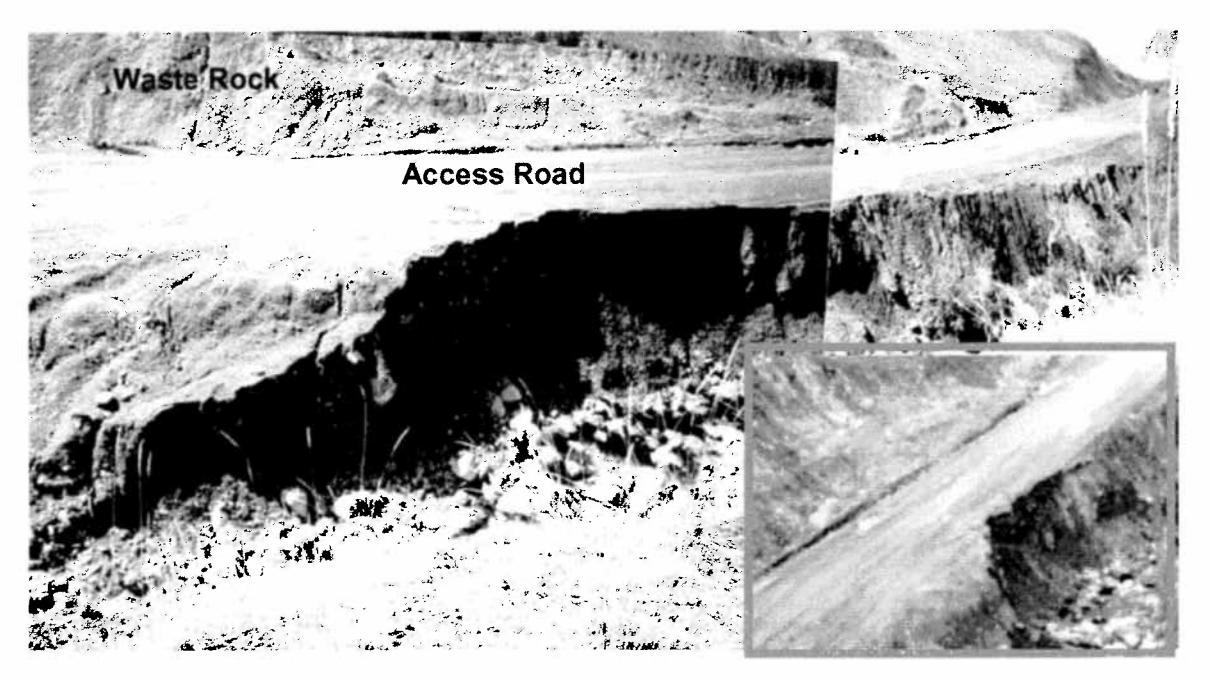
Photos UMA 14-18/19 and UMA 2-8 (Insert) Slope Failure Along Access Road (1998 &1999)

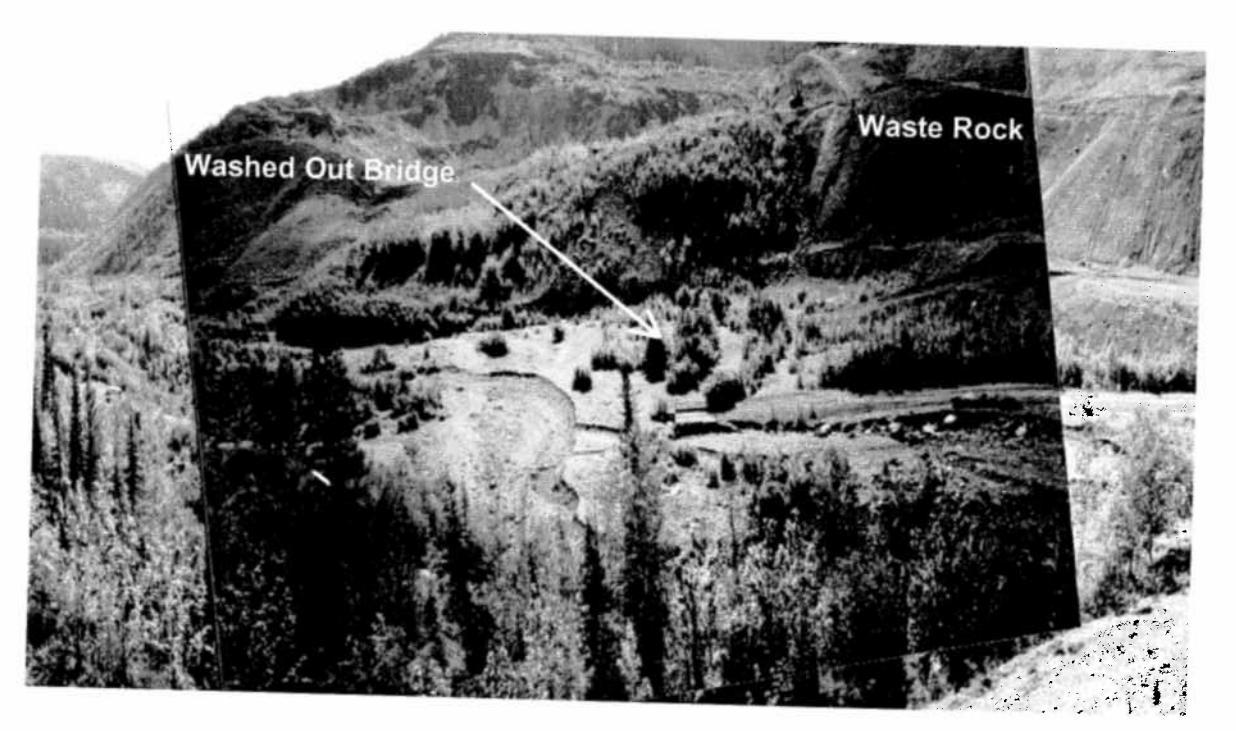
The timber access road bridge at the downstream toe of the waste rock dump was washed out in the spring of 1997 (Drawing 03). The creek valley in the area of the bridge was infilled with out-wash material where a new creek channel was incised (Photo UMA 14-20/21/22). The out-wash (flow debris) material consists of gravel and cobbles up to 200 millimetres in diameter. Several channel remnants and evidence of significantly wider historic channel flow are visible. High water marks on trees immediately downstream of the waste rock dump are about 0.6 metres above the ground surface, or about 1.5 to 2 metres higher than the existing creek channel. At locations as far as 200 metres downstream of the bridge, trees and brush have trapped debris.

Photo UMA 14-20/21/22 Clinton Creek Channel at Washed Out Bridge Location (1998)

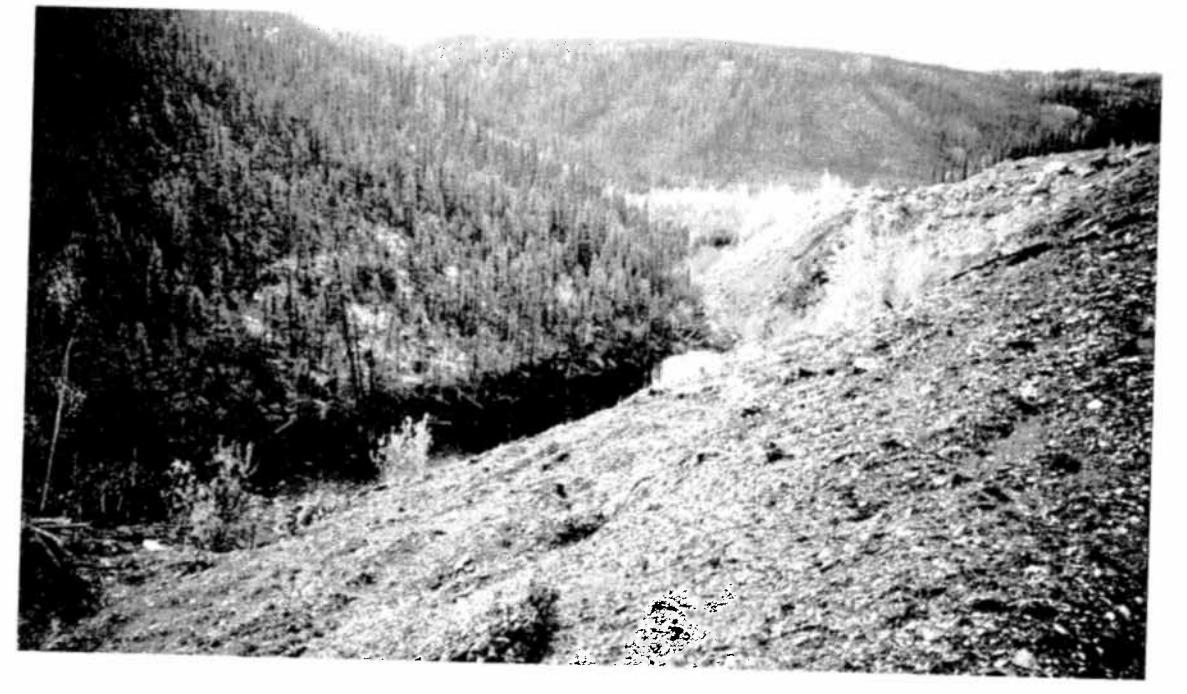
Photo UMA 10-2 Porcupine Creek Northern Waste Rock Blockage (1998)

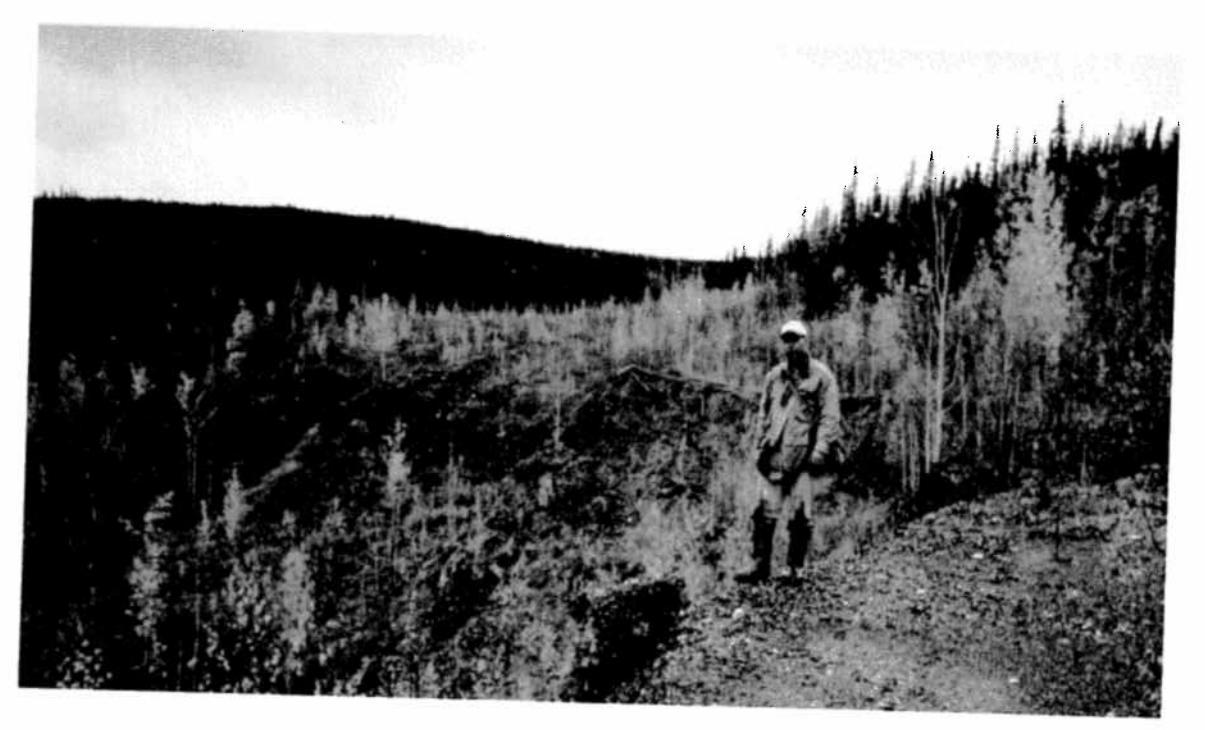
waste rock dump has undergone extensive movement, however, resulting in numerous tension cracks and back scarps as shown in Photo UMA 11-0.

Photo UMA 11-0 Porcupine Creek Waste Rock Failure Backscarp (1998)

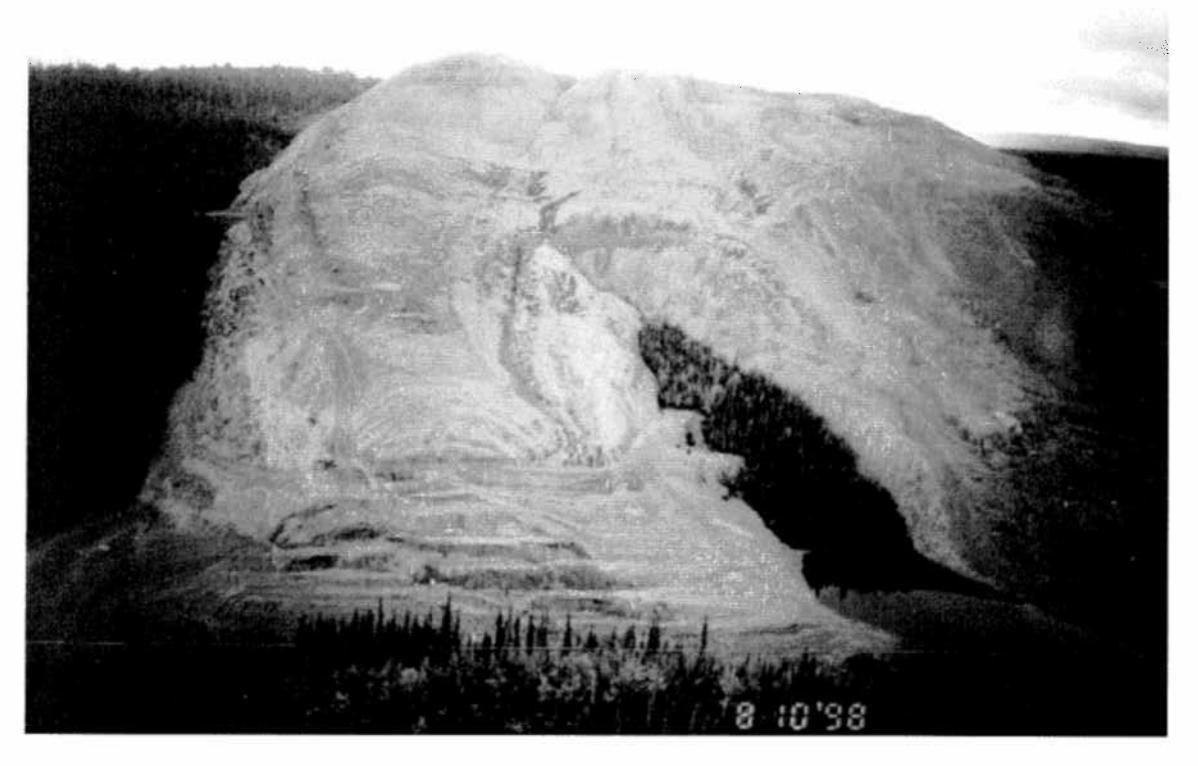
Photo UMA 3-6 View West at Failed Tailings Pile(1998)

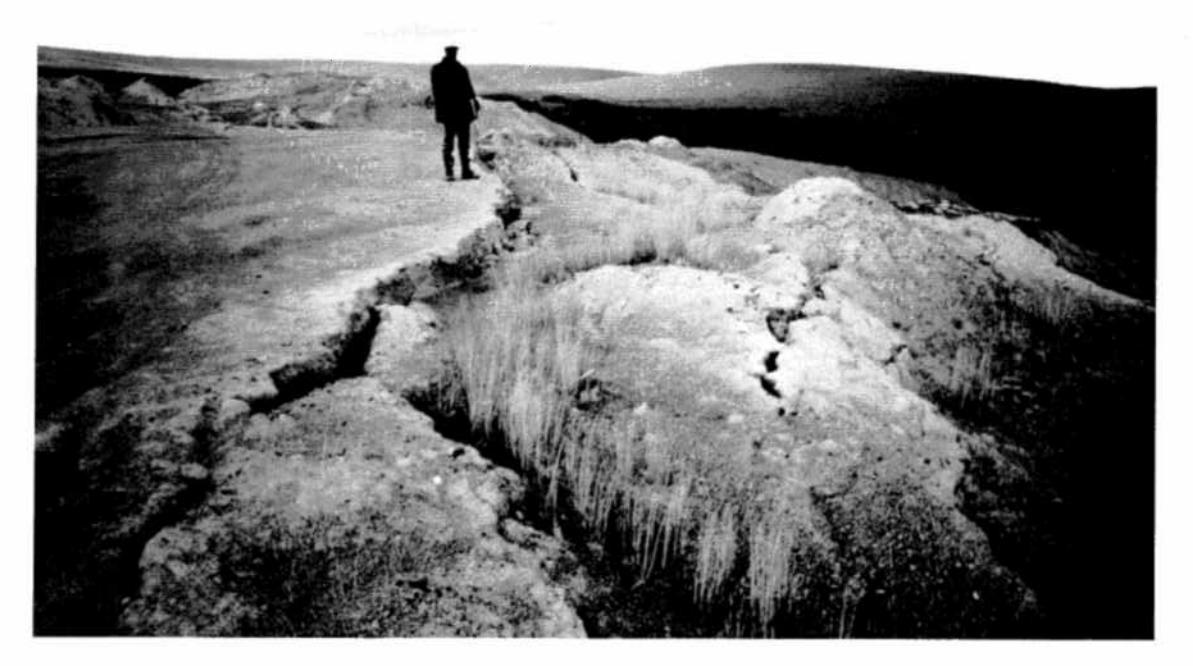
Photo UMA 1-6 Tension Cracks and Slumping at Top of Tailings Pile (1998)

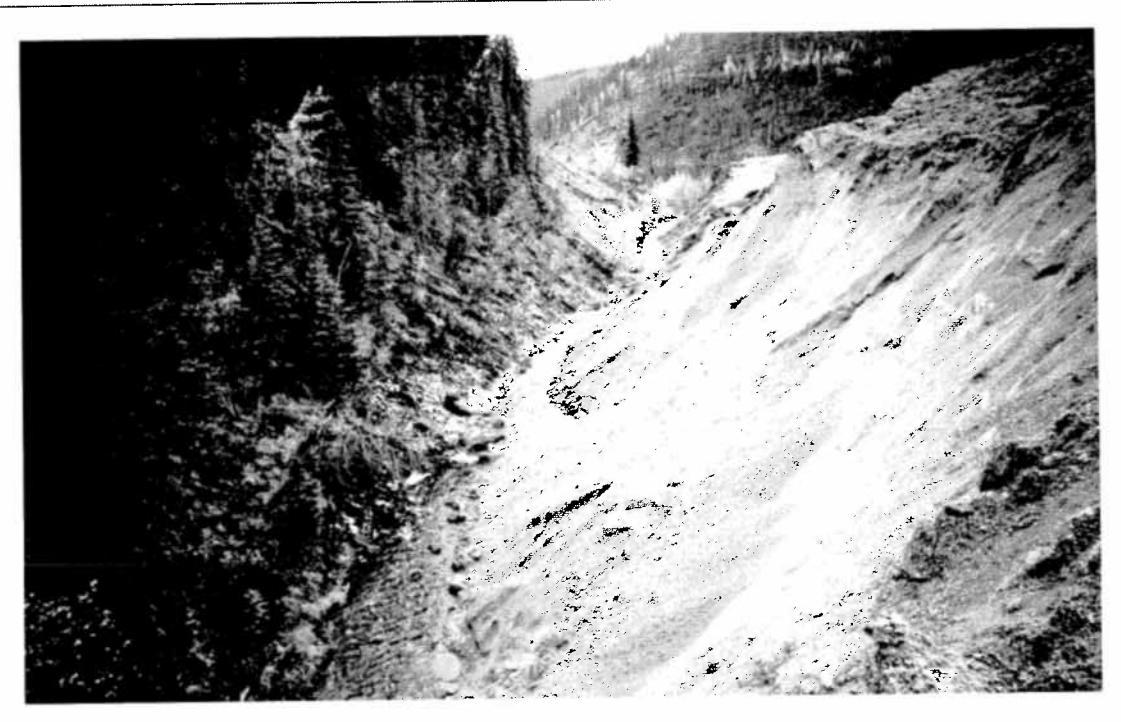
Photo UMA 5-20 Erosion at Toe of Advancing Tailings (1998)

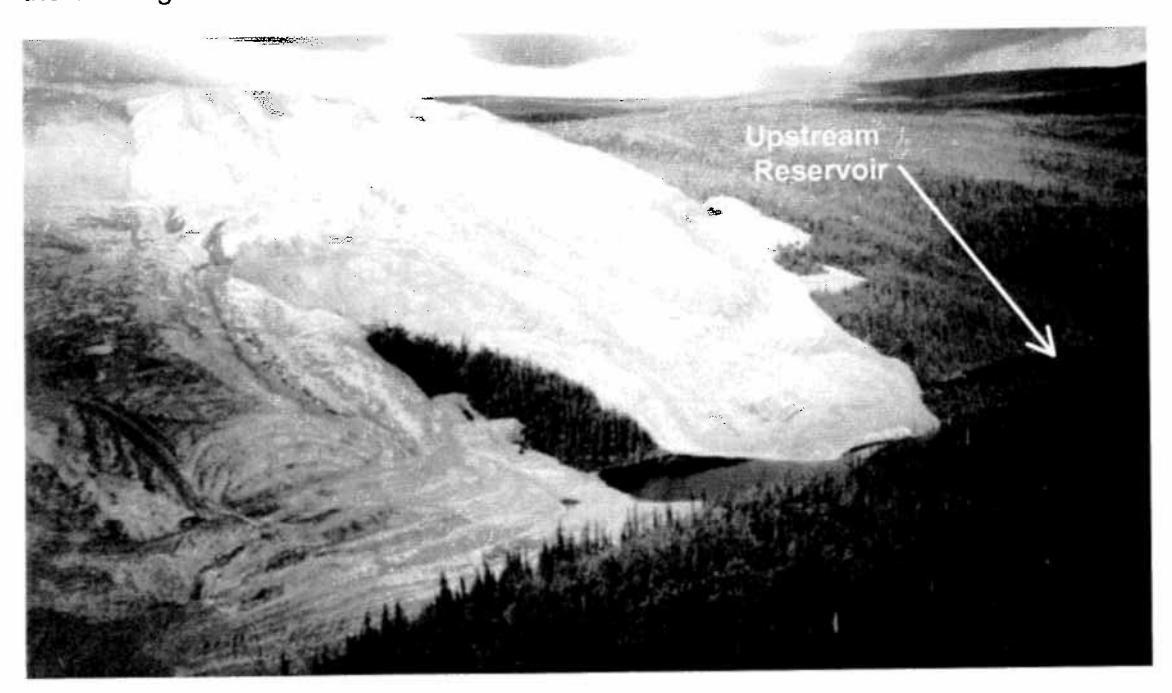
In addition to the channel obstruction created by the advancing tailings, heaving of the valley floor directly in the path of the advancing north lobe is evident (Photo RRU-10). A small reservoir is located upstream of the tailings lobes on Wolverine Creek creating by the blockage of the creek channel as shown on Drawing 05.

Photo RRU-10 View North West at Tailings Pile (1998)
