# HAZARDOUS MATERIALS CLASSIFICATION MT. NANSEN MINESITE YUKON

# REPORT

DECEMBER 2011 ISSUED FOR USE EBA FILE: W23101481

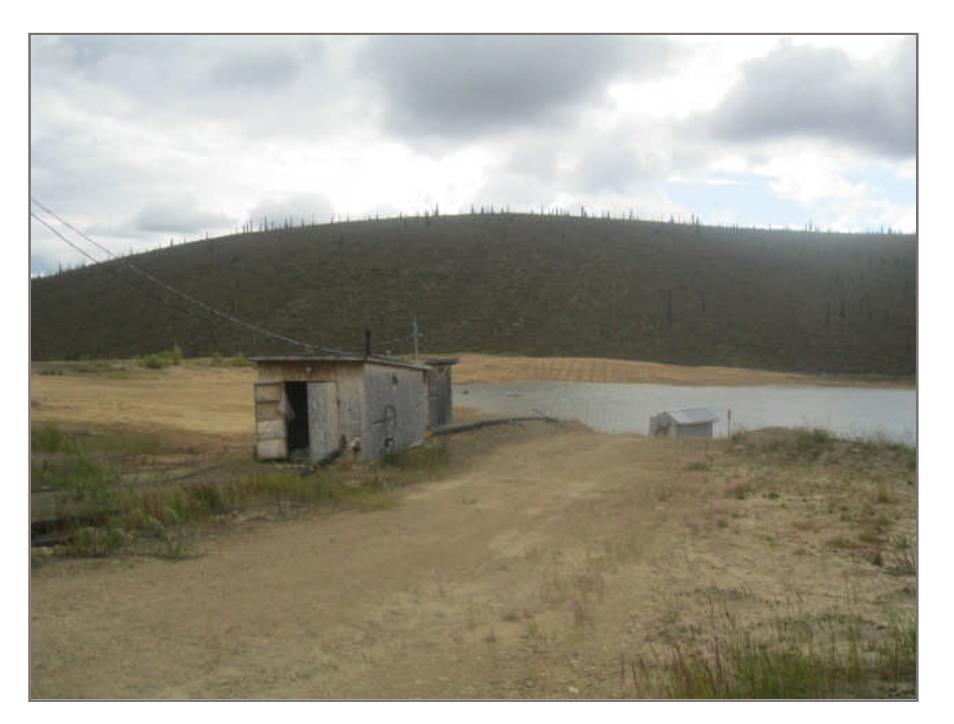
- Tailings reclaim heating house shown in photograph No. 2:
  - Concrete slab on grade foundation measuring approximately 18 m<sup>2</sup>;
  - 2' x 4' frame construction with plywood walls, floor and ceiling;

- Suspect hazardous materials identified;
  - Roofing system consisted of torch on roofing system; and,
  - Components of the structure were intact but visibly impacted by weathering.

Photo 2: Tailings reclaim heating house with reclaim heating electrical house behind, located on the north end of the Tailings Dam

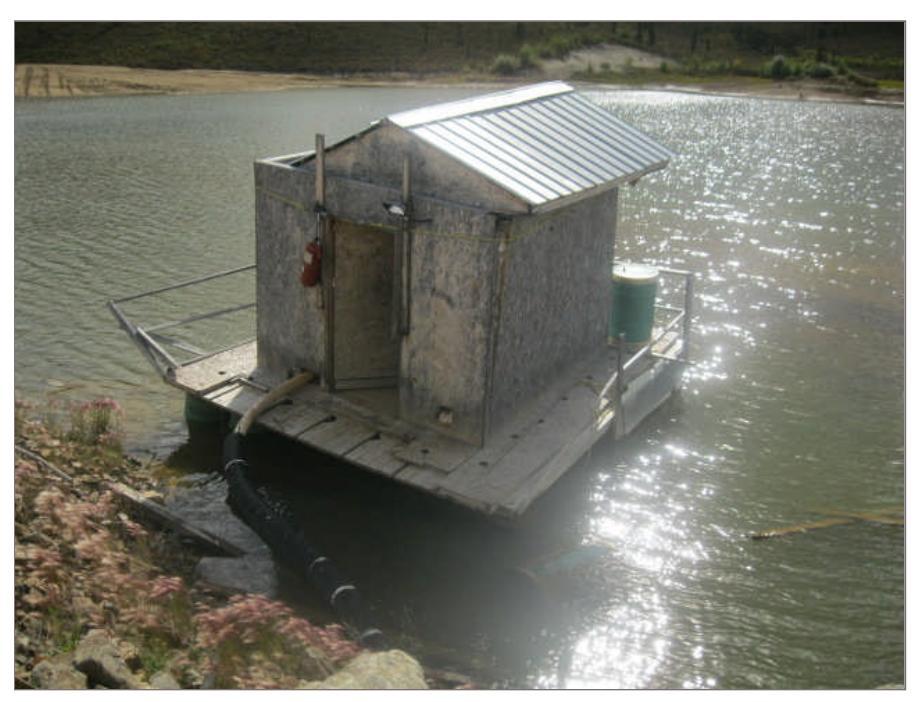
Photo 3: Reclaim heating pump house #1 located on the north end of the tailings dam

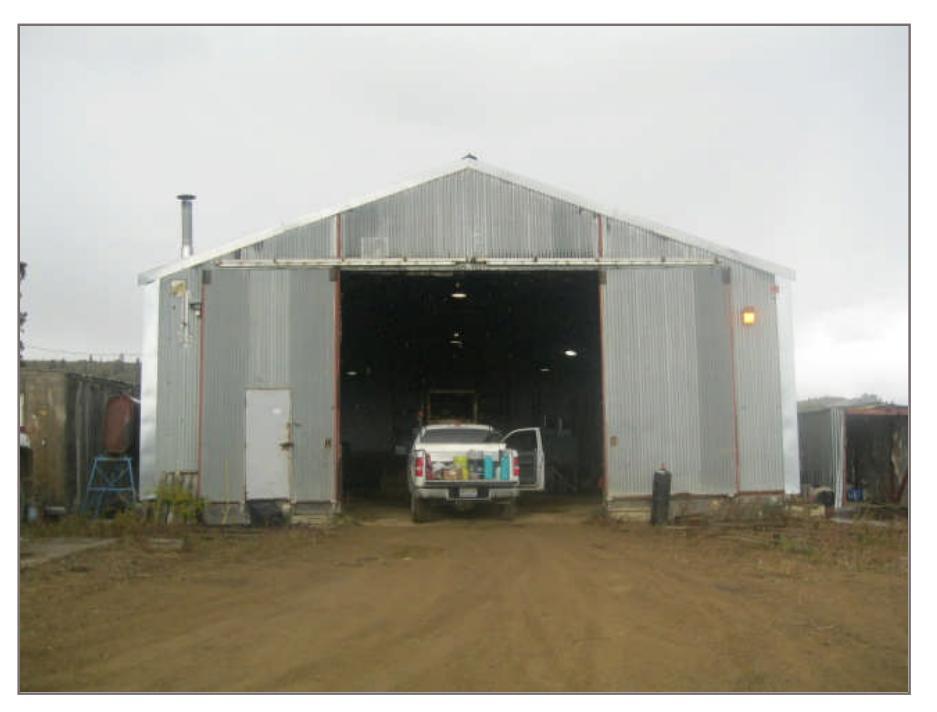
- Foot print of approximately 1,159 m<sup>2</sup>;
  - Suspect hazardous materials identified;
  - Building exhibited water ingress through the roofing system and exterior signs of corrosion and weathering;

- A camping trailer was located behind the shop which was used for storage of old tools and miscellaneous materials; and,
  - Building appeared to be in fair condition.

Photo 6: Ketza mine machine shop

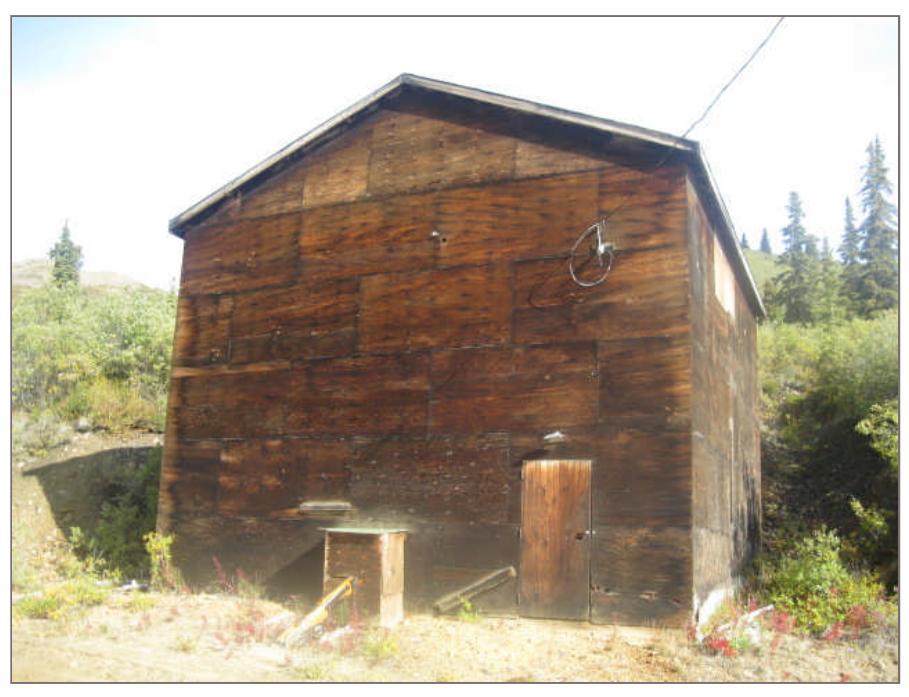
- Water tank building shown in photograph No. 8:
  - 2' x 4' frame construction with OSB walls, floor and ceiling;
  - Approximately 81 m<sup>2</sup>;
  - No suspect hazardous materials identified; and,

Photo 8: Water tank storage building

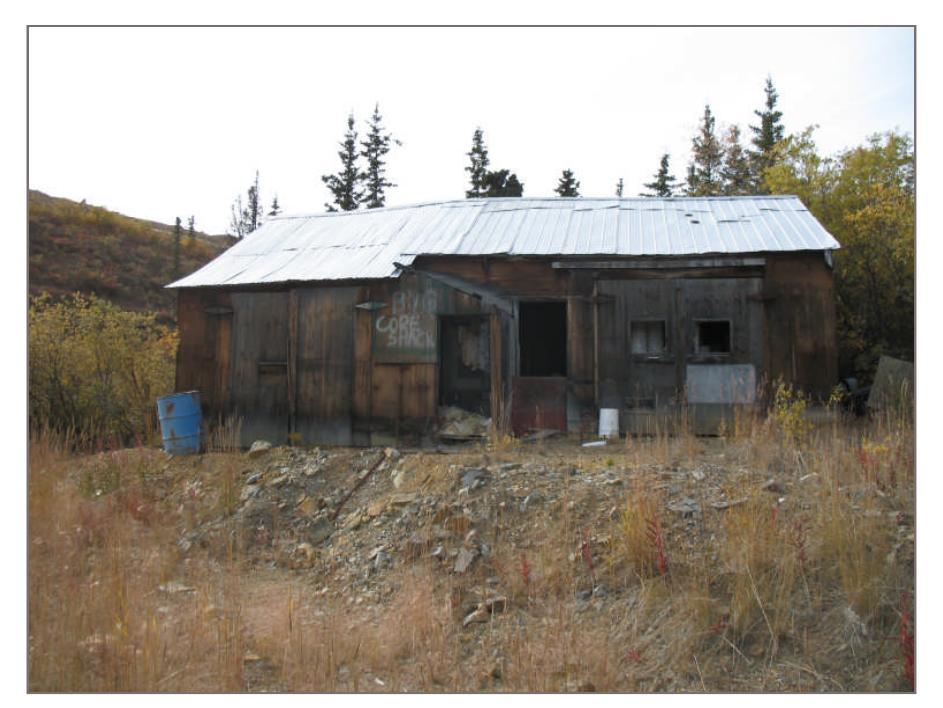
- No suspect hazardous materials identified.
- Core shack as shown in photograph No. 12:
  - 2'x4' frame construction with OSB board under wood lathe on exterior;

- No suspect hazardous materials identified;
  - Approximately 63 m<sup>2</sup>; and,
  - Visibly impacted by weathering with water ingress at the abutment where the walls meet the roof in select locations and interior due to absence of windows.

Photo 12: Core Shack

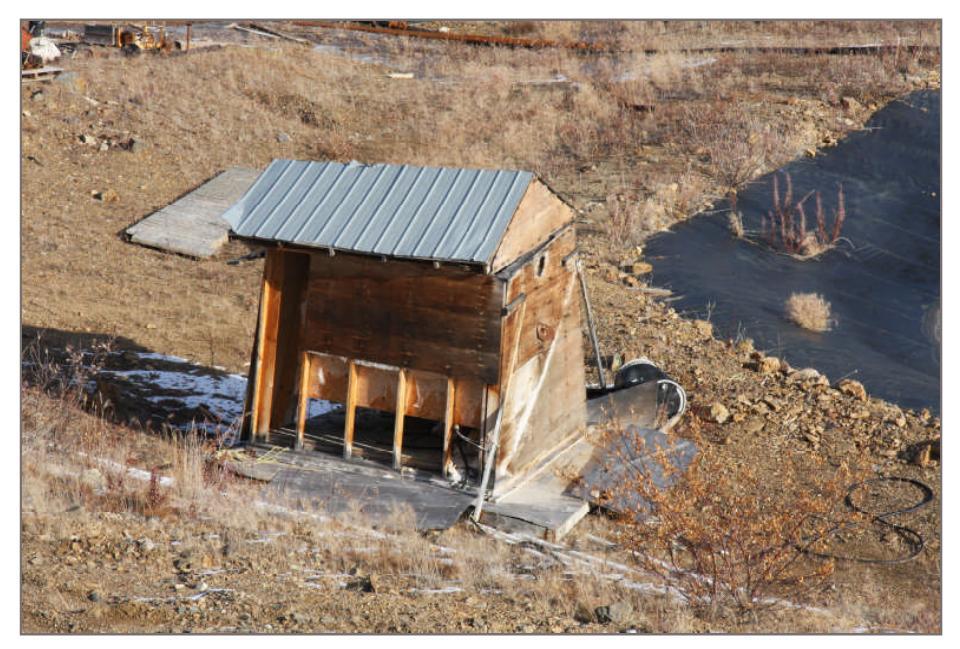
- Reclaim heating pump house adjacent to mill as shown in photograph No. 13:
  - 2'x4' frame construction with OSB board under wood lathe on exterior;
  - No suspect hazardous materials identified;

Photo 13: Reclaim heating pump house by mill

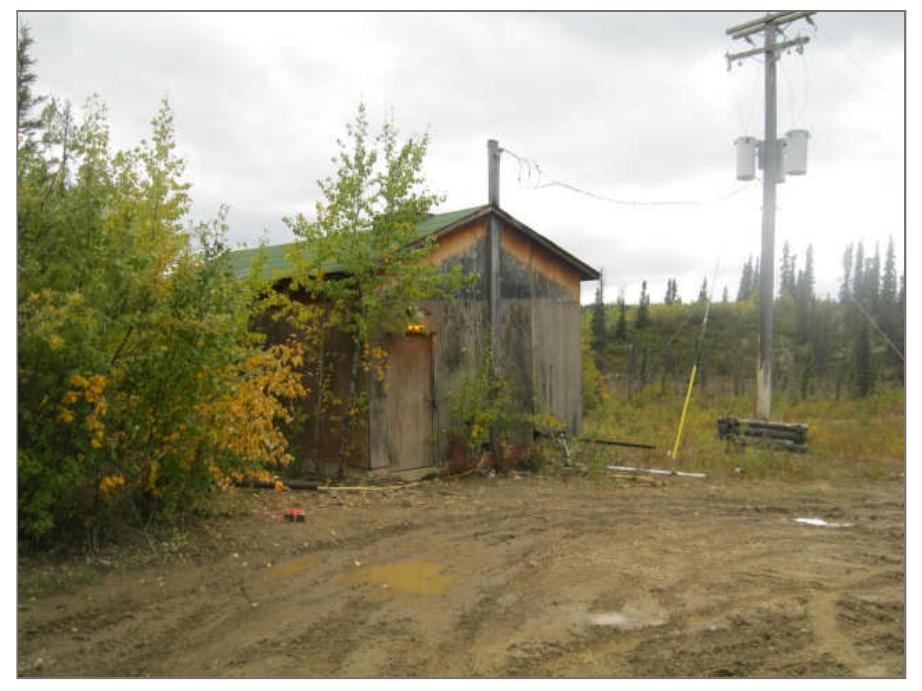
- Visibly impacted by weathering with water ingress in select locations.
- Victoria creek well house as shown in photograph No. 14:
  - 2'x4' frame construction with OSB board under wood lathe on exterior;
  - No suspect hazardous materials identified; and,
  - Visibly impacted by weathering.

Photo 14: Victoria Creek well house

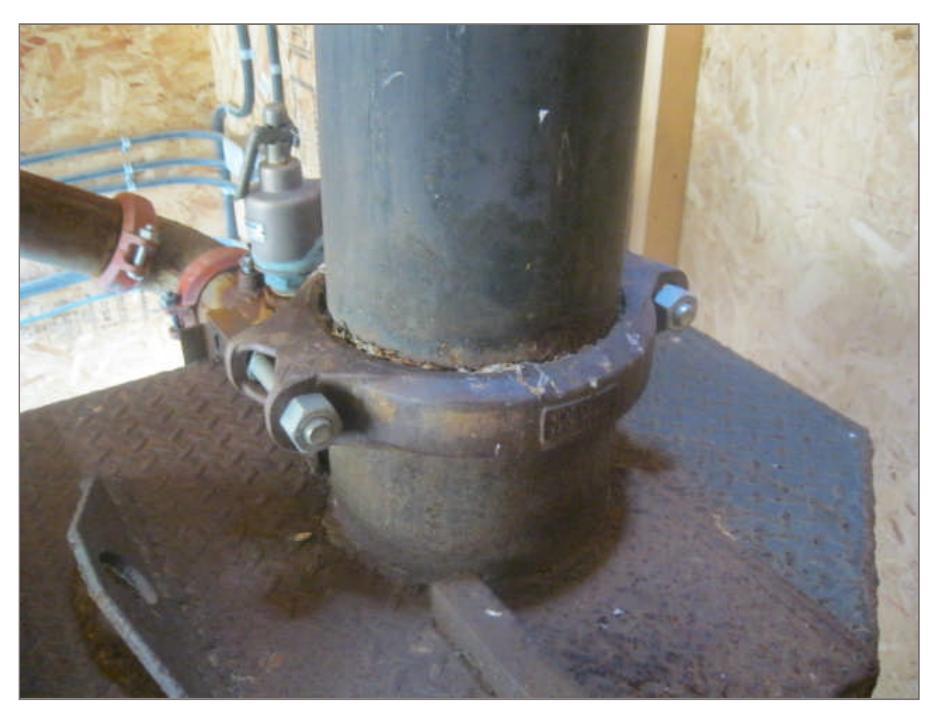
- Asbestos containing furnace gasket totaling approximately 0.3 lin m and asbestos containing transite cement board associated with the furnace within the reclaim heating house totaling approximately 6 m<sup>2</sup>. The ACM was in good condition at the time of assessment;

Photo 15: Asbestos containing gasket on the furnace exhaust within the Reclaim Heating House

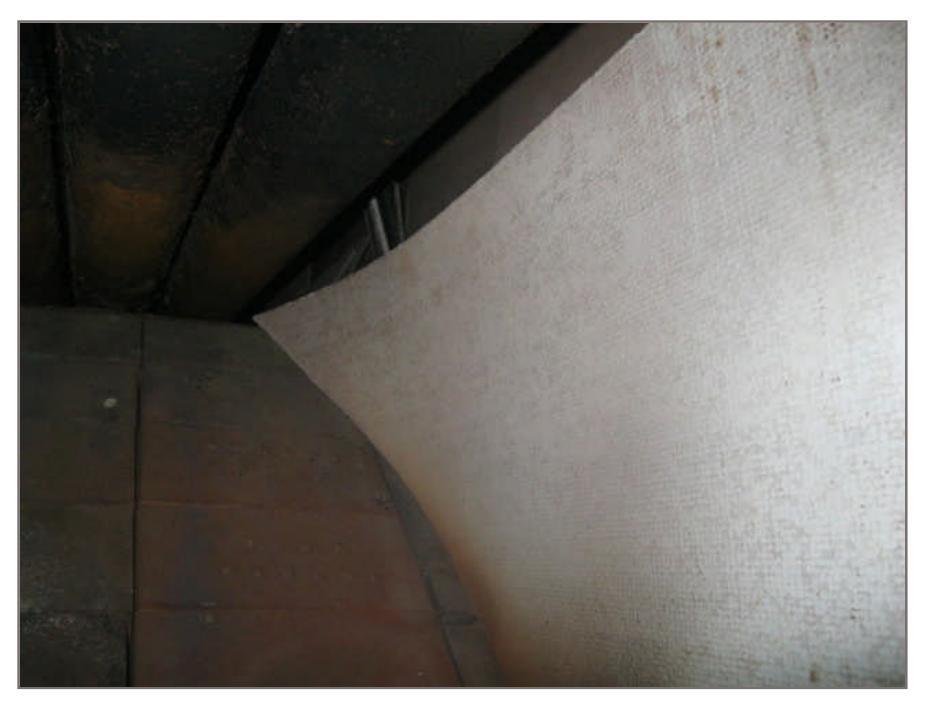
Photo 16: Asbestos containing transite board within the furnace in the Reclaim Heating House

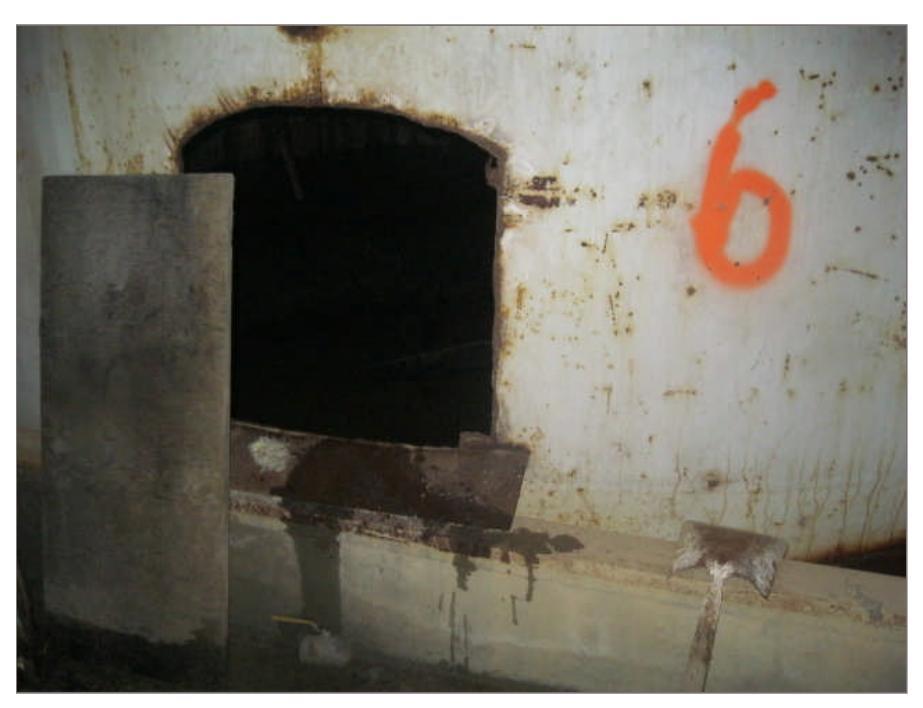
- White lead based paint applied to a mixing tank on the upper level of the mill requiring non-regulated disposal. This paint was visually identified on multiple tanks within the mill and was in fair to poor condition at the time of assessment;

Photo 17: White lead based paint on mixing tank number 6 within the Mill

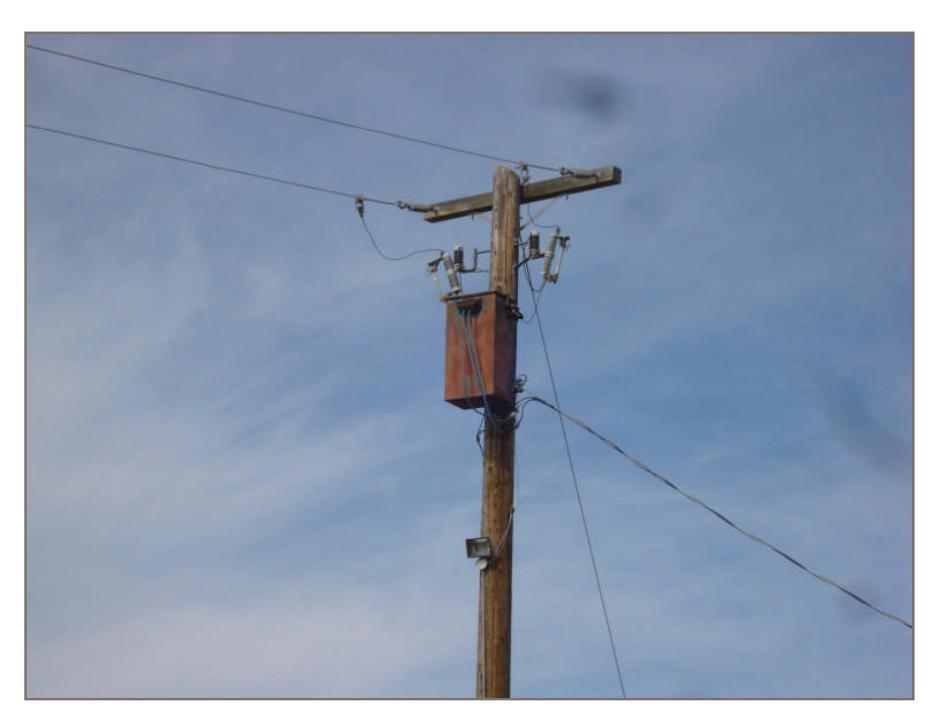
Photo 18: Pole mounted transformer suspect of containing PCB contaminated oil

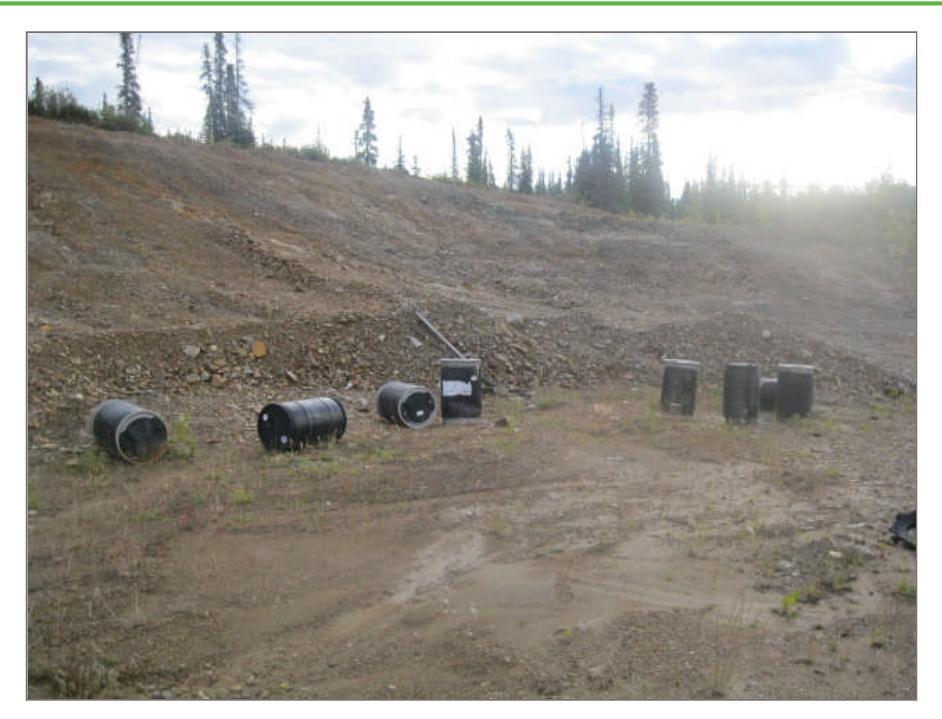
Photo 19: Approximately 8 barrels associated within EBA sample No EBA-2011-MN001

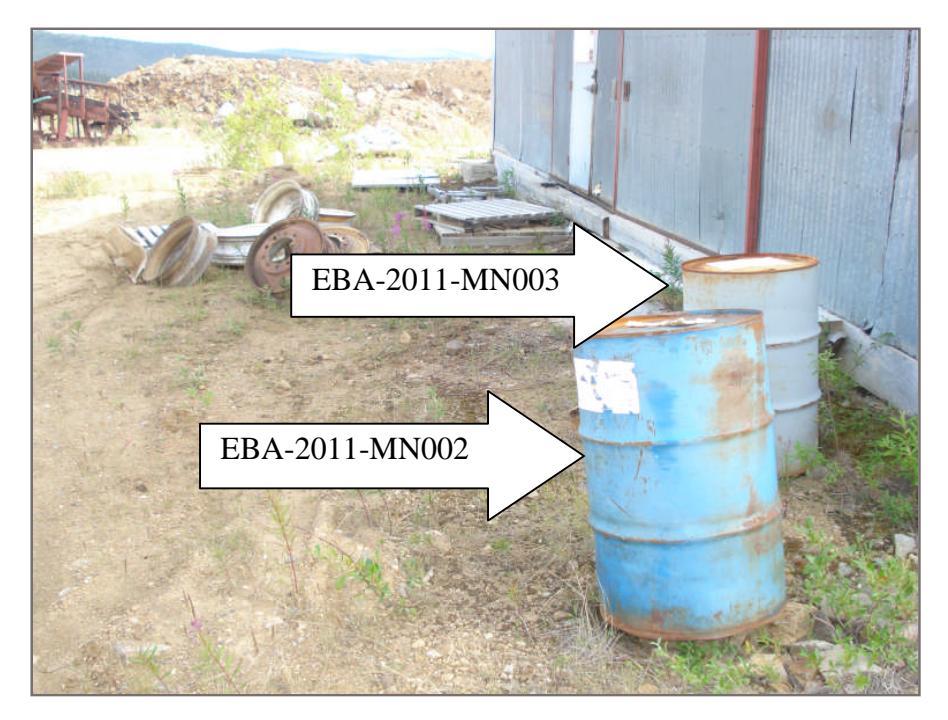
Photo 20: Barrels sampled behind Ketza shop: EBA-2011-MN002 and 003

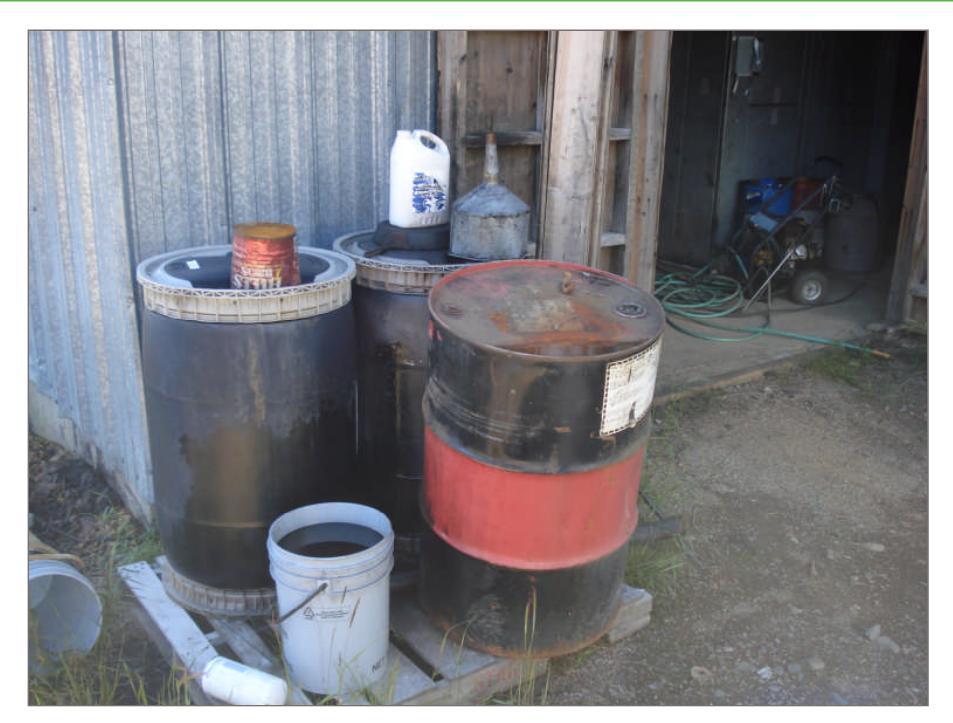
Photo 21: Suspected 3 barrels of Hydraulic Fluid located in front of the generator building with a pail of waste oil in the fore ground

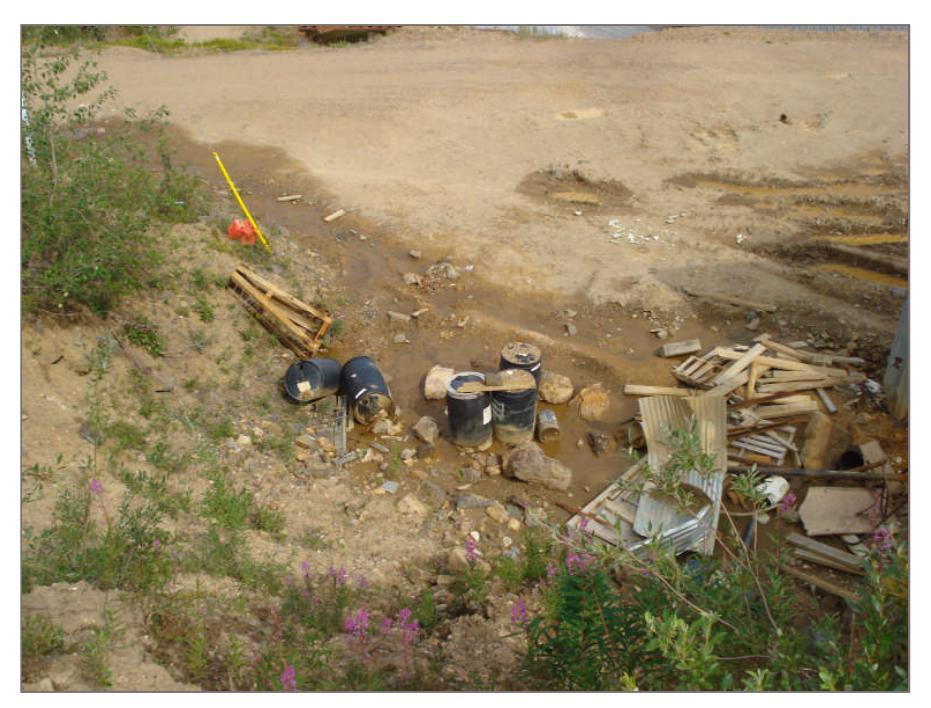
Photo 22: Suspect 5 barrels of Hydraulic Fluid located on Sag Mill road: EBA-2011-MN005

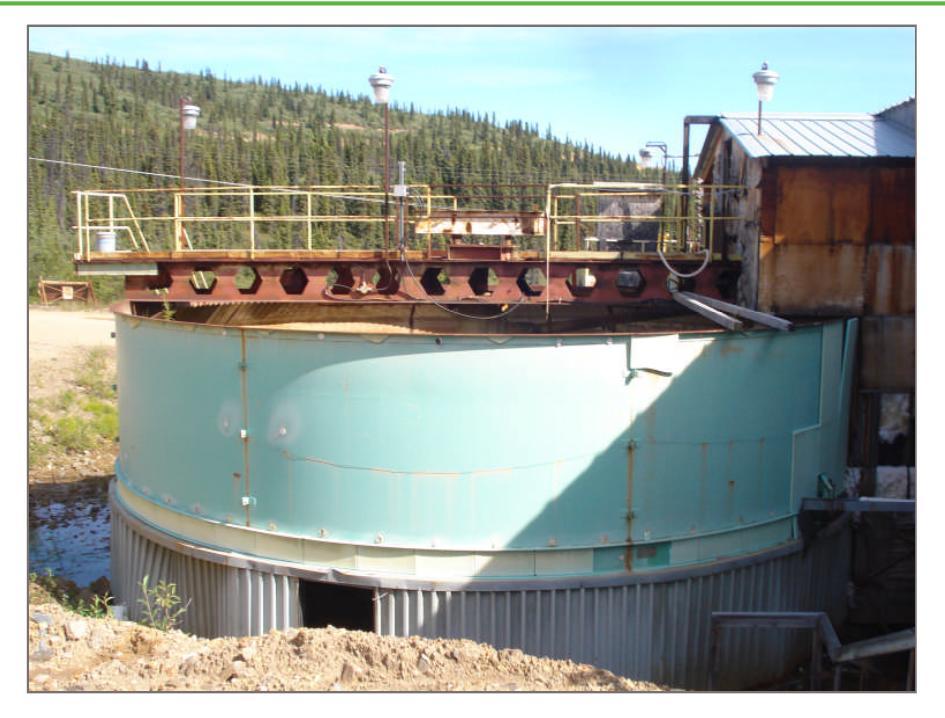
Photo 23: Exterior mixing tank north of the Mill facing east, where samples EBA-2011-MN006 and MN007 were collected

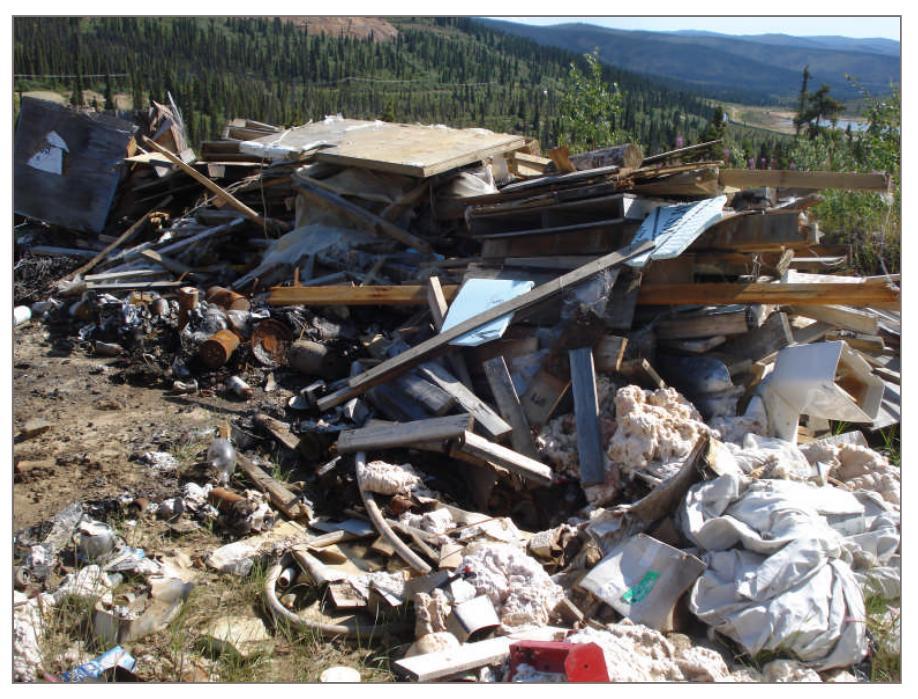
Photo 24: Top side of the historical landfill located south of the Mill facing east

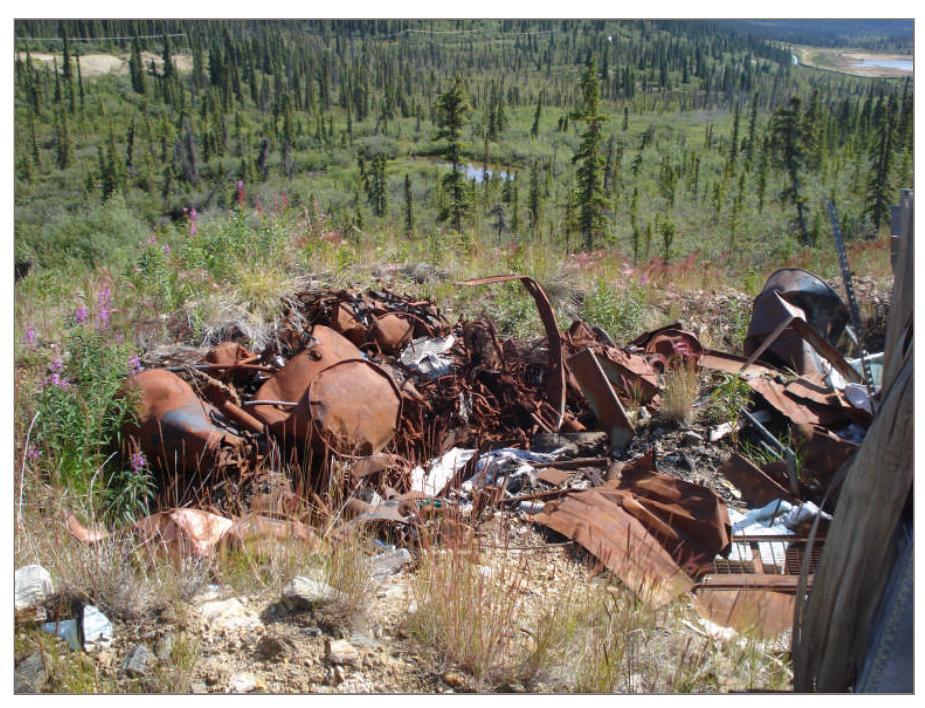
Photo 25: Metal debris associated with the historical landfill located south of the Mill facing east

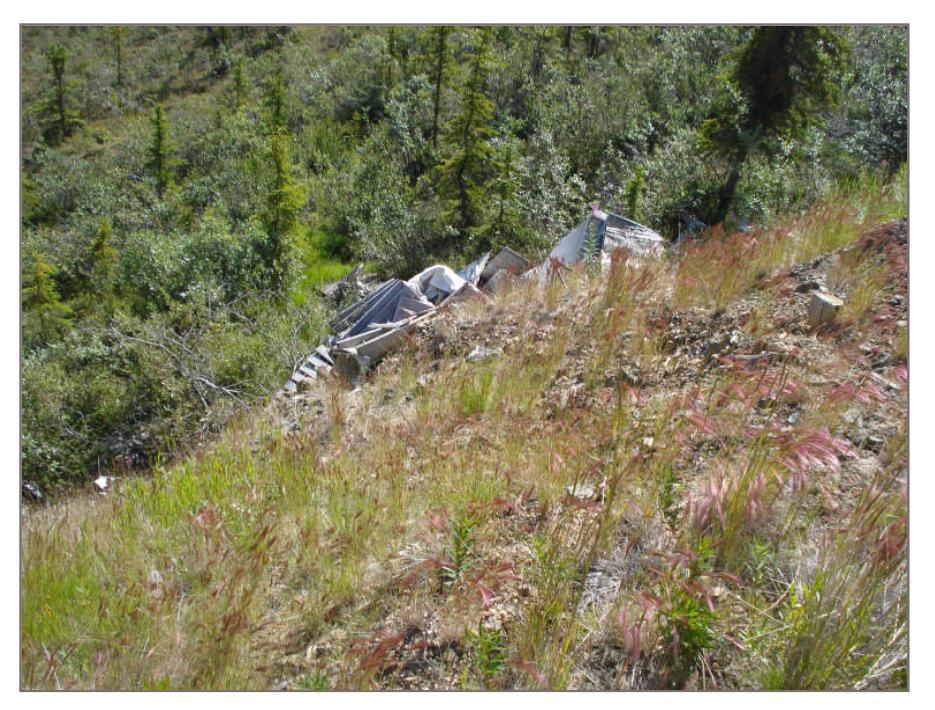
Photo 26: Debris protruding from the base of the historical landfill located south of the Mill facing south

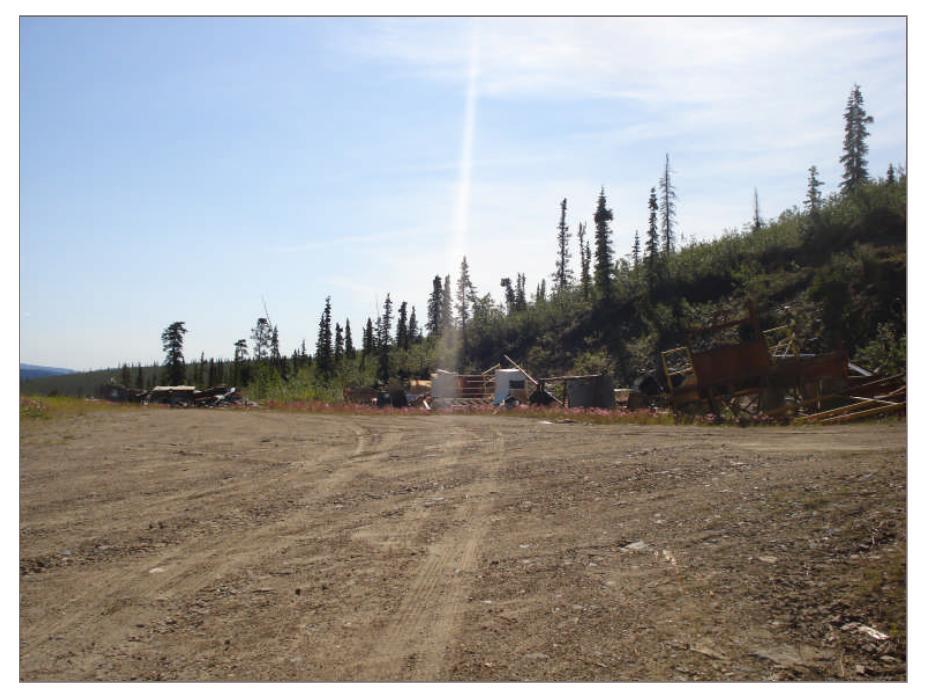
Photo 27: Overview of the historical landfill looking south at the south end of the mill

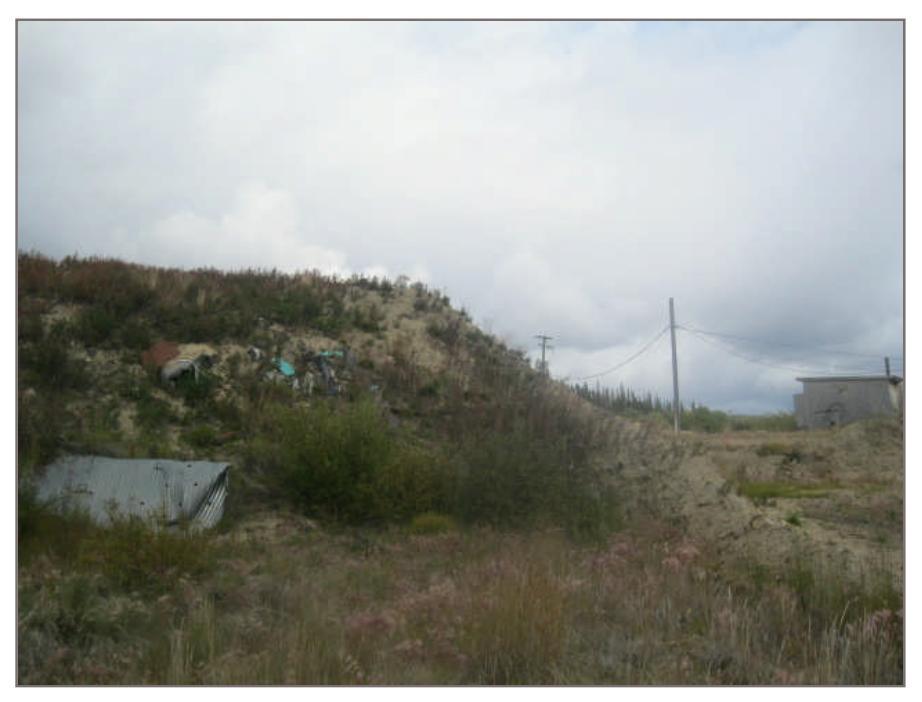
Photo 28: Buried debris located to the north of the Reclaim Heating House

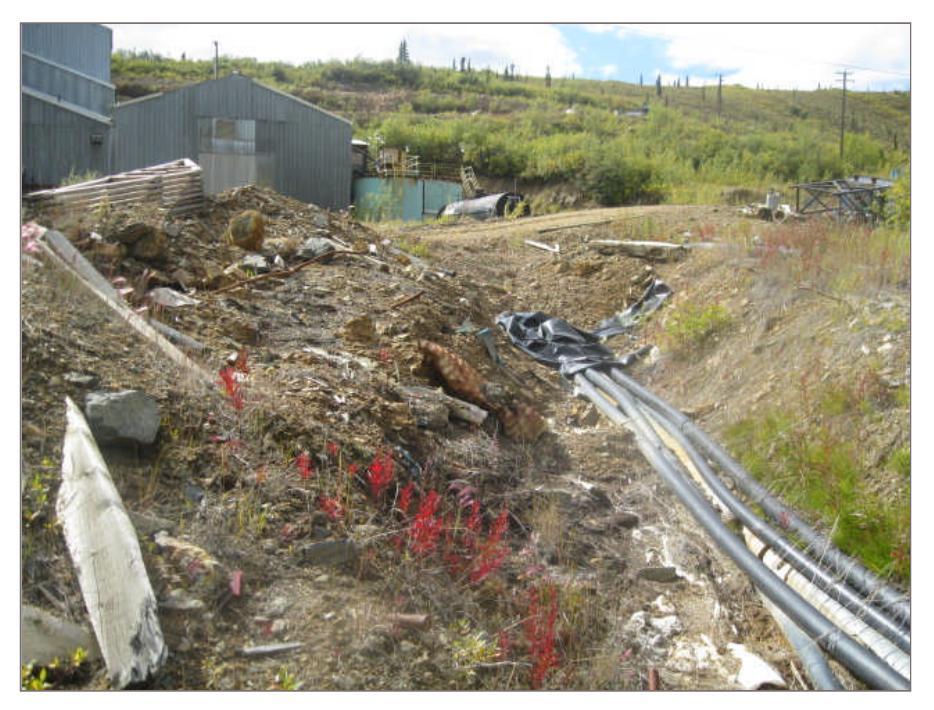
Photo 29: Debris protruding from the eastern slope northeast of the Mill

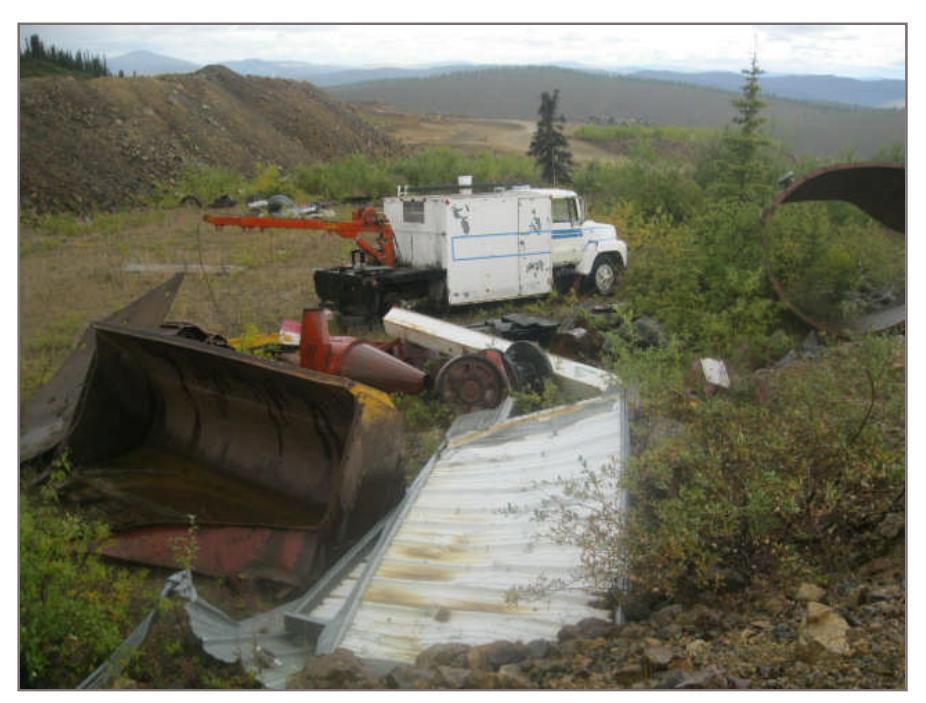
Photo 30: Metal debris and abandoned vehicle located south of Ketza mine shop

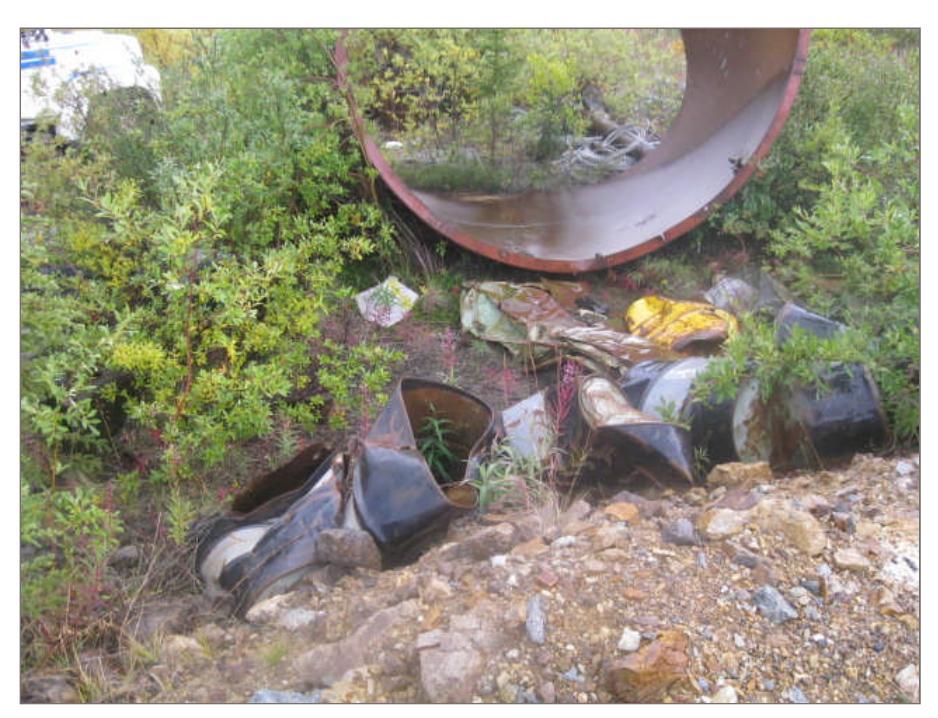
Photo 31: Crushed barrels and metal debris located south of the Ketza mine shop

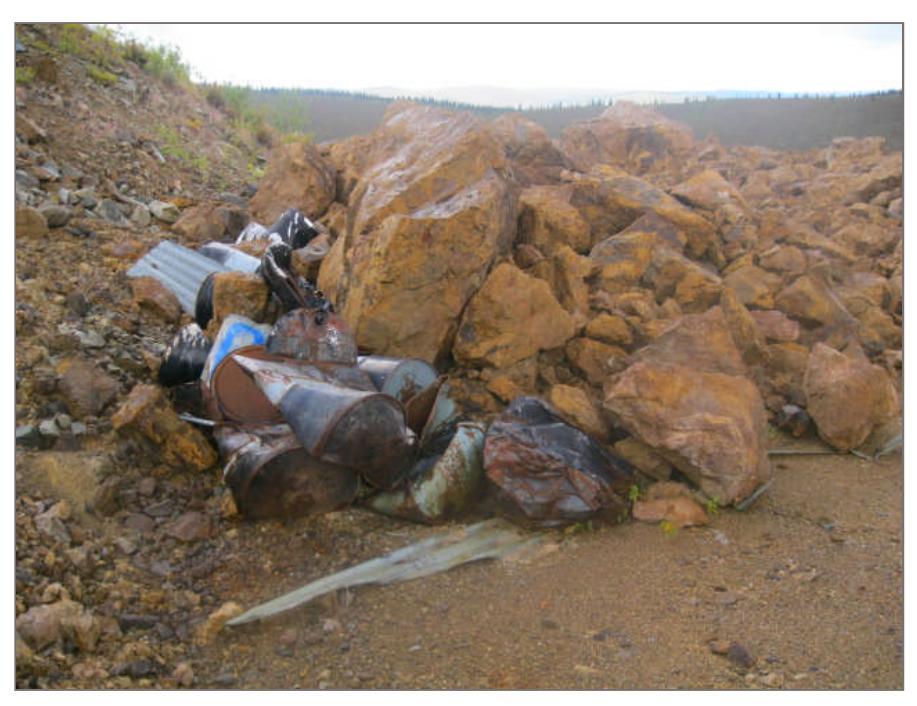
Photo 32: Crushed barrels in the ANFO storage area facing south

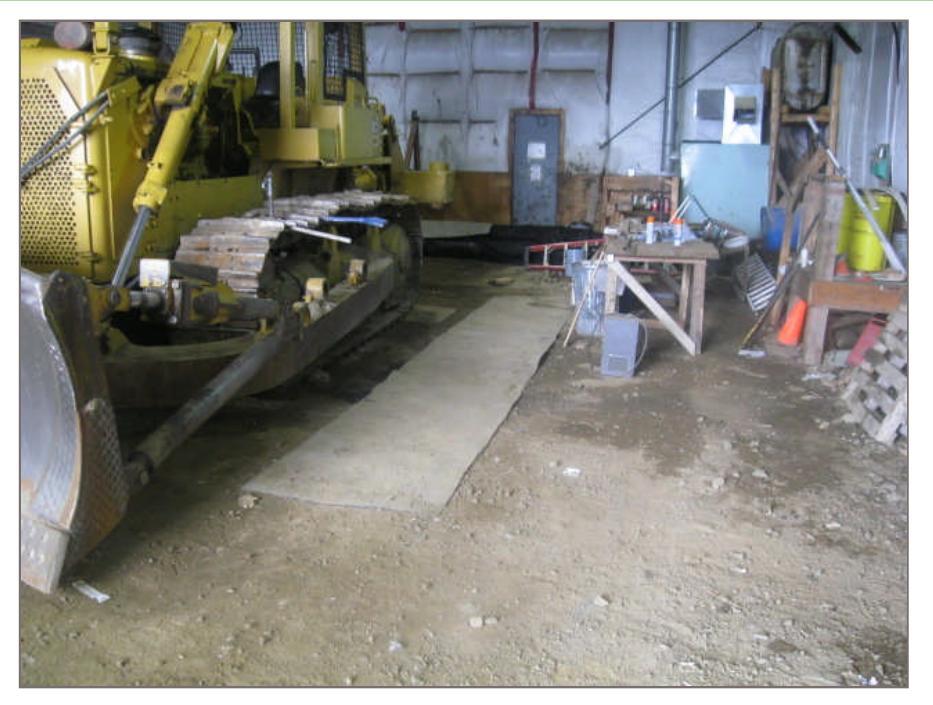
Photo 33: Hydrocarbon staining on the floor of the Ketza mine shop

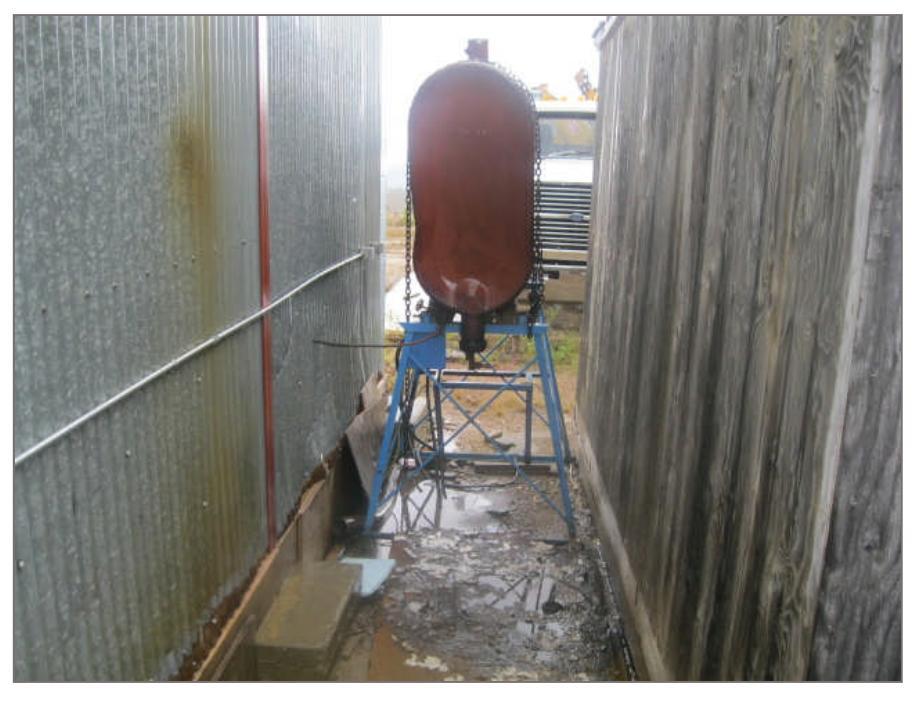
Photo 34: Hydrocarbon staining mixed with water under AST north of Ketza mine shop

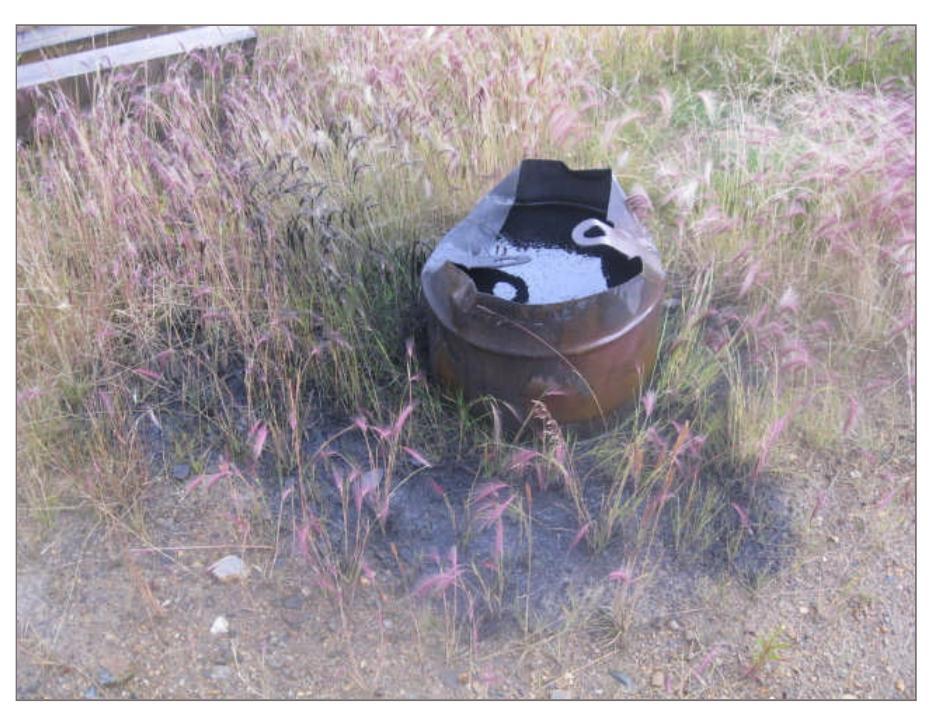
Photo 35: Full waste oil barrel located outside Ketza mine shop with associated staining

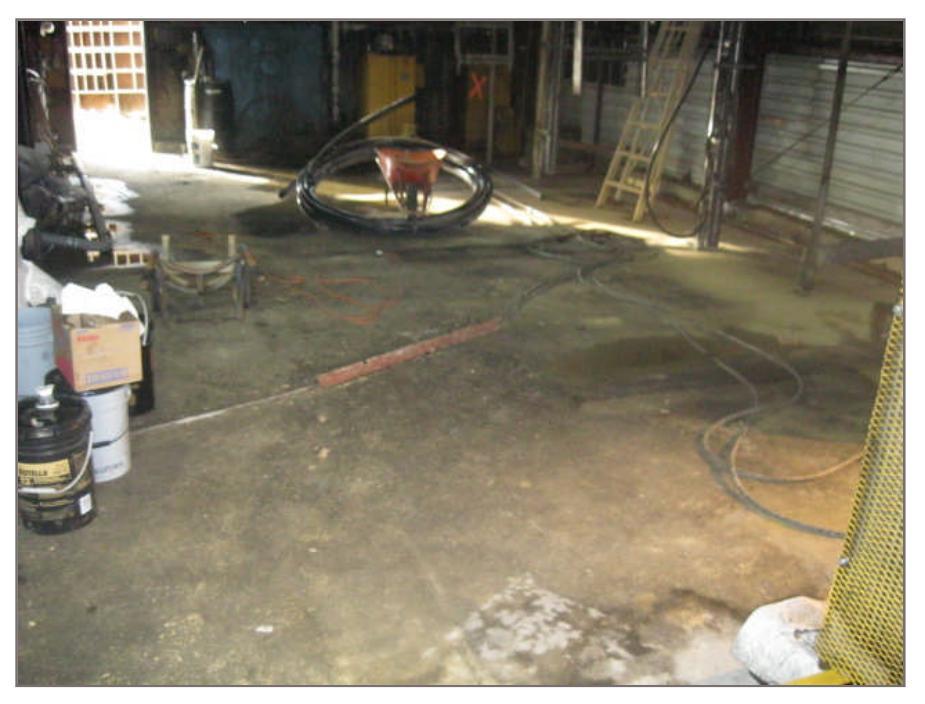
Photo 36: Heavy hydrocarbon staining on the floor of the Generator Building

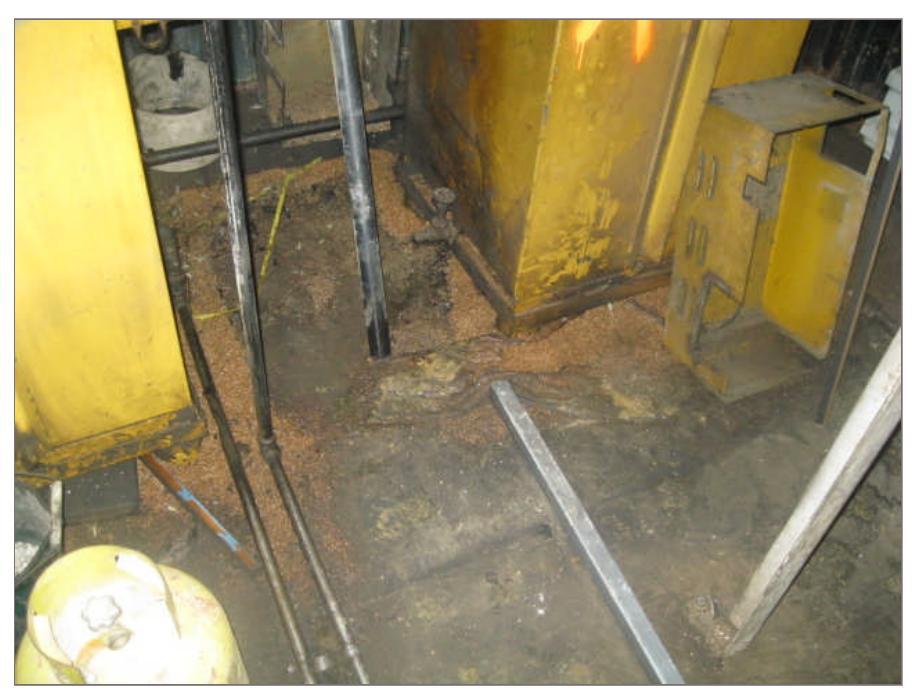
Photo 37: Heavy hydrocarbon staining on the floor next to generators in the Generator Building

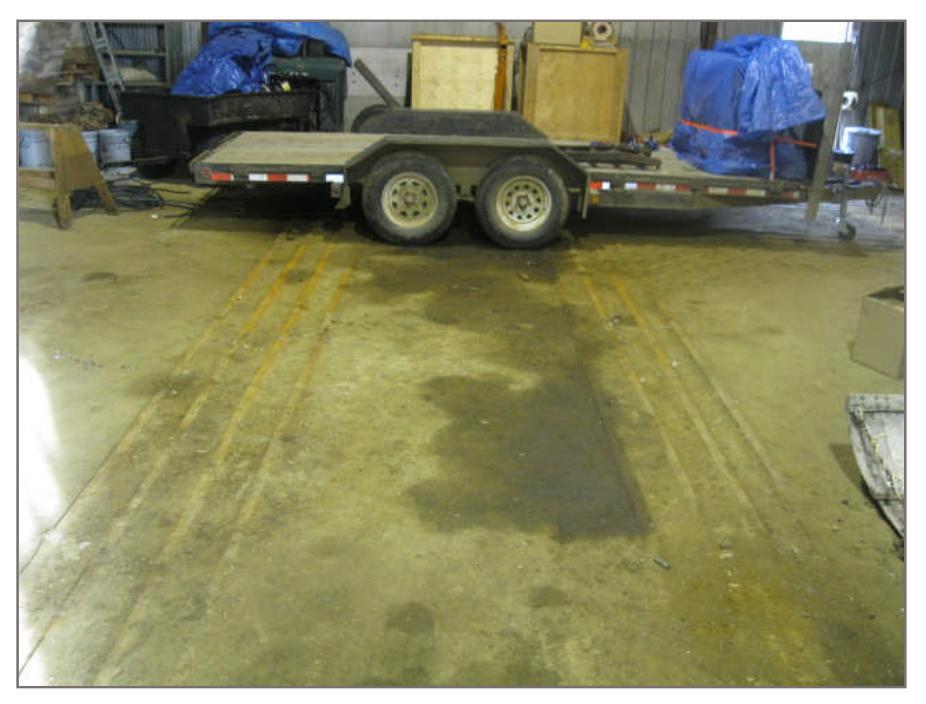
Photo 38: Hydrocarbon staining on the concrete floor of the Warehouse

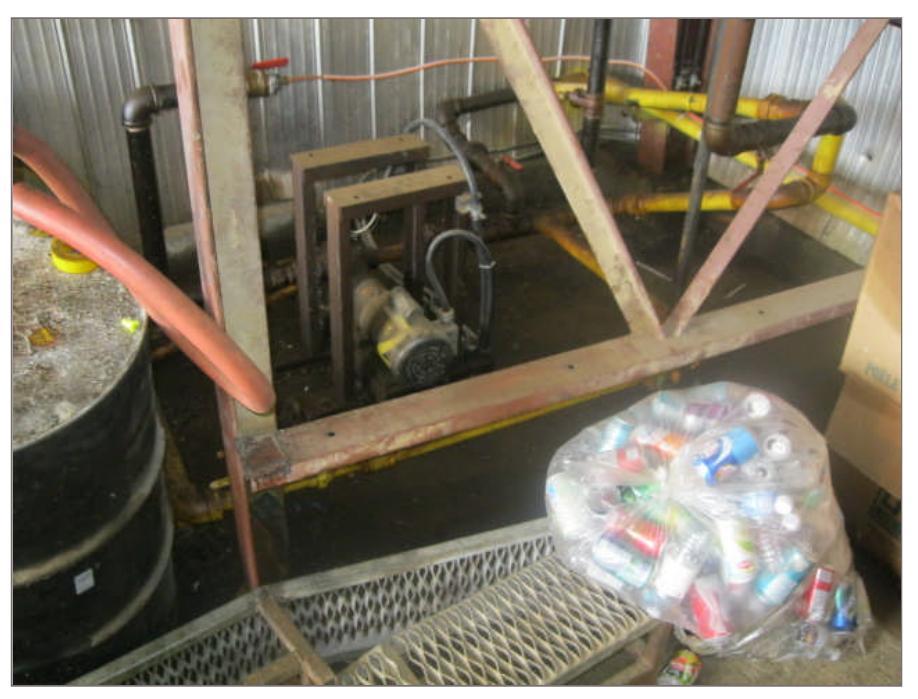
Photo 39: Hydrocarbon staining on the concrete floor in the Warehouse under a raised AST

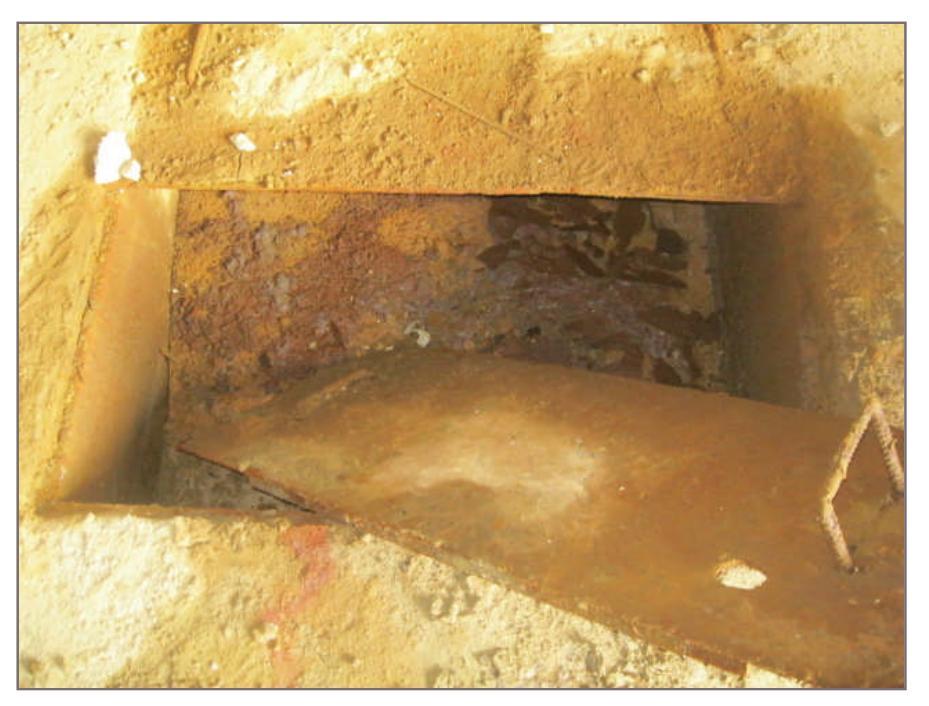
Photo 40: Hydrocarbon contaminated soil in the sump of the Upper Building associated with the Mill
