# HAZARDOUS MATERIALS CLASSIFICATION MT. NANSEN MINESITE YUKON

# REPORT

DECEMBER 2011 ISSUED FOR USE EBA FILE: W23101481

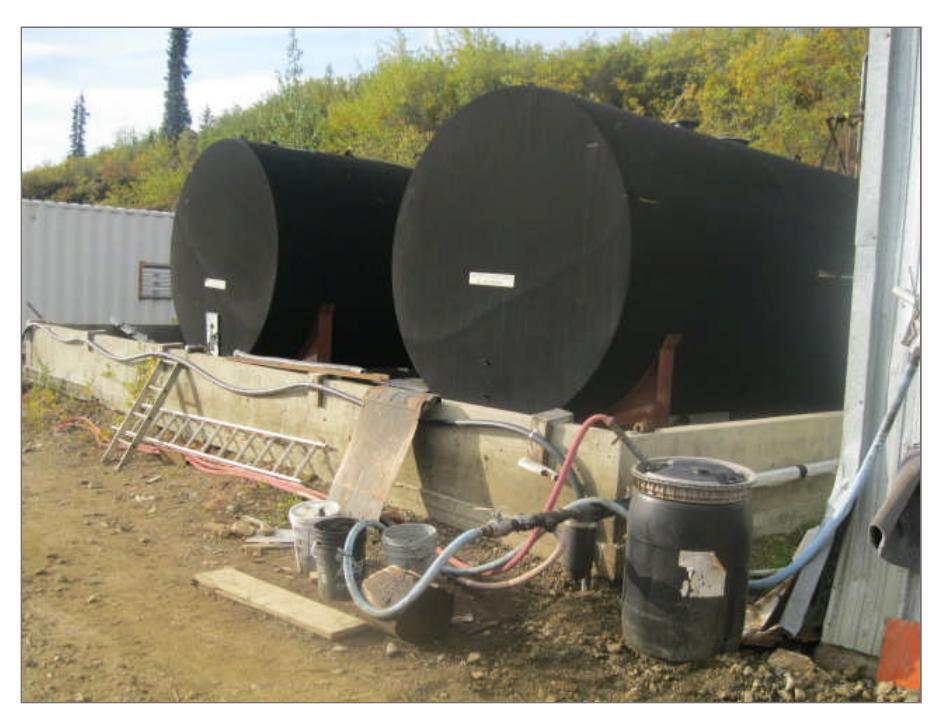
Photo 41: Hydrocarbon staining on soil in front of diesel tank farm

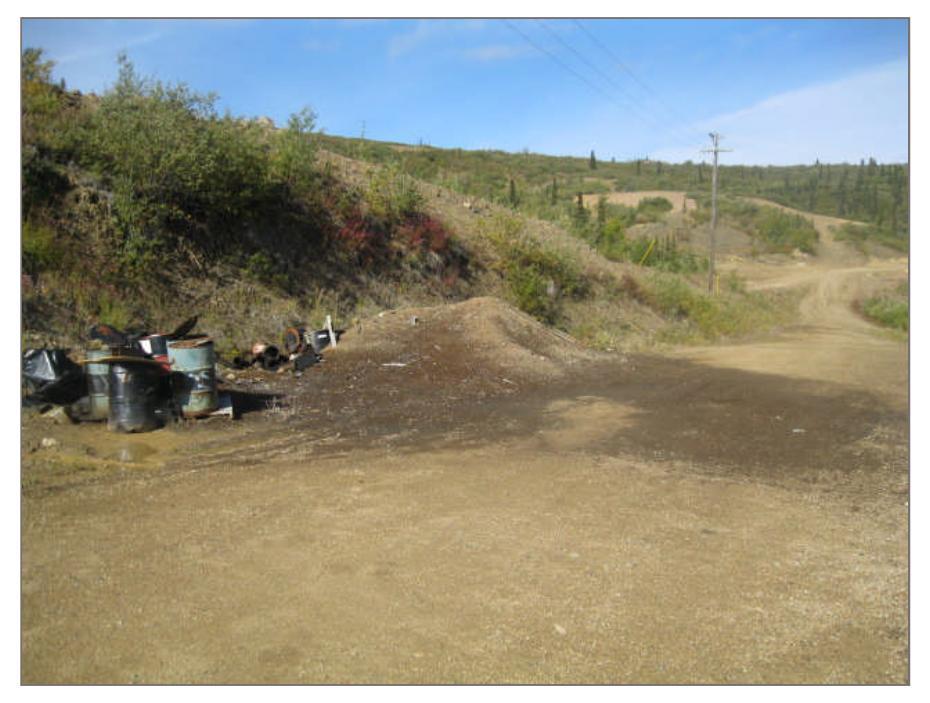
Photo 42: Hydrocarbon stained soil and oil soaked rags located on the upper road to the SAG building

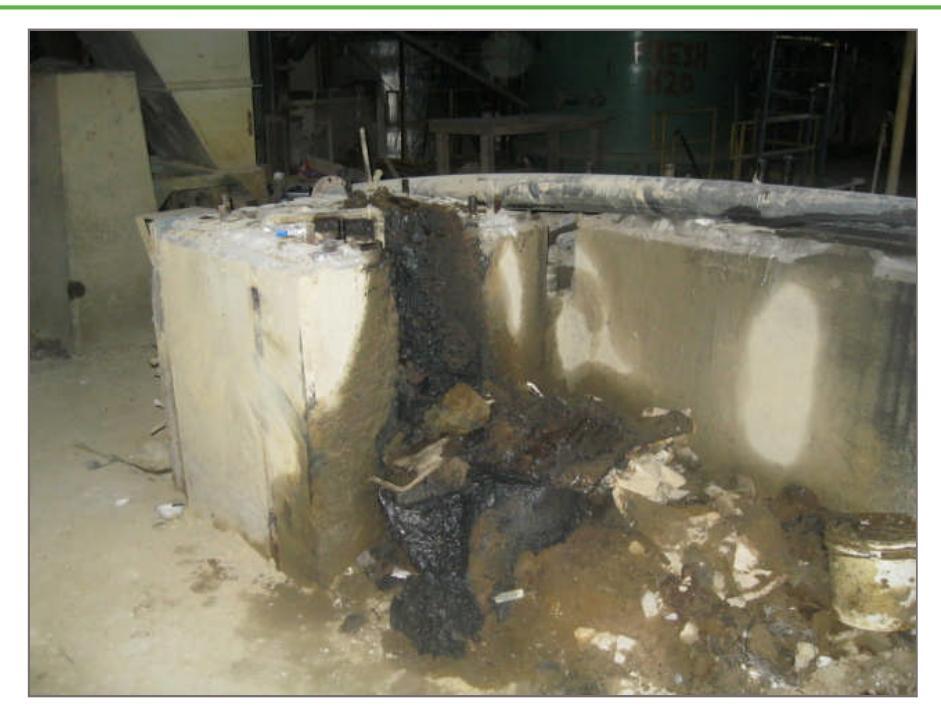
Photo 43: Hydrocarbon sludge within the Mill

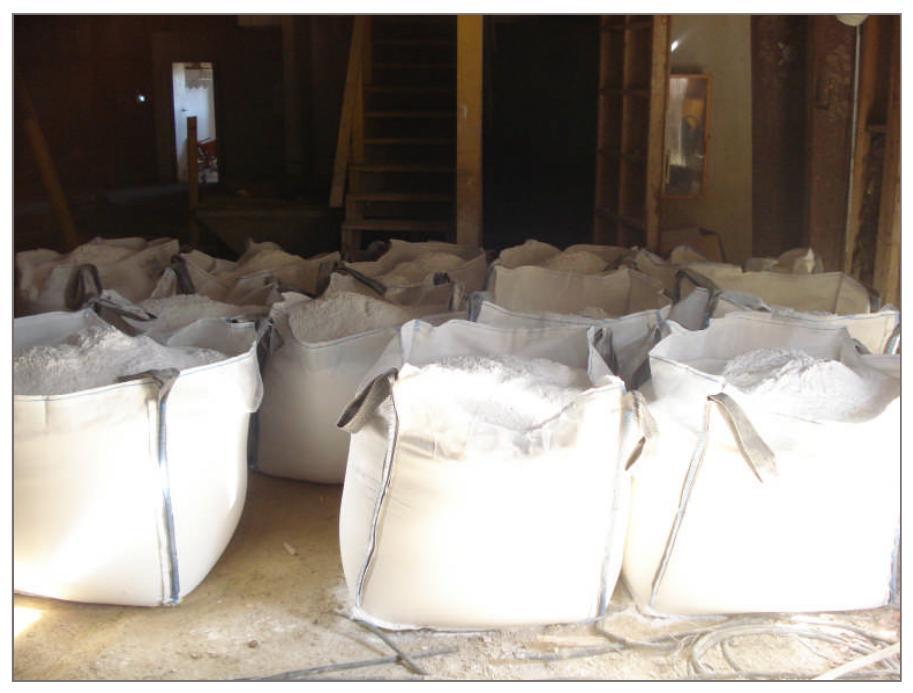
Photo 44: Twelve one ton bags of suspected ferric sulphate located within the Mill

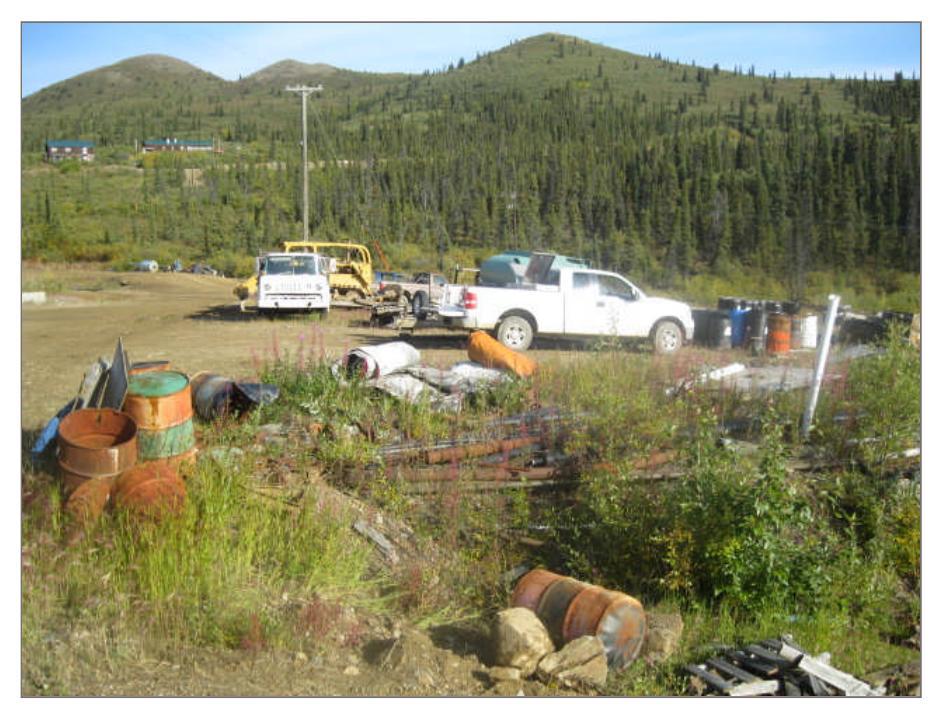
Photo 45: Metal debris and abandoned vehicles located east of the Mill

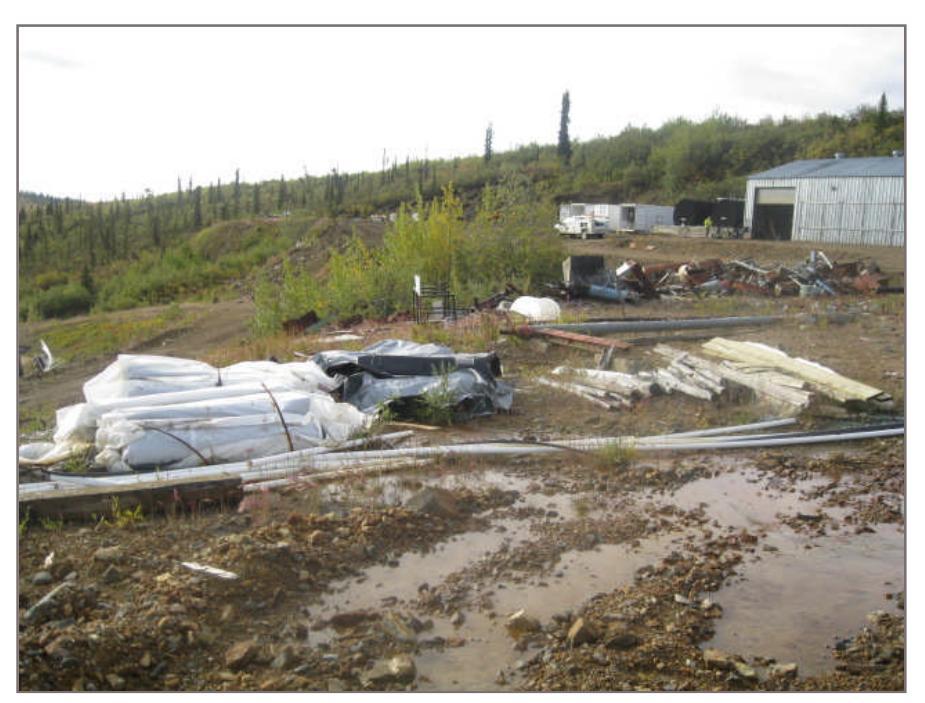
Photo 46: Miscellaneous debris located east of the Mill

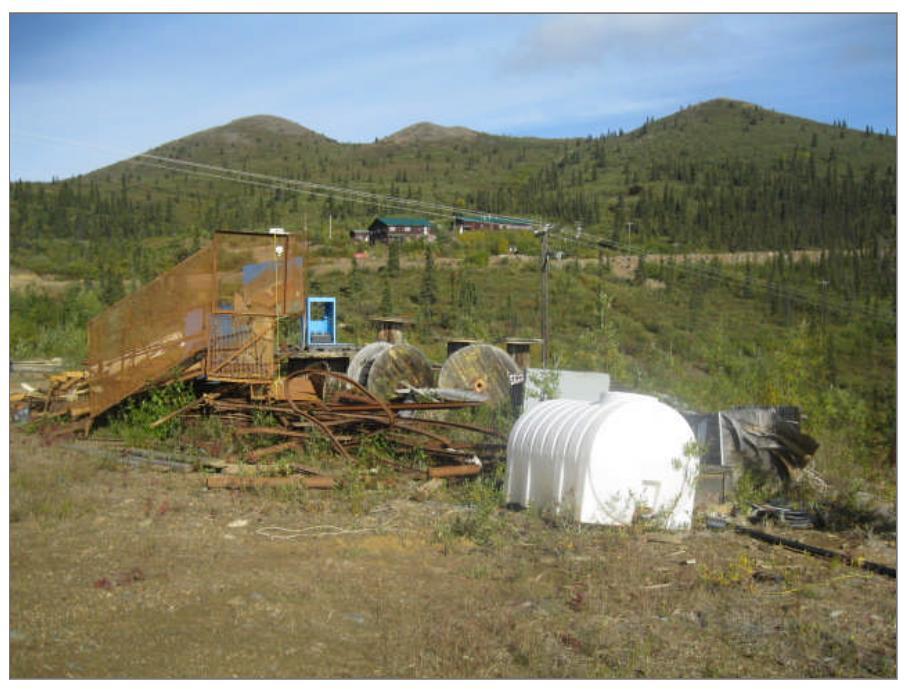
Photo 47: Miscellaneous debris located east of the Mill

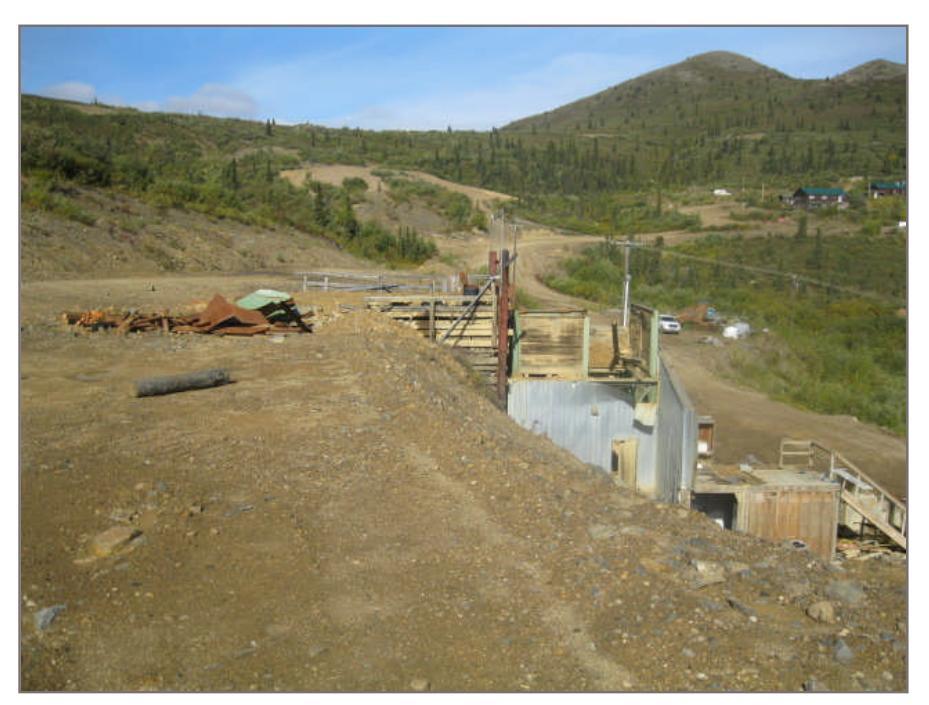
Photo 48: Metal debris and the Sag Mill building located on the Sag Mill road

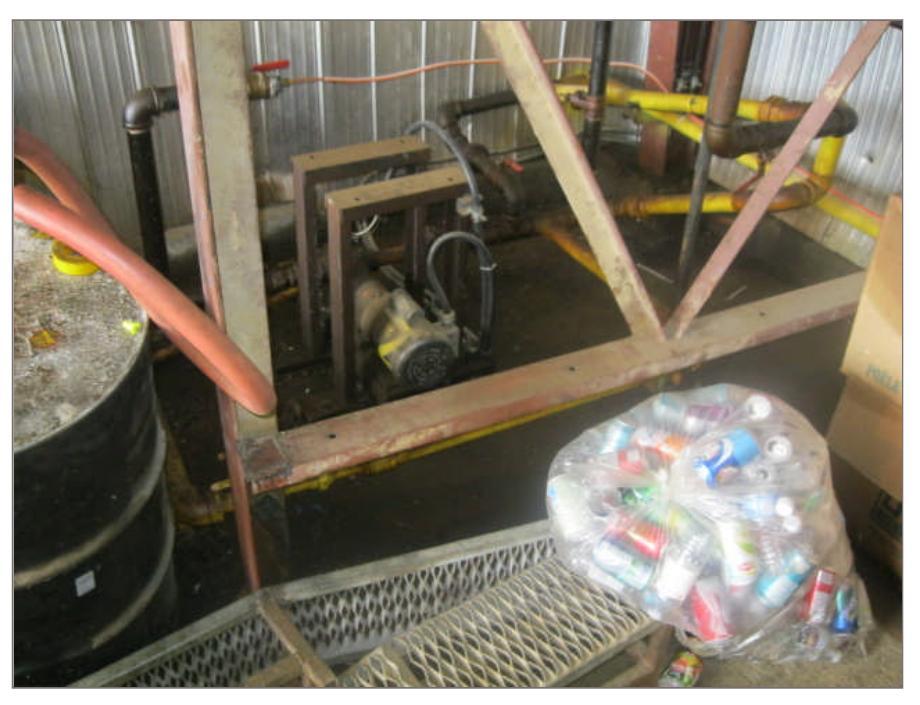
Photo 49: Hydrocarbon staining on the concrete floor in the Warehouse under a raised AST

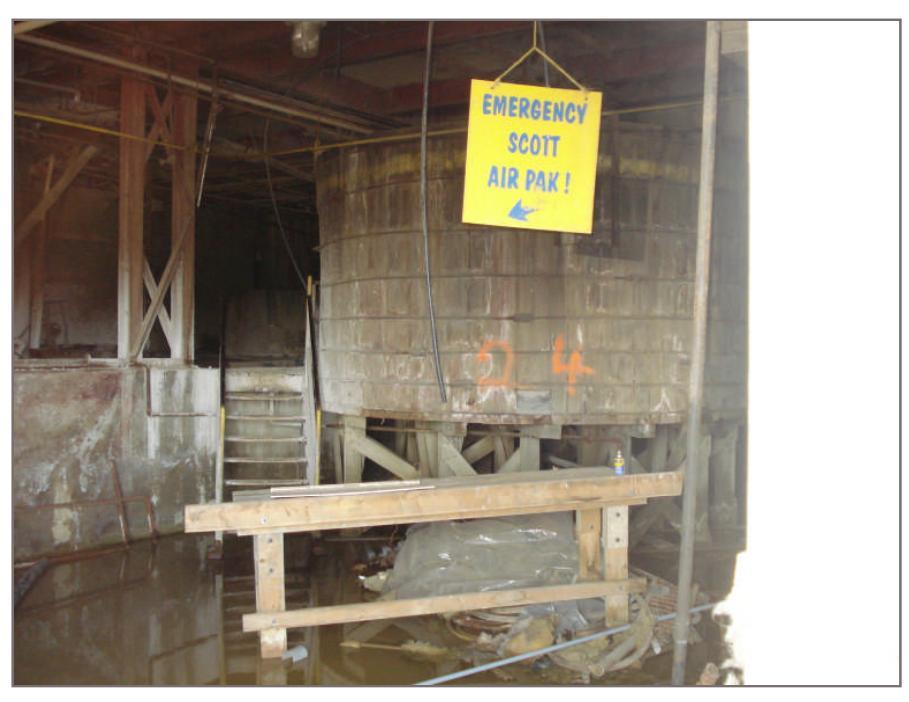
Photo 50: Partial area where water is pooling within the Mill
