ROSE CREEK TAILINGS FACILITY, FARO MINE

Intermediate Dam Spillway - PMF Flood Handling

M09237A06

**Rose Creek Tailings Facility, Faro Mine
Intermediate Dam Spillway - PMF Flood Handling**

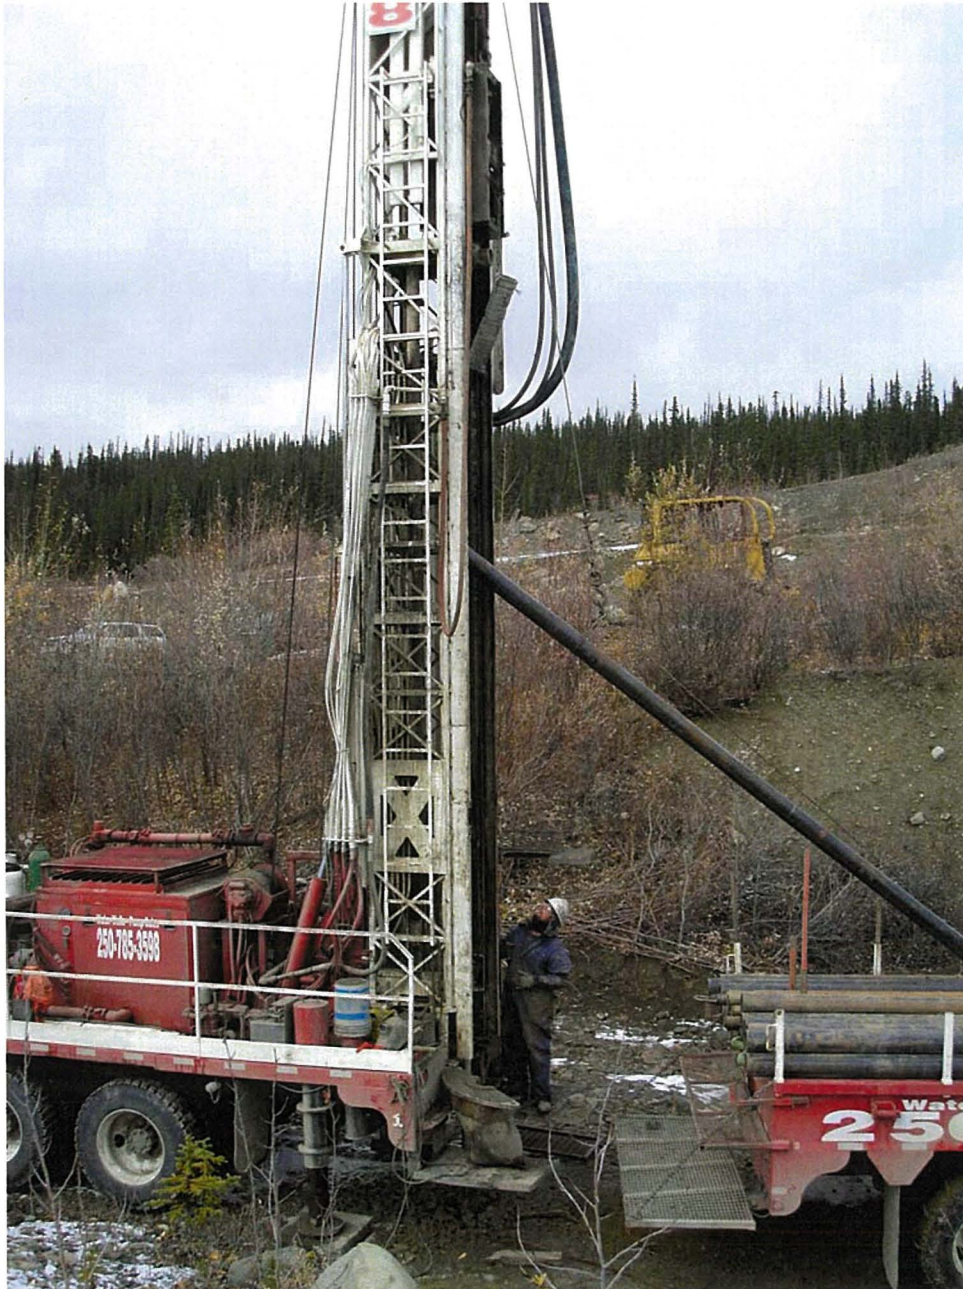
Photo I-1 Truck mounted drill rig at DHKC07-1. A 6" casing is being hoisted into position. Note the outcrop of silty gravel on the right.

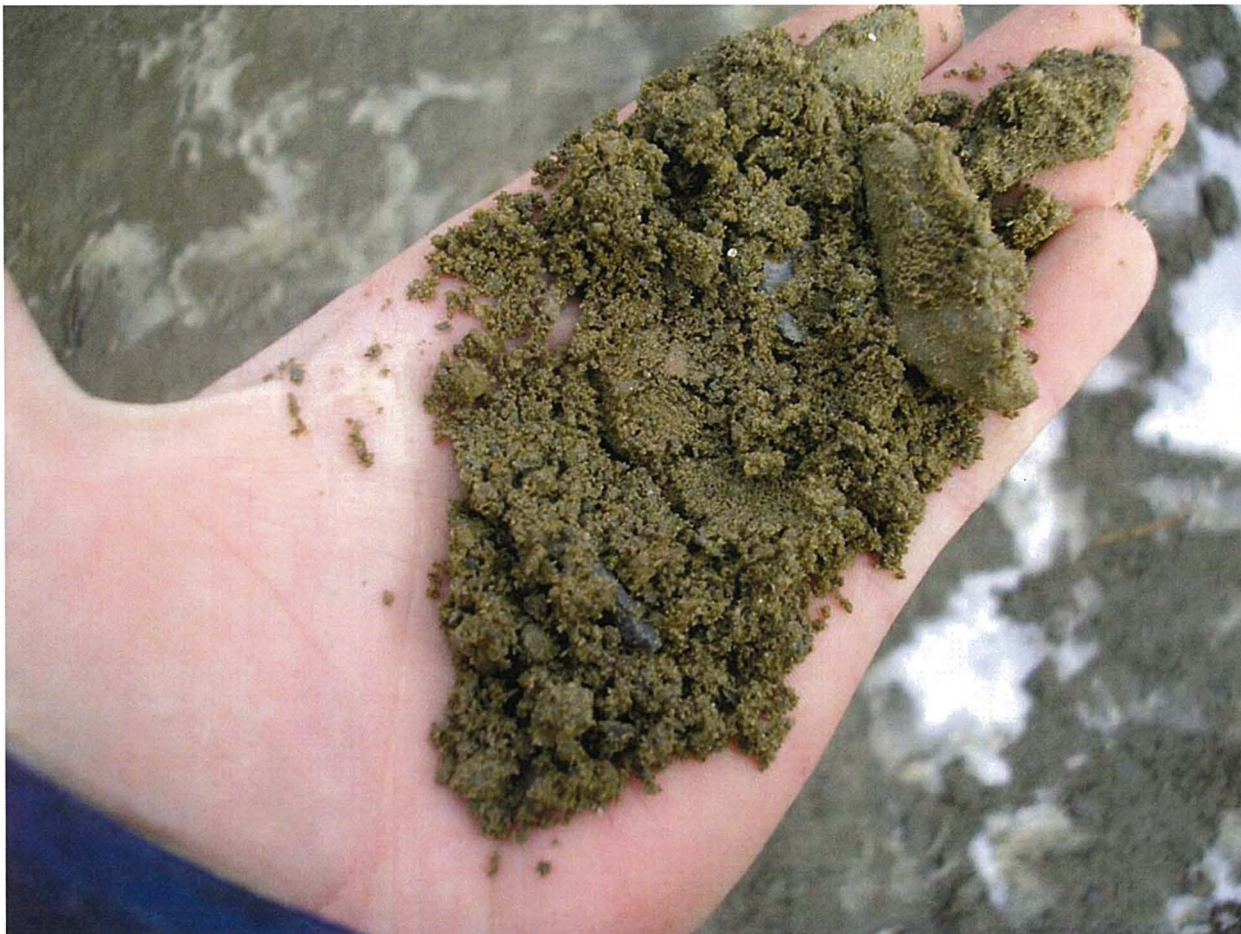
**Photo I-3 Sand and gravel chip sample from tri-cone drilling at about 4 m depth
at DHKC07-1.**

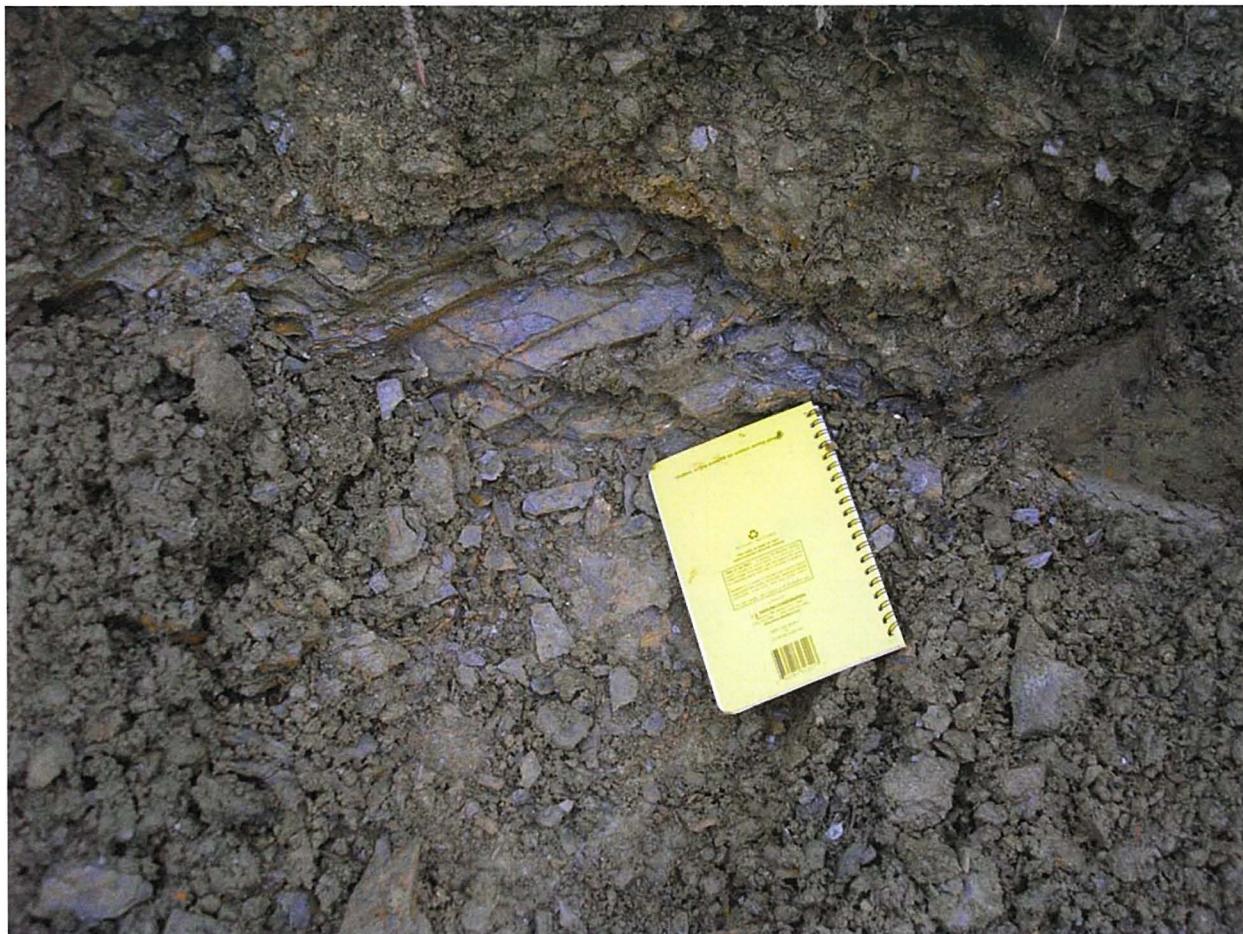
Bedrock encountered on the right abutment is a dark grey, very closely foliated, medium strong schist with quartz veins from 10 to 30 mm thick. Foliation dips at 25 to 27° towards 191 to 203°, which is downslope towards the tailings impoundment. Bedrock was found to be between 0 and 11 m below the surface, with the depth to bedrock increasing towards the impoundment. In most test holes and test pits, the upper 2 metres, at least, of the rock is broken down to gravel size particles.

Photo I-5 Foliated schist bedrock in a dozer cut at DHKC07-2.

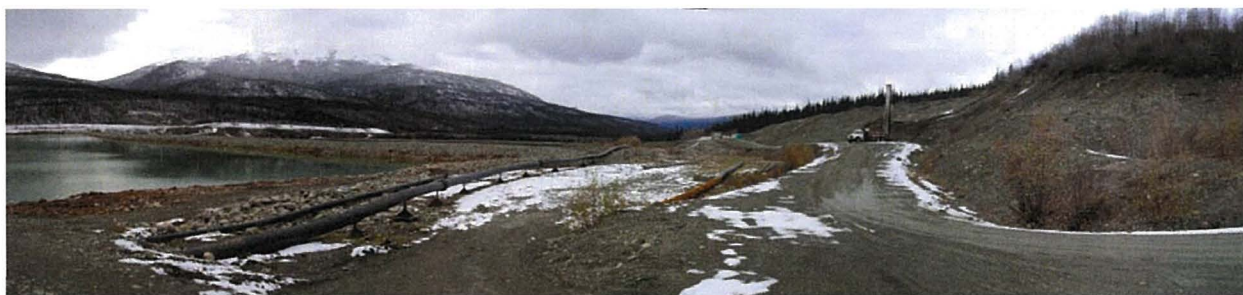
Photo I-6 DHKC07-3 and the intermediate dam. Bedrock is at 5.1 m depth in DHKC07-3. Note the 4 m high roadcut of sand and gravel on the right.

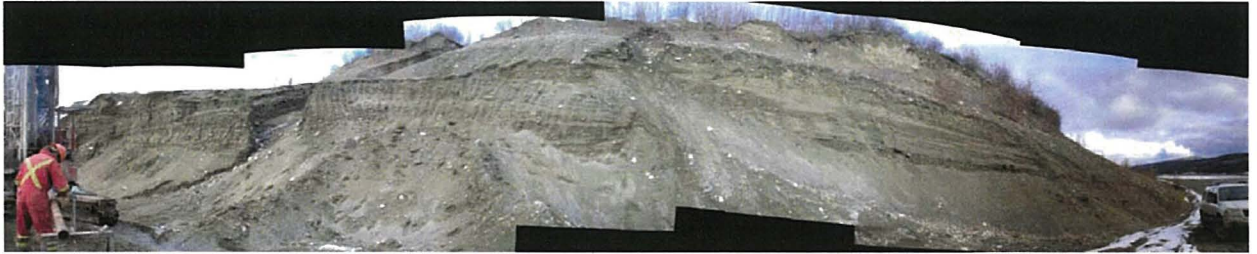
Photo I-7 DHKC07-3 is on the extreme left, where bedrock is 5.1 m below surface. A 4 m high roadcut of sand and gravel is in the centre.

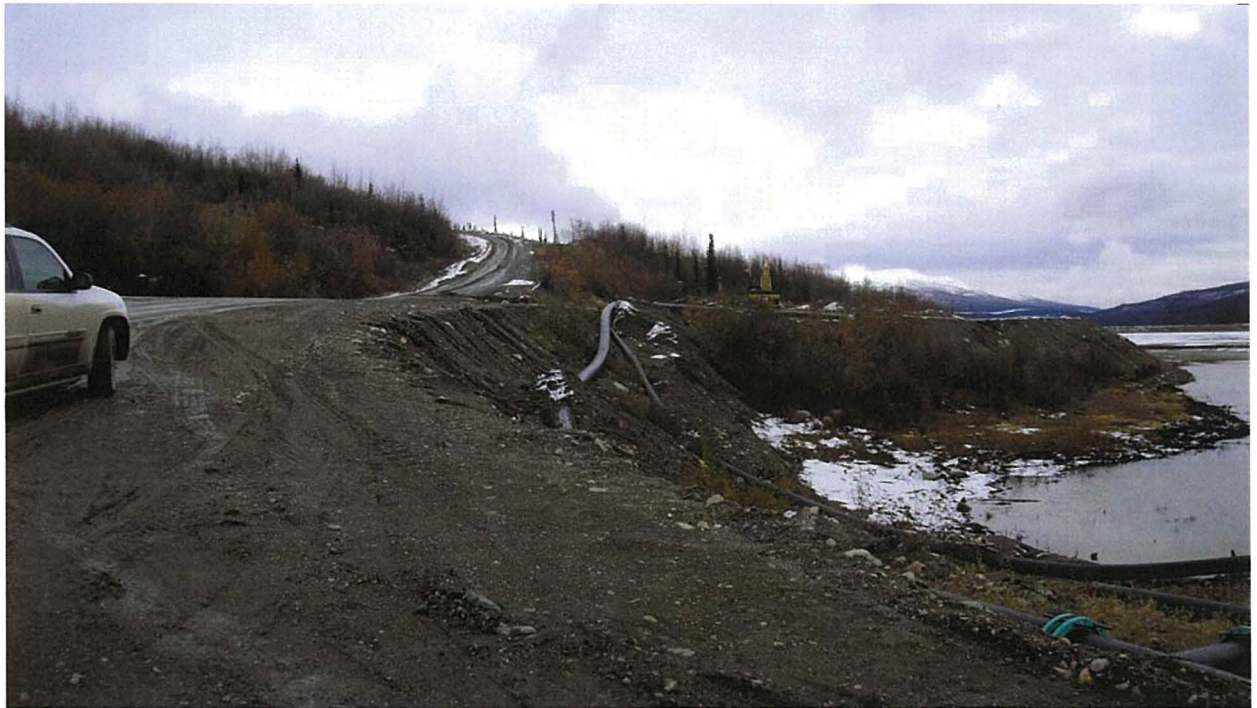
Photo I-8 Excavator is digging TPKC07-3, which is adjacent to DHKC07-4. Bedrock is at 10.5 m depth in DHKC07-4.

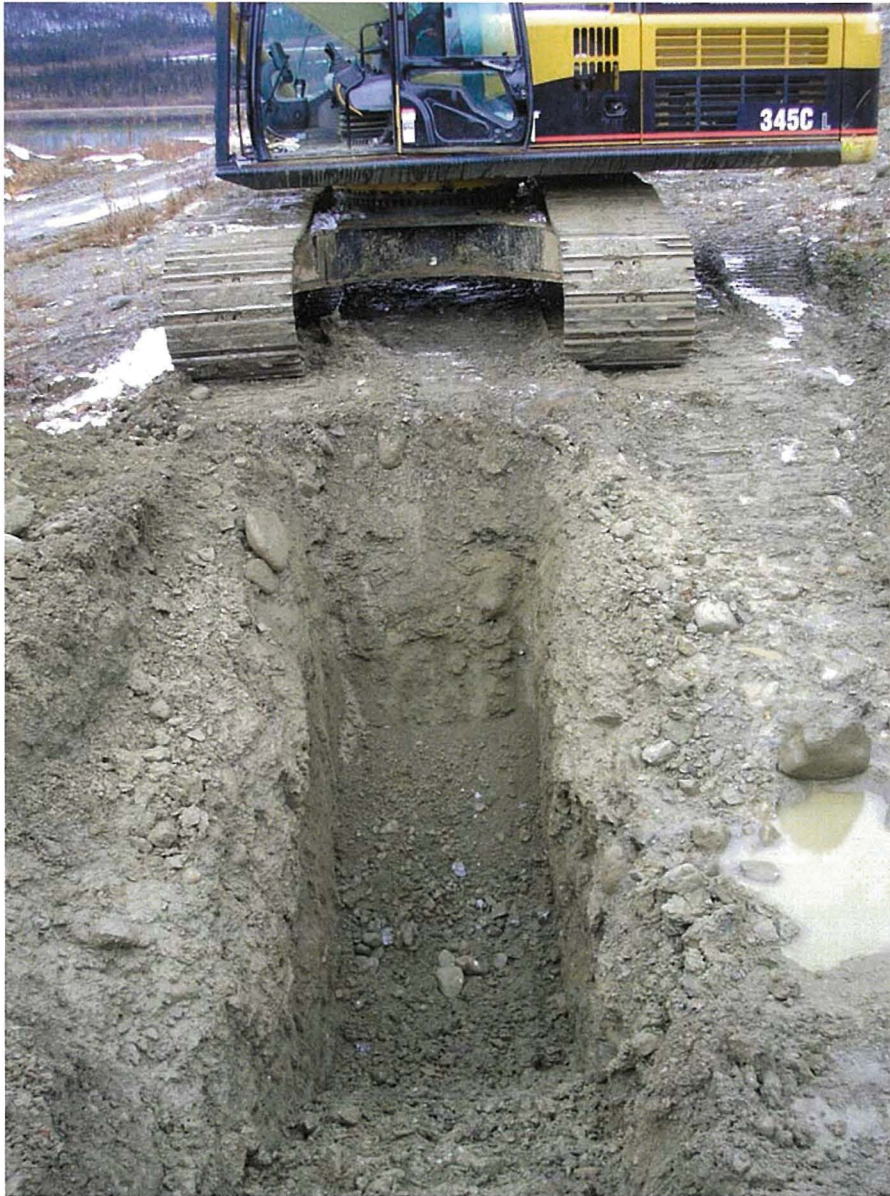
Photo I-9 TPKC07-1 exposed schist bedrock at 3.2 m below surface.

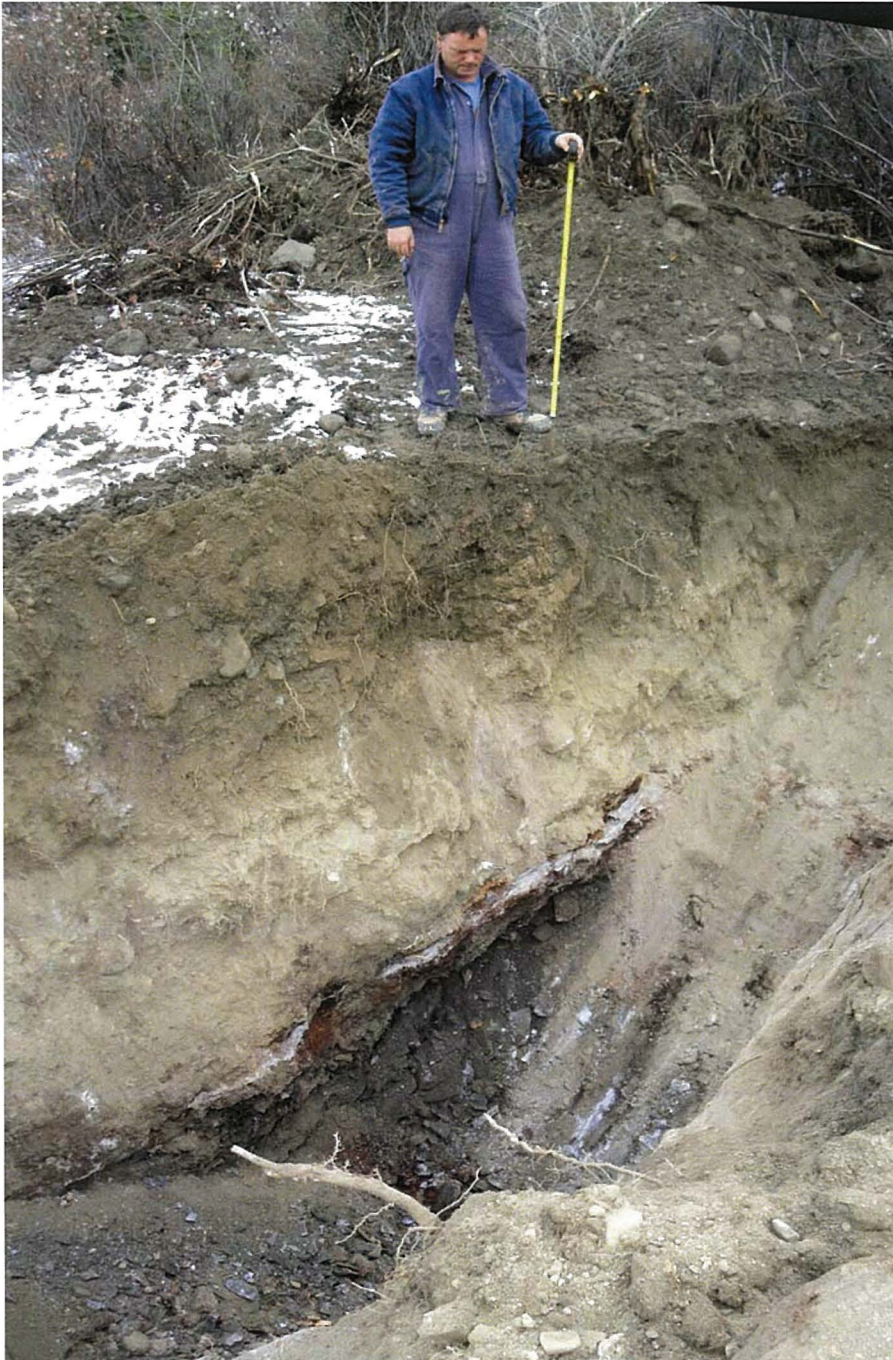
Photo I-10 TPKC07-2 exposed schist bedrock at 1.9 m below surface. Note the darker disturbed material at the top of the test pit.

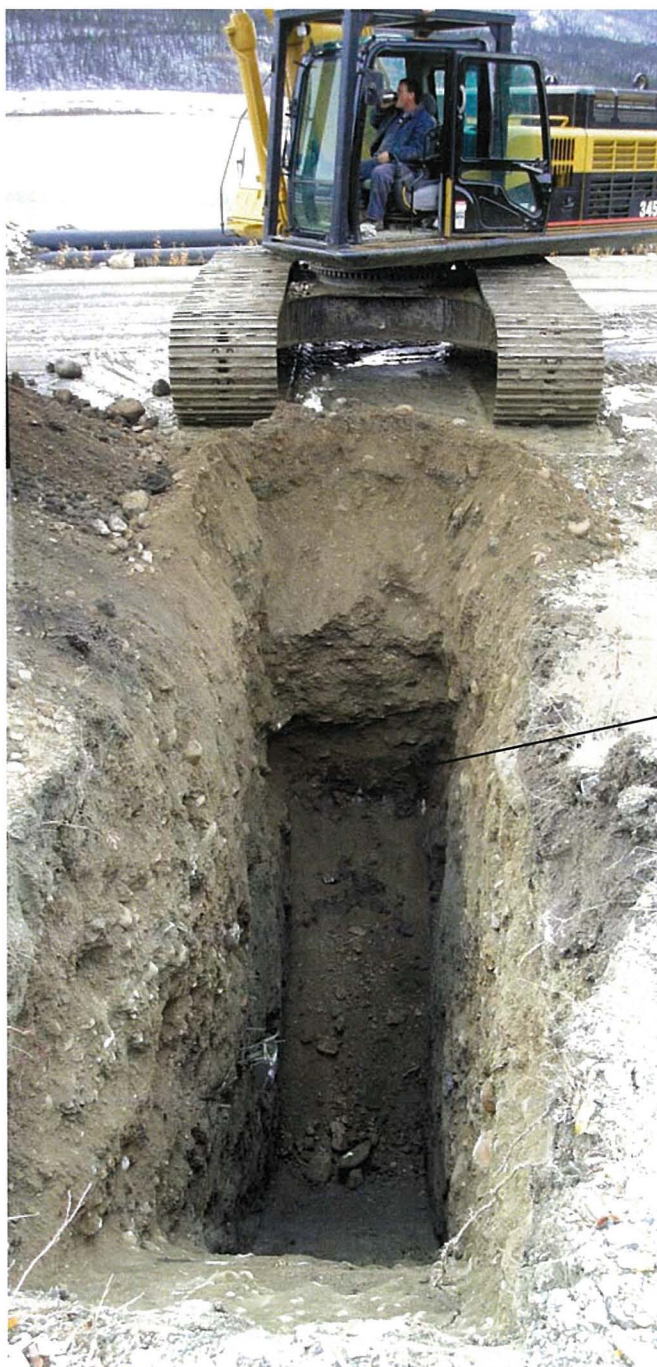
Buried soil horizon.

Photo I-11 TPKC07-3 exposed 3.5 m of fill, with sand and gravel underlying to at least 5.5 m depth. Note the thin black buried soil layer at 3.5 m depth.

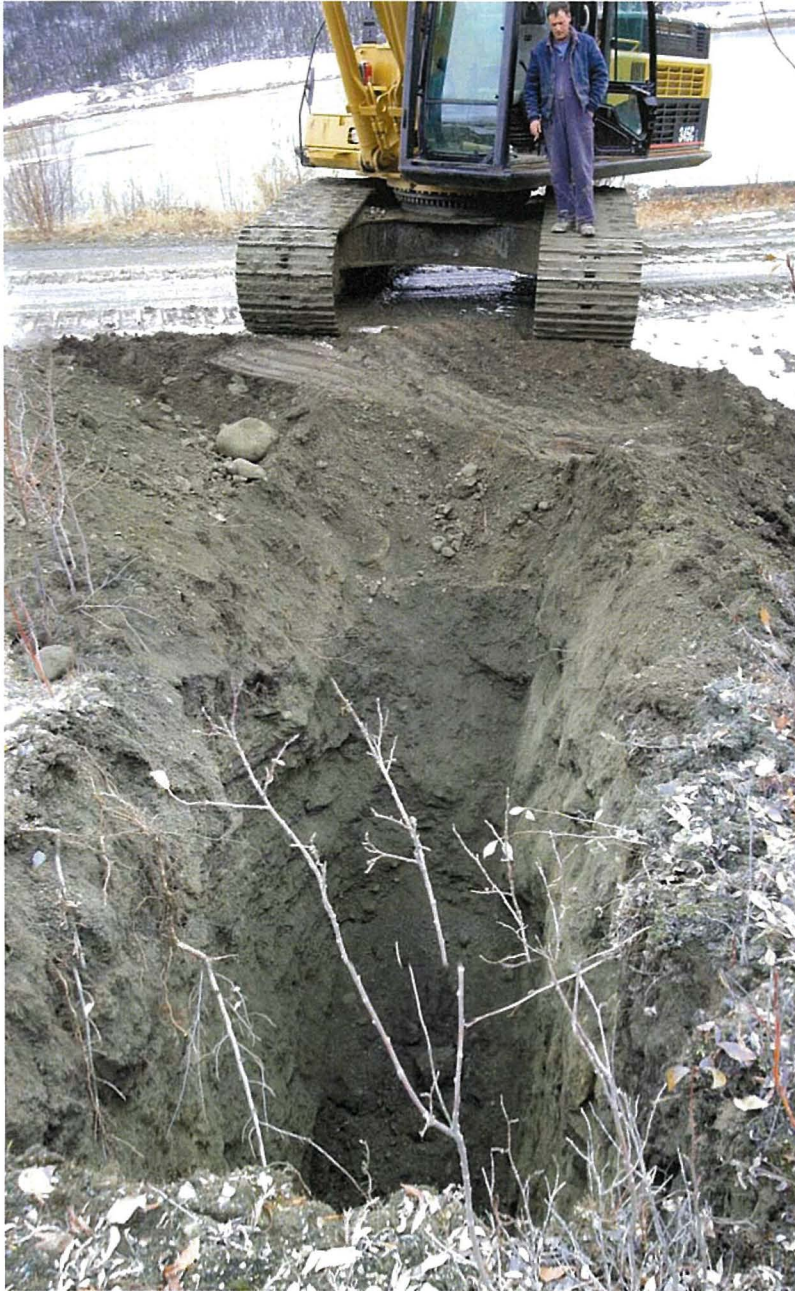
Photo I-12 TPKC07-4 exposes at least 5 m of silty gravelly sand with trace organics.

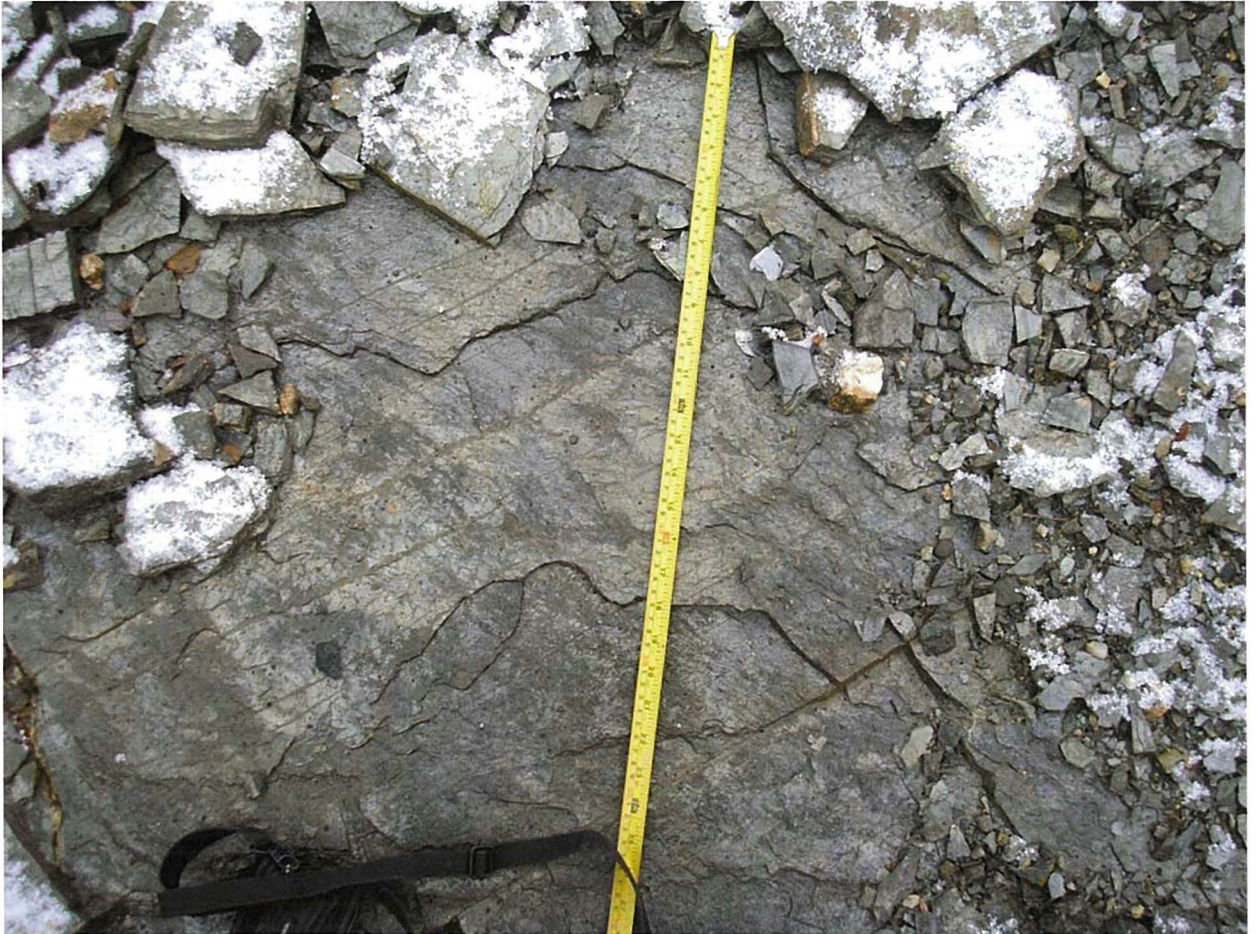
Photo I-13 The smooth, planar surface of foliation in the schist bedrock in a roadcut at 07SE28-1. Foliation spacing is 2 to 10 mm.

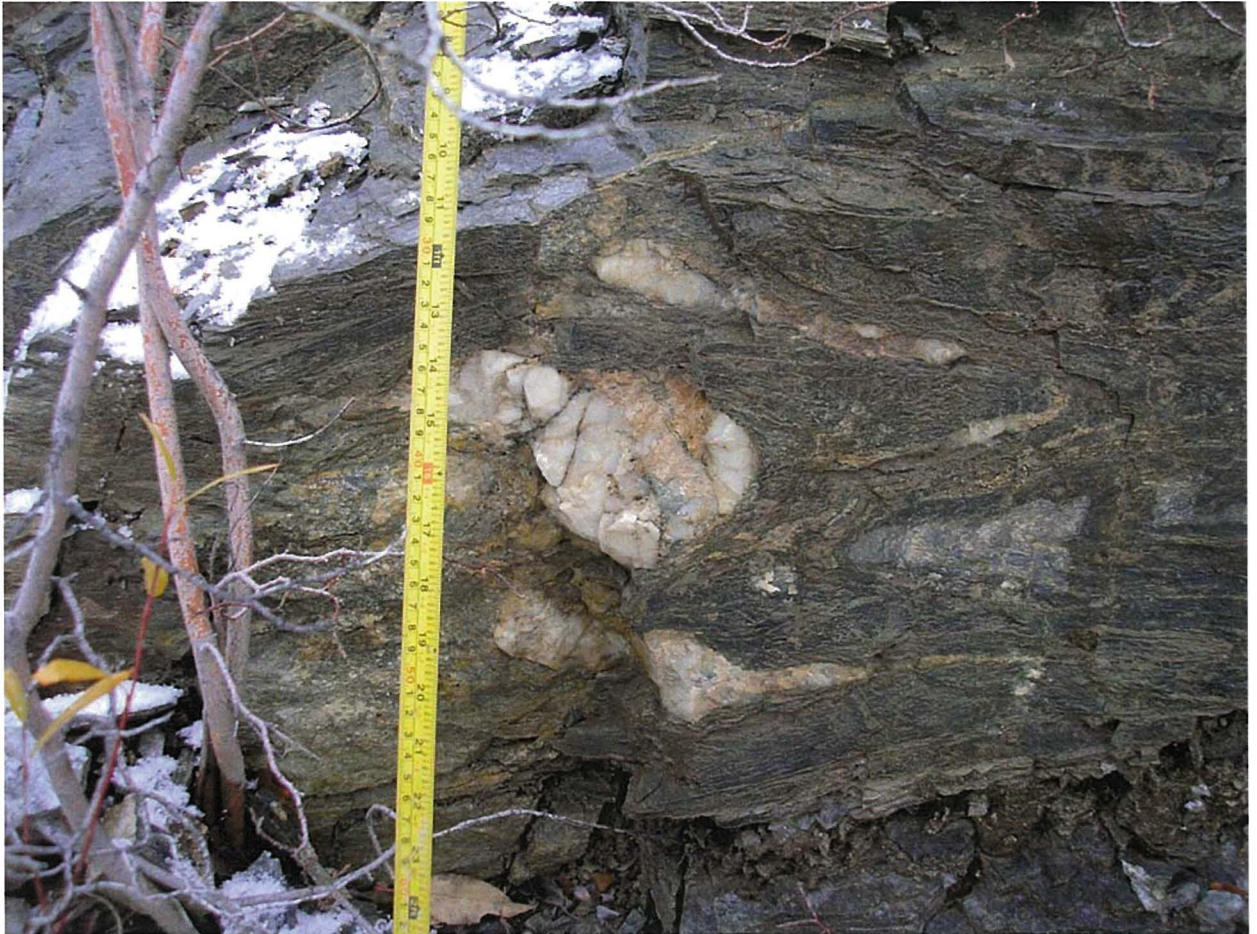
Photo I-14 Closely foliated schist with minor folding in a roadcut at 07SE28-1.
The light material is quartz.

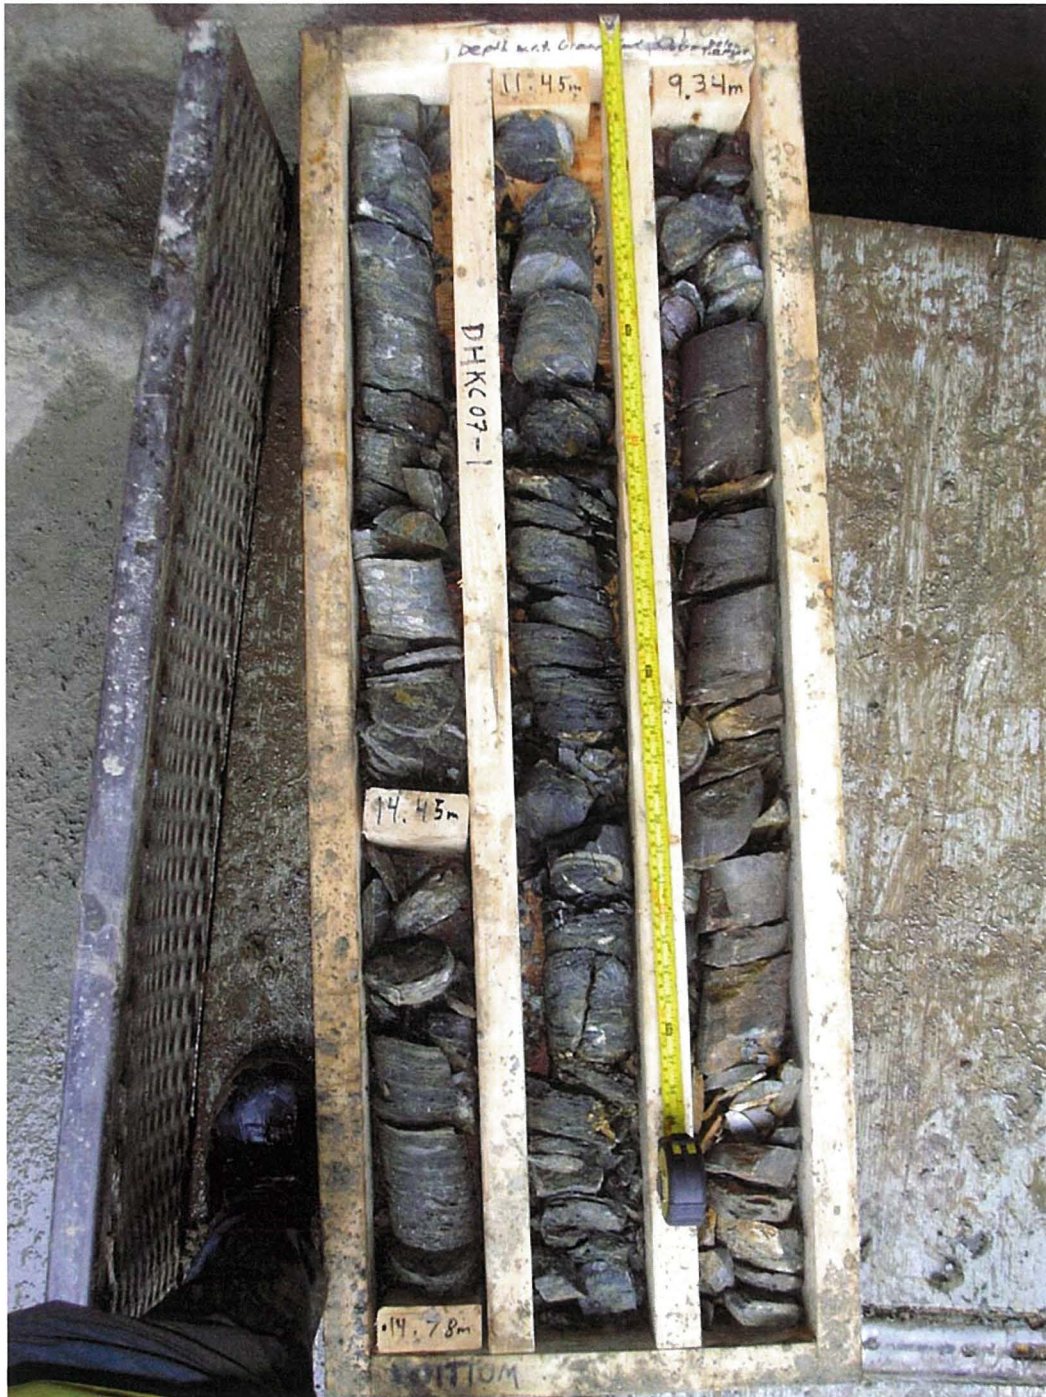
Photo I-15 Core from 9.34 to 14.78 m in DHKC07-1.

The low core recovery and very low RQD of the rock is due, in part, to the interaction of the relatively primitive coring techniques with the foliation. Better coring techniques would improve core recovery but the upper few metres of highly fractured rock would still yield low RQD values. It is very common for large changes in rock quality and rock depth over short distances in these terrains. However, the presence of shallow rock demonstrates that a spillway can be founded on the right abutment but dental concrete or equivalent measures might be necessary on the base and sides of the spillway. This rock

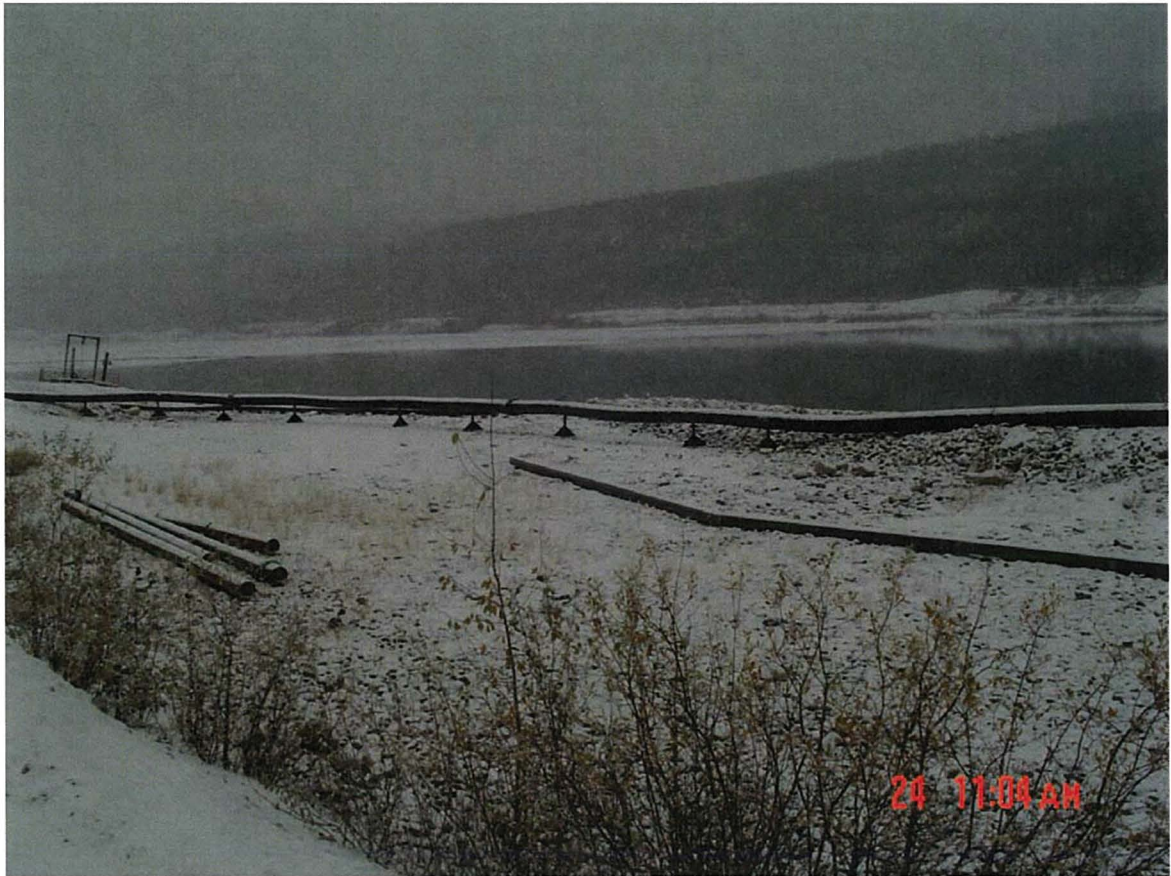
Photo II-5 Inlet of Existing Intermediate Dam spillway channel, looking upstream into impoundment. Note treated water effluent line across spillway channel.

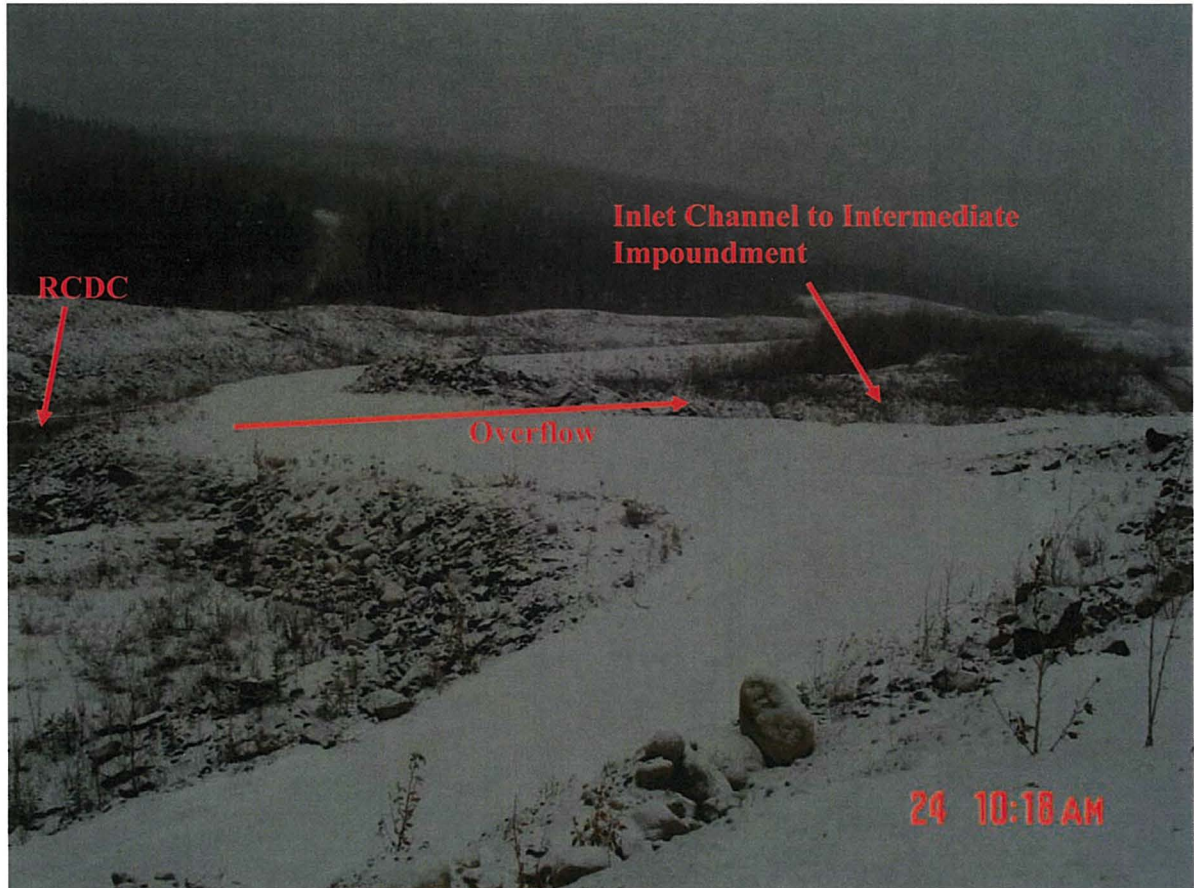
The top of the existing RCDC overflow berm is at El. 1058 m, and we understand that it may also contain some large rock. The estimated 500-year water level in the RCDC near the overflow berm is at El. 1059.5 m, therefore the top of the proposed fuse plug needs to be set at this level such that it fails at the 500-year flood flow. A proposed cross section of the fuse plug is shown in Figure 3.5. Since the existing overflow berm may contain some large rock, it should be removed in its entirety.

Photo II-9 RCDC overflow berm as seen from Secondary Dam East Limb.
