Government of Yukon

Load Rating of Mount Nansen Bridge at Diversion Channel

Final Report (Rev 1)

March 2012

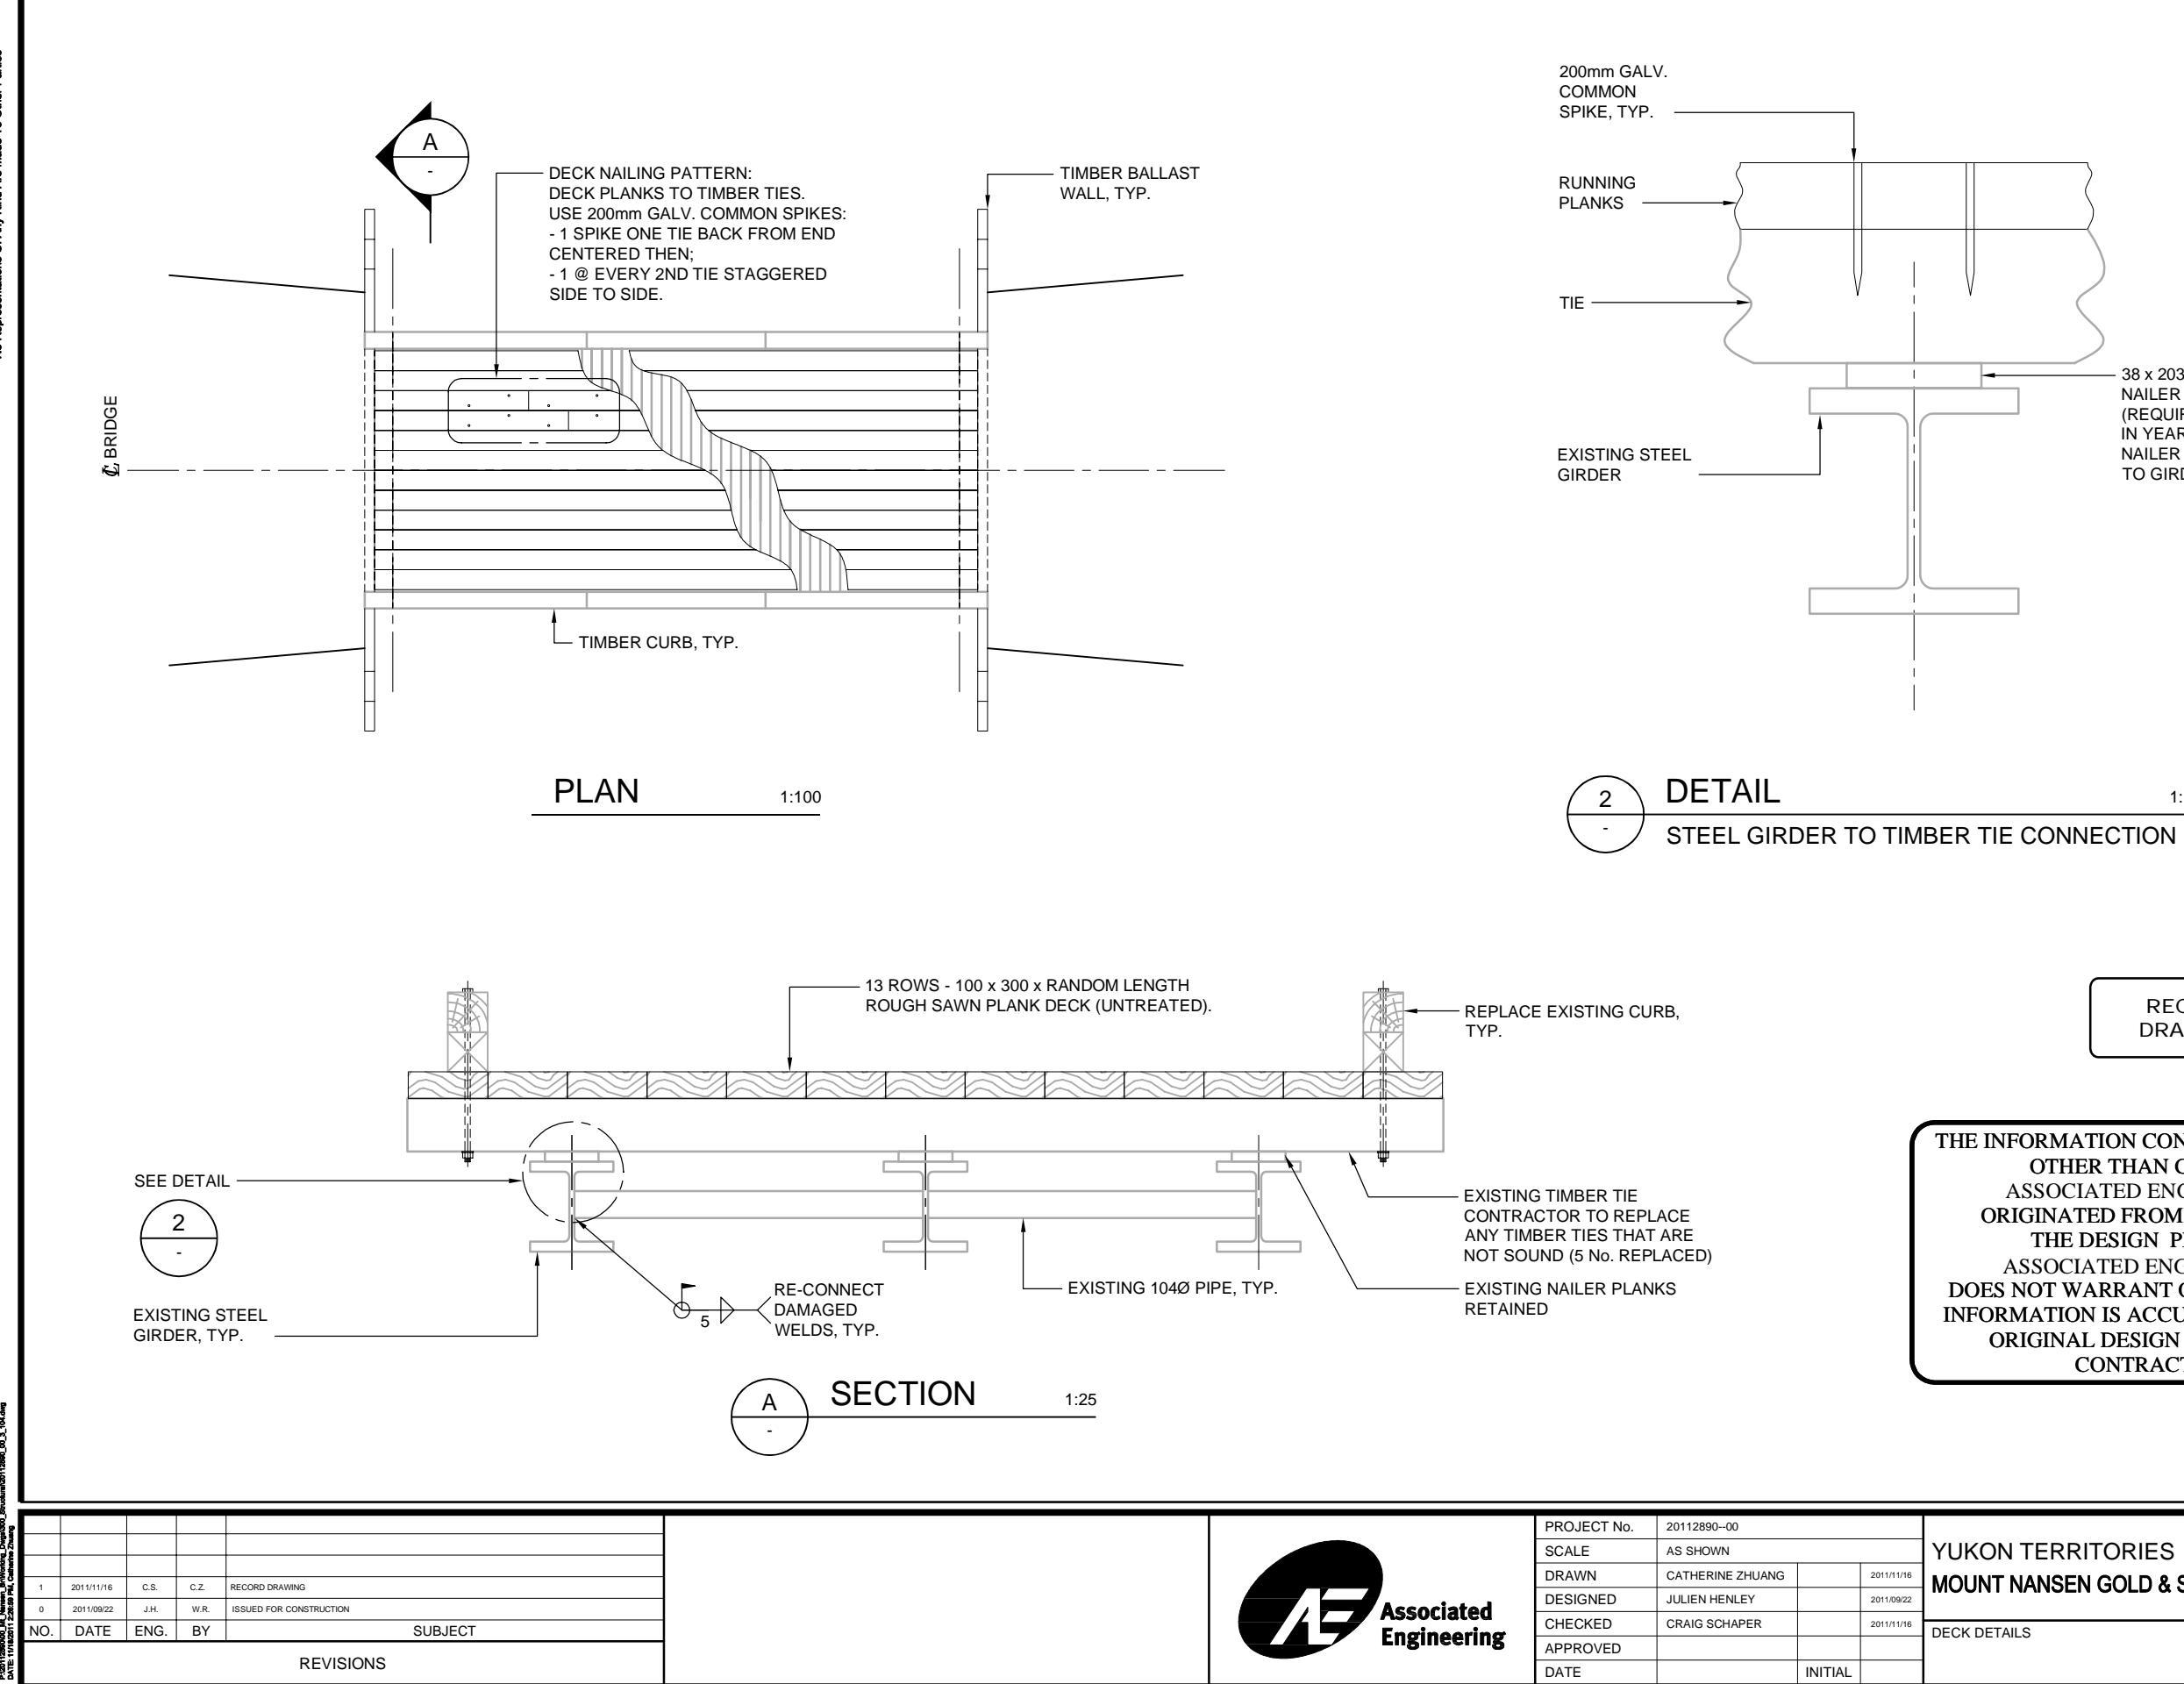
ON TERRITORIES	MOUNT NANSEN BRIDGE AT DIVERSION CHANNEL EMERGENCY BRIDGE REPAIR		
DETAILS	DRAWING NUMBER	REV. NO.	SHEET
	20112890-00-3-104	1	5 5

38 x 203 EXISTING TIMBER NAILER PLANK RETAINED (REQUIRES REPLACEMENT IN YEAR 2012 WITH 100x300 NAILER PLANK SECURED TO GIRDER)
