Mount Nansen Tailings Dam

Emergency Spillway Construction Report

307071-00856 -00-SS-REP-0002

23 December 2014

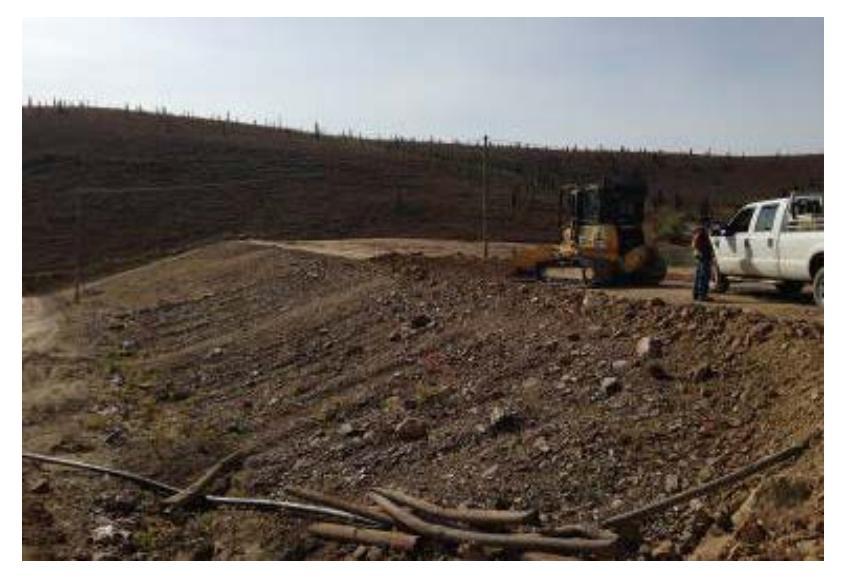
Photo A Dam Crest – Looking Southwest

Although small segments of the regraded dam crest did not achieve an elevation of 1,099.60 m, there is sufficient freeboard (1.0 m during the IDF) to account for this variation. AAM, at its discretion, may choose to fill in the segments identified in Table B with compacted surfacing aggregate.

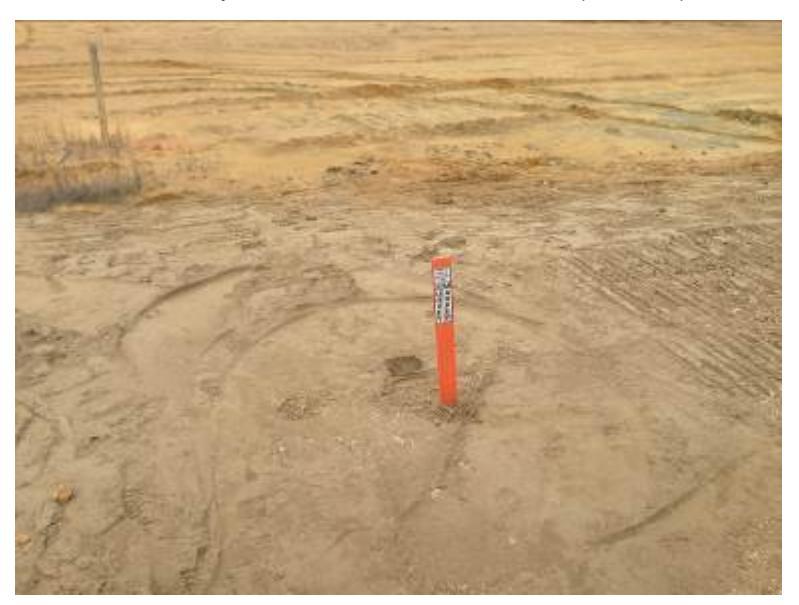
Photo B Survey Marker – Looking West

Four survey markers were installed at approximately 50 m spacing along the west edge of the dam crest. The installation consisted of a steel rod embedded in concrete cast in place in a sono tube. Excavation for the sono tube was achieved using a backhoe to an approximate depth of 2 m. Following concrete placement, the excavation was backfilled with native material and compacted. Plastic markers were installed to identify the locations of the markers (Photo B).

It is recommended that the markers are surveyed to monitor for horizontal and vertical movement based on the following criteria:

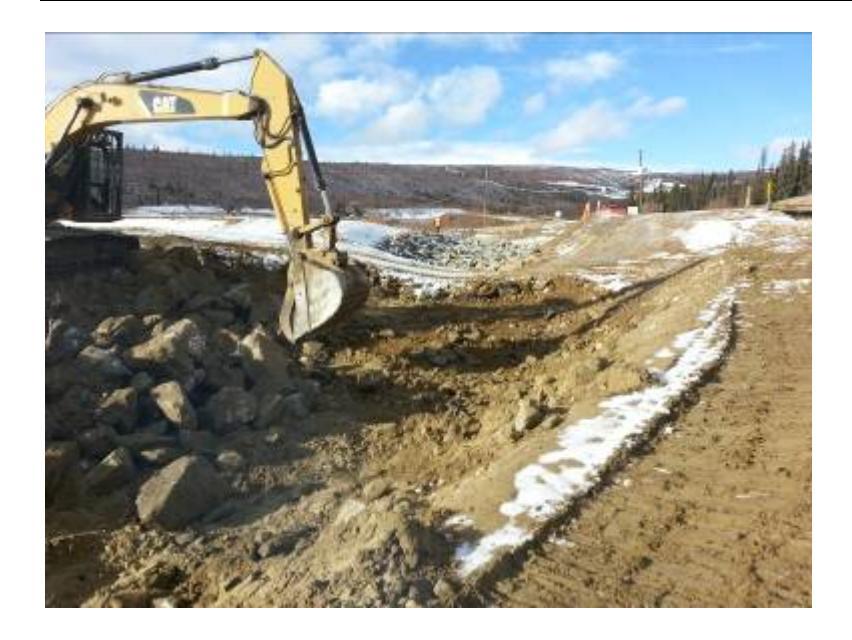
Photo C Removal of Phase 1 Spillway Materials - Looking West (Upstream)

Boreal began removing spillway materials (e.g., riprap and geotextile) soon after mobilizing to the site (Photo C). Riprap was retained on-site for reuse. The geotextile was disposed of at a designated area at the site.

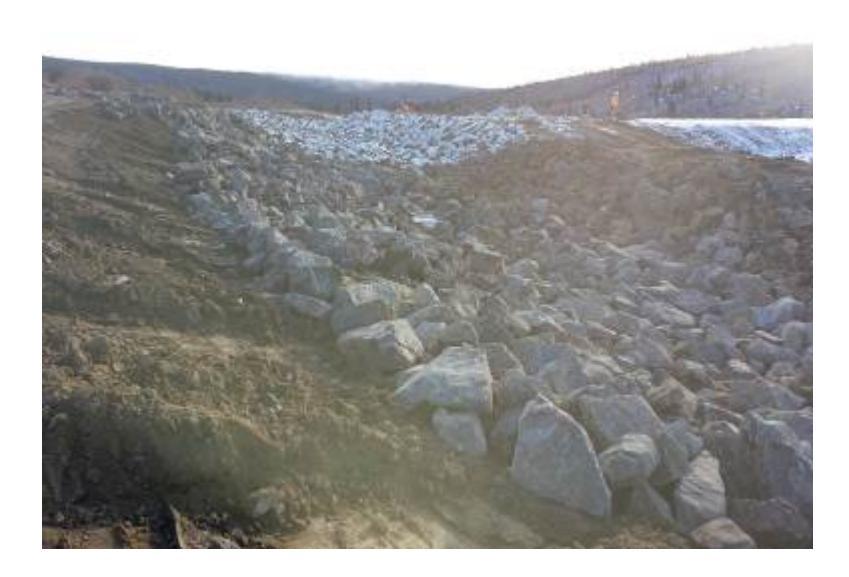
Photo D Construction of Spillway Section 1 – Looking Southeast (Downstream)

The IFC design did not require armouring of Section 1; however, it was determined in the field that riprap armouring should be installed to protect the north channel embankment. The embankment is located on the outside of a channel bend (where hydraulic stress is typically more severe) and is located directly below the primary access road to the dam crest. The IFC and as-constructed dimensions and parameters for Spillway Section 1 are presented in Table E.

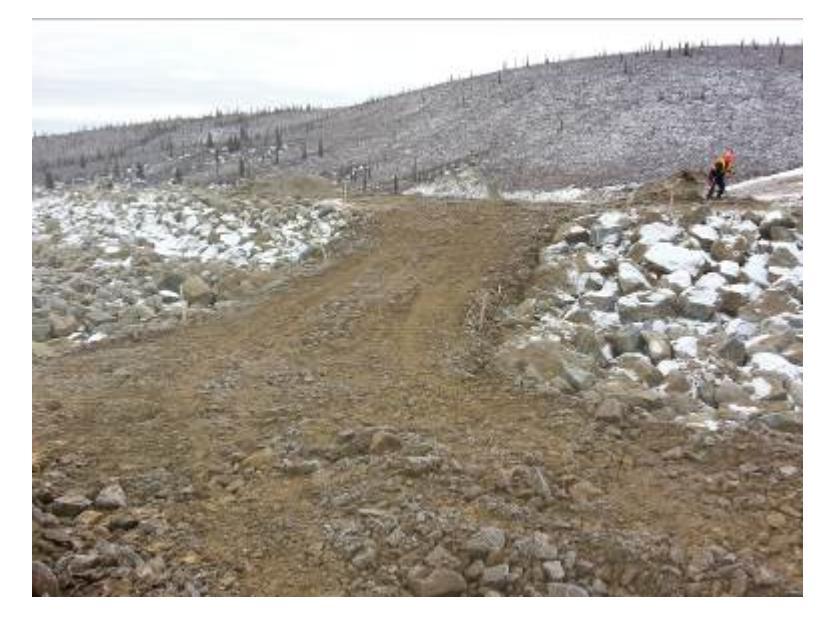
Photo F Access Road - Looking Southeast (Across Channel)

The access road was reinstated across the spillway to facilitate access to the tailings pond dam (Photo F).

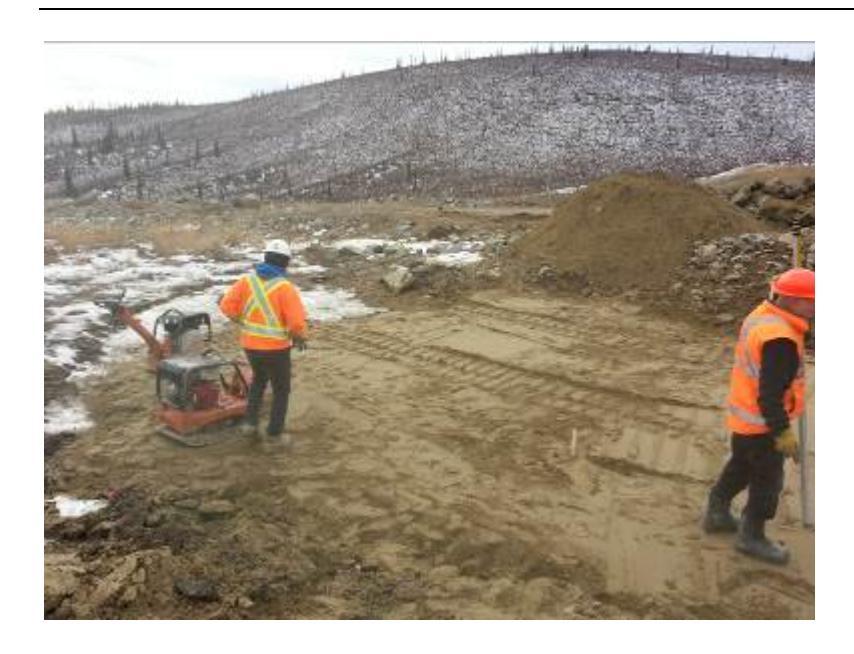
Photo G Subbase at Downstream End of Spillway - Looking Southeast (Downstream)

The subbase was graded and compacted by the excavator (i.e., track-packed). Compaction was also achieved using plate tampers (Photo G). Although in-situ testing was not completed using a nuclear densometer and water was not added to the material, sufficient compactive effort was applied to the subbase material to the satisfaction of WorleyParsons.

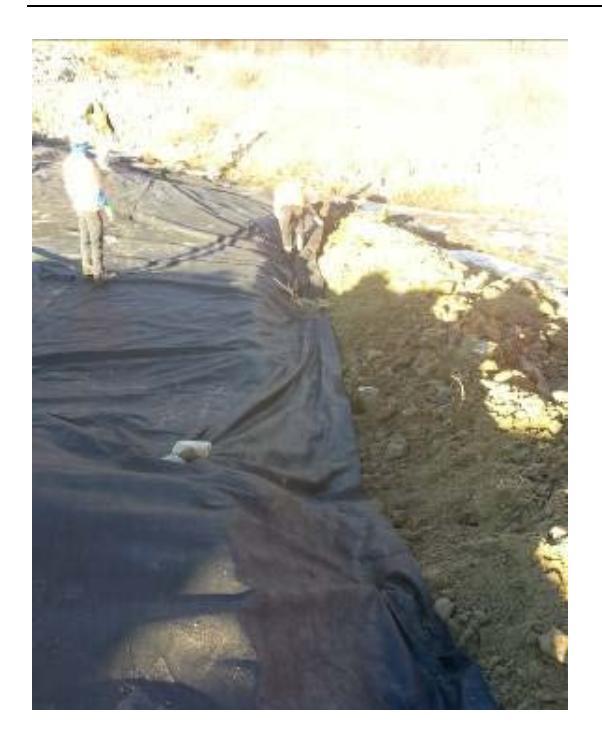
Photo H Geotextile Anchor Trench - Looking Northeast (Across Channel)

Non-woven geotextile (Layfield LP6) was installed along the length of the spillway channel to act as an interface between the subbase and riprap (i.e., providing erosion protection to limit scouring of fine, subbase material). The geotextile was installed from the downstream end of the channel to the upstream end of the channel such that the upstream piece overlapped onto the downstream piece a minimum of 600 mm. At its edges (top of embankment and upstream and downstream ends of the channel), a minimum of 500 mm of the geotextile was buried in an anchoring trench (Photo H).

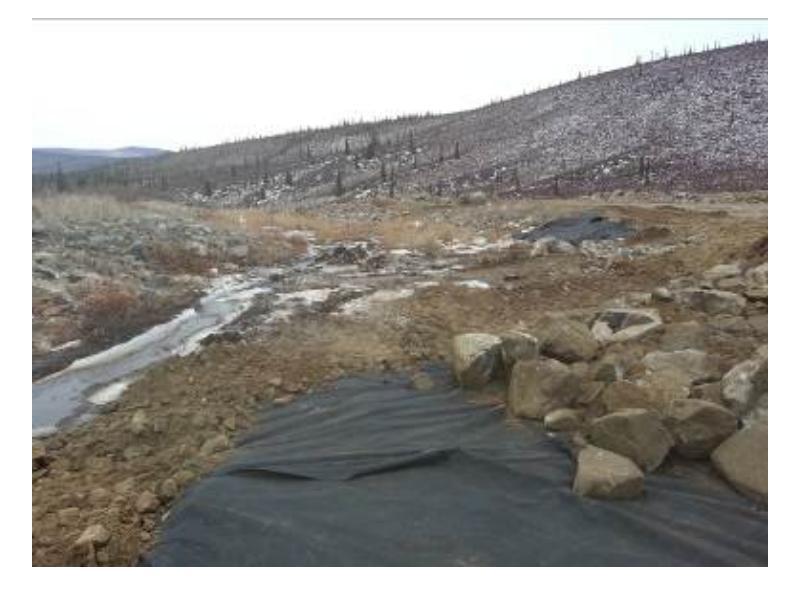
Photo I Geotextile Installed Along Existing Berms at Downstream End of Spillway - Looking Southeast (Downstream)

At tie-in points, the geotextile was extended to wrap around existing embankments to prevent scouring (Photo I) and covered by riprap.

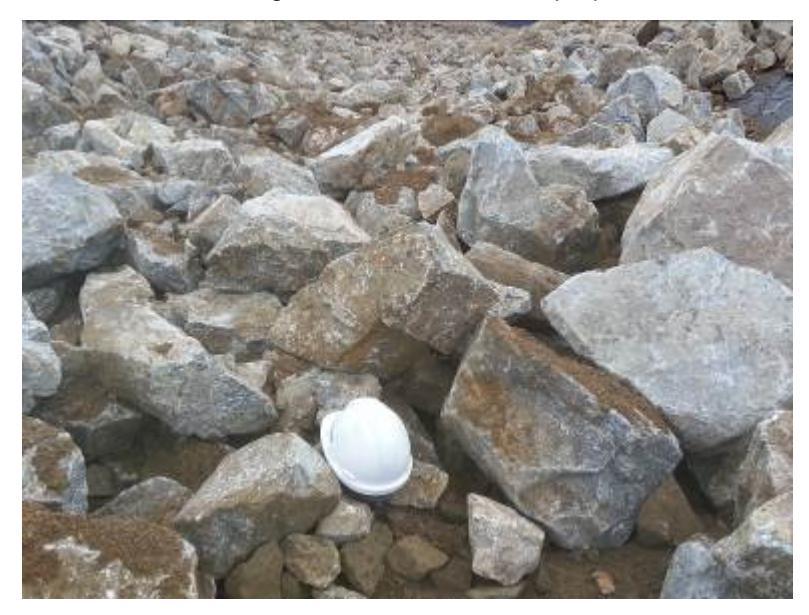
Photo J Riprap Placed Across Spillway - Looking East (Downstream)

The riprap used did not meet the design specification ($D_{50} = 150$ mm and no rock greater than 500 mm) due to a lack of acceptable material available on site; however, the protection provided by the larger rock will be more than sufficient to withstand the IDF (Photo K). The spillway cross-section was adjusted to accommodate the larger rock diameter with riprap thickness between 500 mm to 650 mm.

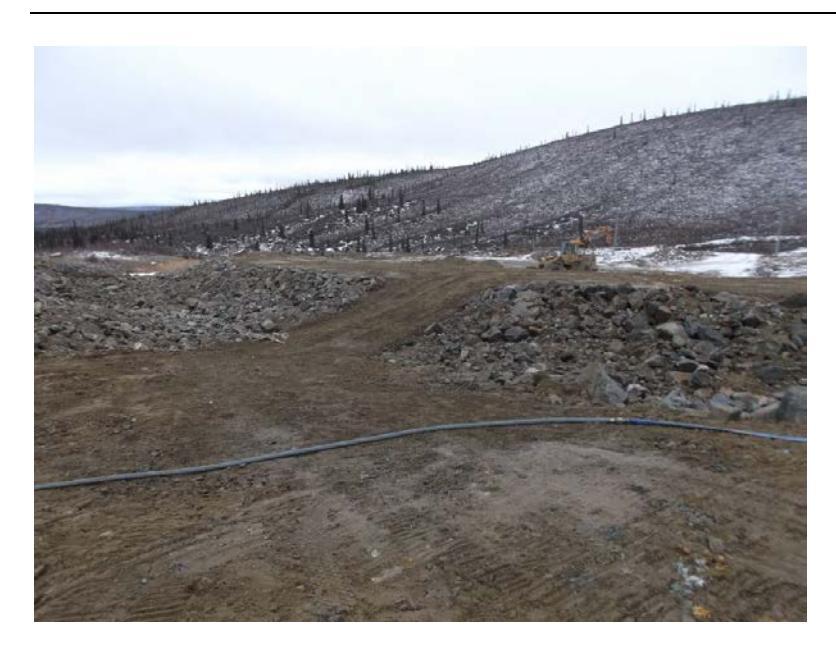
Photo K Access Road Surface - Looking Southeast (Across Channel)

The existing access road across the spillway was reinstated by placing a layer of geotextile across the riprap (Photo K) and topping it with approximately 150 mm of friable rock. The rock was graded and compacted by the excavator (i.e., track packed).

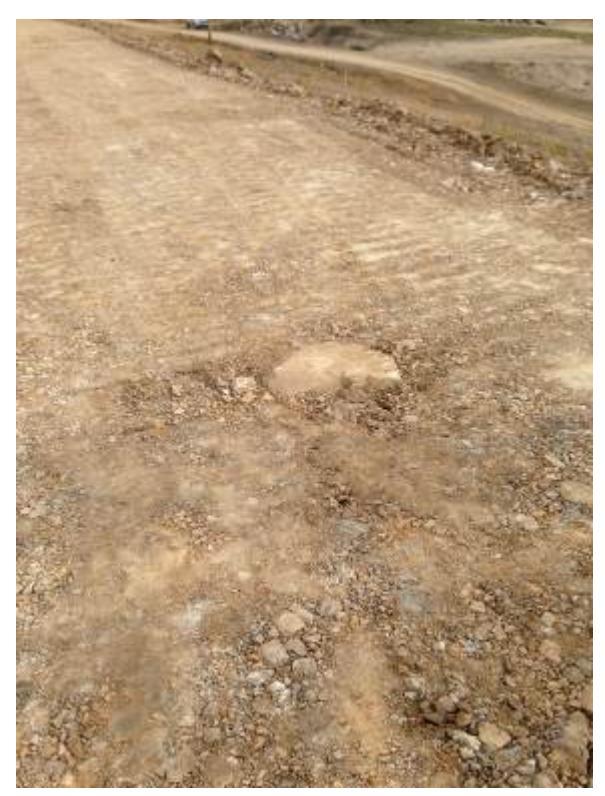
Photo 17 Oversize rock on dam.

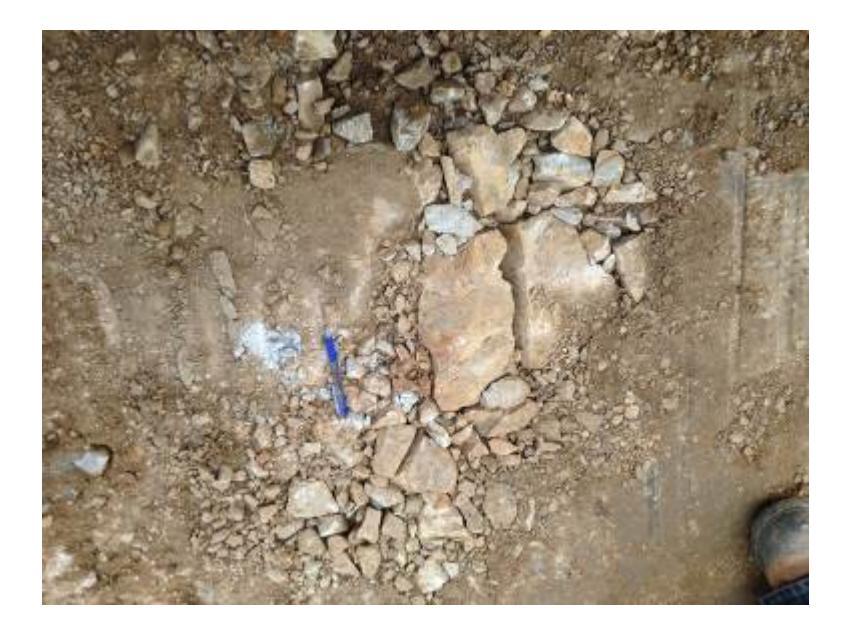
Photo 23 Oversize rock on dam after Norcope re-crushed.
