Clinton Creek Asbestos Mine Wolverine Creek Tailings Piles

## REPORT ON WOLVERINE CREEK TAILINGS PILES

PROJECT:	CLINTON CREEK ASBESTOS MINE
LOCATION:	CLINTON CREEK, YUKON TERRITORY
CLIENT:	BRINCO MINING LTD.
	CRODING DIVISION

OUR FILE: PB 3169-0101 JANUARY 26, 1984

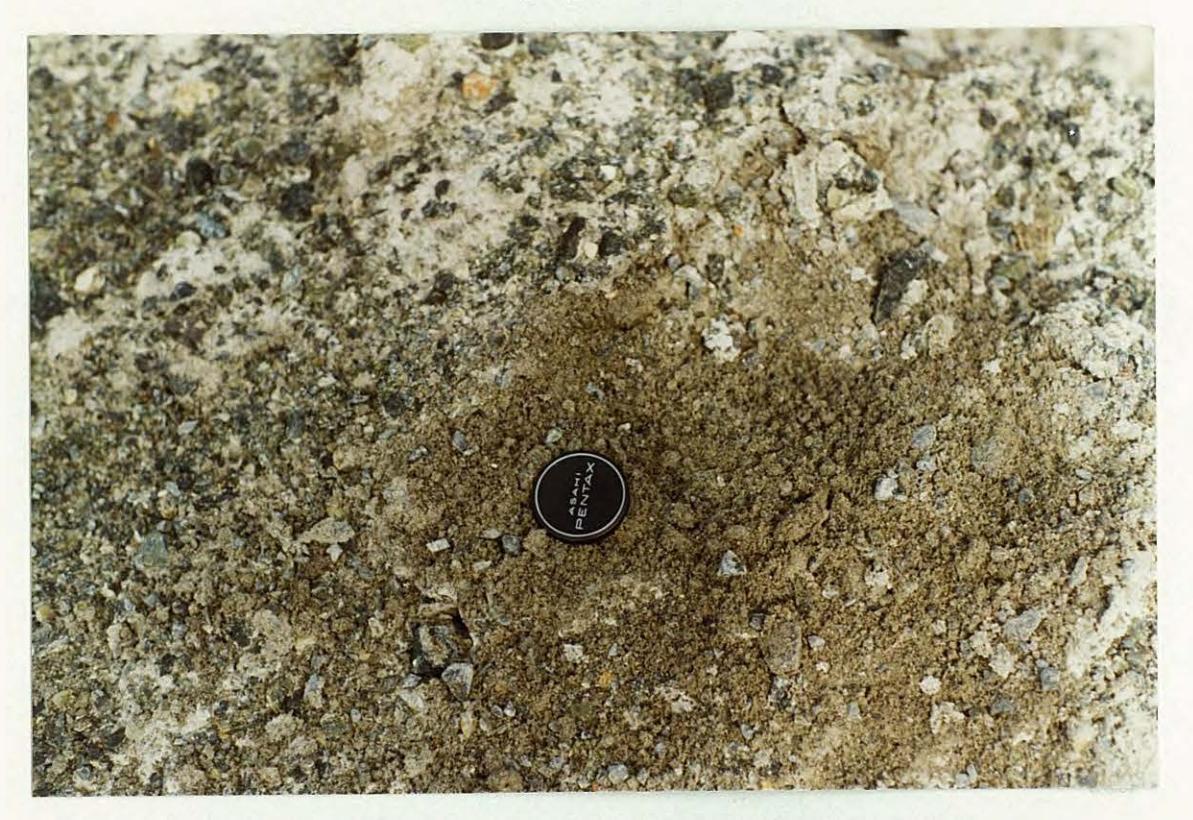
The tailings material consists of well-graded, crushed serpentine rock containing some asbestos fibre not recovered in the milling process. Particle sizes range from about 1 inch to approximately 10% passing the #200 sieve size. The angle of internal friction of the tailings (Golder, 1978) ranges from over 40° at low confining stresses to 33° at higher stresses. The deposited tailings forms a crust so that dust from the tailings piles does not occur. Photograph 1 in Appendix I shows typical tailings material.

Photograph 1: Close-up showing typical tailings material.

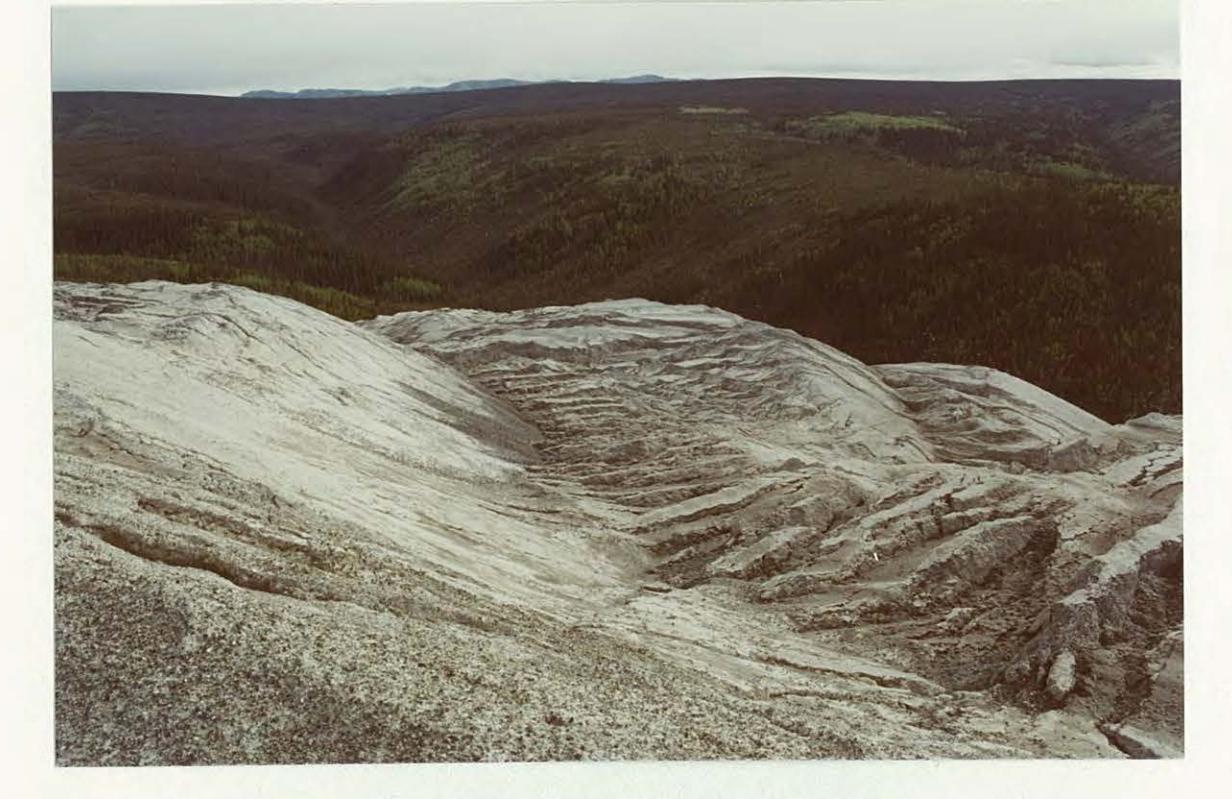
Viewed from above, the north pile can be seen to be obviously undergoing considerable movement. The surface is highly distorted, with a continuous series of scarps from top to bottom (Photo 2). On the lower part of the tailings pile, a series of terraces were created when material was excavated in attempting to stabilize the north lobe in 1978. These terraces, which were originally nearly level, are now highly distorted and cracked, with the centre area displaced considerably downslope compared to the ends of the terraces (Photo 3). A lateral slip plane, shown on Drawing D-1004, can be seen along the north side of the dump where the tailings pile is moving relative to the material which was removed and placed on stable ground to the north.

Photograph 2: View of north tailings lobe looking northeast up Wolverine Creek valley.

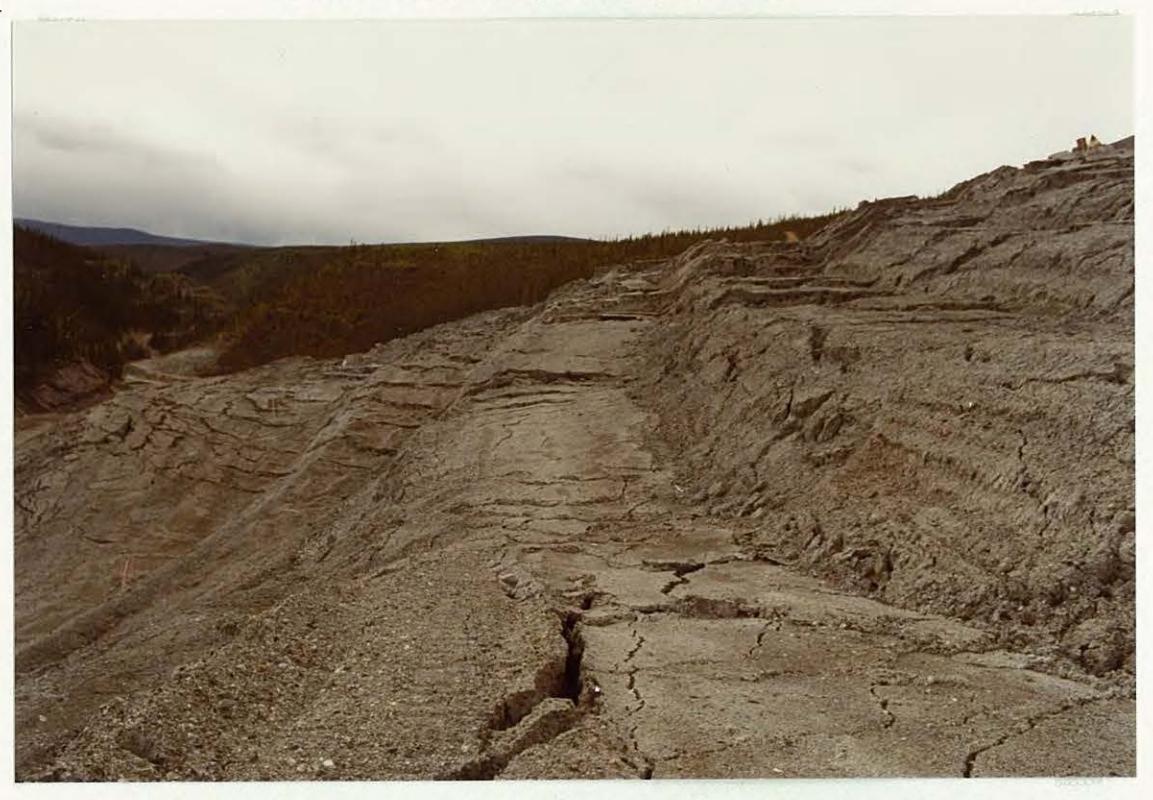
The stabilization measures carried out have not been successful. It would appear that Golder's engineers assumed that the lower portions of the tailings piles were moving independently of the upper portions. Consequently, they were attempting to unload the tops of small slides near the toes. That program of excavation of tailings from the toe areas was unsuccessful in arresting movement of the tailings piles, and downslope movement has continued almost uninterrupted, much larger masses of material being involved.

Photograph 3: Looking south at terraces cut in north lobe during unloading work.

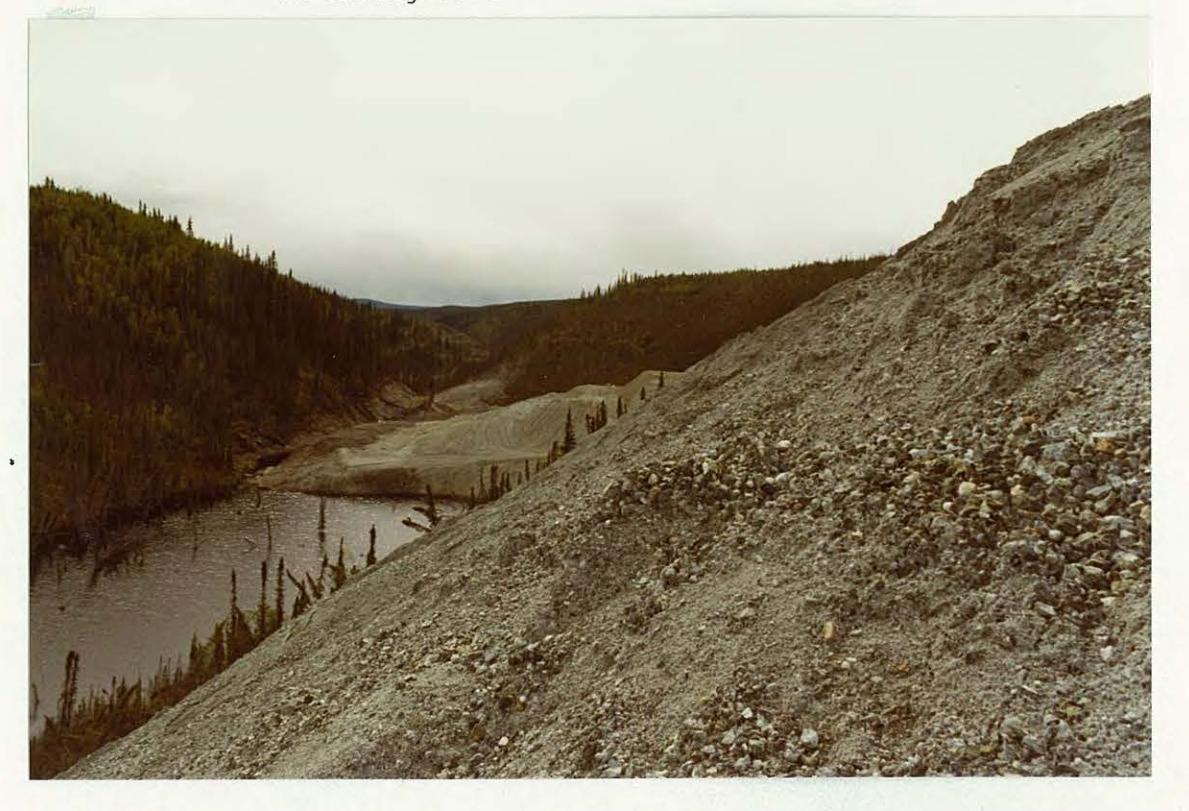
The toe of the north lobe has moved over 300 ft from its position as plotted in 1978, so that the tailings have nearly reached the lake impounded by the south lobe. The tailings pile forms a steep slope (about 38° to 40°) at the base of the north lobe (Photo 4). This steep slope was working actively at the time of our site visit, with material continually rolling down the slope. At the toe area nearest the lake, the tailings pile appears to be overriding the ground without noticeable foundation disturbance. At the northeast toe area, the ground is considerably disturbed, cracked and upthrust to an estimated distance of 150 ft from the toe, showing that movement of the foundation soils is occurring. Photographs 5 and 6 show the locations of the toe relative to the lake in June and September, 1983.

Photograph 4: Oversteepened slope at toe of north lobe. Failure lobe in background.

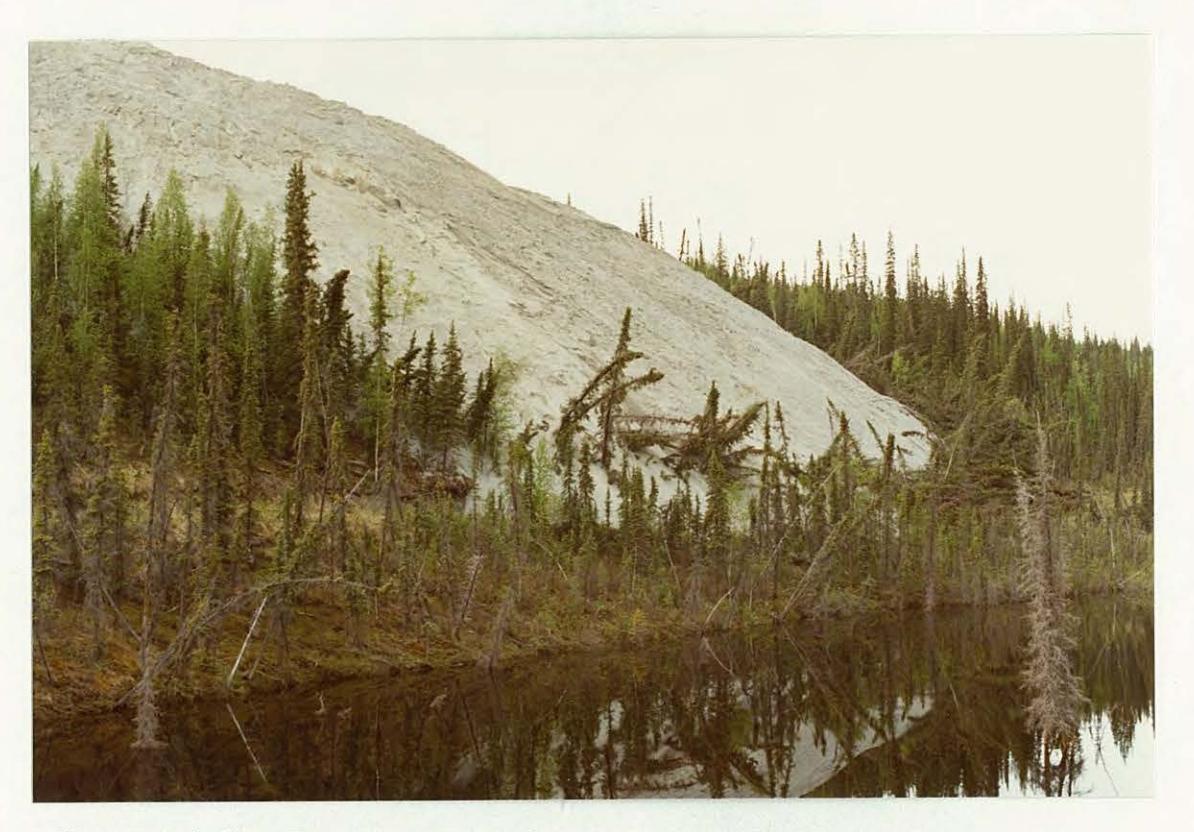
Photograph 5: Toe of north lobe, June 8, 1983.

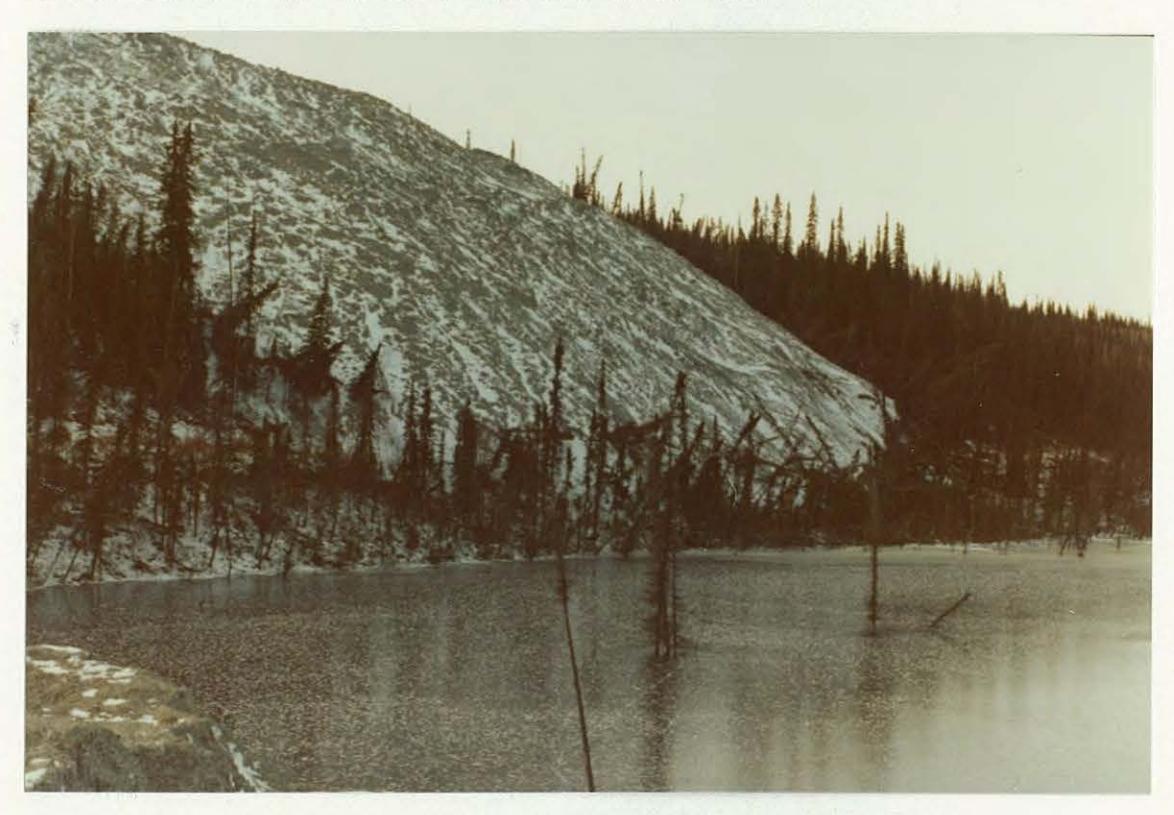
Photograph 6: Toe of north lobe, September 1983.

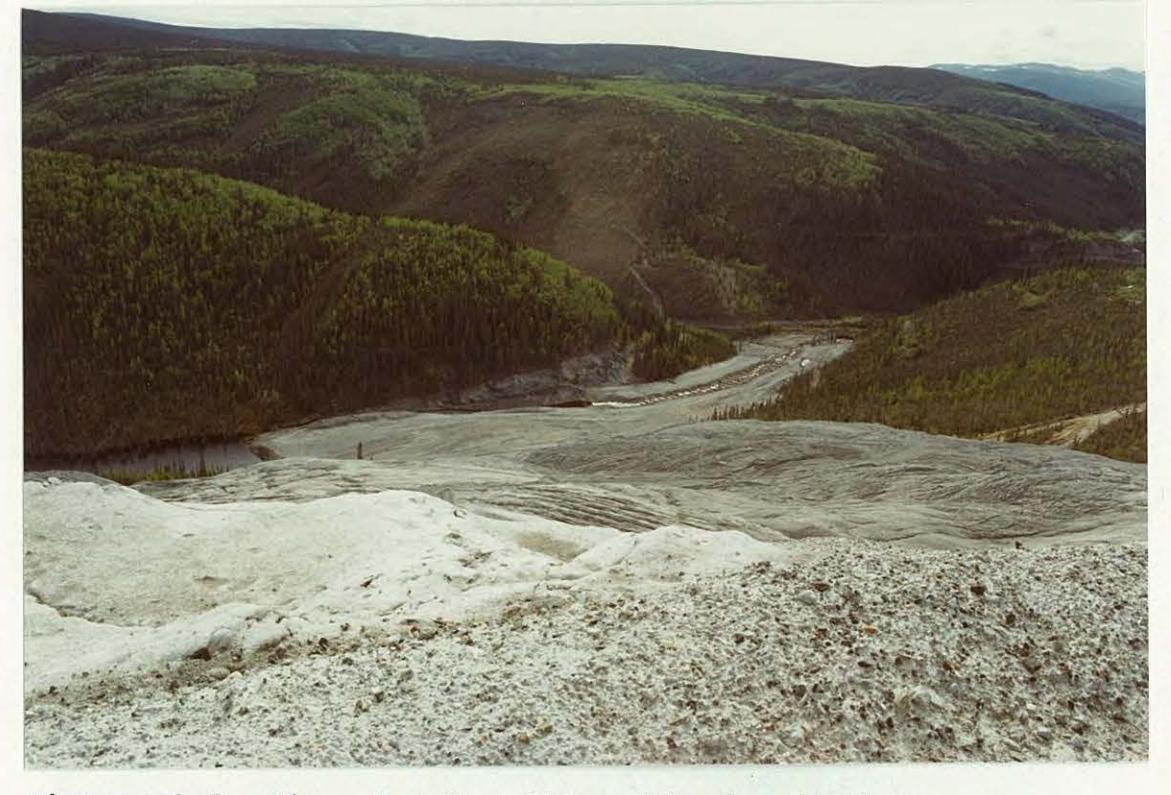
The south lobe appears in a more stable state than the north lobe, although movements are also occurring in this area. The surface is much smoother and does not contain the highly distorted cracking of the north lobe (Photo 7). At the top of the pile, an oversteepened face remains at the previous point of discharge of the stacker conveyor. At the base of this slope, at about the upper one-third point of the south lobe, cracks several feet in height can be seen (Photo 8). At the base of the south lobe in the valley bottom, a number of radial cracks indicate that the toe is continuing to spread. The channel conveying Wolverine Creek over the toe of the south lobe is being squeezed toward the east bank and the toe is moving upward at the channel location (Photo 9). The rock-lined channel downstream of the toe of the south lobe appears to be in satisfactory condition (Photo 10).

Photograph 7: View of south tailings lobe from the top.

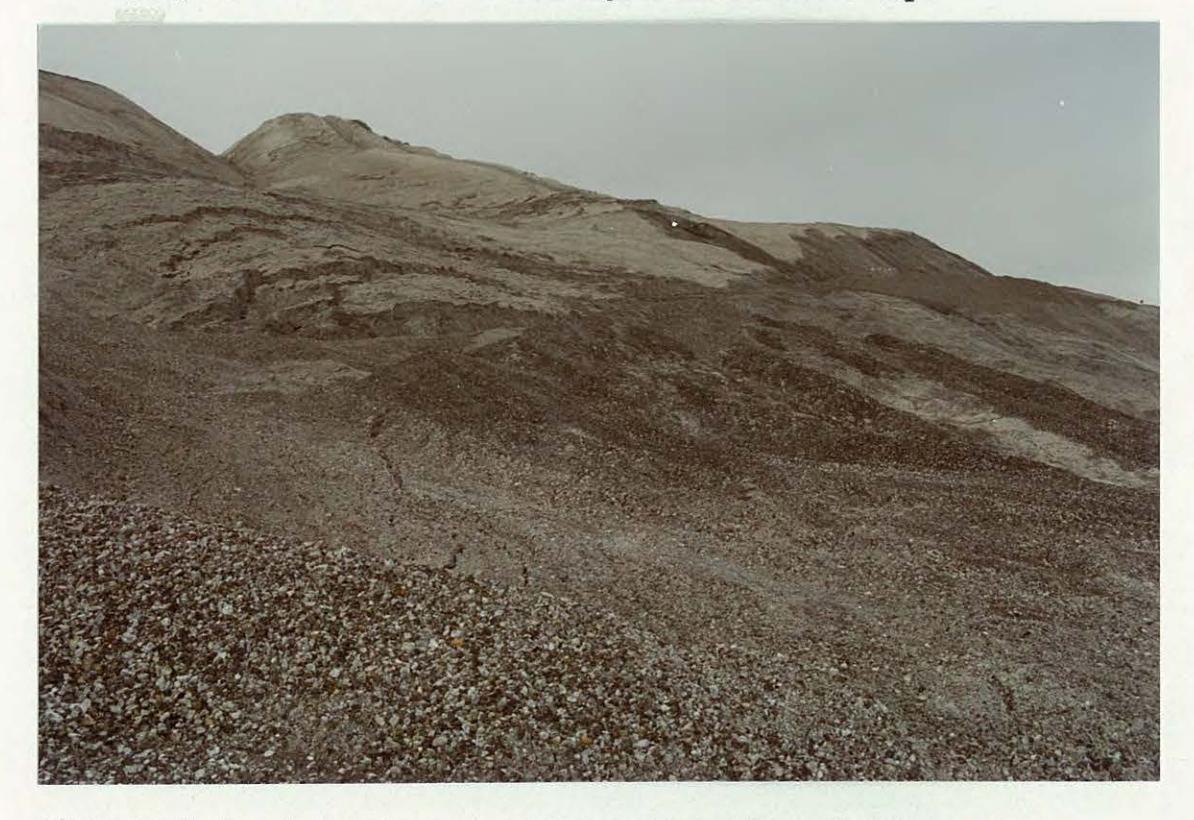
Photograph 8: Looking up at upper portion of south lobe. Note cracking indicating some movement continuing.

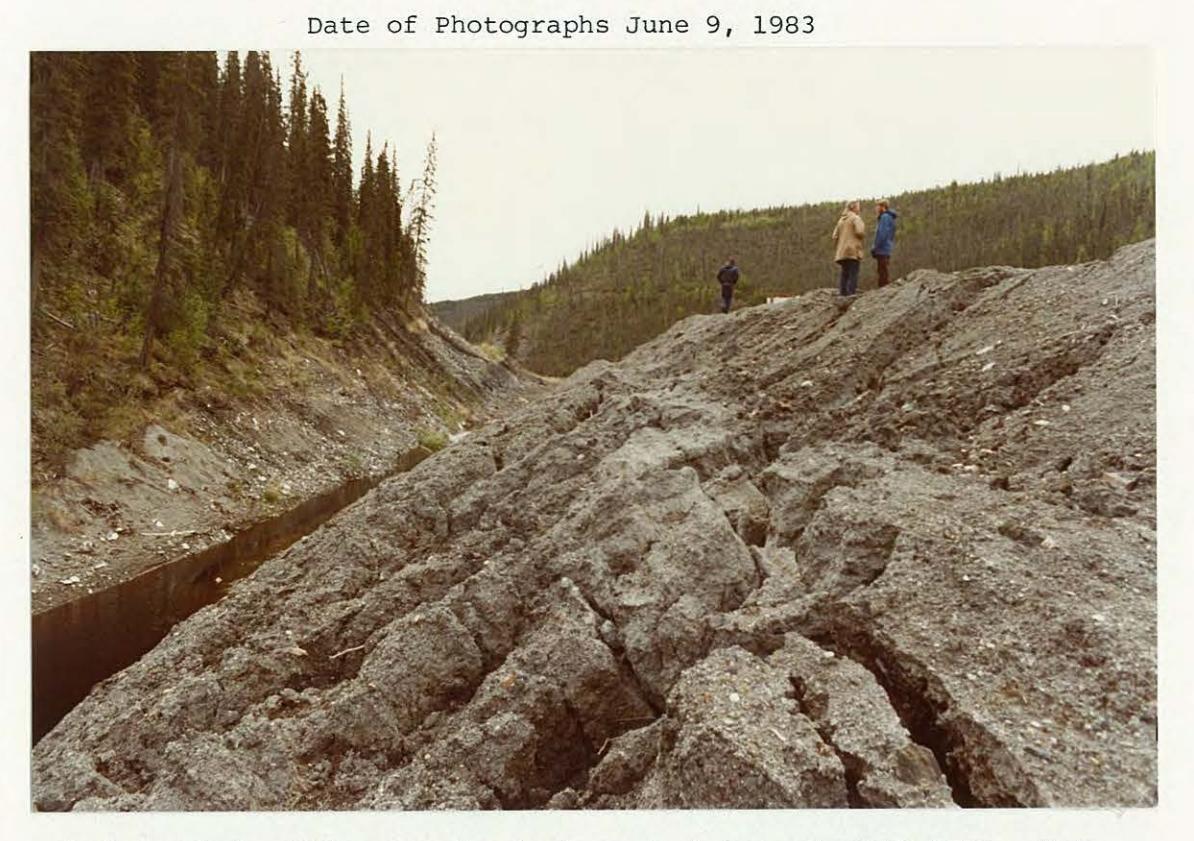
Wolverine Creek channel at toe of south lobe. Note Photograph 9: cracking from upward movement of toe.

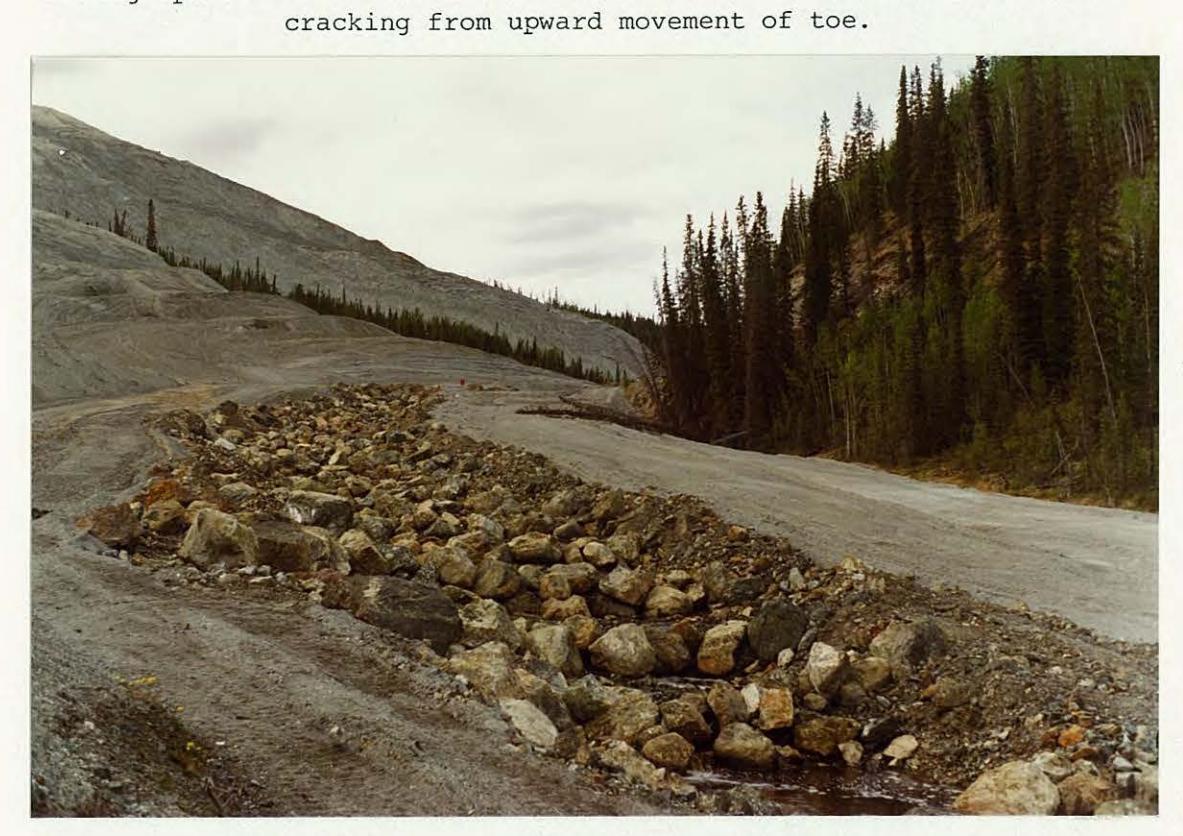
The rock-lined channel was installed in 1978 and appears to have operated satisfactorily to date.

Photograph 10: Rock-lined channel carrying Wolverine Creek over failed south tailings lobe.
