Anvil Range Mining Corporation (Interim Receivership) Rose Creek Tailings Facility

2001 Hydrogeological and Geochemical Investigation Faro Mine, Yukon

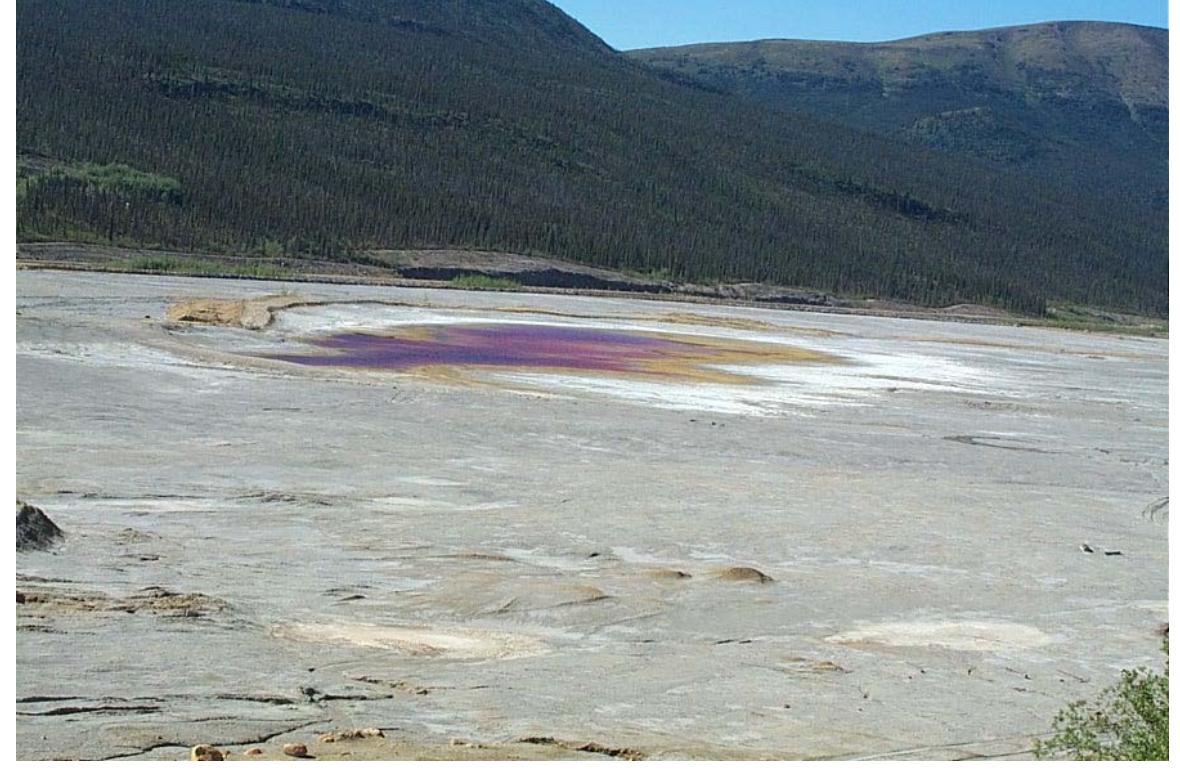
Ponded Water – Original Impoundment

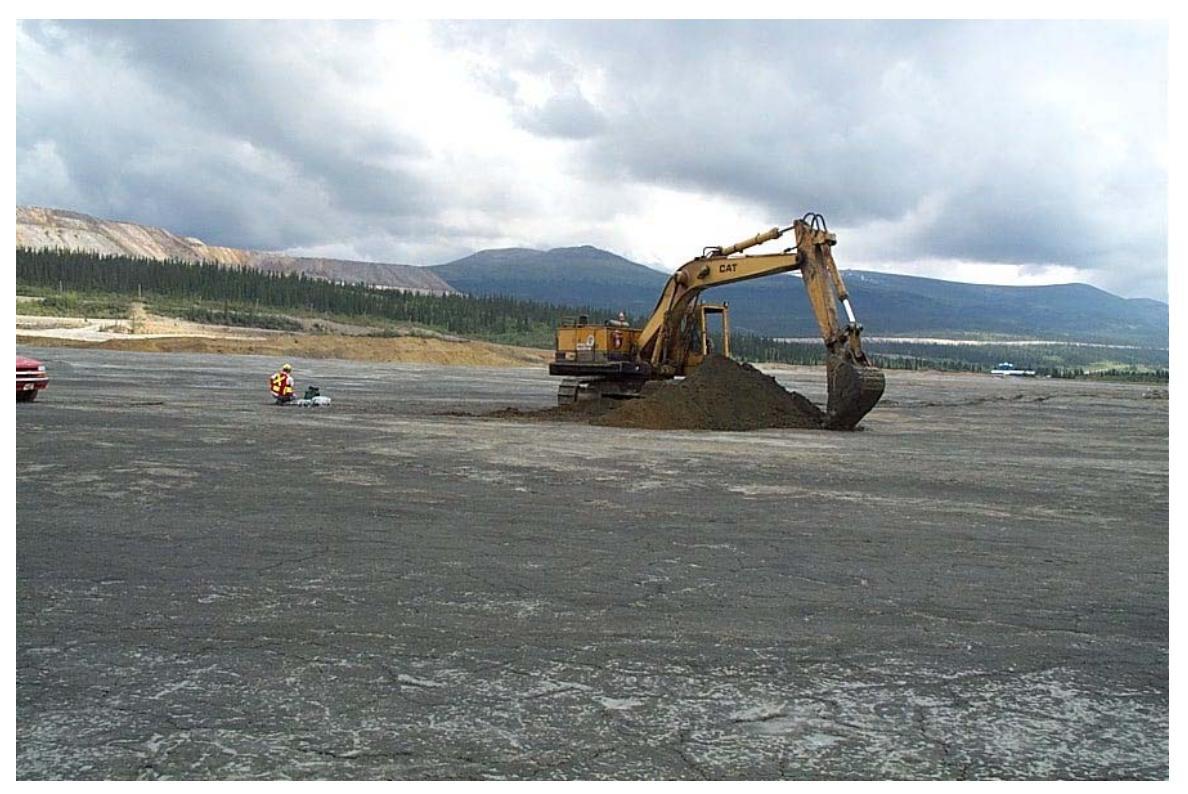
Test Pit Excavation – Location TP4

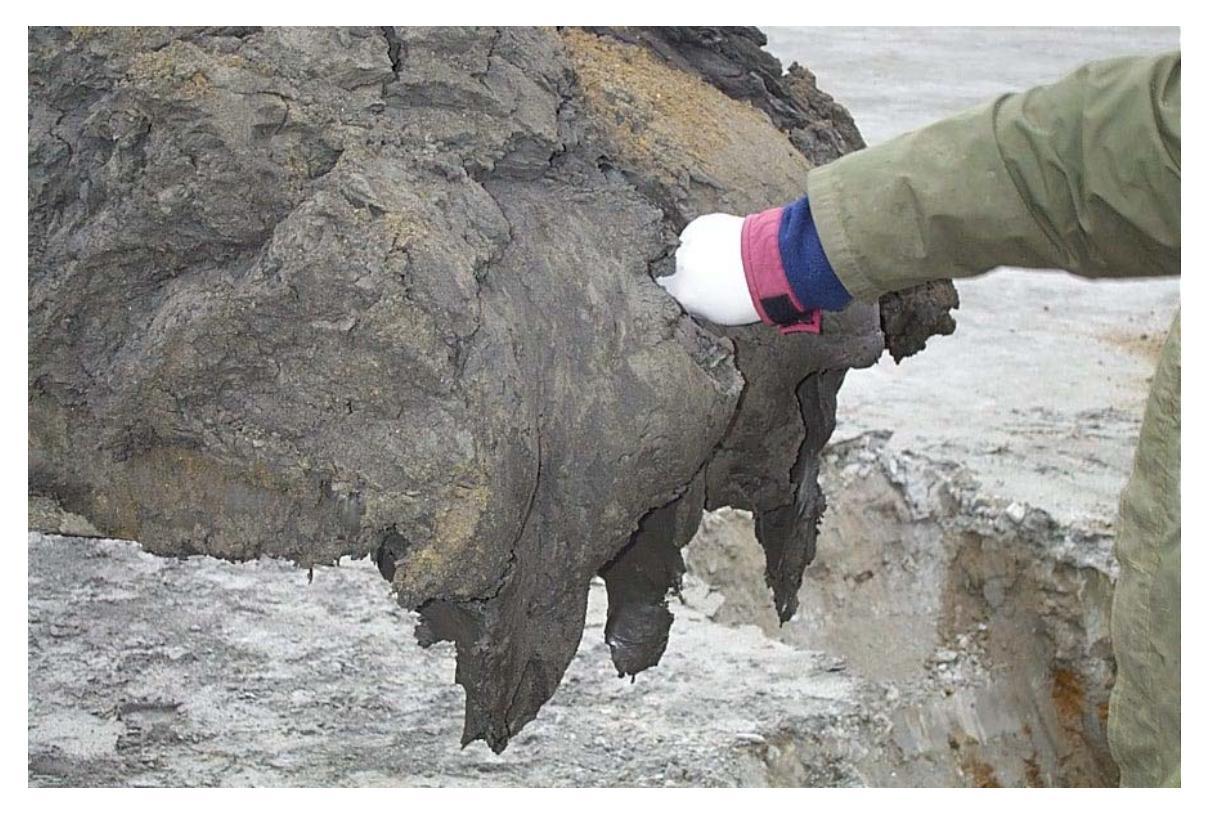
Saturated Tailings – Location P01-10

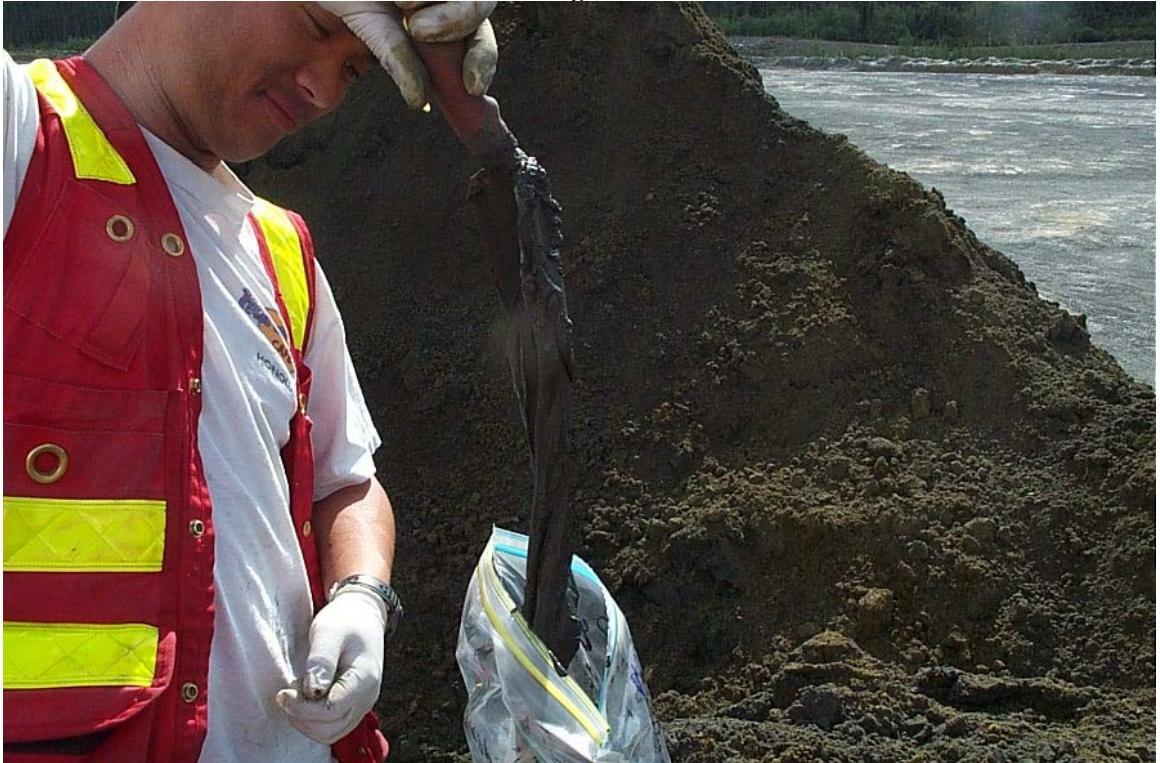
Saturated Tailings – Location TP2

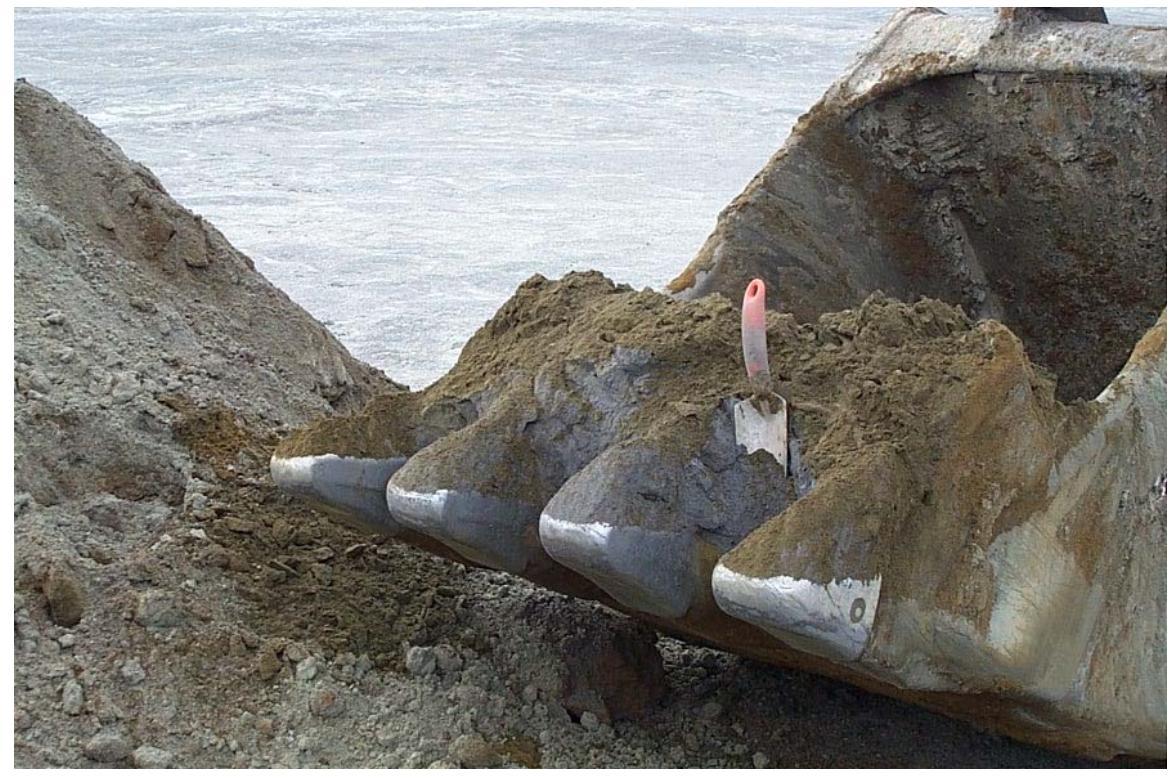
Unsaturated Tailings – Location TP2

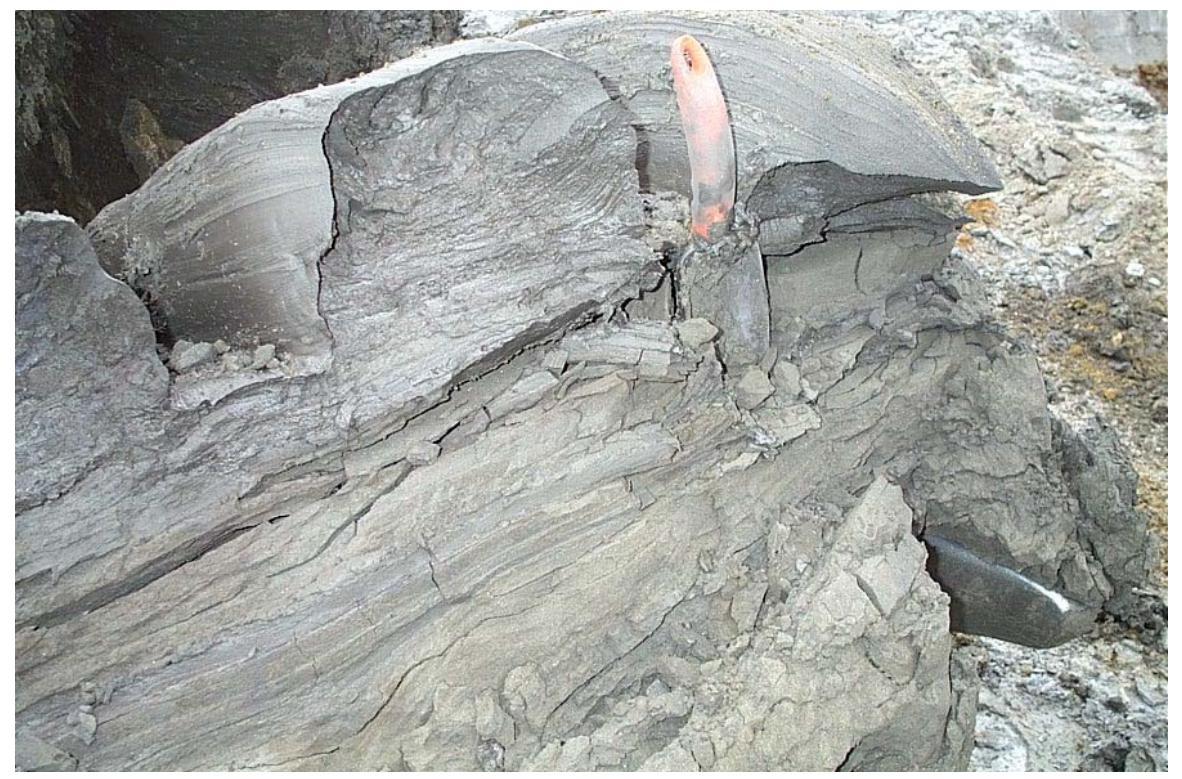
Tailings Profile – Location TP2

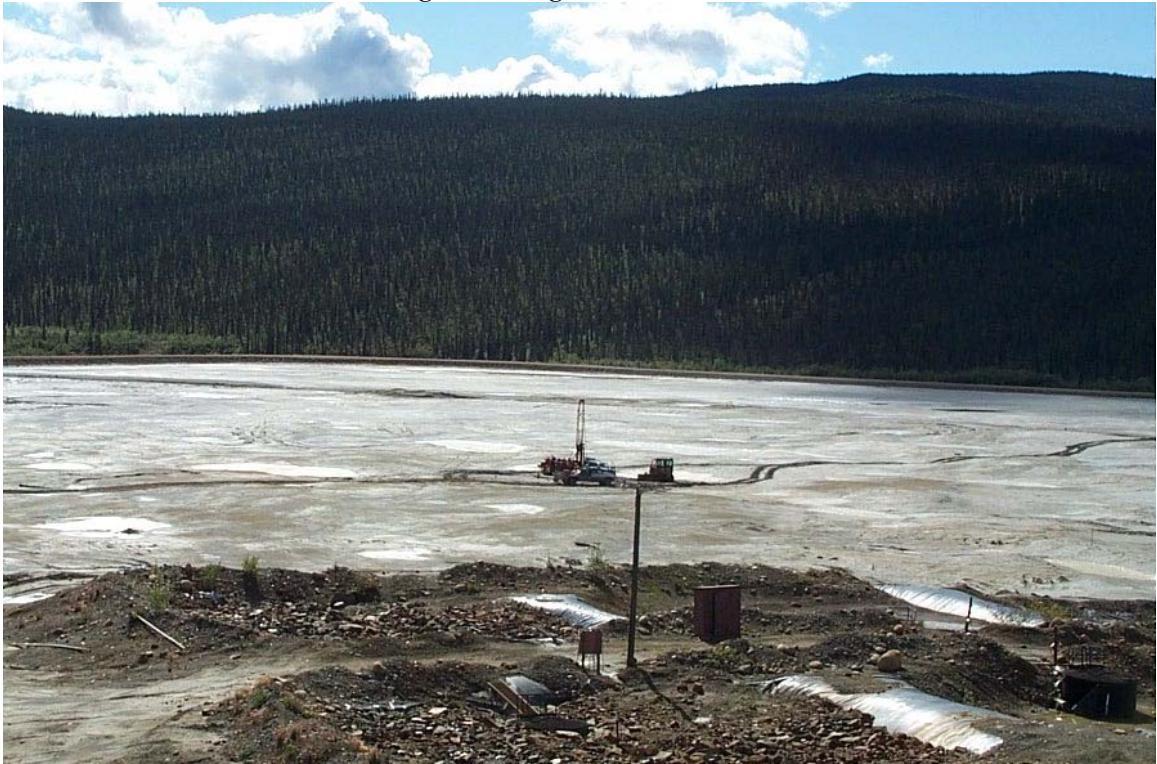
Auger Drill Rig – Location P01-10

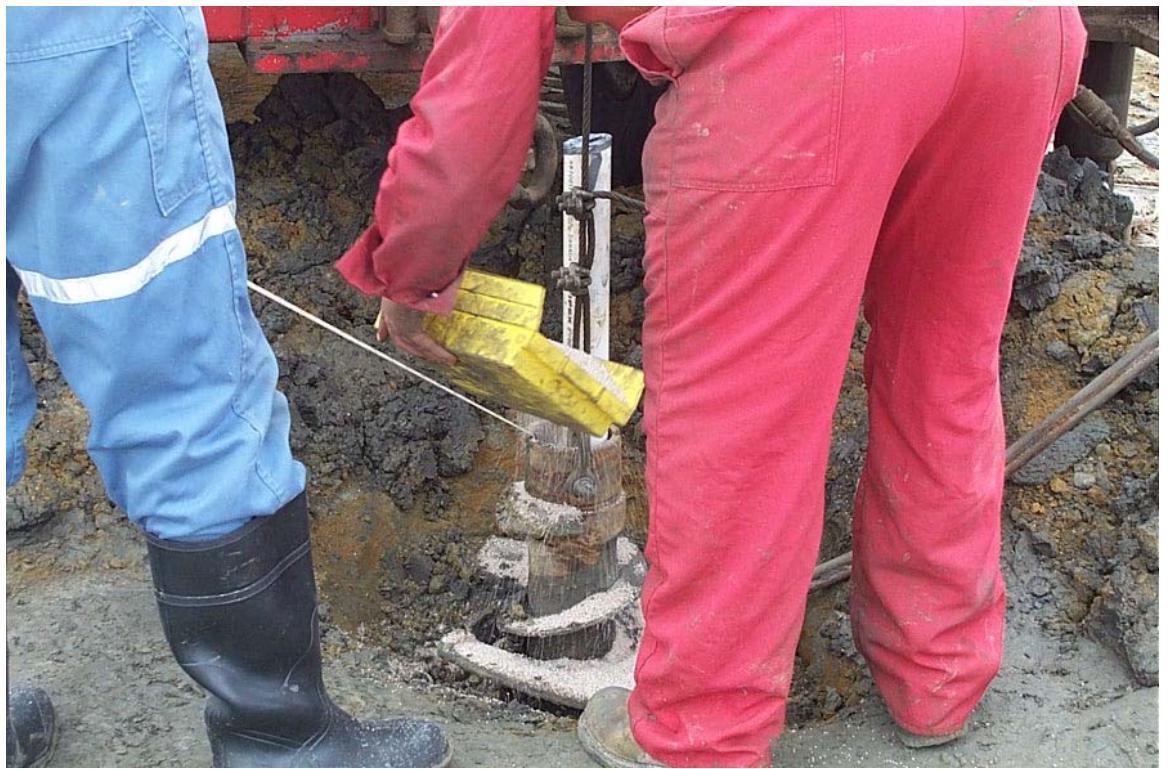
Placement of Sand – Location P01-10
