United Keno Hill Mines

Phase I Water Treatment Systems Modifications Construction Records and Performance Report

Elsa Reclamation Development Company Ltd.

January 2008

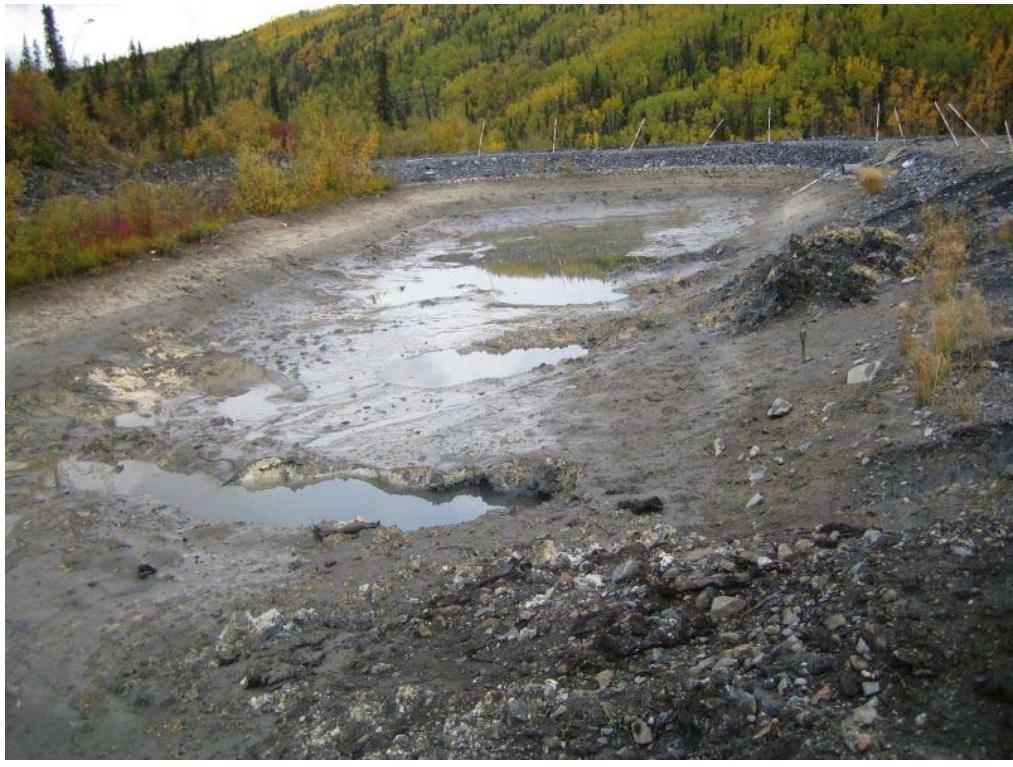
FIGURE 5 BELLEKENO SLUDGE POND BEFORE CLEANOUT AND LINING

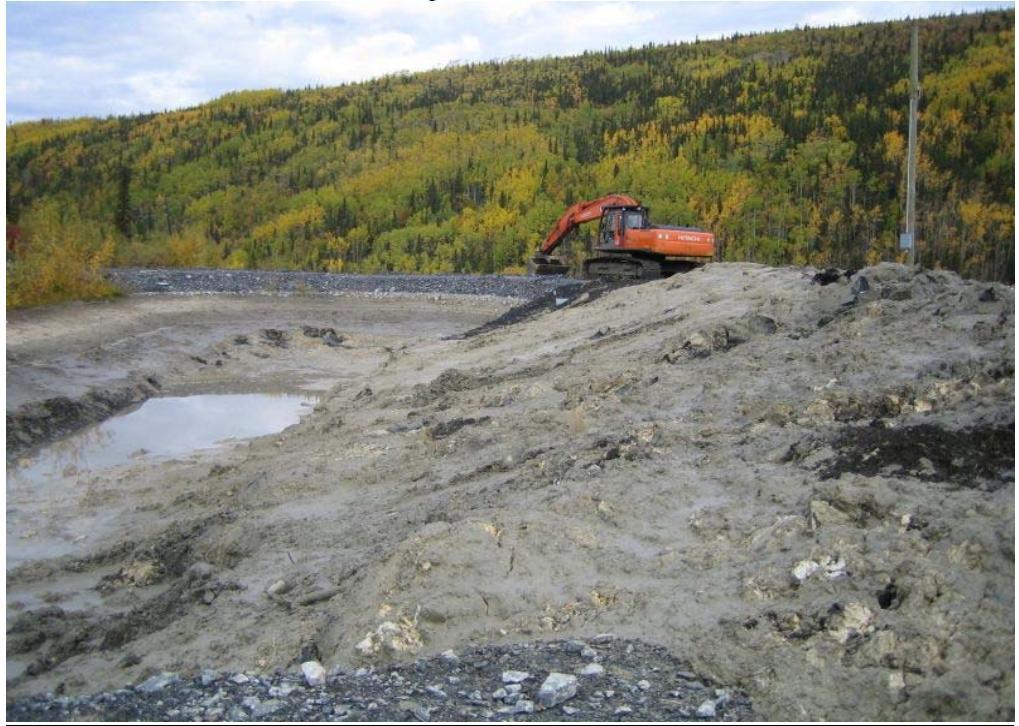
FIGURE 6 COMMENCING EXCAVATION BELLEKENO AND EXCESSIVE SLUDGE (September 8, 2007)

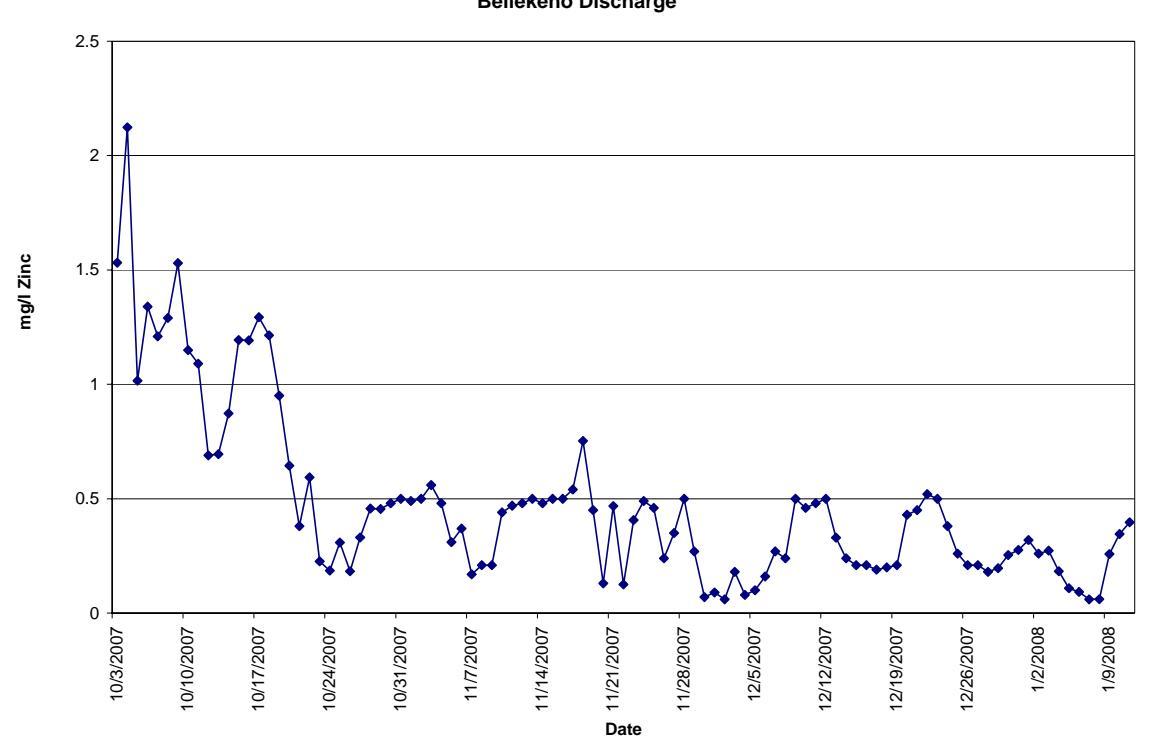
FIGURE 37 BELLEKENO DISCHARGE PERFORMANCE Bellekeno Discharge

From the period April 2004 – March 2007 the Bellekeno discharge was above 0.5 mg/l 7.2% of the time (78 times over 1,077 days). The time period is the same as that presented in the Water Treatment Improvements Study. For comparison, the Bellekeno treatment system was over the 0.5 mg/l criteria 6.1% of the time (5 times over 82 days) since the modifications were complete. The 82 day period starts on October 23, 2007 which is the date when the modified Bellekeno system went below 0.5 mg/l once the new system was commissioned. There were a number of days immediately following commissioning the Bellekeno system that were over the 0.5 mg/l discharge criteria but for the purposes of performance comparison the period presented are when the system came back into compliance. Of interesting note, during the same time period of commissioning the modified treatment system at Bellekeno, the average influent zinc concentration increased to 9.1 mg/l from a previous average of 7.2 mg/l or an increase of approximately 25%. After the new influent pipeline was installed in the Bellekeno adit, the water elevation inside increased by approximately 6-12". This increase in water elevation may have had an impact on the zinc concentration in the adit discharge. Another change that occurred after the modifications is the flowrate of the influent adit waters. Prior to modifications, the nominal flowrate of water from the Bellekeno adit was approximately 3.6 lps. Following the installation of a new HDPE pipe from the adit into the rapid mix tank, the average flow has increased to over 5.0 lps. This increase is understandable given the fact that the old pipe transporting untreated water from the adit to the treatment system was a culvert that had a number of leaking joints. This suggests that an appreciable amount of water from the Bellekeno adit was not being treated at all but was simply infiltrating into the Bellekeno waste dump untreated.

As stated above, the short time period after the system modifications makes a representative percent comparison somewhat bias. One more day over 0.5 mg/l over the same time period increases the percentage over a full percentage point. Nonetheless the Bellekeno system requires ongoing optimization to ensure performance reaches the anticipated level expected. The overall

performance from a treatment perspective at Bellekeno has not been noticeably improved with the system modifications. However given the capture and treatment of all of the water at Bellekeno (as noted by the increase in flow and elimination of leaky culverts) the overall loading of zinc to the environment has been reduced since the modifications have been completed.

One of the reasons for continued swings in the performance appears to be the more effective mixing of the adit water in the RMT. Adjustments to the pH dosage have a much more dramatic effect on overall system pH with the new modifications. Operator attention needs to be made to small incremental changes to lime addition rates.

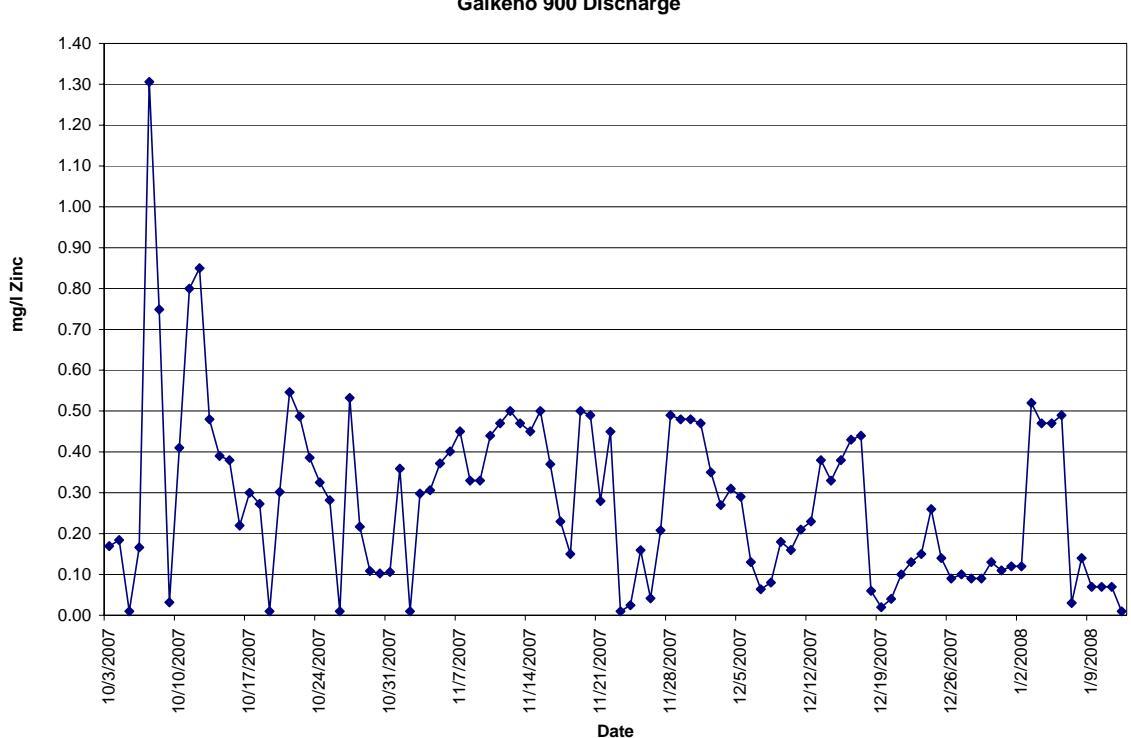
FIGURE 38 GALKENO 900 DISCHARGE PERFORMANCE Galkeno 900 Discharge

With respect to treatment performance the same approach is made for Galkeno 900. From the period April 2004 – March 2007 the Galkeno 900 discharge was above 0.5 mg/l 6.2% of the time (67 times over 1,077 days). The time period is the same as that presented in the Water Treatment Improvements Study. For comparison, the Galkeno 900 treatment system was commissioned on October 1, 2007 and was over the 0.5 mg/l criteria 7.3% of the time (7 times over 104 days). Two of these instances were the following 2 days after commissioning. The overall performance from a treatment perspective at Galkeno 900 has not been noticeably improved with the system modifications. However the important safety consideration of removing the treatment system
