#### DRAFT REPORT

# GEOTECHNICAL ASSESSMENT

#### PA 2295.01.01

OFFICE AIRPHOTO STUDY OF TERRAIN CONDITIONS IN PROPOSED DEVELOPMENT AREA SOUTH OF WHITEHORSE, YUKON

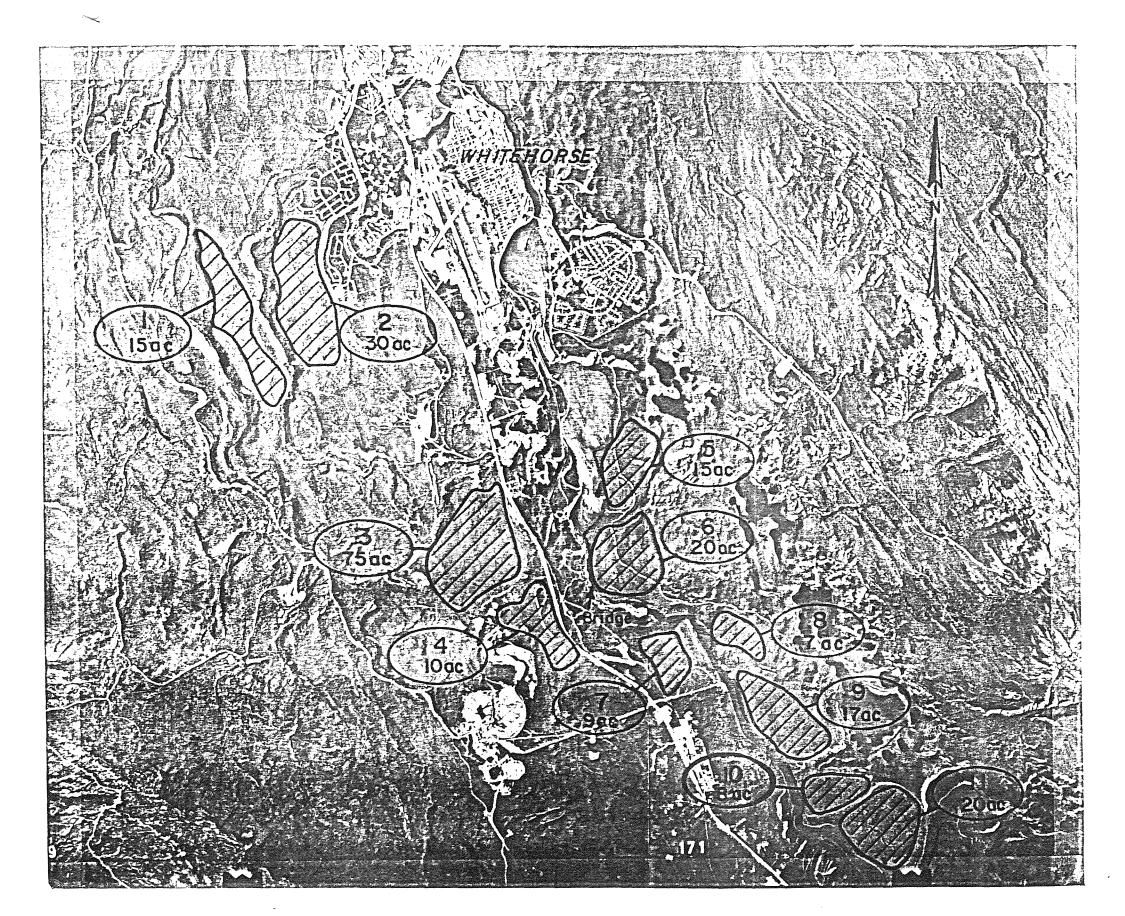
PHOTOMOSAIC SHOWING POTENTIAL SUBDIVISION AND /OR ACREAGE AREAS SOUTH OF WHITEHORSE, YUKON 5 Km
