**ASSESSMENTS OF THE REVEGETATION OPTIONS
CONDUCTED AT THE
WASTE ROCK DUMP AT CLINTON CREEK
- YEAR ONE -**

Yukon

ASSESSMENT AND ABANDONED MINES

November 2009

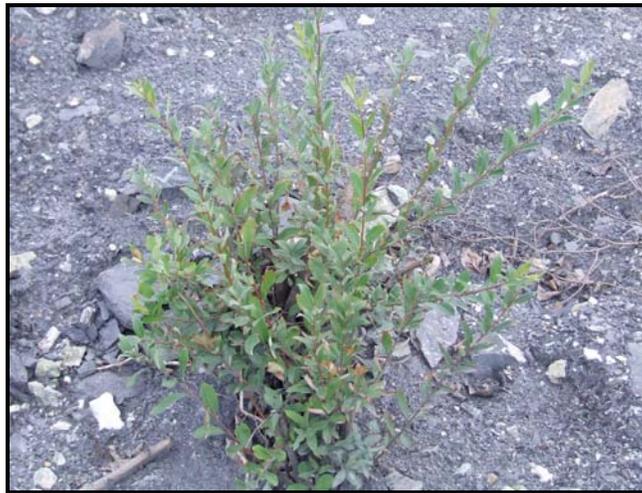
A healthy willow crown at Plot 1, July 21, 2009.
