FARO MINE CLOSURE

Infrastructure Support Assessment

March 31, 2008

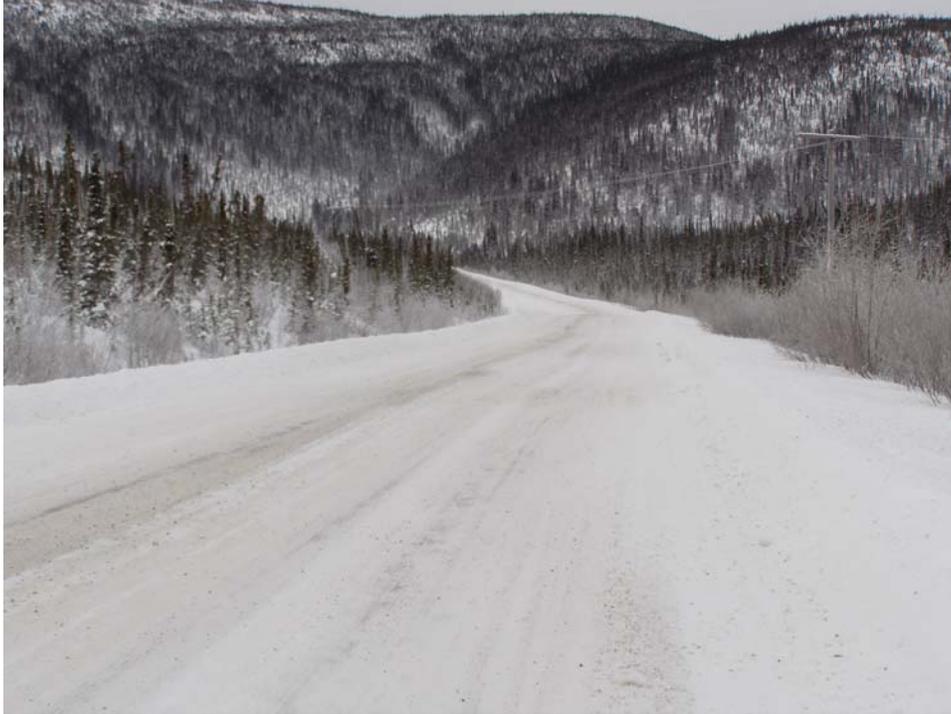
In general, the access road is in fair condition and is graded every year by YG Maintenance. However, there are some areas where road settlement has occurred over the years that should be upgraded (see photos). The acting foreman indicated that some drainage control work is required including a culvert replacement and a new culvert installation. Glaciation has been causing problems in some areas which can be alleviated to some extent with excavation work along the sides of the road.

Photo 1 – Access road from Faro to mine site showing typical road settlement.

- Haul, place and compact pit run in various low spots where road settlement has occurred
- Ditch excavation and drainage work to help alleviate glaciation problems
- Replace one culvert and install one new culvert.
- Reconstruct culvert crossing at Rose Creek if necessary
- Reshape and grade the entire roadway

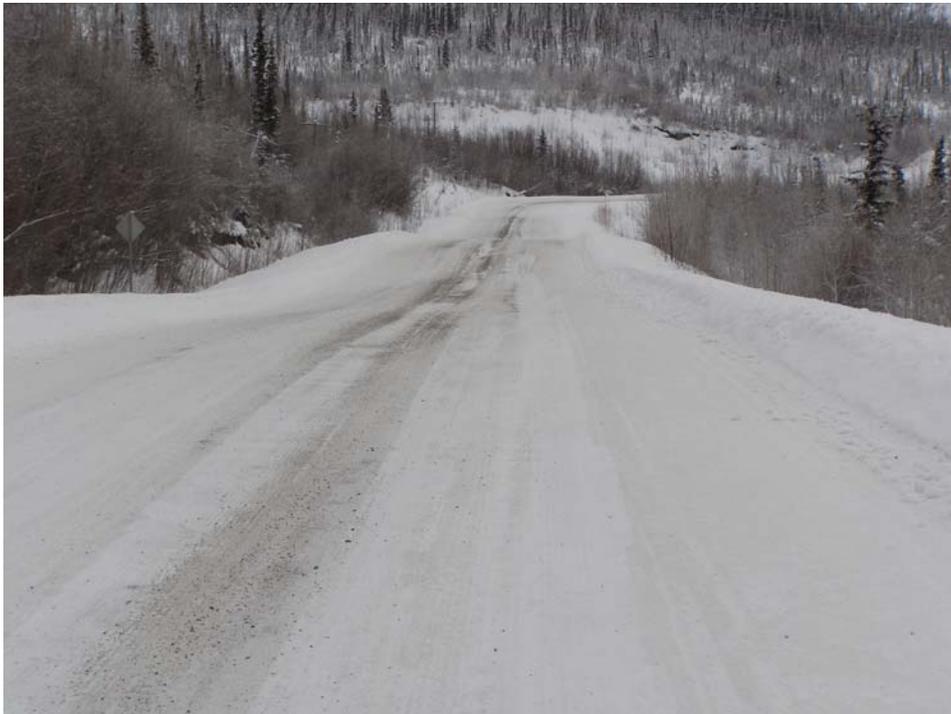
Photo 2 – Access Road. and typical road settlement.

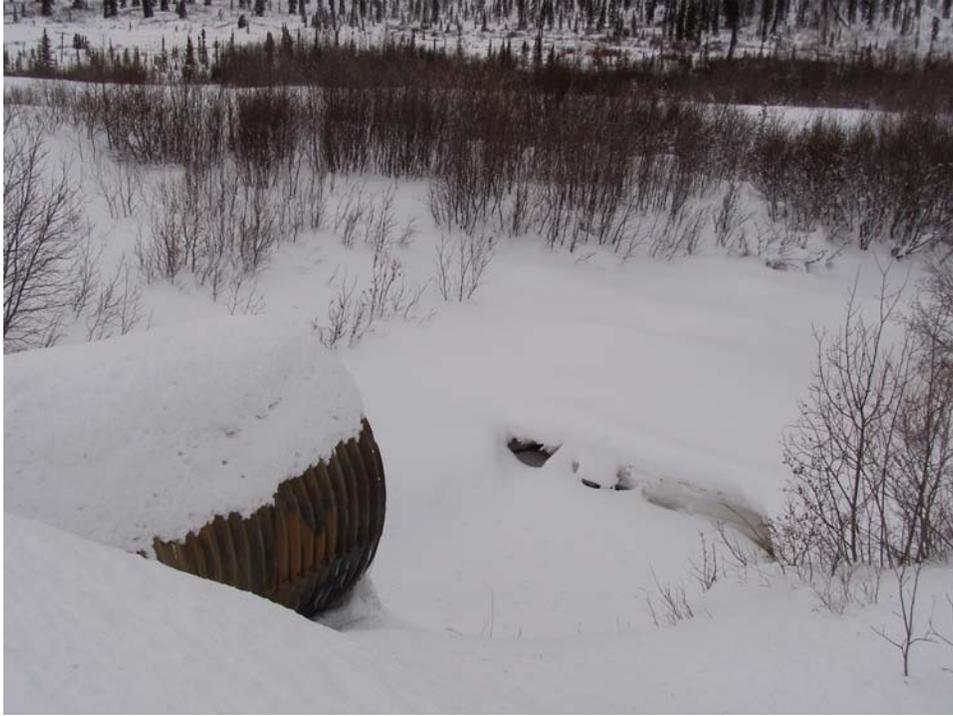
During the site visit, a hanging culvert was noted at the Rose Creek Crossing (Km. 9.8), which is a barrier to fish passage. If this section of the creek is found to be fish habitat, then the culvert should be replaced with one which allows for fish passage.

Photo 3 – Perched culvert at Rose Creek crossing.

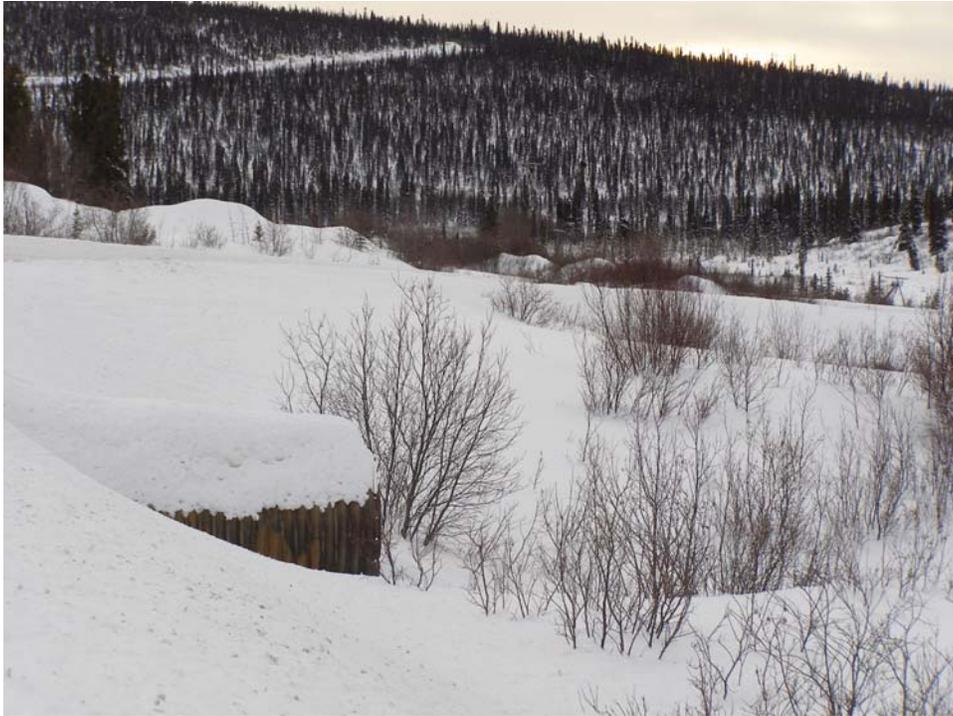
Photo 4 – Other end of perched culvert.

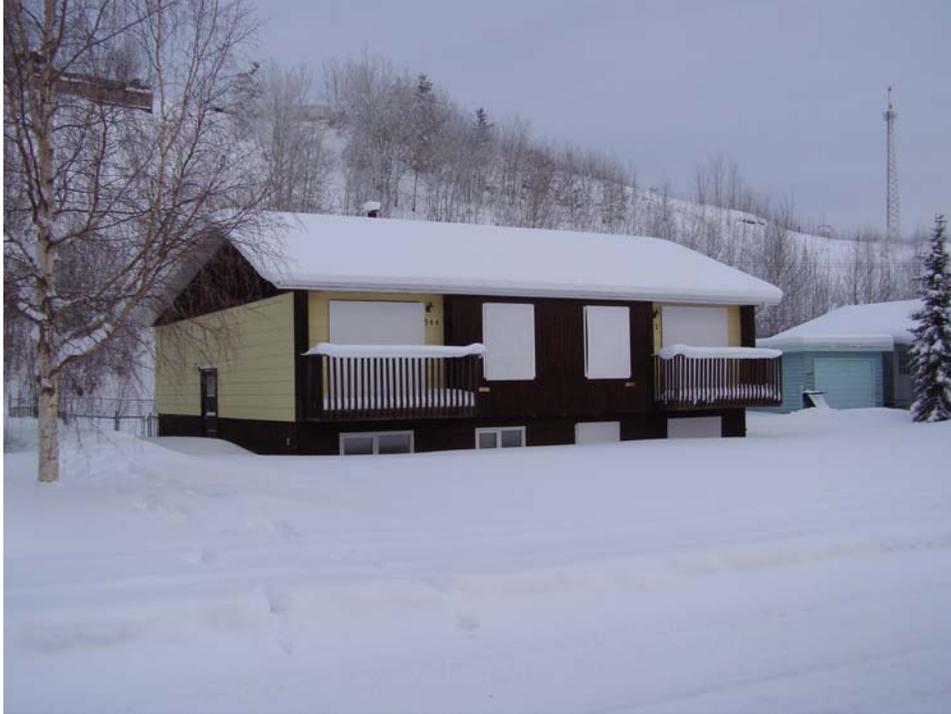
There were few structural problems noted in the buildings. The foundations generally consist of concrete footings and walls, and for the most part appear to remain stable. Although Faro is in a discontinuous permafrost area, most of the housing has not been adversely affected by soil settlement over the years. Since the townsite has been disturbed for many years due to roads and housing development, further melting of permafrost and settlement is unlikely to occur. (See photos.)

Photo 5 – Typical unoccupied duplex.

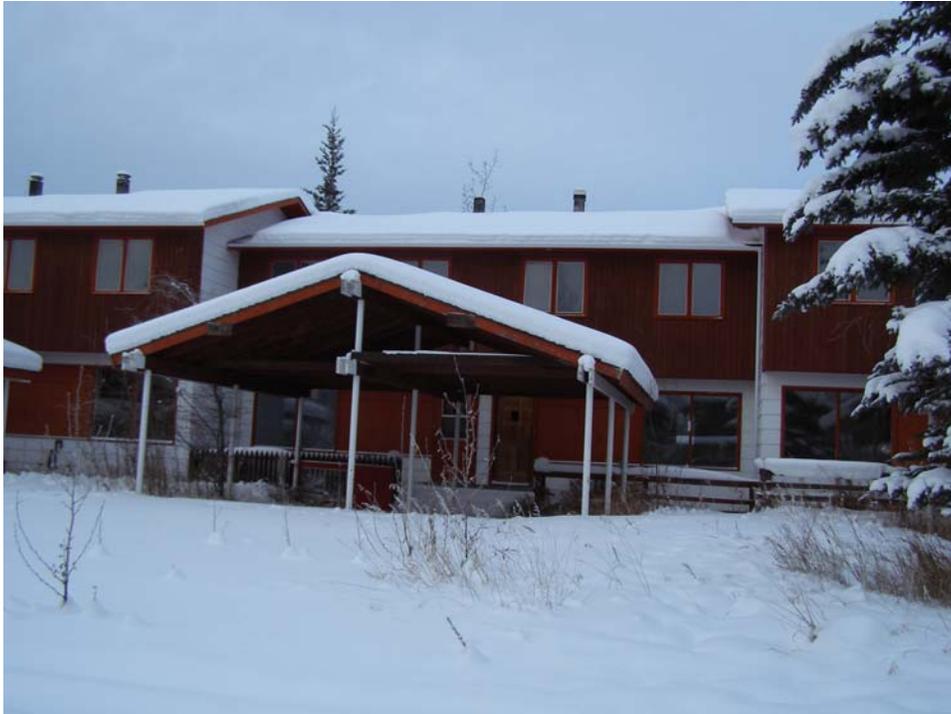
Photo 6 – Typical unoccupied row housing.

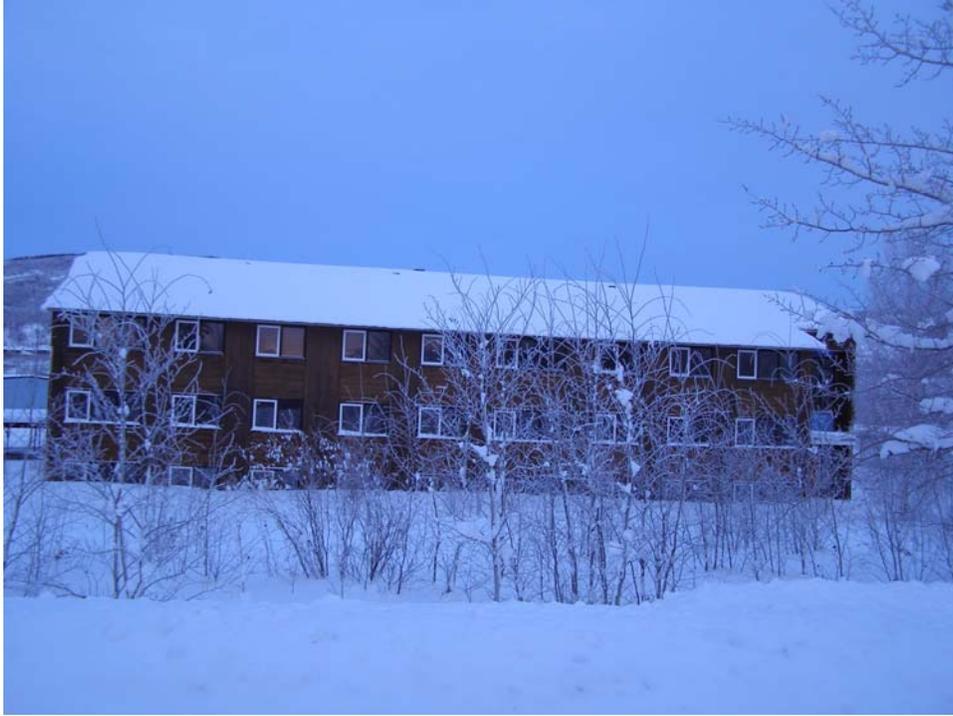
Photo 8 – Unoccupied apartment.

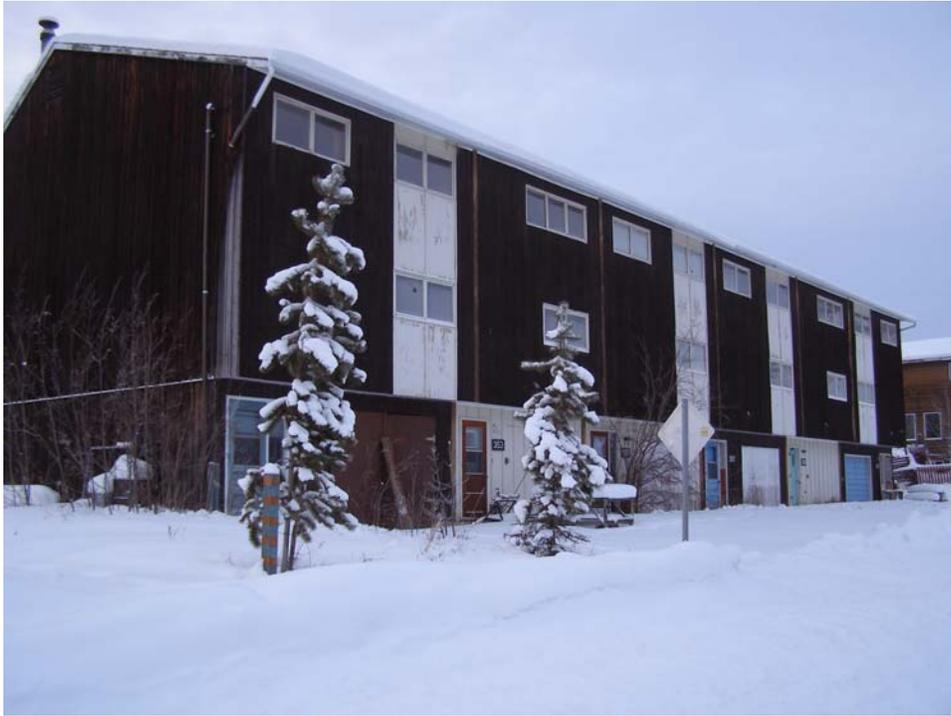
Photo 10 – Unoccupied 6 plex.
