May 24, 2013

EDI Job Number: 13-Y-0167

Re: Mount Nansen Surface Water Quality Field Memo: May 21-23, 2013

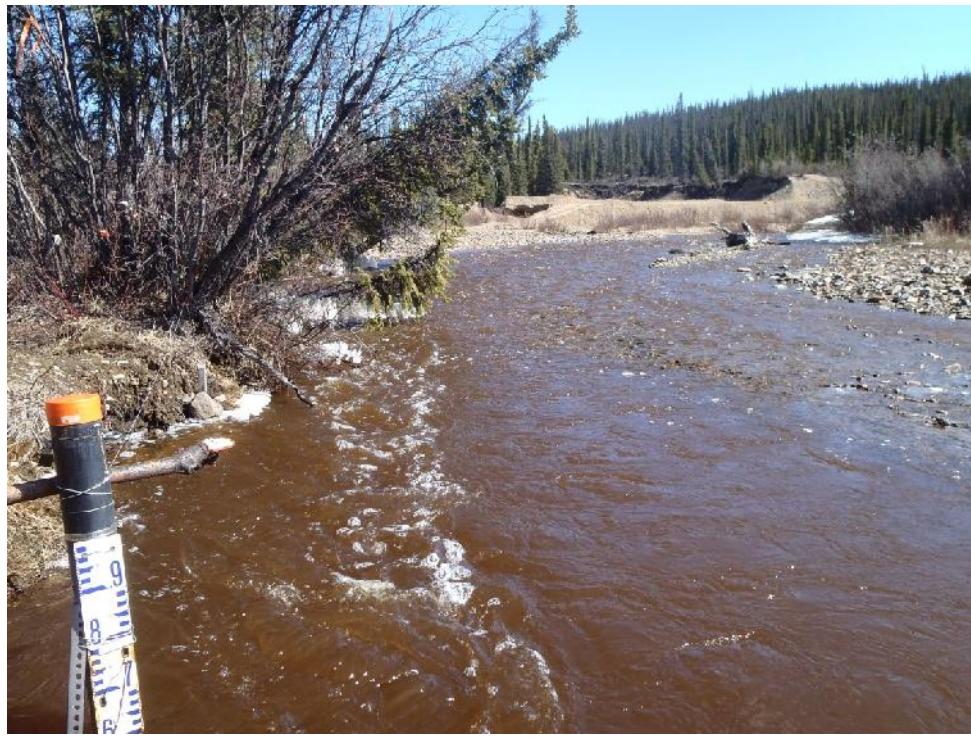
The hydrometric station at H-VC-R was repaired following displacement during high flows preceding the May 15th field visit. The stilling well, data logger and staff gauge assembly was reconstructed to sustain higher flows and shifts in channel morphology.

Photo 1. Victoria Creek Station H-VC-R looking upstream.

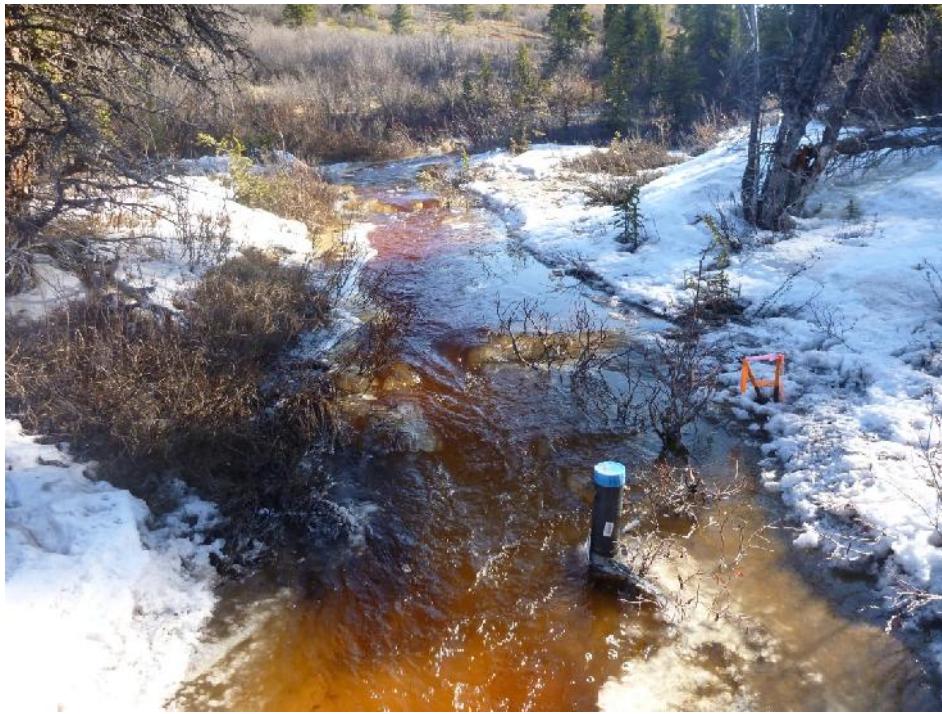
Photo 2. H-MN station on Minnesota Creek looking upstream.

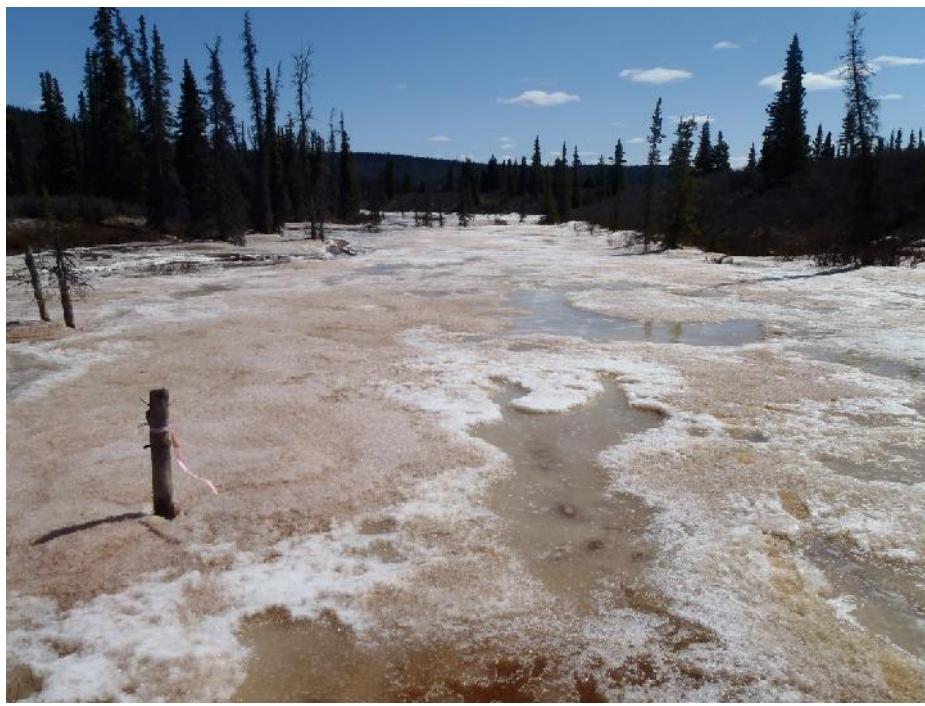
H-DC-R	None	Water partially flowing across the Mount Nansen Road, and on the surface of the overflow ice. Conditions not suitable for a discharge measurement due to the absence of a well-defined channel. Significant quantities of overflow ice remain covering the channel and hydrometric station downstream of road, up to approximately 1 m thick.
H-VC-REF	ADV	Victoria Creek at the REF station is ice free. Water levels were moderate and lower than the previous visit. Water level loggers were downloaded and surveyed. Discharge measured using the mid-section method.
H-VC-U	ADV	Station location is completely free of ice. Water levels near bankfull conditions. Discharge measurement completed using the mid-section method.
H-BC	Salt Slug	Station location is open with moderate discharge. Bed and suspended sediment load remains high. Salt tracer method used to measure discharge. Water level logger downloaded.

Photo 3. H-DC-R station looking downstream. Note the channel to the left.

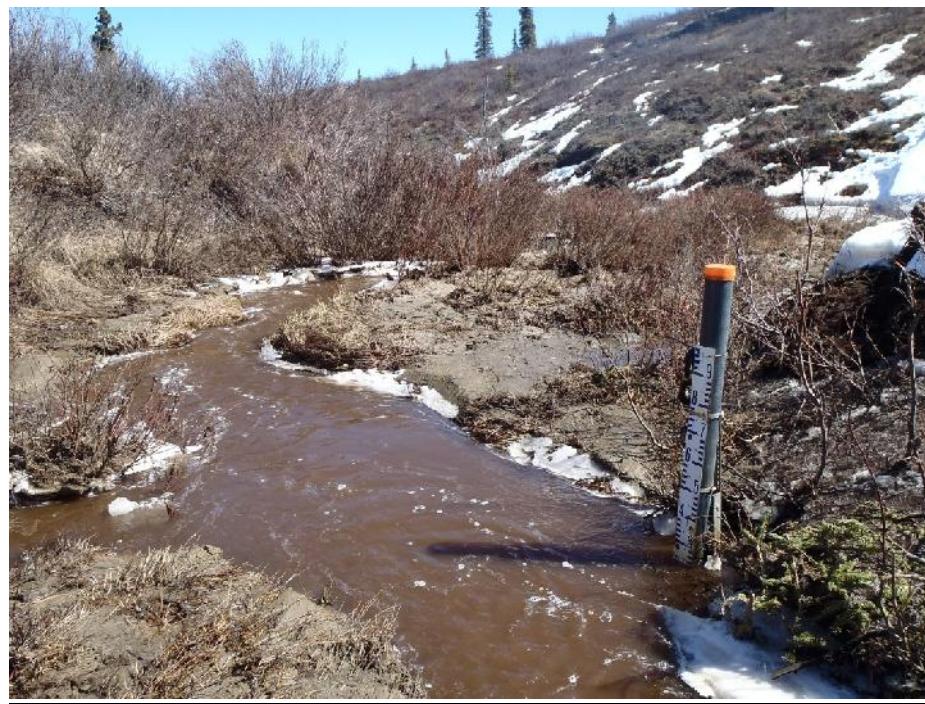
Photo 4. H-DC-M station looking downstream.

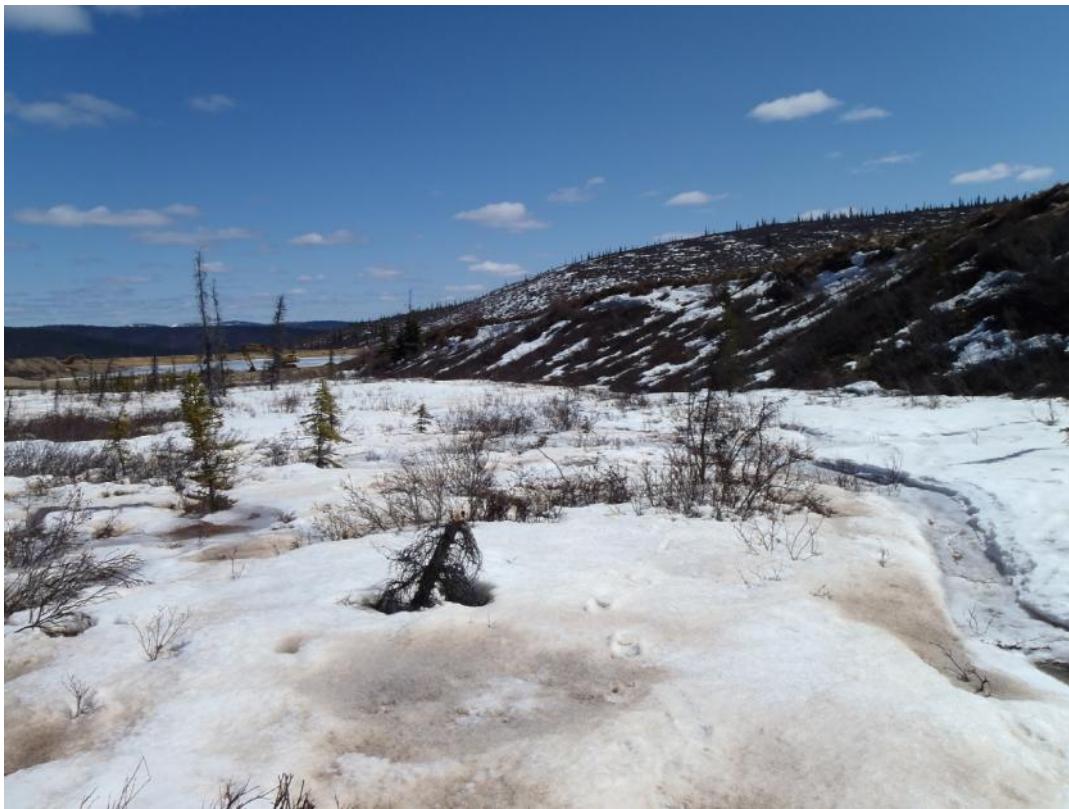
Photo 5. H-DC-U1 site looking downstream towards tailings pond. Large quantities of overflow ice remains present.

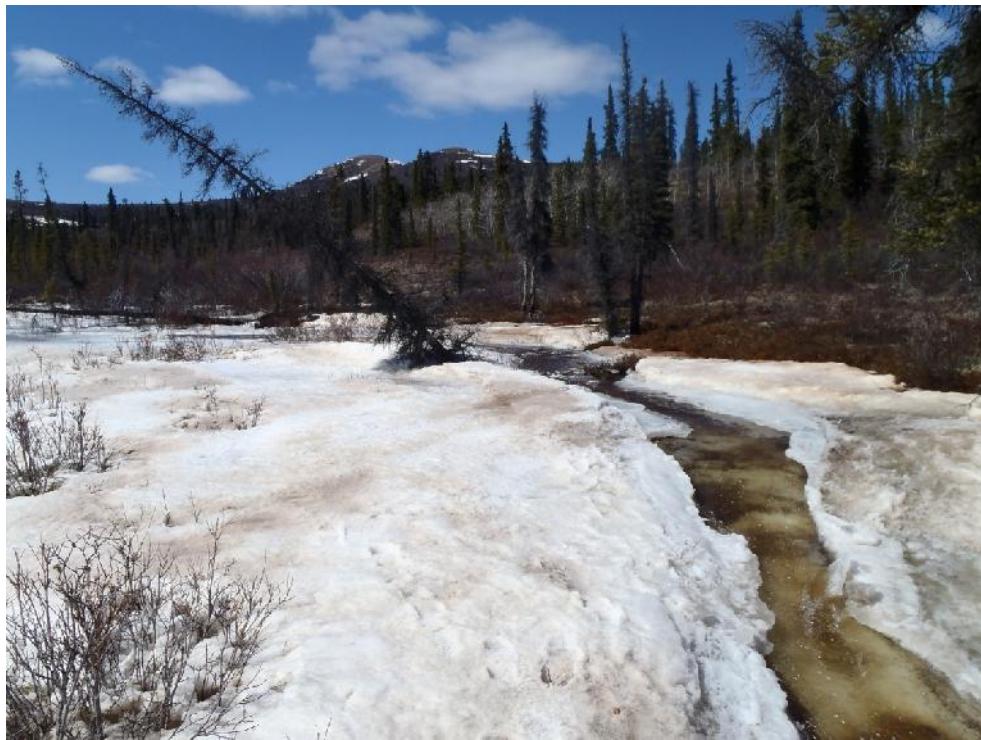
Photo 6. The H-DC-U2 station looking upstream. Channel becoming more well defined and incising channel in overflow ice.

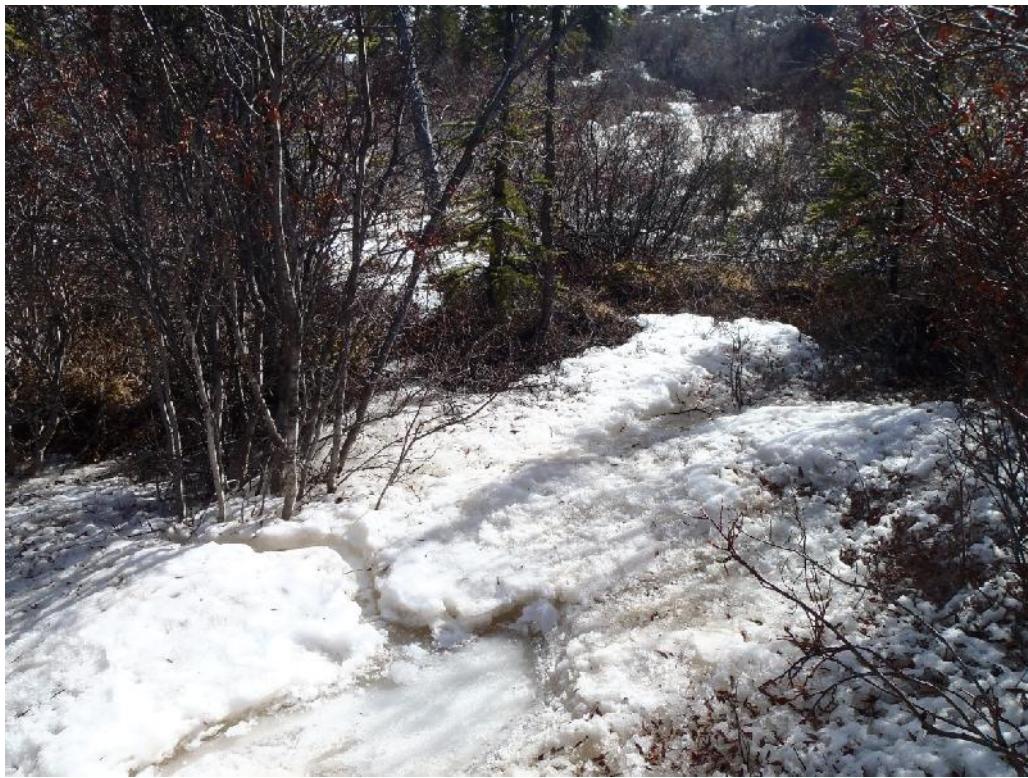
Photo 7. H-DC-D1 station looking downstream. Frozen conditions remain with no flowing water apparent.

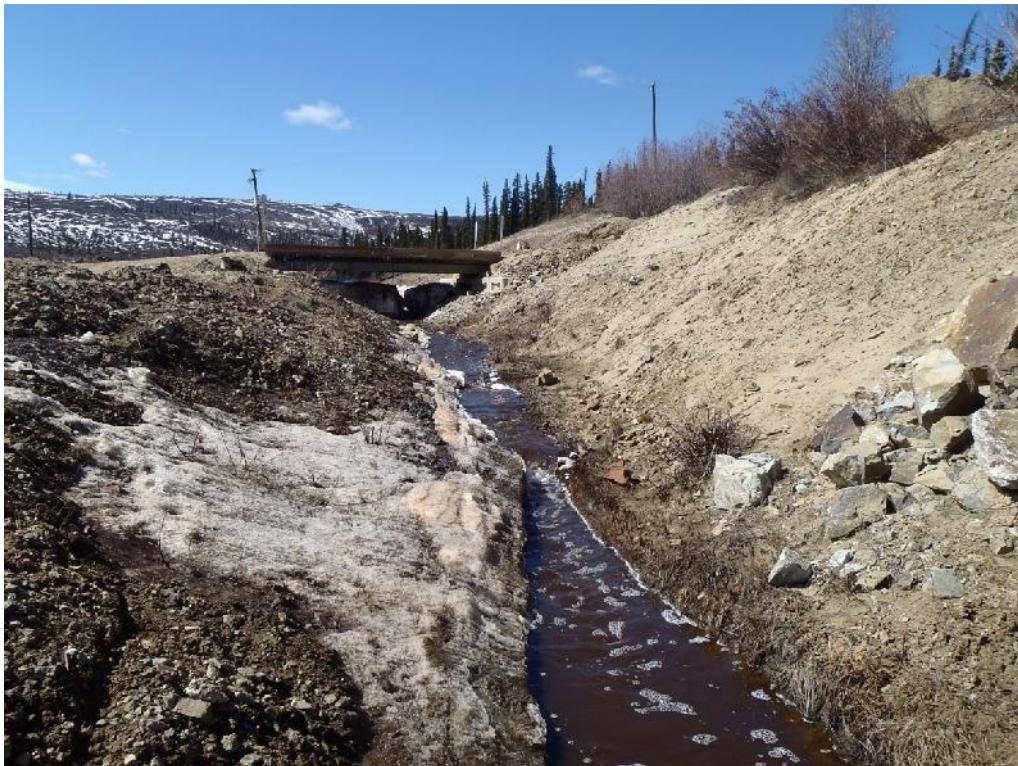
Photo 8. H-DC-DCB looking upstream. Small quantities of snow and some ice remain along north-facing channel slopes.

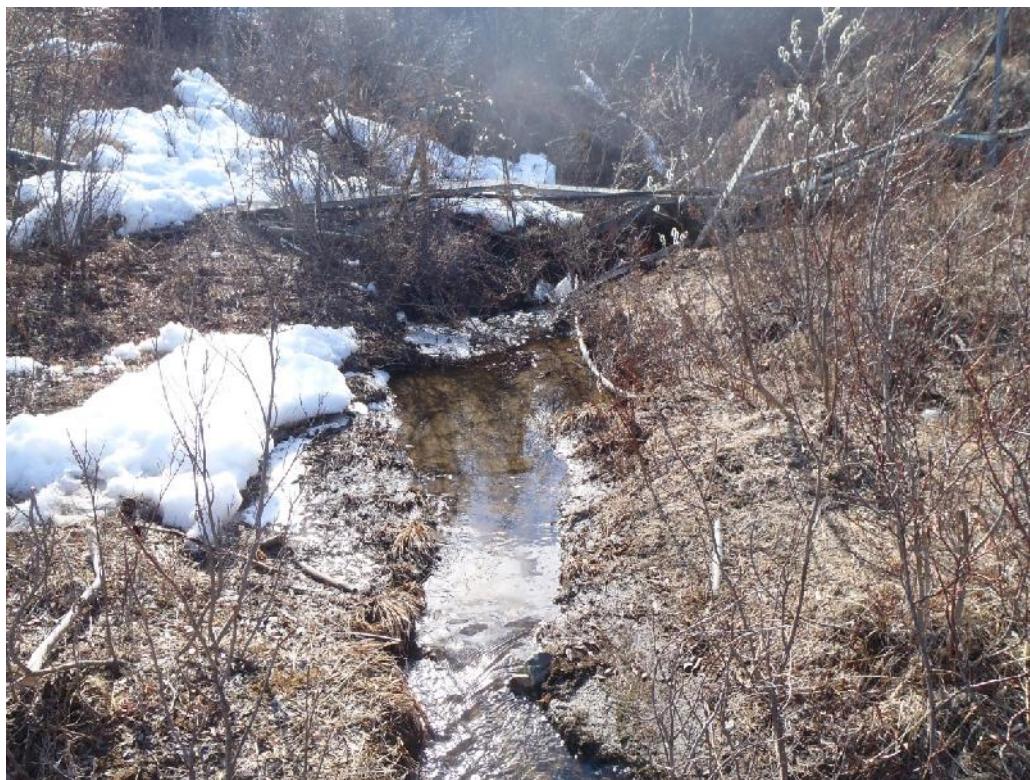
Photo 9. H-DC-DX+105 looking upstream.

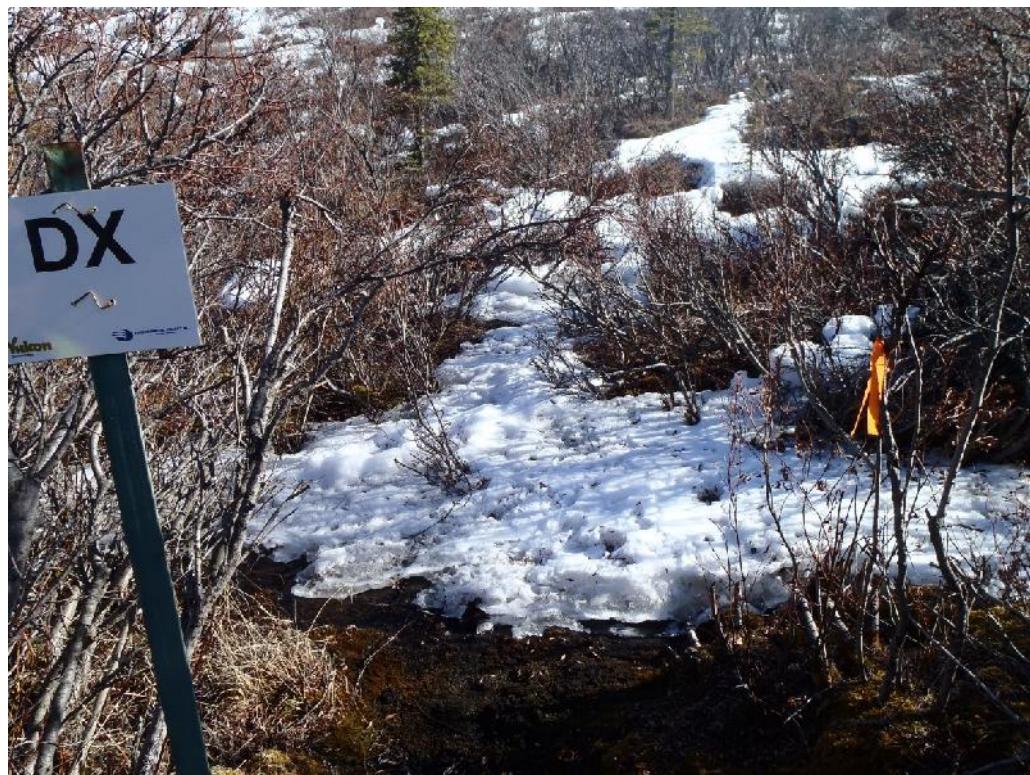
Photo 10. H-DC-DX with moderate ice and snow cover on portions of the channel.

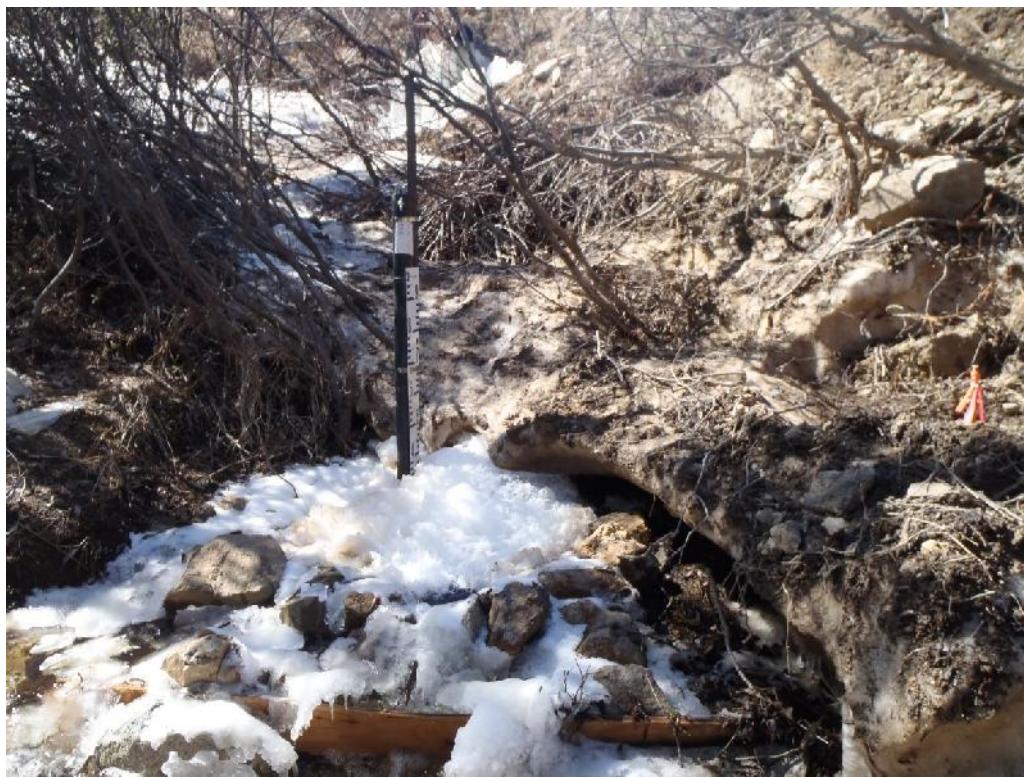
Photo 11. H-PC-DSP hydrometric station looking upstream. Note: the white material by the stilling well is foam, not ice.

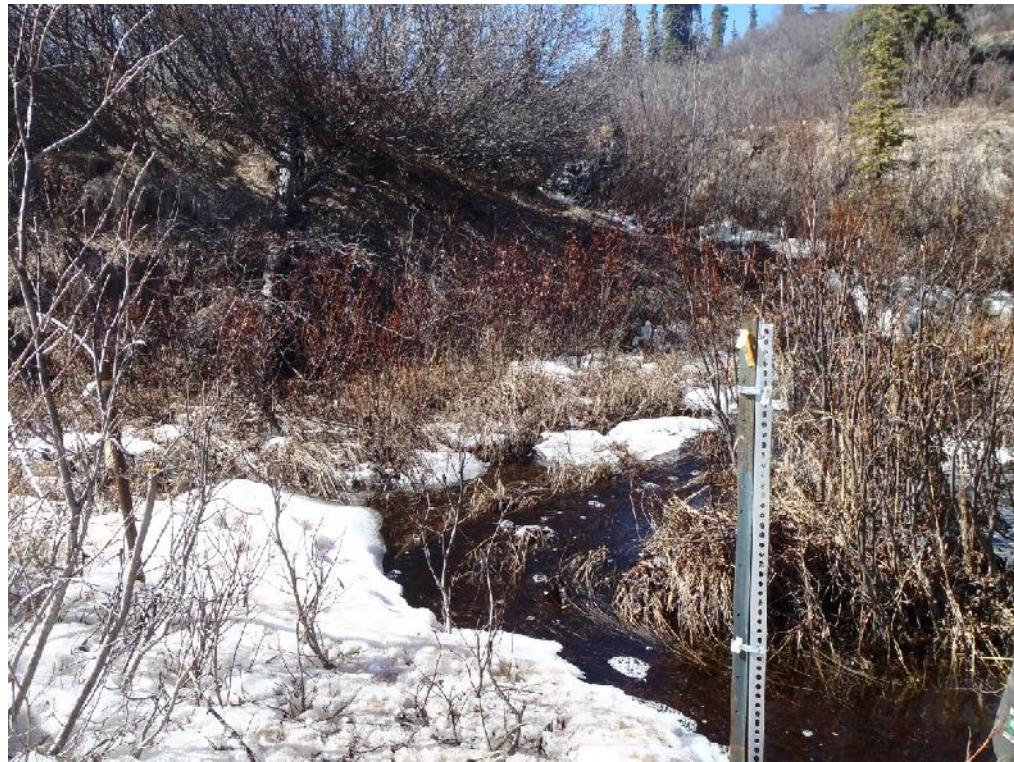
Photo 12. H-PC-U looking upstream. Flow diverted from the weir (right) re-joins the channel on the left of the image.

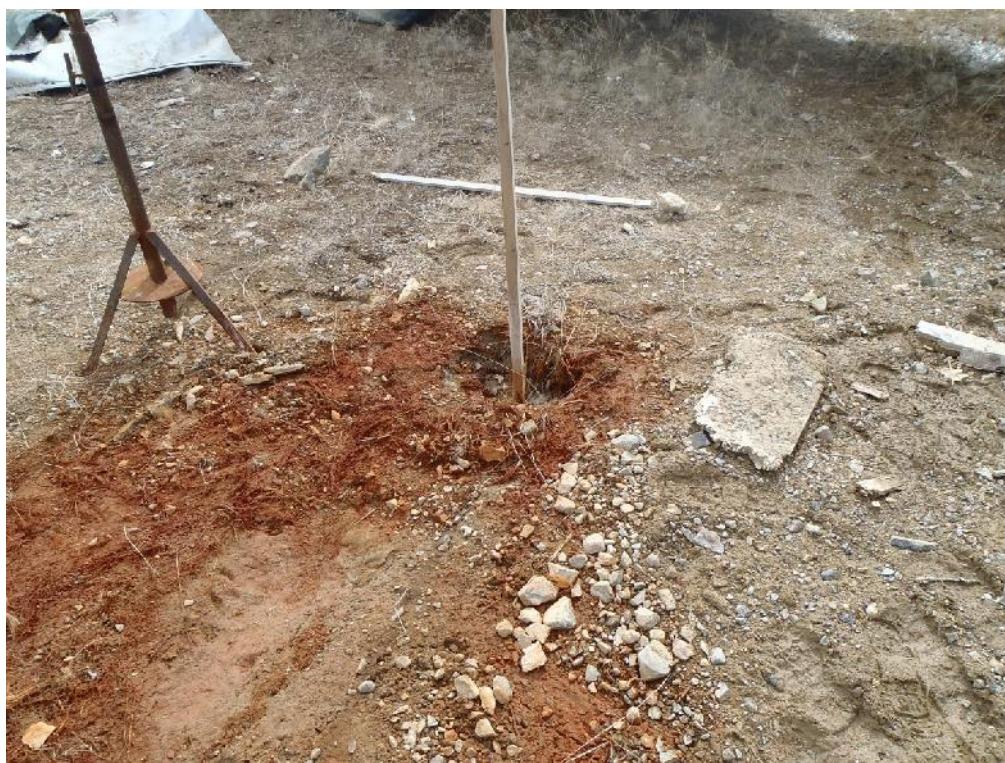
Photo 13. WQ-MS-08 monitoring location. Mill seep was dry with no standing or flowing water.
