Options for Closure of Mt. Nansen Mine

Technical Review Version

July, 2008

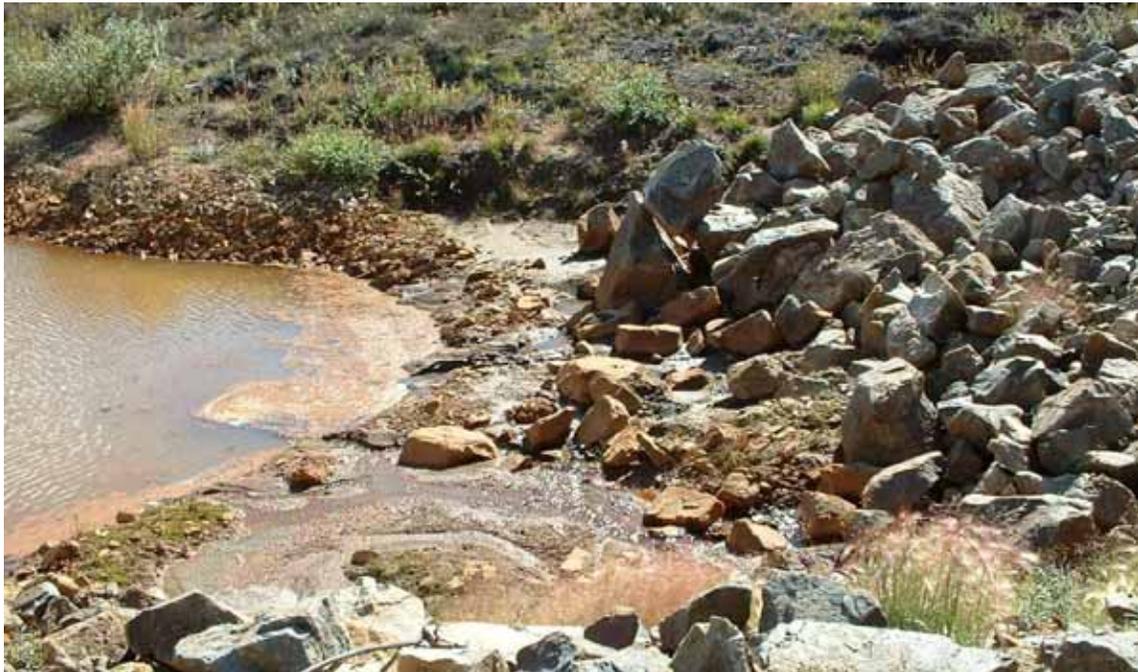
A preliminary dam safety assessment by EBA and Klohn Crippen in 1999/2000 found no evidence of imminent dam failure, but indicated possible problems with the dam structure including obvious thawing of foundation soils, the presence of organics and loose sand within the foundation, and high seepage rates.

The stability of the tailings impoundment was thoroughly assessed by EBA in 2000/2001 (reported in 2002). They found that construction of the dam was probably not completely in agreement with the design, likely with insufficient foundation stripping and insufficient compaction of the sand fill which may have affected the permafrost, seepage rates and stability of the dam. The design also called for a tailings beach with a width of 50m directly upstream of the dam that was to be formed as the tailings were deposited into the impoundment. The actual tailings beach did not meet the 50m width in the design which likely partially influenced the higher than expected seepage rates. The water balance of the tailings impoundment exceeded the design water balance resulting in problems with higher than expected water volumes behind the dam, which contribute to the problems with seepage and stability.

Seepage from Main Dam

A new dam assessment will be conducted in July 2008 which will include a cost estimate to upgrade the existing dam, should it remain in place.

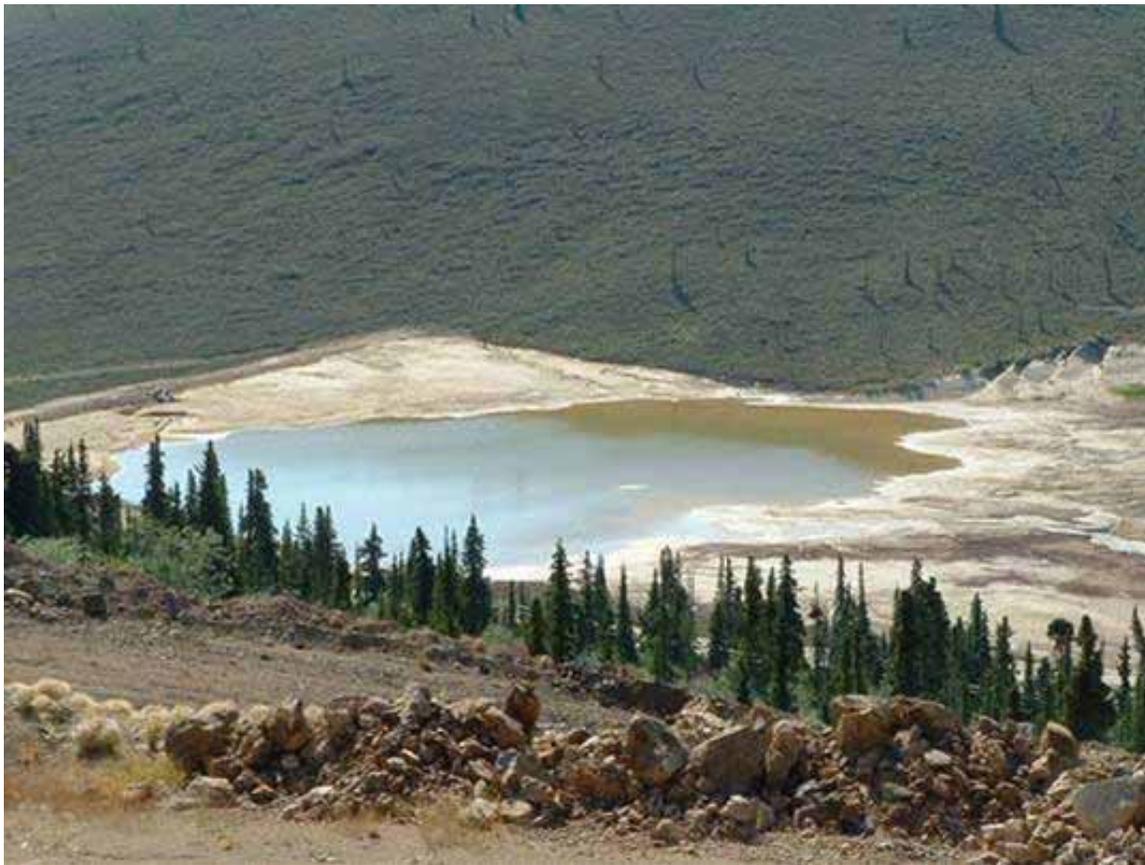
Tailings Impoundment, 2004 – pond water volume has since decreased

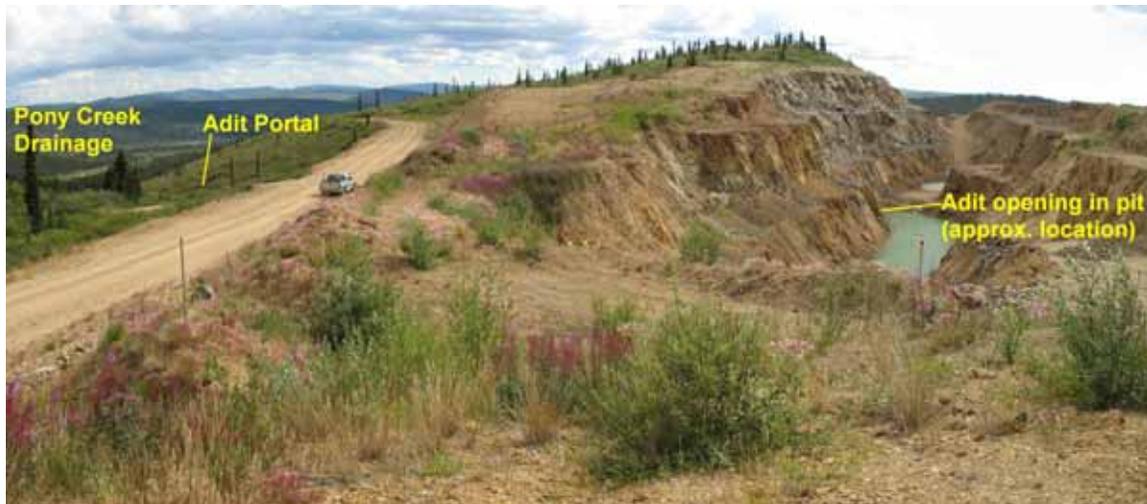
During operations no significant volume of water collected in the open pit, and the Pony Creek adit was dry. Since shut down, water has collected in the pit and the pit has been partially pumped out three times, in 2001, 2002 and 2004 (GLL MN056-R30 Figure 8) in order to lower the water level and prevent the water from entering the open Pony Creek adit and spilling through to the Pony Creek drainage. A hydraulic bulkhead was installed in the adit in 2006 to further prevent the possibility of future through flow. The water level has varied for the past few years, with a tendency to increase in the summer and decrease in the winter; however, water in the pit has remained at least 3m below the exposed adit. A 2004 water balance investigation by Gartner Lee Ltd. suggested that the water level would likely fluctuate for 6-8 years before stabilizing.

Pony Creek Drainage and Brown-McDade Pit

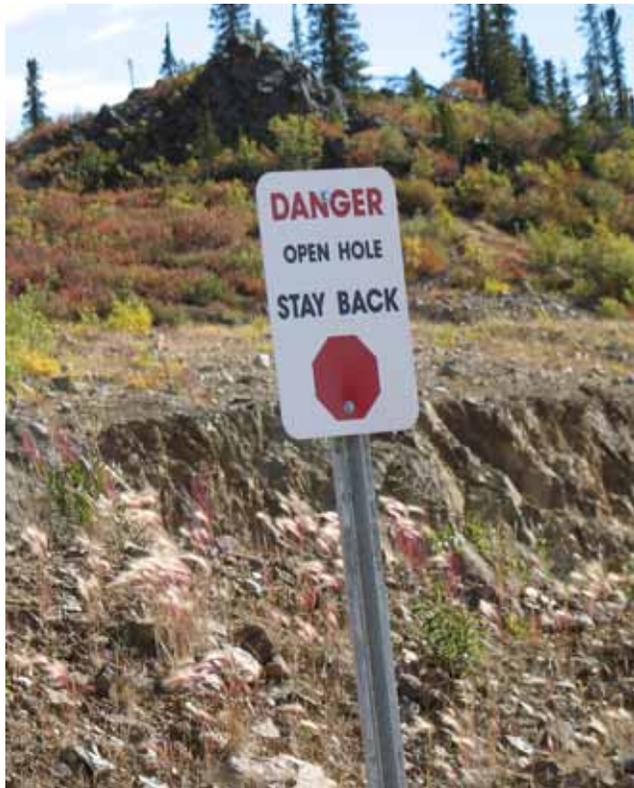
Signage around pit

Signage was installed in 2006, around the perimeter of the pit warning people of the hazard. Depending on the closure option chosen for the pit, final pit security measures including a ditch and berm system and/or partial backfill may be completed.

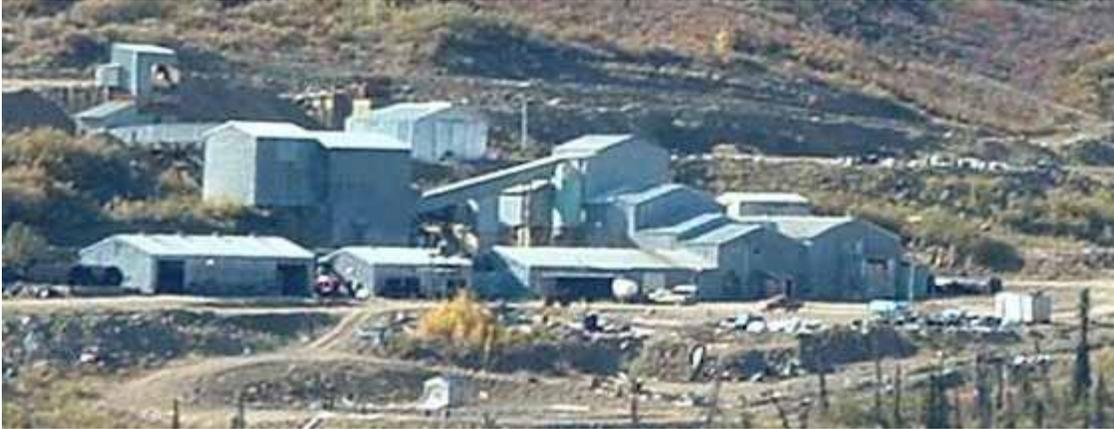
The mill complex and associated buildings remain as they have been since the site was abandoned. Portions of the mill were converted for water treatment purposes in 1999. This facility has not been required since 2004. Most hazardous chemicals and low level PCB containing transformers were removed from the site in 2006. An investigation of remaining unidentified substances was undertaken in Spring 2008, with demolition of the mill and crusher buildings intended to start Summer/Fall 2008. The majority of the

potentially hazardous or contaminated materials remaining on site are mill process wastes similar to tailings that have been left as residue or sediments in the bottom of tanks. The contaminants in these materials vary, but tend to be relatively high levels of metals (usually As, Cu, Pb and Zn) and in some cases CN. A few samples were of unused industrial chemicals, sediments in mix tanks with extremely high concentrations of copper (presumed to be from the copper sulphate used in the water treatment process), carbon with high metal levels, and sludge resulting from ferric sulphate use. These materials will be removed prior to demolition. Once the mill and crusher buildings are removed the area will be assessed for any contaminants that may be present.

Mt. Nansen Mill Complex

- Mill demolition – the unused mill and crusher buildings will be demolished, removing the safety hazards and liability of these deteriorating buildings. The attached workshop, warehouse and generator buildings will remain for continued use during closure.

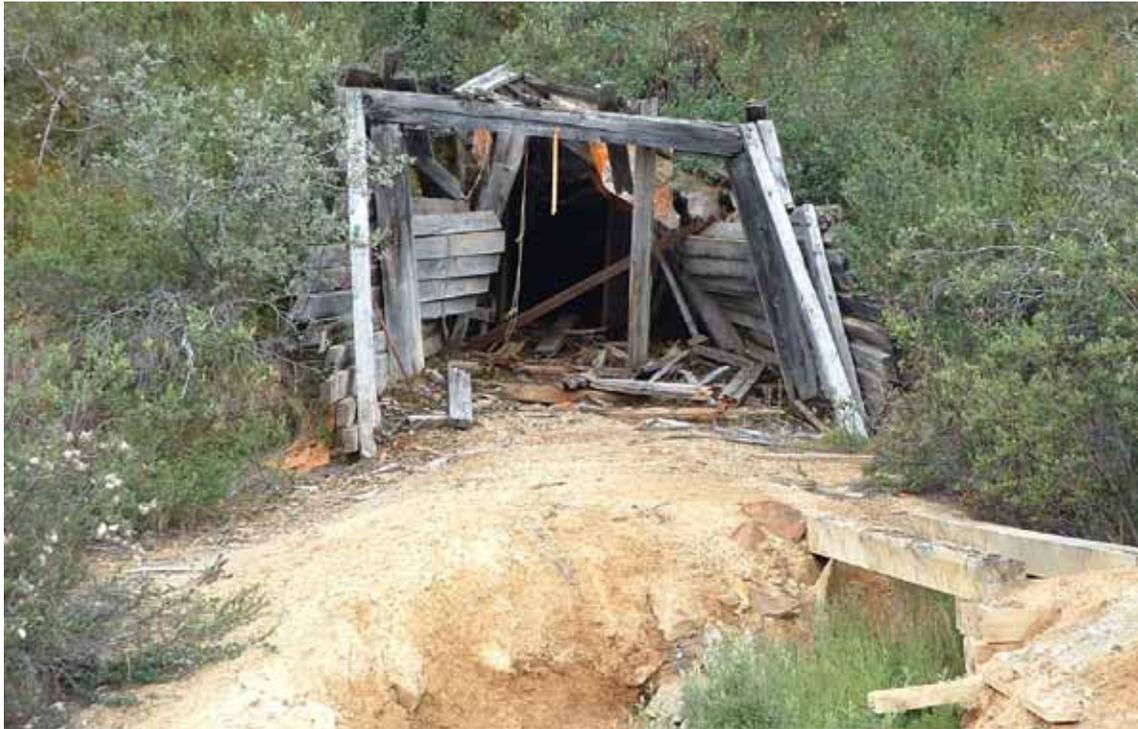
Pony Creek Adit before improvements

- Installation of a hydraulic plug in the Pony Creek adit to stop pit water from flowing down gradient into the Pony Creek drainage and improvements to adit portal stability;

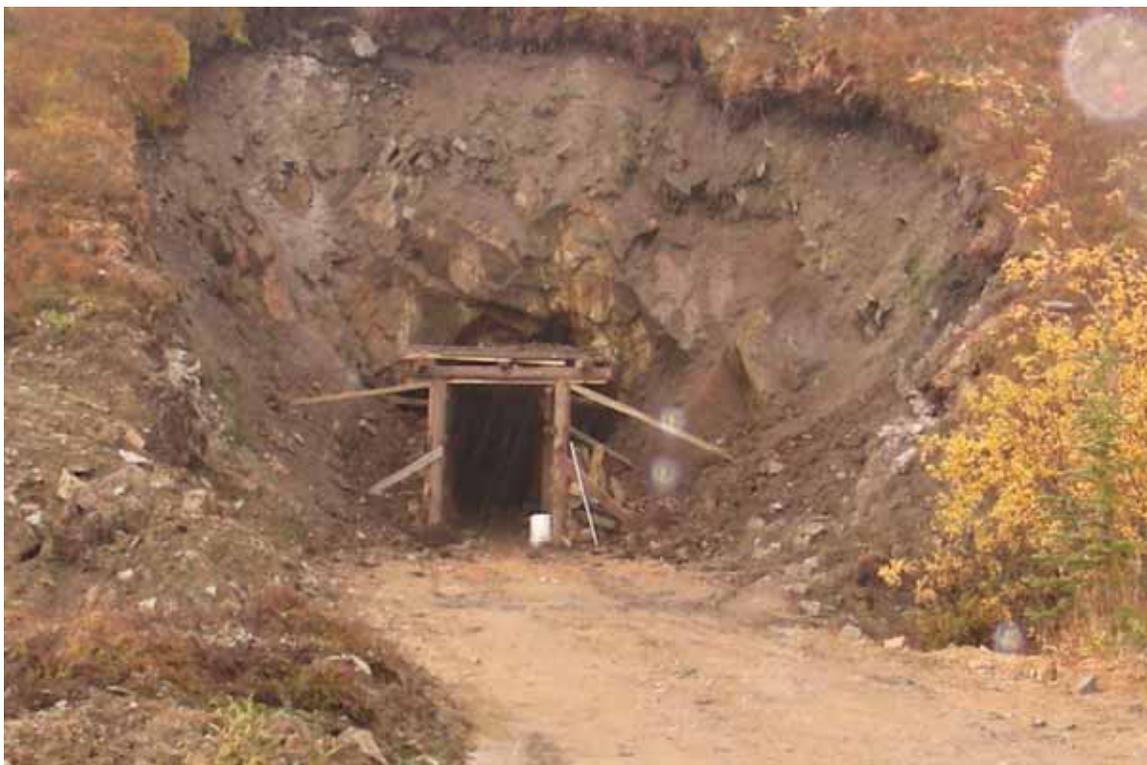
Pony Creek Adit after improvements – a locked gate prevents access inside
