Desktop Geotechnical Assessment Vacant Lots 519 and 520, Copper Ridge Whitehorse, YT

Project No. 106908-01

July 4, 2022

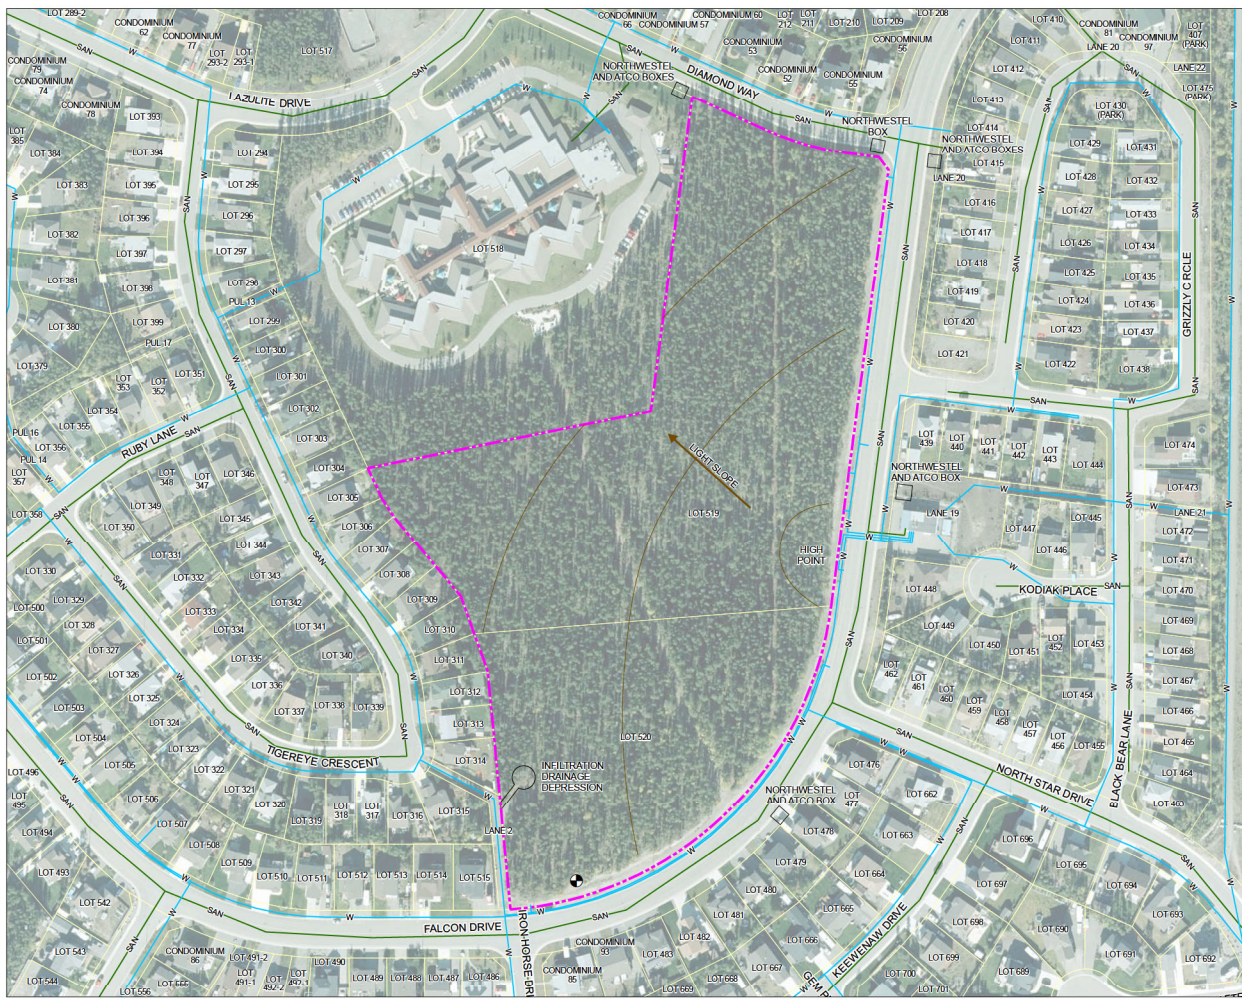
Development Potential

During the site visit the vacant parcel was examined for potential geotechnical features that would require setbacks. The site was generally flat, and no features were identified that would warrant any geotechnical setbacks. The slope away from the high point is less than 5% and should not be a limiting factor to development.

From the site visit, area development, and the anticipated surficial geology there are no geotechnical hinderances to residential road and housing construction.

Prior to development a geotechnical investigation should be conducted to determine the subsurface soil stratigraphy, depth to bedrock and properties as they impact the proposed development. This investigation should be completed after the development plan has been drafted but prior to detailed design and should include the presence and condition of permafrost, potential for thaw settlement, presence of bedrock, and design parameters for foundation design.

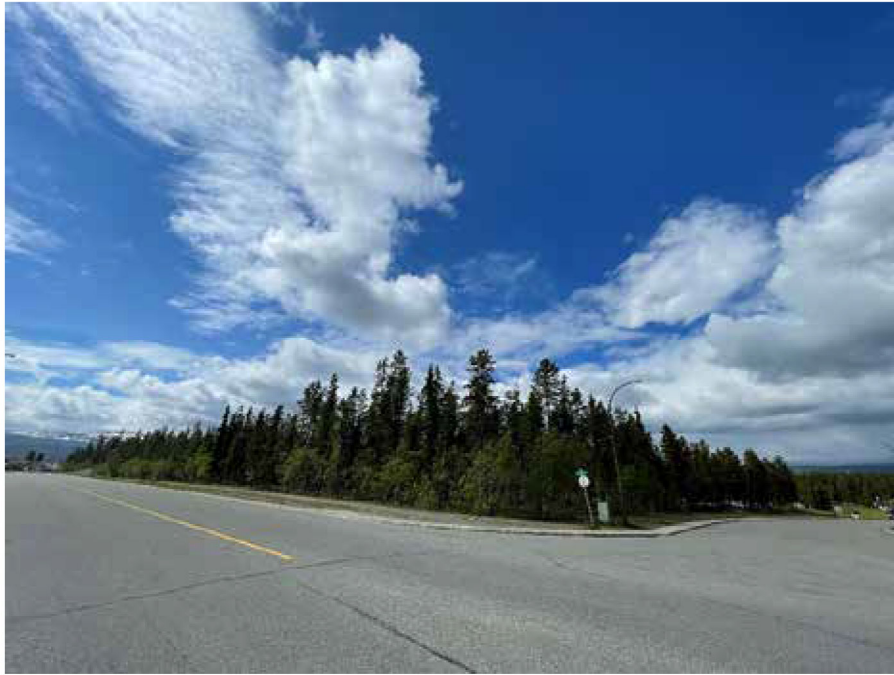
Photo 1 View of vacant parcel site facing South-West during site visit (June 15, 2022).

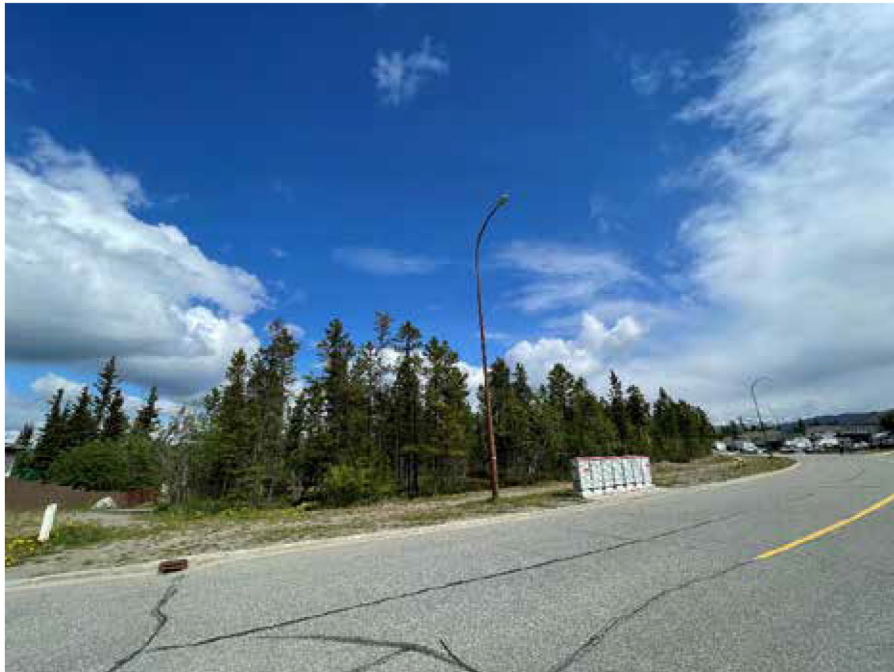
Photo 2 View of vacant parcel site facing North during site visit (June 15, 2022).

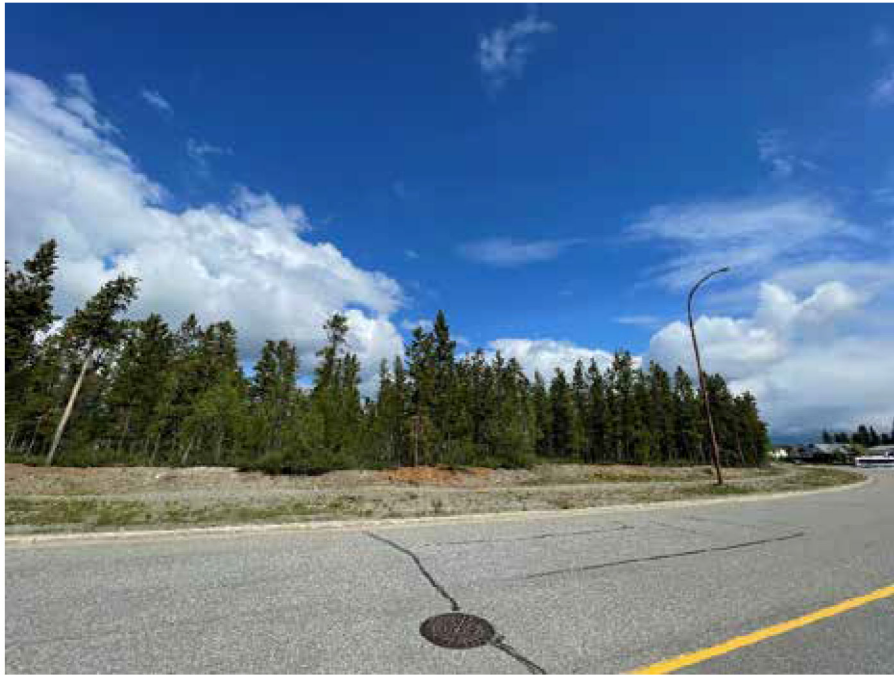
Photo 3 View of vacant parcel site facing West along Falcon Dr. during site visit (June 15, 2022).

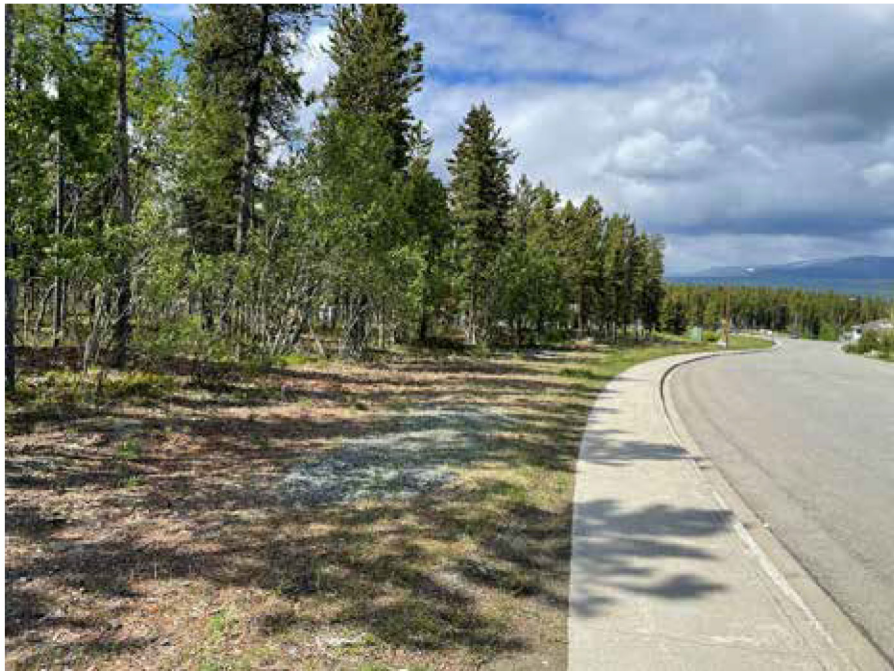
Photo 4 View of North-East edge of vacant parcel site along Diamond Way during site visit (June 15, 2022).

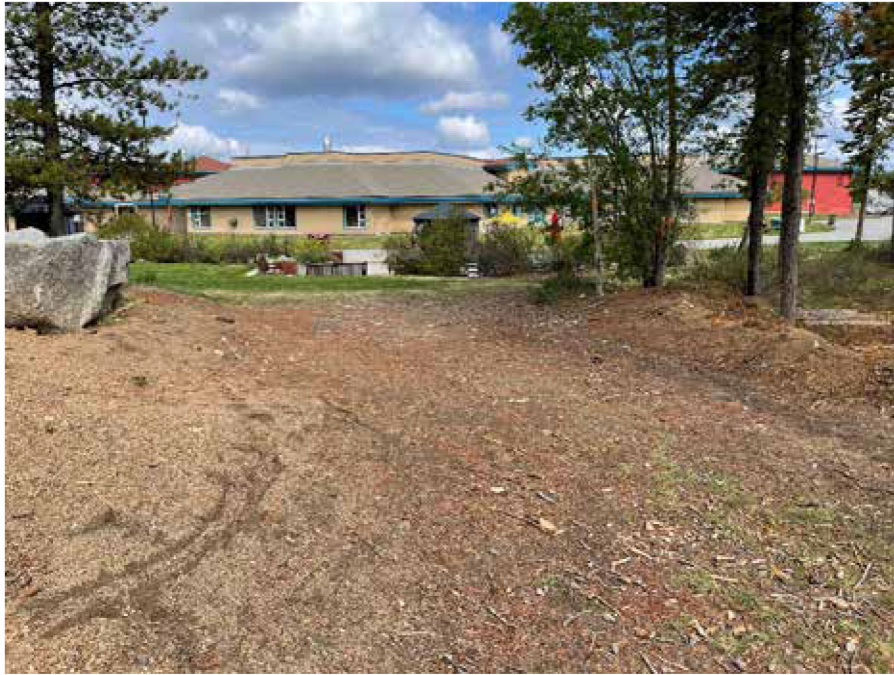
Photo 5 View of North West side of vacant parcel site facing towards Copper Ridge Center during site visit (June 15, 2022).

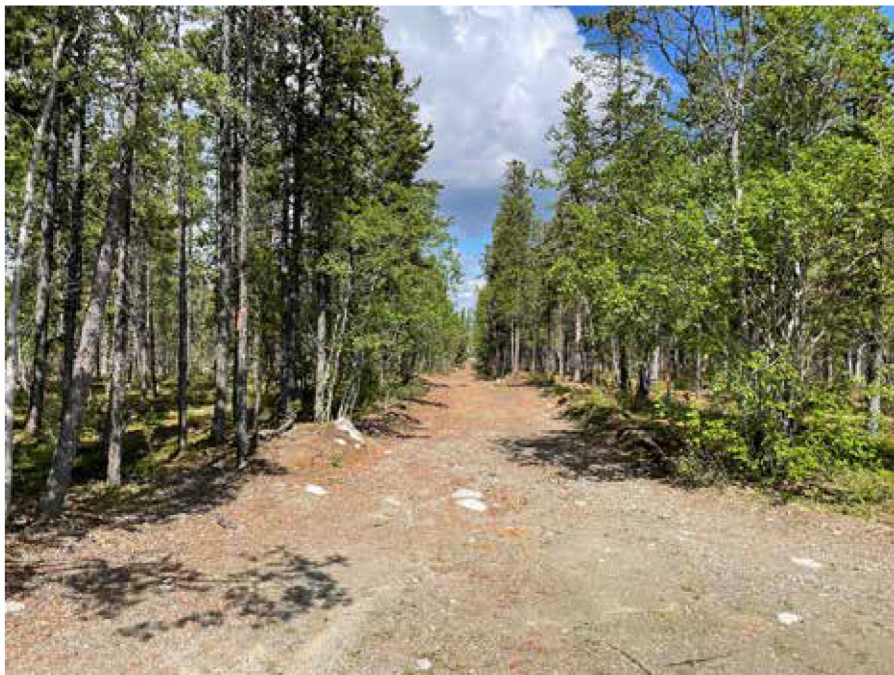
Photo 6 View of cutline on vacant parcel site facing North-West during site visit (June 15, 2022).

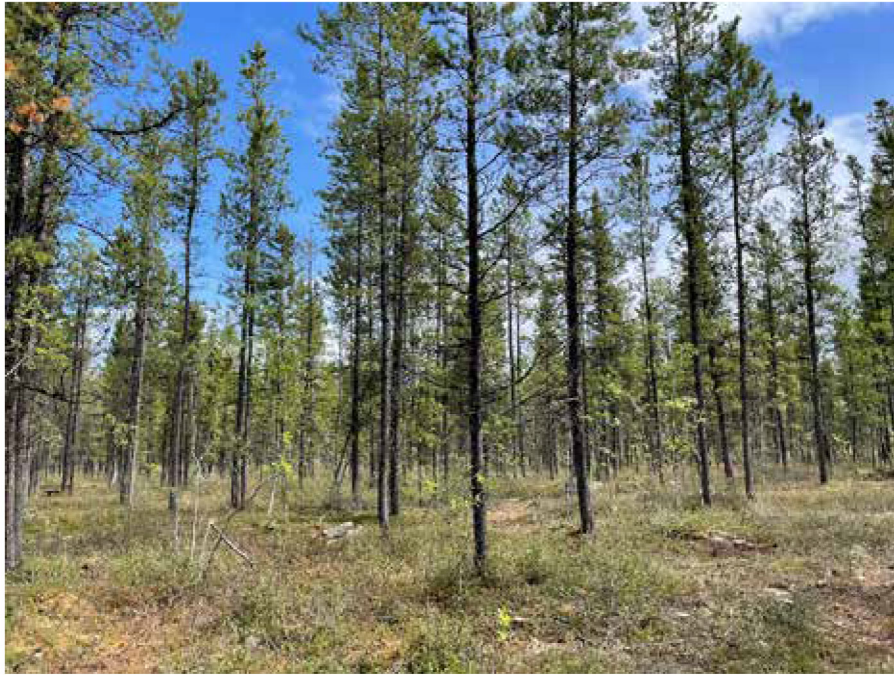
Based on the site visit and available data there are no severe natural Hazards Risk to the site. Flooding is a low risk because the site appears to have good drainage. For fire the site is moderately vegetated with Spruce and Pine trees (Photos 7 in **Appendix A**) but is surrounded by at least 250 m of residential development (from natural forested areas) and is not considered at risk. According to the topographic data and available soils data there is negligible risk of slope or ground movement. Drainage is expected to be good on-site with the natural slope to the north.

Photo 7 View of vegetation on vacant parcel site facing North during site visit (June 15, 2022).

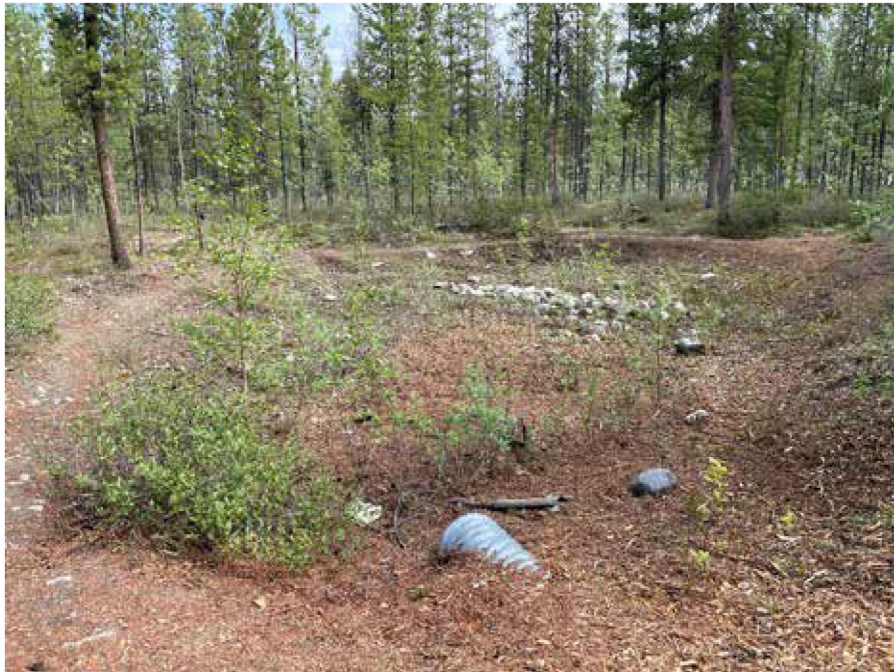
The field site visit was carried out on June 14, 2022, by Aidan Allen of Hemmera. The visit consisted of a site walkthrough and general assessment. The site has a high point on the South-East side and is generally sloped towards the North-East but does not have any apparent limiting geological features. There is a monitoring well on-site on the South side of the parcel (Photo 9 in **Appendix A**). On the South-West side of the site there is also a small infiltration drainage depression (Photo 8 in **Appendix A**).

Photo 8 View of infiltration depression on South end of vacant lot during site visit (June 15, 2022).

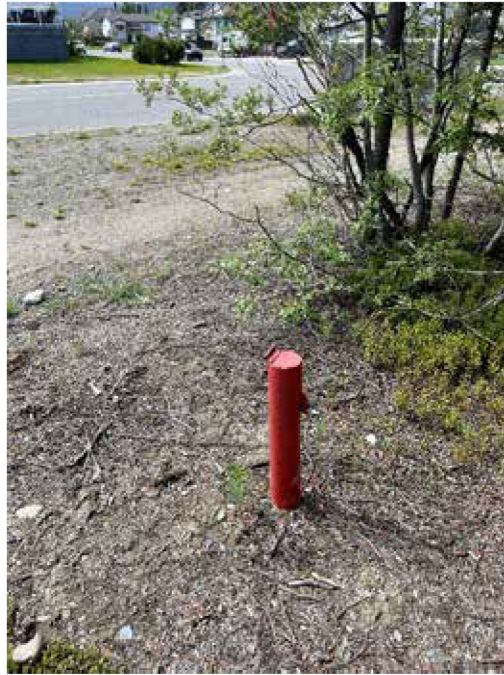
According to historical data from a study in 2014 which included the monitoring well on-site, groundwater was never observed in the 7.7m deep well. Nearby wells from the same study within 500m of the site have had groundwater observed between 4.5 and 6.5 meters below ground surface (mbgs).

Photo 9 View of stickup monitoring well on South side of vacant lot during site visit (June 15, 2022).
