# Faro Mine Complex Care & Maintenance

**Tlcho Engineering and Environmental Services**  
**Quarter 1 Performance Report**  
**August 2012**

## **Q1 Performance Presentation**

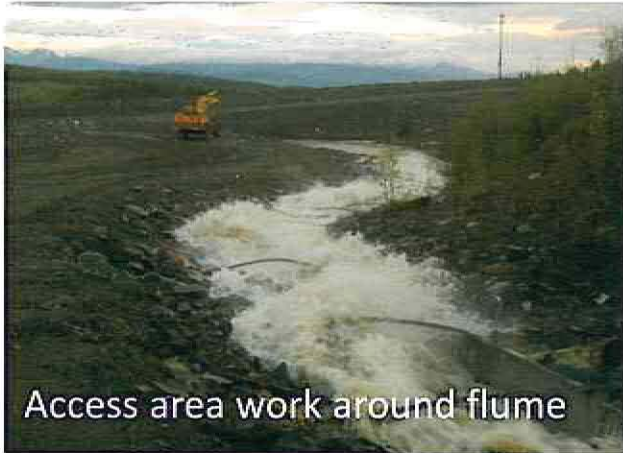
Access area work around flume

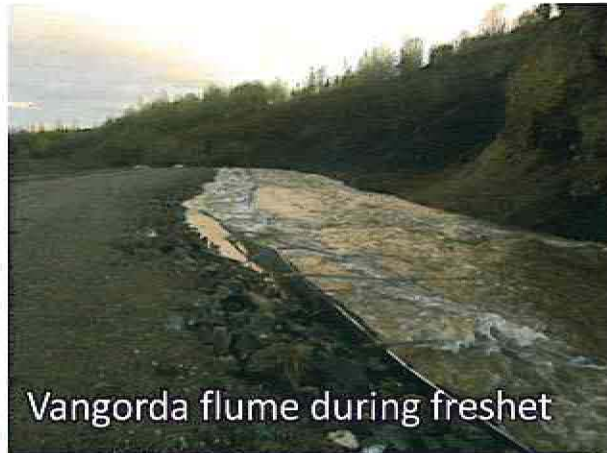
Vangorda flume during freshet

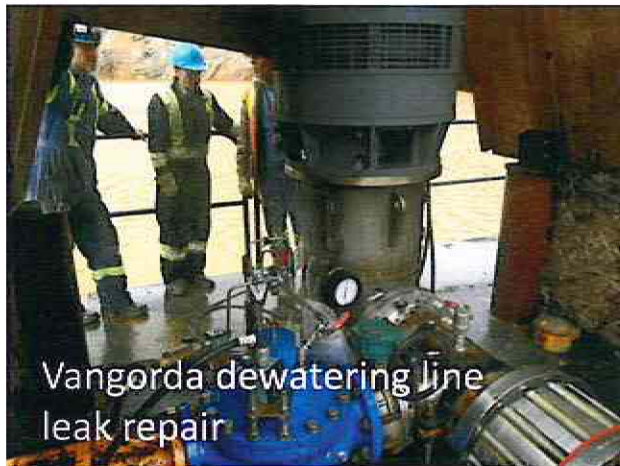
Vangorda dewatering line  
leak repair

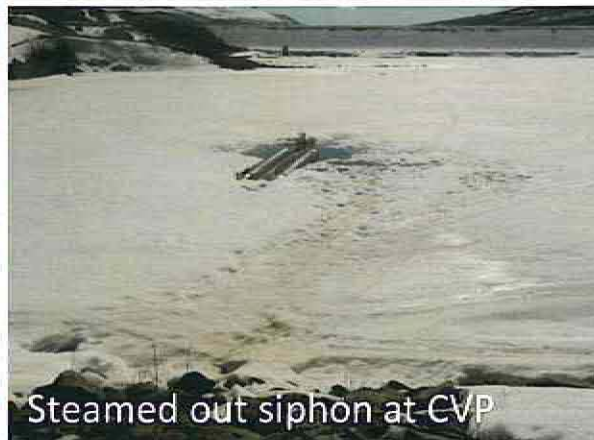
Steamed out siphon at CVP

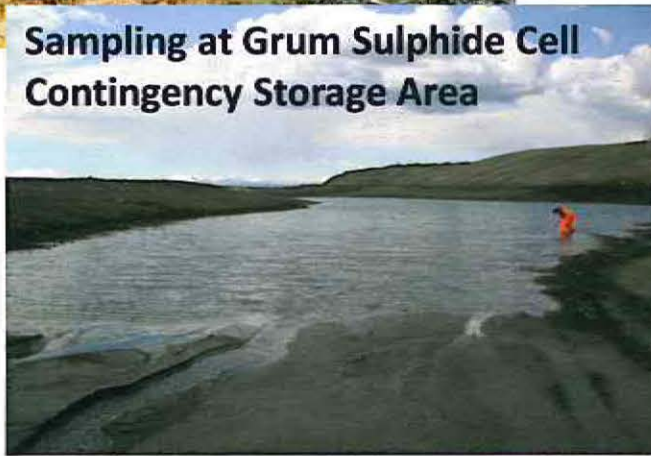
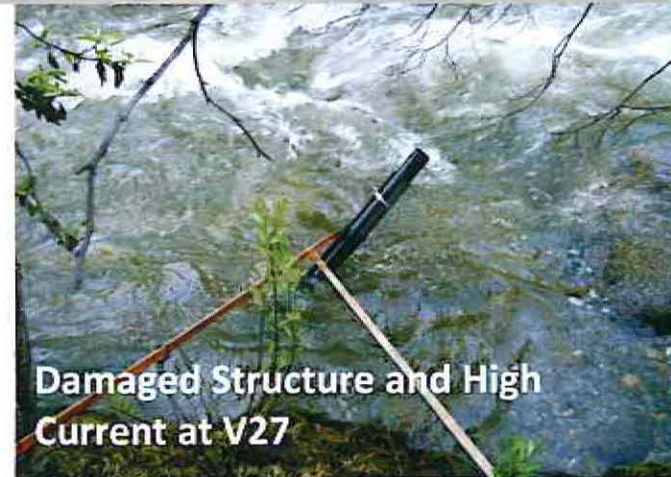
Damaged Structure and High  
Current at V27

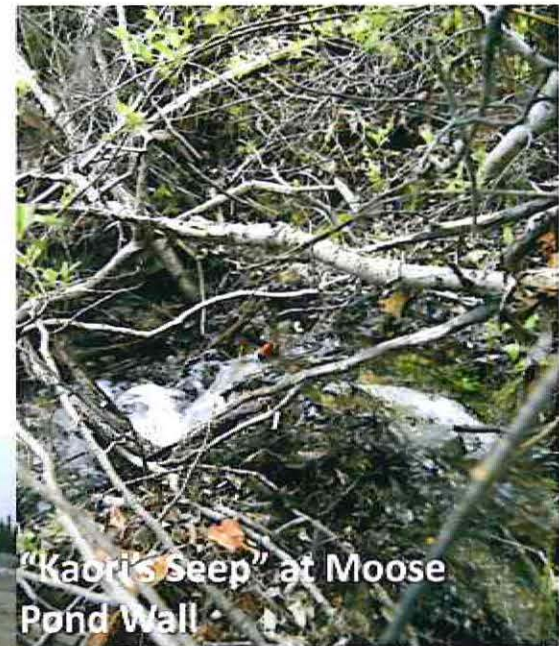
**"Kaori's Seep" at Moose Pond Wall**

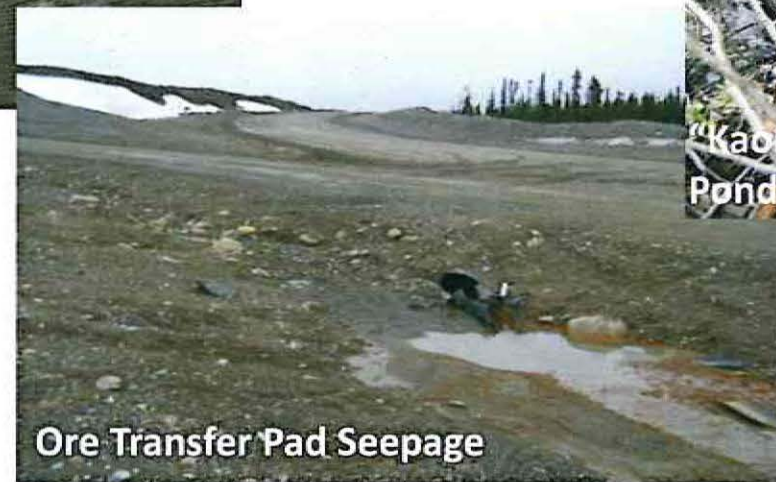
**Ore Transfer Pad Seepage**
