Vangorda Creek Diversion Design of Emergency Spillway and Recommendations for Flume Upgrade

*Project Reference Number:
SRK 1CD003.62*

October 2004

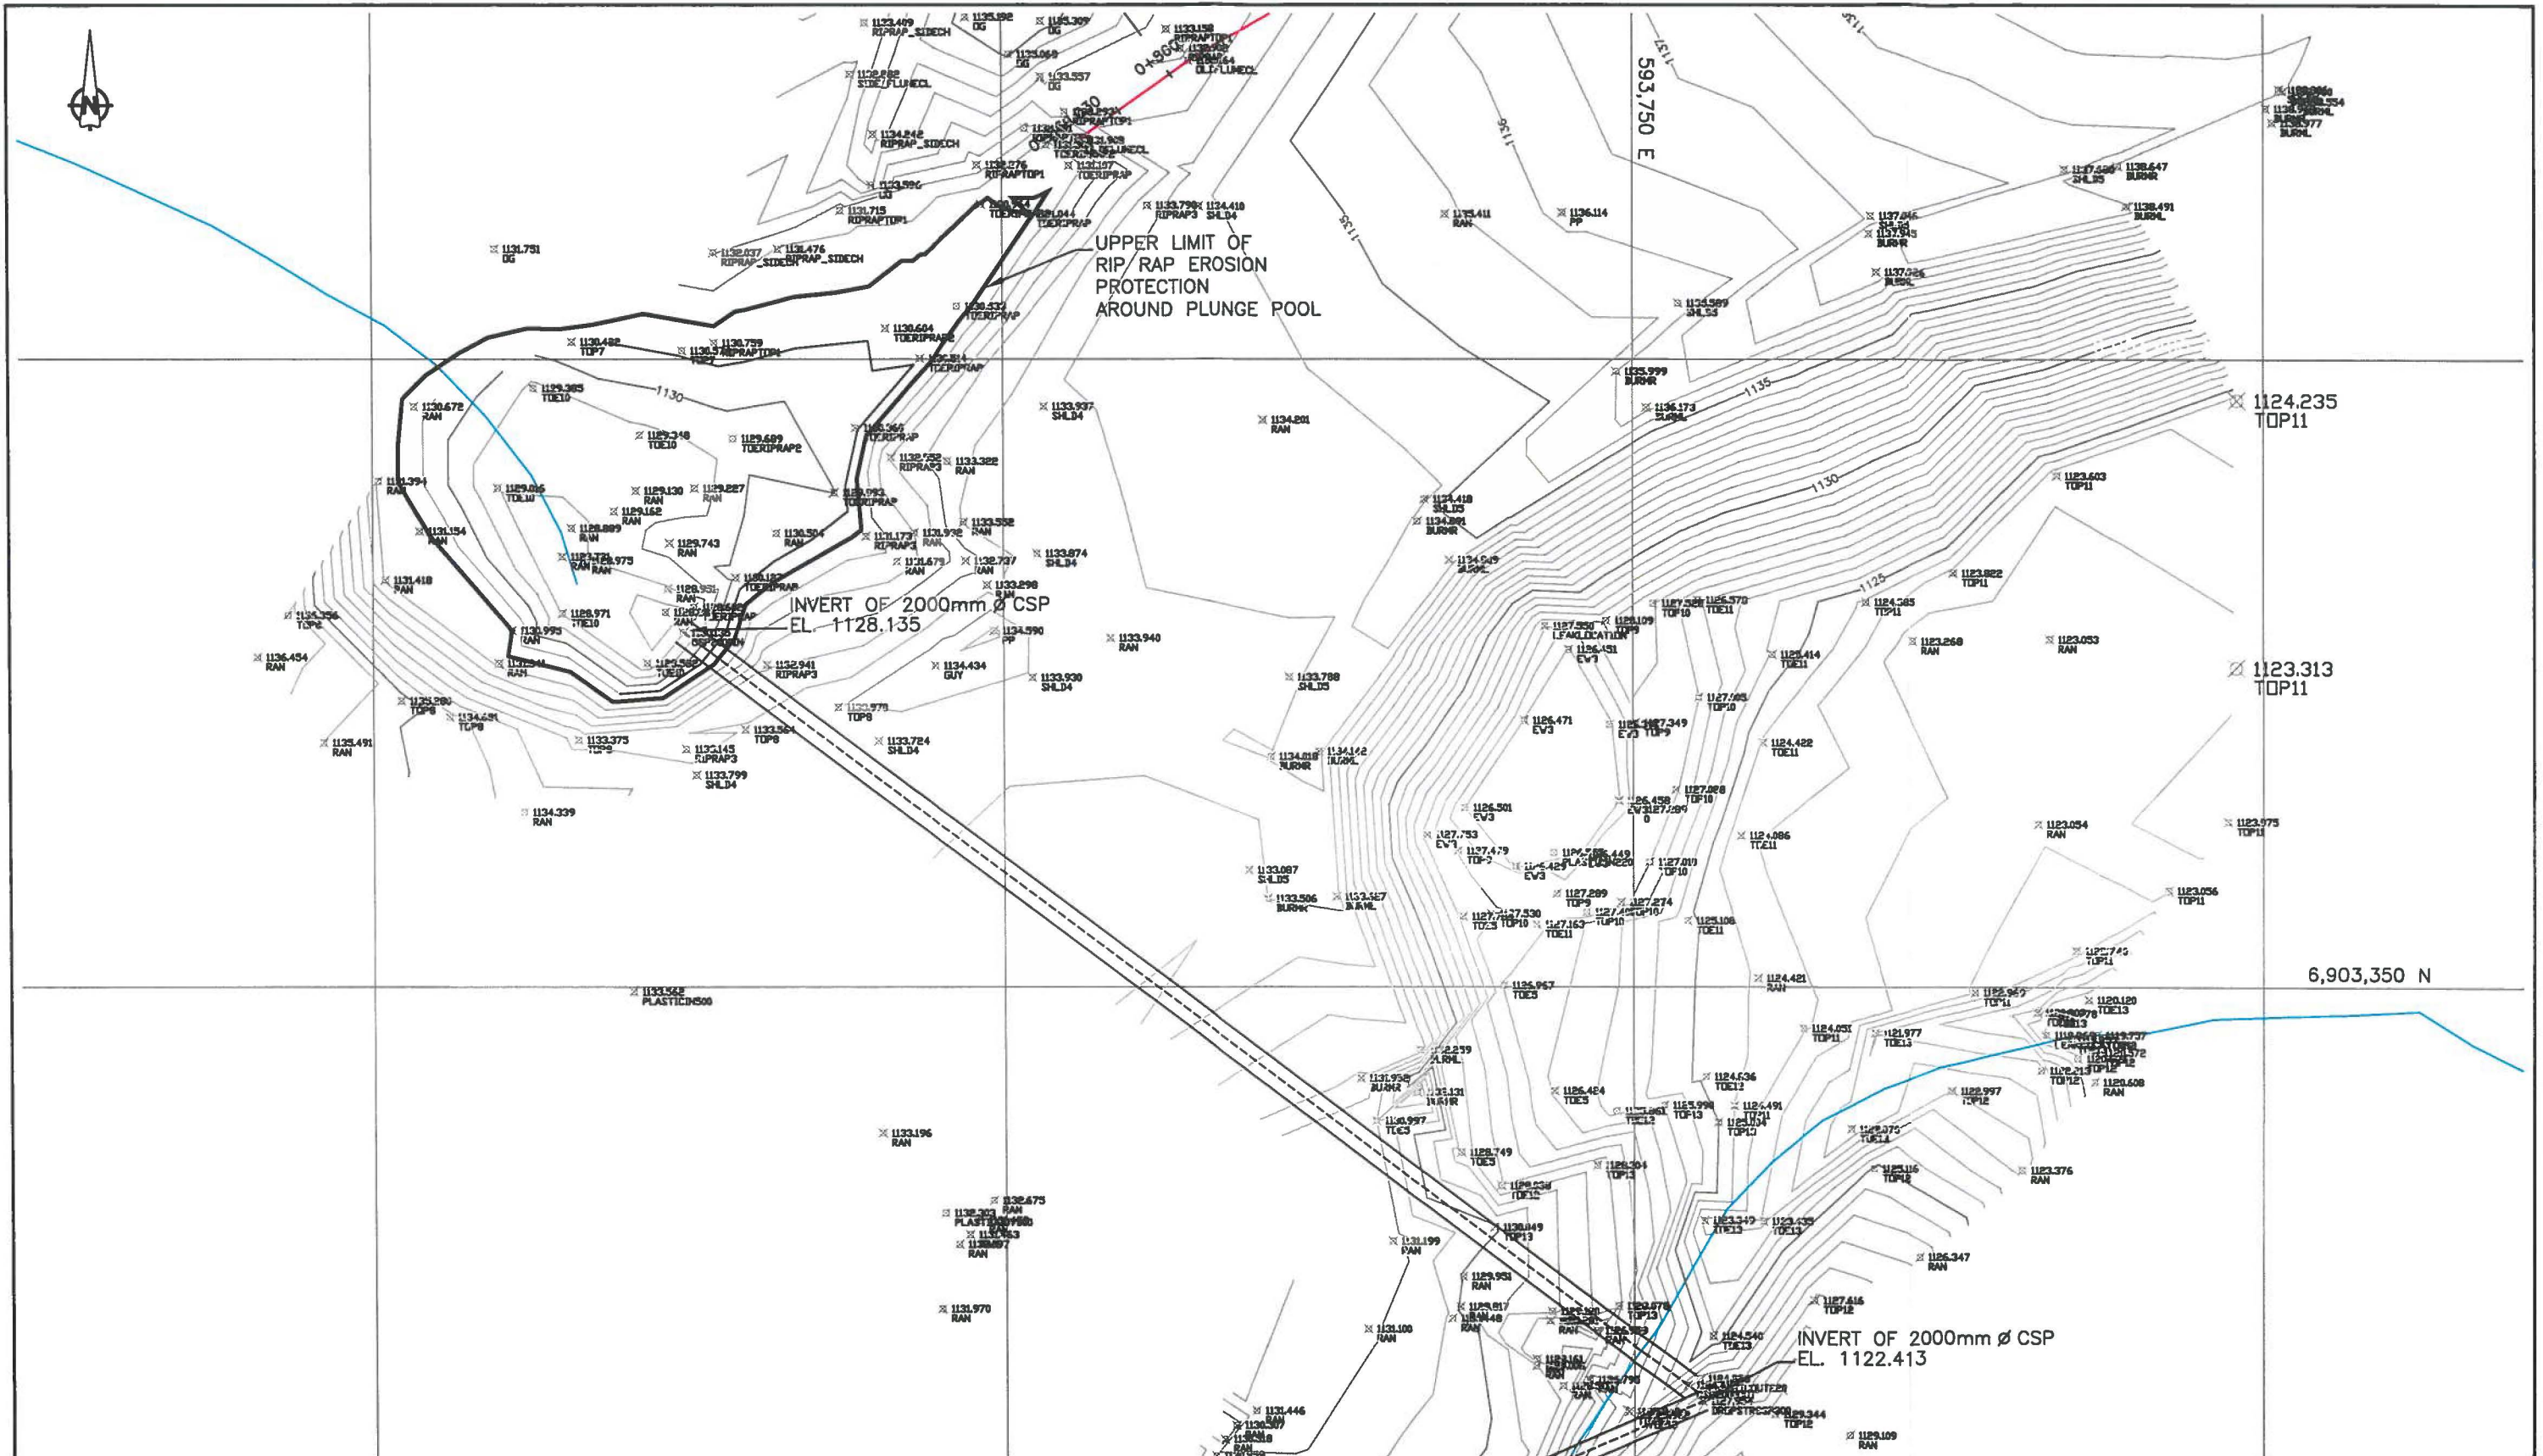
VANGORDA CREEK DIVERSION		
PLUNGE POOL SITE PLAN		
PROJECT NO. 1CD003.62	DATE OCT. 2004	FIGURE 13

During the June 8, 2004 flood event, a significant amount of debris accumulated in the bottom of the plunge pool and there was erosion of the sideslopes. SRK recommends that the debris be excavated out of the pool and riprap erosion protection be placed around the sides of the plunge pool to an height of at least 1m above the crown of the 2000mm CSP culvert. The riprap should have a D_{50} of at least 250mm and should be about 0.5m thick. Geotextile filter fabric should be placed on the slope prior to placing the riprap. The slopes should be no steeper than 1.5:1 (H:V). A layout of the plunge pool is shown on Figure 13.

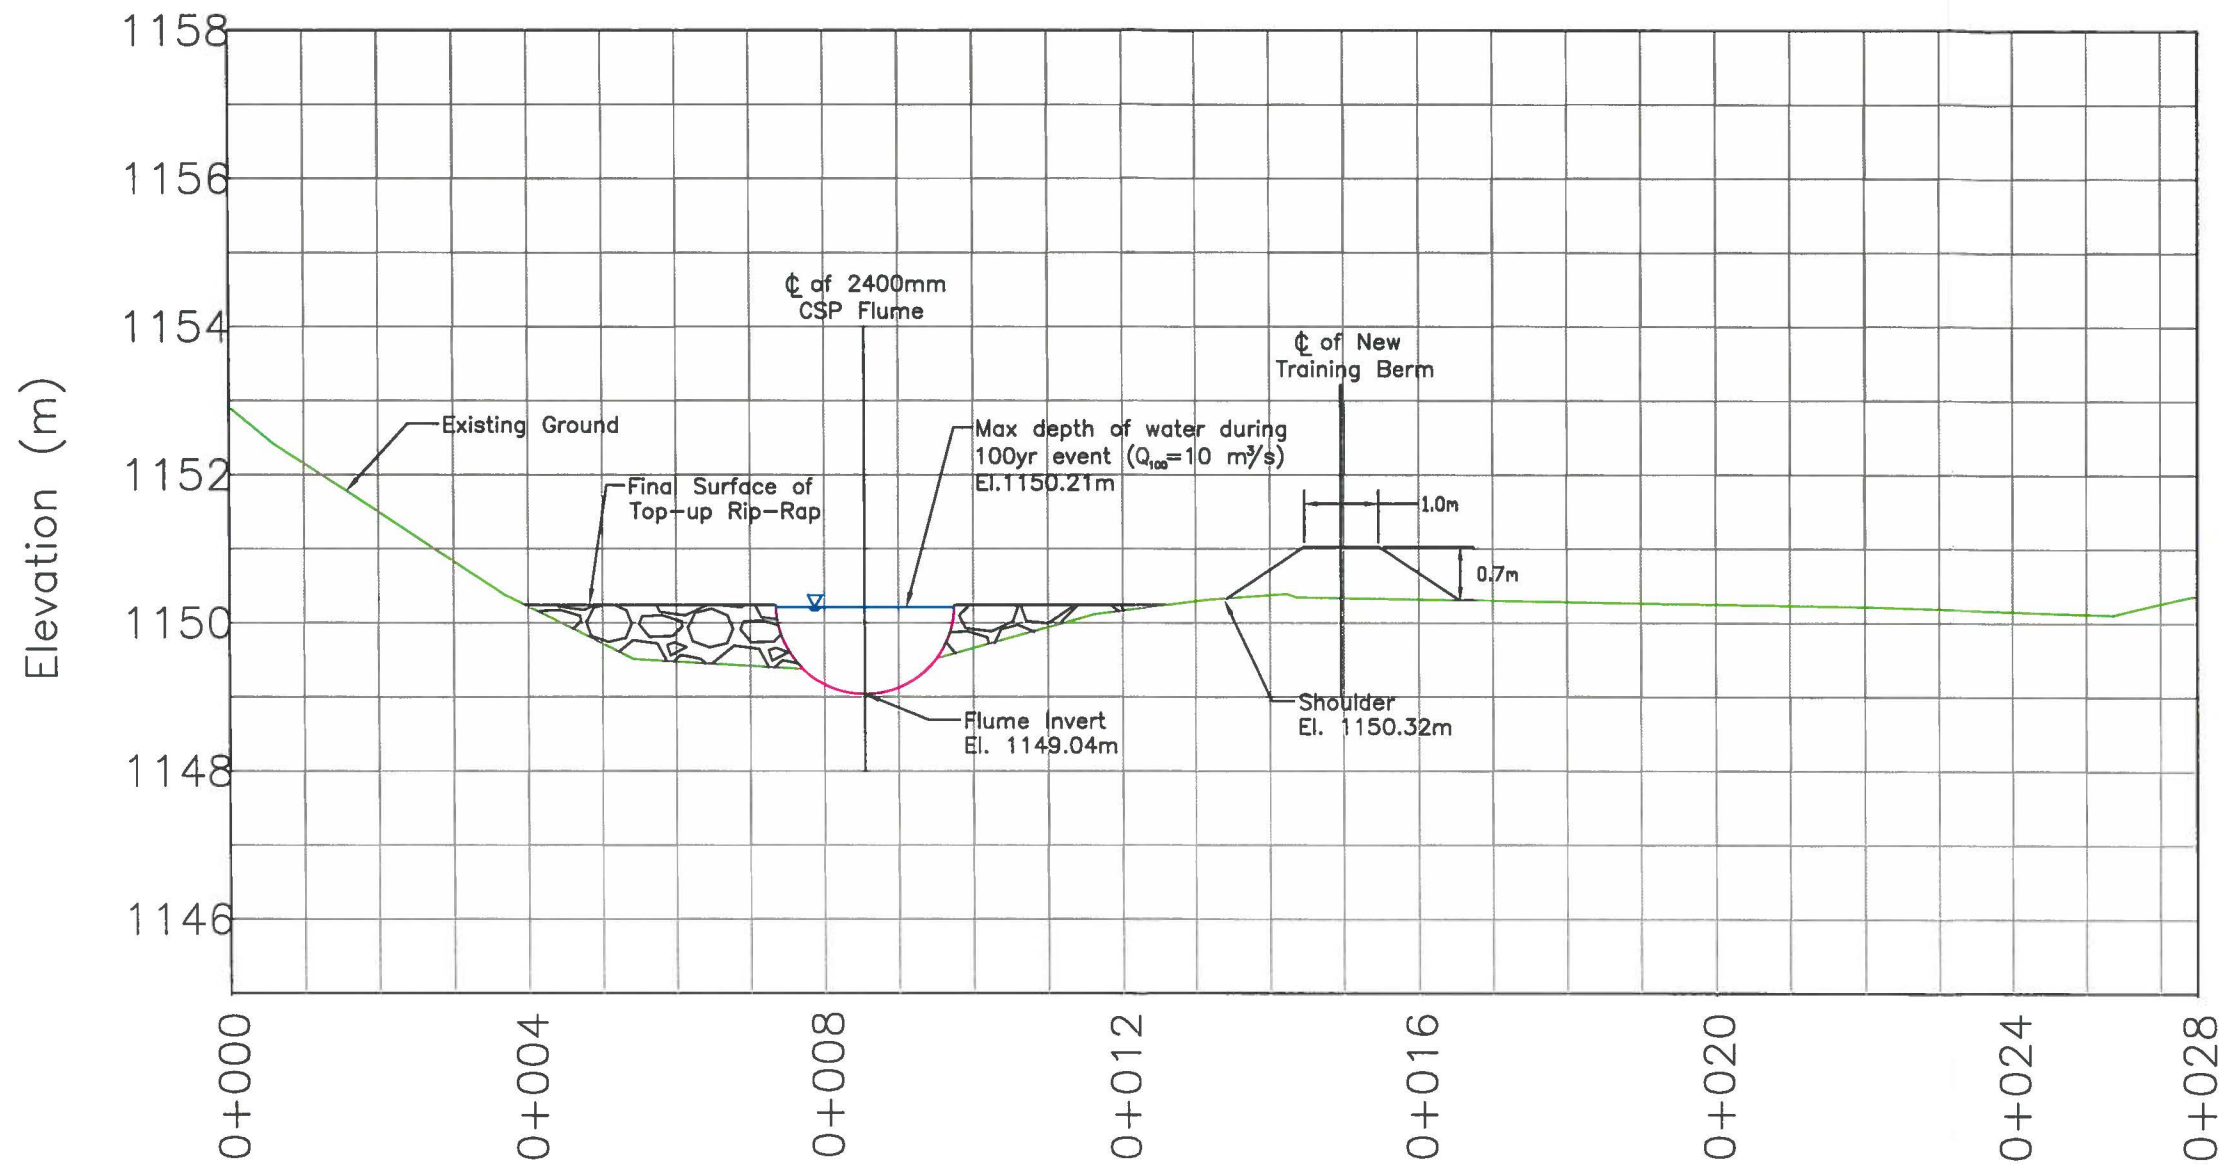
SRK Consulting <small>Engineers and Scientists</small>	VANGORDA CREEK DIVERSION		
	FLUME SECTION STATION 0+640		
 Deloitte & Touche	PROJECT NO. 1CD003.62	DATE OCT. 2004	FIGURE 15

Using the survey data provided by YES and input from the flood hydrology, a number of sections along the entire flume were developed to assess the hydraulic capacity of the current flume and overflow channel during the 100 year flood event ($Q_{100} = 10\text{m}^3/\text{s}$). It was found that in most places, as shown in Table 2, that the current configuration of the flume could accommodate the design event while maintaining a freeboard of 0.5m. However, between STA 0+610 and 0+650, the freeboard above the water surface during the peak flow of the 100 year event dropped below 0.5m. Sections along the flume between these stations are shown in Figures 15 to 17.

- Top-up the riprap within the overflow channel so that it becomes level with the top of the flume (See Figures 14 to 17)
- Construct a new training berm along the overflow channel from STA 0+610 to 0+650.(See Figure 18)

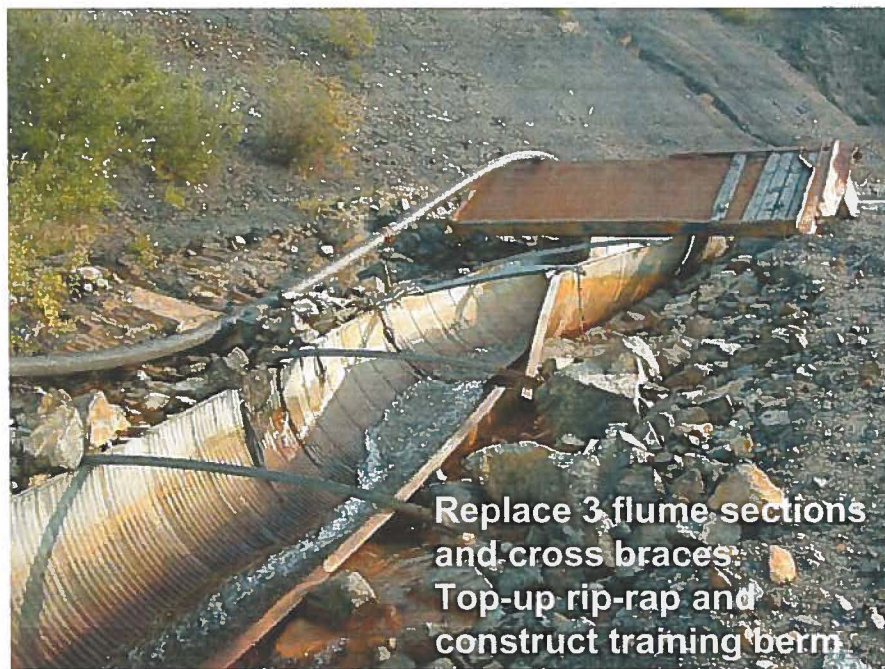
Photo 4: STA 0+640

The Vangorda Diversion flume was originally designed for a flow of 10m³/sec and consisted of a 2400mm half round CSP flume constructed within a riprap lined open channel. The flume was anchored down by steel plates connected by cables to cross braces laid over the flume. Although the current configuration of the flume performed well during the June 8, 2004 flood, the overflow channel came close to overtopping in a number of places. Furthermore, in many areas the riprap protection was washed away on each side of the flume which put hydraulic pressure on one section of the flume (STA 0+640) causing the flume to lift.

- Remove the old flume sections between STA 0+460 and 0+640;
- Replace damaged flume sections and cross braces;
- Repair flume sections and replace anchor plates where applicable;

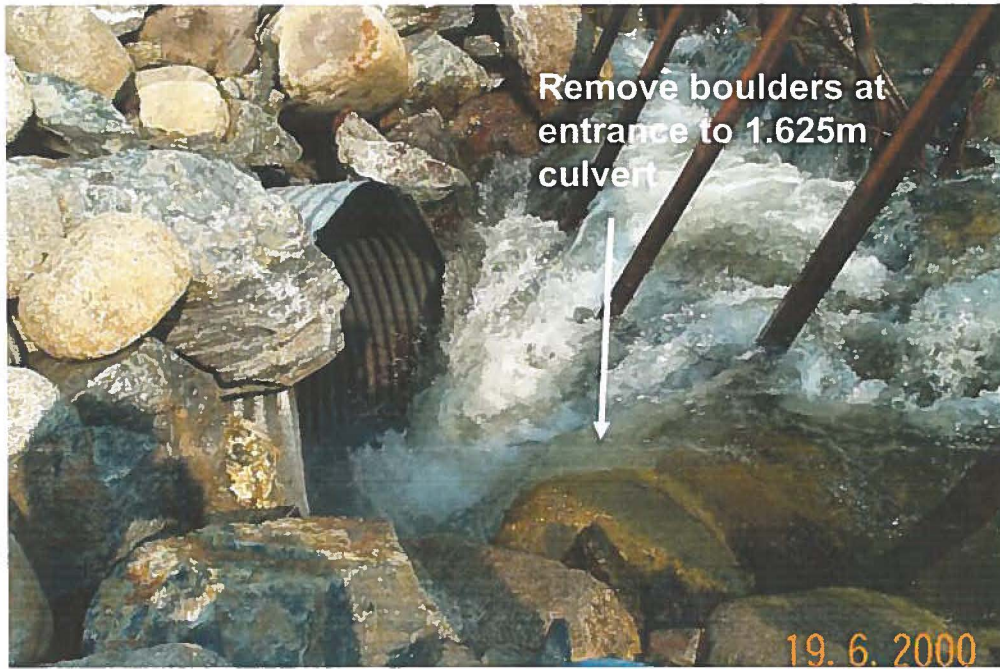
Photo 13:

As for the pool, debris also accumulated in the area immediately upstream of the existing culvert beneath the headworks embankment. Boulders partially block the entrance to the culvert as shown on Photo 13. SRK recommends that the debris in the immediate area above culvert be removed including the boulders.
