# Desktop Planning and Geotechnical Assessment, Vacant Lot, Golden Horn, Whitehorse, YT

Project No. 106523-01

April 13, 2022

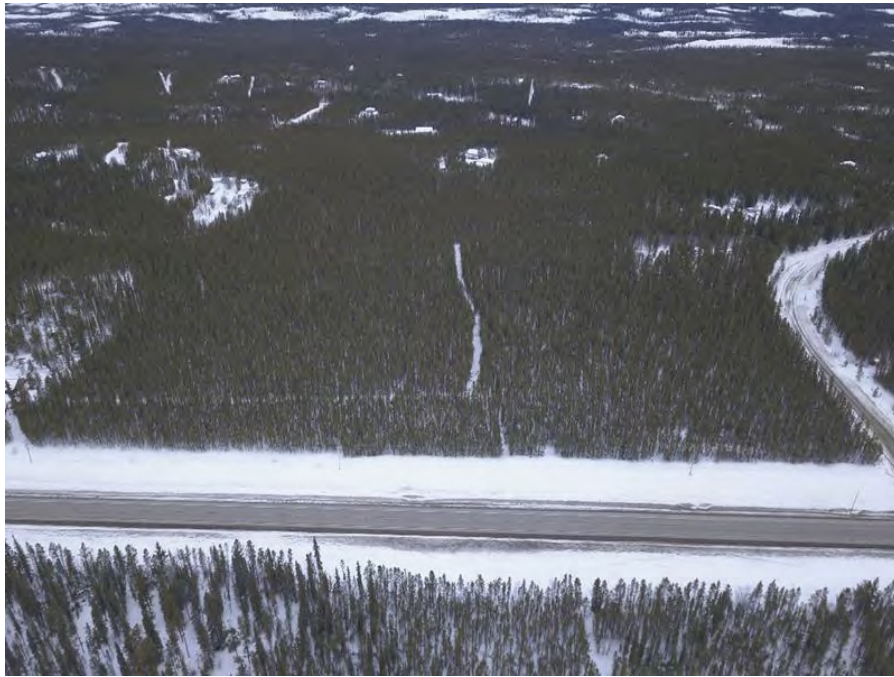
**Photo 1** View of vacant parcel site facing North during site visit (March 23, 2022).

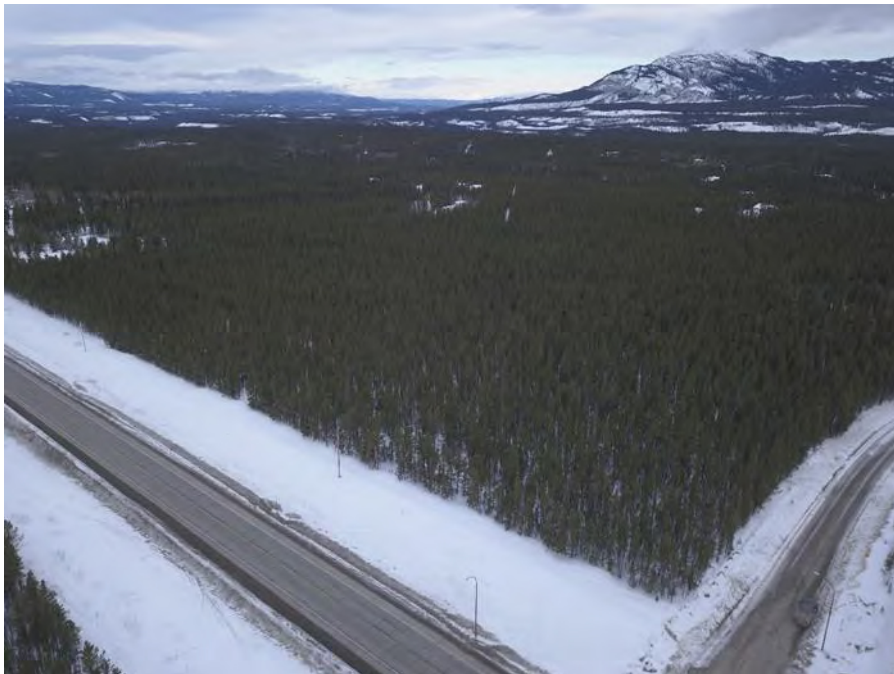
**Photo 2** View of vacant parcel site facing North-West during site visit (March 23, 2022).

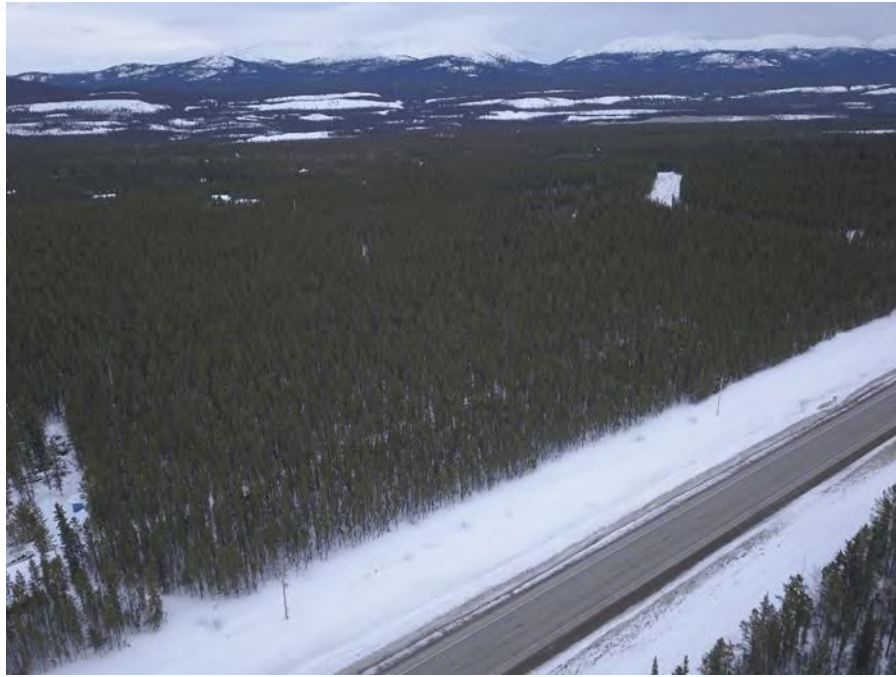
**Photo 3** View of vacant parcel site facing North-East during site visit (March 23, 2022).

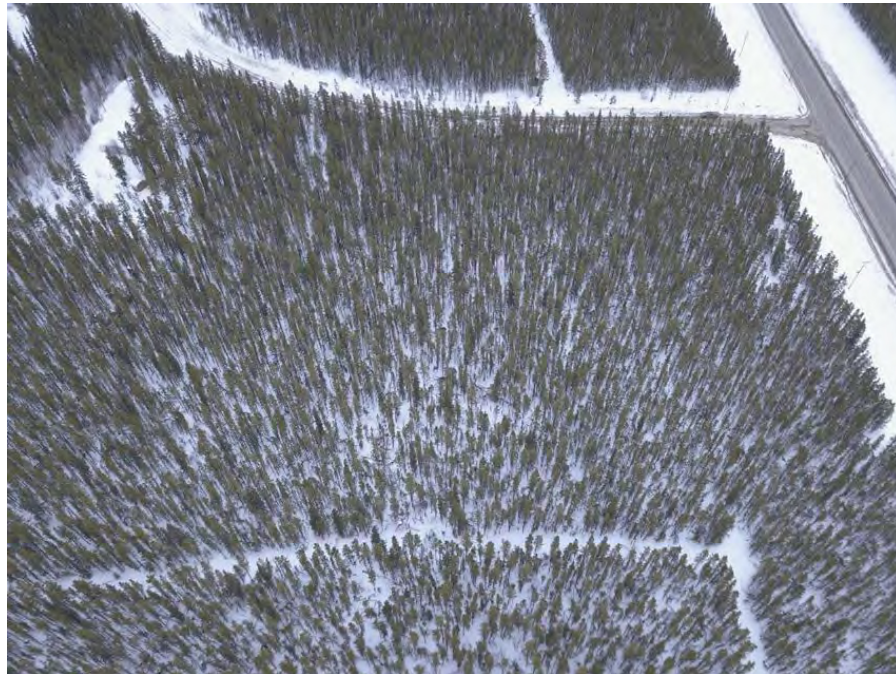
**Photo 4** View of West portion of vacant parcel site facing West during site visit (March 23, 2022).

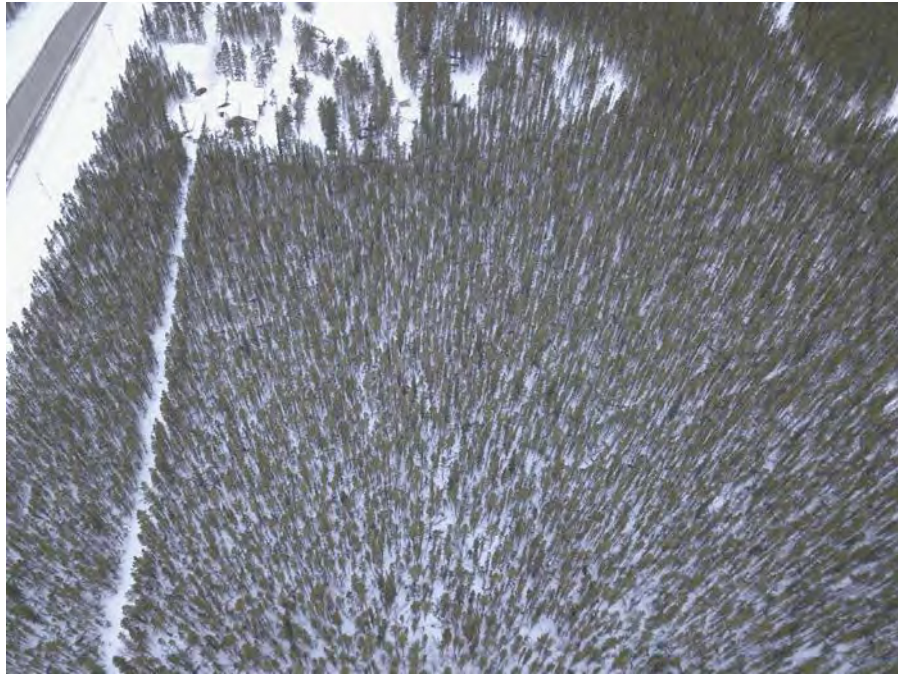
**Photo 5** View of East portion of vacant parcel site facing East during site visit (March 23, 2022).

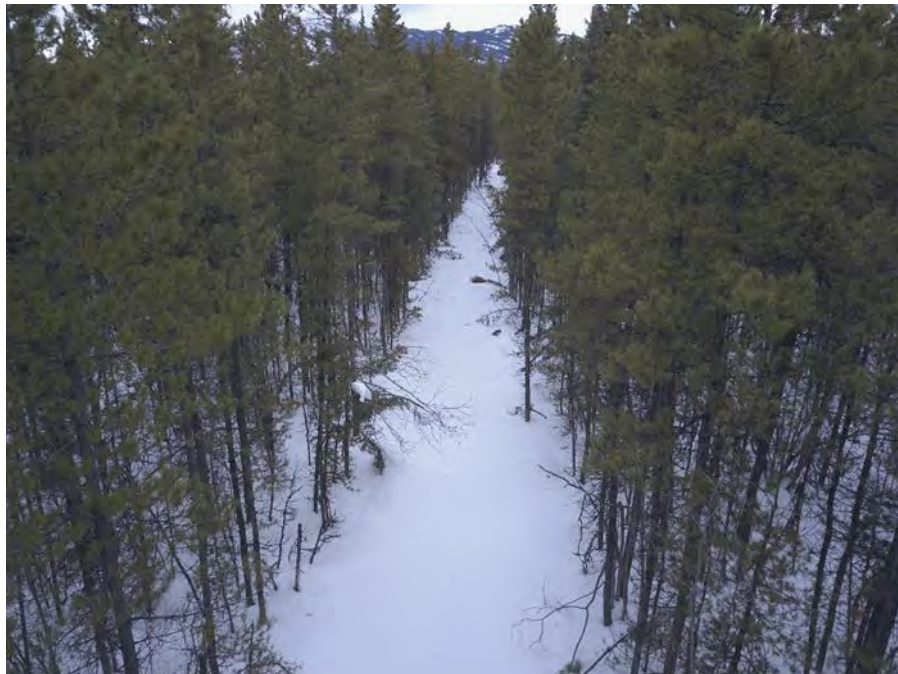
**Photo 6** View of cutline on vacant parcel site facing North during site visit (March 23, 2022).

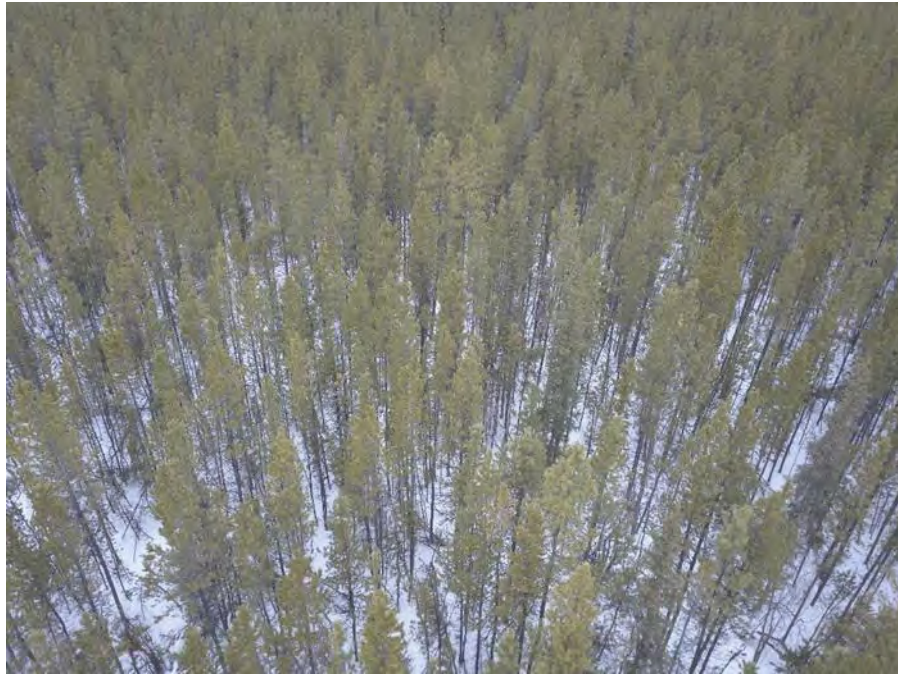
The Site is 6.18ha in size, unoccupied, generally flat and covered with spruce and pine trees (Photos 7 and 8 in **Appendix A**). It does not seem to have been previously disturbed except for a narrow cutline that runs from the North side of the site down the center before exiting to the West of the site. The cutline's purpose is unknown, but it is approximately 3.8m wide which is not wide enough to be a powerline easement. The site is surrounded by rural residential properties to the north, one commercial property to the West, and a powerline easement land disposition immediately to the South. Further south bordering the site is the Alaska Highway right-of-way. A map showing the details of the surrounding properties is attached (**Figure 5**).

**Photo 7** View of vegetation on vacant parcel site facing North during site visit (March 23, 2022).

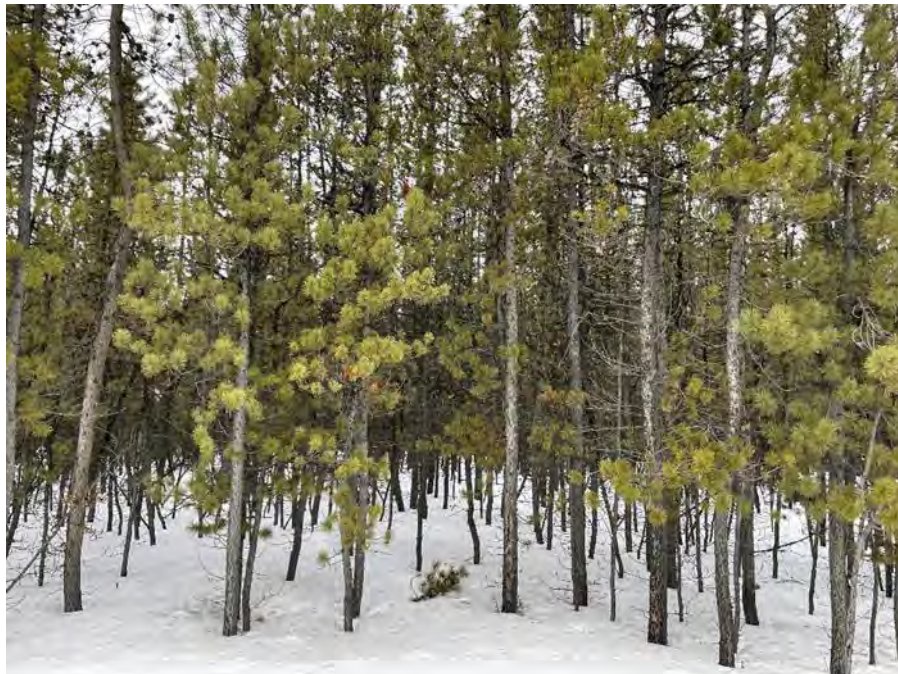
**Photo 8** Close up View of vegetation on vacant parcel site facing West from Venus Road during site visit (March 23, 2022).

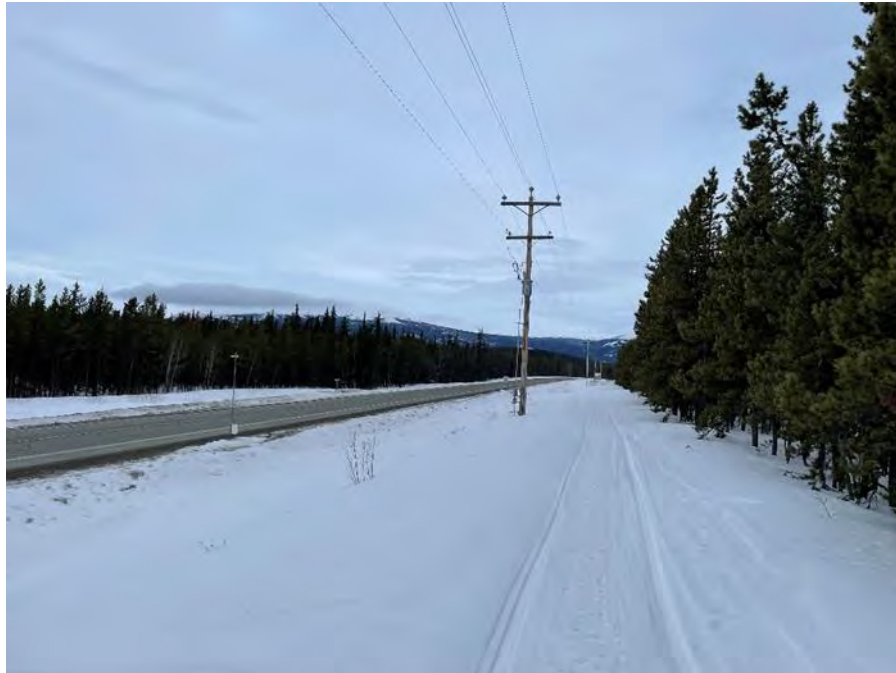
The only land disposition near the site is the overhead utility powerline easement to the South that borders the edge of the site and runs along the Alaska Highway. There are also various reservation land dispositions for environmental and gravel quarry purpose in the area.

**Photo 9** View of overhead powerline easement along the Alaska Hwy facing West during site visit (March 23, 2022).
