BACKGROUND PAPER ON  
HAINES-FAIRBANKS (YUKON) FUEL-OIL PIPELINE

## HAINES-FAIRBANKS PIPELINE - YUKON TERRITORY

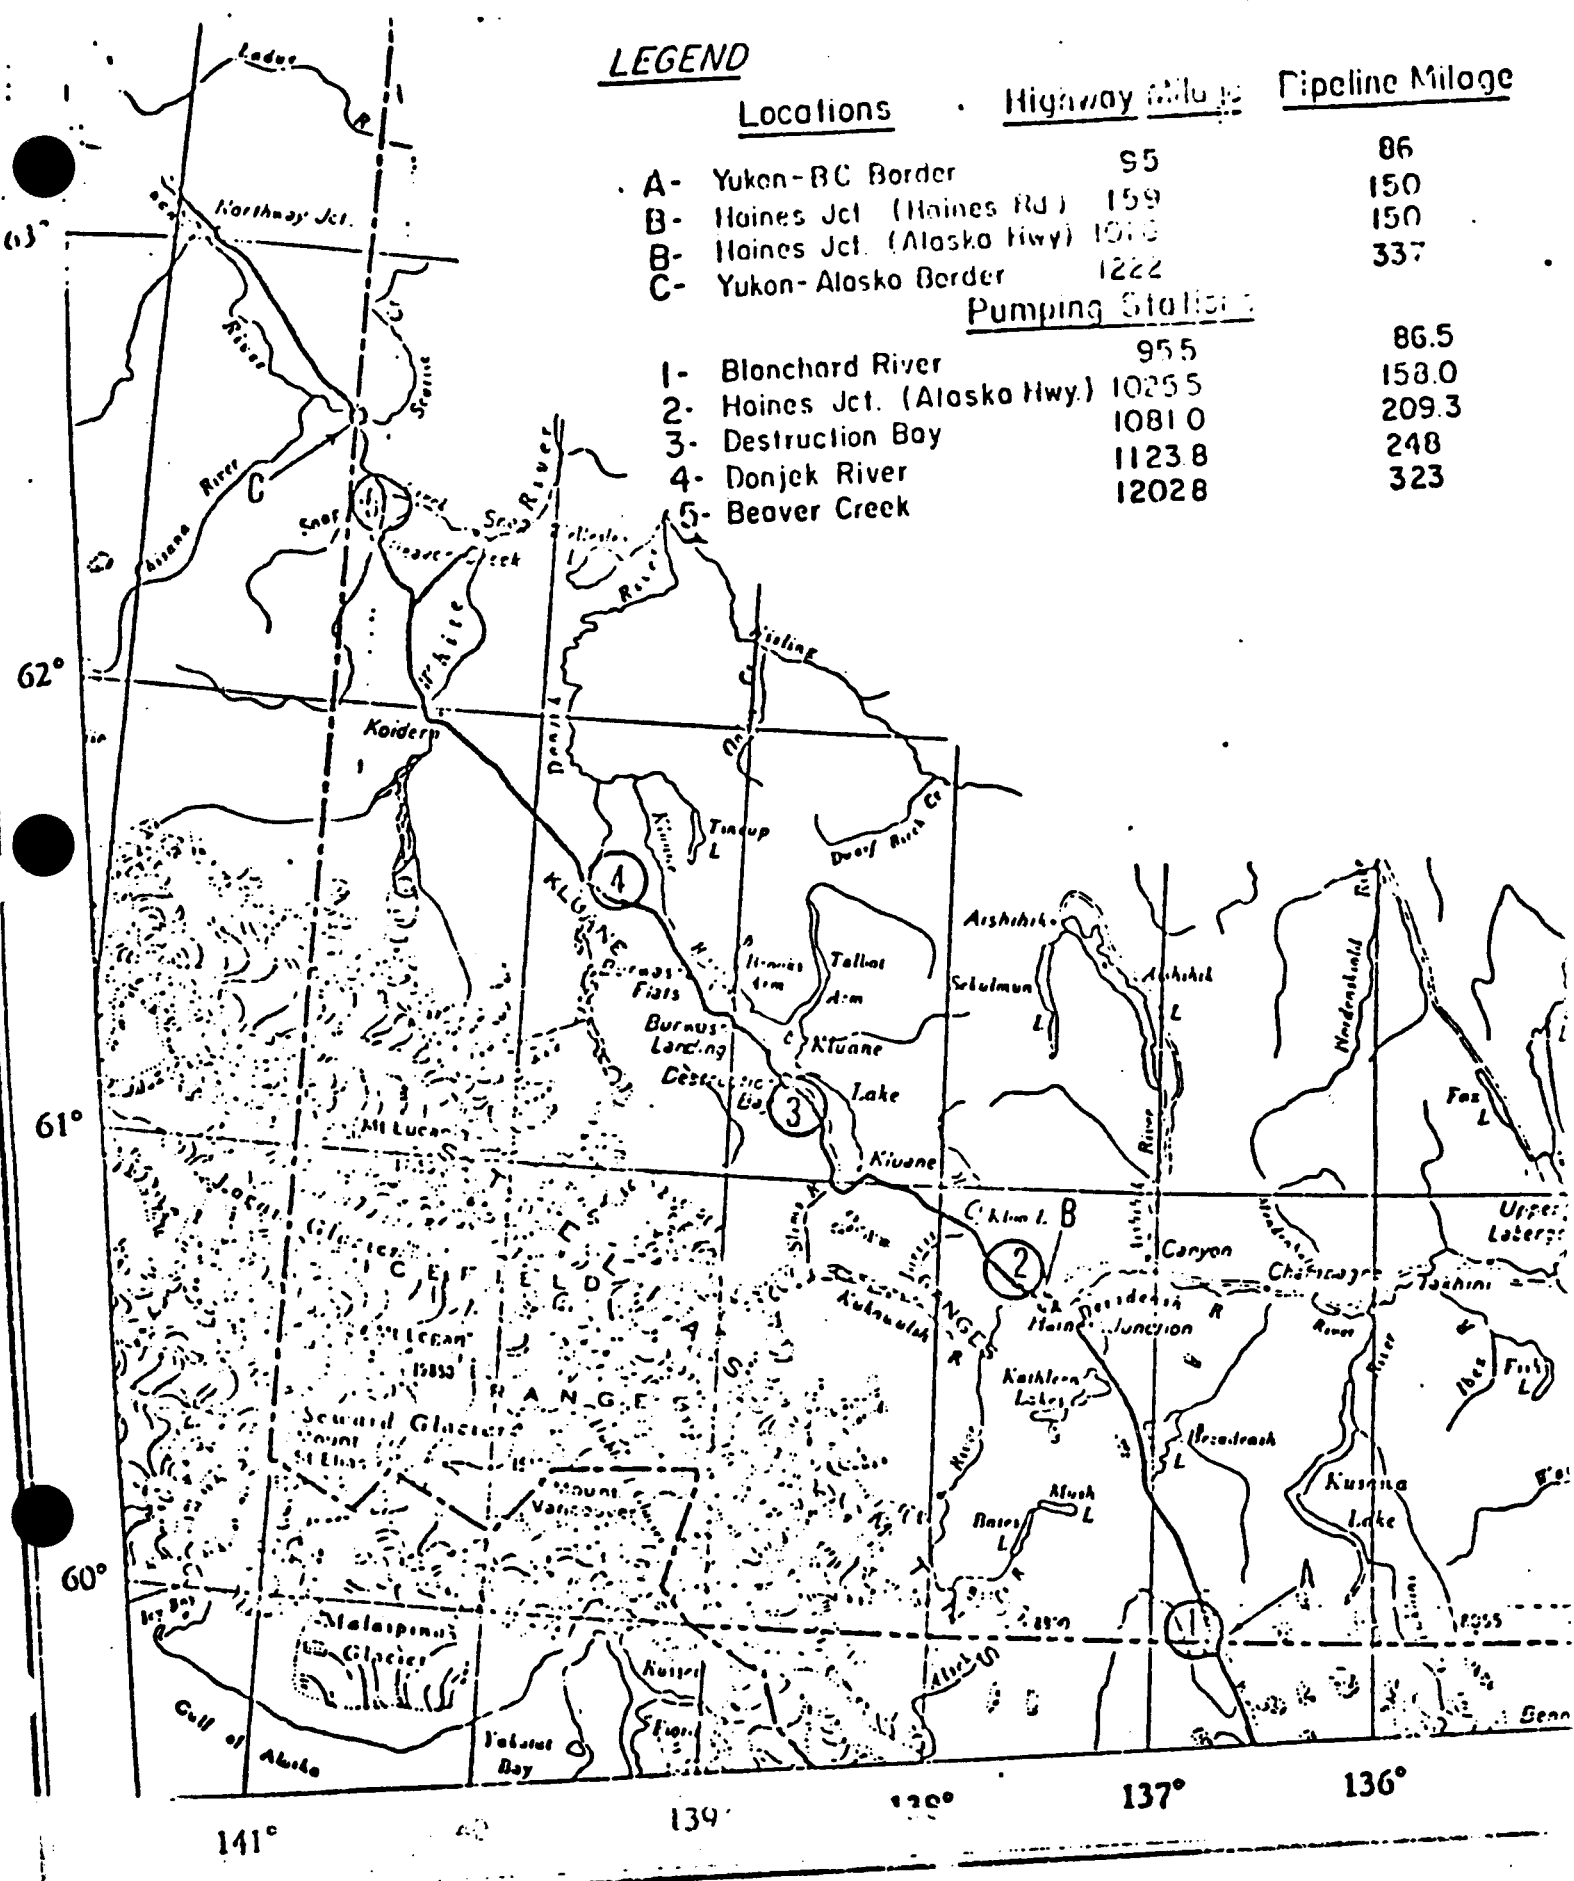
A reference map is presented in Figure 1 indicating the pipeline route.
