Annual Quartz Mining Licence Report for 2024

Property Sä Dena Hes Mine
Company Sä Dena Hes Operating Corporation
 c/o Teck Resources Limited
Permit # QML-0004

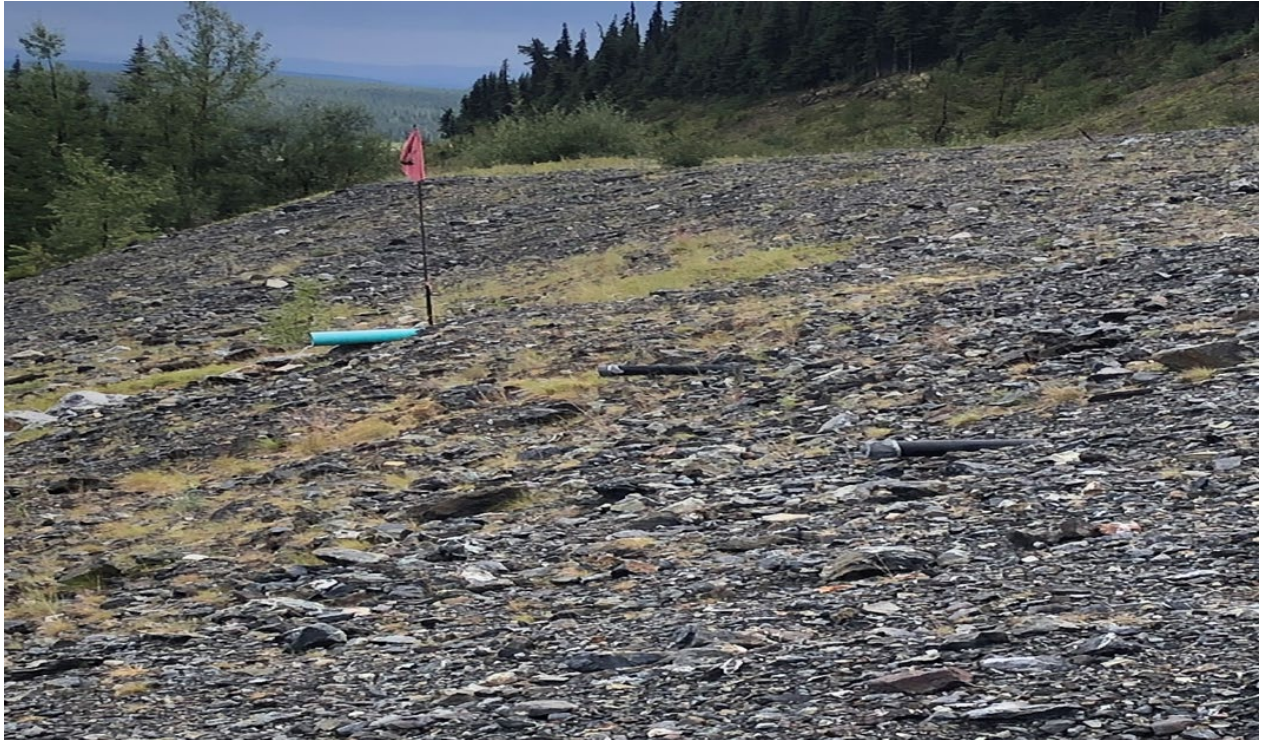
Looking East towards three portal drains
