GEOLOGICAL SURVEY OF CANADA
TOPICAL REPORT NO. 100

YUKON RIVER DRAINAGE BASIN
DAM SITE INVESTIGATION

SITE No. 24

INDEPENDENCE DAM SITE
(MAP AND PRELIMINARY REPORT)

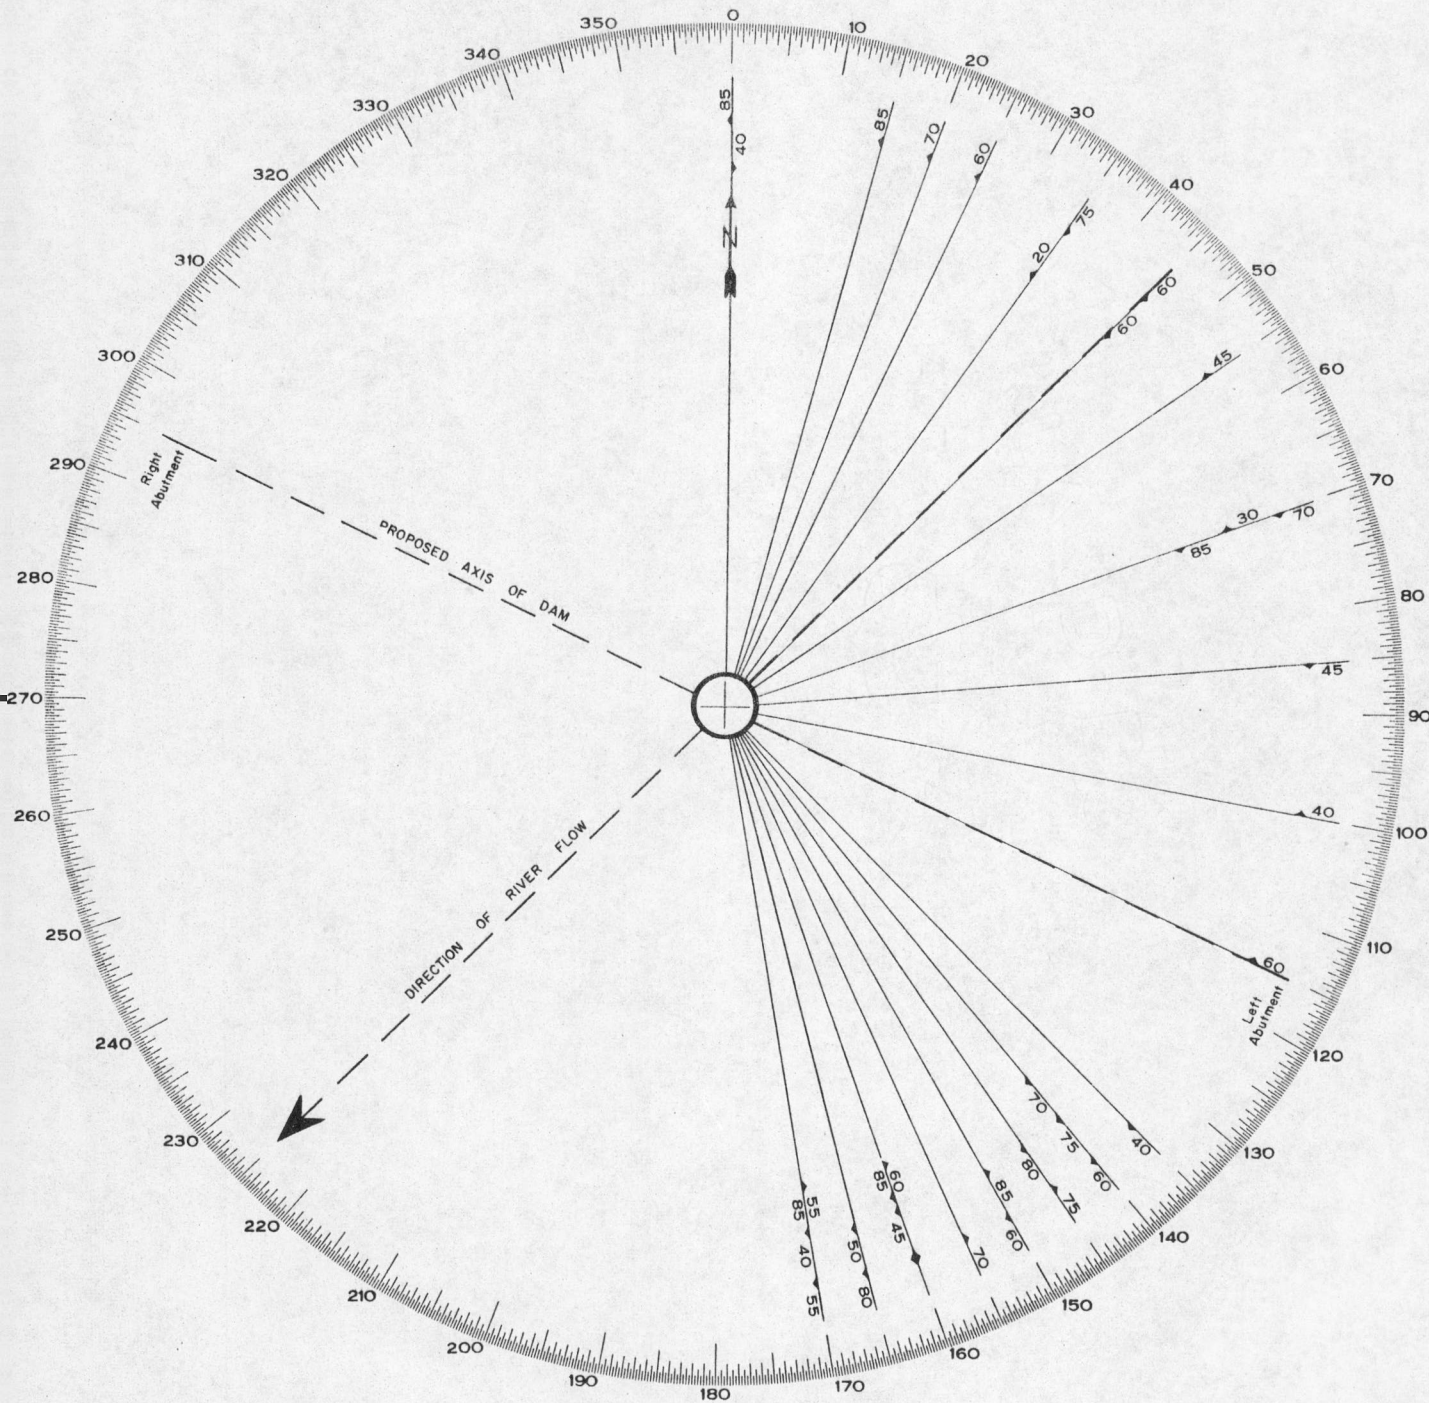
JOINT ROSETTE

on the left abutment slope. The fresh granite is a sound, competent rock and should provide satisfactory abutment and foundation material. Jointing is the only structure which might effect its competency. Two fairly prominent joint sets are present, one is parallel to the river and the other at about 60 degrees. The spacing varies from a few inches to several feet. The jointing is commonly tight but some grouting will be necessary to prevent leakage beneath the dam. On bedrock surface some of the fractures are open as much as 3 inches. The attitudes on the accompanying joint rosette are representative of the jointing at the site.

The above illustration presents diagrammatically the direction and dip of jointing in bedrock exposed at Independence site

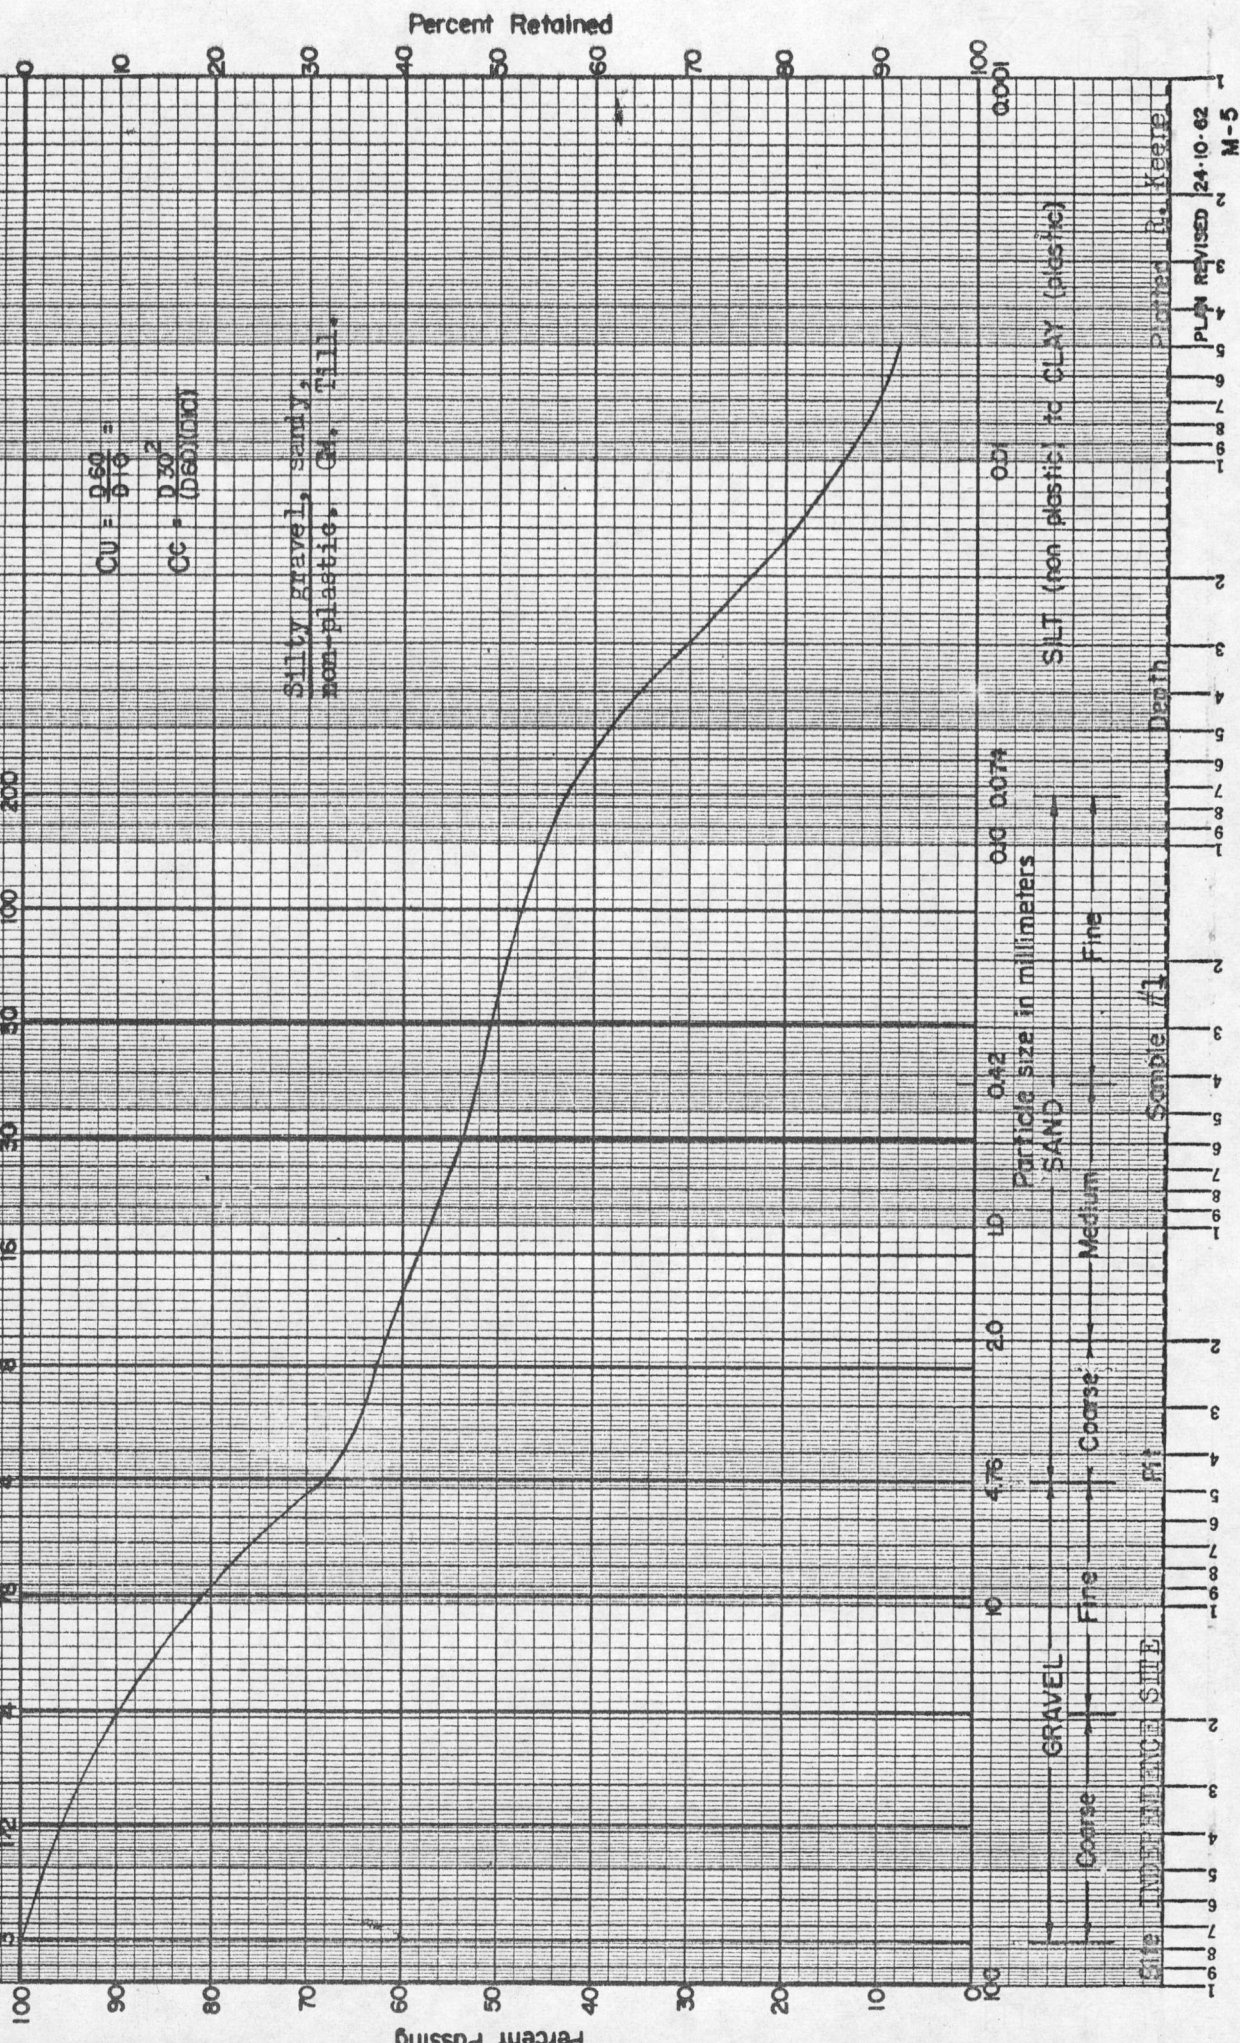
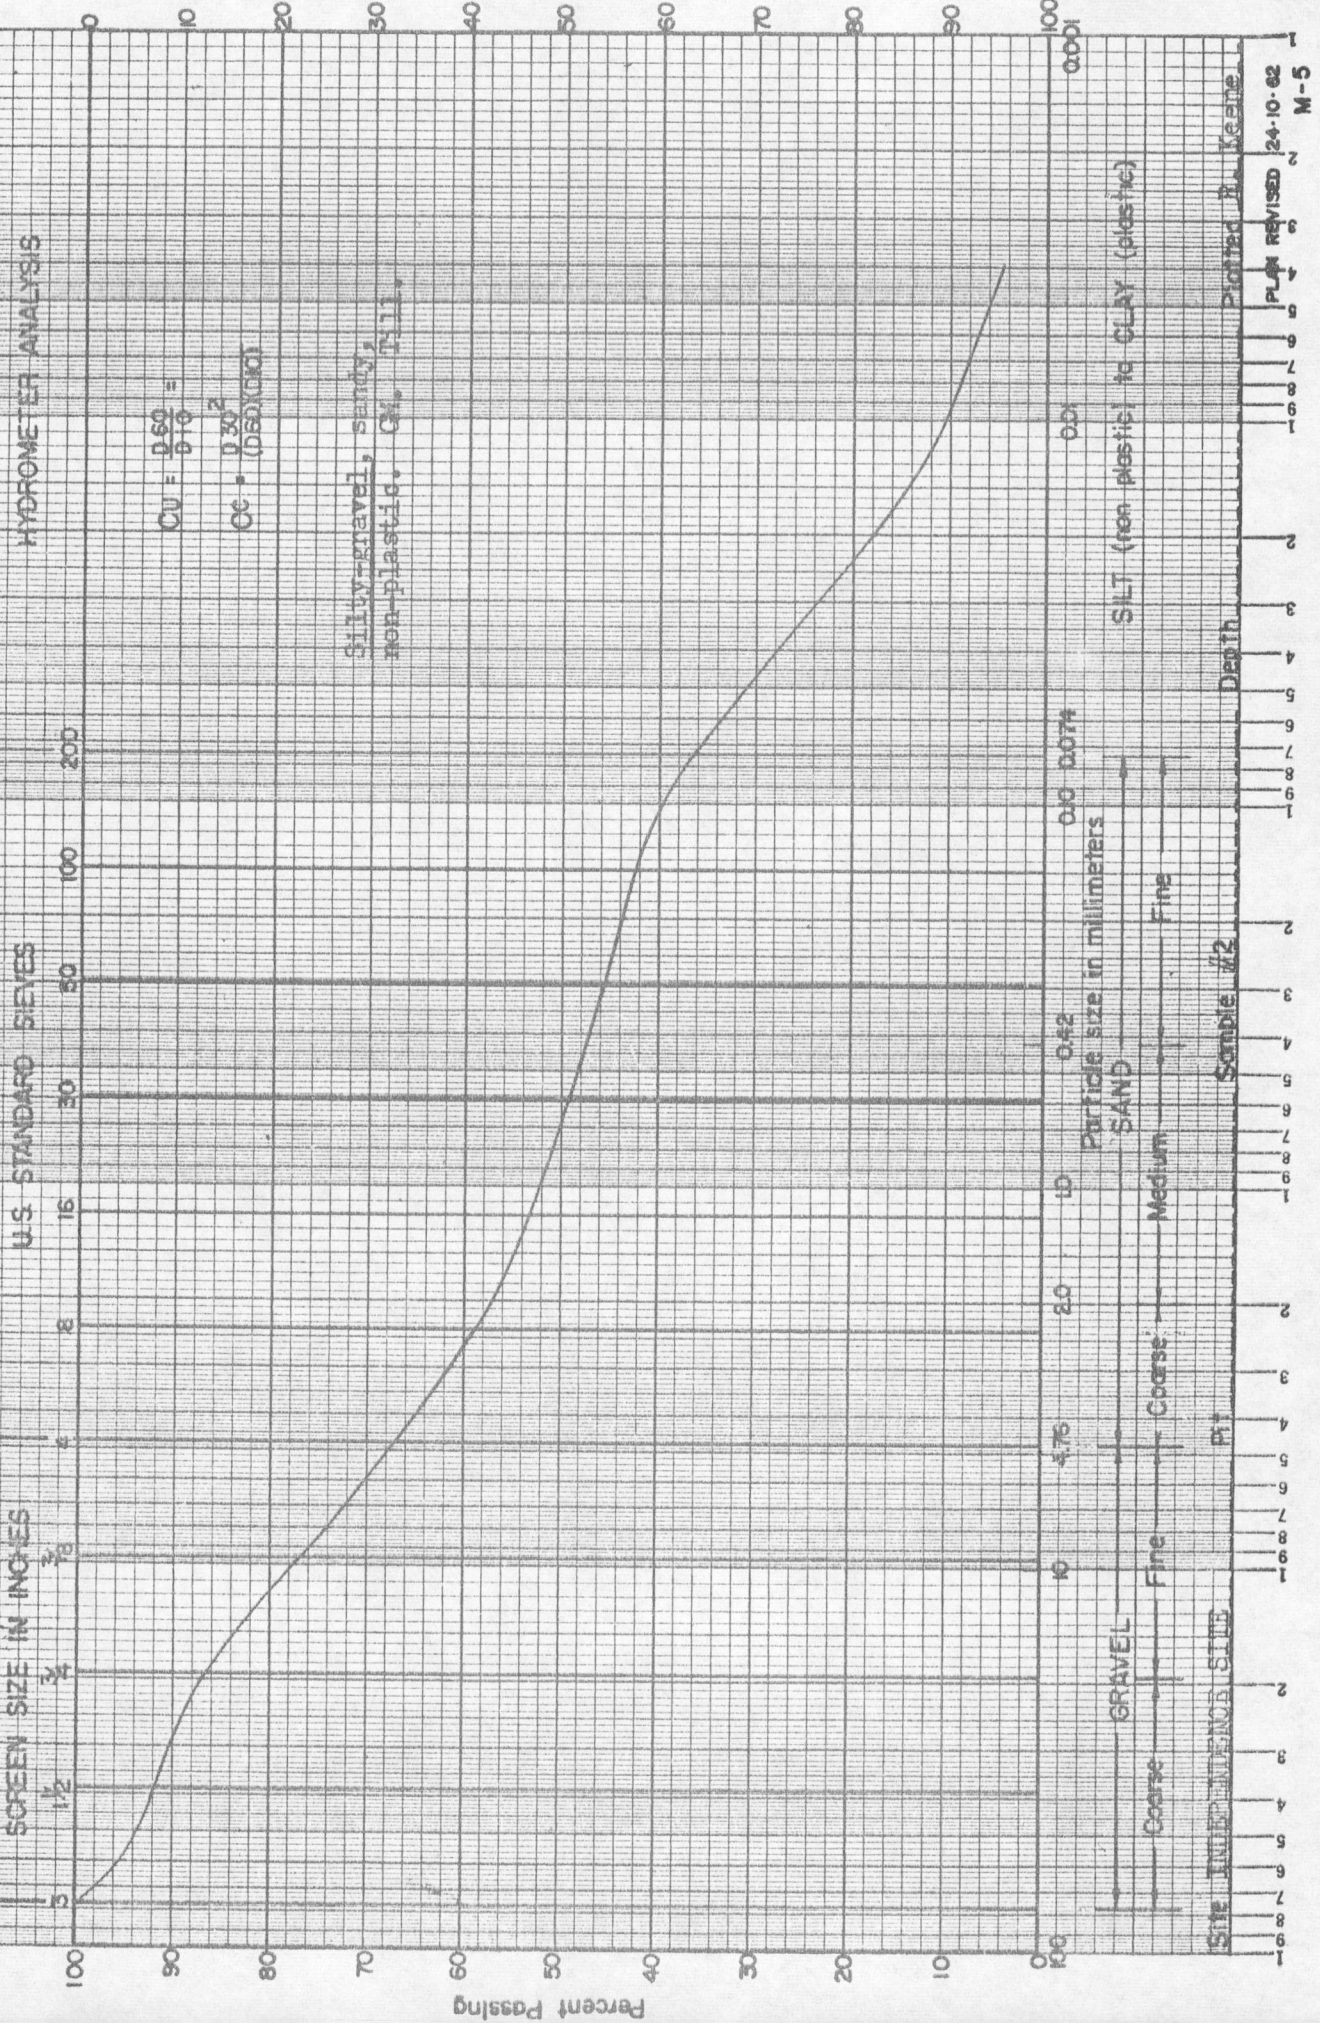
Sample Number	Location	Field Description of Material	Field Description of Overburden	Thickness of Deposit	Areal Extent (Estimated)	Remarks
1	Station E-30; 3 feet beneath ground surface; left abutment area	Till: grey, silty, sandy; angular boulders to 12 inches chiefly schist, white quartz and weathered granite with many small, black chert pebbles	None	3+ feet	very large	Frost line at 42 inches
2	Station E-29; 30 inches beneath ground surface; left abutment area	Till: grey, silty, sandy, medium dense; angular pebbles and cobbles to 8 inches of schist, white quartz and weathered granite, about 25% of pebbles are black chert.	None	30+ inches	very large	Frost line at 36 inches

Silty-gravel, sandy, non-plastic, GW, fill.

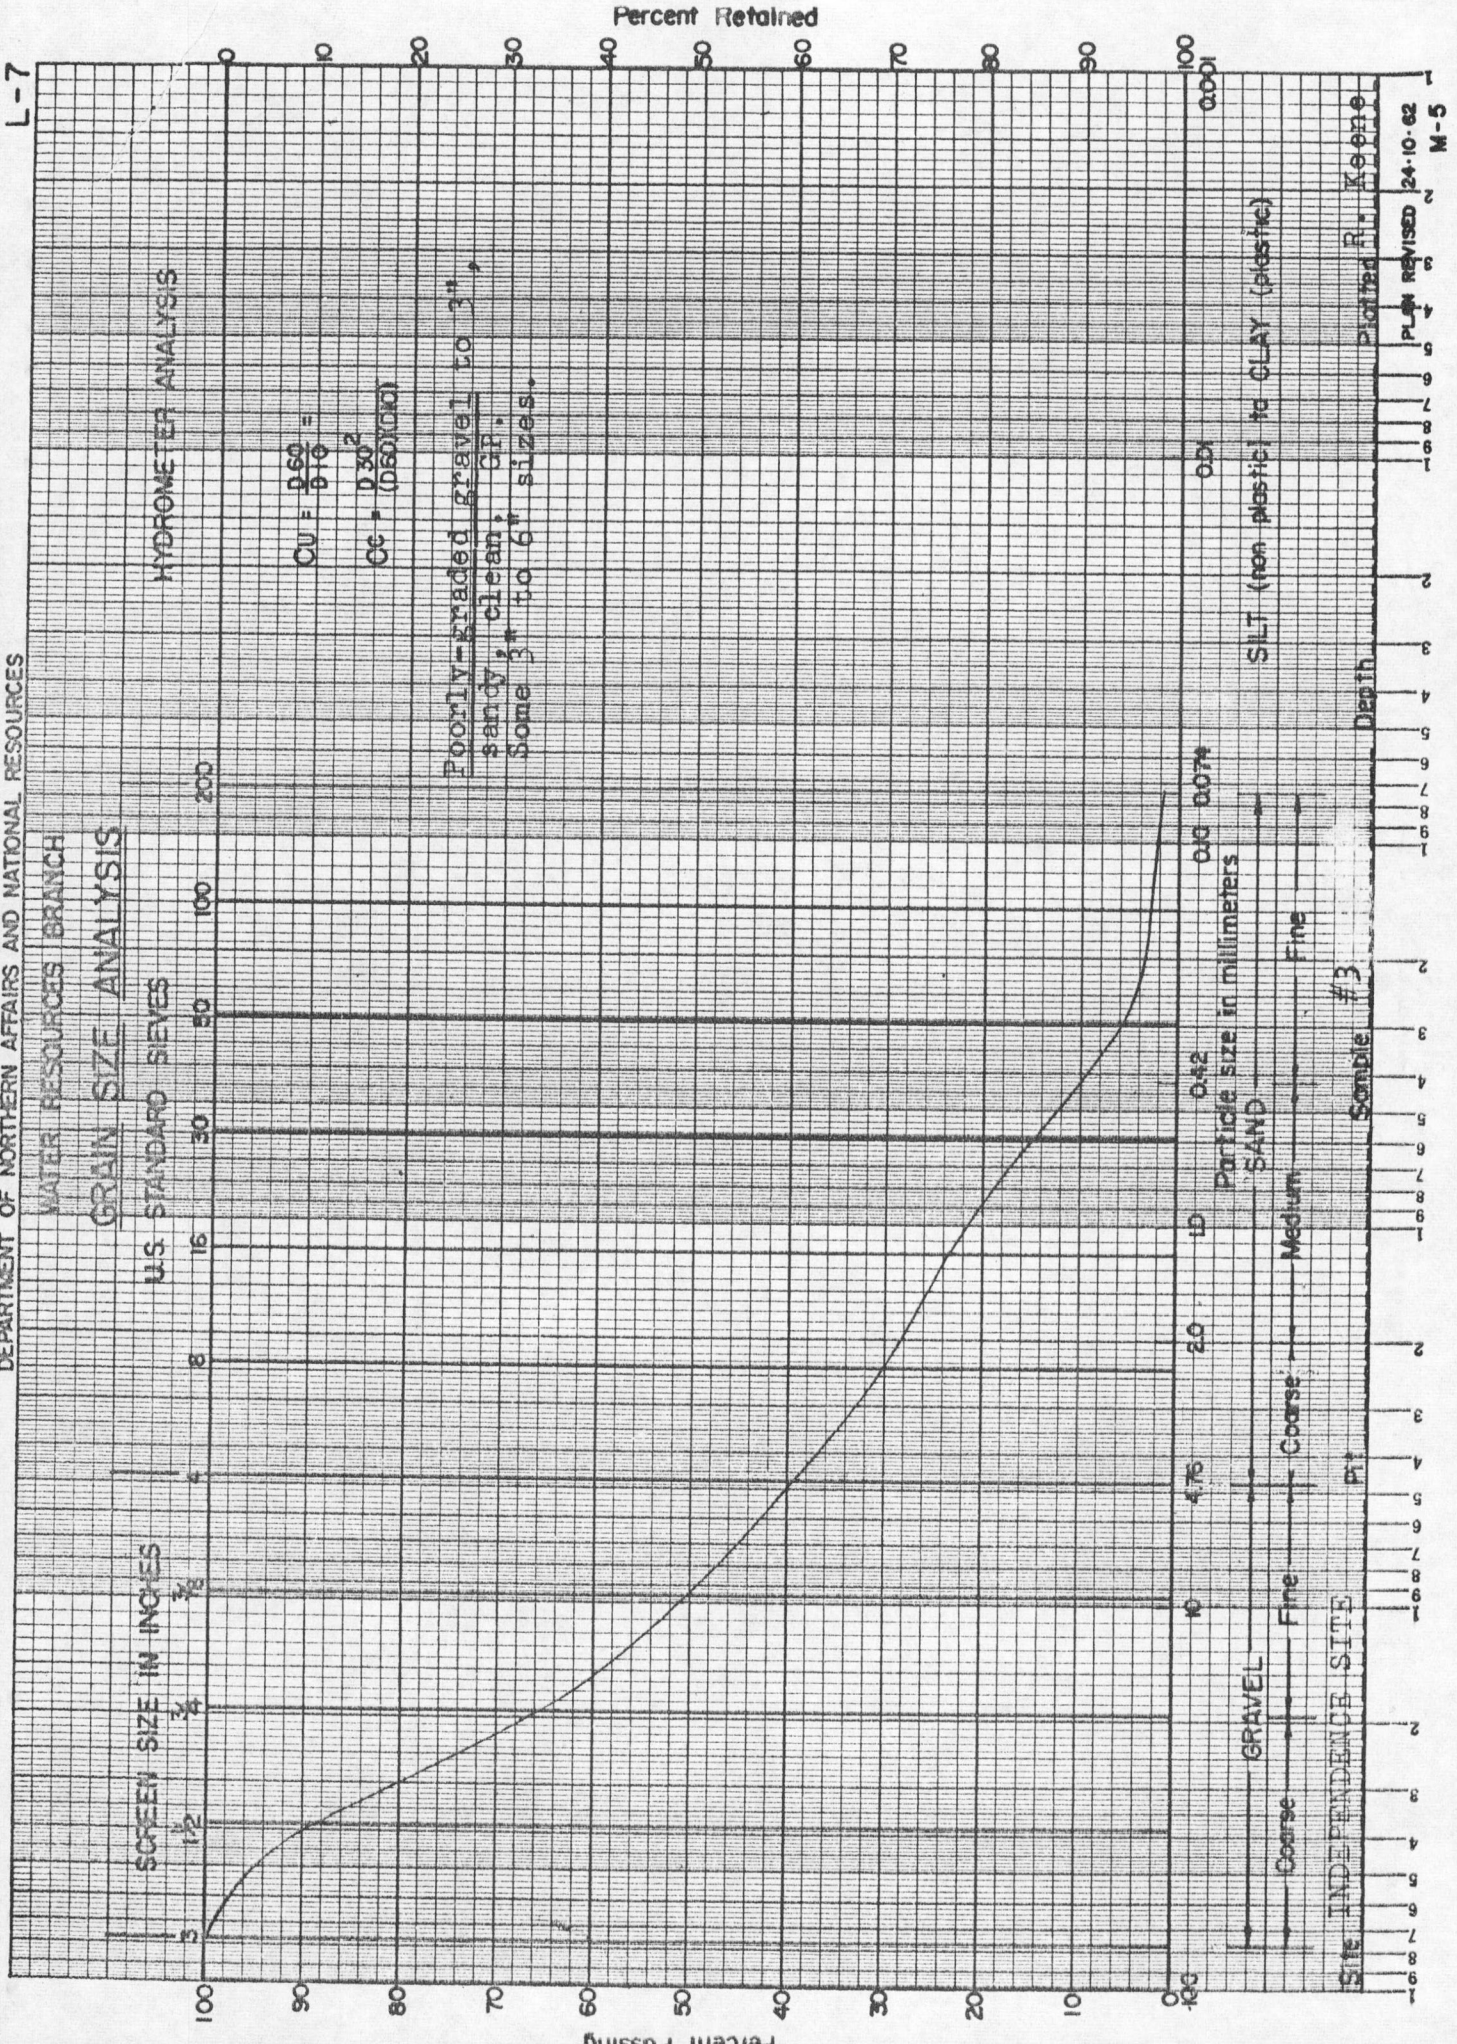
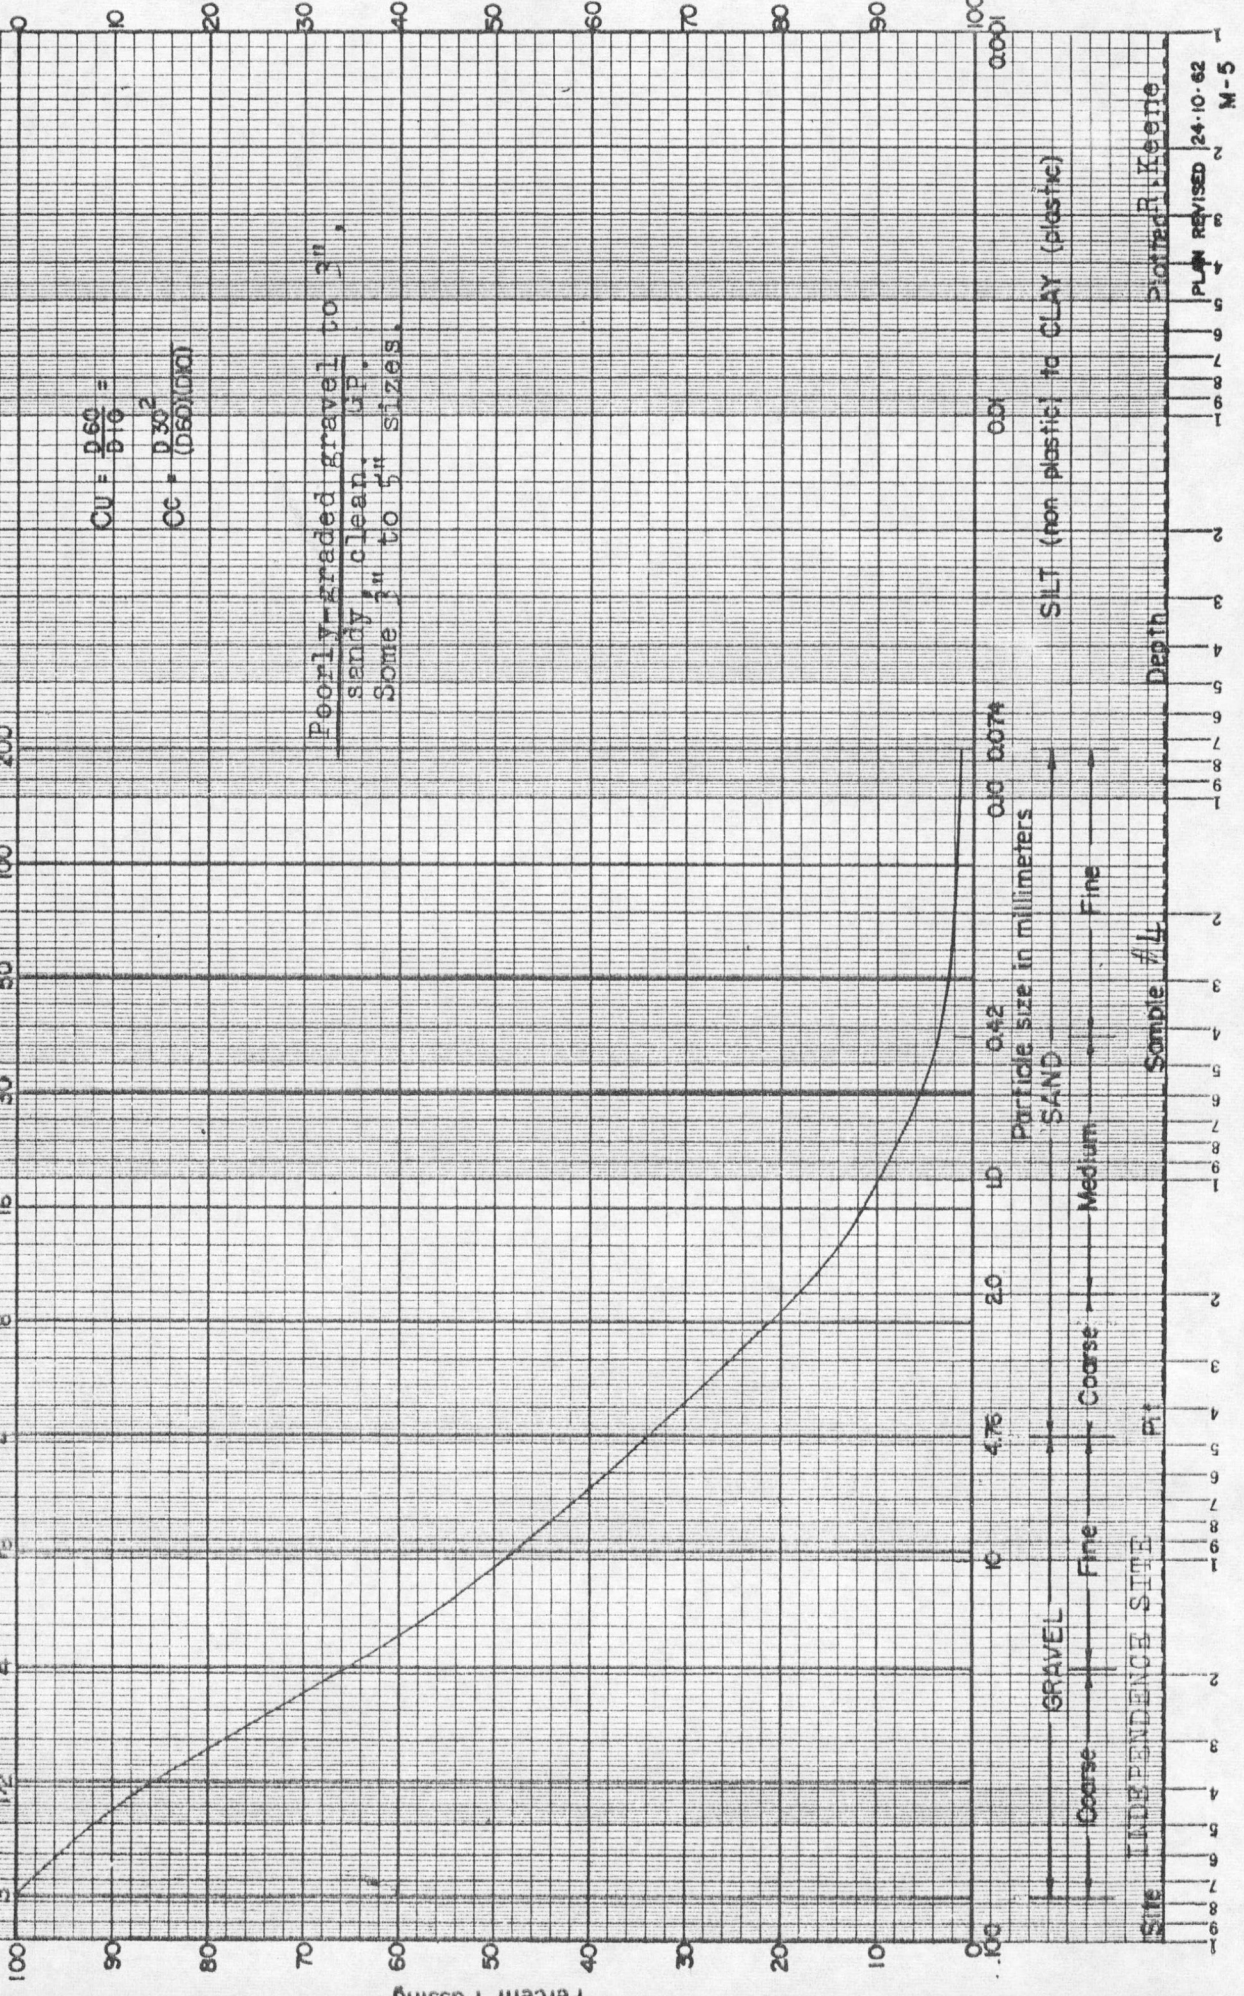
Sample Number	Location	Field Description of Material	Field Description of Overburden	Thickness of Deposit	Areal Extent (Estimated)	Remarks
3	On terrace along left side of Stewart River 1/2 mile upstream from site; 50 feet above river; 3 feet beneath ground surface	Gravel: brown, sandy, no silt, poor grading; loose, cobbles to 6 inches; considerable weathering.	None	Unknown	Large	No frost line noted, may be dry frozen
4	At station T-5 on right aboutment; 34 inches beneath ground surface	Gravel: brown, sandy, no silt, poor grading; cobbles to 5 inches; considerable weathering	None	Unknown	Large	No frost line noted, may be dry frozen.
5	On terrace along left side of Stewart River 14 miles upstream from site; 75 feet above river; 24 inches beneath ground surface	Gravel: grey, sandy, no silt, poor grading; loose; minor weathering; cobbles to 6 inches consisting of chert, quartzite, granite, diorite, gneiss, schist and minor shale	None	35+ feet	Large; extends 2 miles along left side of river	Unlimited supply; less weathered than gravel at dam site.

Poorly-graded gravel to 3"
sandy, clean, GP.
Some 3" to 6" sizes.

Poorly-graded gravel to 3"
 sandy clean, up
 Some 1" to 5" sizes.

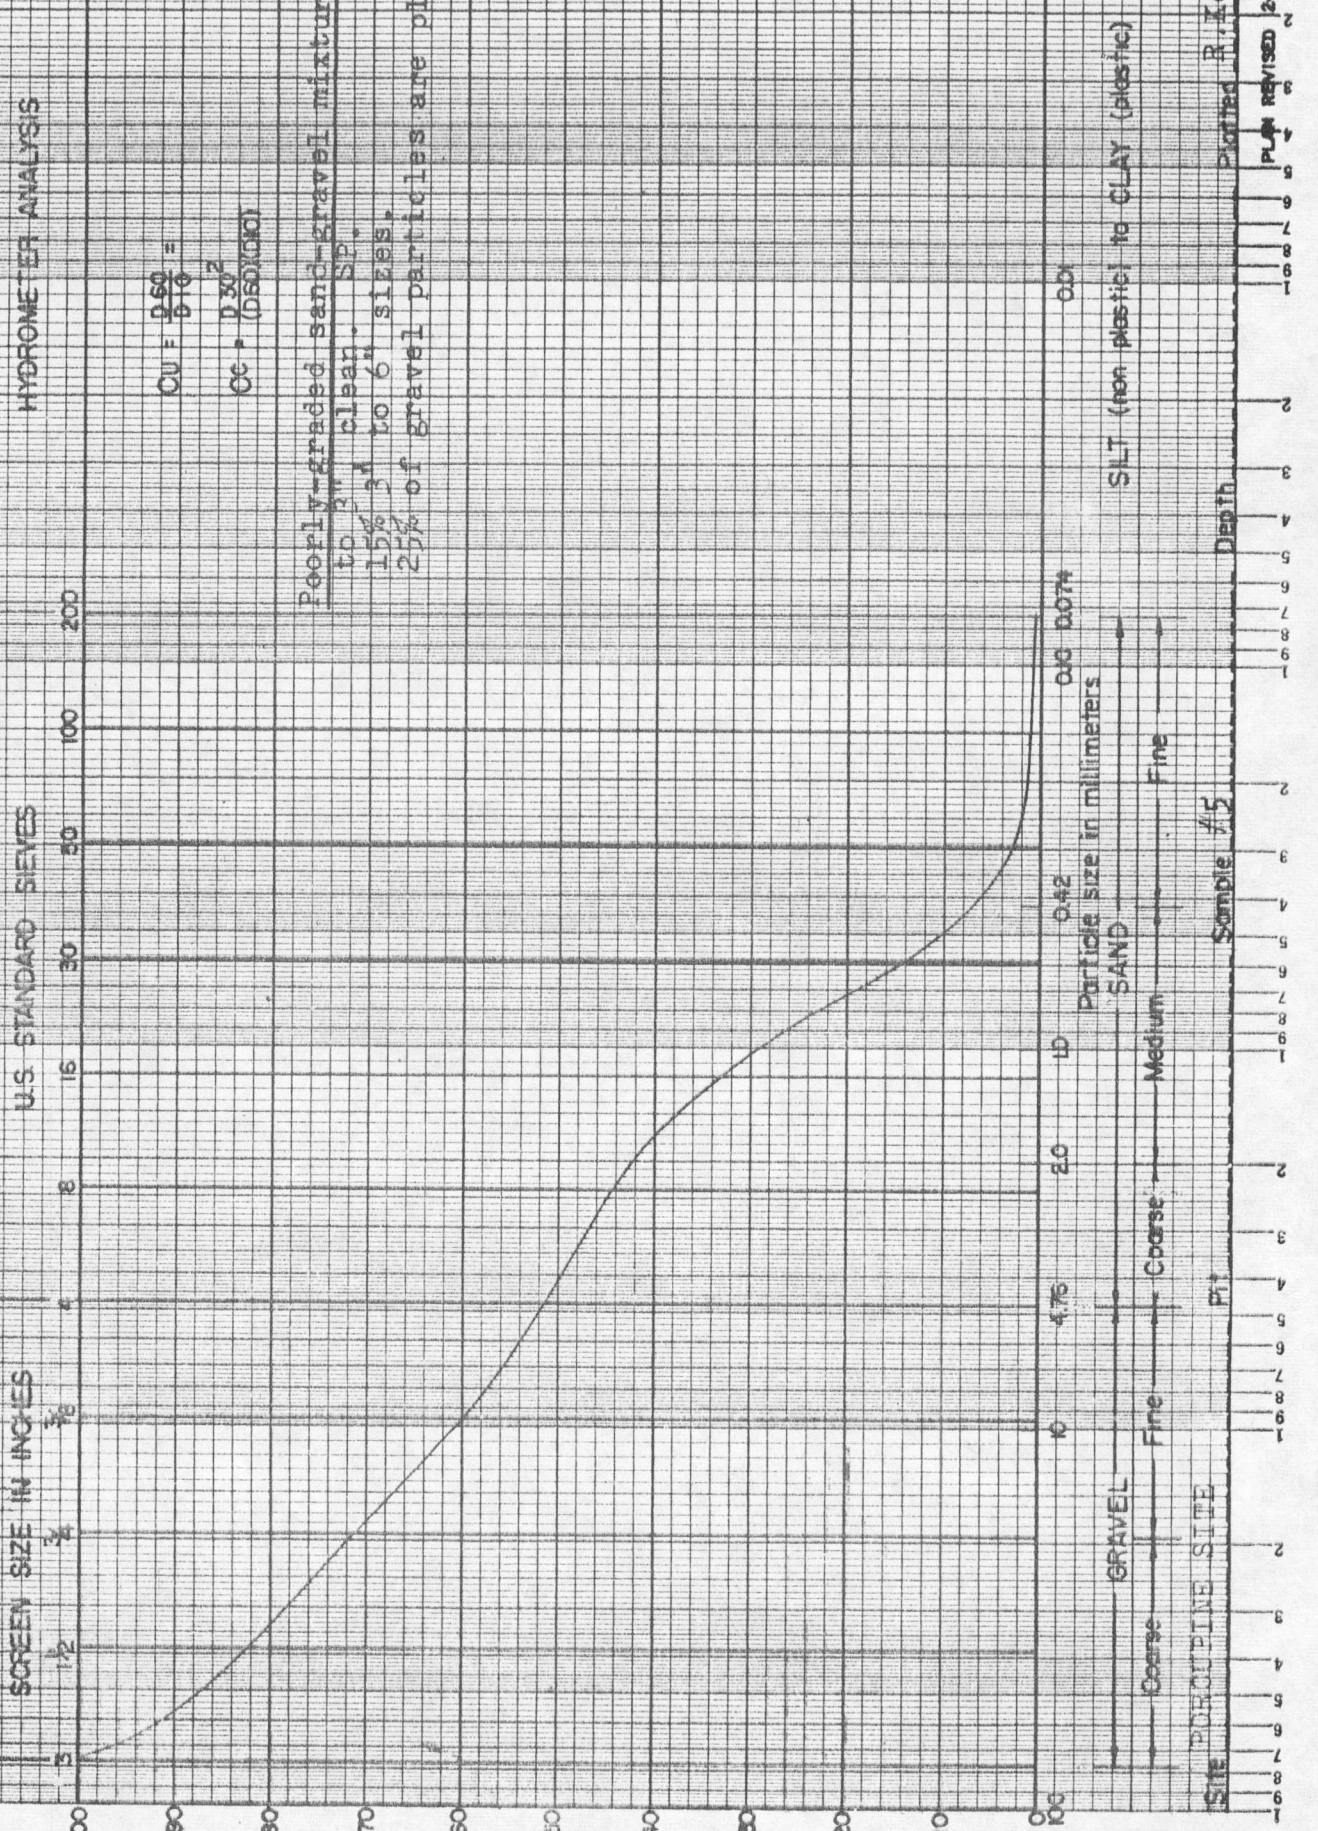
Poorly-graded sand-gravel mixture to ³⁰clean. Sp. 15% ^{3/4} to ⁶ sizes. 25% of gravel particles are platy

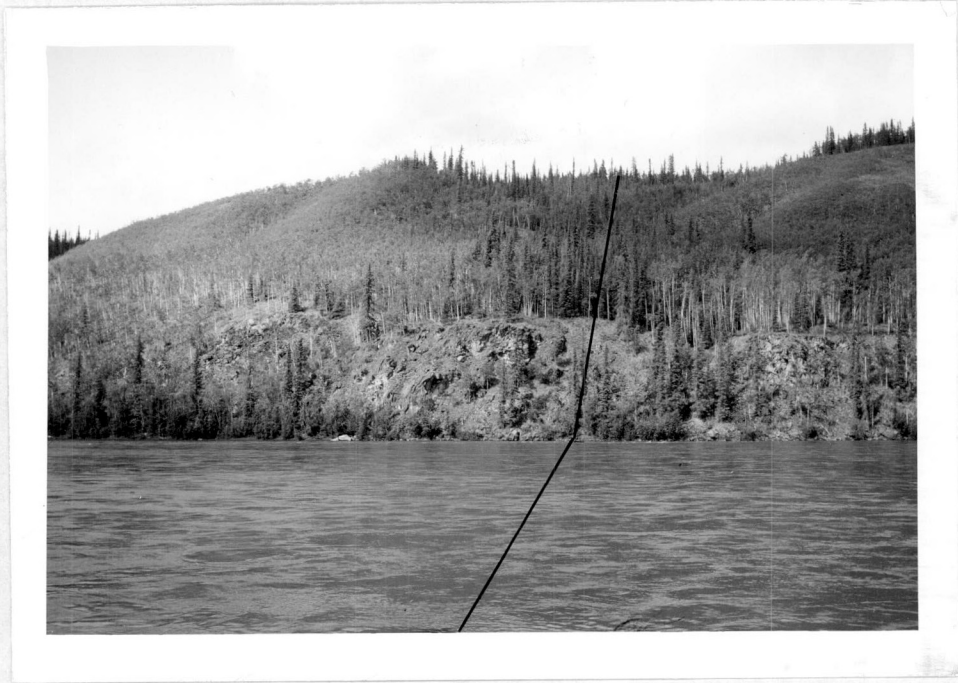
Plate 1

Right abutment, Independence dam site, the black line indicates the approximate location of the centre line, the rock bluff in the foreground is about 60 feet high.

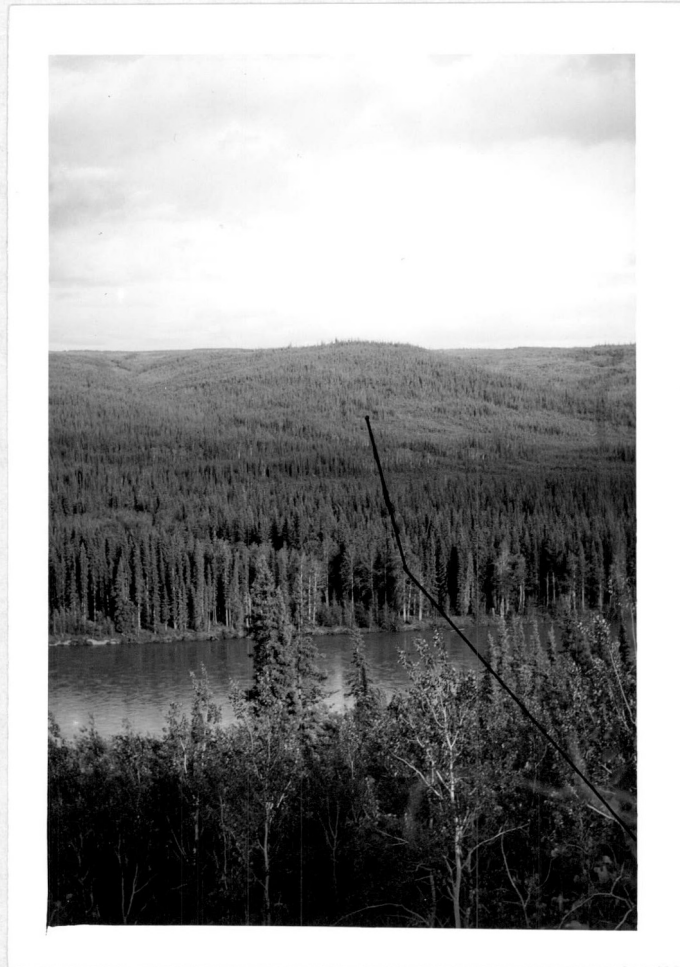
Plate 2

View of left abutment area from right abutment, approximate location of proposed centre line indicated by black line.
