GEOLOGICAL SURVEY OF CANADA  
TOPICAL REPORT NO. 102

YUKON RIVER DRAINAGE BASIN  
DAM SITE INVESTIGATION

SITE No. 22

**FIVE MILE RAPIDS DAM SITE**  
(MAP AND PRELIMINARY REPORT)

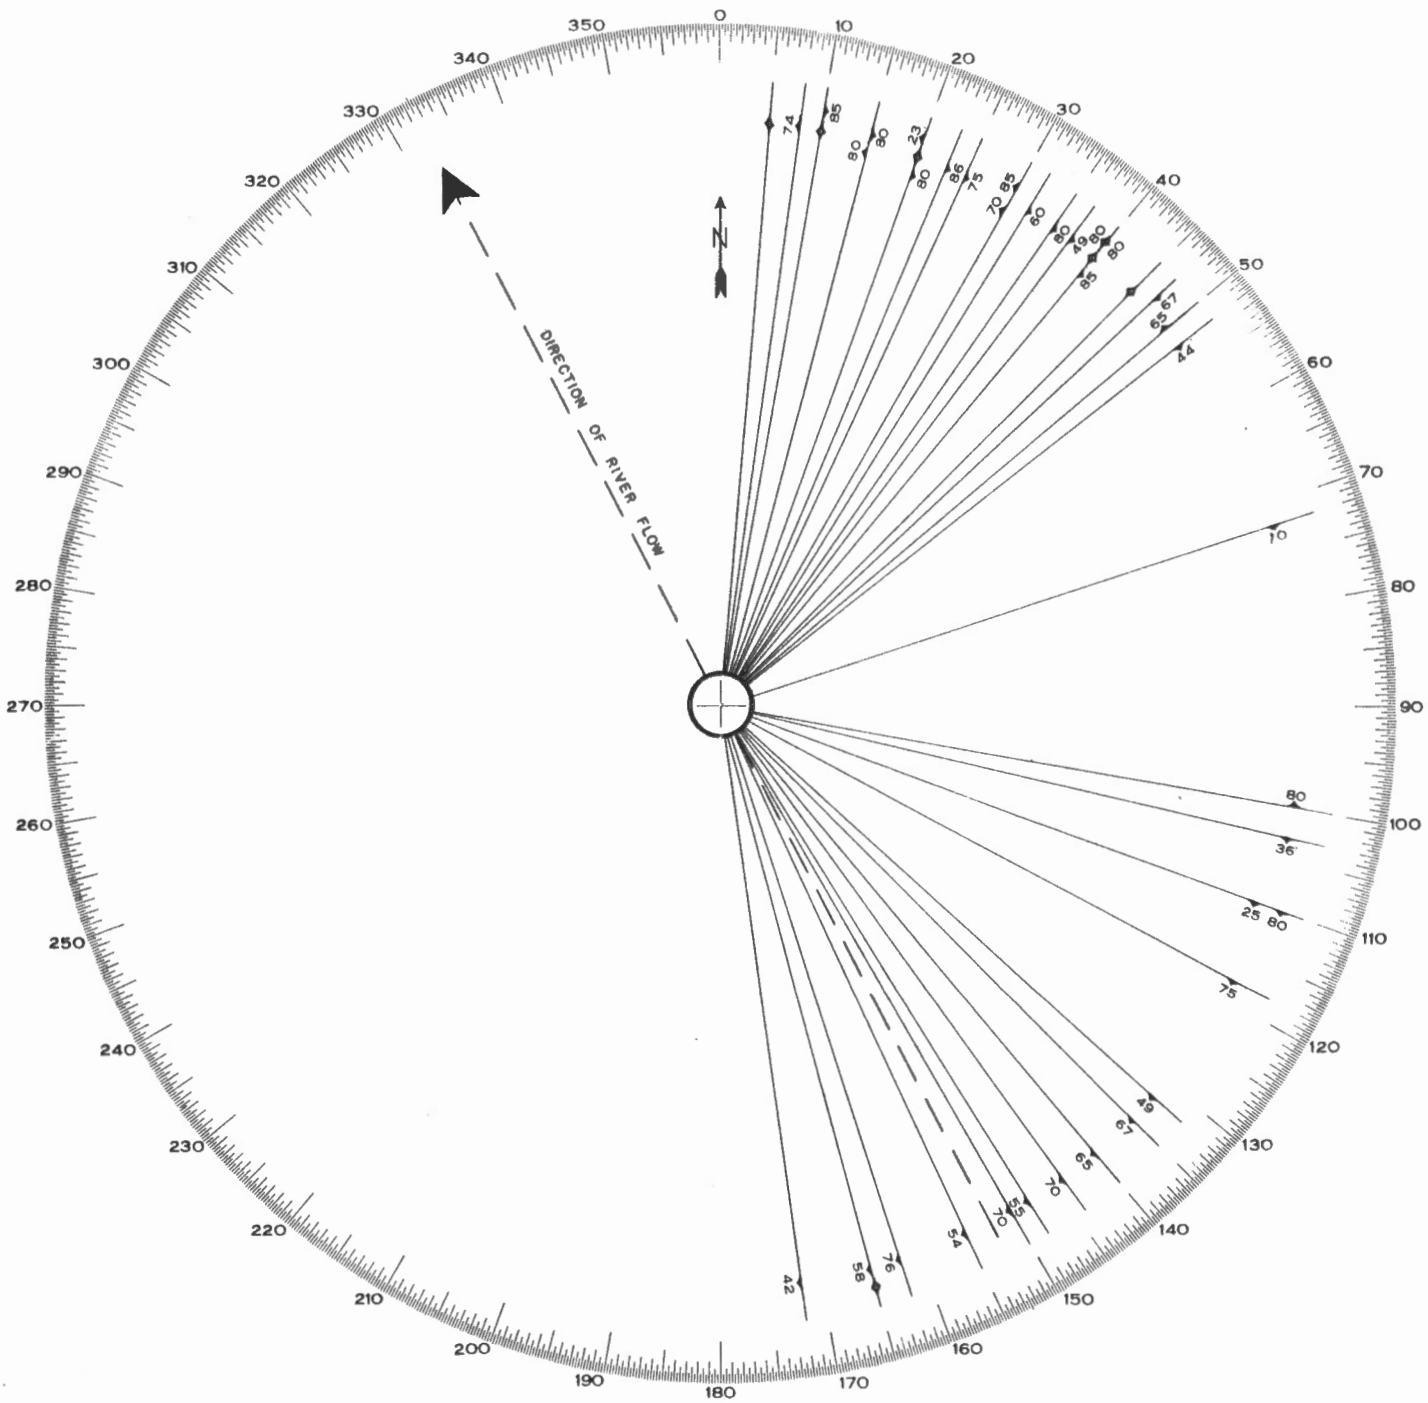
**JOINT ROSETTE**

There are 2 prominent joint sets at Five Mile Rapids site. One of these which closely parallels a prominent set at Fraser Falls site strikes from 5 to 50 degrees east and, in general, dips steeply toward the right abutment. The other intersects the first at about 60 degrees and dips at more shallow angles into the left abutment. The spacing varies from a few inches to more than 4 feet. Open fractures up to 3 inches in width frequently occur along the jointing. These fractures probably do not extend far into bedrock but their presence helps to increase the amount of weathering in the surface rock.

The above illustration presents diagrammatically the direction and dip of the jointing in bedrock exposed at Five Mile Rapids site.

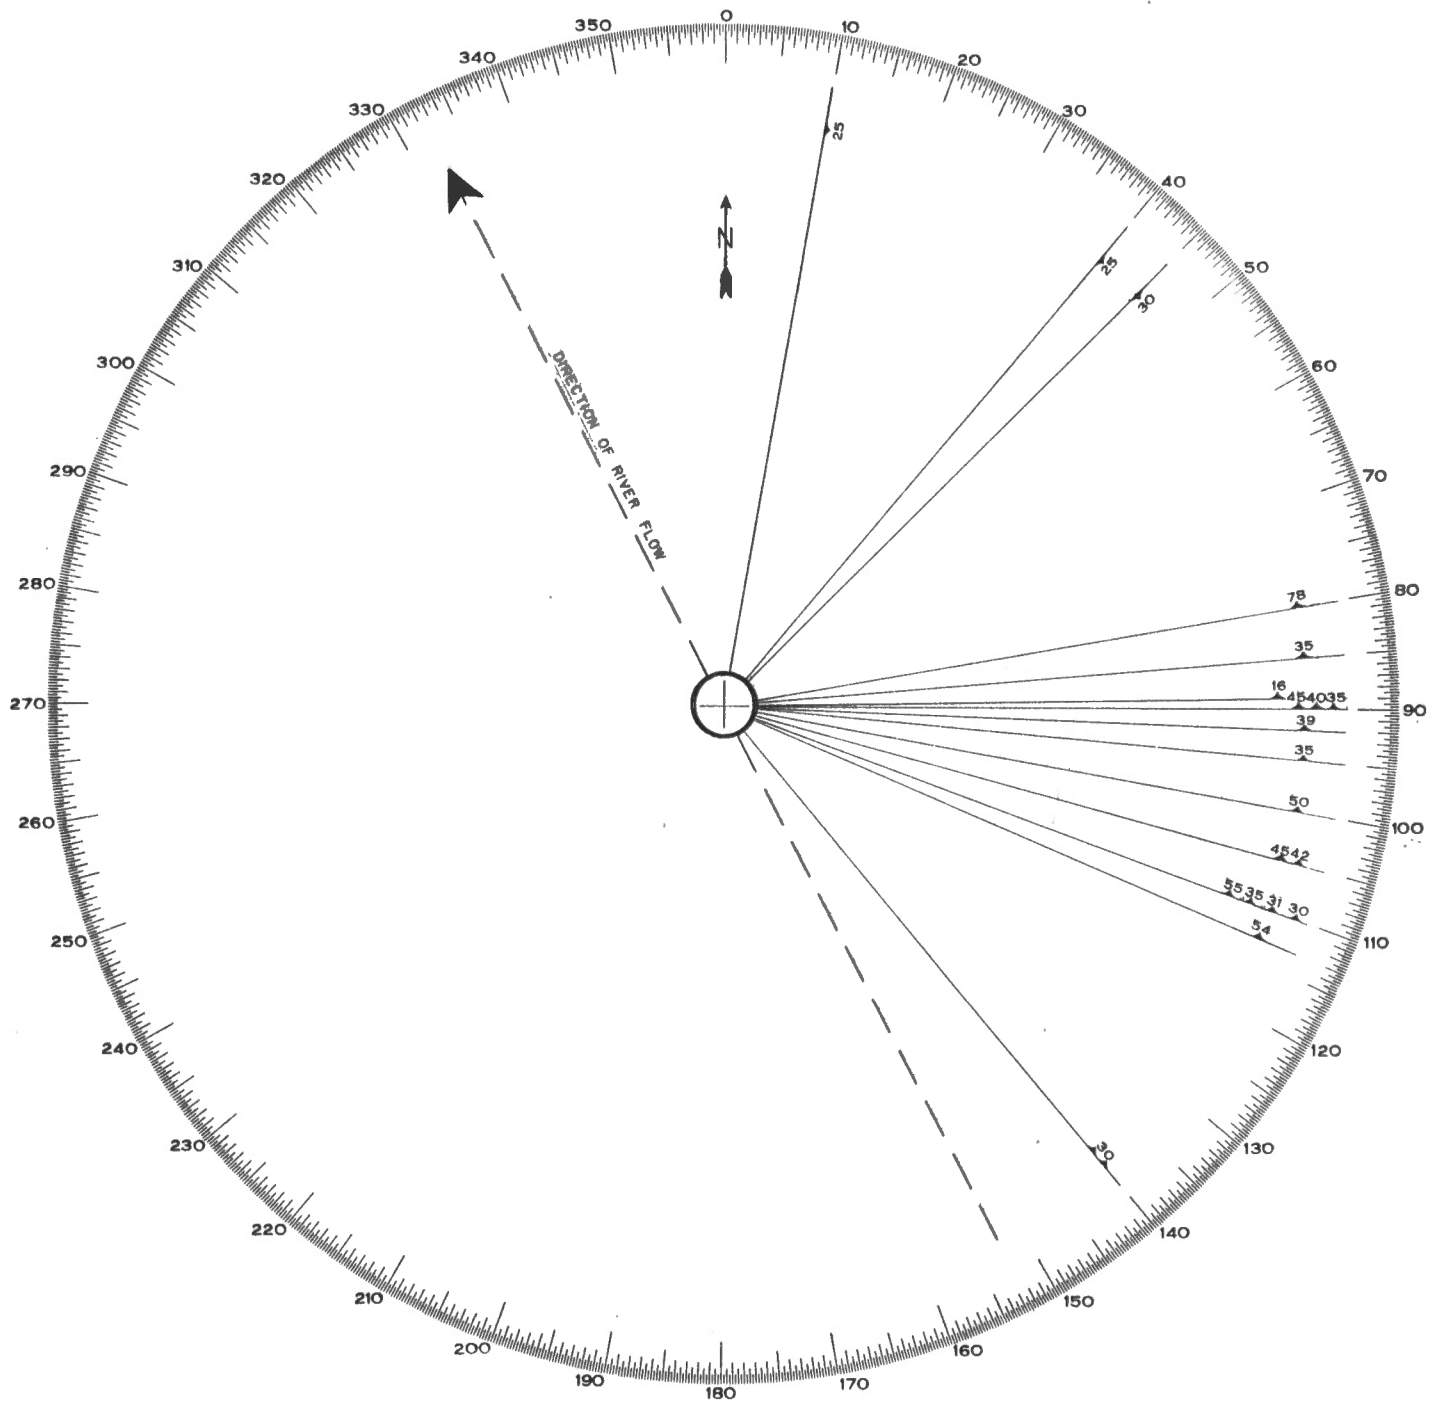
**BEDDING ROSETTE**

bedding is more apparent at Five Mile Rapids site. It is almost parallel to the ~~schistosity~~ and has a similar downstream dip.

The above illustration presents diagrammatically the direction and dip of the bedding in bedrock exposed at Five Mile Rapids site.

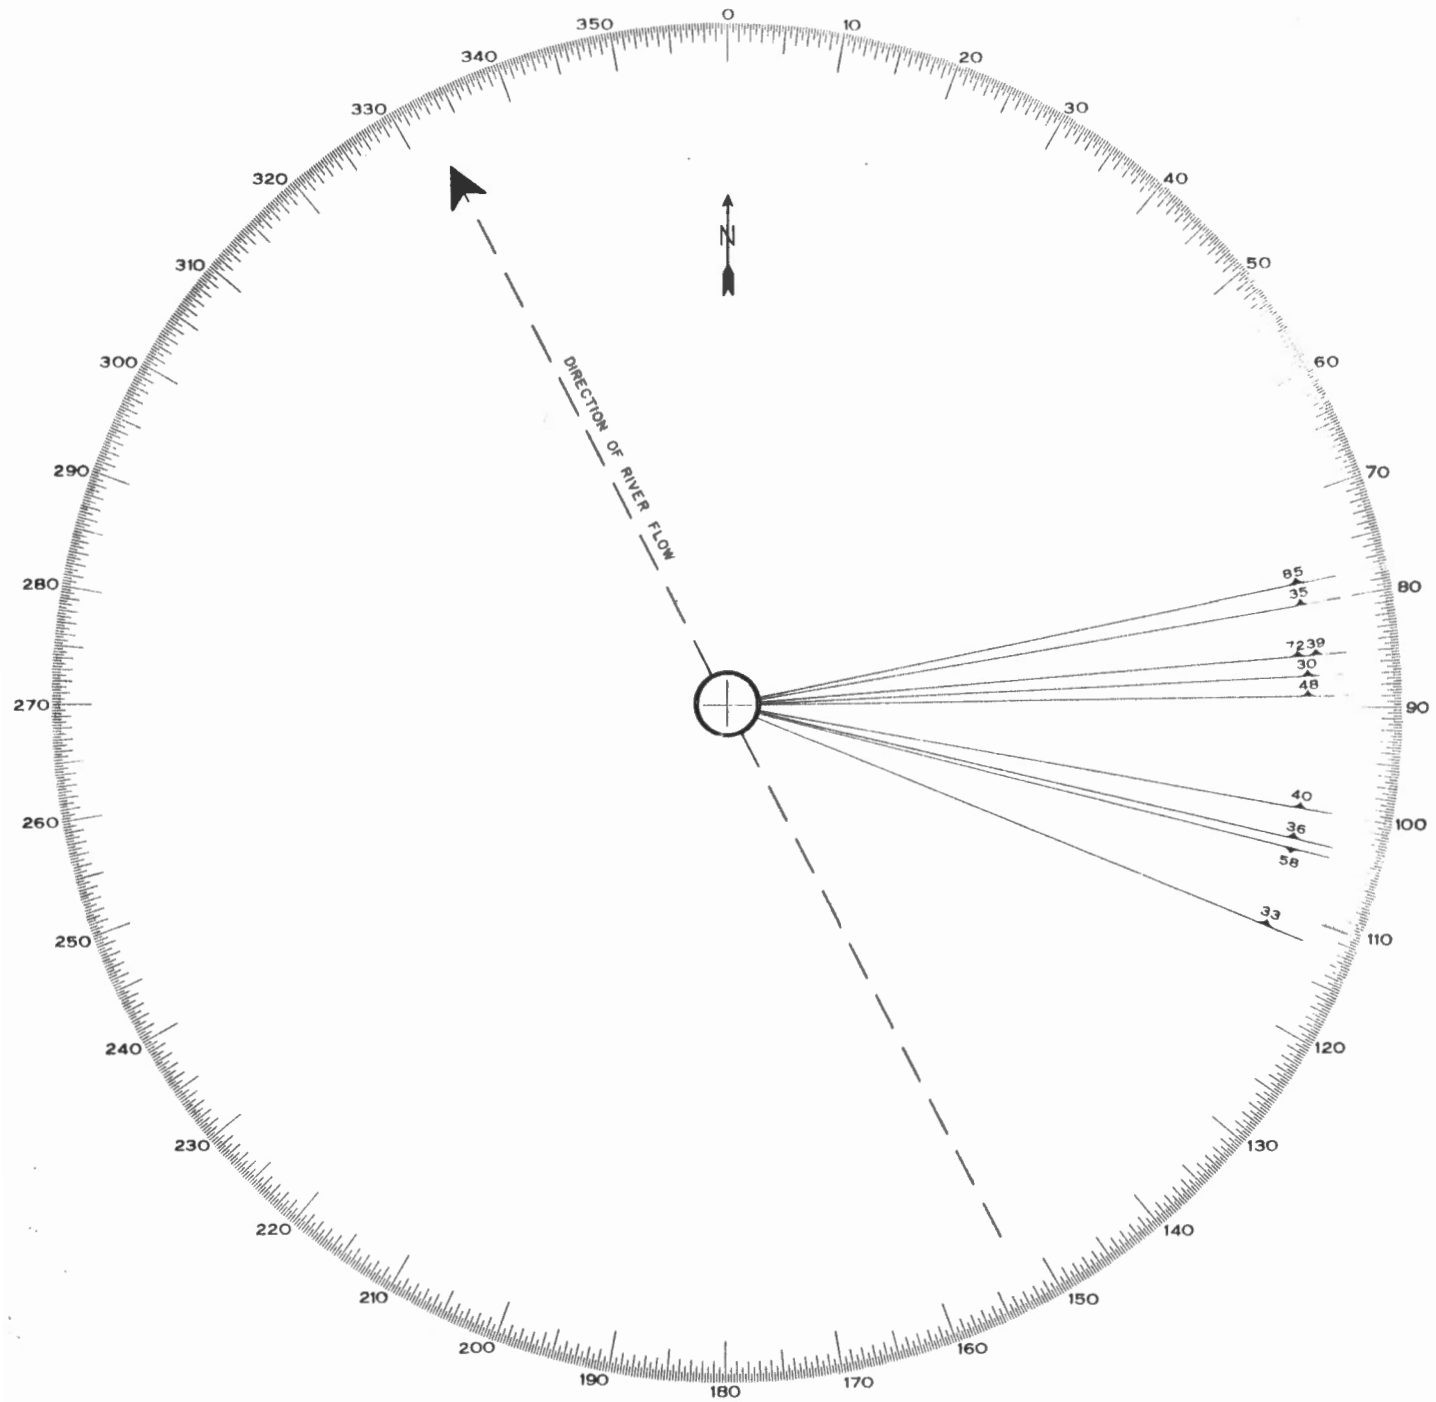
FOLIATION ROSETTE

As at Fraser Falls site the schistosity which is the chief structural feature present strikes generally across the river. However at Five Mile Rapids site the dip of the schistosity is downstream which is the reverse to that at Fraser Falls. This is less favourable for construction of a dam. The

The above illustration presents diagrammatically the direction and dip of the schistosity in bedrock exposed at Five Mile Rapids site.

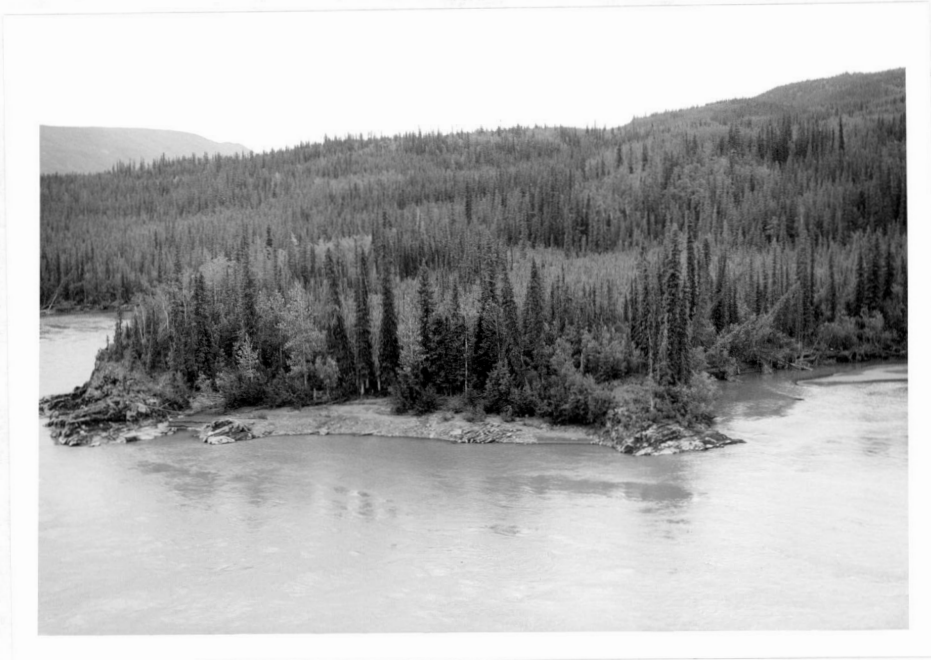
Plate 1

Alluvium consisting of silt and sand covers a sloping terrace which extends from the river to the base of the rock outcrop forming the left abutment. The maximum elevation at which this material occurs is 1,735. The deposit is probably thin. The material has no value as a construction material but would have to be removed if the dam were extended across the terrace.

Left abutment area, Five Mile Rapids dam site;  
view from the right abutment.

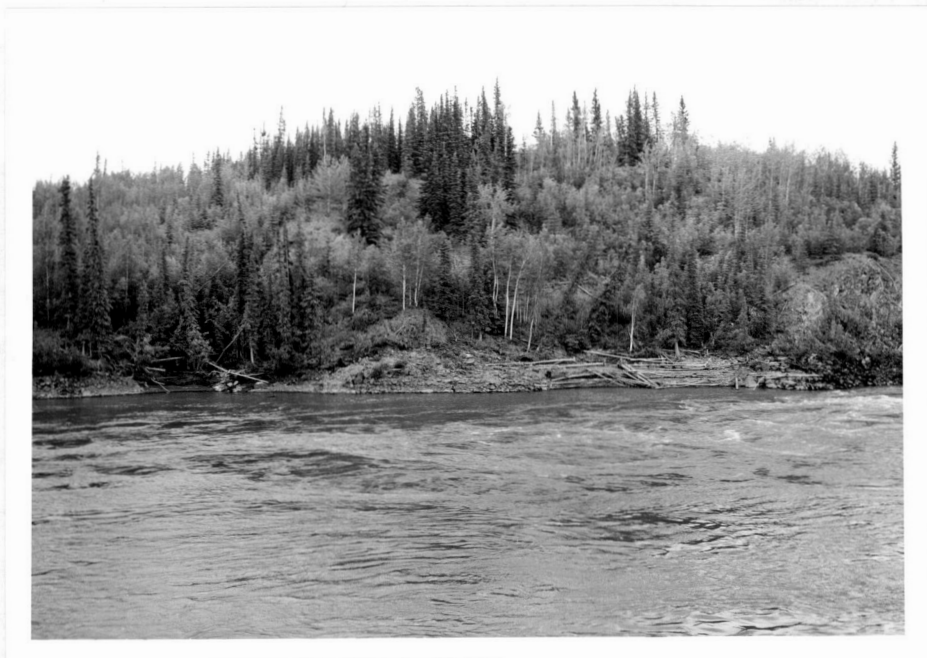
Plate 2

materials extend east from the right abutment into an area of extensive thermo-karst topography. Their presence may limit the height to which the dam can be built. They are not stable and could not be used as foundation material. Numerous slides have taken place in this material along the right side of Stewart River downstream from the site. The wide, shallow valley floored with silty clay in the centre of the right abutment is probably an old slide scar.

Right abutment, Five Mile Rapids dam site; view from left side of Stewart River; a large, old slide area exists immediately downstream.

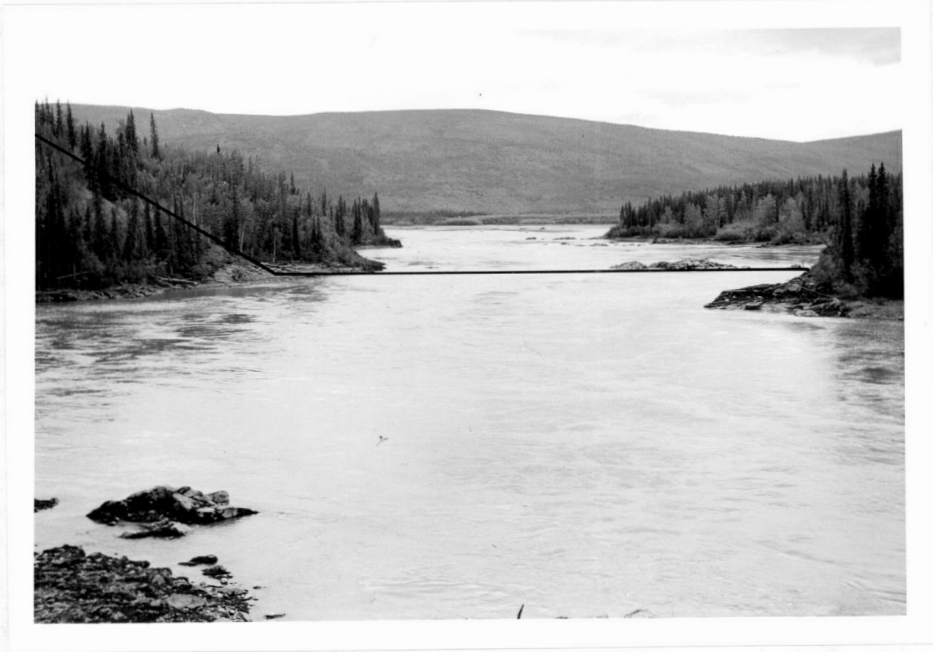
Plate 3

View looking upstream through Five Mile Rapids  
dam site; suggested location of dam indicated  
by the black line.

4. The best location for the dam would be in the upstream part of the site area immediately downstream from a small rocky island. The concrete structures would be located at the river with an earth section extending across the bedrock terrace west of the river to the left abutment. This dam would be similar to that proposed for Independence site but on a smaller scale. Another location could be along the fold axis in the downstream part of the site area which is indicated on the accompanying geological map.
