GEOLOGICAL SURVEY OF CANADA TOPICAL REPORT NO. 103

MACKENZIE RIVER DRAINAGE BASIN DAM SITE INVESTIGATION

UPPER CANYON DAM SITE (Frances River)

(MAP AND PRELIMINARY REPORT)

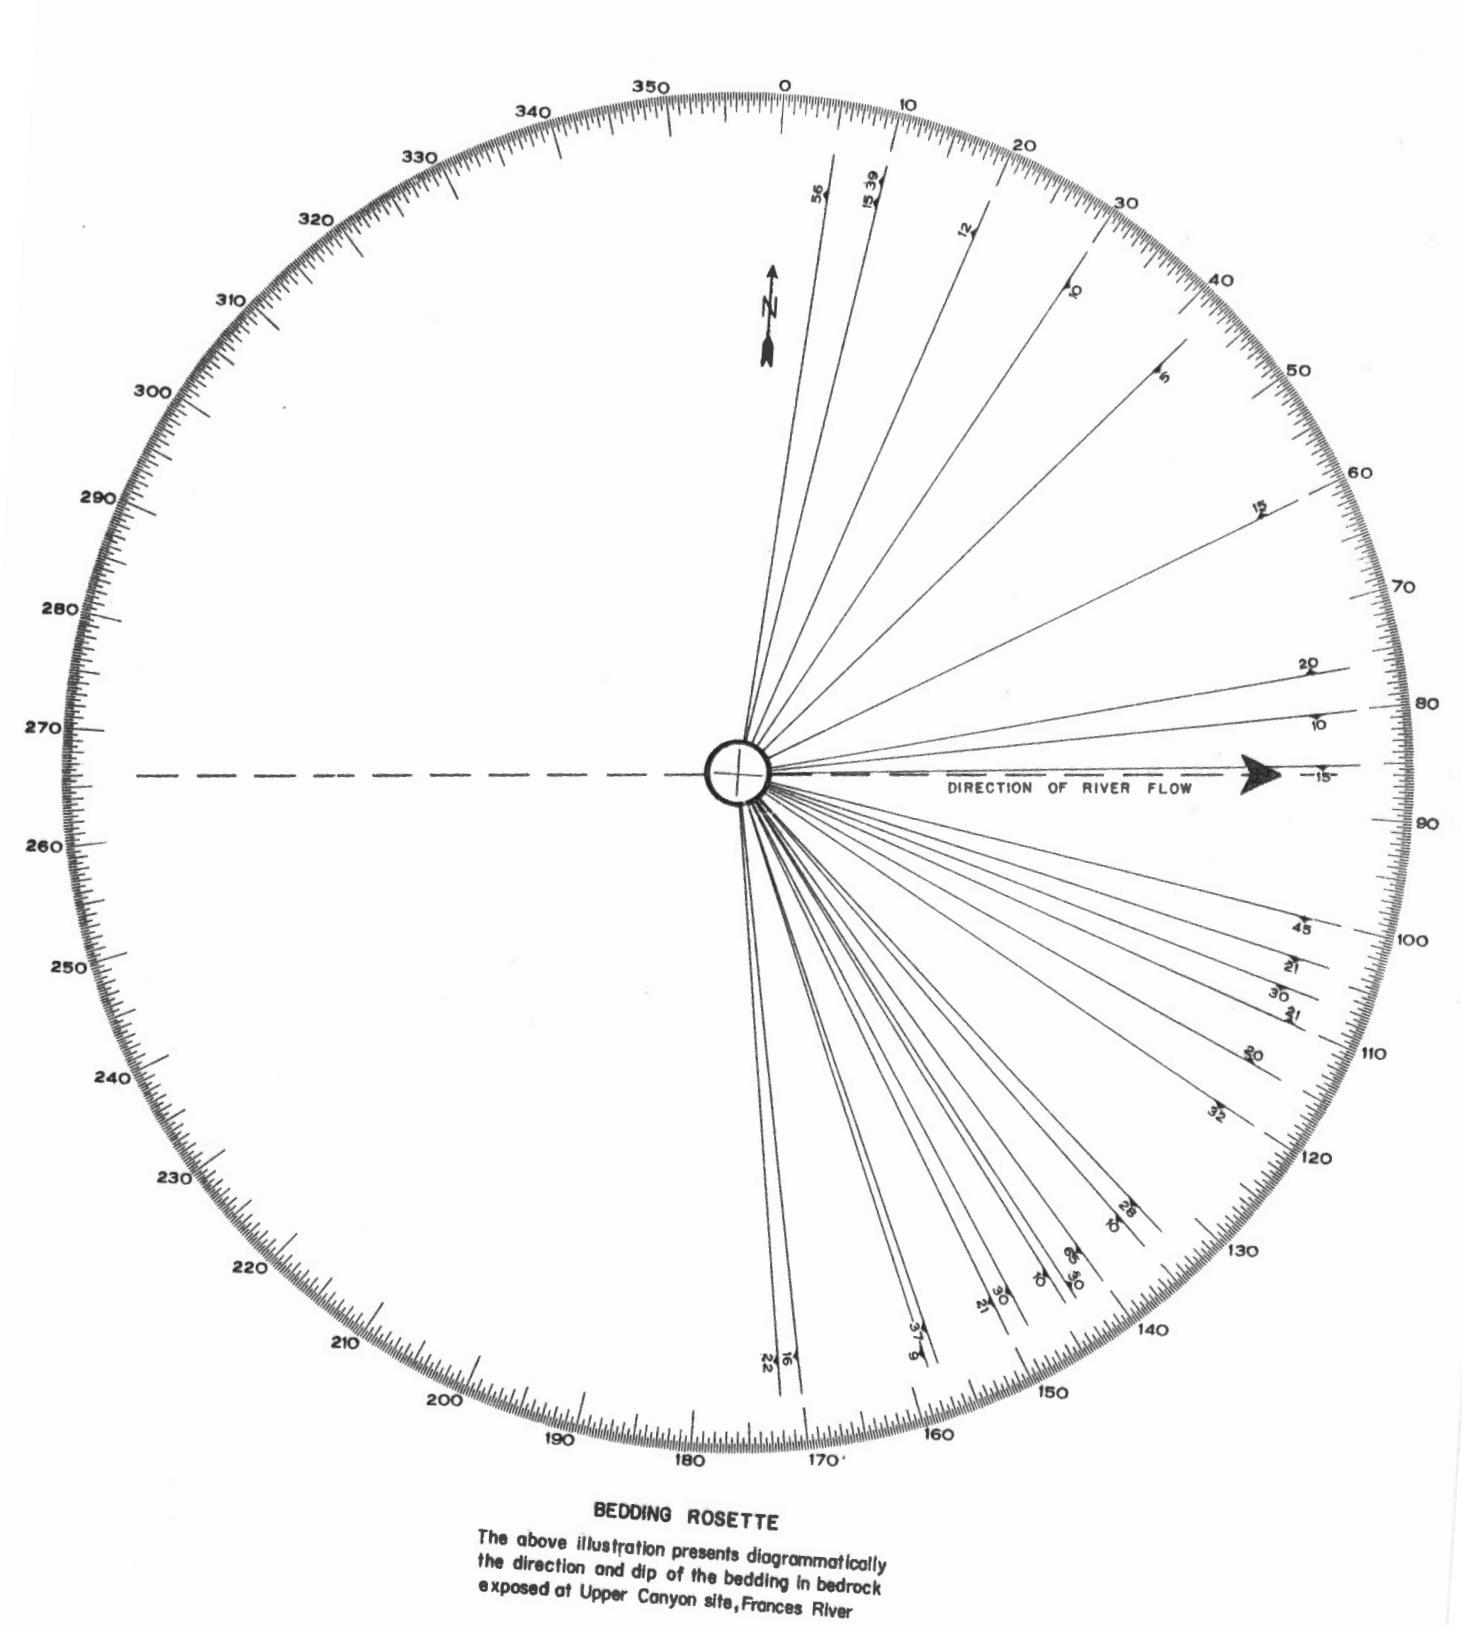
The above illustration presents diagrammatically the direction and dip of the bedding in bedrock exposed at Upper Canyon site, Frances River

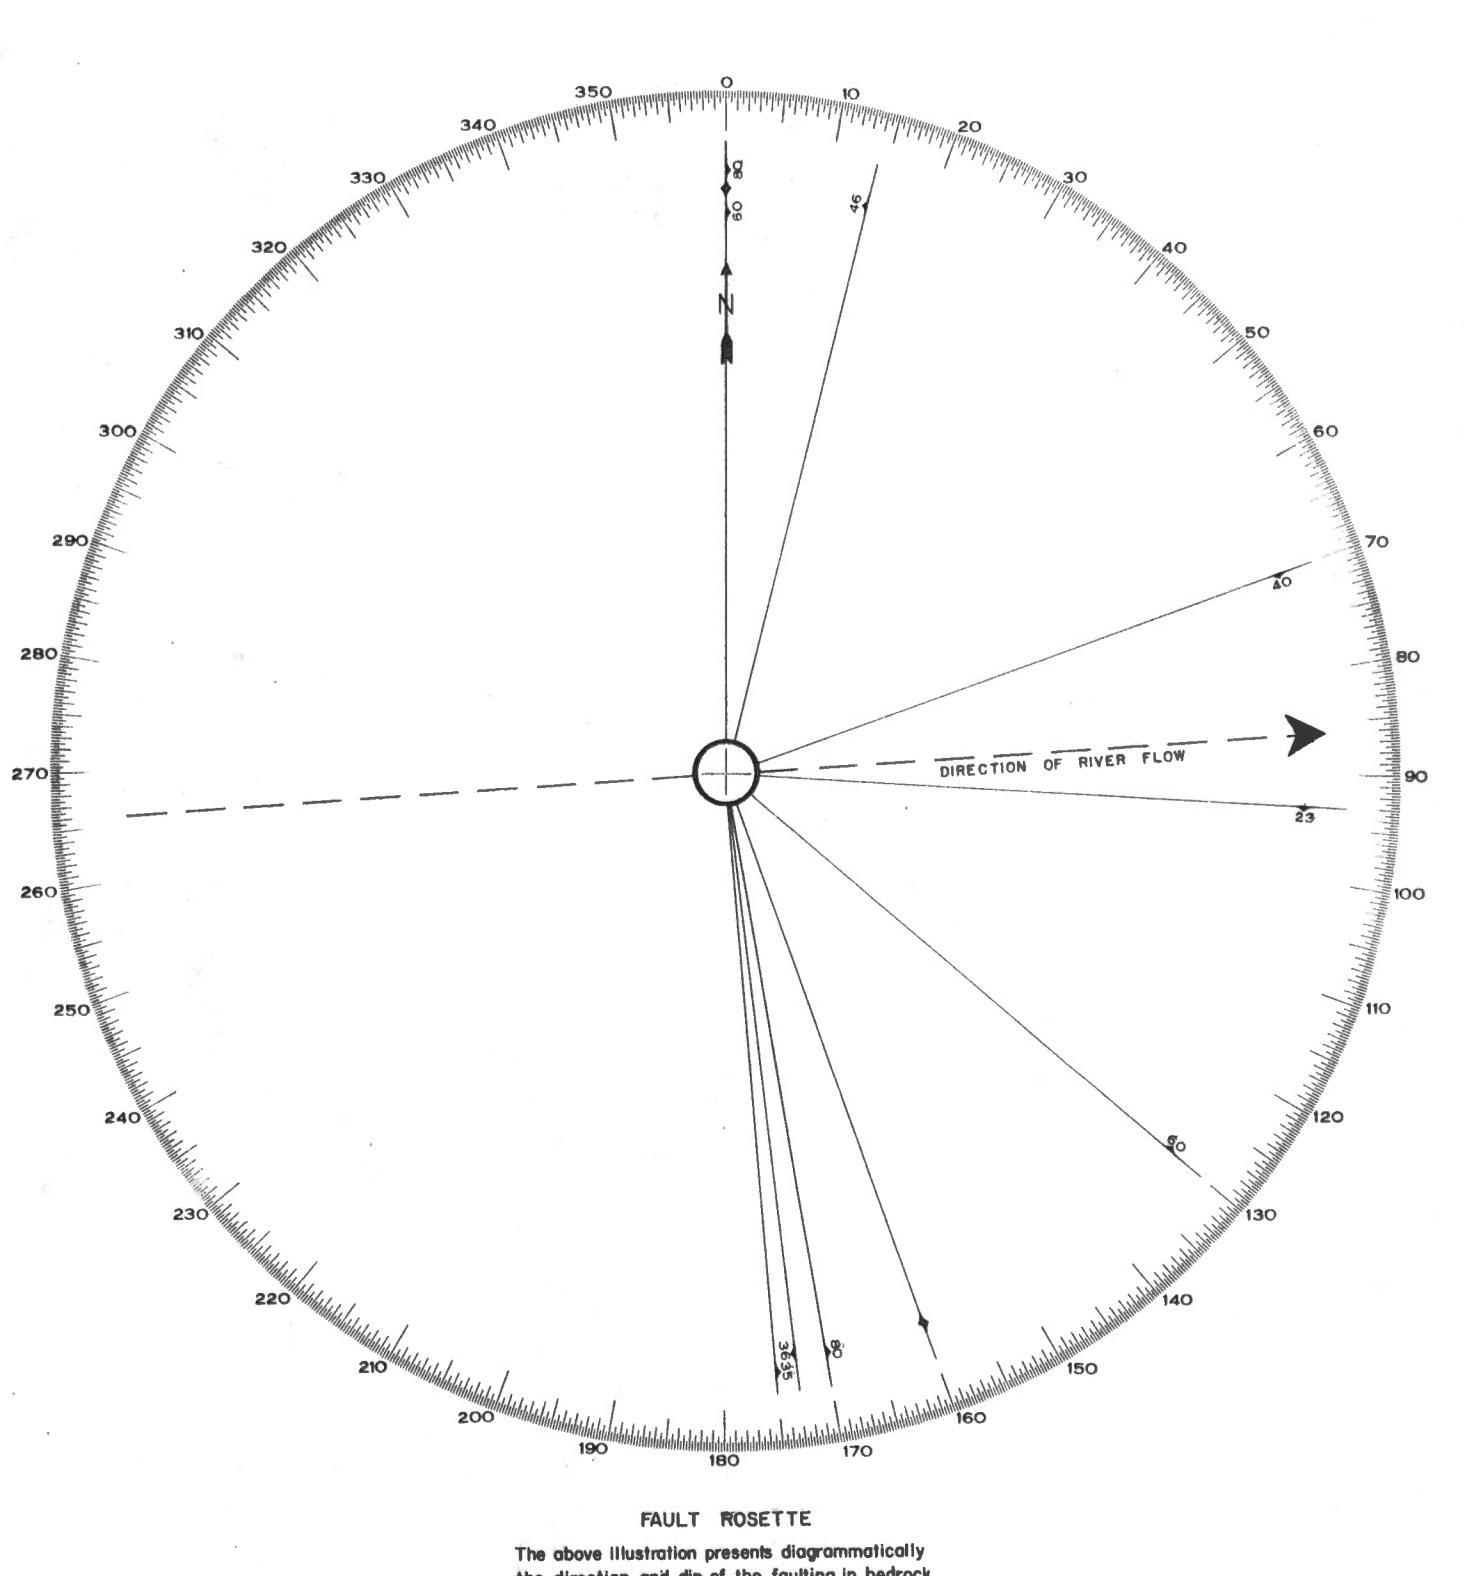
FAULT ROSETTE

The above Illustration presents diagrammatically the direction and dip of the faulting in bedrock exposed at Upper Canyon site, Frances River

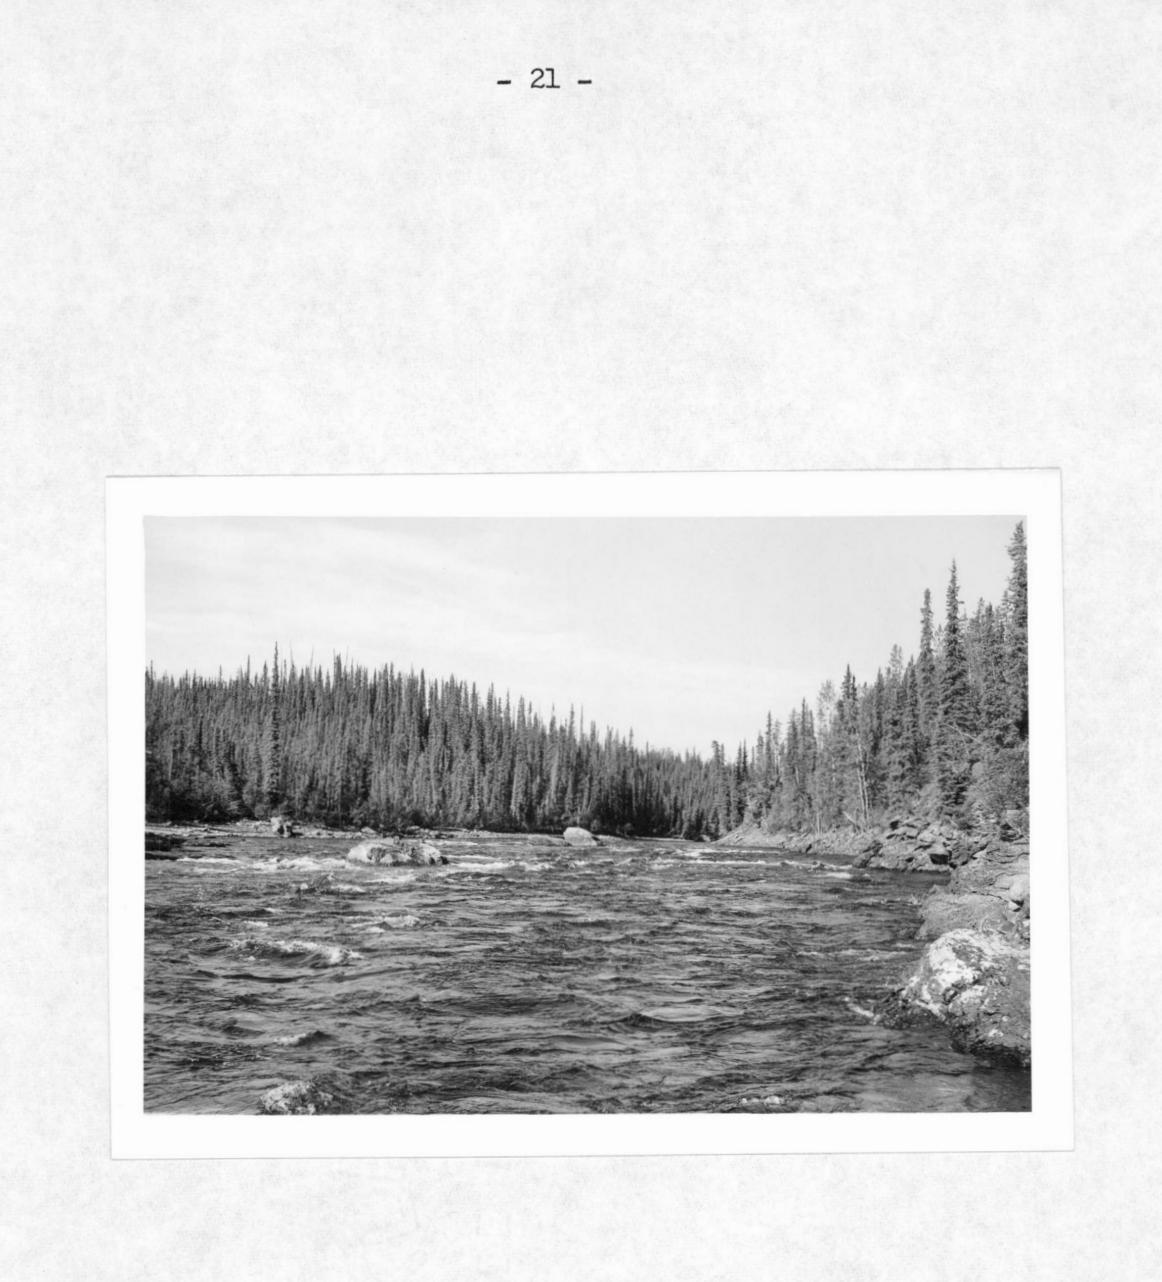
G.S.C. 10-3-62

View looking upstream through Upper Canyon from station G-2 located on the left abutment near the centre of the dam site area.

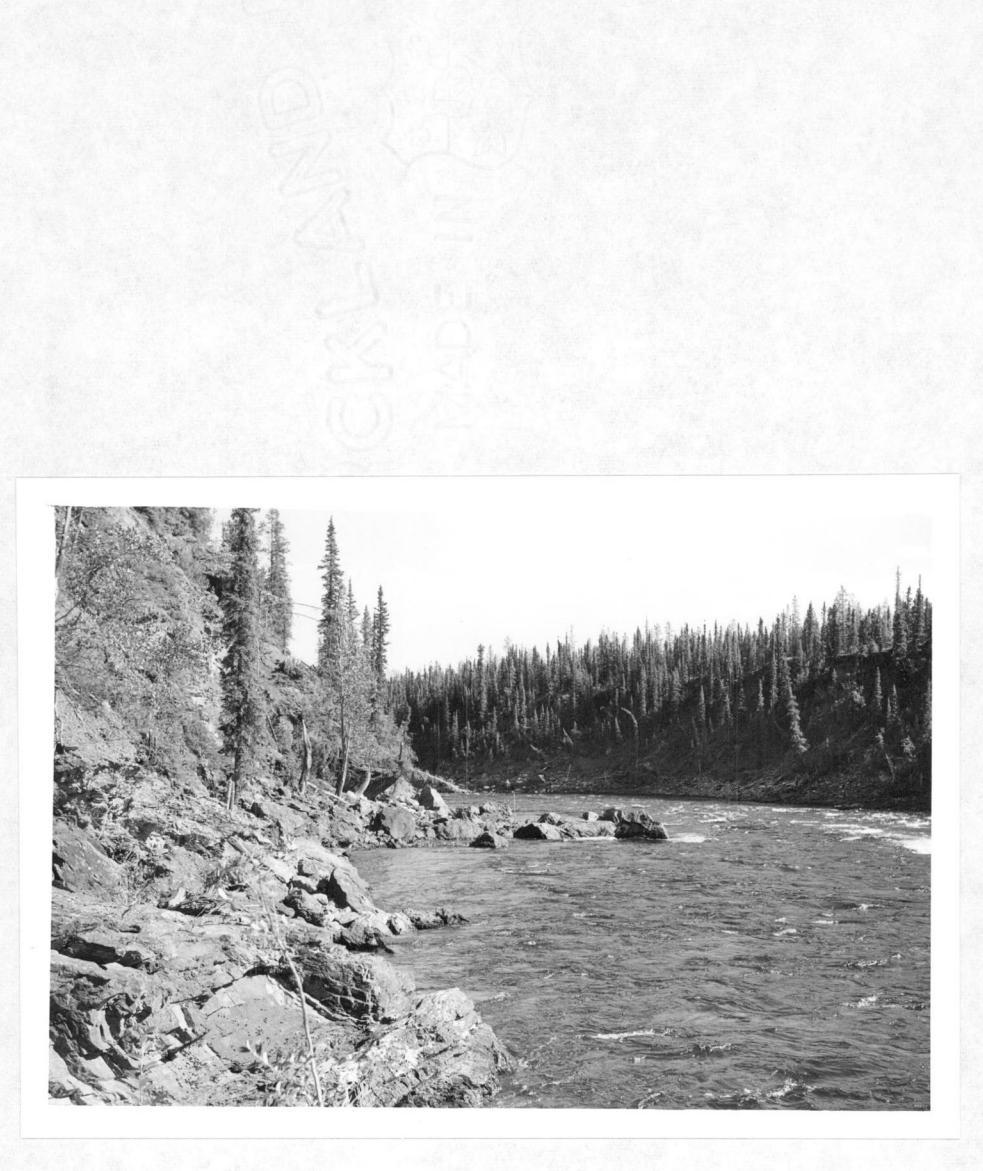
G.S.C. 10-4-63

View looking downstream along rocky toe of left abutment, Upper Canyon dam site.
