YUKON RIVER DRAINAGE BASIN
DAM SITE INVESTIGATION

SITE No. 18

DETOUR DAM SITE
(MAP AND PRELIMINARY REPORT)

BY
E. B. OWEN

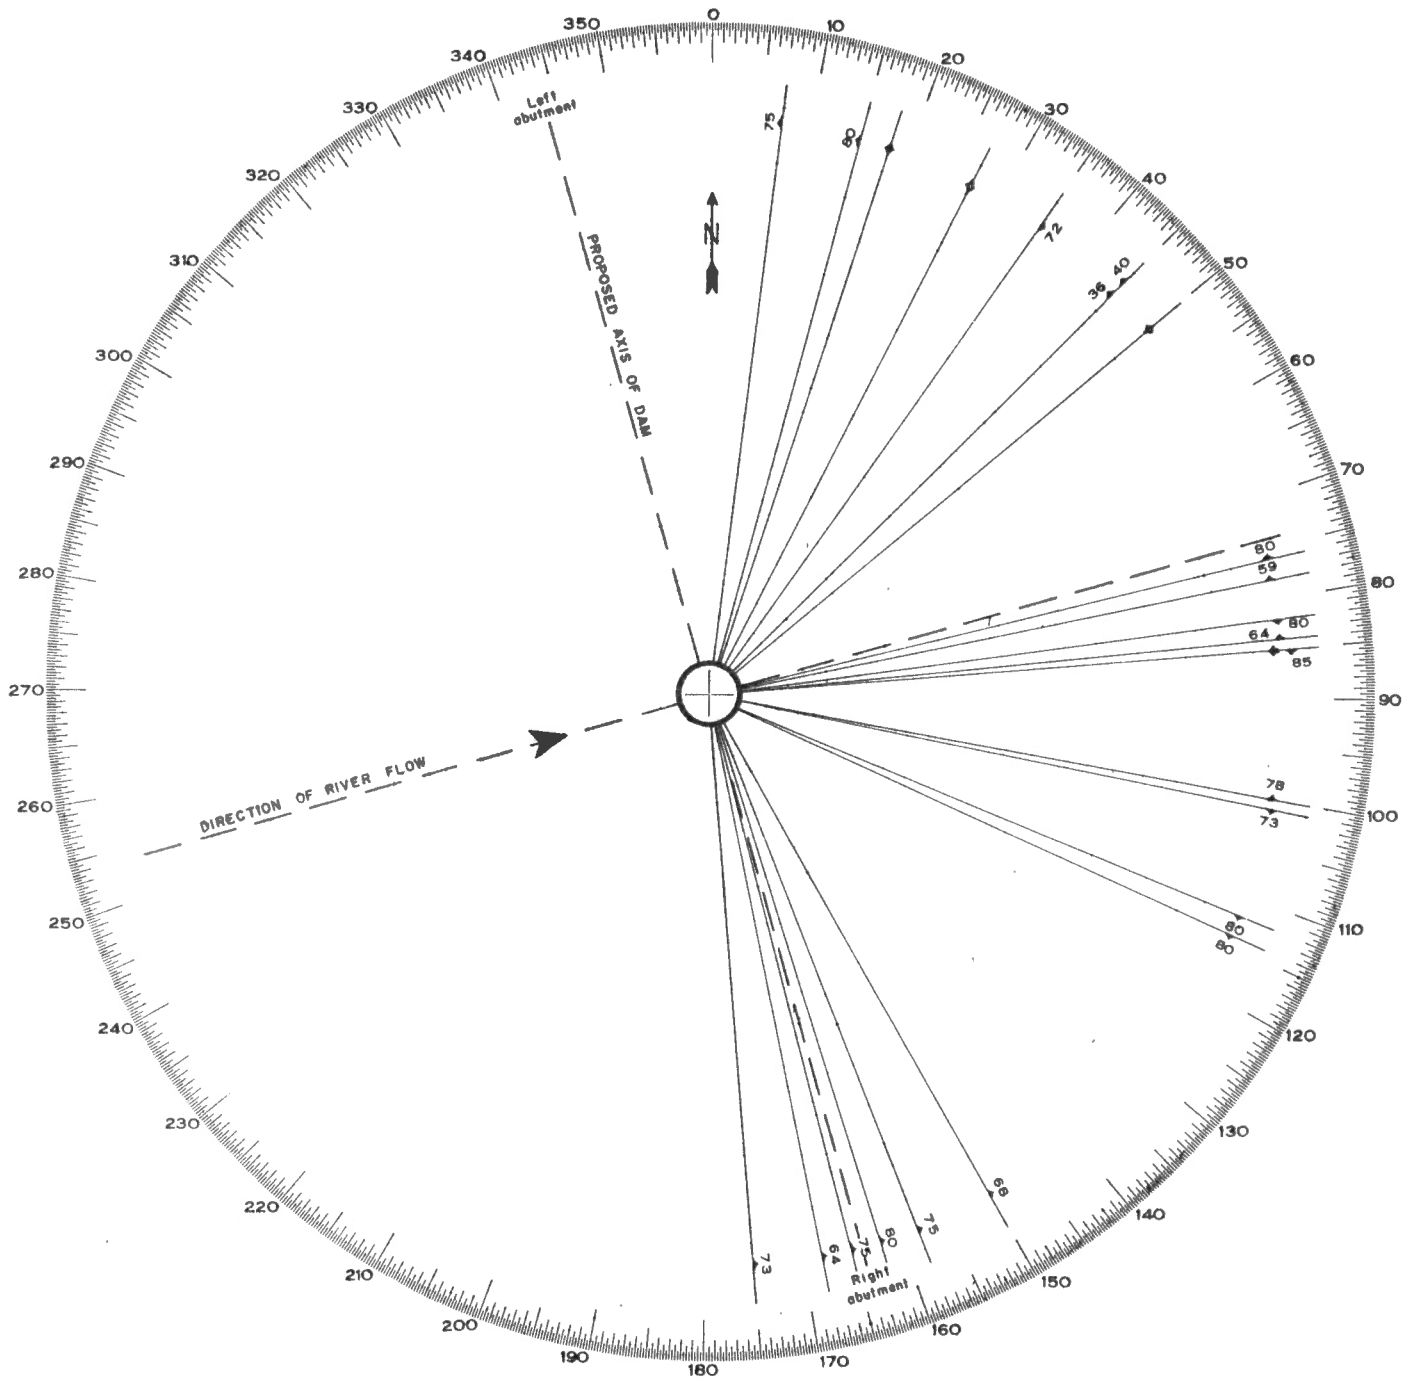
JOINT ROSETTE

The above illustration presents diagrammatically the direction and dip of jointing in bedrock exposed at Detour dam site

Jointing and schistosity are the structures which affect the competency of bedrock exposed at Detour dam site. Faulting was not observed in spite of the fact that Tintina Trench in which the site is located is the locus of a major zone of faulting¹. The jointing is irregular with considerable variance in its attitudes. There are, however, two fairly prominent sets roughly at right angles to one another. One set intersects the river at angles varying from 70 to 90 degrees and dips steeply downstream. The other closely parallels the river and dips steeply into both abutments.

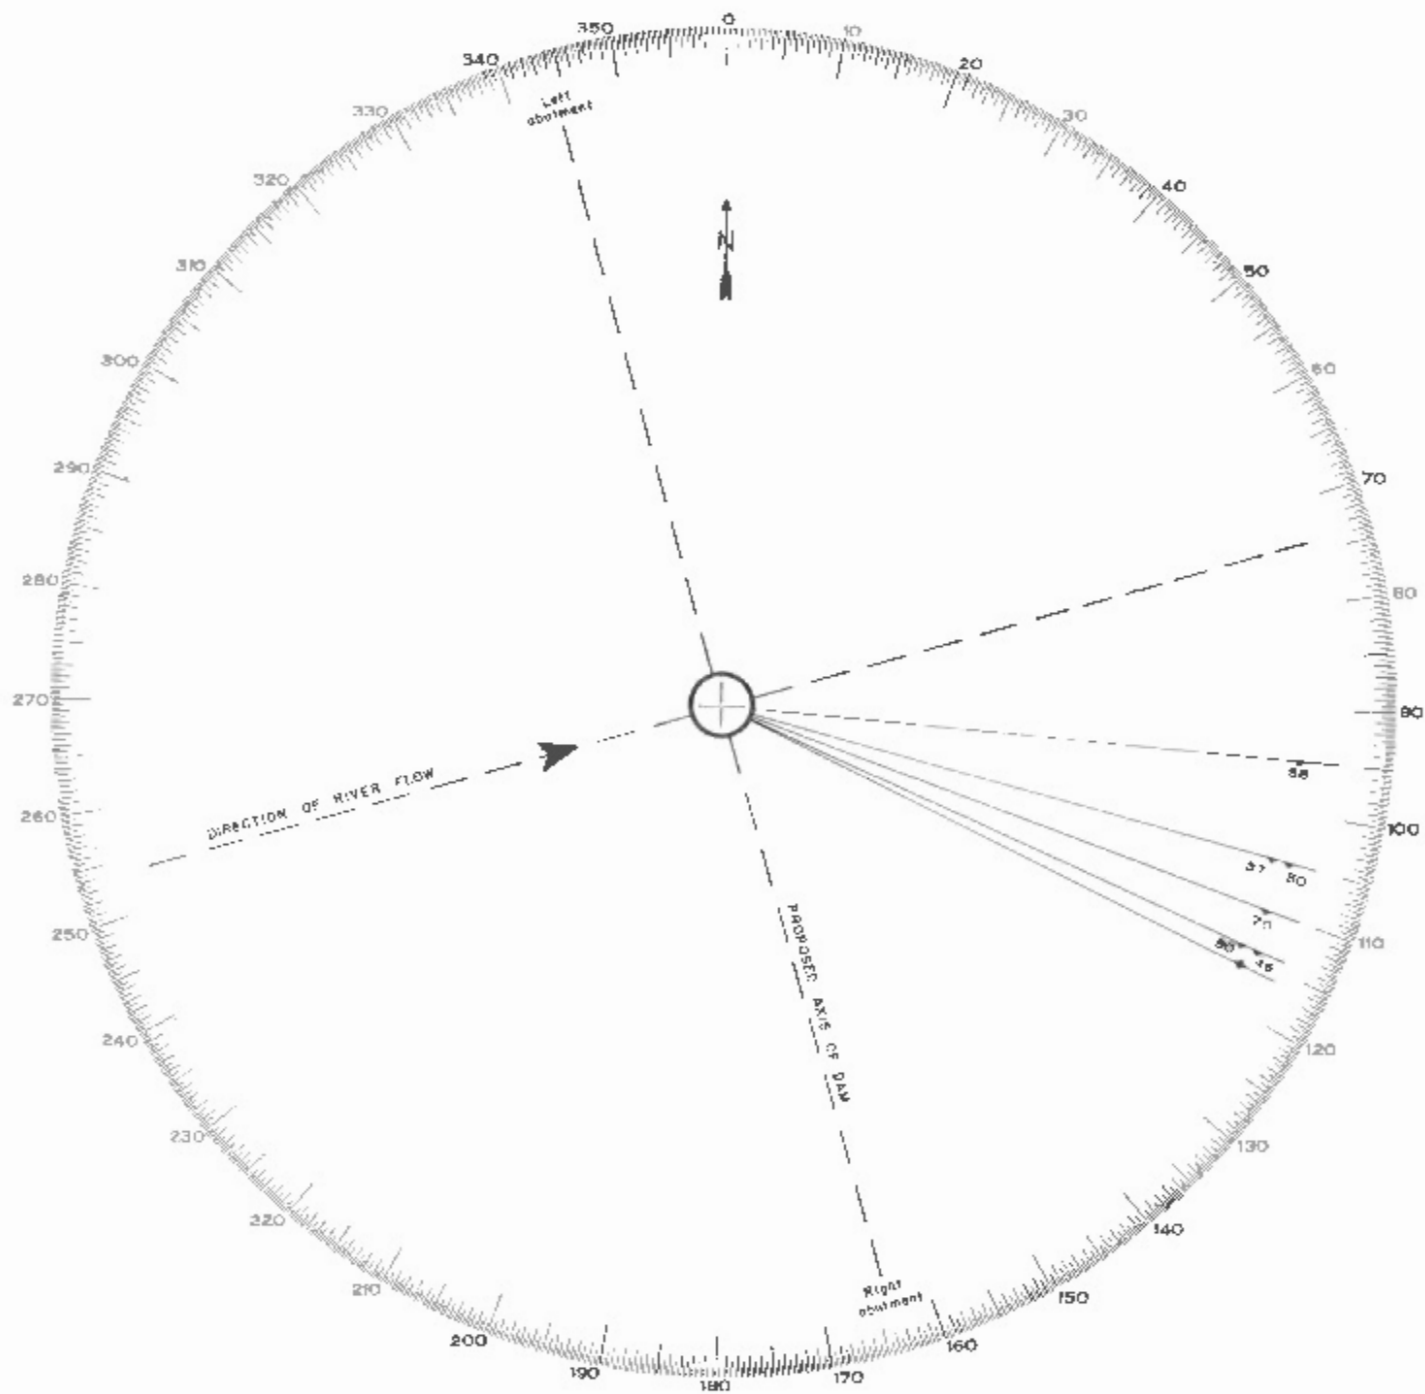
SCHISTOSITY ROSETTE

The above illustration presents diagrammatically the direction and dip of the schistosity in bedrock exposed of Detour dam site

The strike of the schistose zones which varies from 5 to 20 degrees north of west closely parallels the trend of Tintina Trench. The dips range from 37 to 80 degrees east, i.e. toward the right abutment.

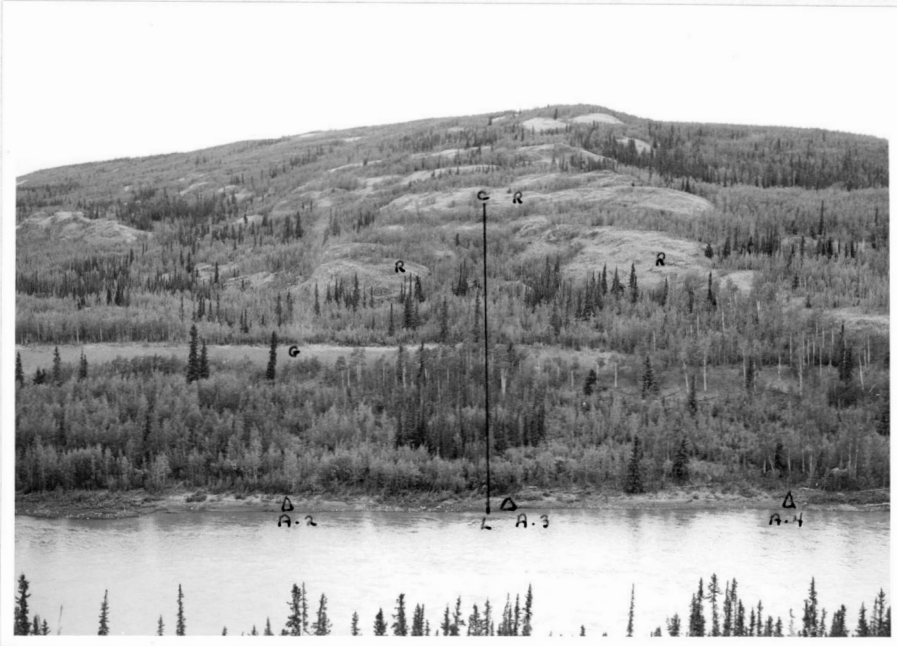
Plate 1

Left abutment of Detour dam site looking along proposed centre line from right abutment; G. - gravel terrace, R. - bedrock outcrop, C.L. - centre line of abutment, Δ - survey station.

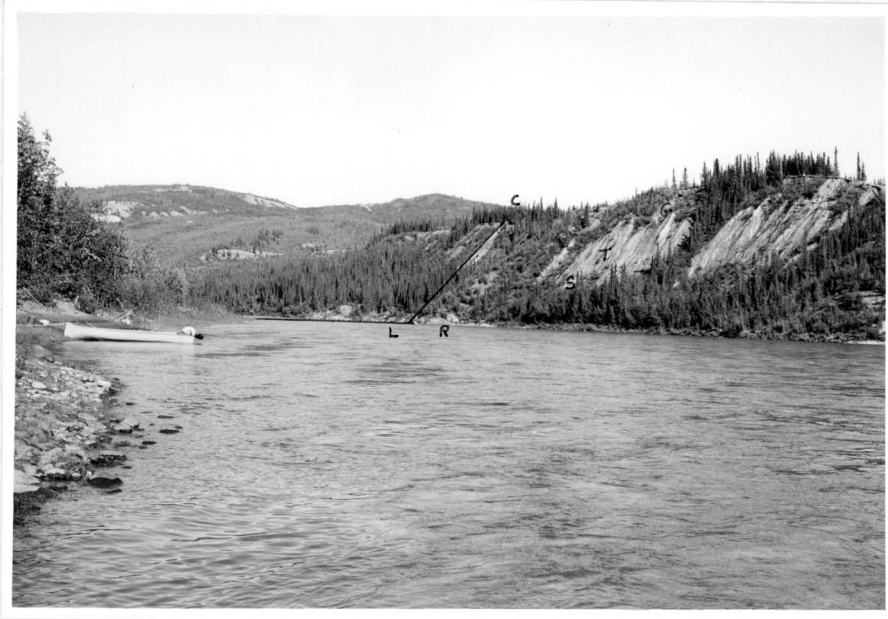
Plate 2

Looking downstream through Detour dam site from the left side of Pelly River; G. - gravel, T. - till, S. - slide debris, R. - bedrock outcrop, C.L. - centre line of abutment.

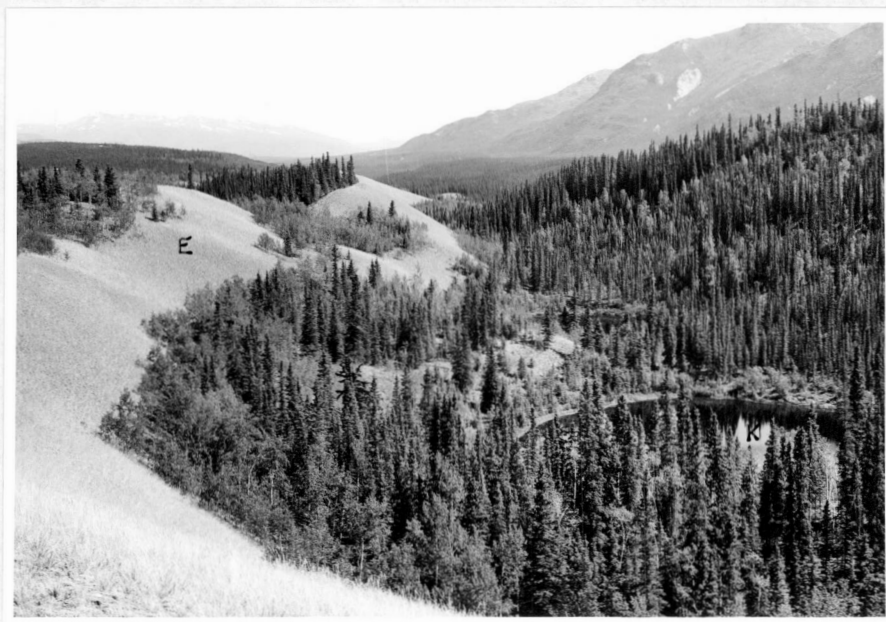
Plate 3

Potential aggregate at the upstream end of "The Detour" about one mile from the dam site; exposed material varies from fine-grained sand to fine-grained gravel; E. -esker (?), K. -kettle.

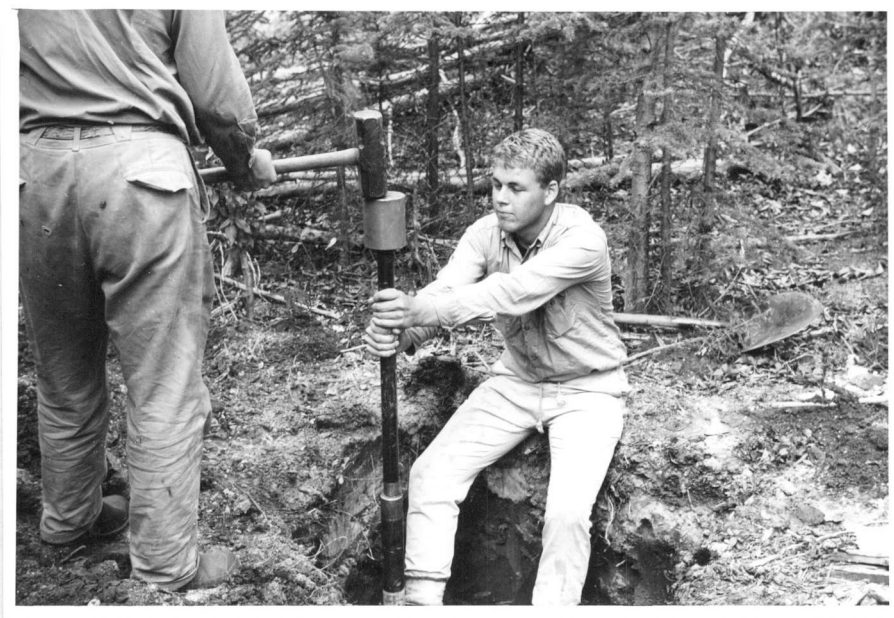
Plate 4

Taking a drive sample of frozen soil at Detour dam site.
