52.6
GEOLOGICAL SURVEY OF CANADA
TOPICAL REPORT NO. 114

YUKON RIVER DRAINAGE BASIN
DAM SITE INVESTIGATION

SITE No. 19

GRANITE CANYON DAM SITE
(MAP AND PRELIMINARY REPORT)

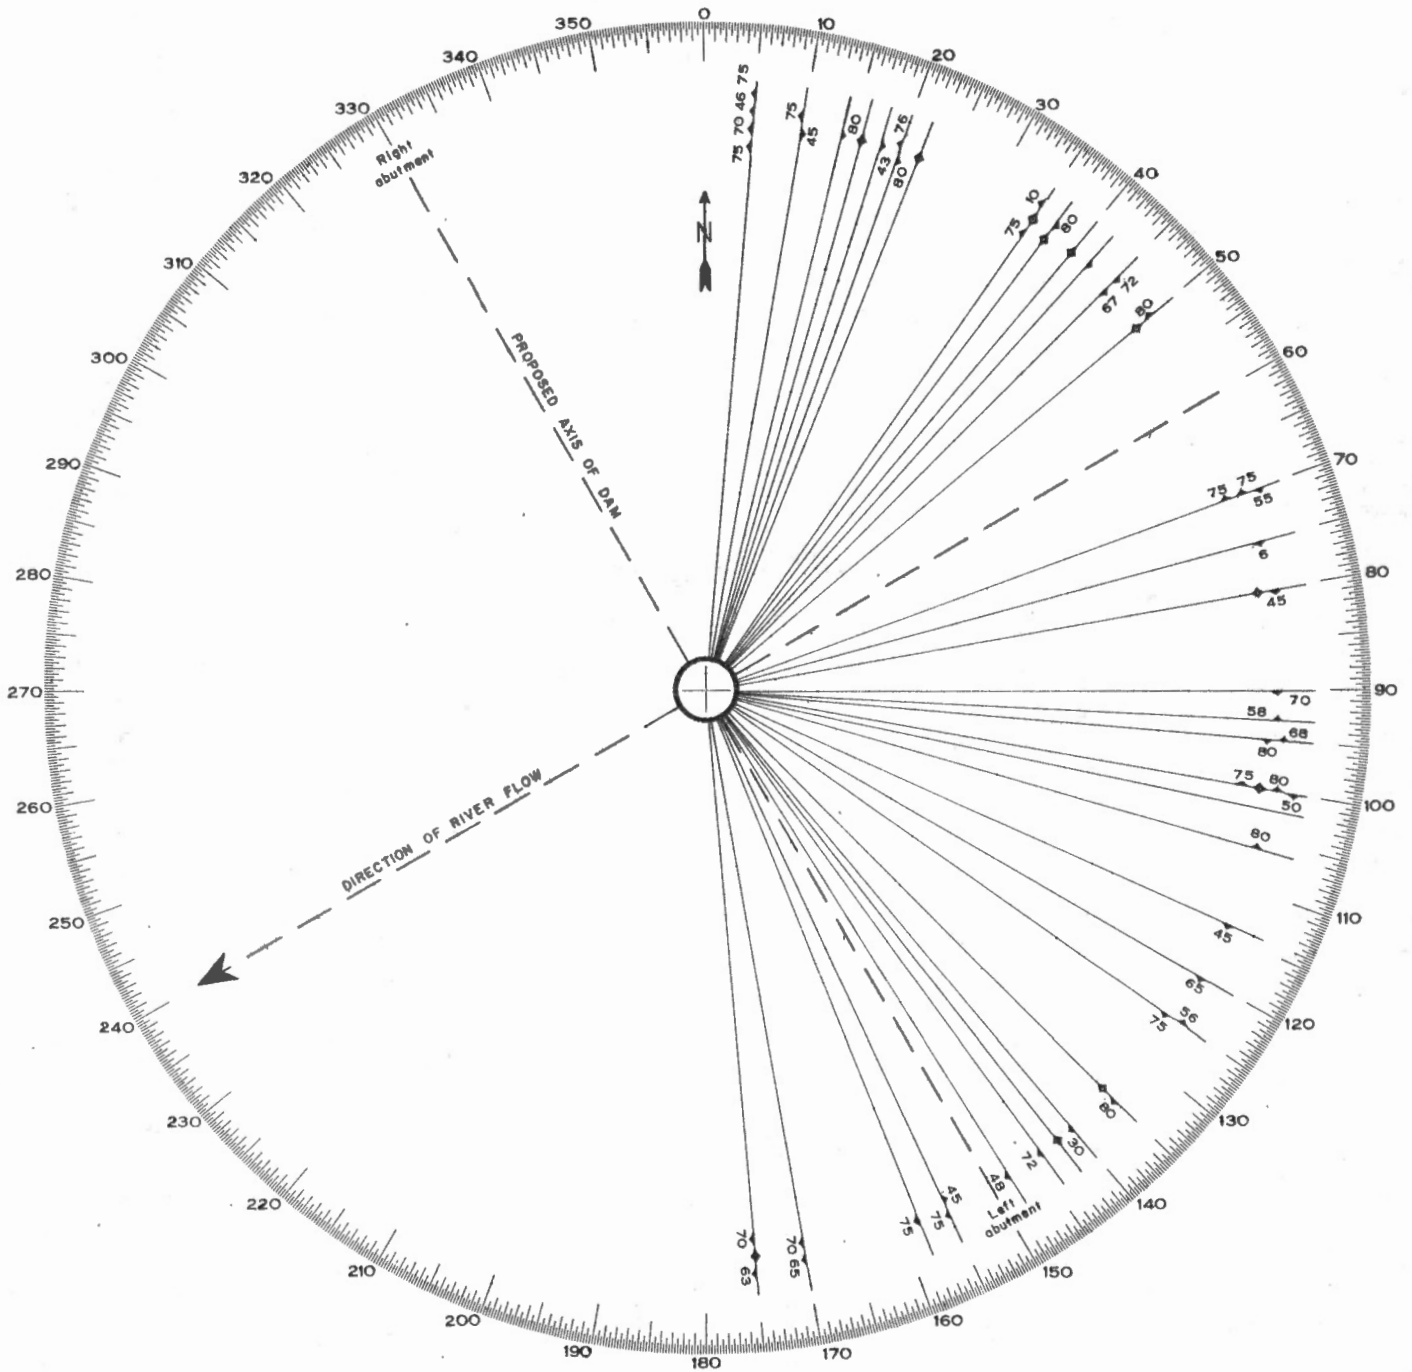
JOINT ROSETTE

Jointing is common in the granodiorite exposed at Granite Canyon dam site. Although the altitudes are unusually irregular there are 3 sets to which most of the joints can be assigned. One set strikes from 5 to 20 degrees east of north and dips steeply east and west. A second set which closely parallels the river strikes from 35 to 50 degrees east of north and dips steeply into both abutments. The third set intersects the river close to right angles. It strikes from 20 to 33 degrees east of south and dips

The above illustration presents diagrammatically the direction and dip of jointing in bedrock exposed at Granite Canyon dam site

downstream at angles varying from 48 to 75 degrees. A local set of flat joints evenly spaced at about 12 inches occurs at the foot of the right wall of the canyon near the proposed centre line. The intersection of these joints with a vertical set at 90 degrees to the river gives the face of the rock a distinctive blocky appearance. Sheet jointing which commonly develops parallel to the exposed surfaces of igneous rocks was not observed at Granite Canyon dam site. There is no indication of any movement along or parallel to the jointing. The major movement has been at right angles to the surface of the fracture.

Single joints can frequently be traced on bedrock surface for distances up to 150 feet. Open fractures associated with them range up to 12 inches in width. Many of the larger rock fragments in the talus have broken off along the joint set parallel to the river.

The jointing is the only structure which could affect the competency of bedrock. Test borings will be needed to determine if the joints decrease in number from surface downward and also the depths to which the open fractures extend. The intensity of the jointing present at the dam site will probably result in grouting being necessary to consolidate the rock.

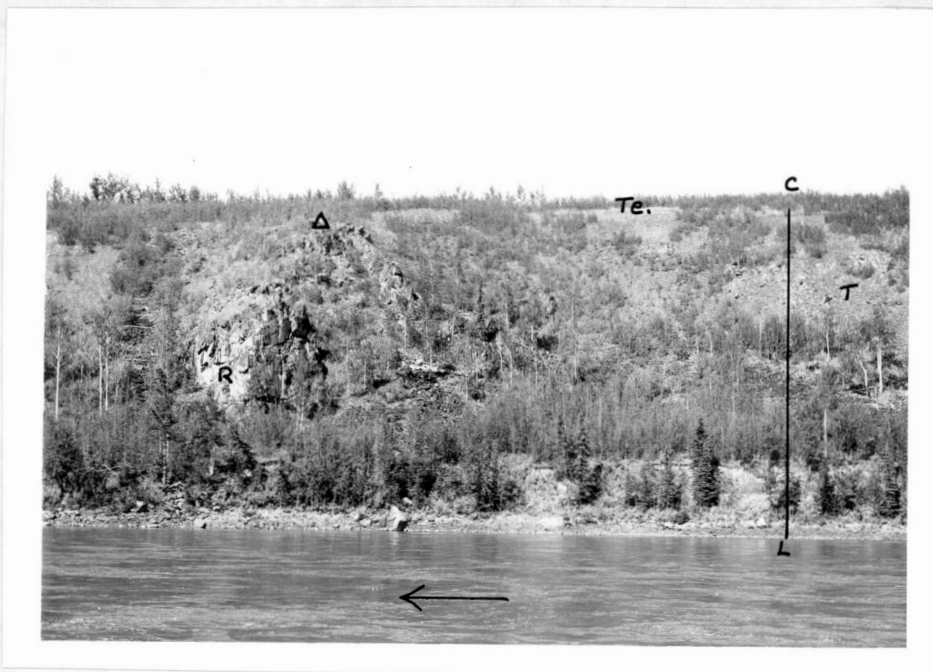
Plate 1

Right abutment, Granite Canyon
dam site, CL - approximate
centre line, Δ - survey station E-4,
Te - gravel-covered terrace, R - steep bedrock
bluff, T - talus.

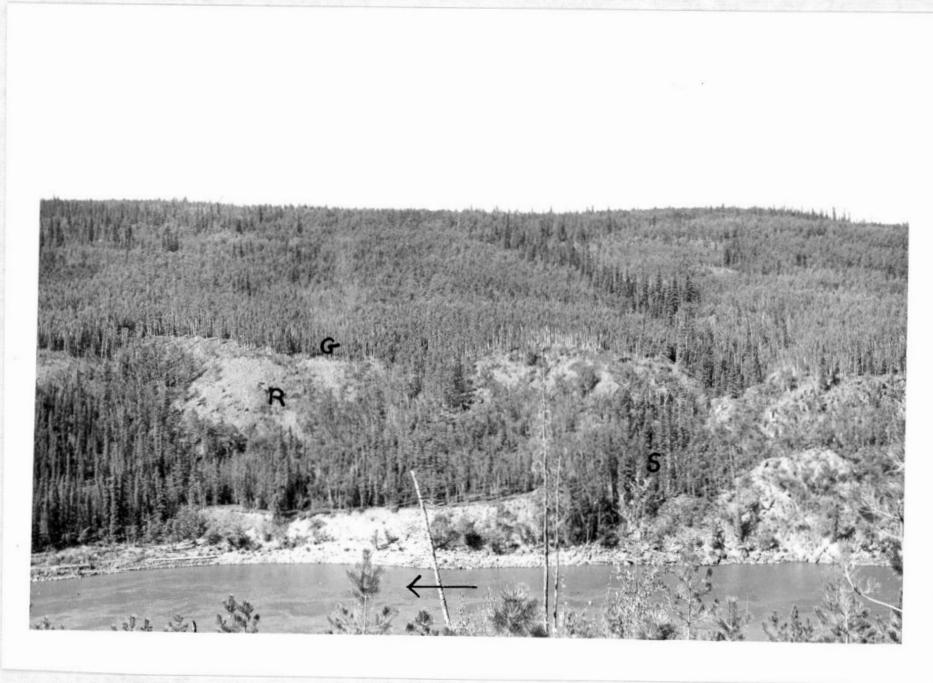
Plate 2

Two springs exist in the dam site area; both are located in the downstream part of the right abutment. One spring occurs on the floor of the deeply incised valley of Diamain Creek about 200 feet north of and 70 feet above Pelly River. The other is about 600 feet upstream from the creek and 550 feet north of the river. This spring is about 125 feet above the river. At the time of the investigation Diamain Creek which drains Diamain Lake 2 miles north was completely dry.

Downstream end of right abutment; S - spring in valley of Diamain Creek, elevation 1,695 (approx.), G - gravel-covered terrace, elevation 1,905 (approx.), R - bedrock bluff partly covered with talus.

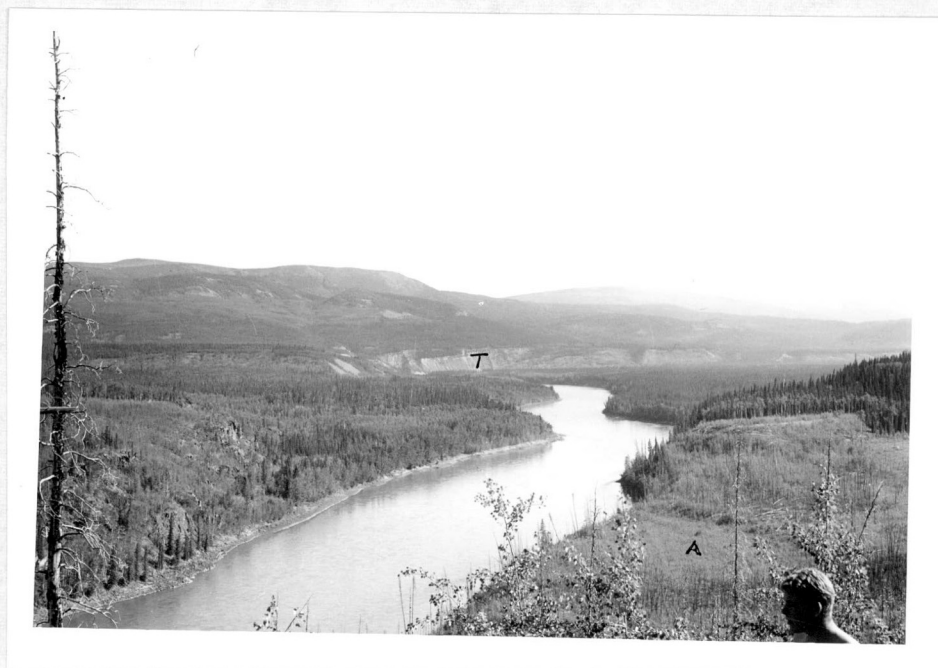
Plate 3

Frozen soil was encountered only on the low, alluvium-covered terrace on the upstream part of the left abutment. On July 25, 1965 the frost line existed at depths of 12 to 18 inches beneath ground surface. The depths to the frozen material depended upon the thickness of the overlying layer of moss and decayed organic material. In places where the thickness of the organic material exceeded 24 inches the frost line was at about 12 inches whereas in other localities where there was little or no organic material the frozen soil was deeper or was not encountered in test pits dug to 36 inches. Samples of the frozen soil were not taken at Granite Canyon dam site. However similar materials were sampled further downstream in the vicinity of Pelly Crossing. These were all taken from places that lie within the reservoirs of the proposed dams at Bradens Canyon and Gerc. The samples were taken by driving BX casing or a 2-inch, O.D. split tube with a 10-pound sledge hammer. Descriptions of the frozen material and grain size analyses curves are included on the following pages.

View looking upstream from left abutment of Granite Canyon dam site. A - alluvium-covered terrace with frozen soil at 12-18 inches, T - 200-foot bluff of potential impervious material (till), sample No. 5.
