GEOLOGICAL SURVEY OF CANADA
DEPARTMENT OF ENERGY, MINES AND RESOURCES

MACKENZIE RIVER DRAINAGE BASIN
SITE NO. 23
LOWER DIRECTION DAM SITE
TO ACCOMPANY TOPICAL REPORT NO. 120
GEOLOGY BY E.B. OWEN, 1964

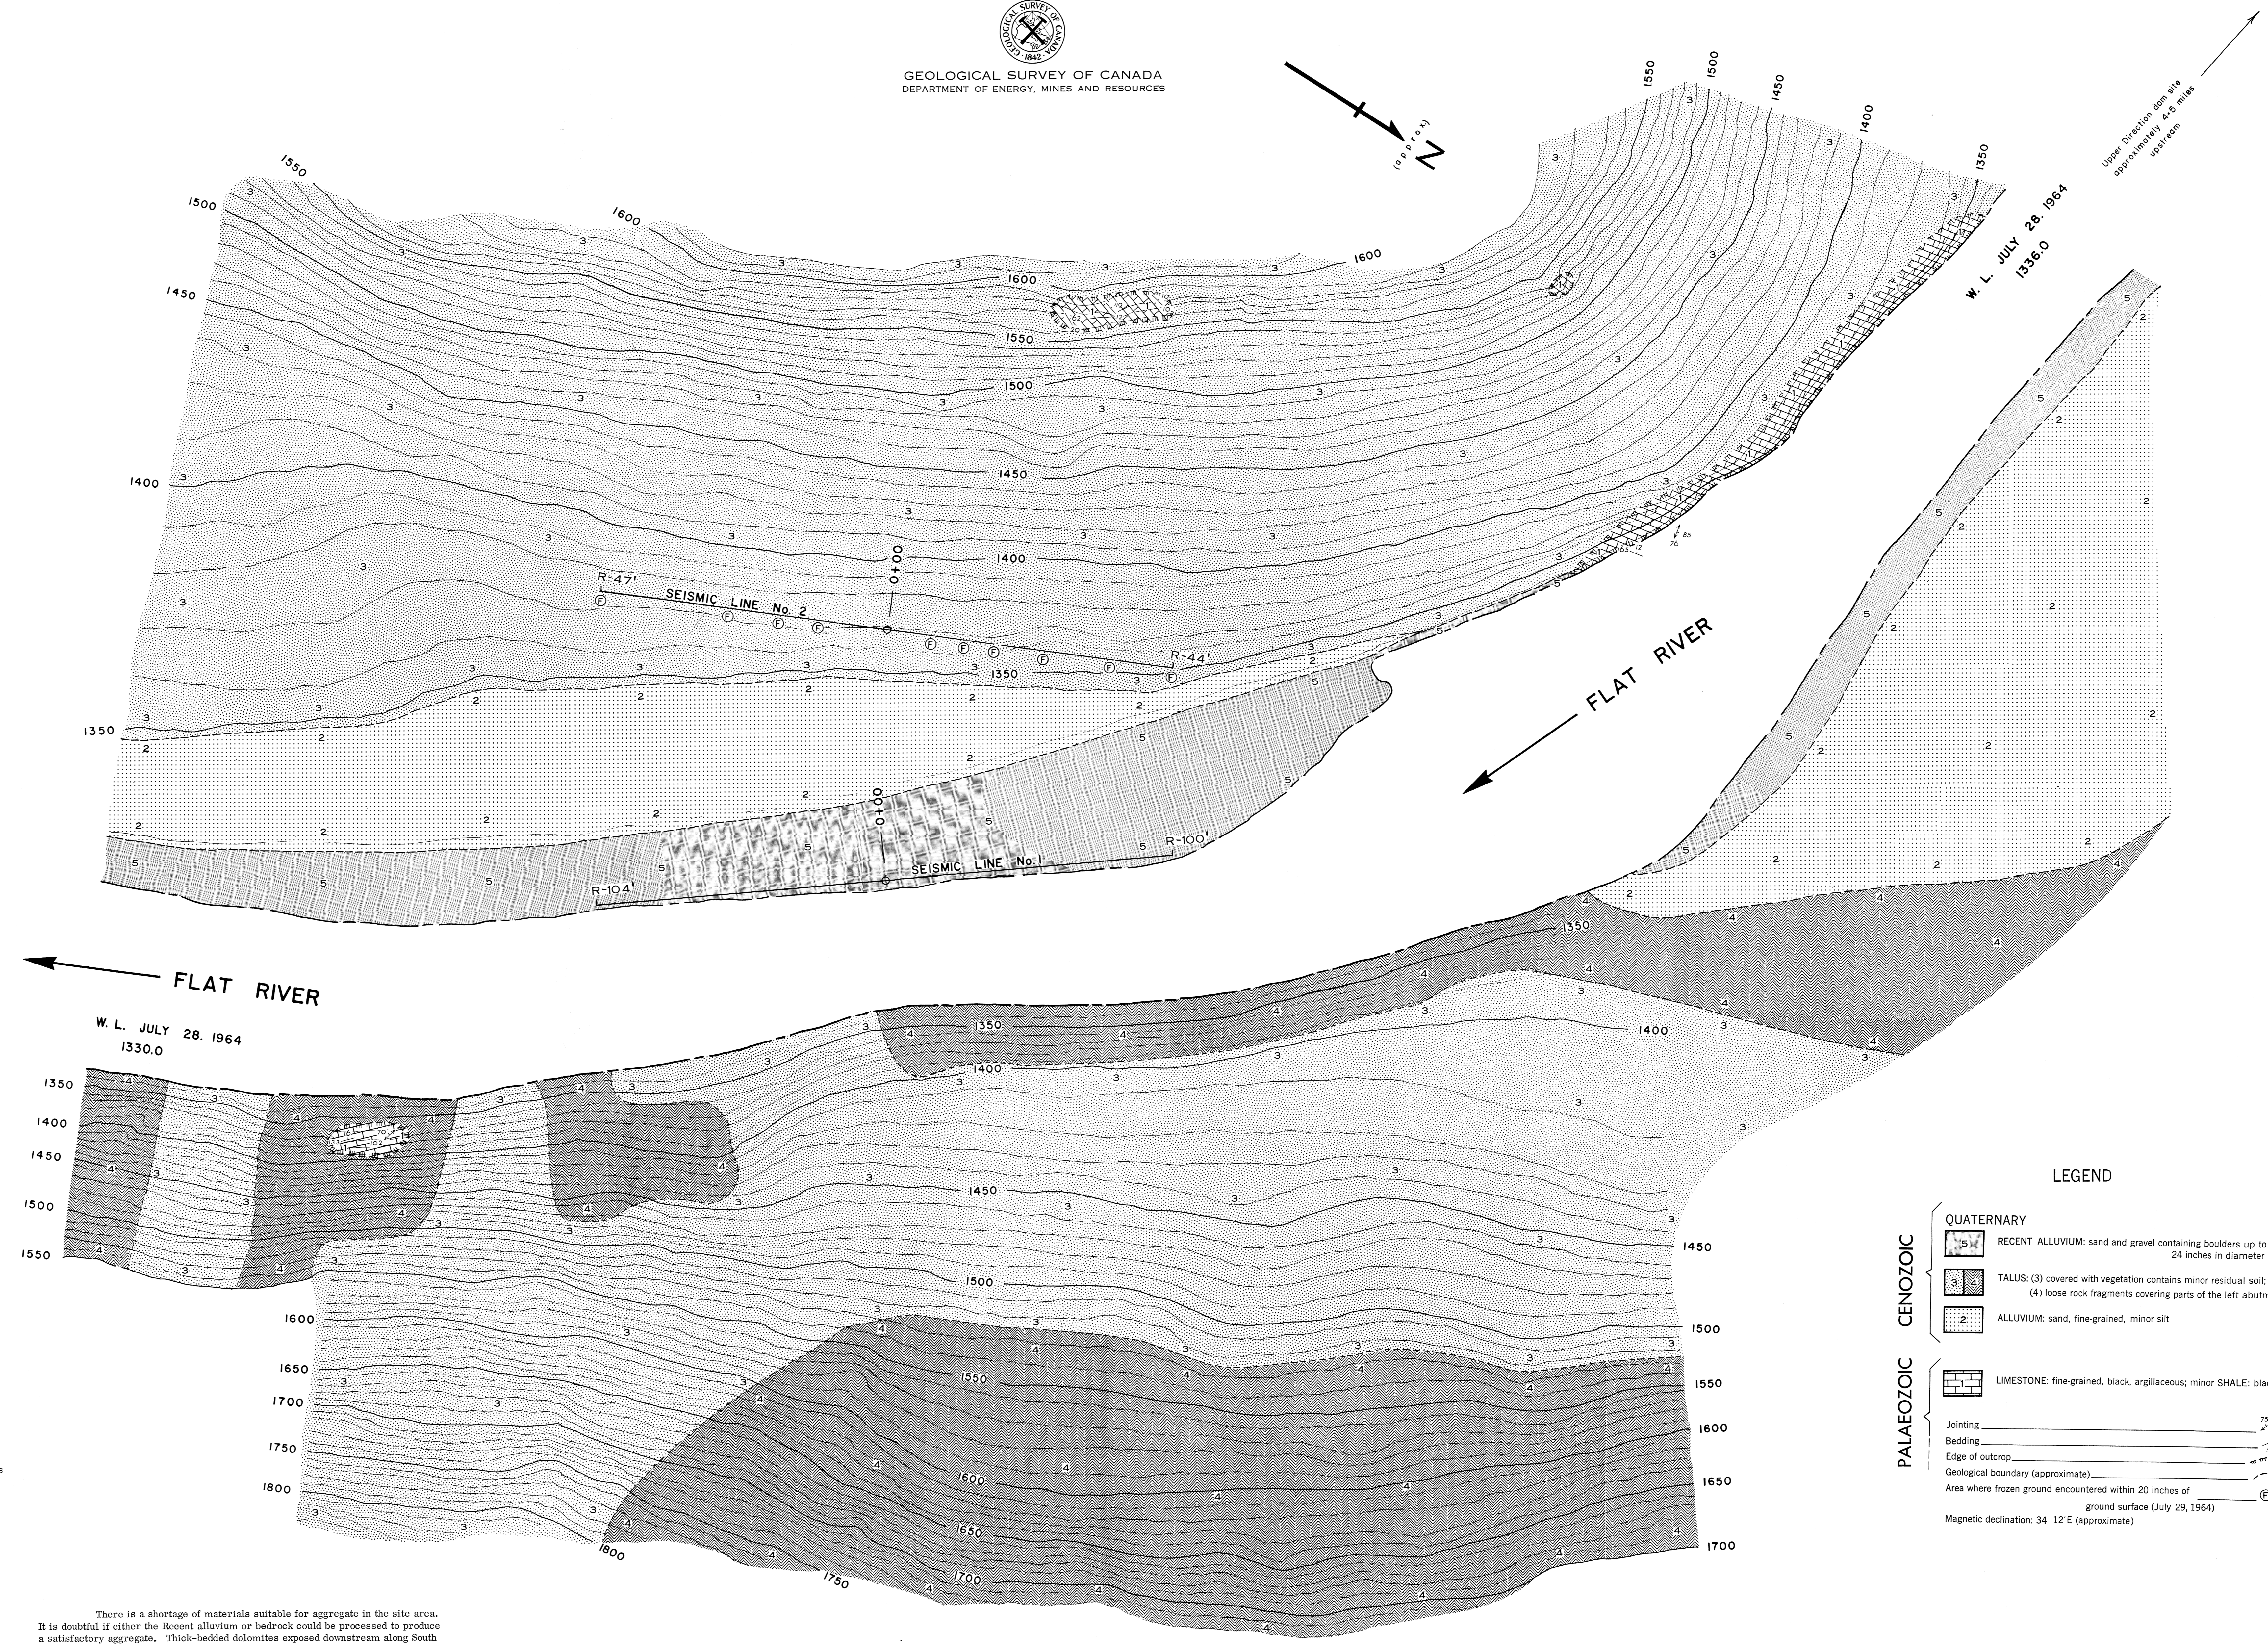
Overburden at the site consists of Recent alluvium, alluvium and talus. The Recent alluvium is exposed in a large bar along the right side of the river. The material consists chiefly of sand and gravel containing boulders up to 24 inches in diameter. The results of seismic line No. 1 indicate the thickness of overburden beneath the bar varies from 100 to 104 feet. Consequently, if the dam were founded upon bedrock, large quantities of this material would be excavated. The high shale content of the Recent alluvium would preclude it from being used as aggregate. The alluvium covers level terraces along both sides of the river up to elevation 1,348 (about 20 feet above the river). It is not a flood plain deposit but is believed to have been laid down at some previous time when Flat River flowed at a higher elevation. The alluvium consists of fine-grained sand with minor silt (Sample No. 14). Talus consists of rock fragments which have resulted from the mechanical disintegration of adjacent bedrock. The size and shape of the fragments derived from sedimentary rocks is dependent upon the thickness of the beds and the spacing of the jointing as well as the angles at which these structures intersect. Most of the fragments in the talus at Lower Direction dam site range from sand-size particles to angular boulders less than 12 inches in diameter. In places, however, there are accumulations of boulders up to several feet in diameter.

The thickness of overburden on the sides of the valley should seldom exceed 10 feet. However the thickness of the colluvium, which is a mixture of talus and residual soil, along the bottoms of the slope is greater than 40 feet. This is indicated by the results of seismic line No. 2. The depths to bedrock obtained from seismic line No. 1 (100 - 104 feet) suggests bedrock surface continues to slope steeply downward beneath the river.

Bedrock exposed in the dam site area consists chiefly of fine-grained, dark grey to black, argillaceous limestone in beds varying in thickness from 2 to 12 inches. Interstratified with the limestone are thin beds of black shale which are seldom more than 3 inches thick. Similar rocks are exposed along the left side of the valley above the site area. Interbedded with these rocks is a distinct, plainly visible bed of fine-grained, grey-weathering, dolomitic limestone some 25 feet in thickness (Plate 1). Many of the large rock fragments in the talus are from this massive bed. In general, the bedding is parallel to the river and dips at low angles into the right side of the valley. Minor undulations, however, have resulted in some variations in its attitude. The prominent dolomitic limestone bed exposed high up on the left side of the valley projects downward toward the bottom of the right side. There is no joint set that is prominent throughout the dam site area. Most of the jointing is irregular with the spacing ranging from 2 to 12 inches. The north-trending thrust faults visible in the upper part of the left side of the valley are parallel to the valley at the site. It is possible the direction of the valley is controlled by the bedding and/or the faulting. Also, a fault parallel to the valley may underlie the river at the site. The existence of a fault beneath the river would seriously effect construction at the site and should be taken into consideration in the design of the structures.

There are no groundwater springs or seepages in the dam site area nor was groundwater encountered above the frost line in the shot holes of seismic line No. 2. However, minor seeps occur along the thrust faults in the upper part of the left side of the valley. Frozen soil was encountered in the fill-like colluvium exposed in the shot holes of seismic line No. 2. In most instances it occurred within 20 inches of ground surface. The depth depended upon the thickness of the overlying cover of moss and organic material.
