GEOLOGICAL SURVEY OF CANADA
TOPICAL REPORT NO. 35

YUKON RIVER DRAINAGE BASIN
DAM SITE INVESTIGATION

SITE NO. 26

LOWER CANYON DAM SITE
(MAP AND PRELIMINARY REPORT)

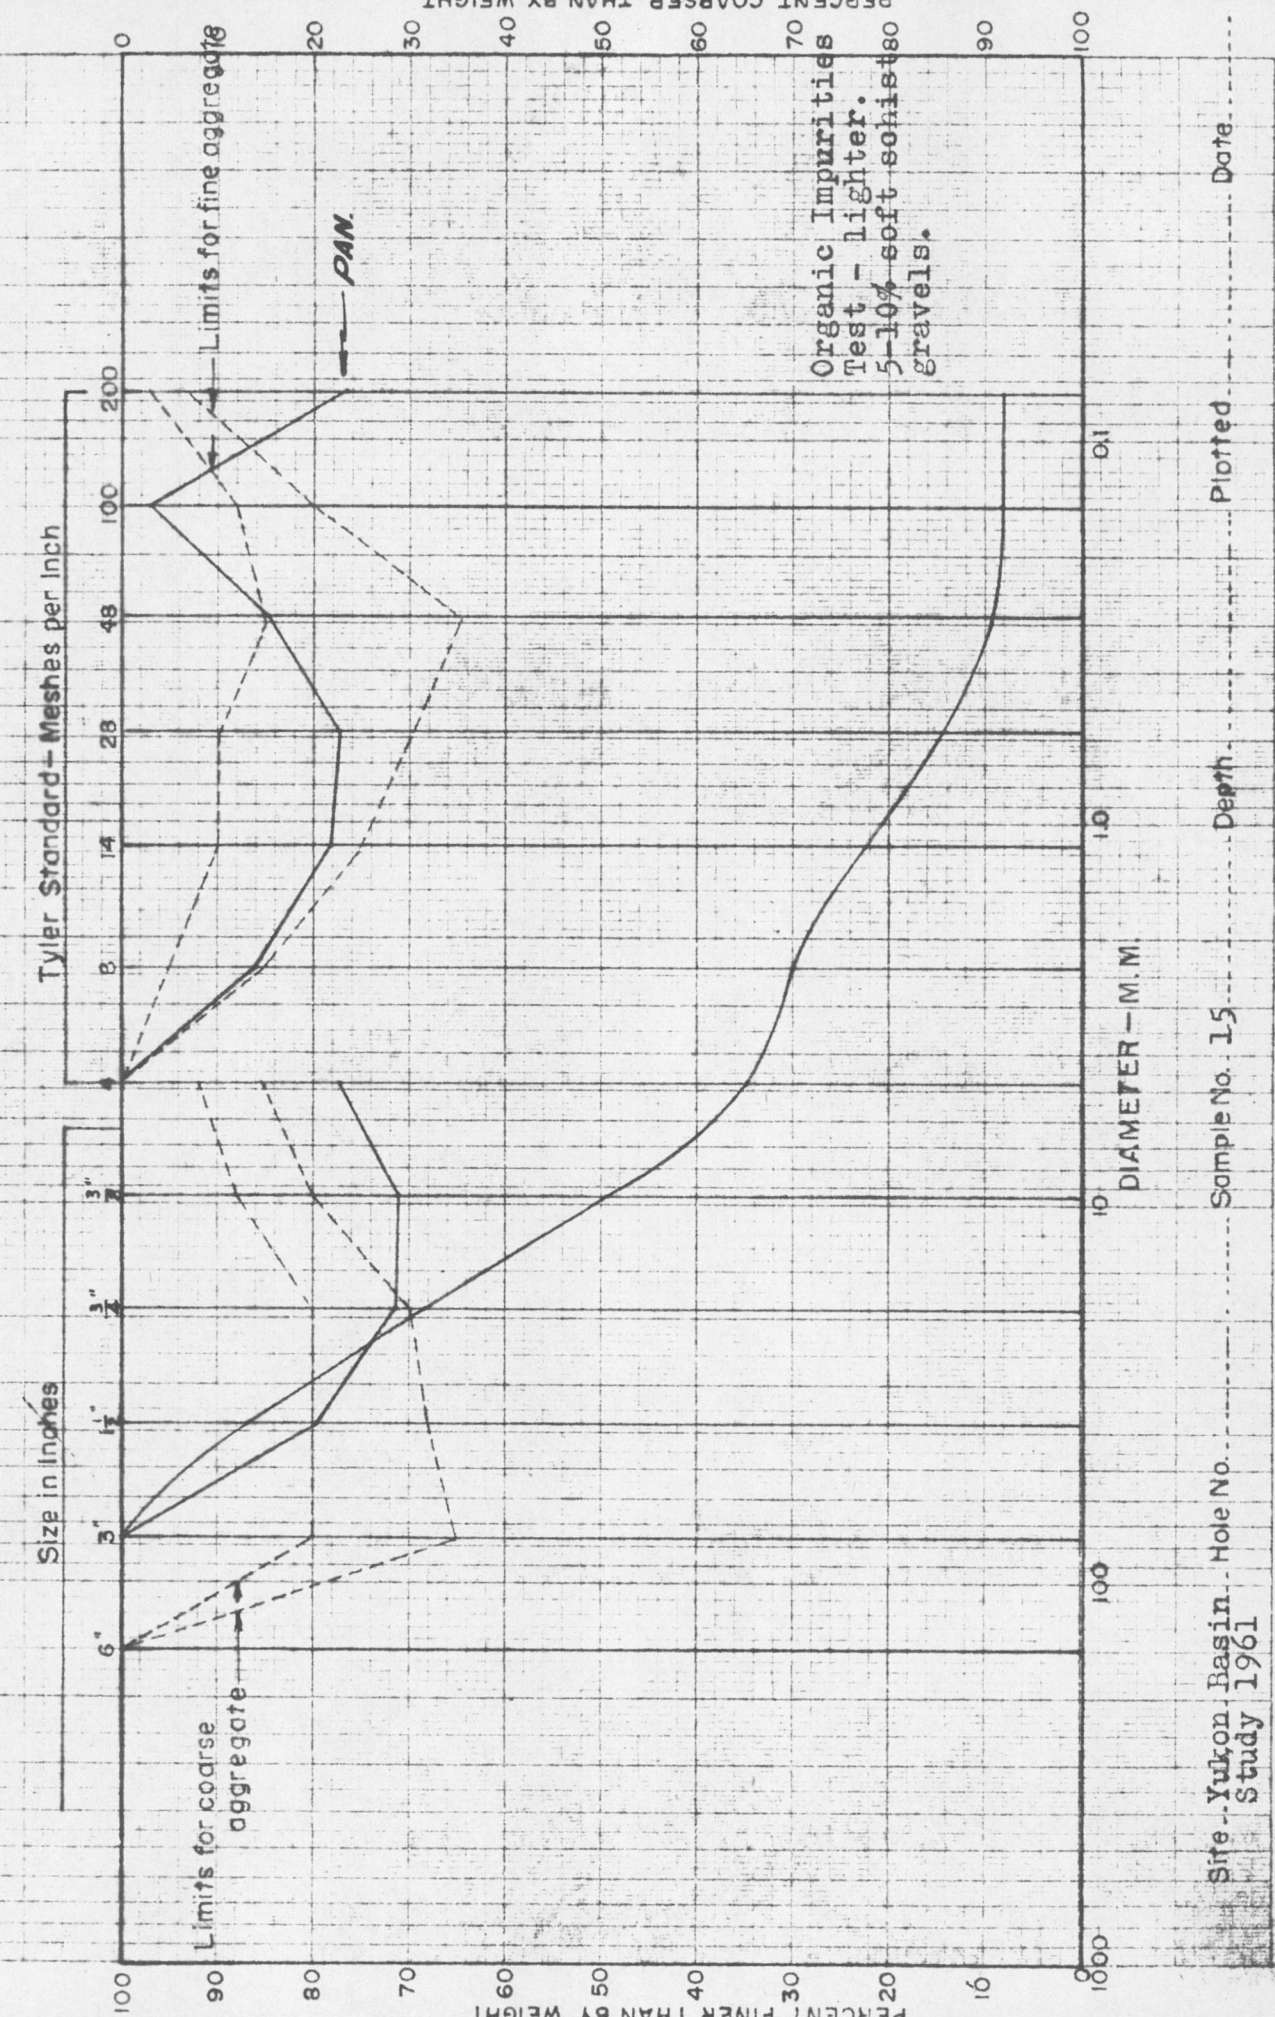
Sample No. 15 Depth Date

Organic Impurities
 Test - lighter.
 5-10% soft schists
 gravels.

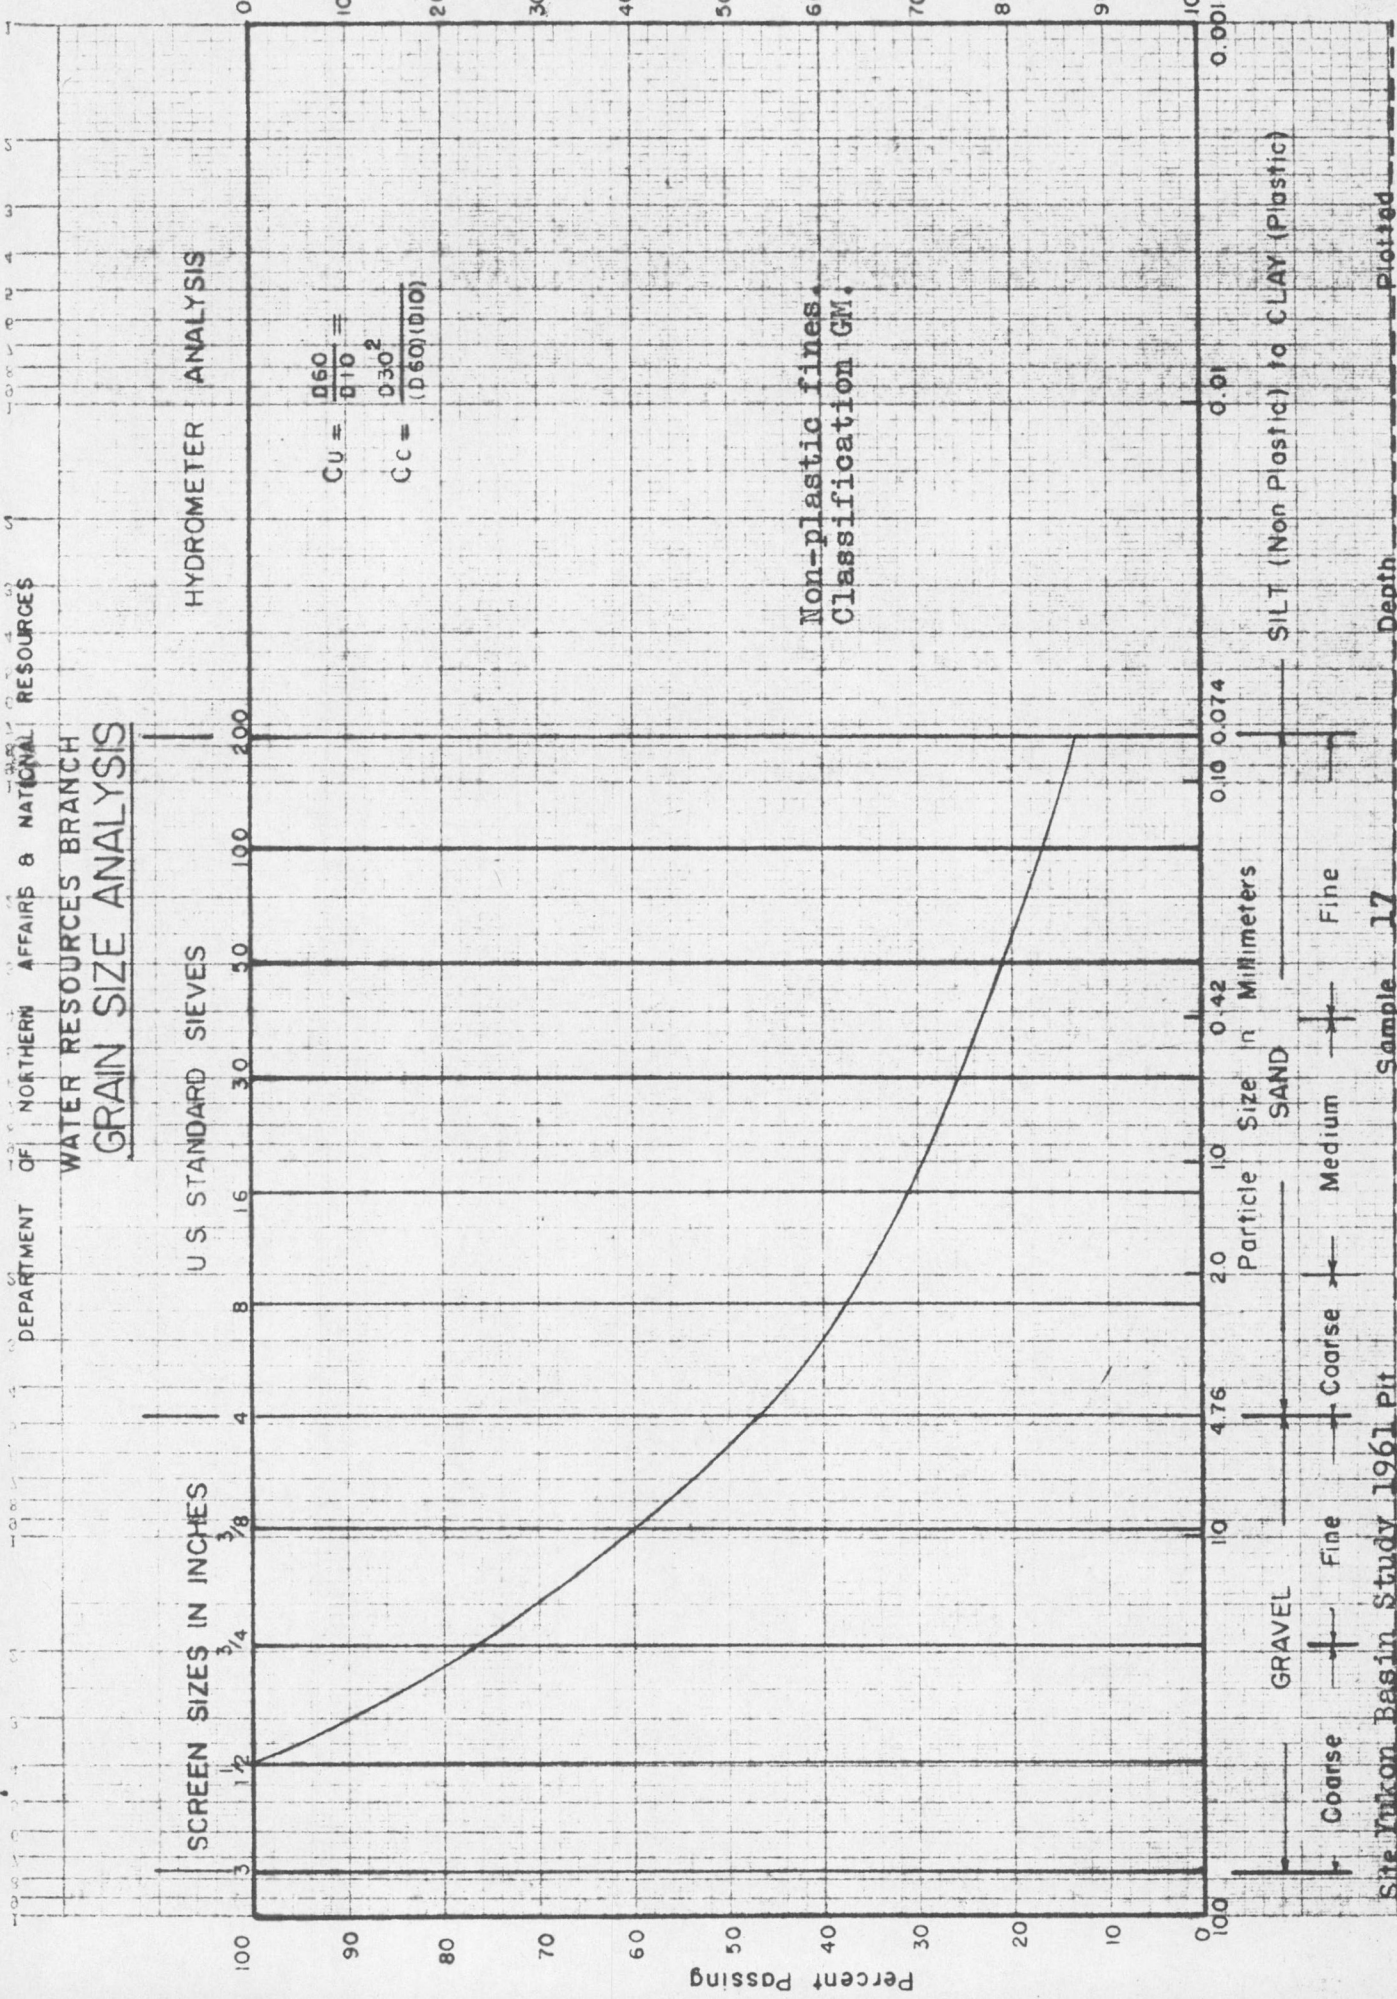
Sample 17

Non-plastic fines,
 Classification GM.

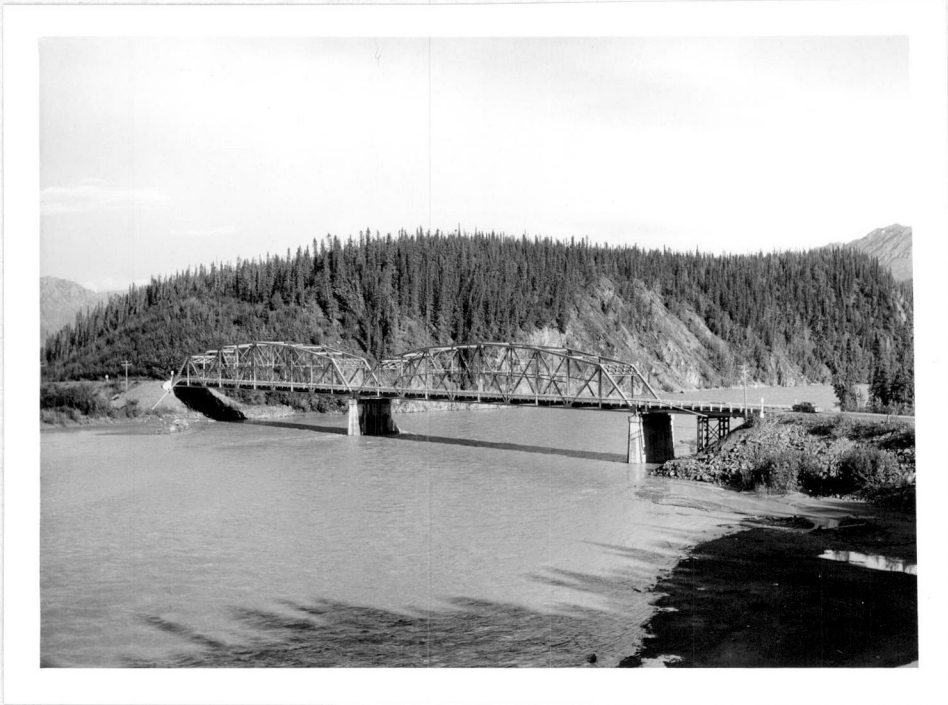
Plate 1

Bridge over White River at mile 1169.2, Alaska
Highway; right abutment in background.

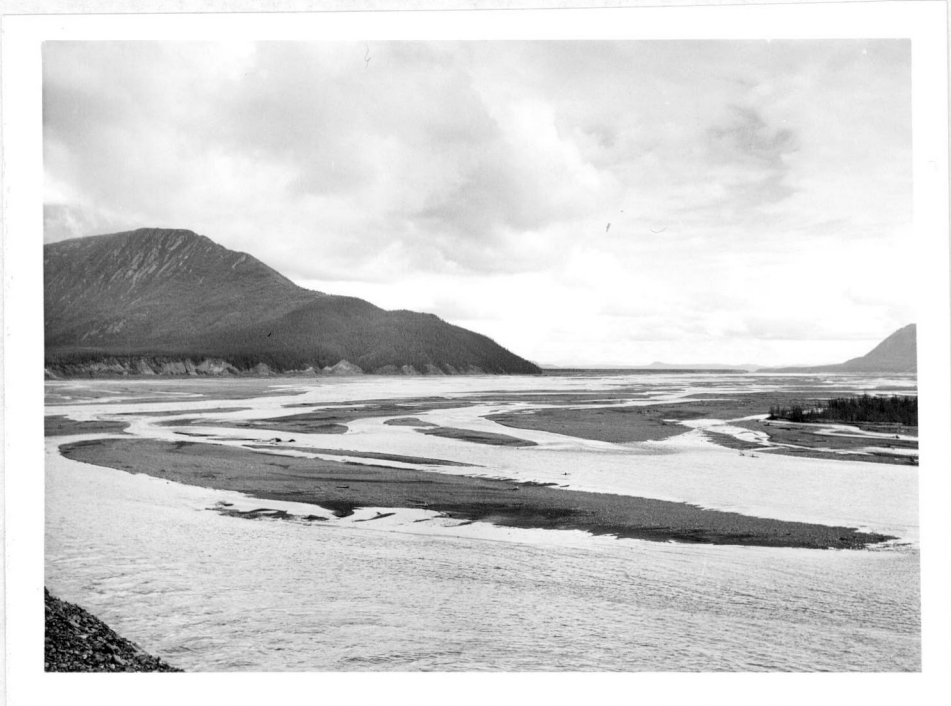
Plate 2

Bare flood plain of White River immediately downstream from Lower Canyon dam site; a potential source of natural aggregate.

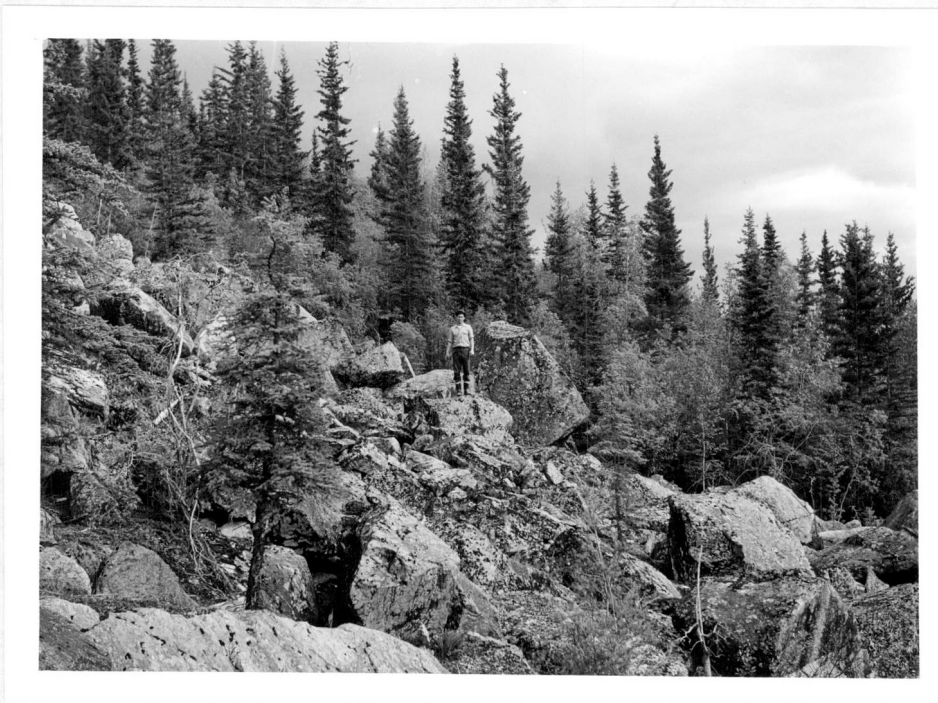
Plate 3

Talus consisting of large fragments of granodiorite;
south end of Horse Camp Hill; potential riprap.
