GEOLOGICAL SURVEY OF CANADA
TOPICAL REPORT NO. 40

MACKENZIE RIVER DRAINAGE BASIN
DAM SITE INVESTIGATION

SITE NO. 2

FALSE CANYON DAM SITE
(MAP AND PRELIMINARY REPORT)

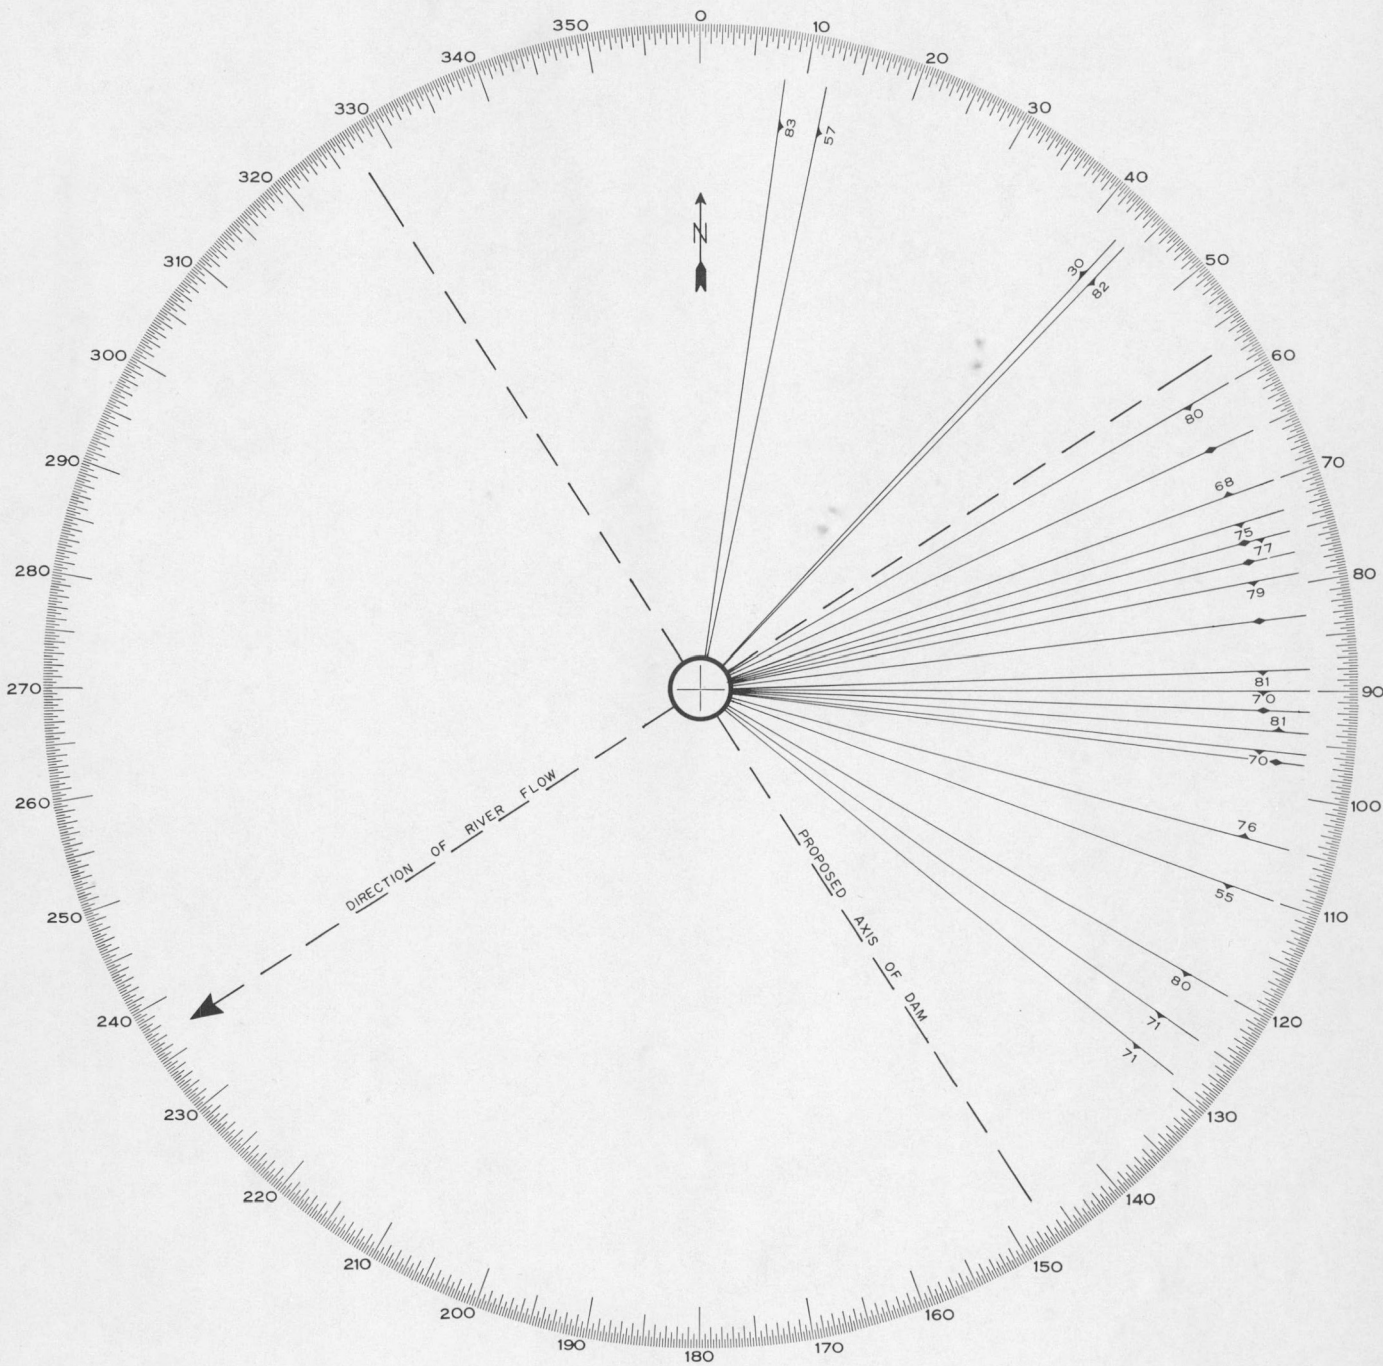
JOINT ROSETTE

Jointing is common and usually closely spaced. It intersects the proposed centre line of the dam at angles varying from zero to 69 degrees and dips steeply downstream or into the right abutment. The most prominent set intersects the centre line at angles from 42 to 69 degrees. The set would undoubtedly exert considerable influence on the manner bedrock would break during blasting.

The above illustration presents diagrammatically the direction and dip of the jointing in bedrock exposed at False Canyon dam site, Frances River

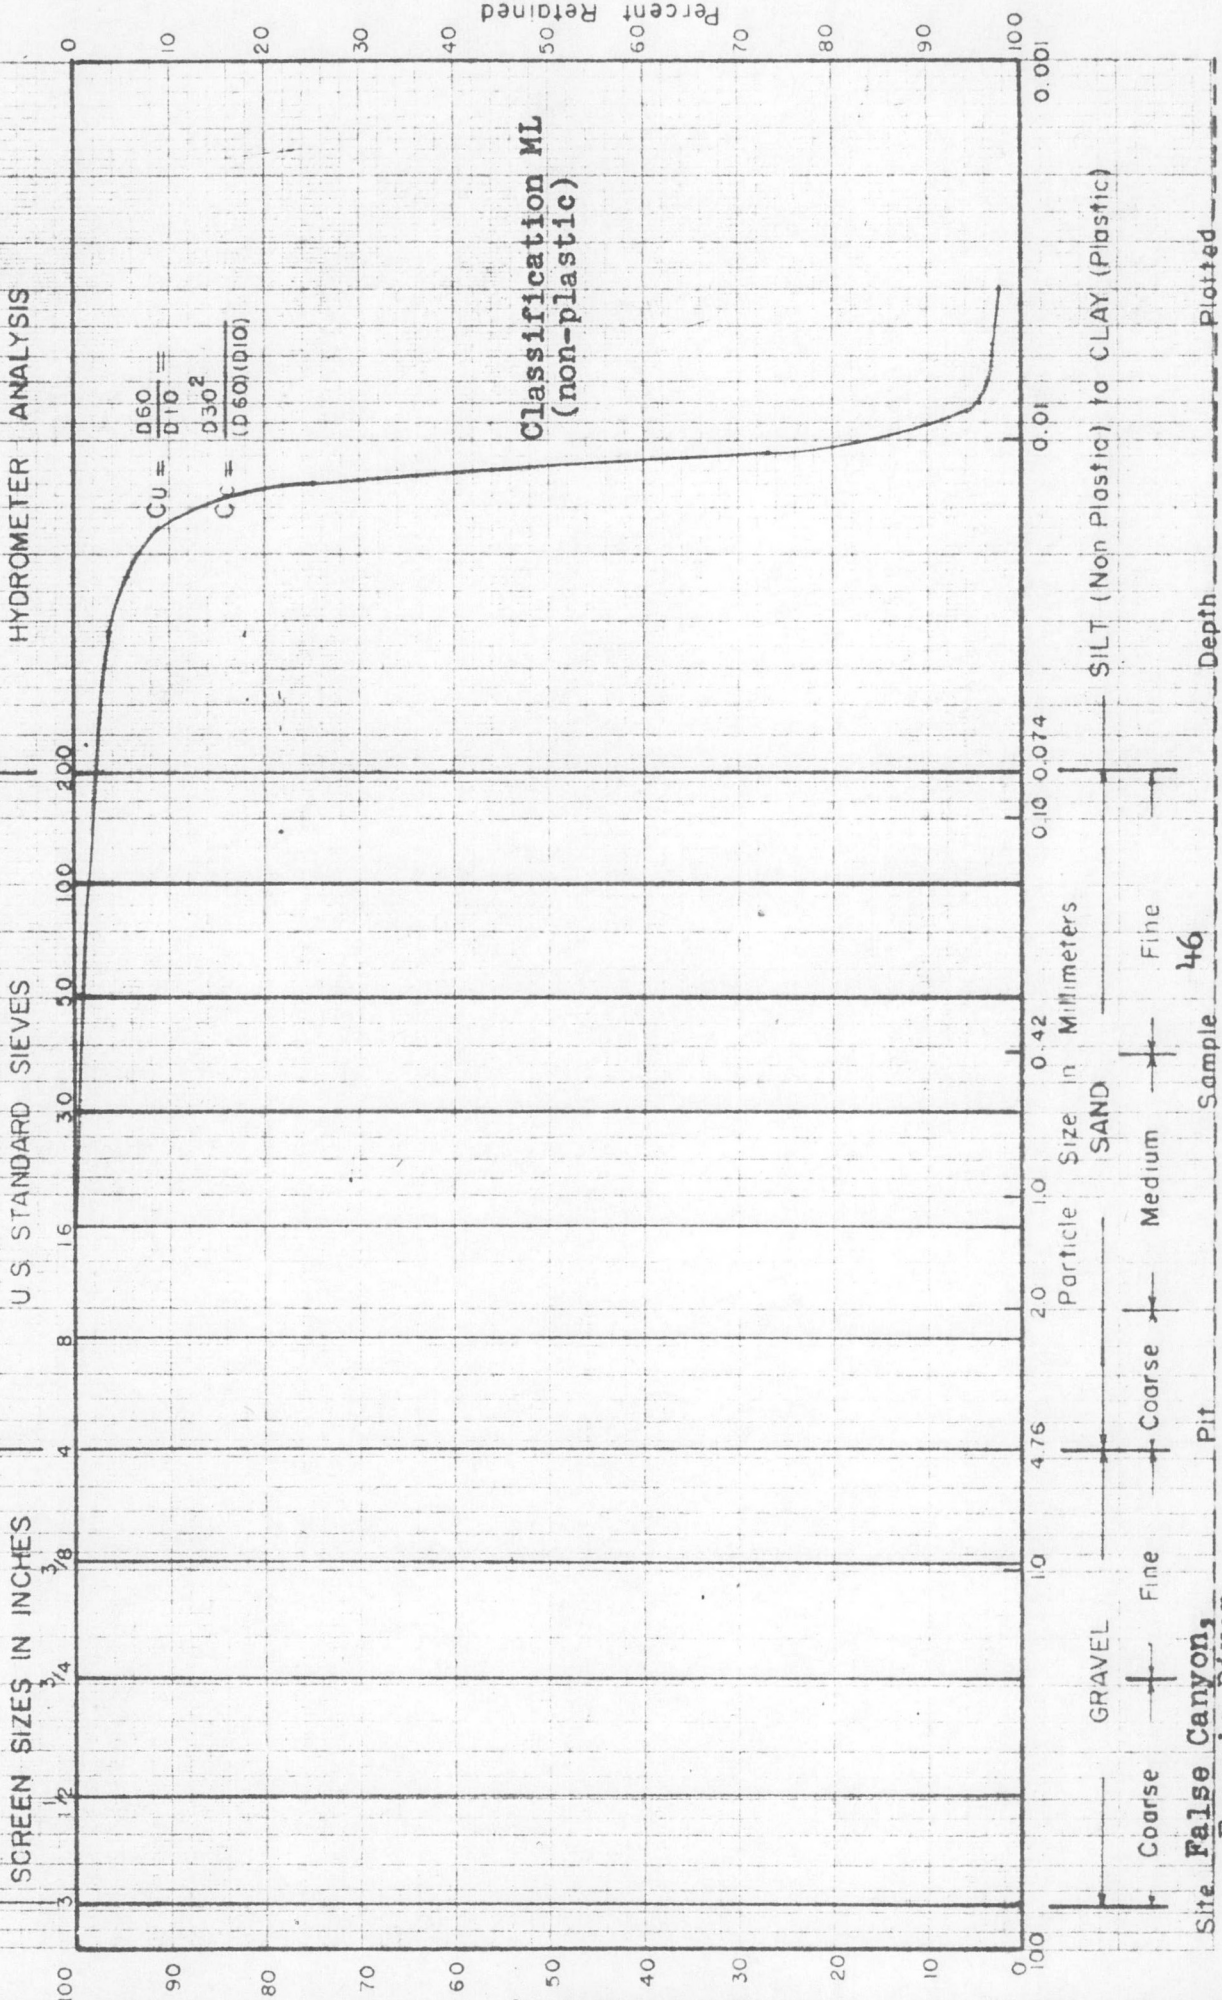
Sample **46**

The results of the analyses indicate the fine-grained, silty sand, which is the only soil type occurring in large quantities near the site, would not be desirable material for a rolled earth dam. It could probably be used satisfactorily in the low-head dyke suggested for the draw valley.

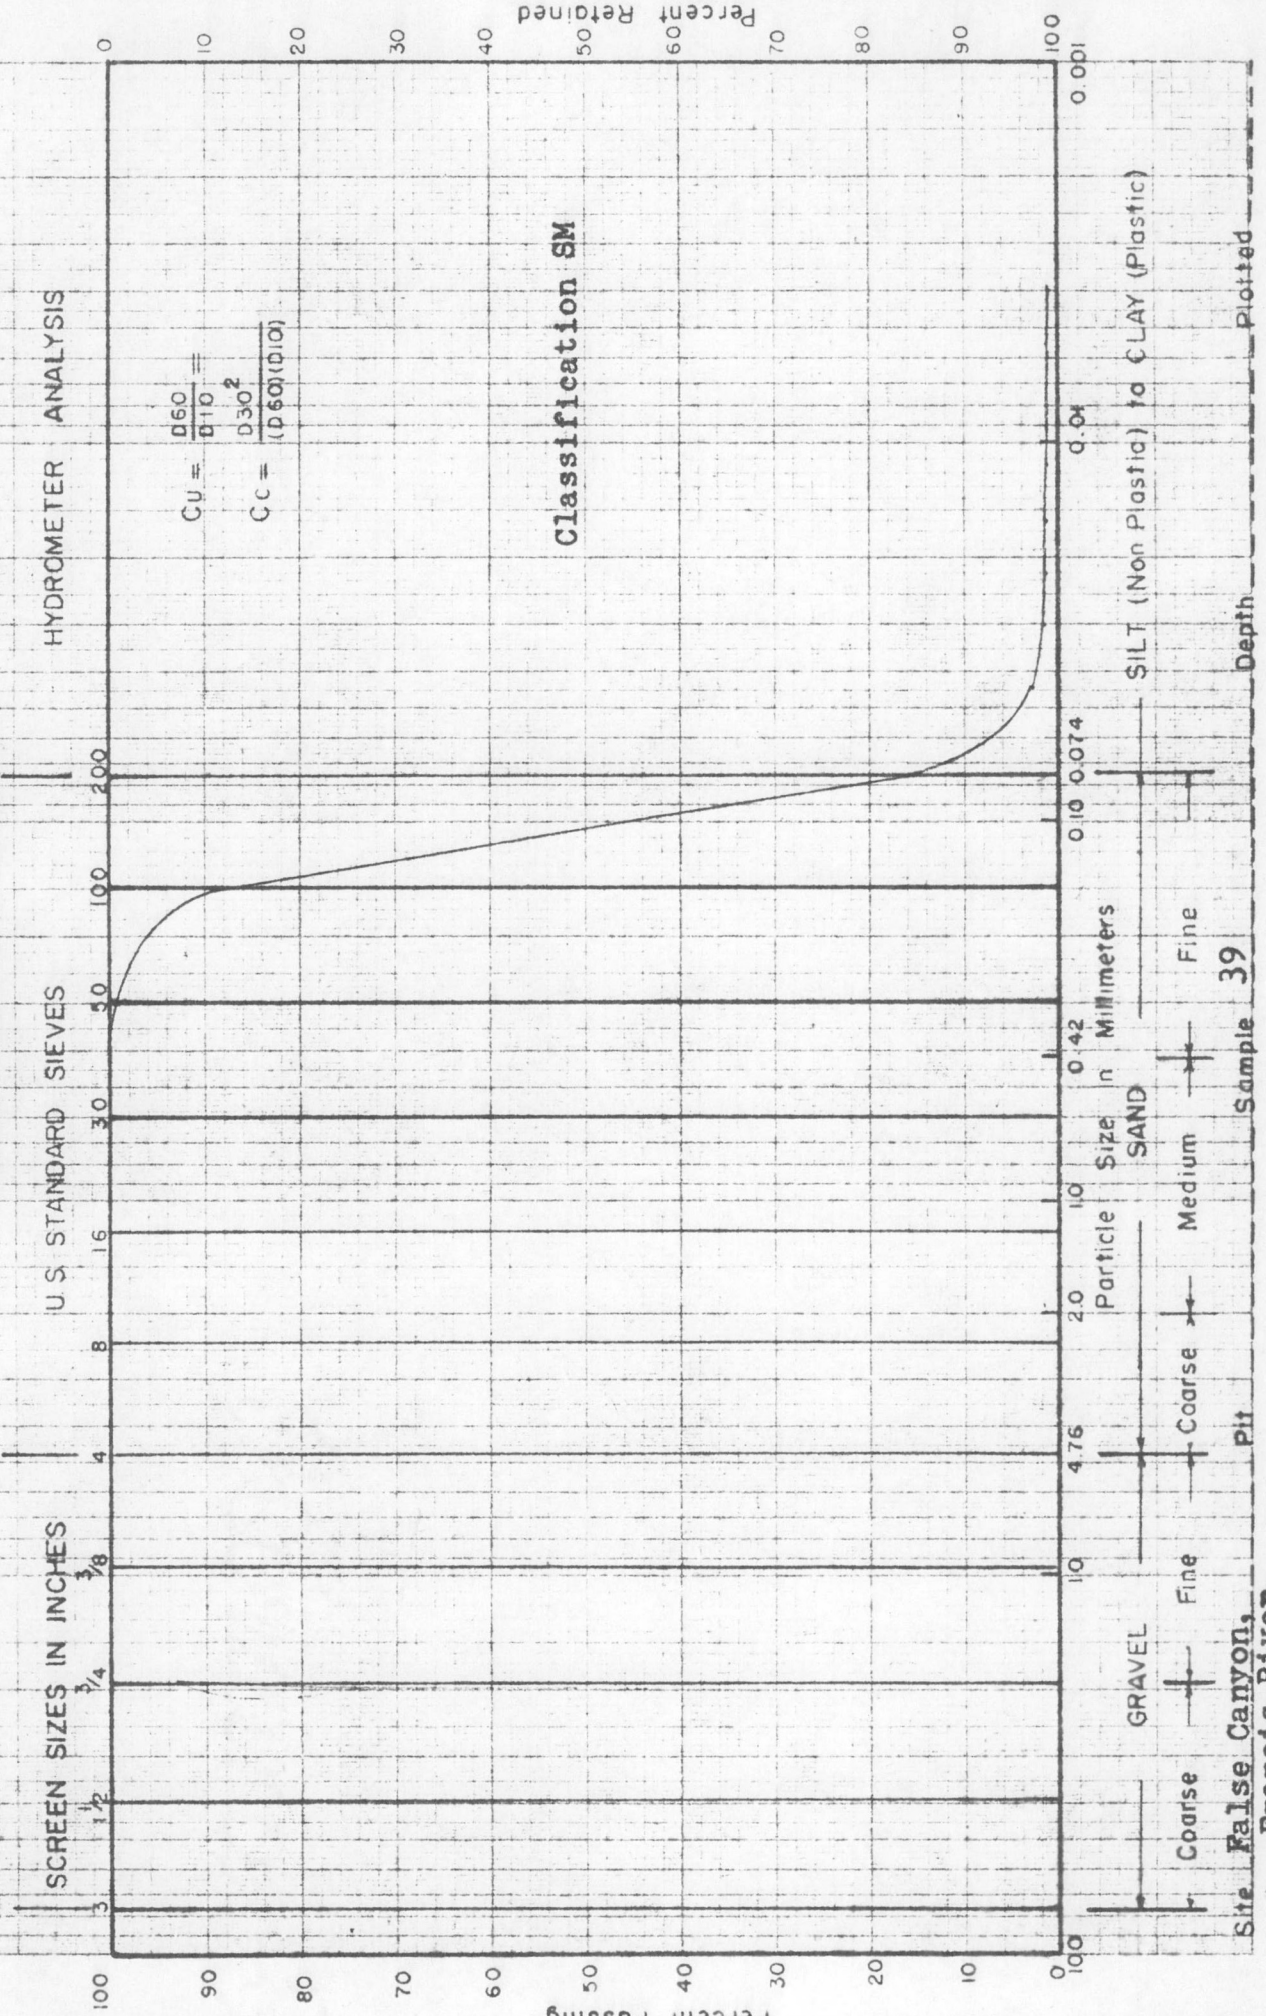
Sample 39

Sample Number	Location	Field Description of Material	Field Description of Overburden	Thickness of Deposit	Permeability* cm./sec.	Remarks
39	100 feet south of P.B.H.-7; 5 1/2 feet beneath ground surface	Fine-grained, brown, silty sand; poorly graded; unstratified; no pebbles	None	6+ feet	10^{-4}	Material is alluvium filling valley 250 feet northwest of site; leakage of reservoir water is an important problem here
40	200 feet west of P.B.H.-9; 7 1/2 feet beneath ground surface	Poorly graded, sandy gravel; argillite pebbles up to 3 inches in diameter; no cobbles or boulders	7 feet of sand	12 inches	10^{-2}	A 12-inch bed of permeable gravel directly overlying bedrock and underlying sand as in sample No. 39

Classification SM

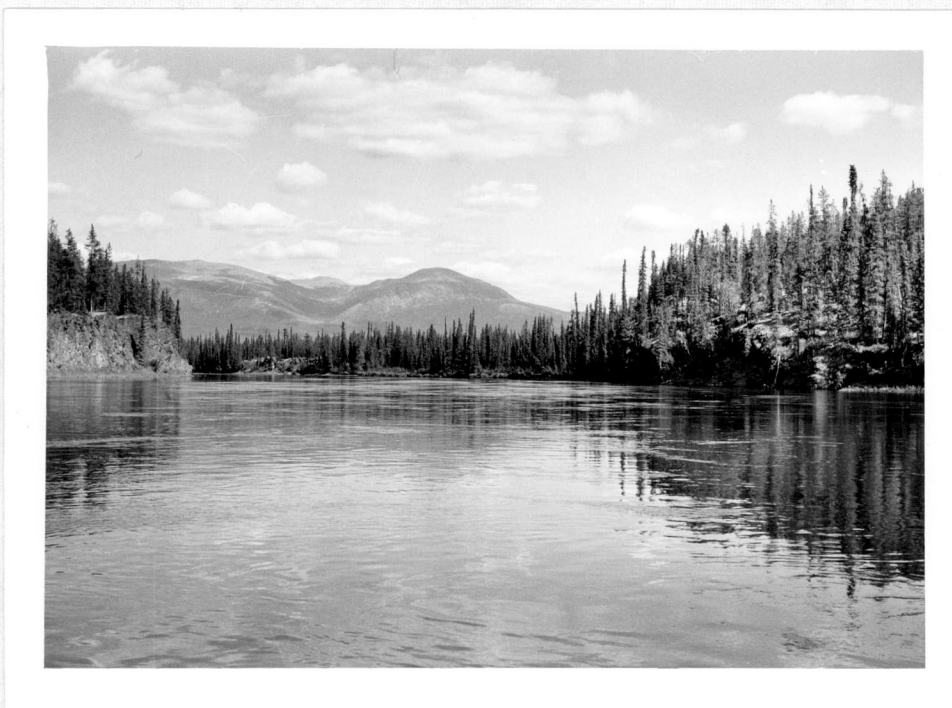
Plate 1

False Canyon looking upstream from the centre of
Frances River.

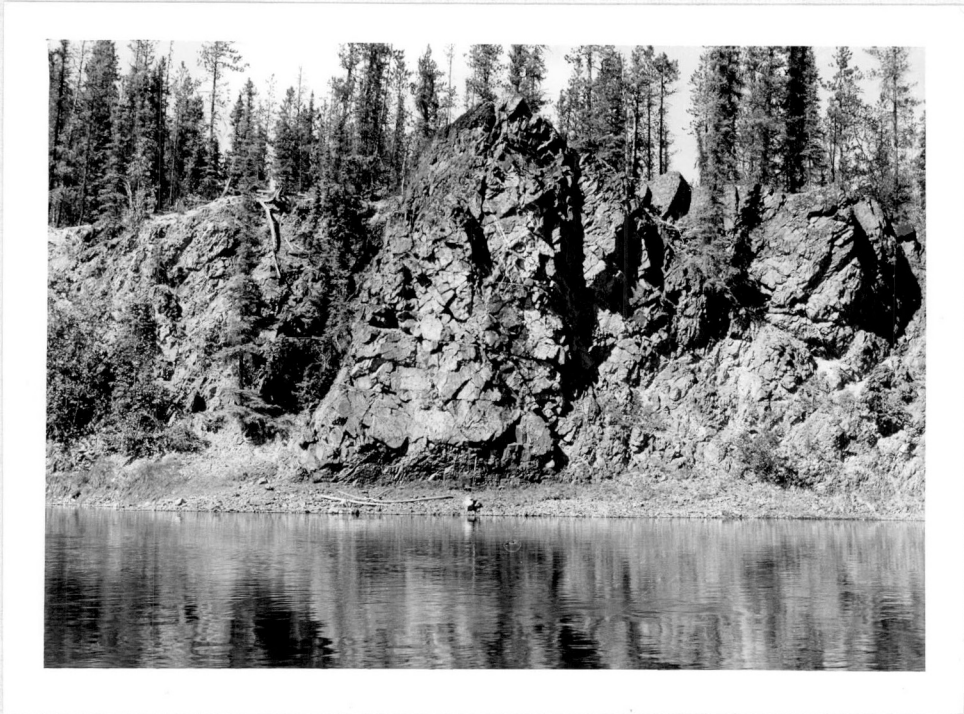
Plate 2

Right abutment rising about 40 feet above Frances River.

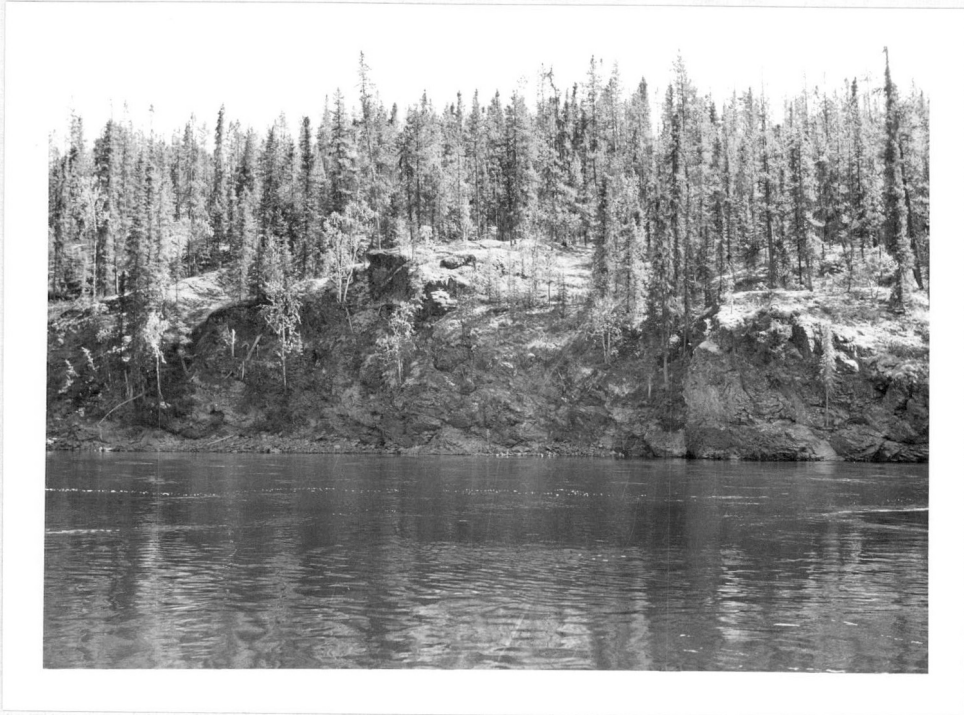
Plate 3

Left abutment rising about 40 feet above Frances River.
