GEOLOGICAL SURVEY OF CANADA TOPICAL REPORT NO. 68

# MACKENZIE RIVER DRAINAGE BASIN DAM SITE INVESTIGATION

# SUMMIT LAKE DAM SITE (MAP AND PRELIMINARY REPORT)

BY E. B. OWEN

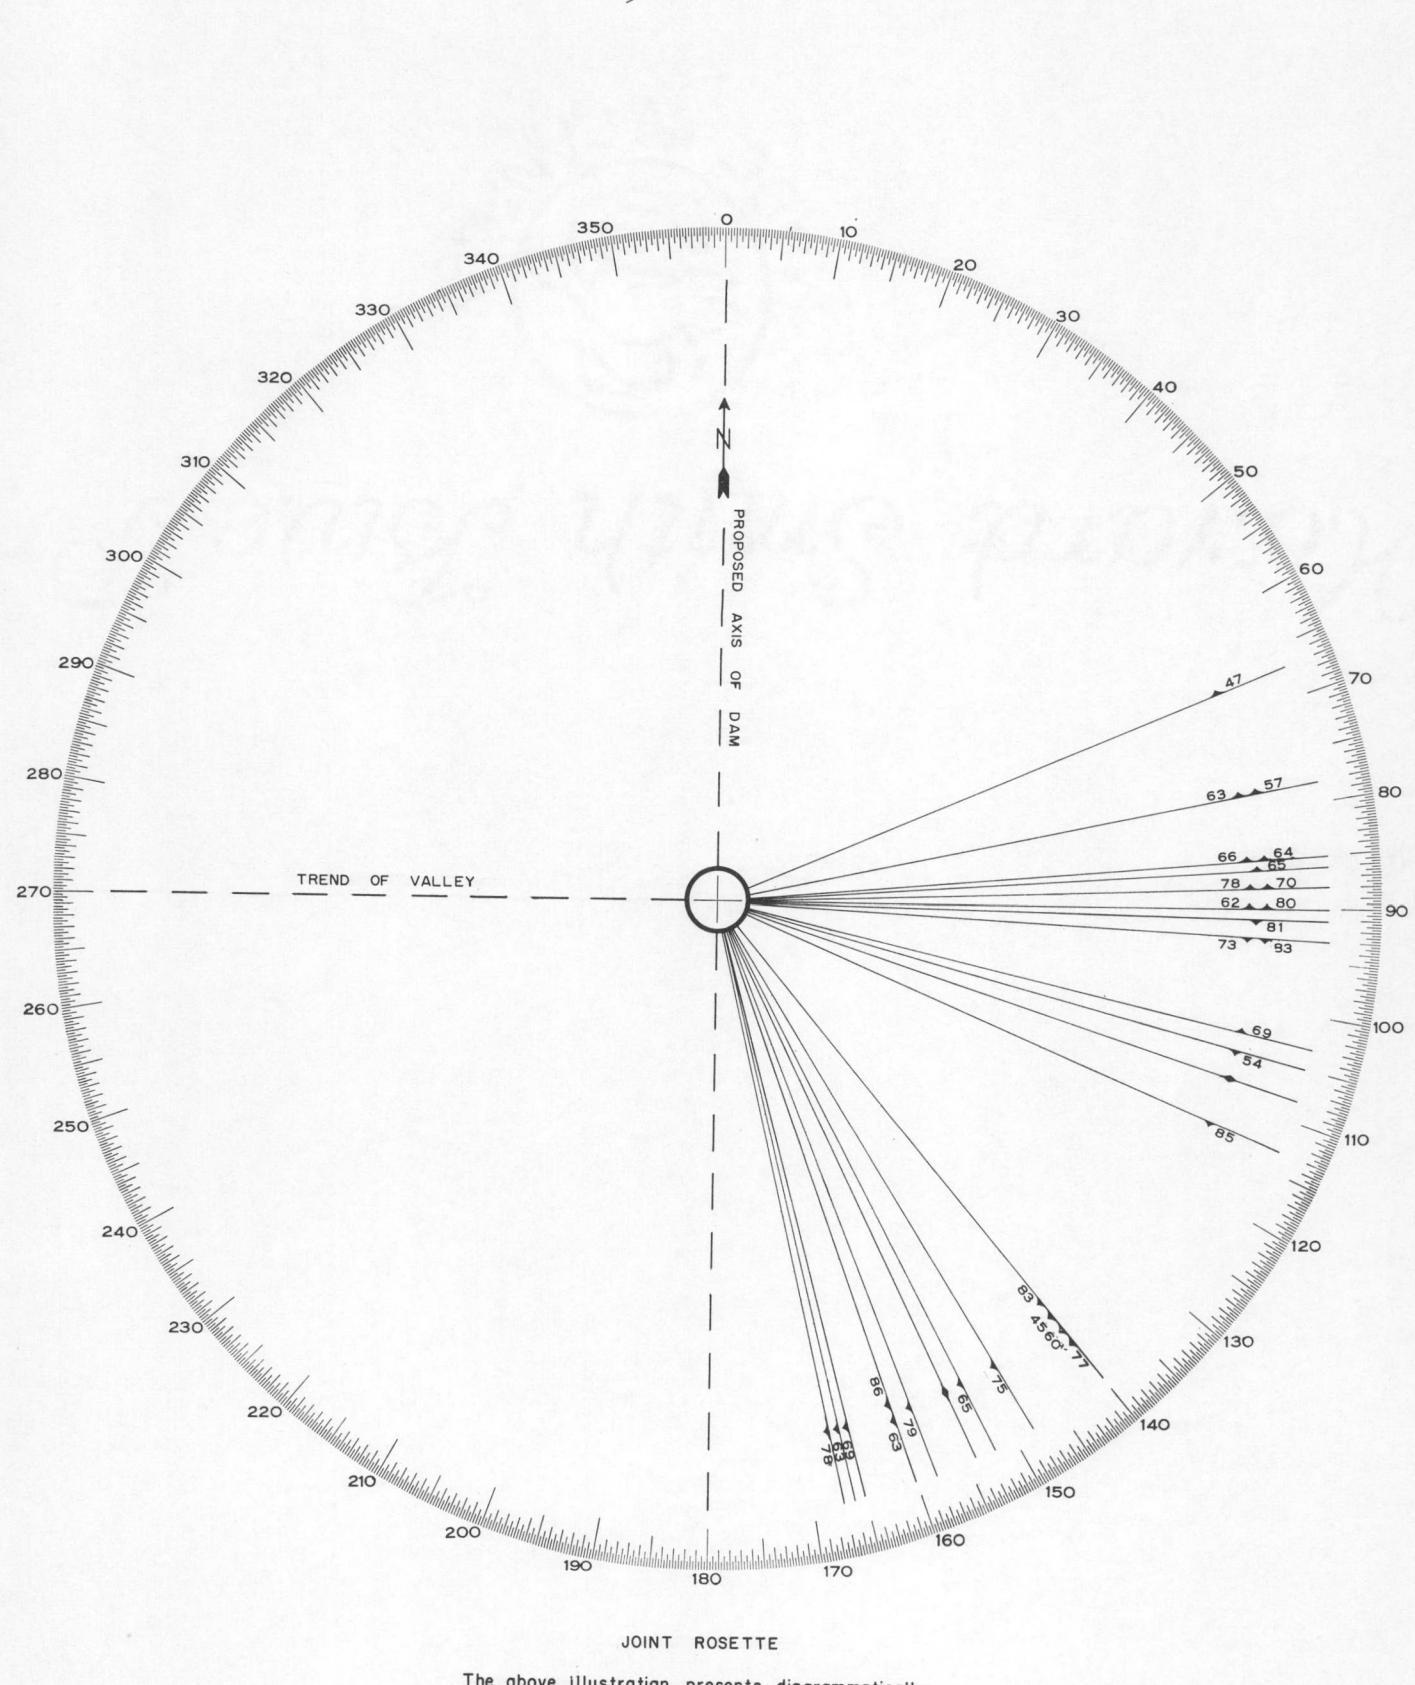
#### JOINT ROSETTE

There are two prominent joint sets in bedrock occurring in the site area. In the surface exposures they are represented by open fractures up to 6 inches in width and 50 feet in length. The jointing exerts considerable influence on the extent of weathering and the manner in which bedrock disintegrates to form talus. The spacing is exceedingly variable ranging from 1 inch to several feet in the more massive beds. The prominent sets intersect one another at approximately 65 degrees. One set dips 63 to 82 degrees west or into the south abutment while intersecting the centre line at angles between 15 and 45 degrees. The second set intersects the centre line at 70 to 90 degrees and dips into the north abutment at 47 to 80 degrees. A less prominent set parallel to the second dips steeply into the south abutment.

The above illustration presents diagrammatically the direction and dip of jointing in bedrock exposed at Summit Lake site

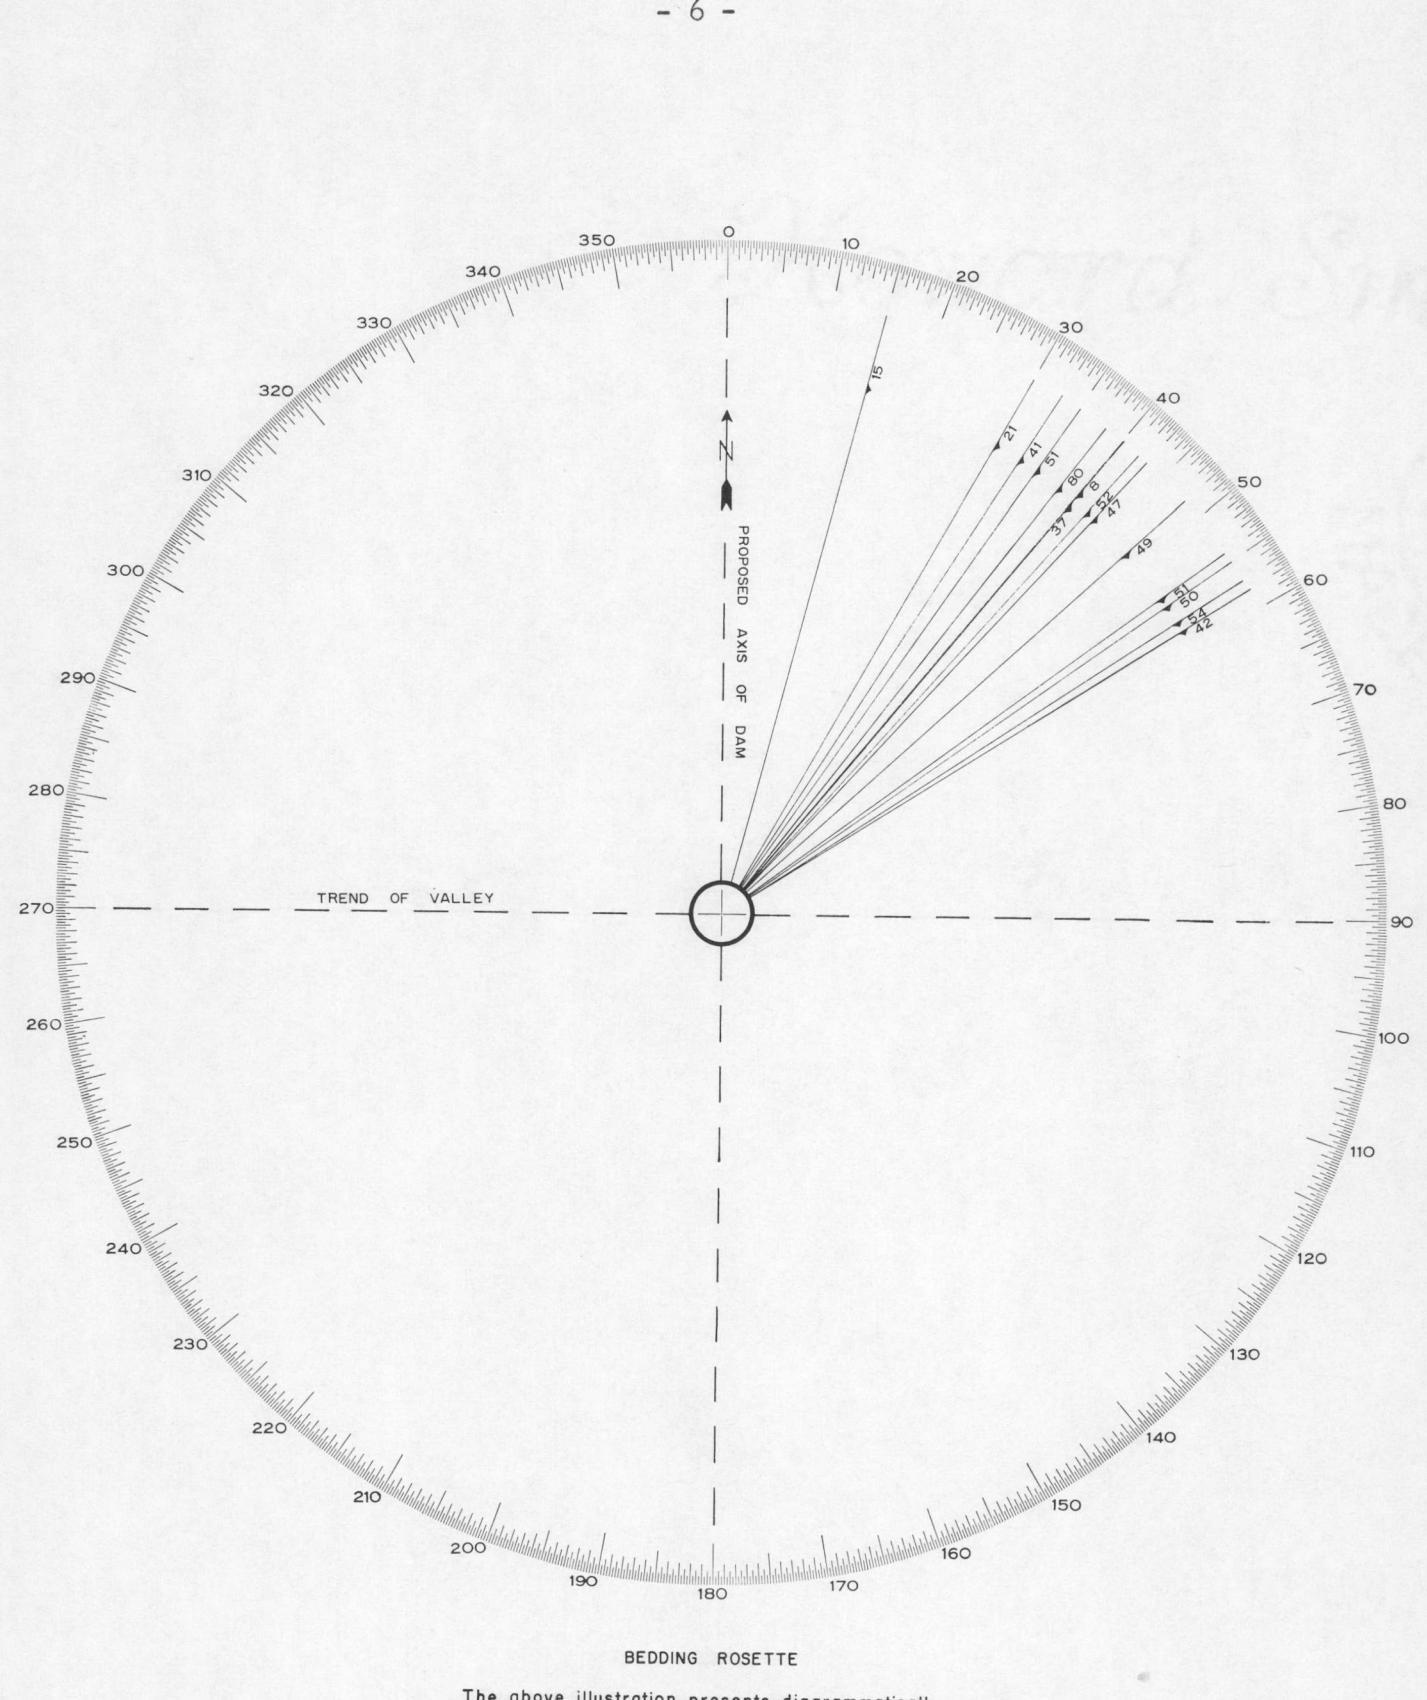
#### BEDDING ROSETTE

The trend of McDougall Pass in the site area is close to east. Consequently the direction of the proposed centre line of the dam is north-south. The bedding intersects the centre line at angles between 33 and 58 degrees and dips consistantly east or into the south abutment at angles varying between 37 and 54 degrees. The attitudes of the quartzite and limestone beds exposed near the area mapped are similar.

The above illustration presents diagrammatically the direction and dip of bedding in bedrock exposed at Summit Lake site

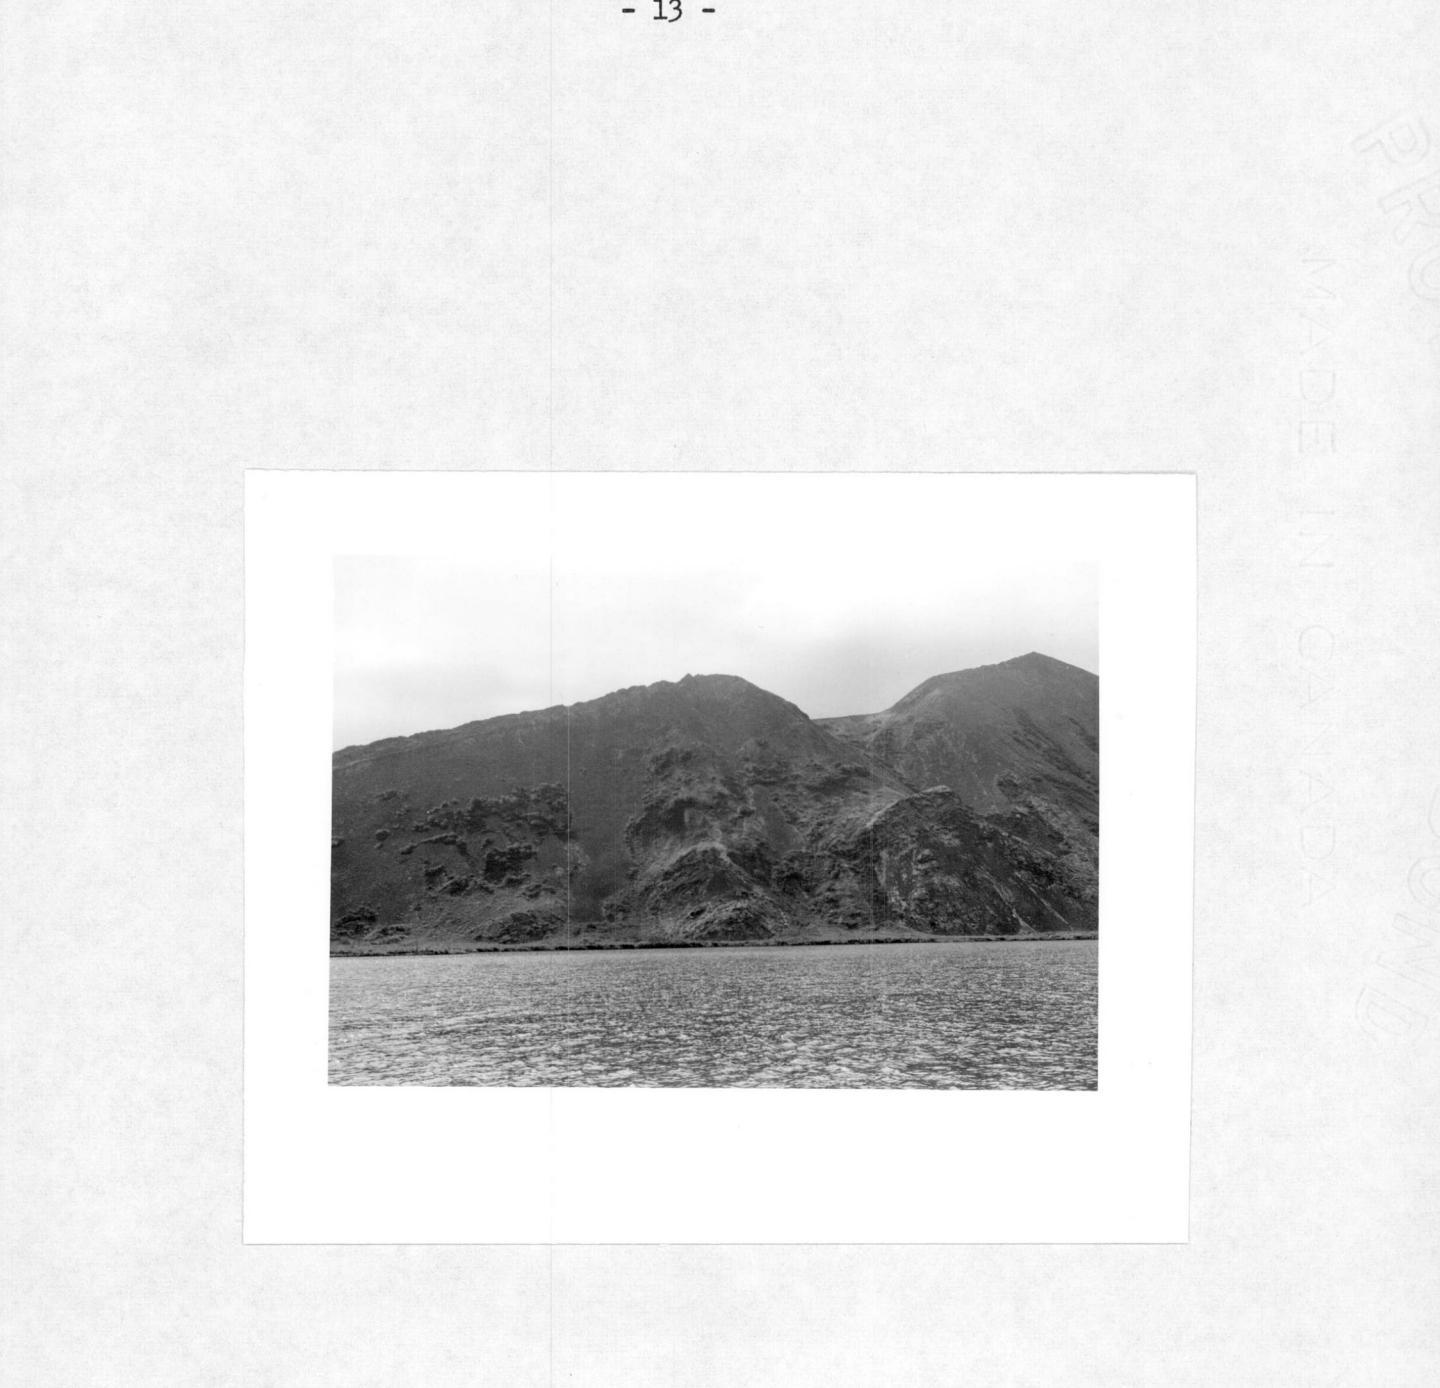
# Plate 1

Bedrock occurring at the Summit Lake site is believed suitable for the abutments and foundations of the low-head structure proposed for this area. The rock exposed in the south abutment is a fairly massive to massive sandstone which is believed competent and should provide satisfactory abutment material. The thickness of the individual beds ranges up to 8 feet. Weathering is negligible and little surface rock would have to be removed to obtain fresh surfaces against which concrete or dyke material could be placed. The large size of the fragments in the talus derived from this rock is an excellent indication of its quality.

South abutment, Summit Lake site.

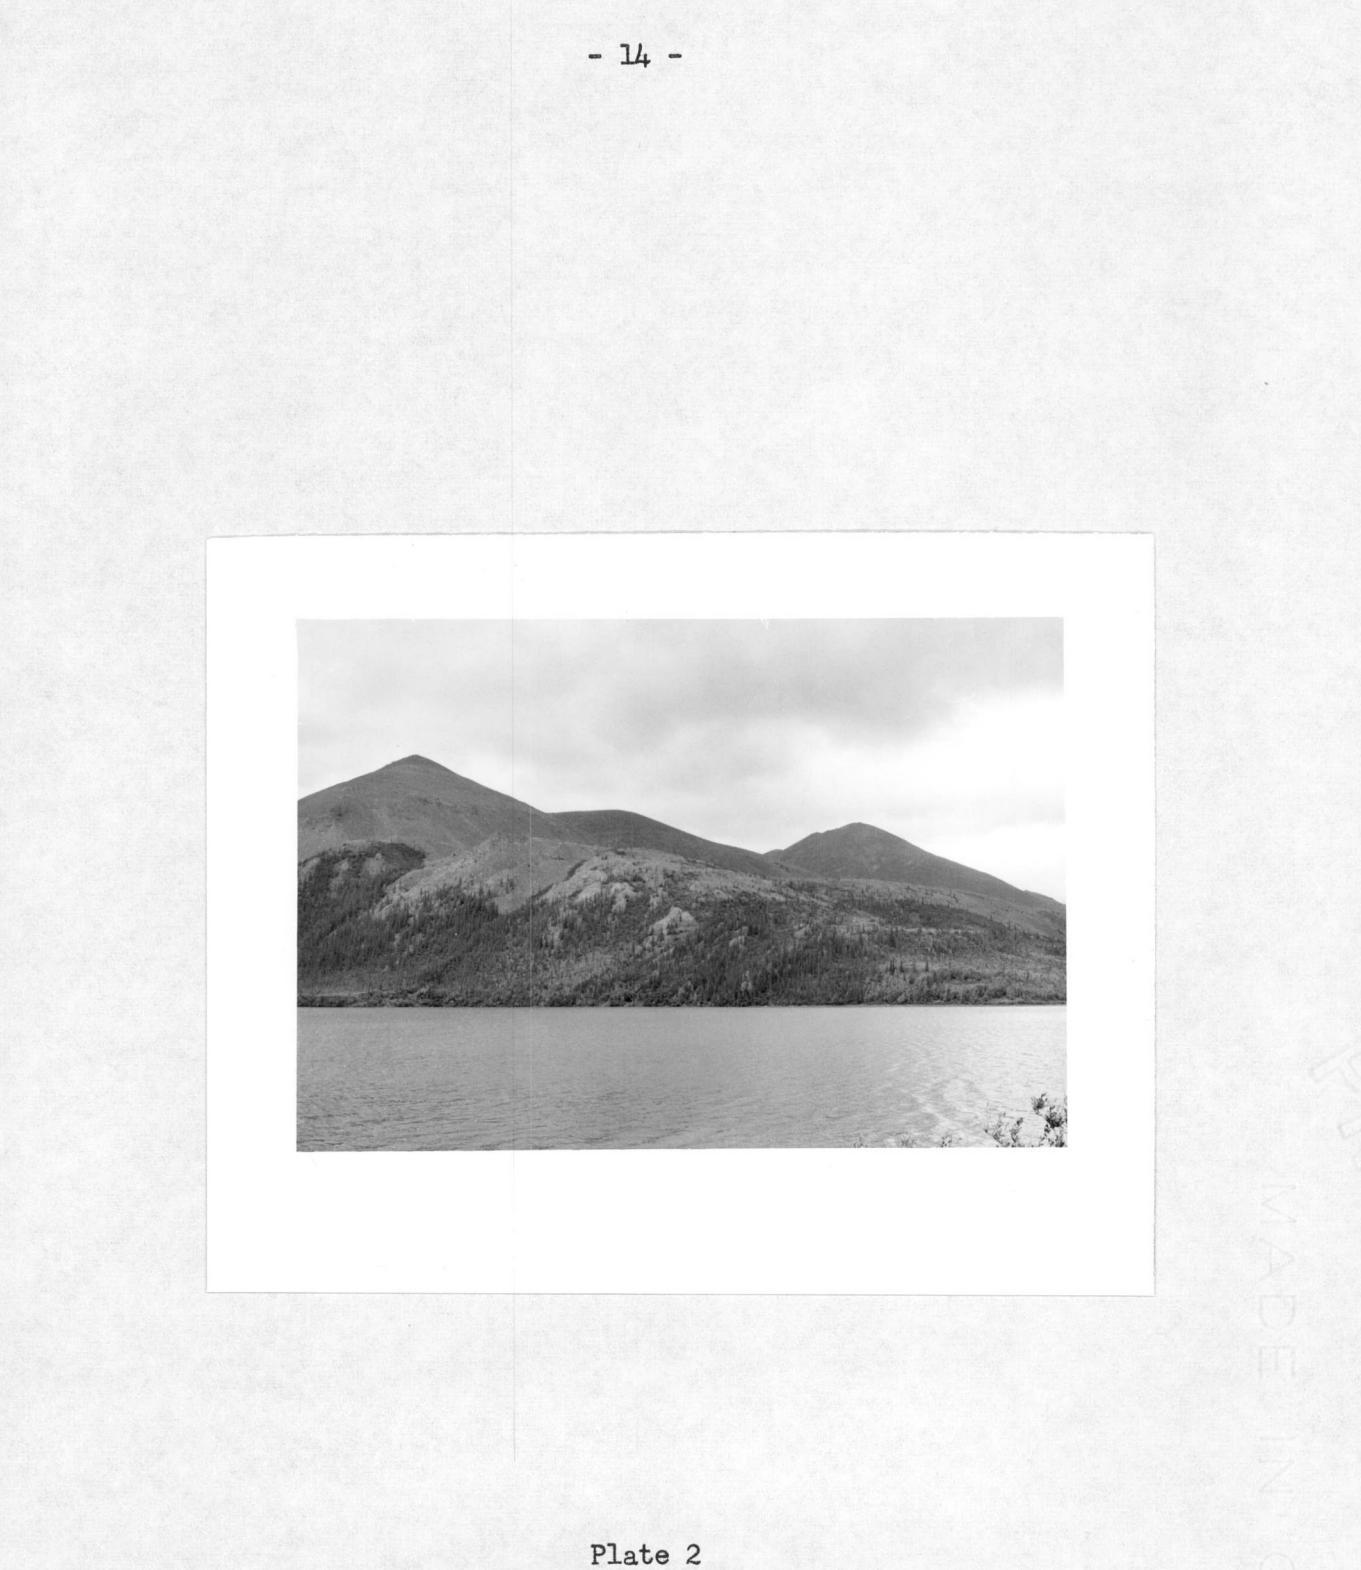
Weathering is more common in the sandstone exposed in the west part of the bluff in which the north abutment will be located. This is due to the more thin-bedded character of the rock and to the presence of local shear zones where the rock is frequently shattered into relatively small fragments. Further east along this bluff the rock is more competent and is comparable to that in the south abutment.

North abutment, Summit Lake site. G.S.C. 32-7-62.

It is suggested the dam axis be moved as far east in the site area as possible to take advantage of the better bedrock conditions. The proposed location of the axis indicated on the accompanying geological map is considered to be the farthest west that the dam should be constructed. Beyond this the competency of the rock in the north abutment decreases sharply. If required a diversion tunnel could most easily be constructed in the south abutment or in the east part of the north abutment.
