GEOLOGICAL SURVEY OF CANADA  
TOPICAL REPORT NO. 83

MACKENZIE RIVER DRAINAGE BASIN  
DAM SITE INVESTIGATION

SITE NO. 16

ABERDEEN FALLS DAM SITE  
(MAP AND PRELIMINARY REPORT)

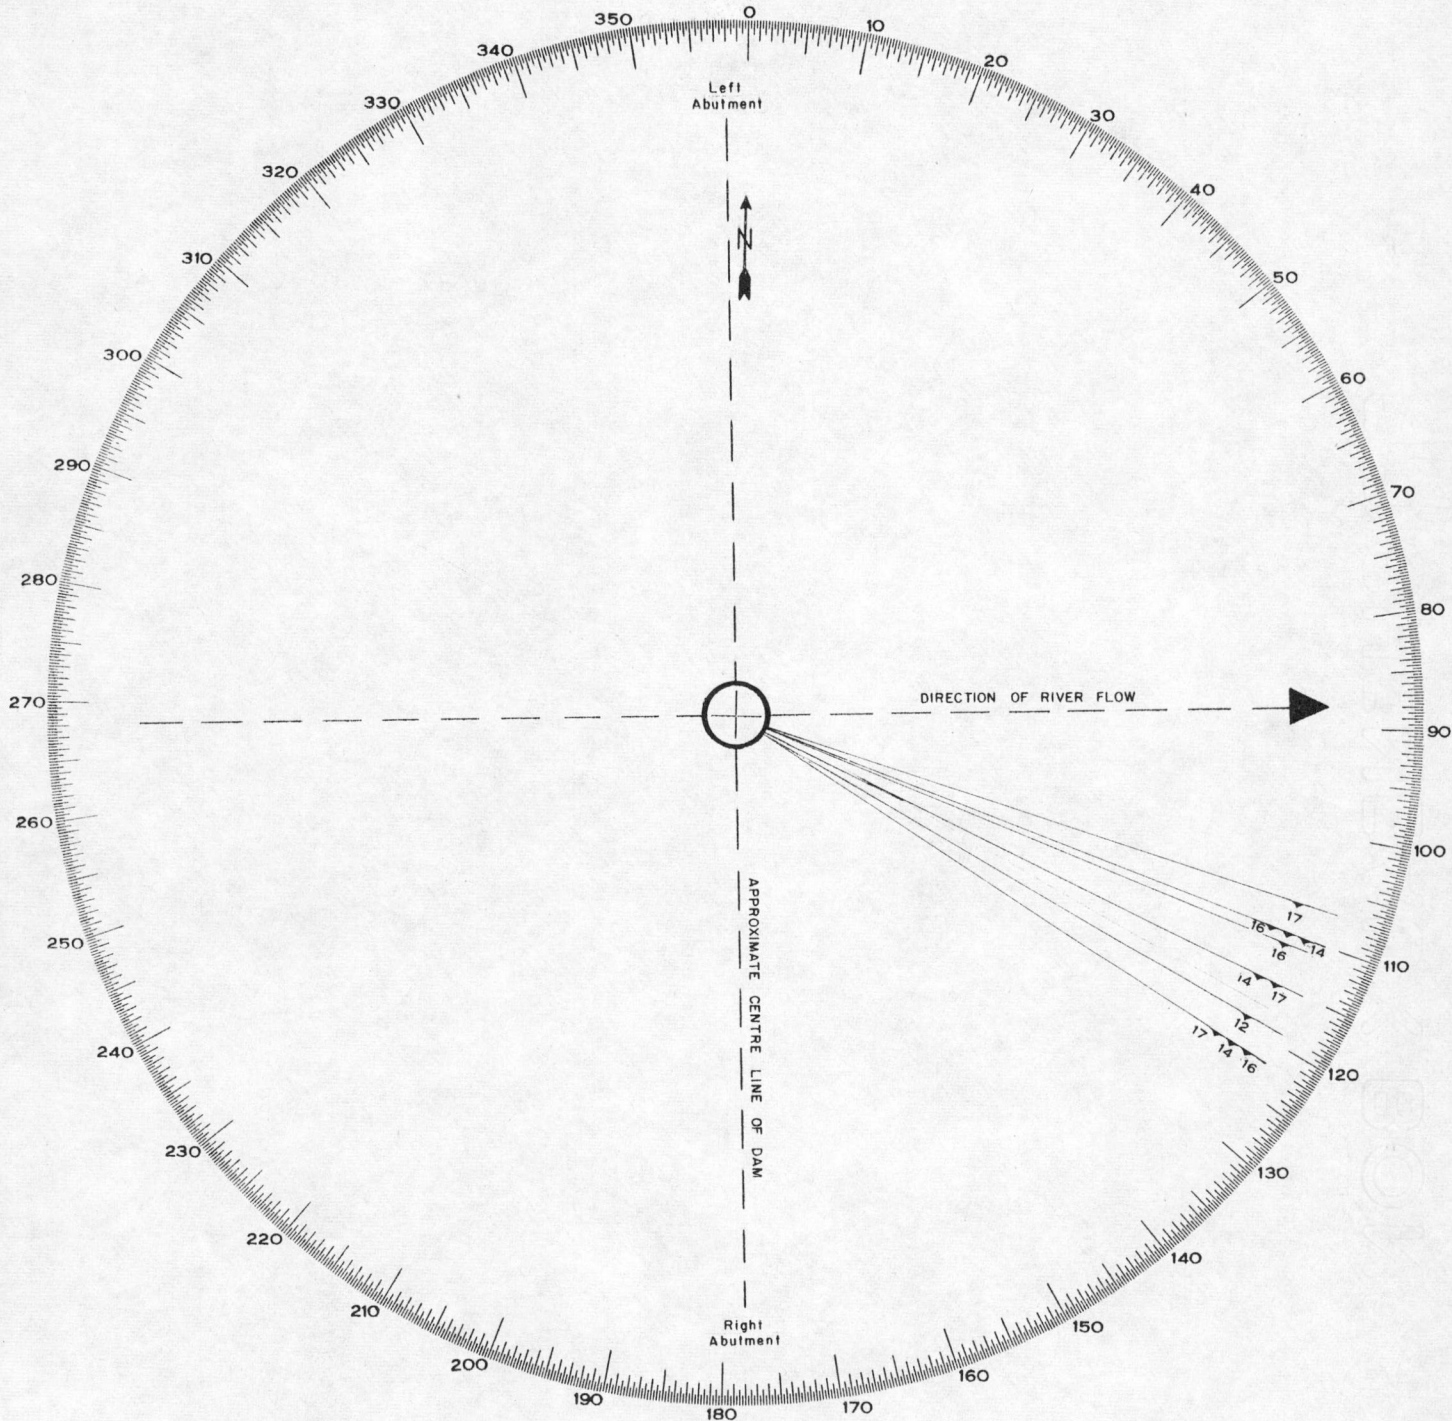
BEDDING ROSETTE

The above illustration presents diagrammatically the direction and dip of bedding in bedrock exposed in the downstream part of Aberdeen Falls dam site

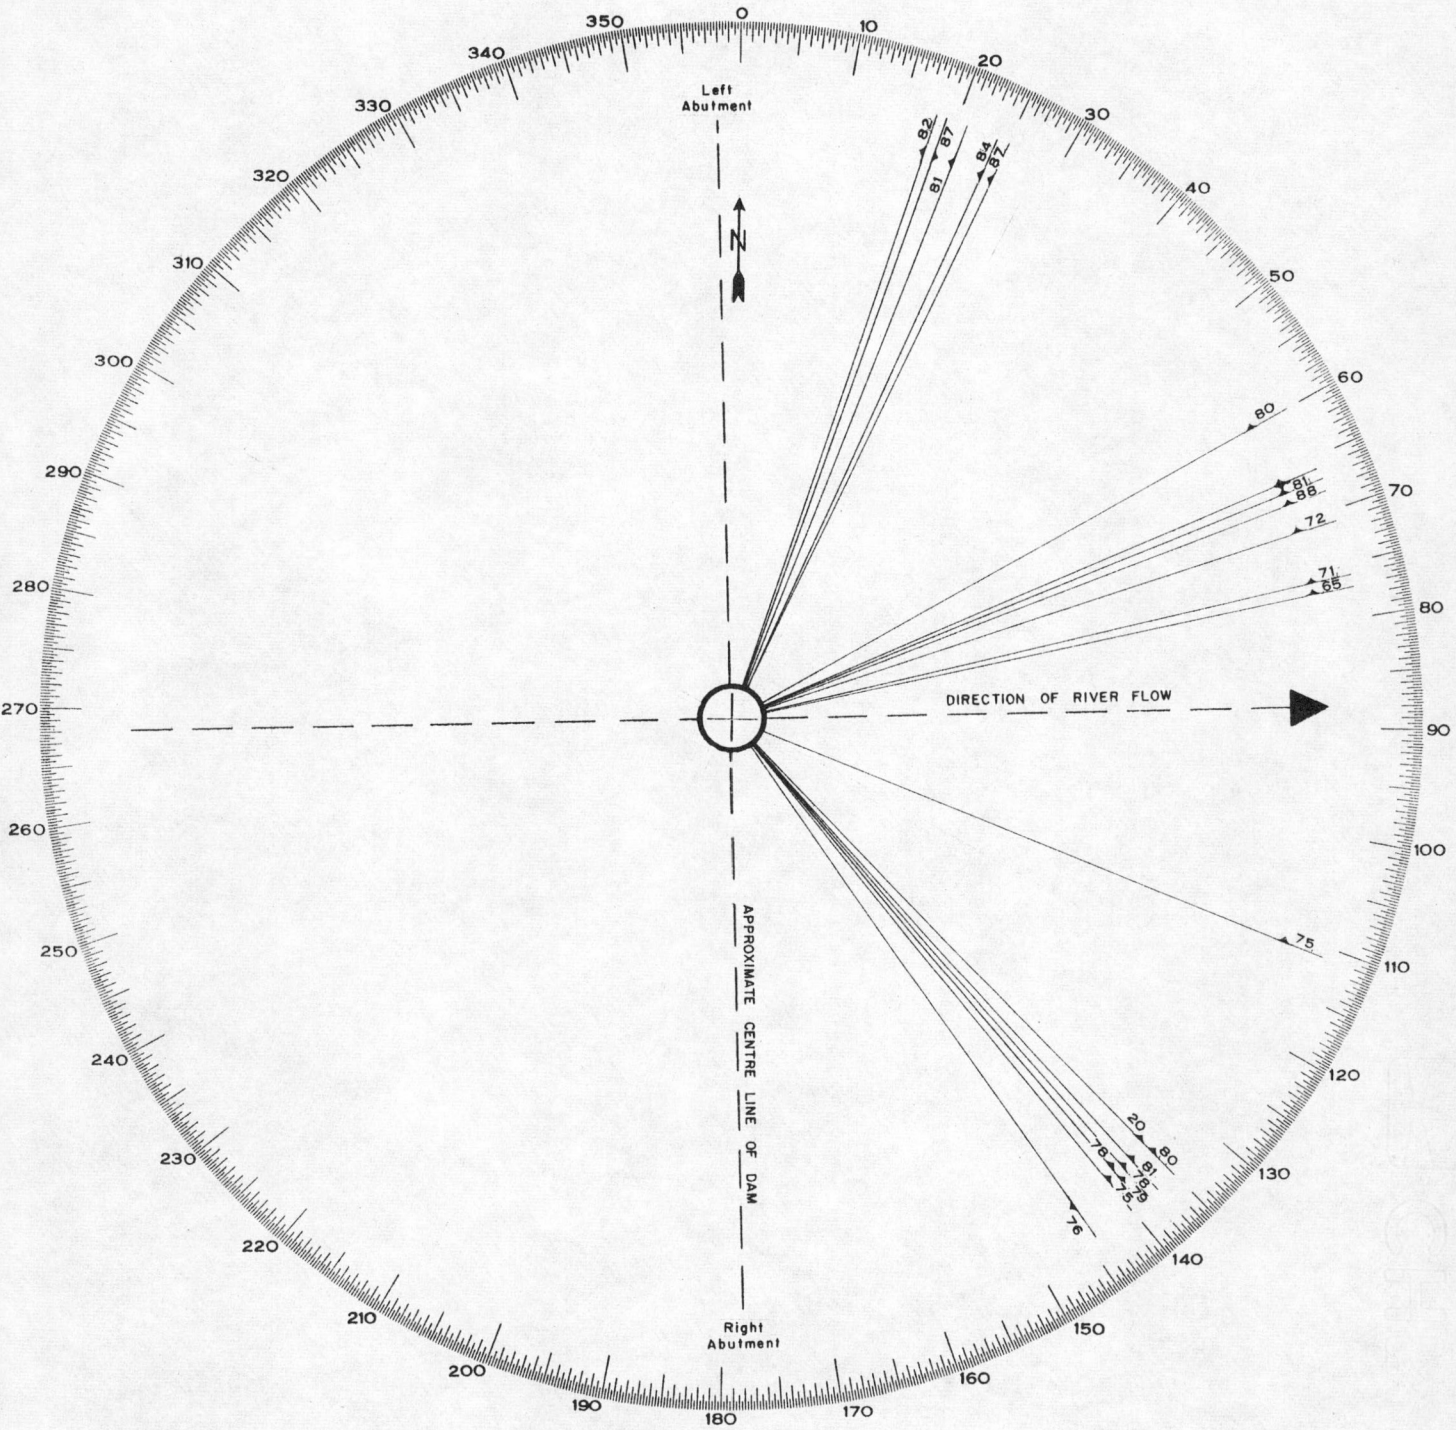
JOINT ROSETTE

The above illustration presents diagrammatically the direction and dip of jointing in bedrock exposed in the downstream part of Aberdeen Falls dam site

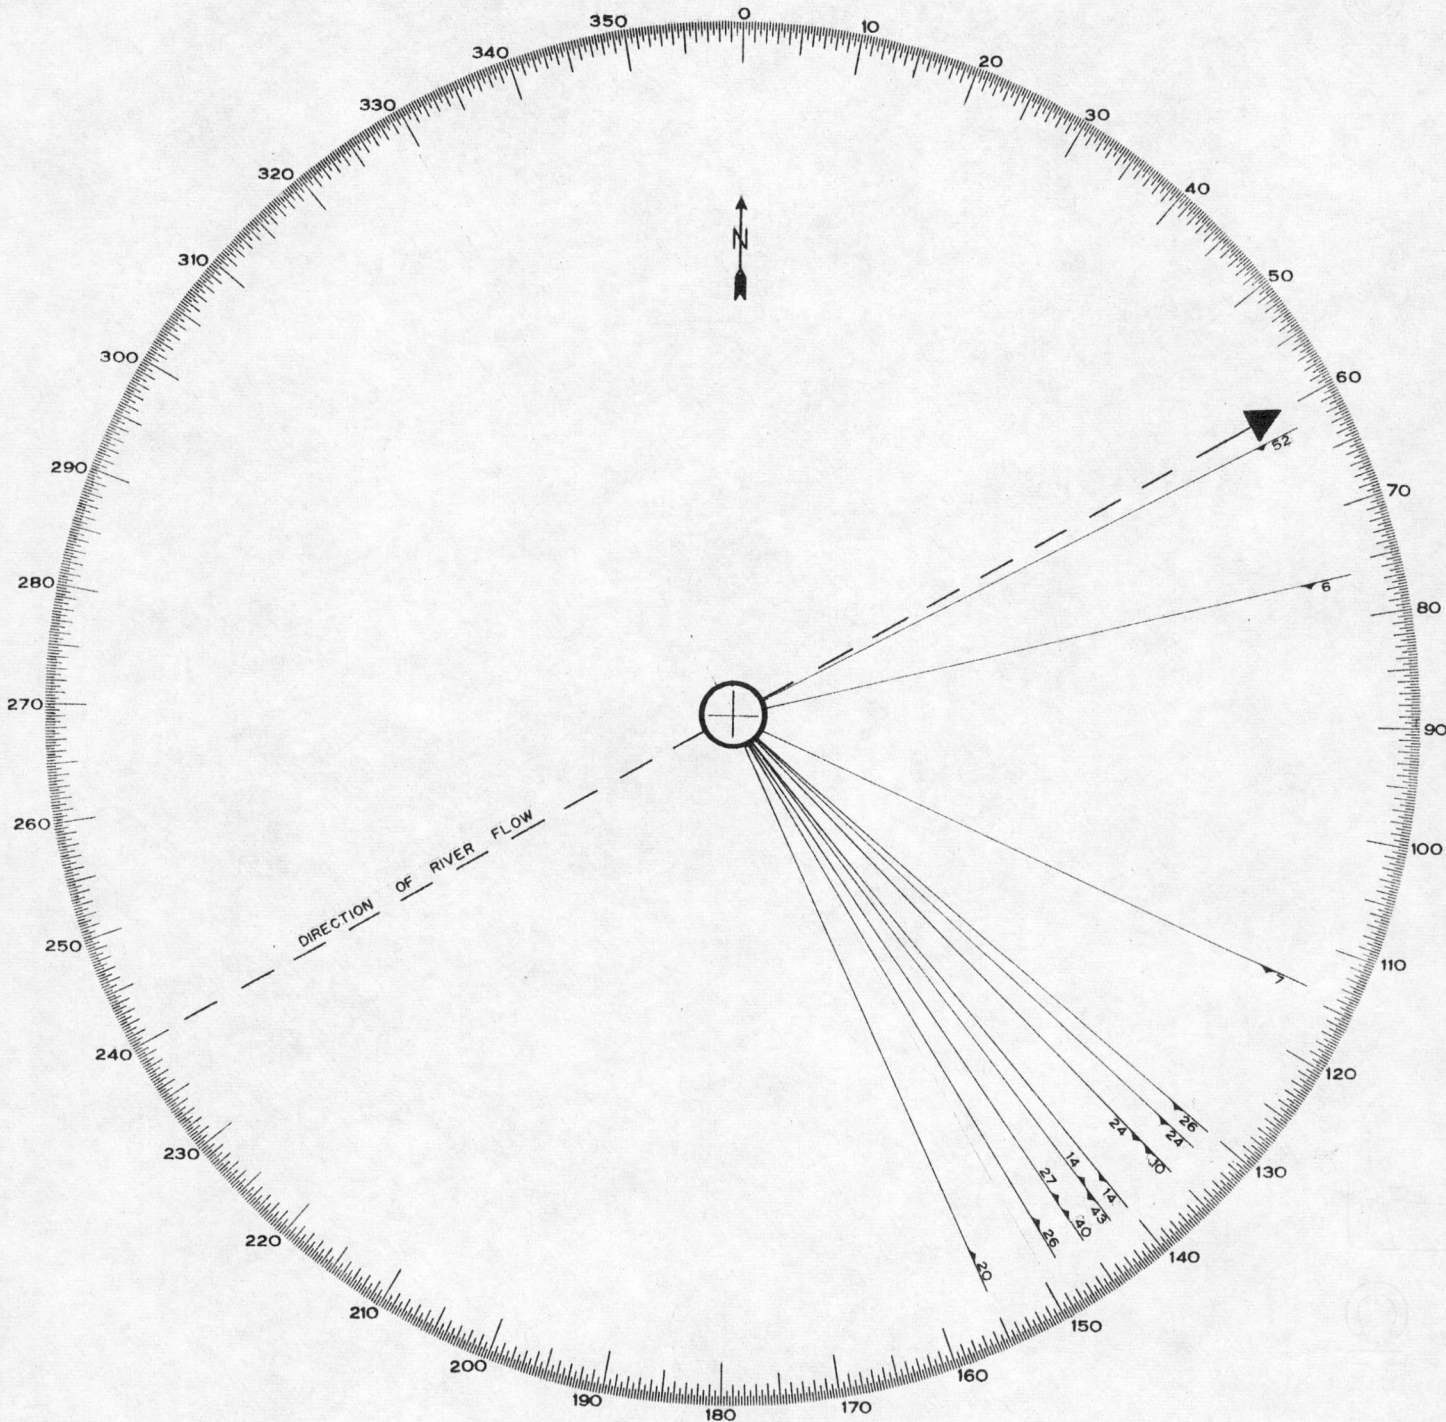
BEDDING ROSETTE

The above illustration presents diagrammatically the direction and dip of bedding in bedrock exposed in the centre part of Aberdeen Falls dam site

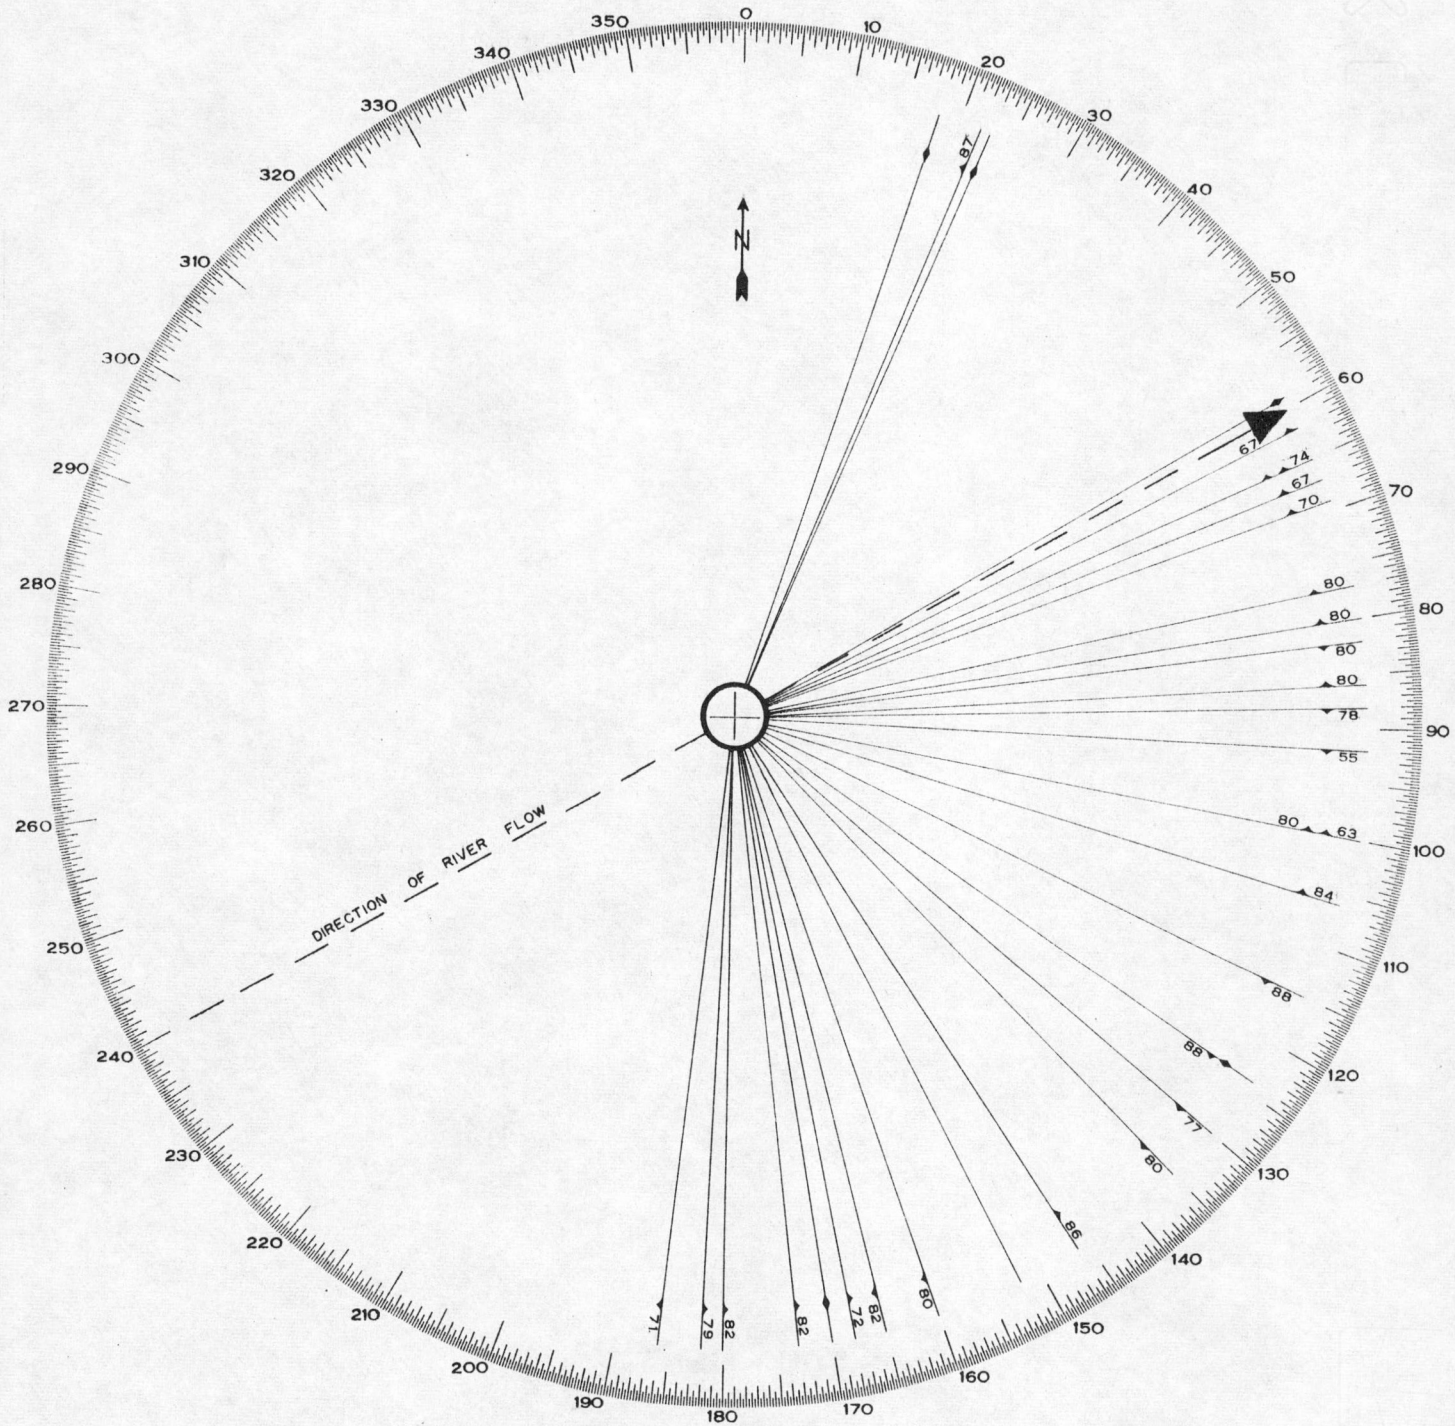
JOINT ROSETTE

The above illustration presents diagrammatically the direction and dip of jointing in bedrock exposed in the centre part of Aberdeen Falls dam site

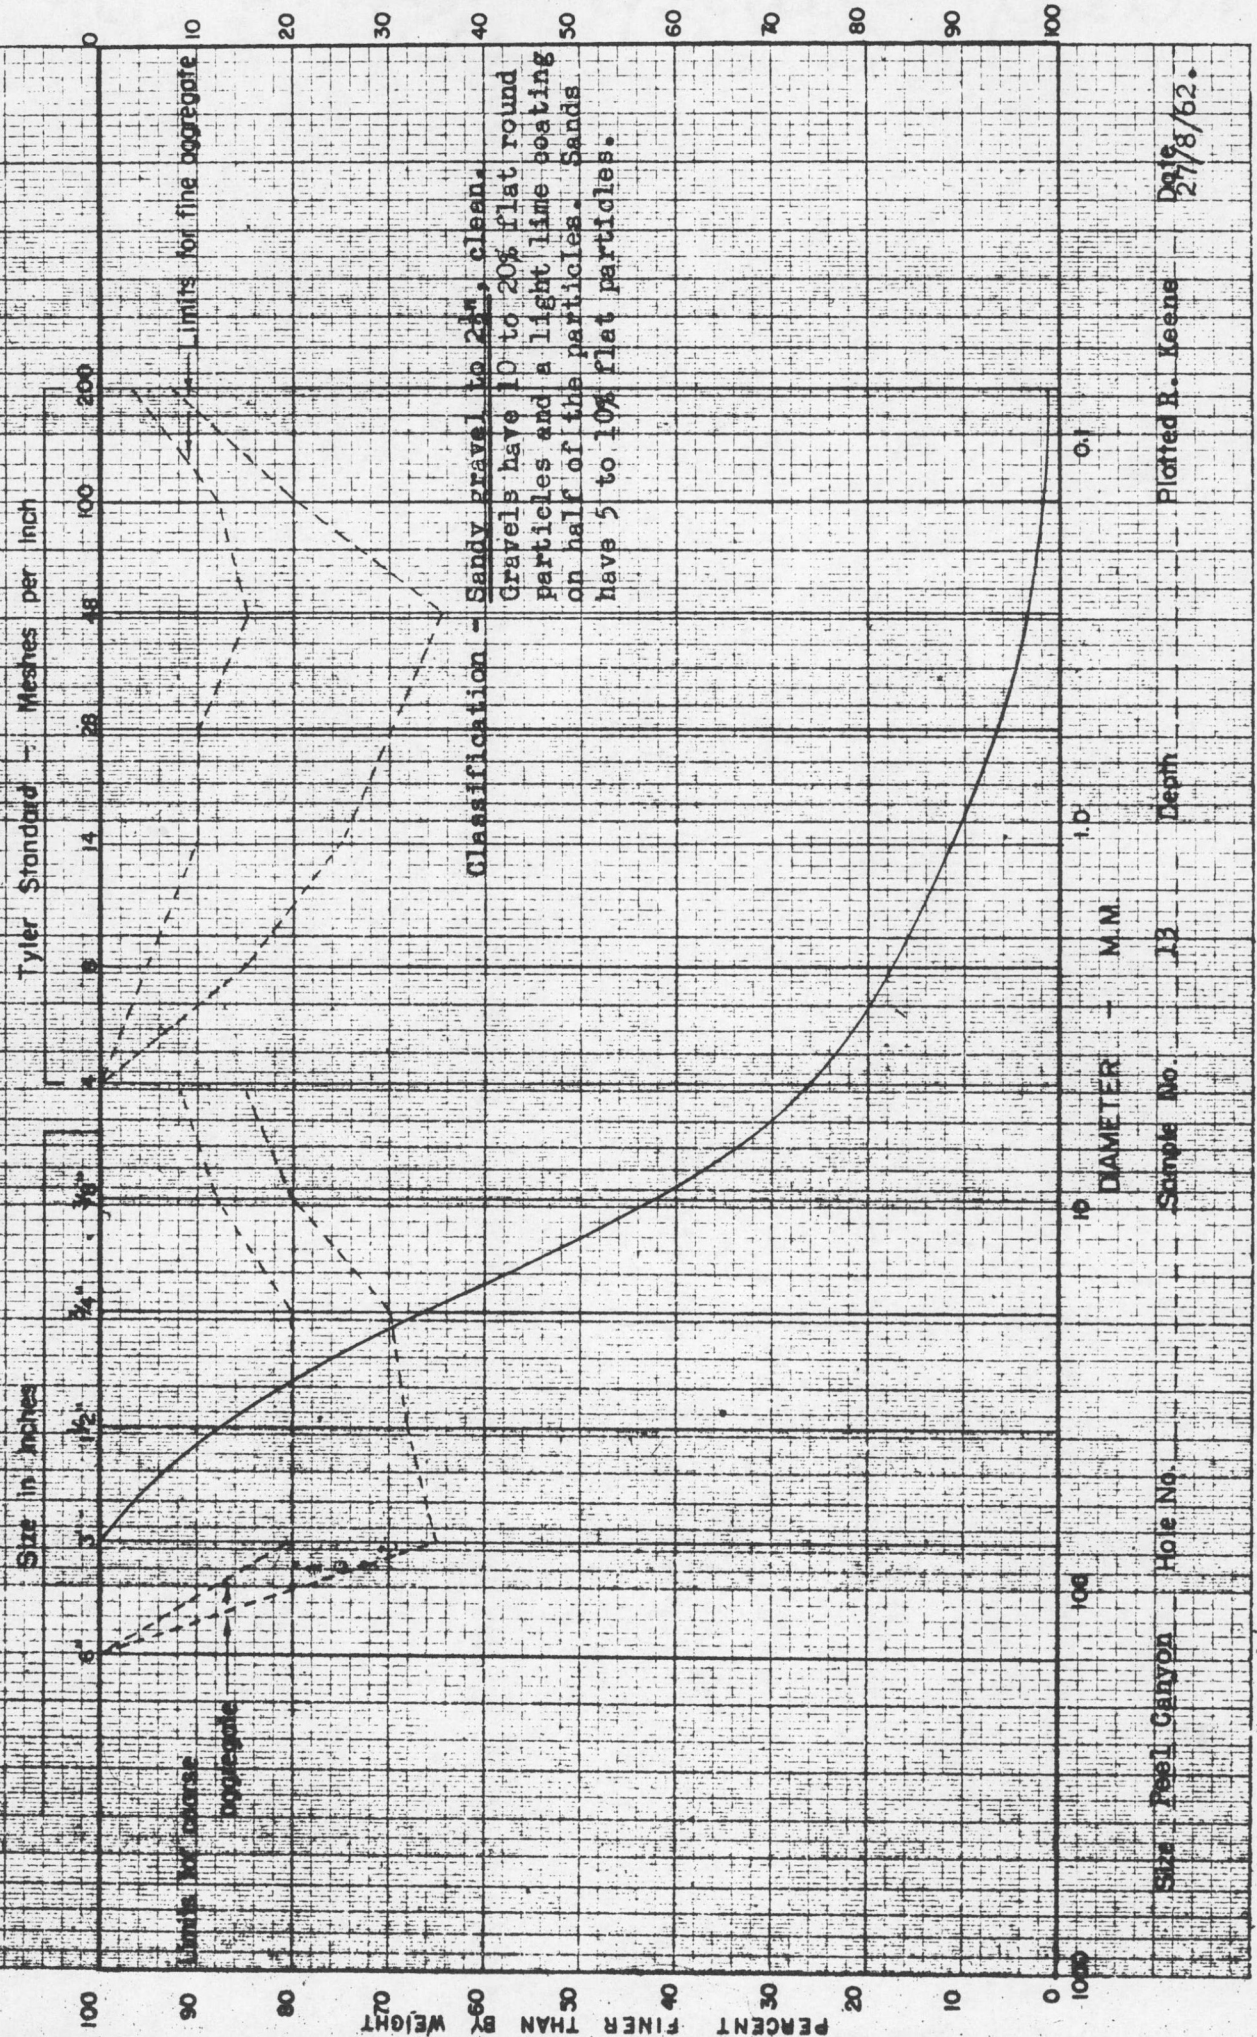
Sample No. 13

Classification - Sandy gravel to 2 1/4, clean.  
 Gravels have 10 to 20% flat round particles and a light lime coating on half of the particles. Sands have 5 to 10% flat particles.

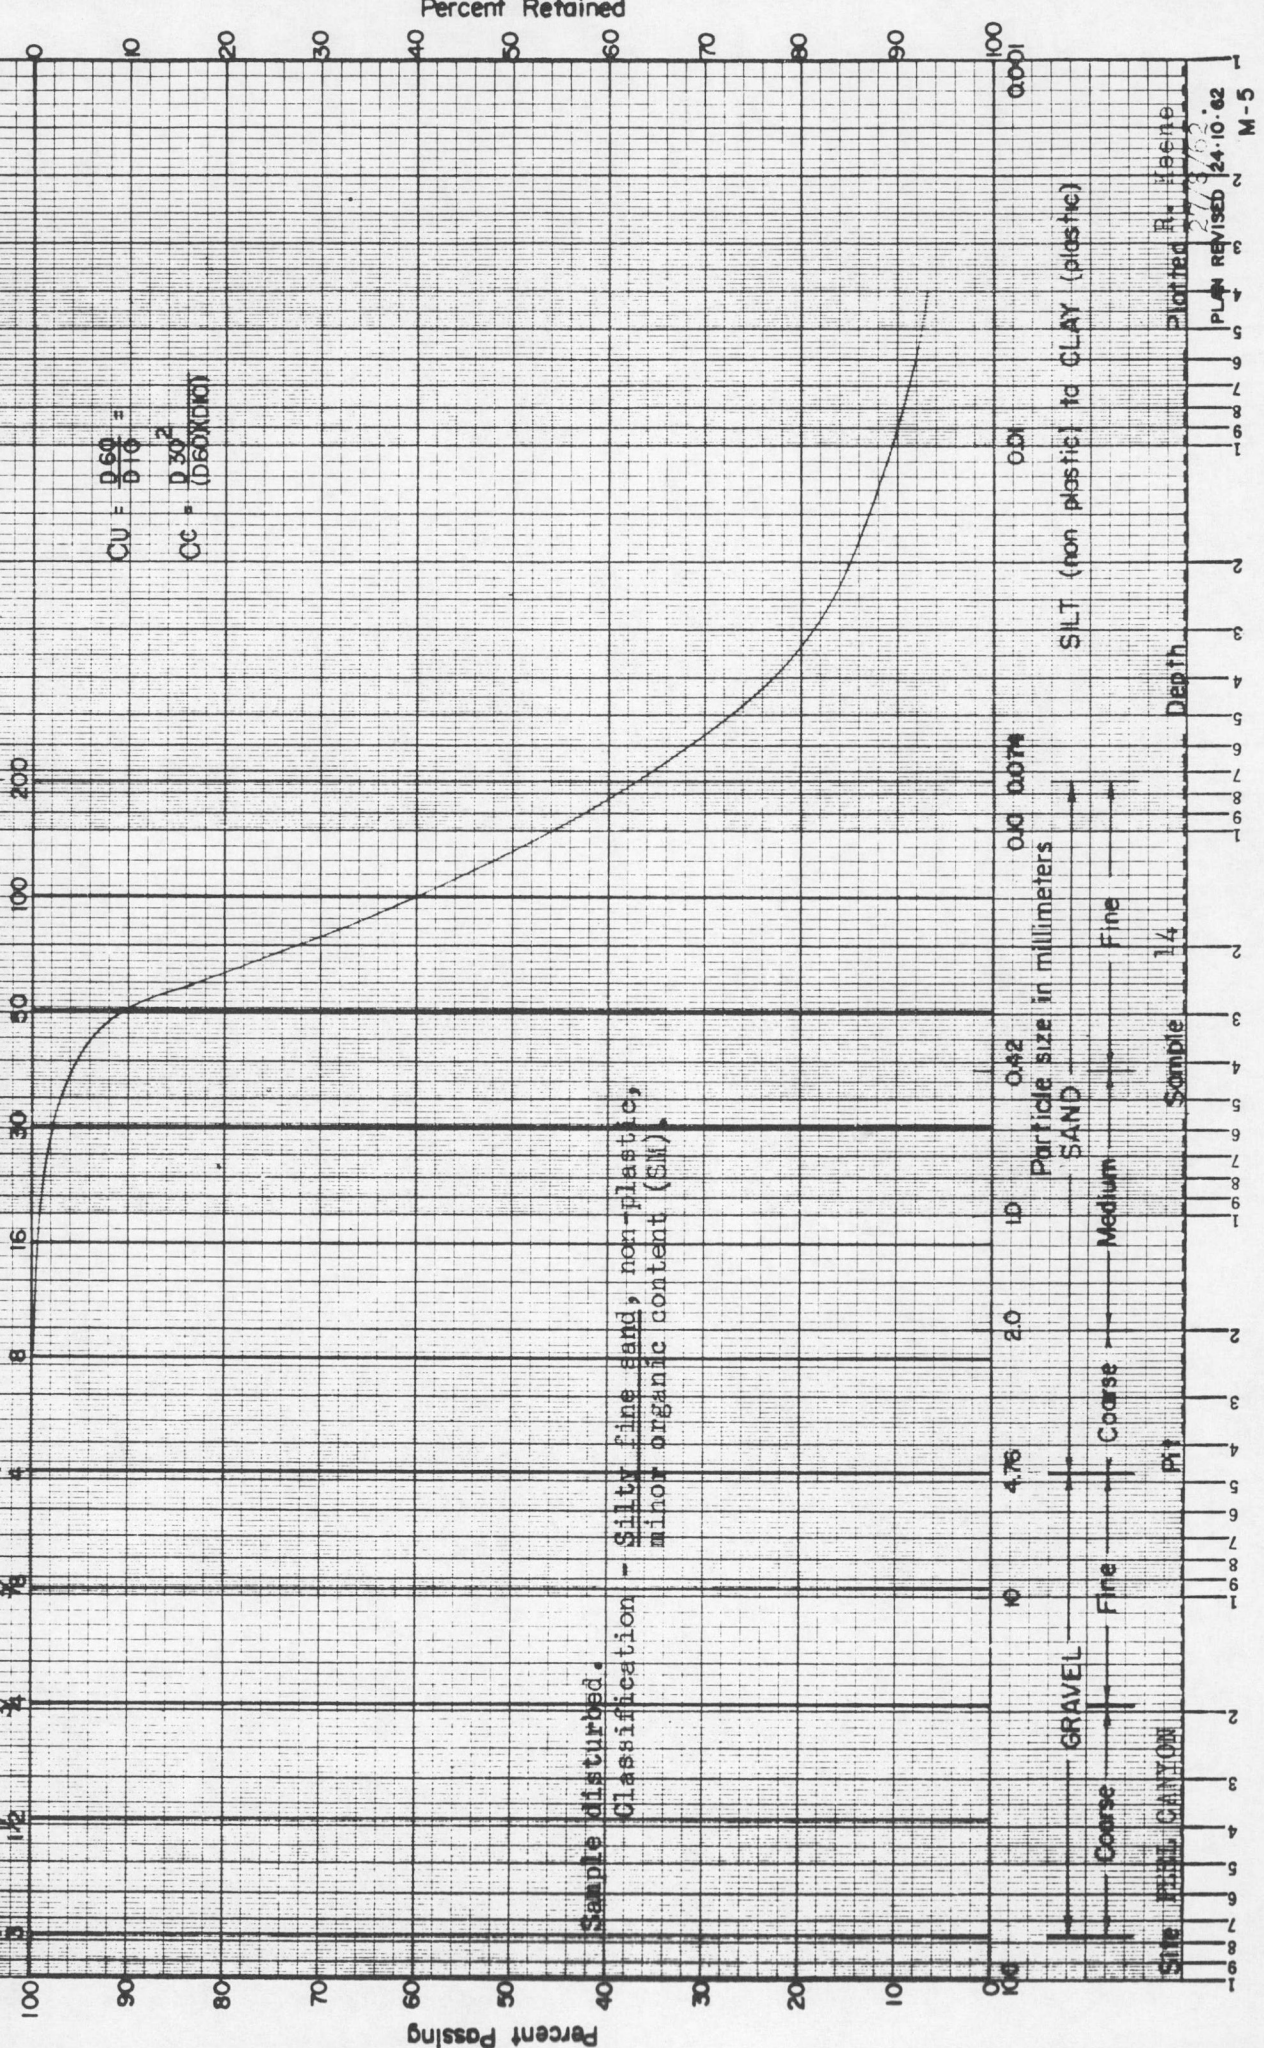
14

Sample disturbed.  
 Classification - Silty fine sand, non-plastic,  
 minor organic content (SM).

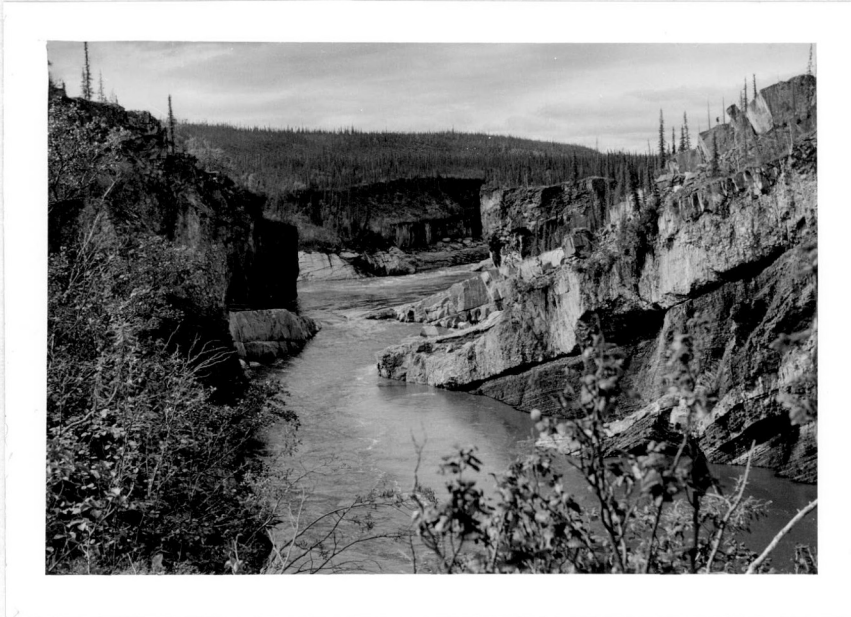
Plate 1

View looking upstream toward folded area in centre part of site; upstream dipping limestone and limestone breccia beds in right foreground are a continuation of horizontal beds in centre background.

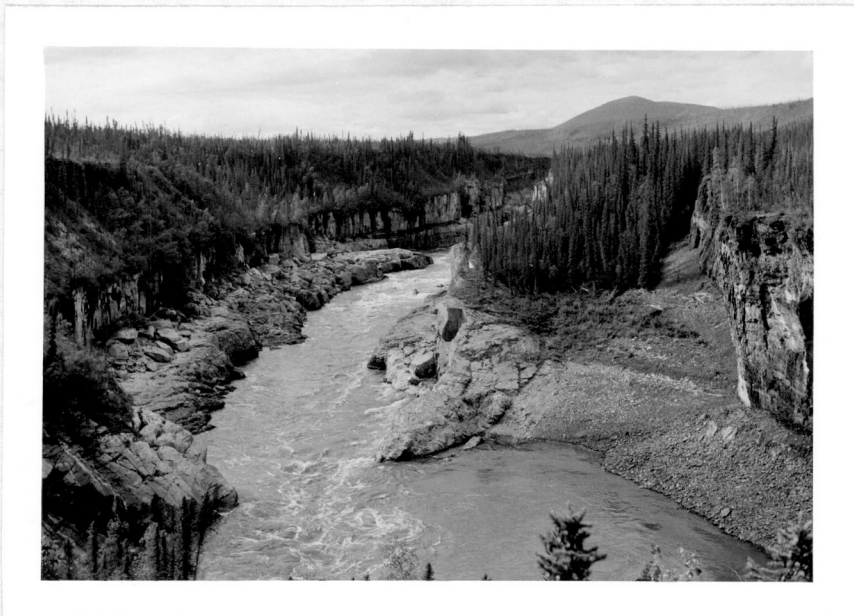
Plate 2

View looking upstream through the canyon from a point on the fold axis; horizontal limestone and limestone breccia beds are visible along right wall of the canyon.

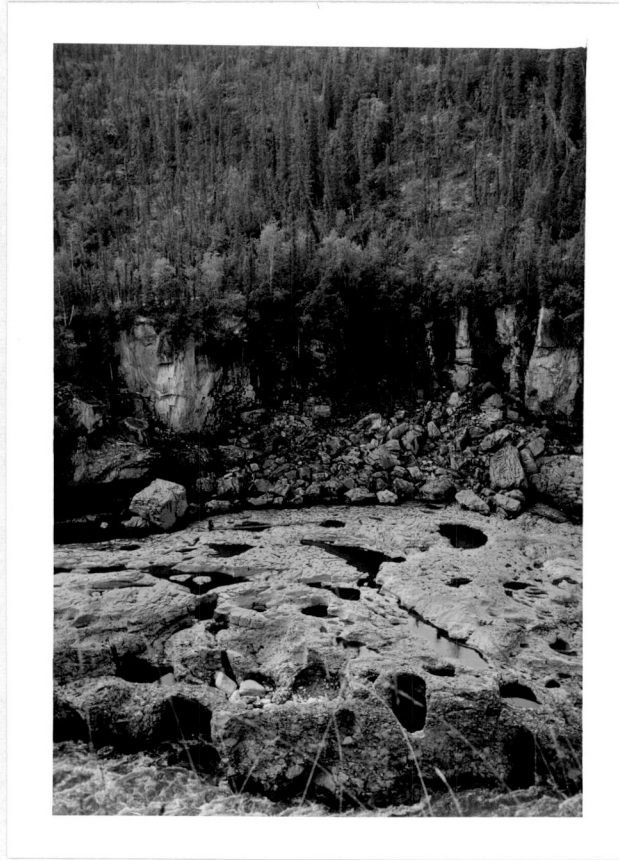
Plate 3

Potholes in limestone breccia in upstream part of the canyon.

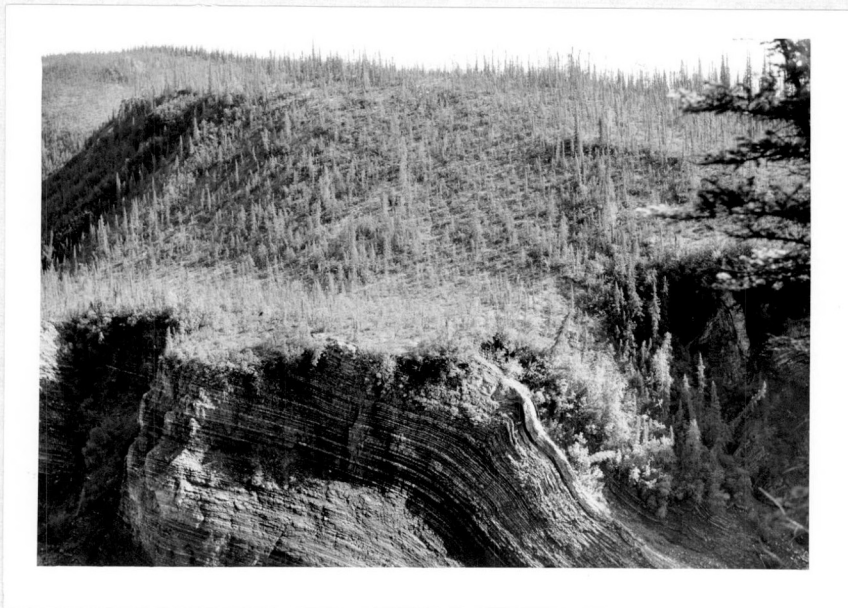
Plate 4

The least competent rocks are the contorted shales which are exposed in the walls of the canyon in the centre of the site area immediately downstream from the fold. These rocks overlie the massive limestone. They are also exposed in a fairly continuous 25- to 75-foot bluff about 50 feet south of the right wall of the canyon near stations G-3 and G-4. Here they are flat-lying and are not deformed. The thin-bedded shale and argillaceous limestone occurring in the downstream part of the site area are believed competent. These rocks underlie the massive limestone beds. They are exposed in a few places on the floor of the canyon where the river has cut down through the limestone.

Folded, thin-bedded shale and argillaceous limestone exposed on the right wall of the canyon downstream from the fold axis.

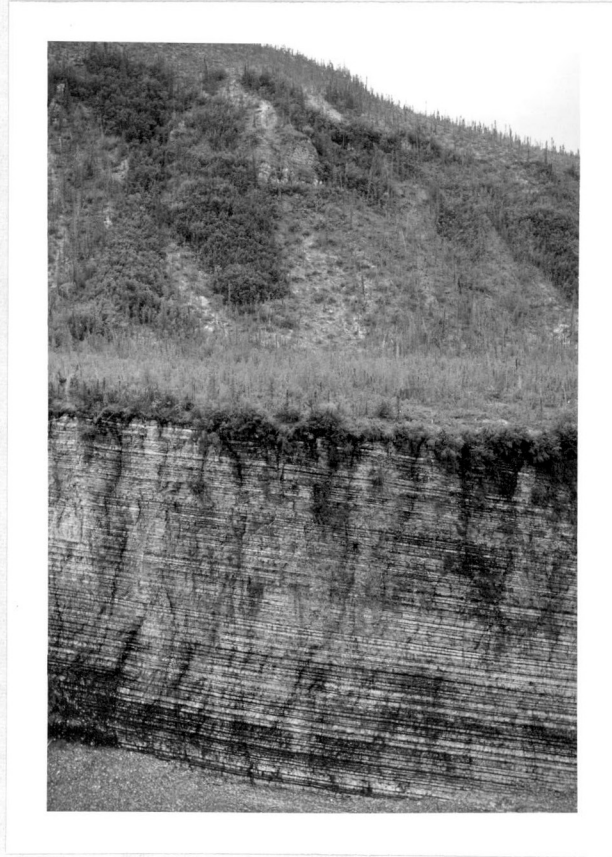
Plate 5

Thin-bedded shale and argillaceous limestone exposed in right wall of downstream part of canyon; dip is gently upstream; proposed right abutment is in background.
