GEOLOGICAL SURVEY OF CANADA
TOPICAL REPORT NO. 84

MACKENZIE RIVER DRAINAGE BASIN
DAM SITE INVESTIGATION

SITES NOS. 17-18

WIND RIVER AND BONNET PLUME SITES

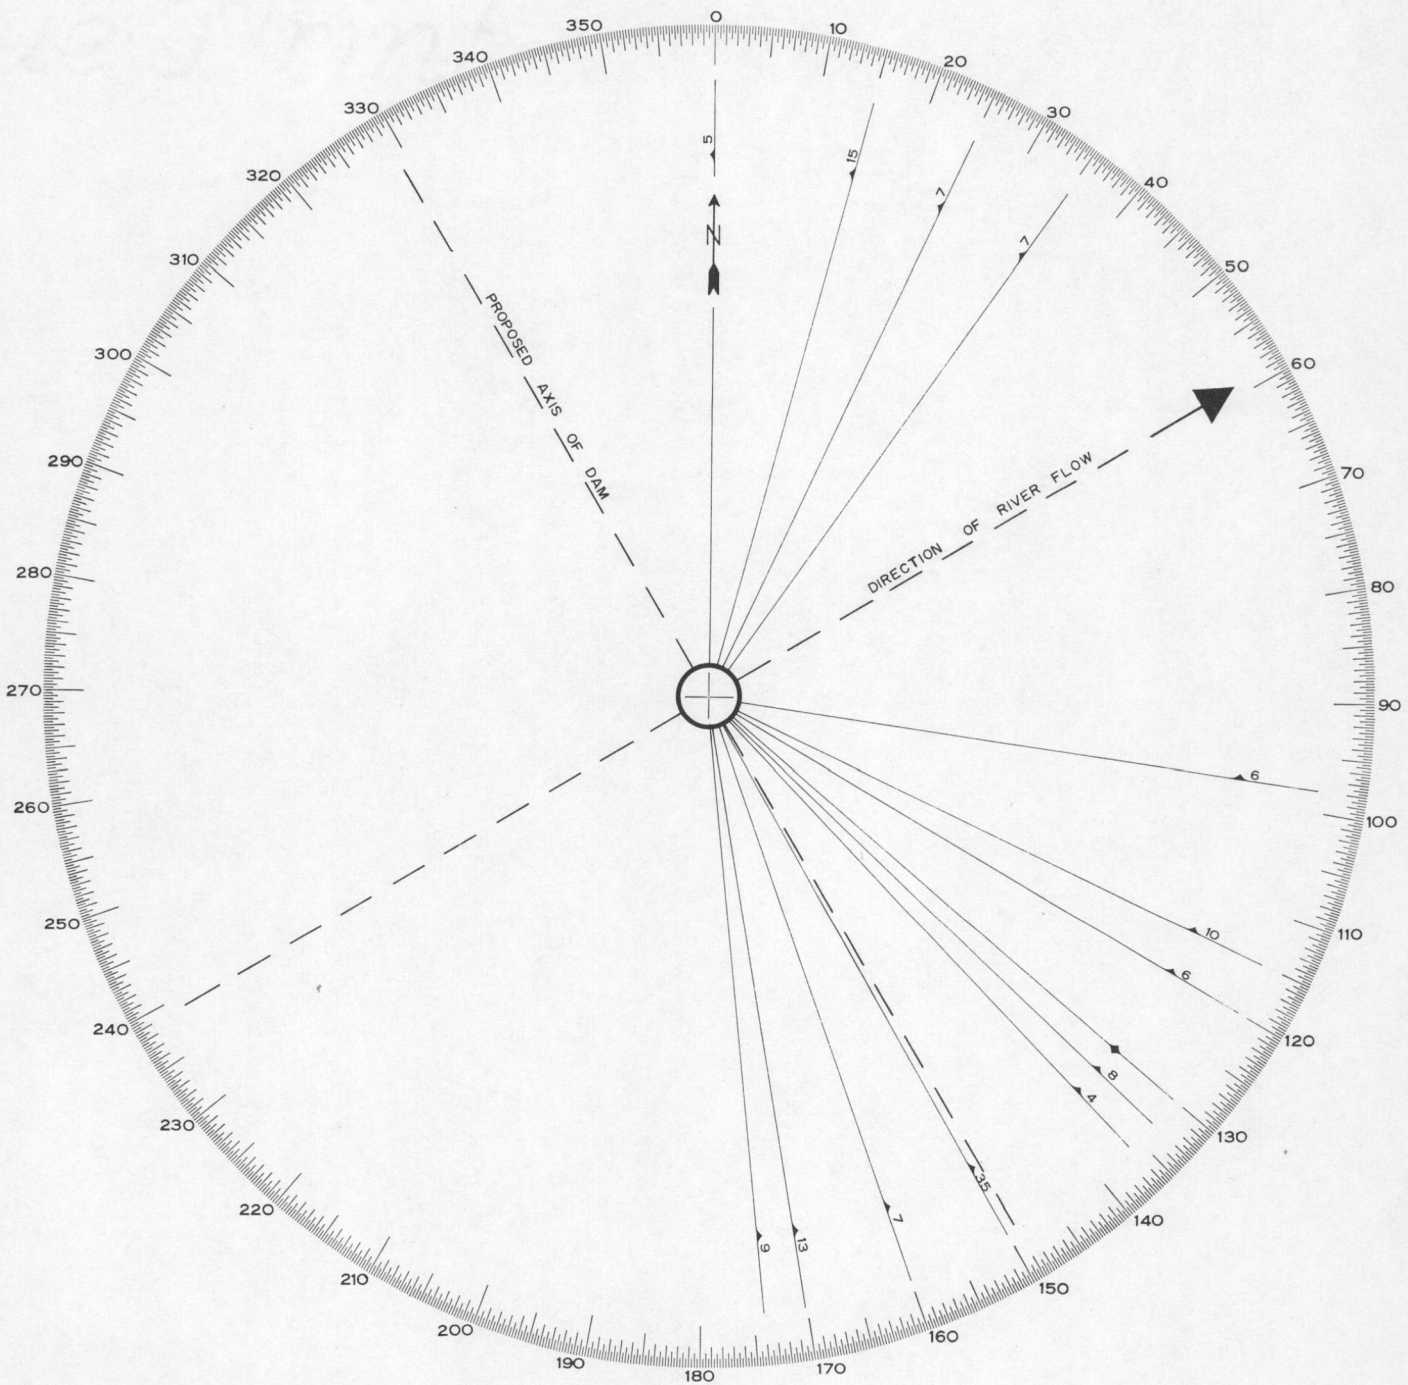
BEDDING ROSETTE

In general the dip of the bedding varies from 4 to 15 degrees upstream or into the right abutment. This can be seen in photograph G. S. C. 44-7-62 which is included at the end of this report. In places, however, minor undulations in the strata have resulted in low angle downstream dips.

The above illustration presents diagrammatically the direction and dip of bedding in bedrock exposed at Wind River site

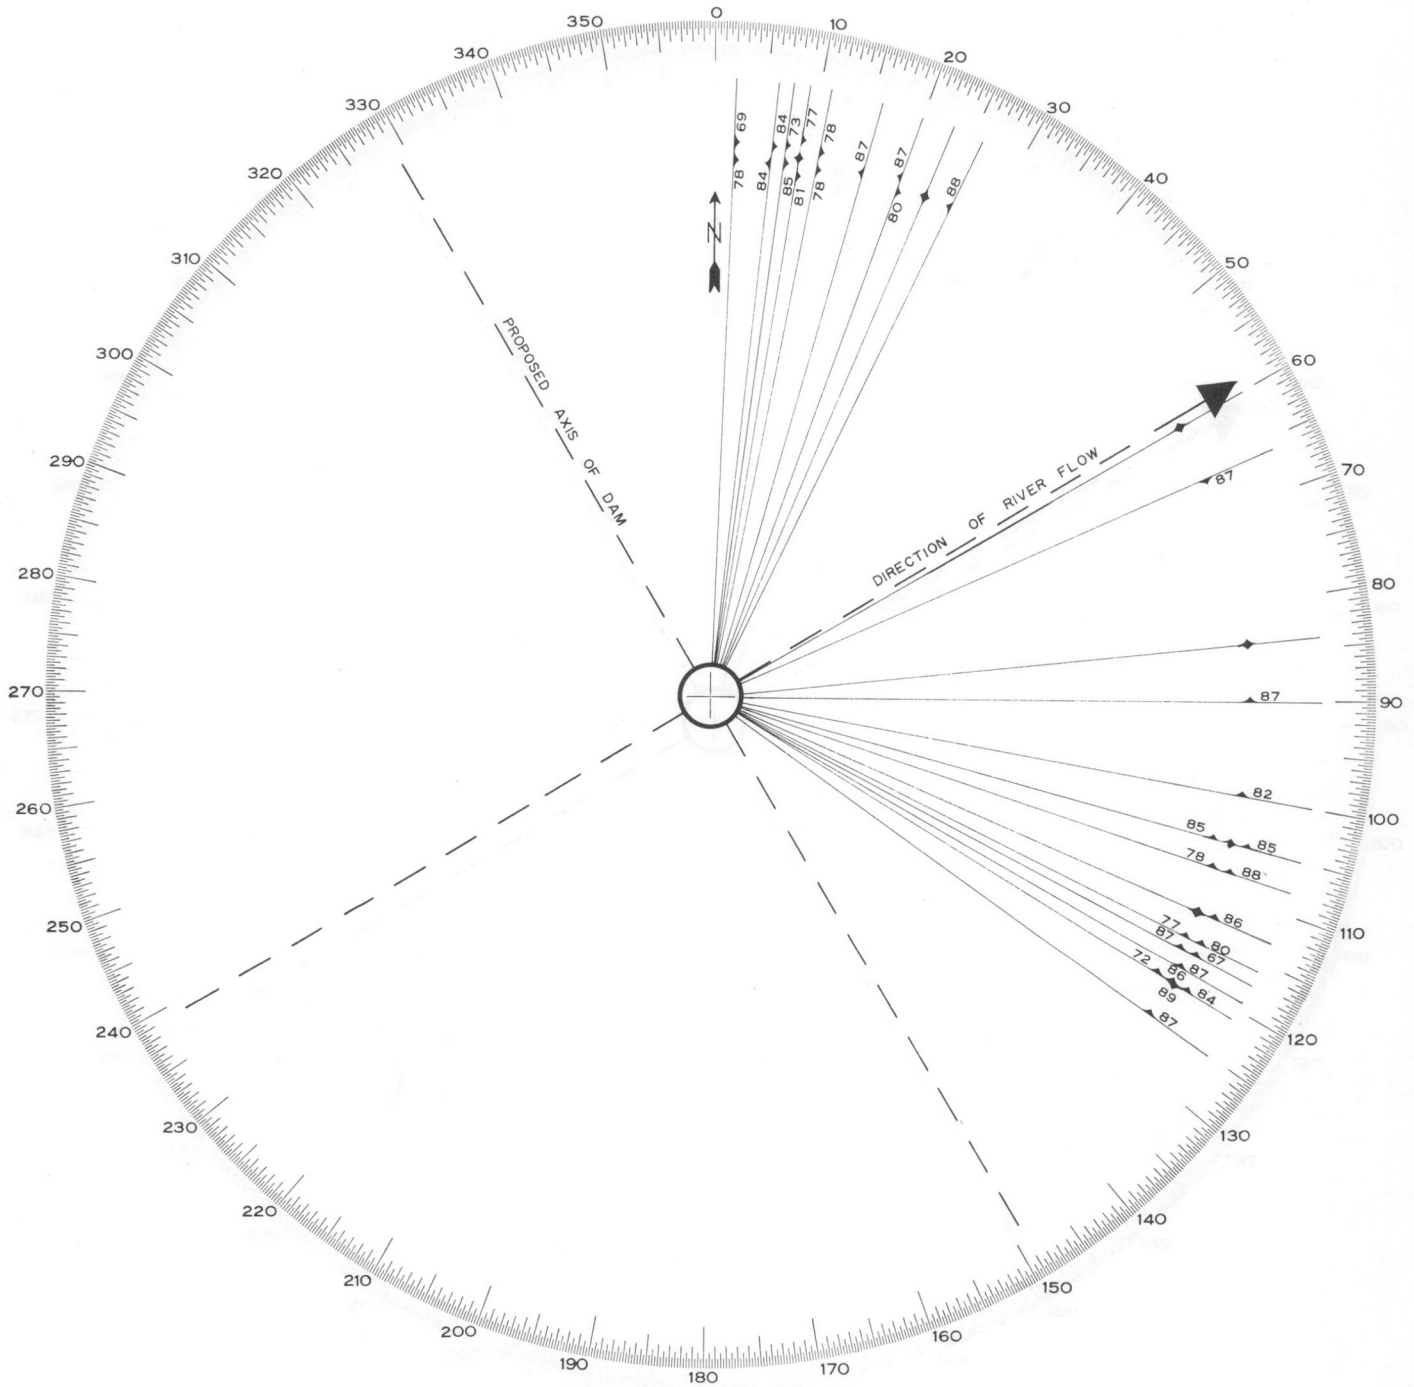
JOINT ROSETTE

There are two prominent joint sets which intersect one another at angles between 60 and 80 degrees. One set which closely parallels the bedding dips steeply downstream or into the left abutment. The other set also dips downstream at high angles or into the right abutment. Many of the flat, vertical faces in the rock exposed in the walls of the canyon are joint planes from which rock fragments have fallen. The spacing of the joint fractures varies from a few inches to 4 feet or more. They are usually tight except in the upper 3 to 4 feet where they may be open as much as 3 inches.

The above illustration presents diagrammatically the direction and dip of jointing in bedrock exposed at Wind River site

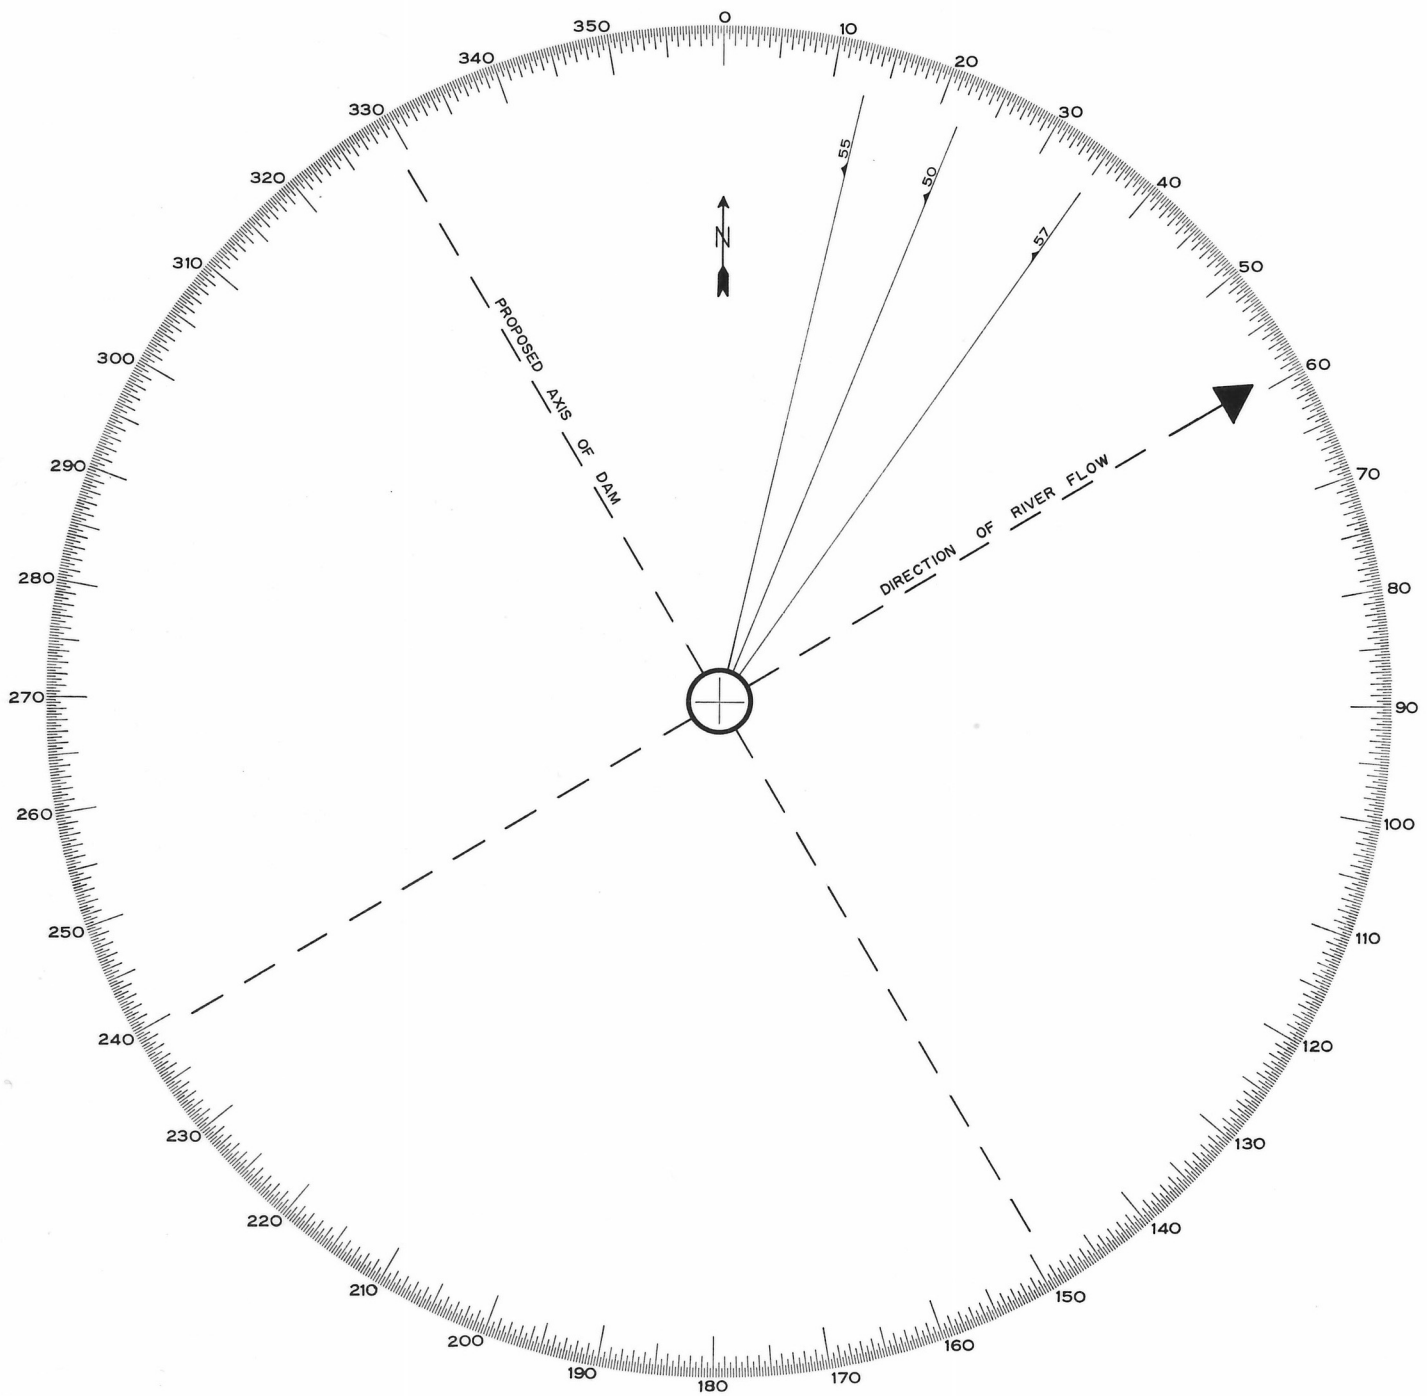
FAULT ROSETTE

Faulting is not common in the site area. Only one of the three faults depicted on the accompanying fault rosette for Wind River site occur within the area. The remaining two are located a few hundred feet downstream. All the faults are normal. The vertical displacement varies from a few feet to 75 feet. In all instances they are continuous across the canyon. The average width of the zones of broken rock associated with the faulting is about 10 feet. The quantity of gouge varies from about 1 inch in the harder rocks to 3 or more inches in places where the shear plane intersects shale beds. Minor slickensiding exists along the bedding and joint planes indicating some movement has also occurred along these surfaces.

The above illustration presents diagrammatically the direction and dip of faulting in bedrock exposed at Wind River site

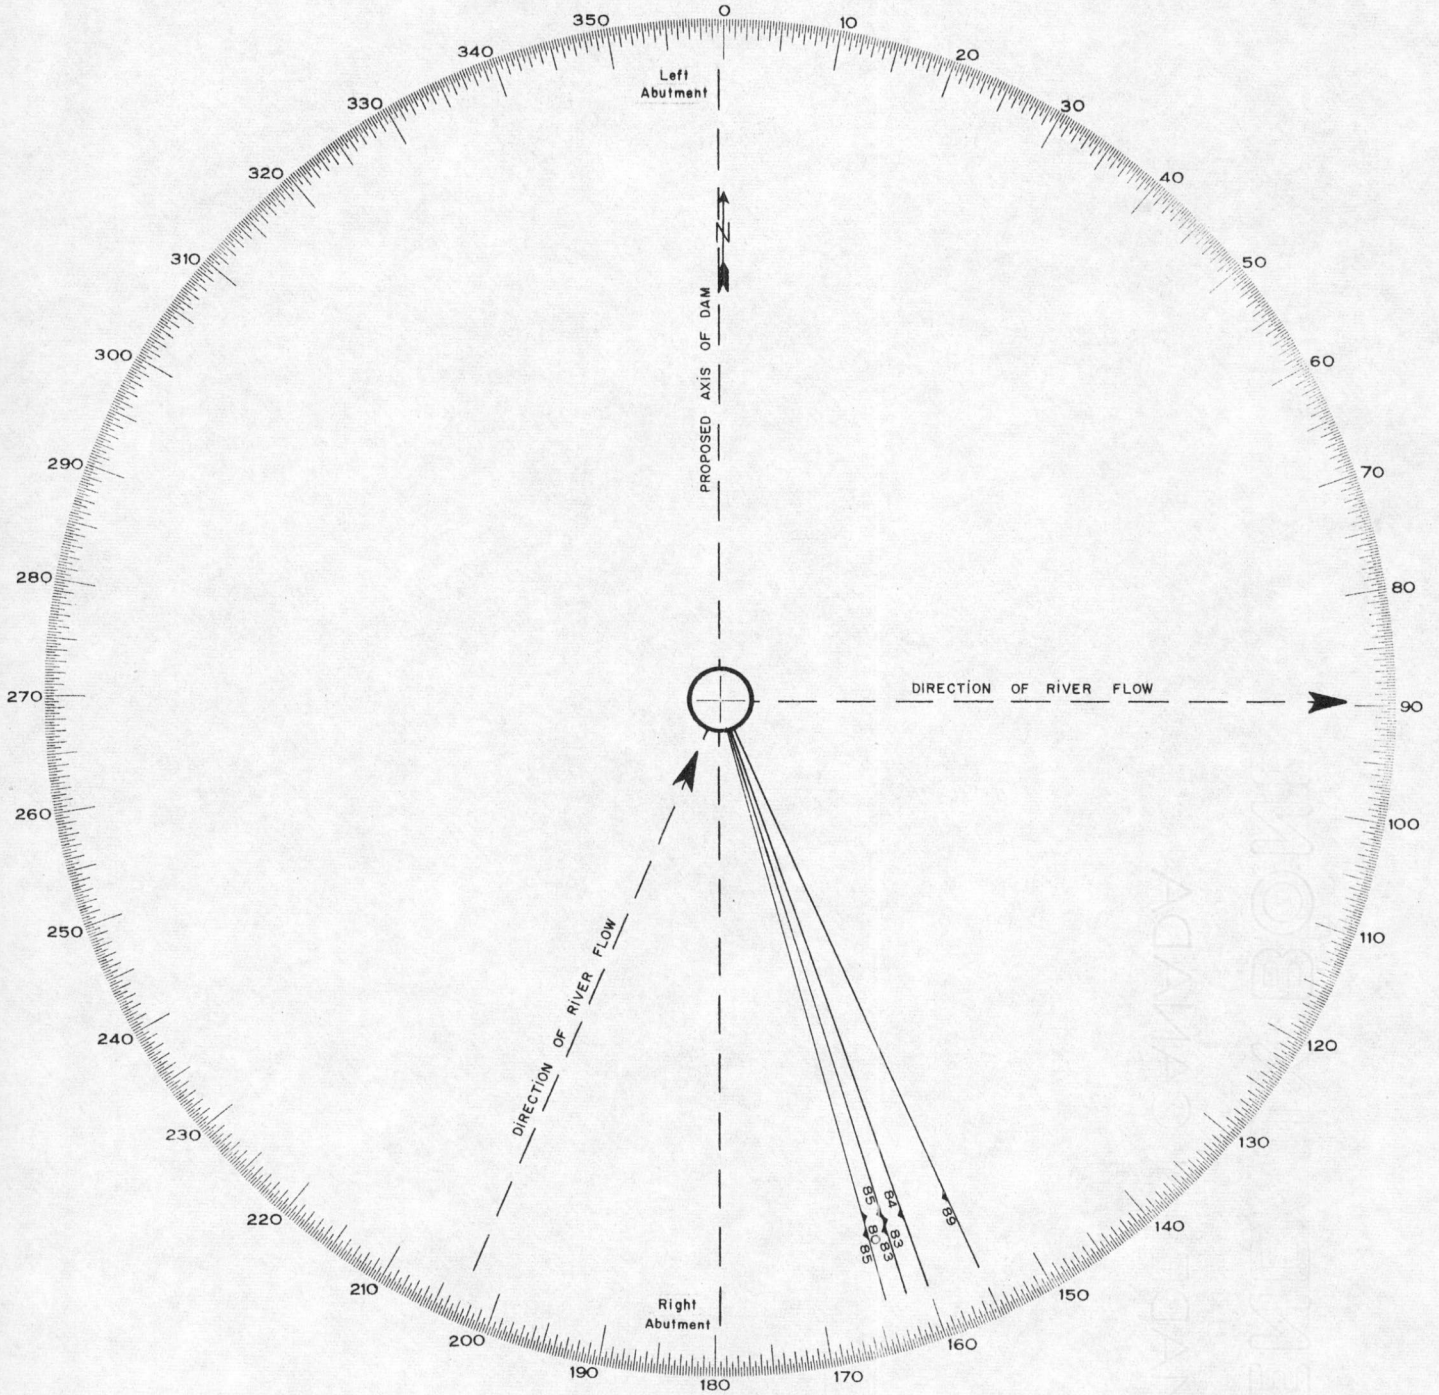
BEDDING ROSETTE

The above illustration presents diagrammatically the direction and dip of bedding in bedrock exposed at Bonnet Plume site

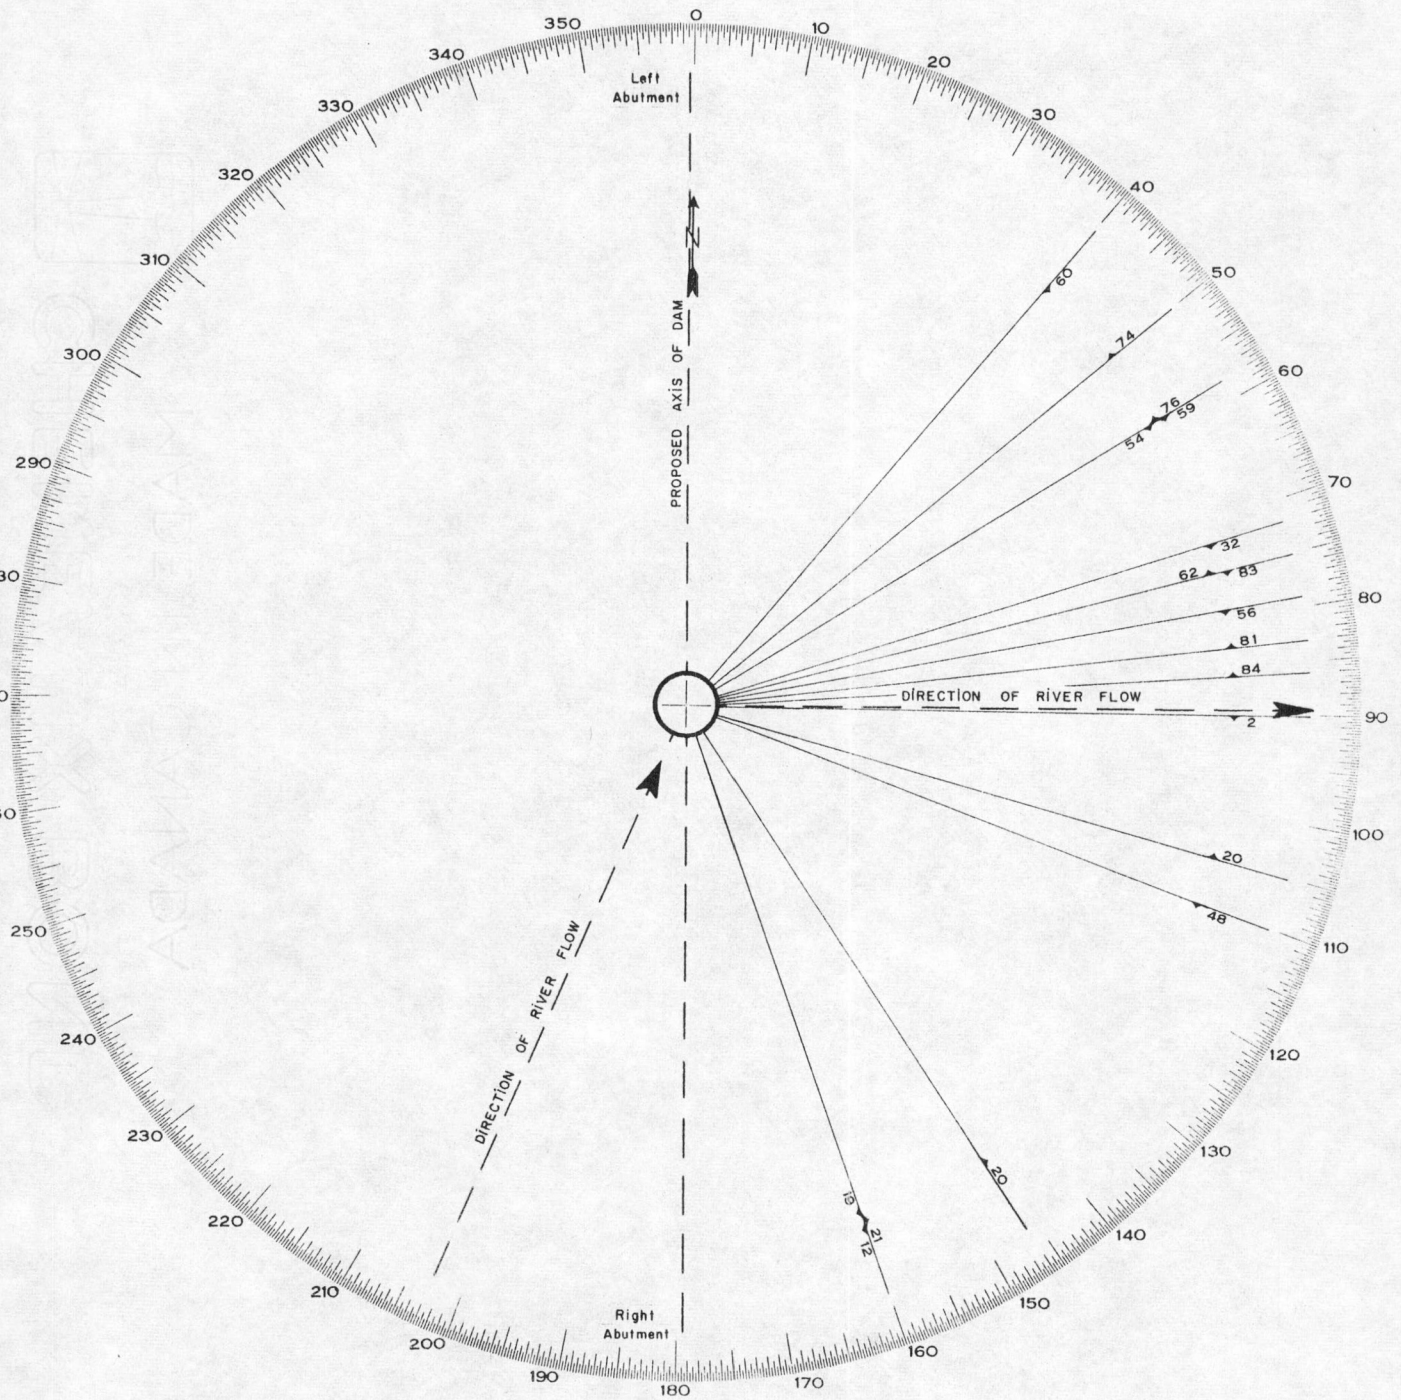
JOINT ROSETTE

The above illustration presents diagrammatically the direction and dip of jointing in bedrock exposed at Bonnet Plume site

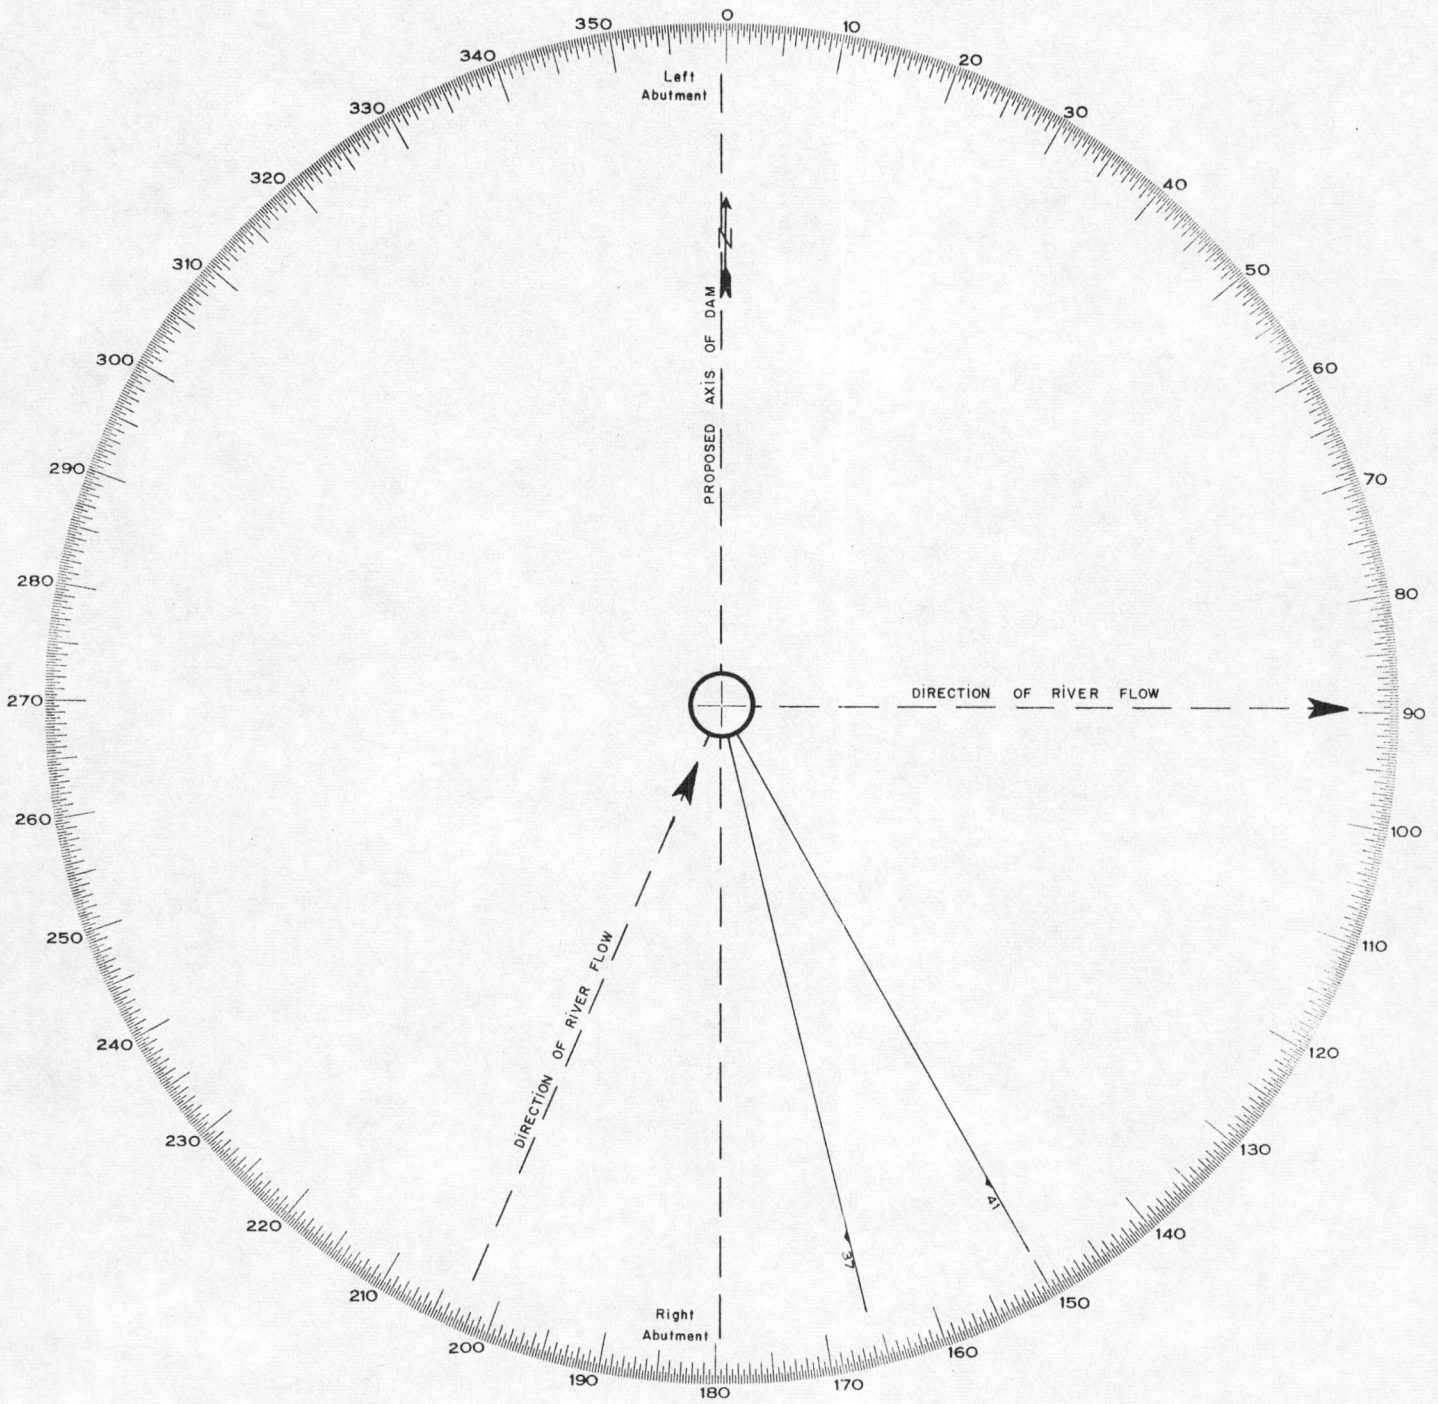
FAULT ROSETTE

The above illustration presents diagrammatically the direction and dip of faulting in bedrock exposed at Bonnet Plume site

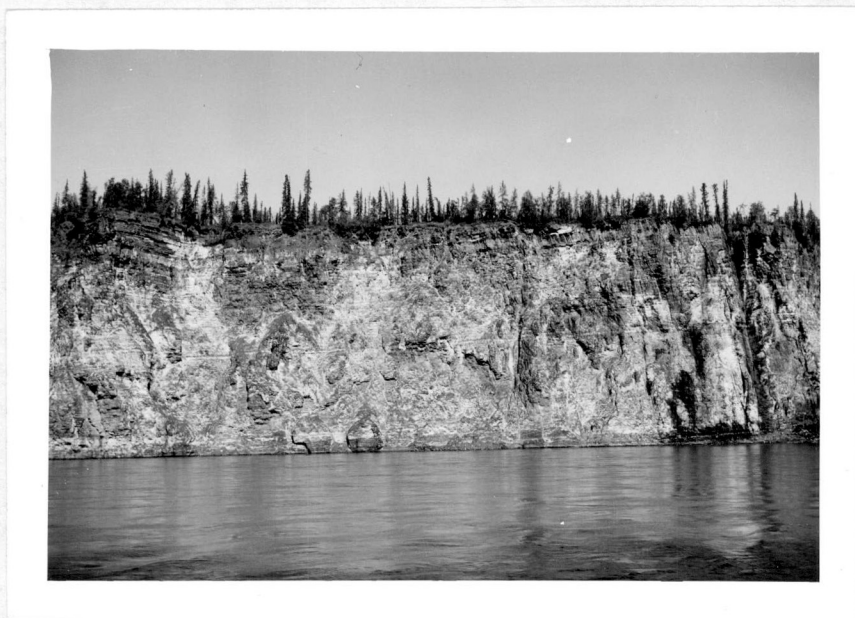
Plate 1

Left abutment, Wind River site; the vertical height
height of the bluff is about 180 feet.

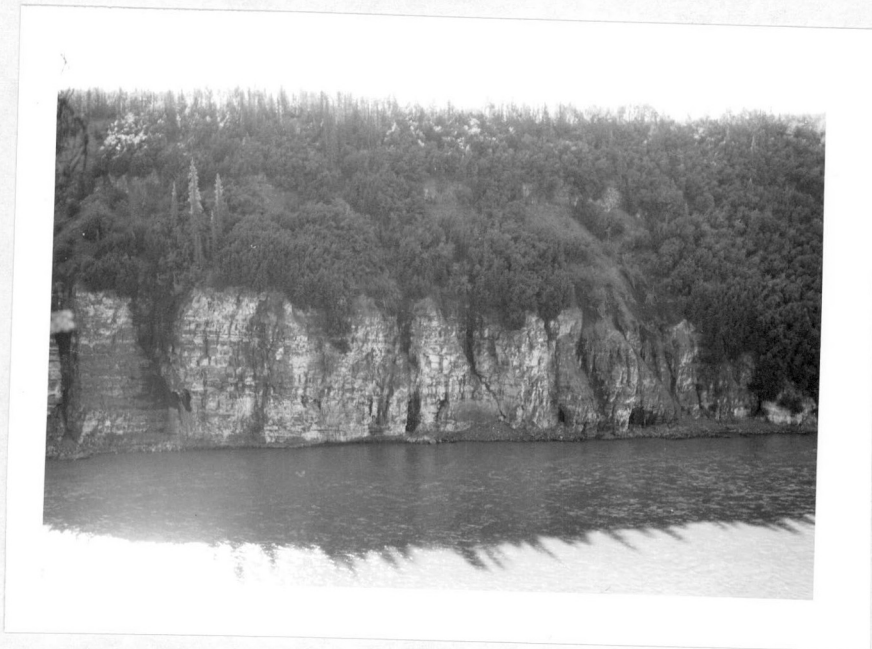
Plate 2

2. Talus: Talus is material resulting from the mechanical disintegration of adjacent bedrock. At Wind River site it covers a large part of the bluff along the right side of the river. This is especially true in the downstream part where the bluff is less steep. Very little talus occurs on the bluff along the left side of the river. The talus consists of small, rock fragments ranging from sand-size particles to platy cobbles 6 inches in diameter. Most of the larger fragments consist of black argillite or sandstone. In places where bedrock consists chiefly of shale quantities of soft, black, clayey material are present.

Right abutment, Wind River site; the upper part concealed by vegetation is covered with a thin mixture of talus, silt, sand and gravel.
