GEOLOGICAL SURVEY OF CANADA  
TOPICAL REPORT NO. 88

YUKON RIVER DRAINAGE BASIN  
DAM SITE INVESTIGATION

SITE No. 36

**BELL DAM SITE**  
(MAP AND PRELIMINARY REPORT)

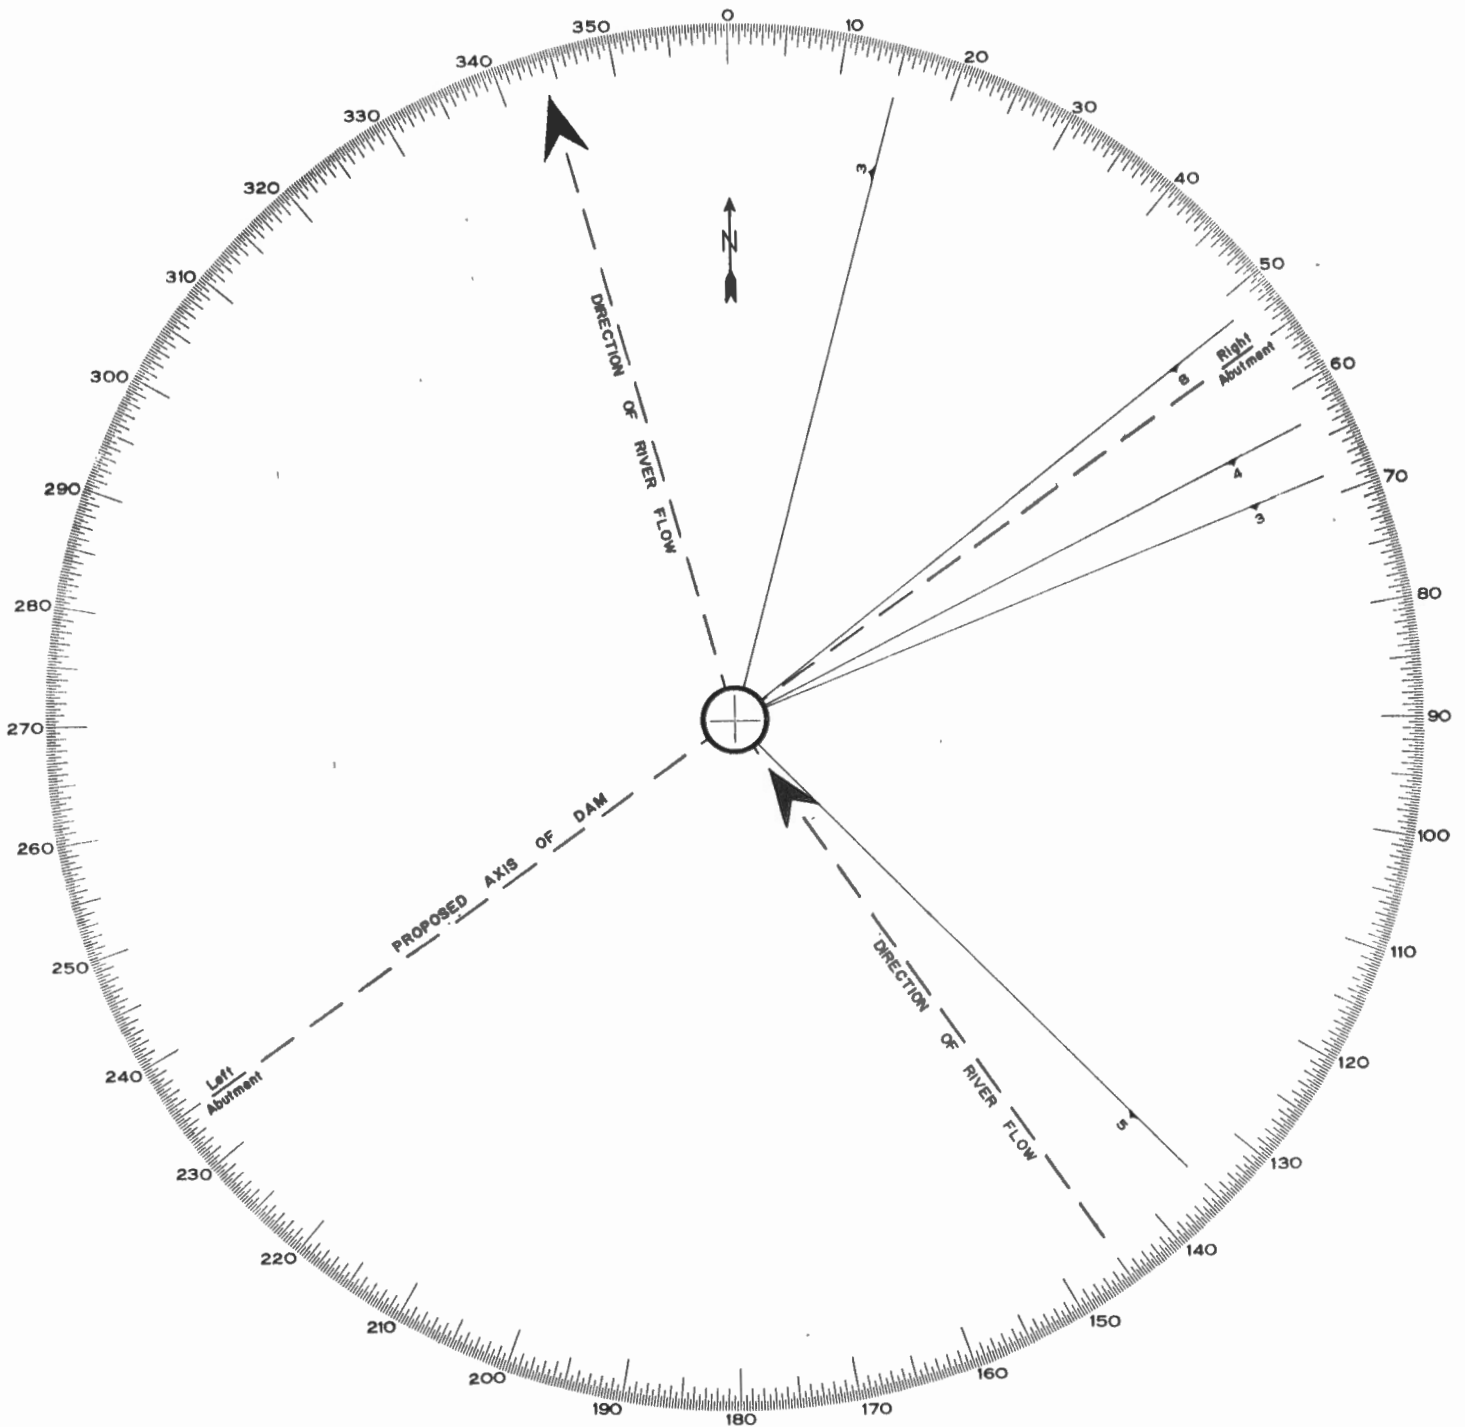
BEDDING ROSETTE

accompanying bedding rosette it can be seen the bedding closely parallels the proposed axis of the dam and dips upstream.

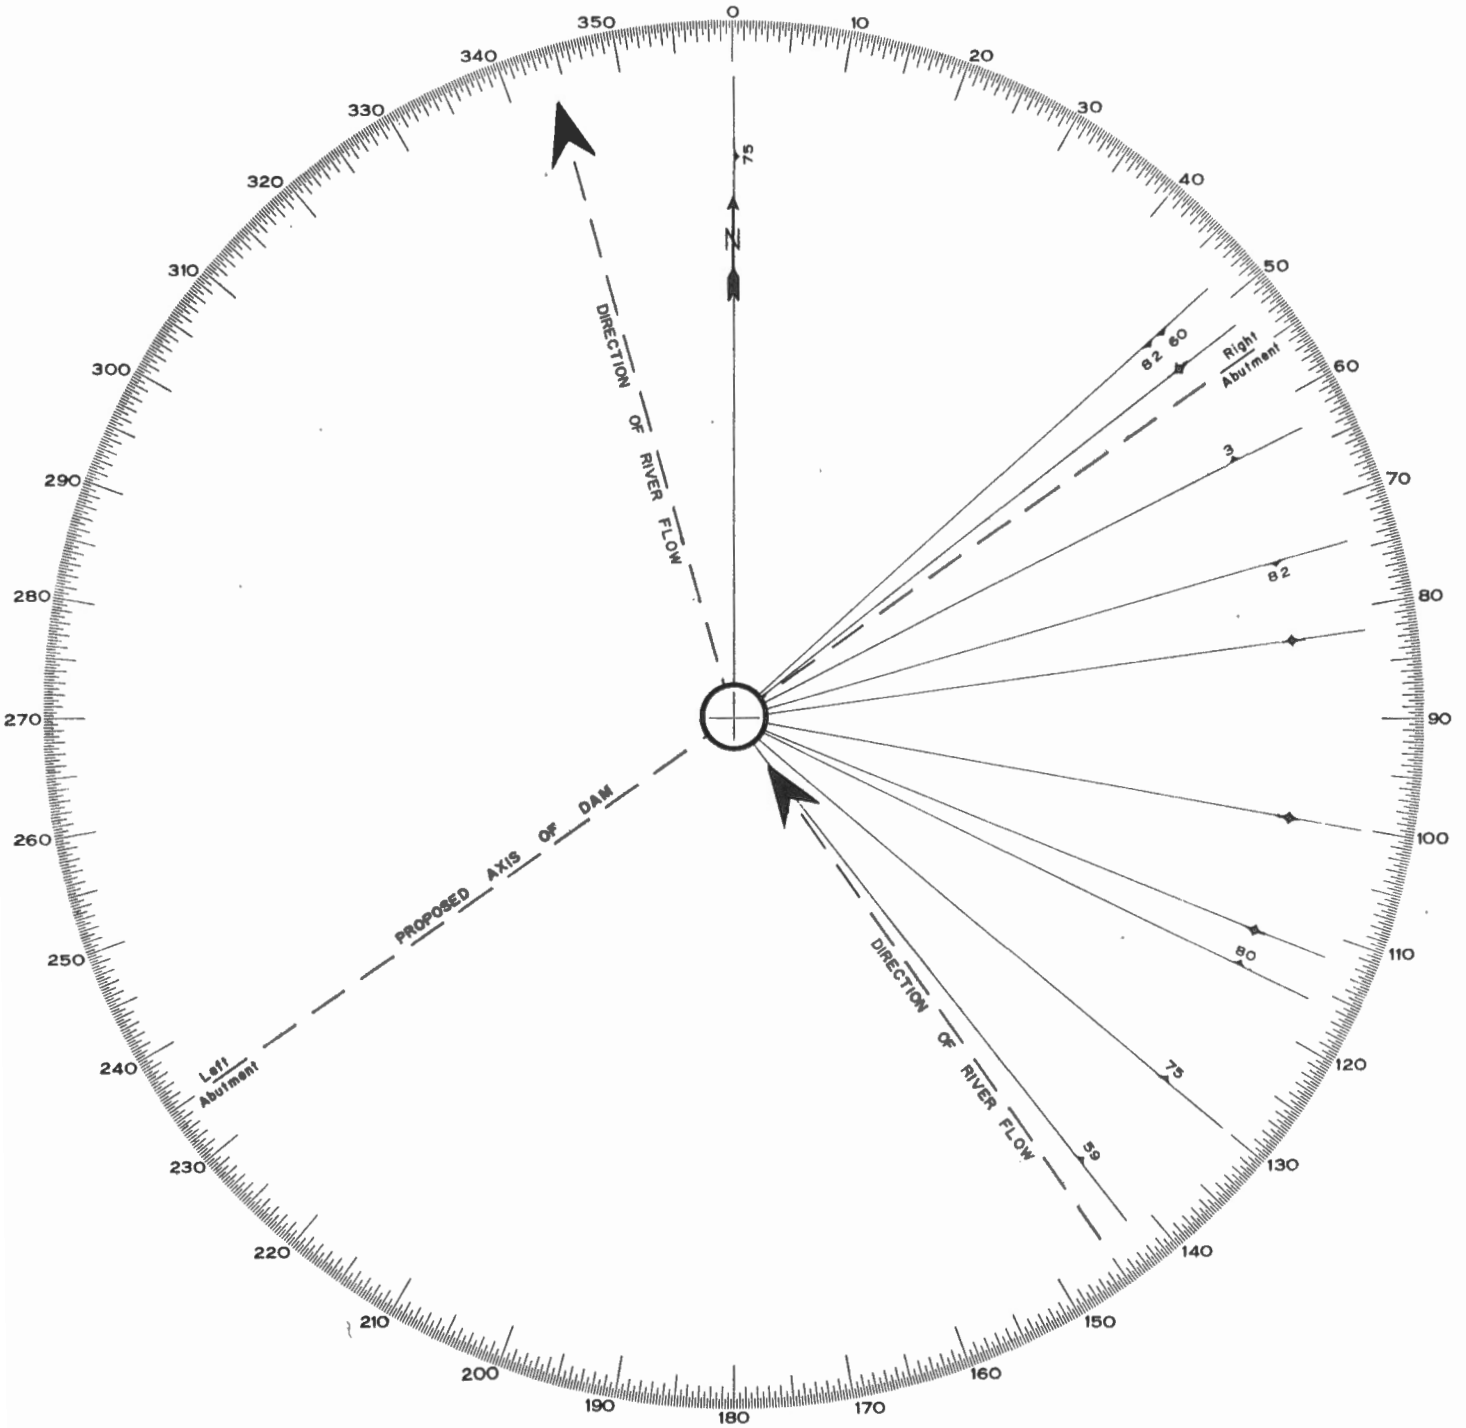
JOINT ROSETTE

The strike of the jointing is extremely variable although the dips are relatively steep ranging from 59 degrees to vertical. One result of the great variation in the jointing is the many different shapes of rock fragments in the talus which in most instances have broken off along joint and bedding planes.

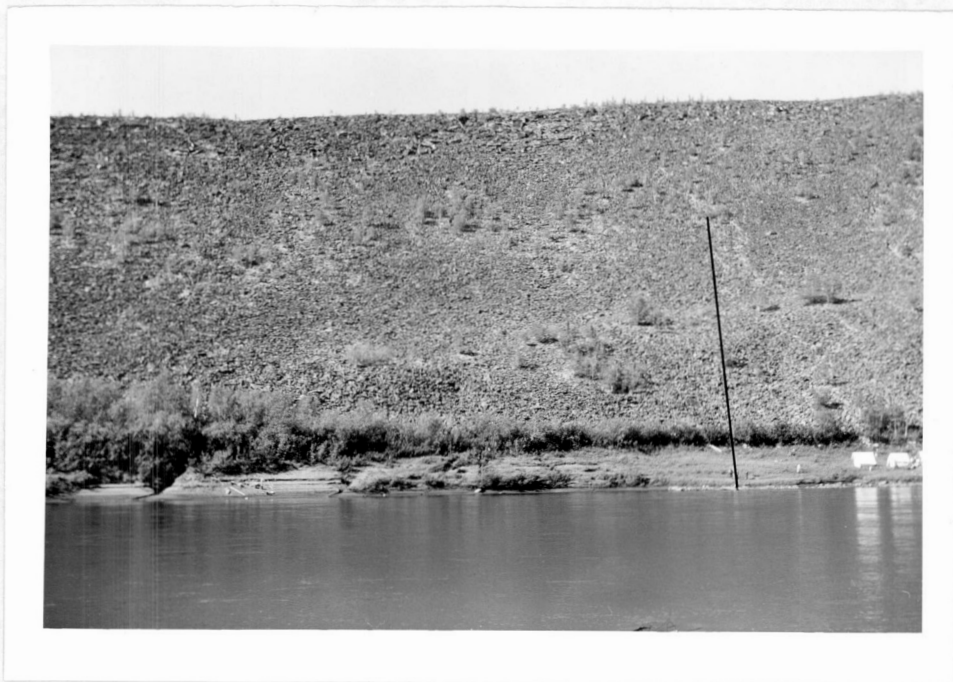
Plate 1

Both sides of the valley are covered almost entirely with talus. The size of the rock fragments on the slopes increases upwards suggesting they have originated up slope and while moving downward are disintegrating into smaller fragments. The left (west) side of the valley extends steeply upward to a bedrock terrace some 600 feet above the river. This is well beyond the limit included on the accompanying map. Bedrock exposed on the terrace is deeply weathered and broken into large, angular blocks separated by open fractures many of which are several inches in width.

Talus-covered left abutment, Bell dam site, showing the approximate location of the proposed centre line; height from river to level plateau above slope is about 550 feet.

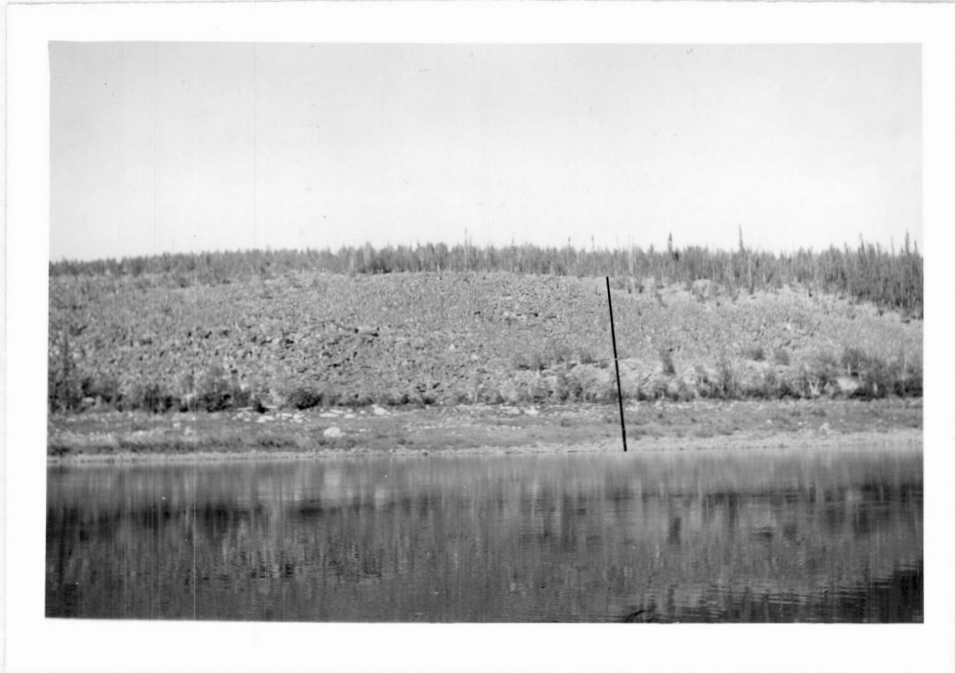
Plate 2

The right side of the valley rises steeply to a height of about 200 feet and then gradually levels out to a less steep gradient. In the upper part the fragments consist of weathered, angular blocks which are apparently creeping gradually downslope toward the steeper, talus-covered side of the

Talus-covered right abutment, Bell dam site, showing the approximate location of the proposed centre line.

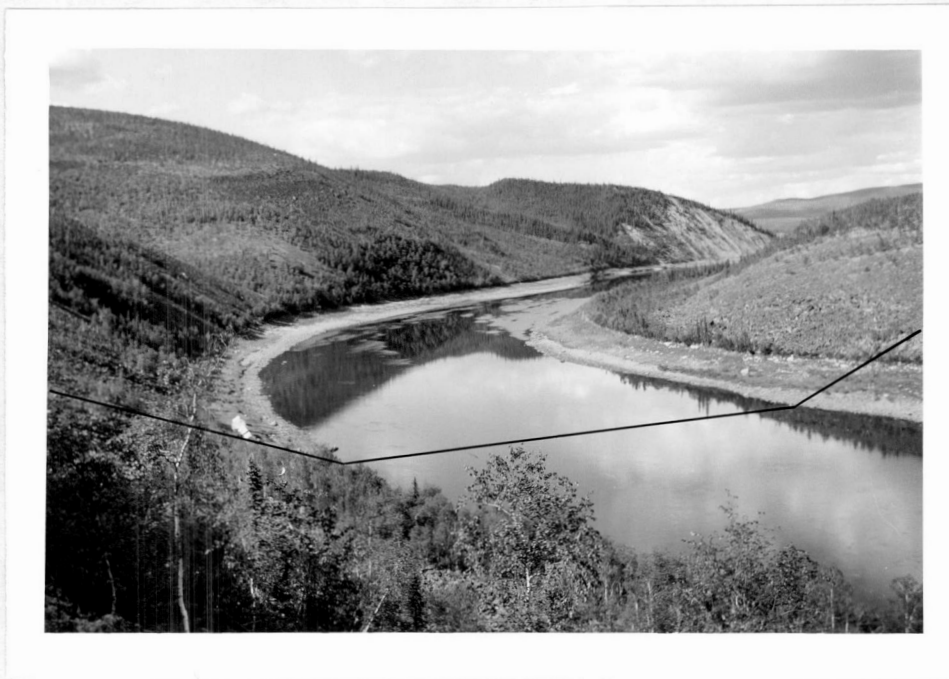
Plate 3

Bell dam site looking downstream showing the  
approximate location of the dam.
