GEOLOGICAL SURVEY OF CANADA  
TOPICAL REPORT NO. 98

YUKON RIVER DRAINAGE BASIN  
DAM SITE INVESTIGATION

SITE No. 23

**FRASER FALLS DAM SITE**  
(MAP AND PRELIMINARY REPORT)

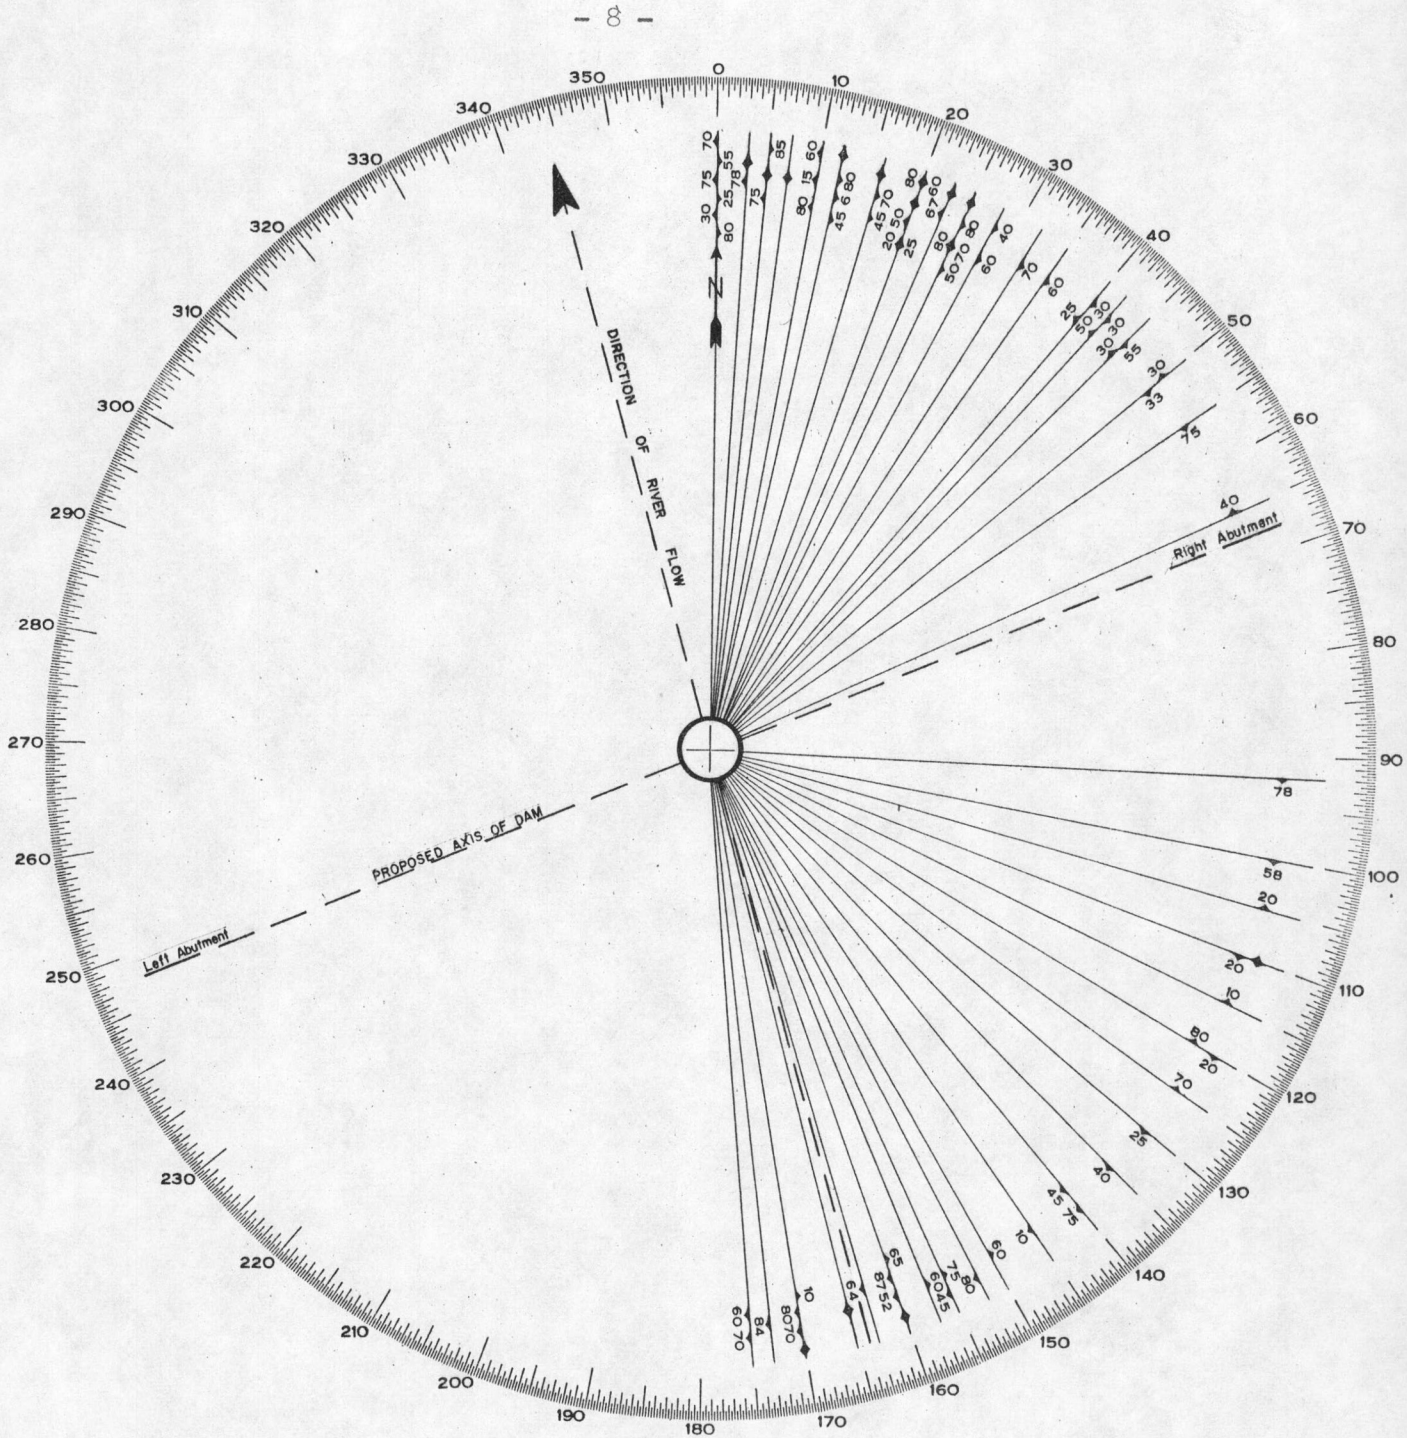
**JOINT ROSETTE**

Jointing is irregular. The most prominent set strikes between north and north 27 degrees east and, in general, is vertical or dips steeply to the west. This set intersects the dam axis at 40 to 67 degrees and dips into the left abutment. Other less prominent sets intersect the axis at 25 to 65 degrees and dip at relatively low angles in both upstream and downstream directions.

The above illustration presents diagrammatically the direction and dip of the jointing in bedrock exposed at Fraser Falls site.

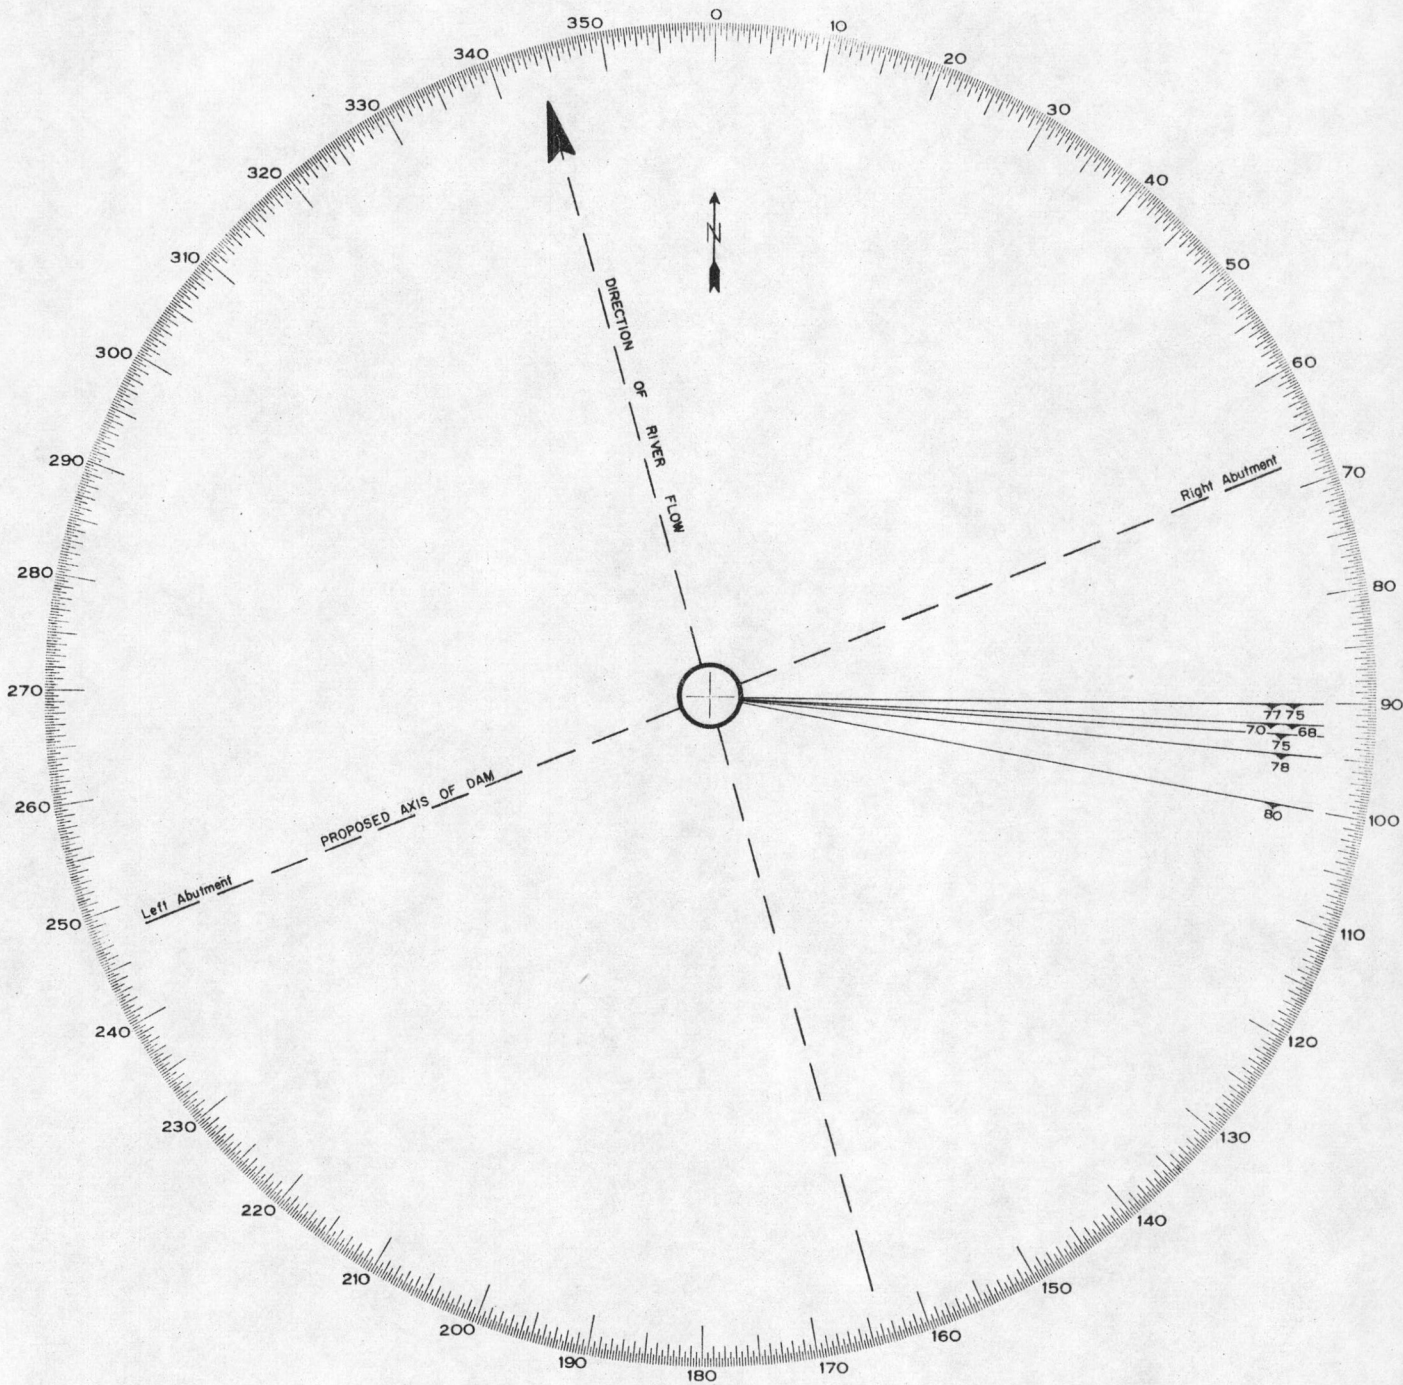
**BEDDING ROSETTE**

The above illustration presents diagrammatically the direction and dip of the bedding in bedrock exposed at Fraser Falls site.

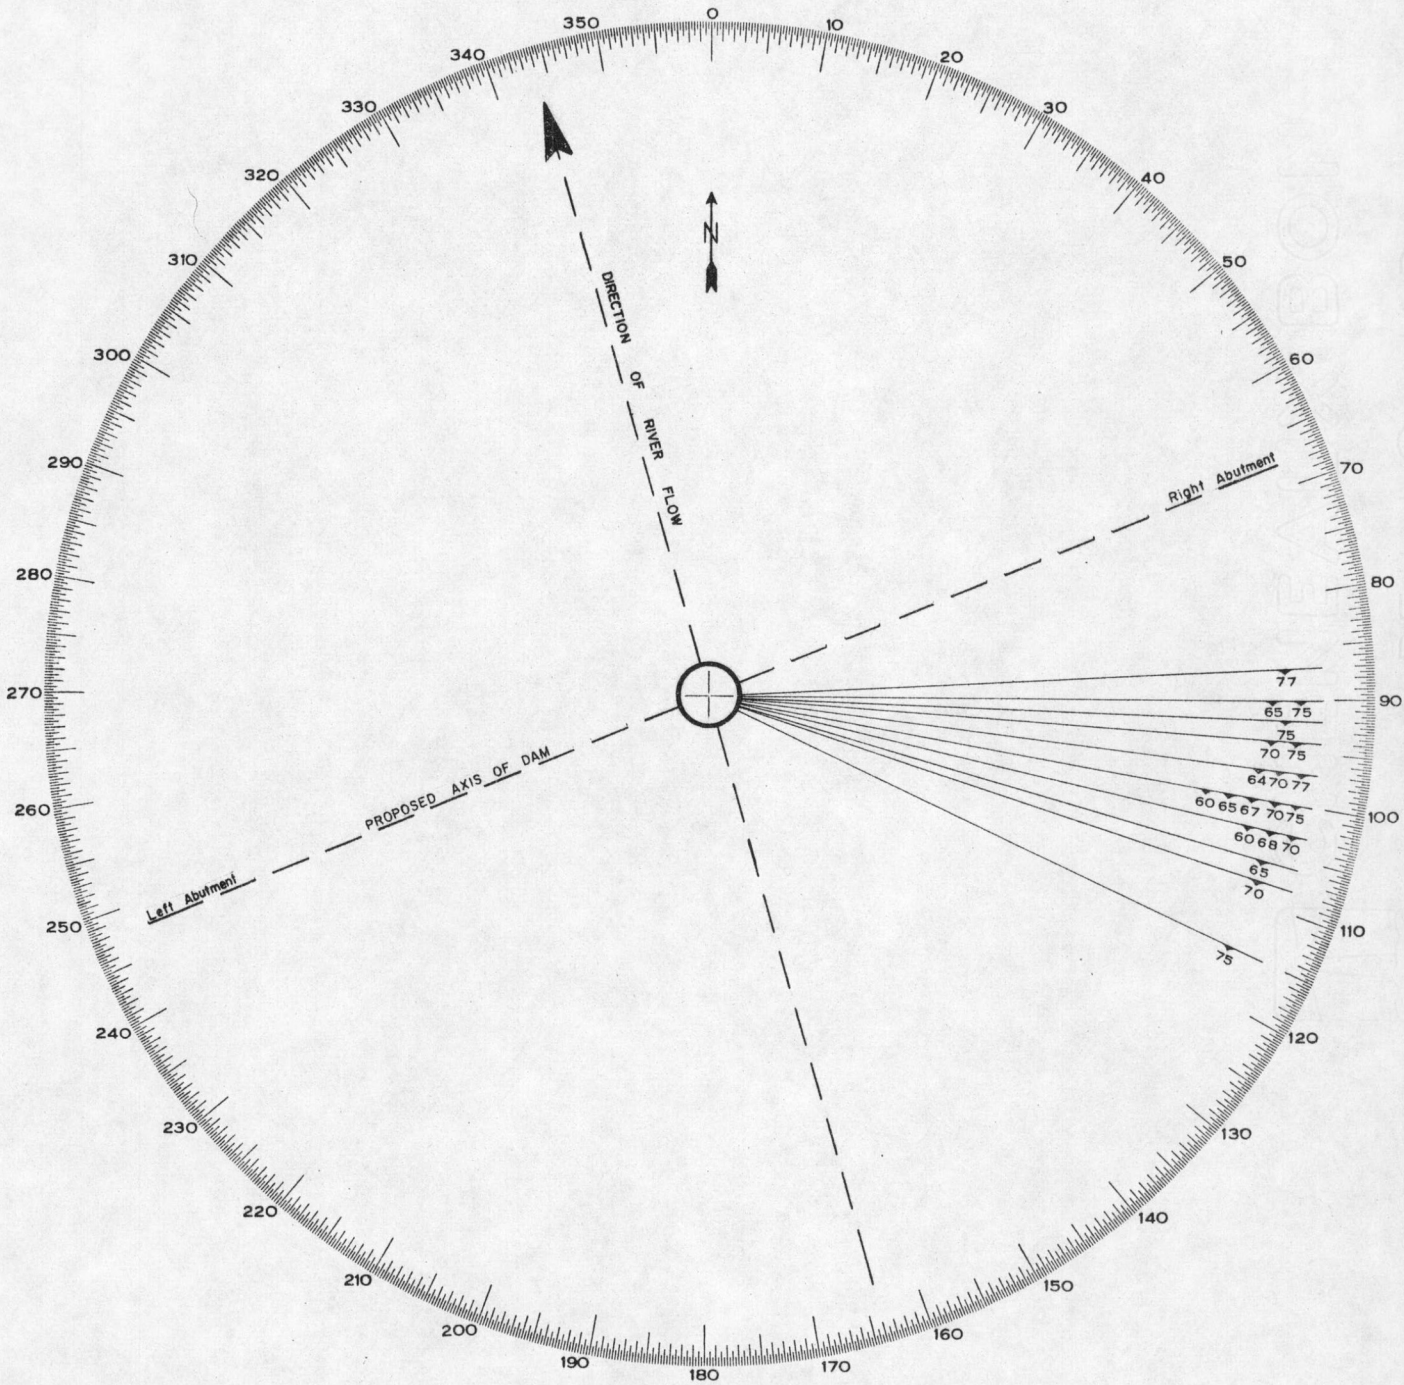
FOLIATION ROSETTE

The most prominent structure in bedrock at the site is the schistosity which intersects the proposed dam axis at angles varying from 17 to 47 degrees and dips upstream at 58 to 80 degrees. The bedding of which there are only traces remaining is almost parallel to the schistosity, diverging from it by about 5 degrees. It has a similar upstream dip.

The above illustration presents diagrammatically the direction and dip of the schistosity in bedrock exposed at Fraser Falls site.

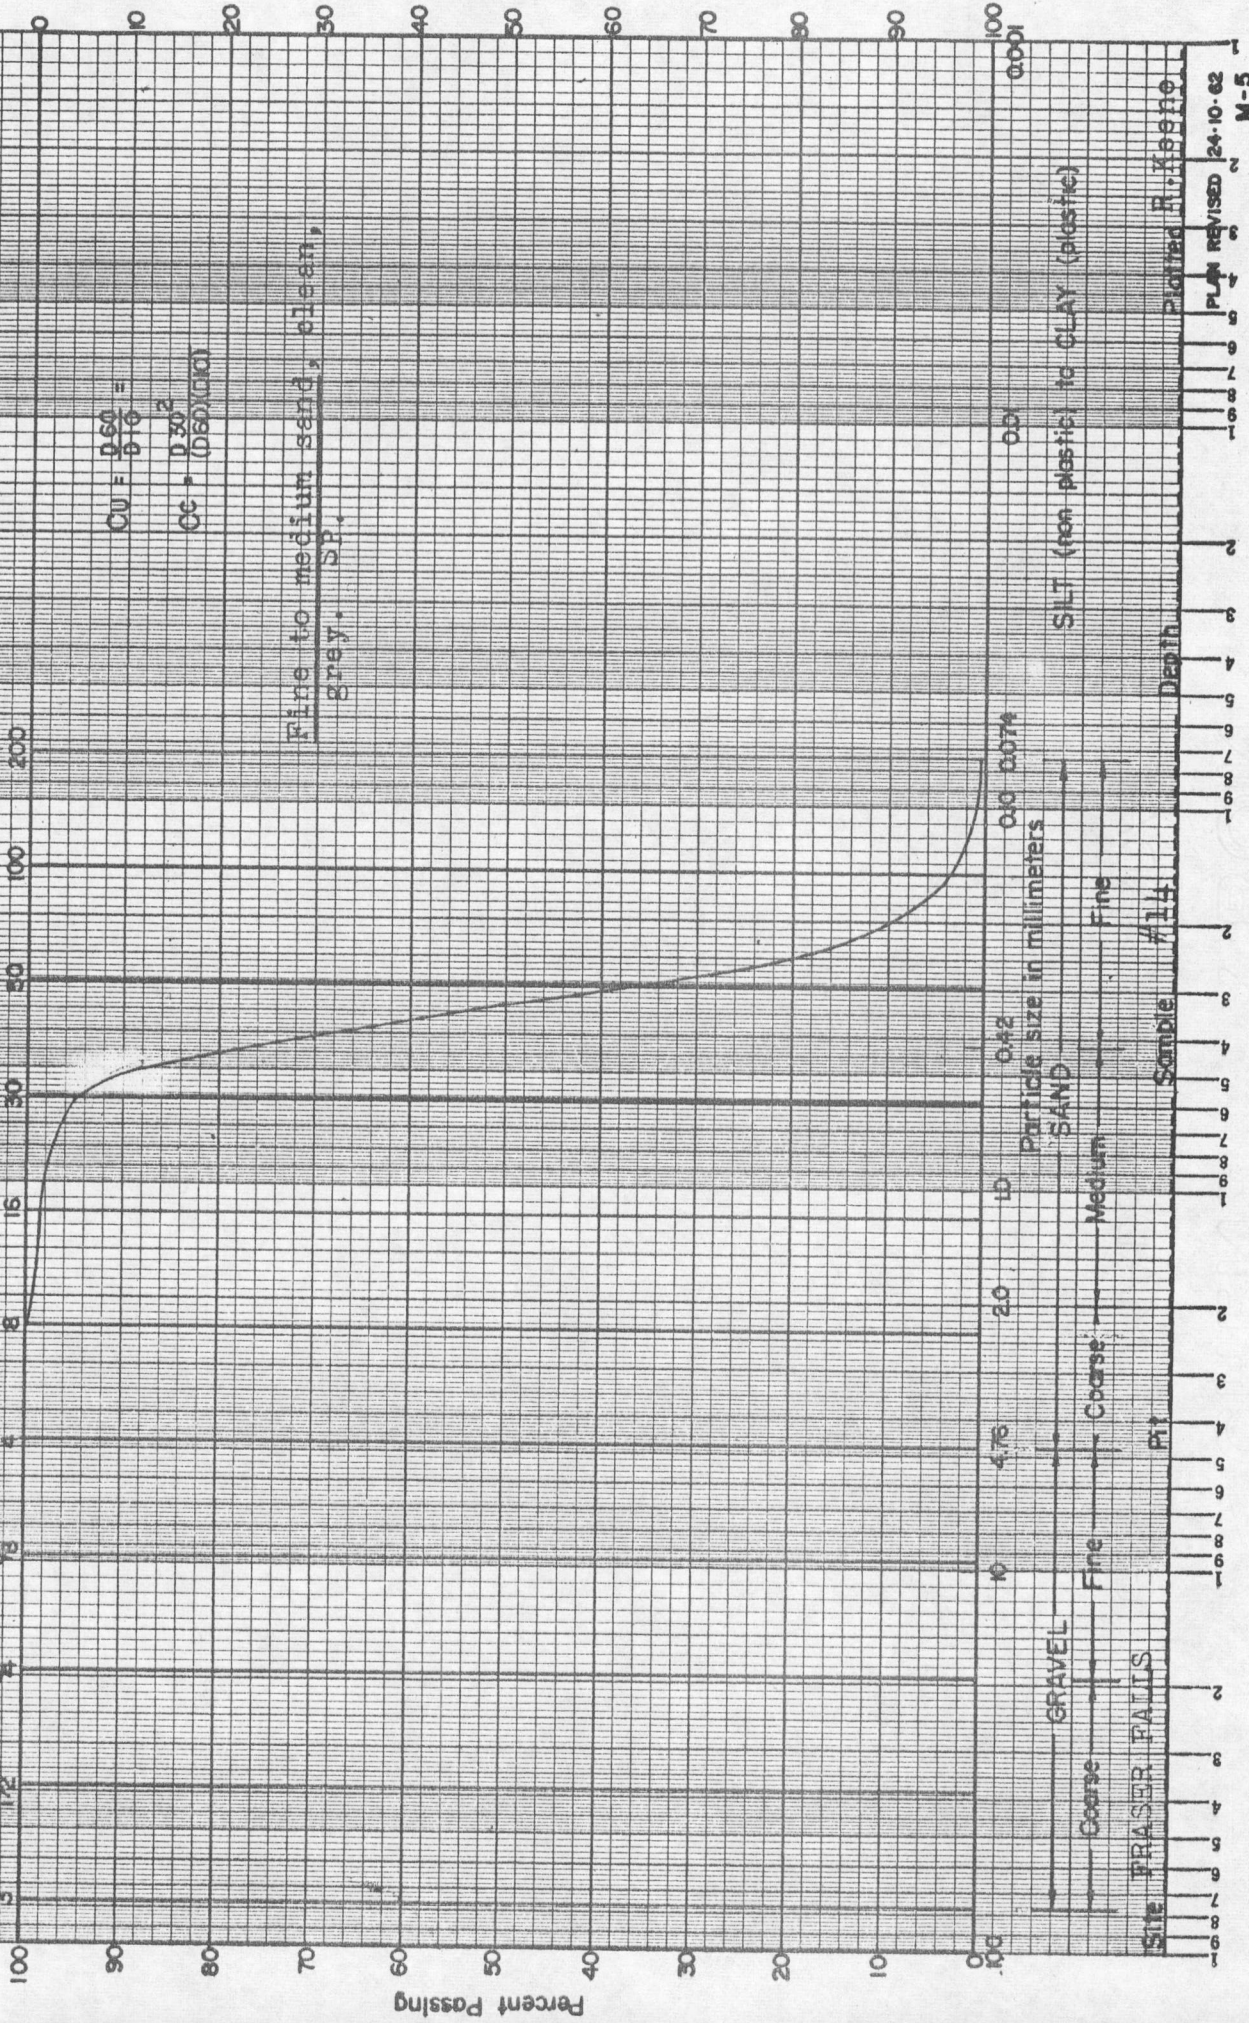
L-7

Fine to medium sand, clean, grey, SP.

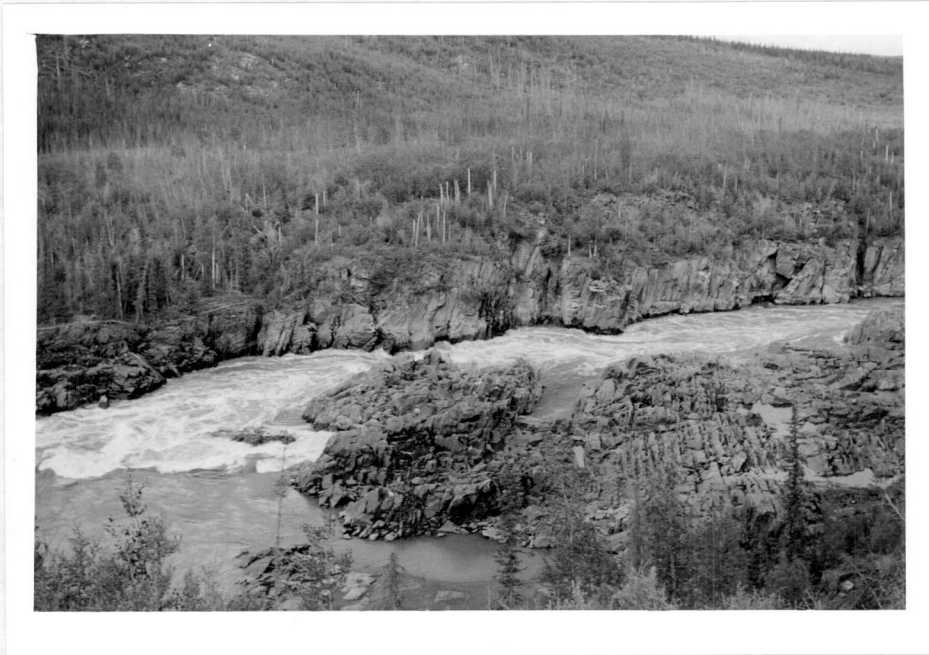
Plate 2

Along the left side of the river a bedrock bluff rises almost vertically from the river to a height of about 60 feet. Above this bluff a gently sloping, alluvium-covered, bedrock terrace extends west to the toe of a steep, rocky bluff which rises beyond the limit of the area mapped. The proposed dam would extend across the terrace to this bluff in which the right abutment would be located. The bluff is covered chiefly with talus although till occurs on its upstream end.

View from right abutment showing vertical, 50-foot high, rock bluff along left side of gorge.

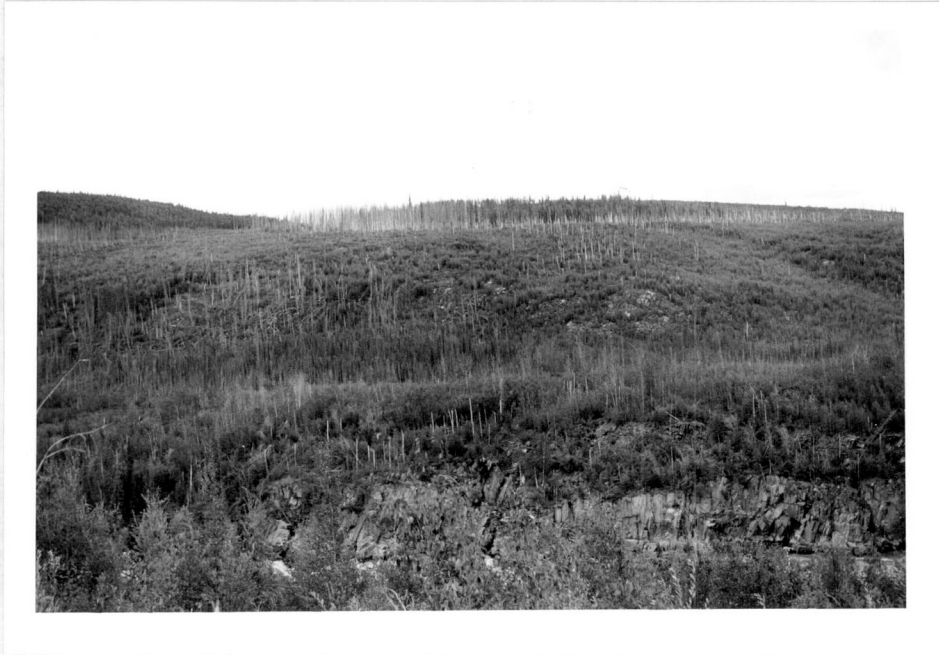
Plate 3

View of left abutment area from right abutment showing bedrock terrace extending west from left side of river to toe of abutment.
