# Shakwak Highway Project Environmental Assessment Update

Km 1664.5 - 1788.5 Alaska Highway #1

Volume I, Main Report & Technical Appendices

February, 2000

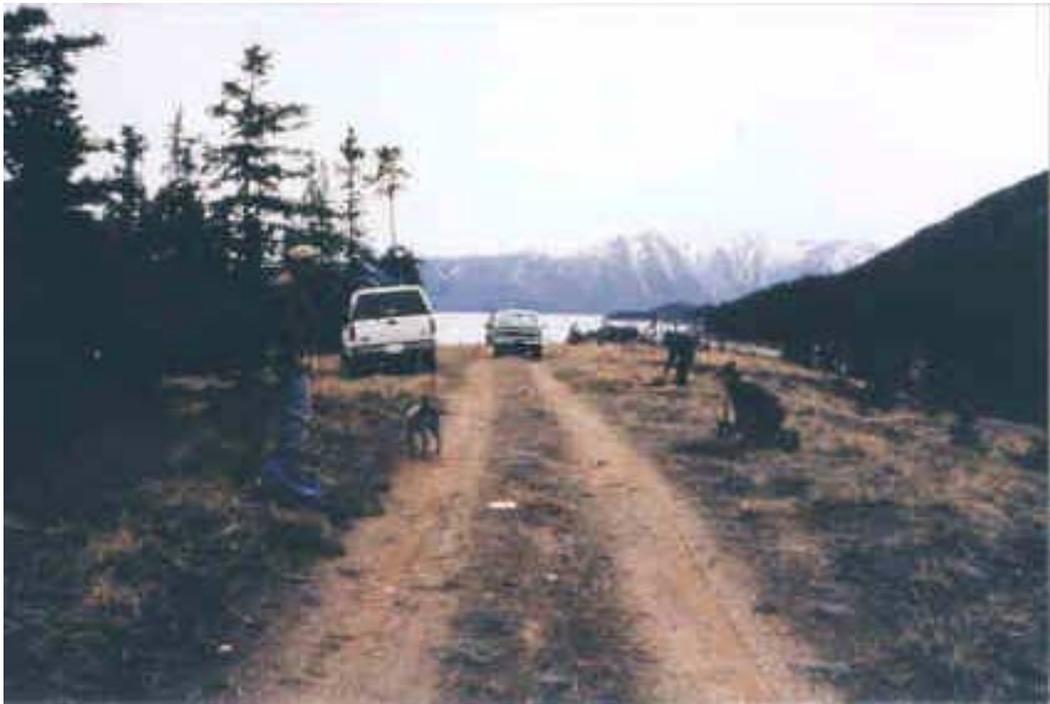
**Plate 6.** HR-23: Crew excavated test pits at destroyed archaeological site JgVp-2.

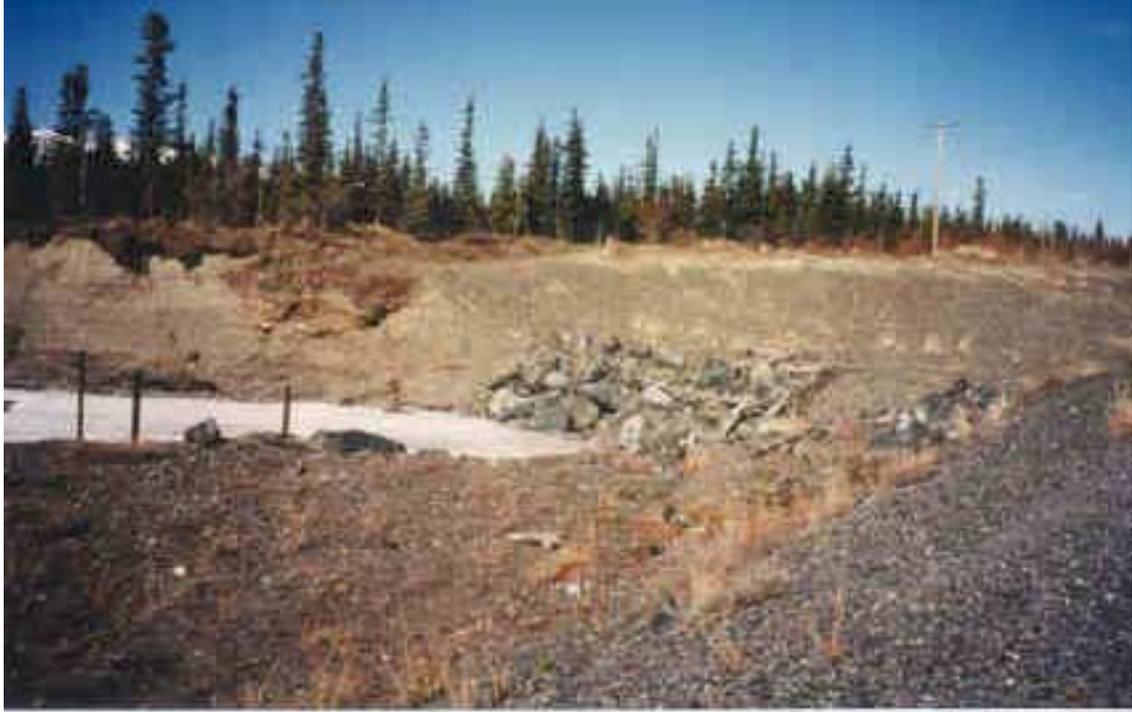
**Plate 11.** HR-37: Recent disturbance at Copper Joe Creek where JhVr-3 once existed.

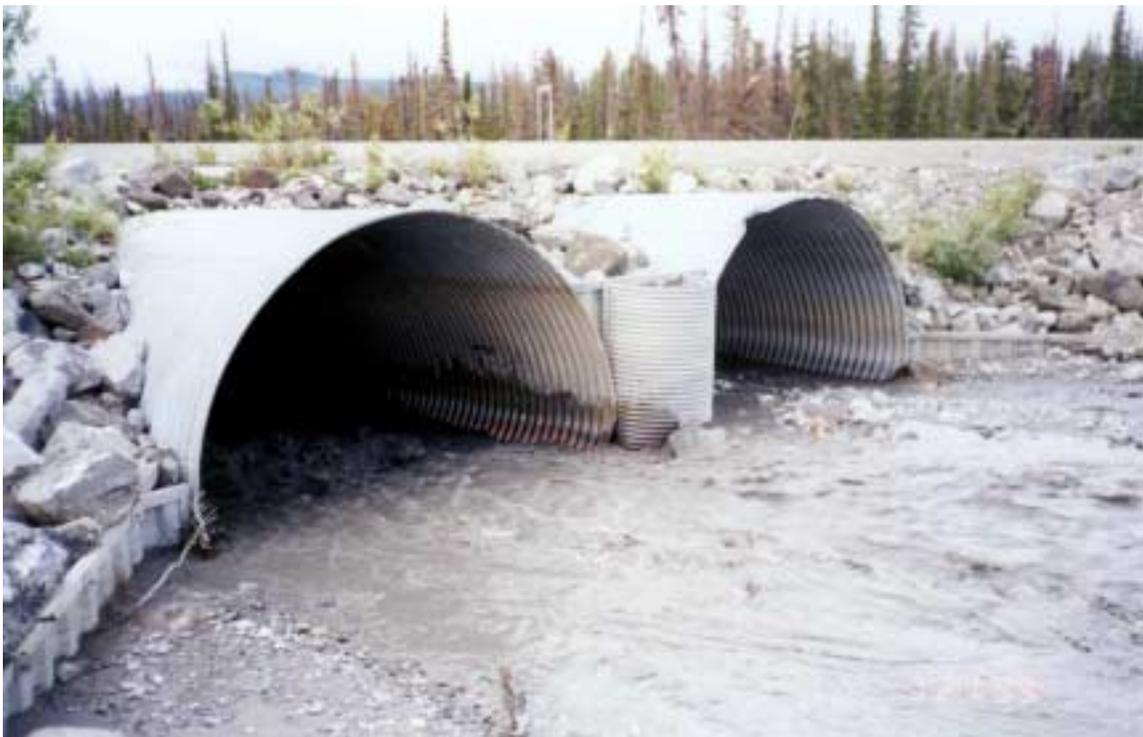
Silver Creek culverts inlet with steel sheeting headwalls, semi-circular central pier. Note water drop at inlet on left.

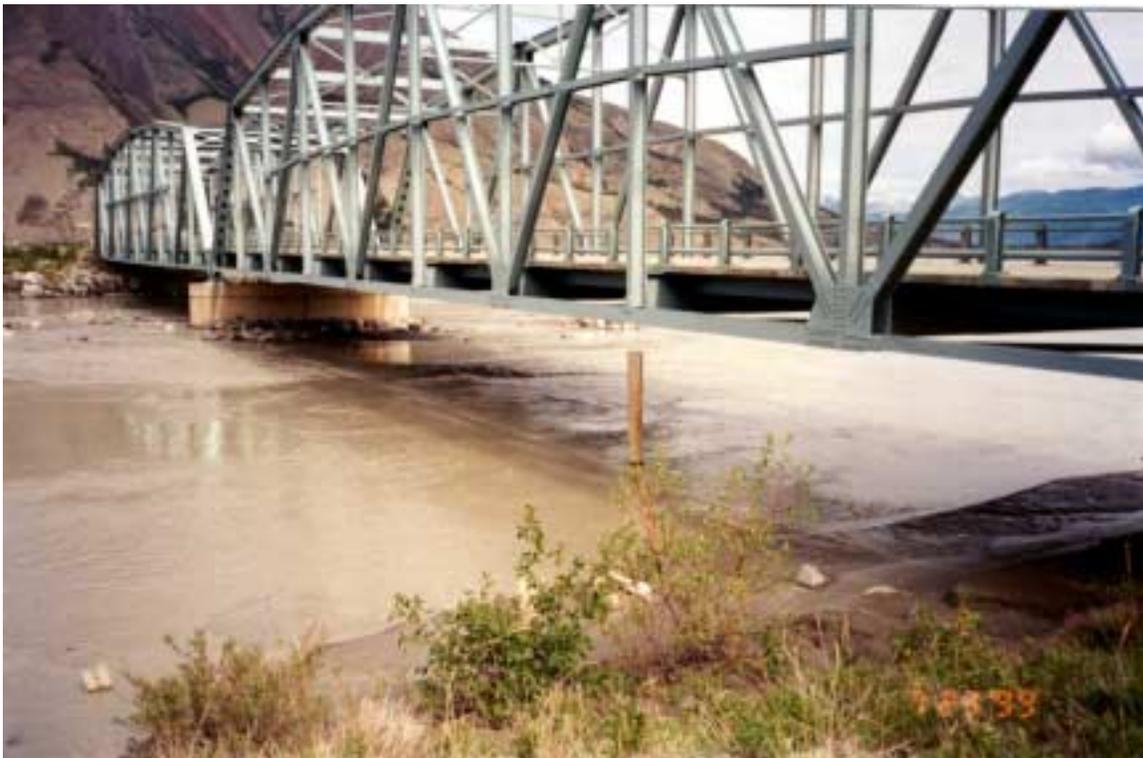
Slims River bridge upstream from right abutment. Note riprap around central pier and within left (far) bridge opening.

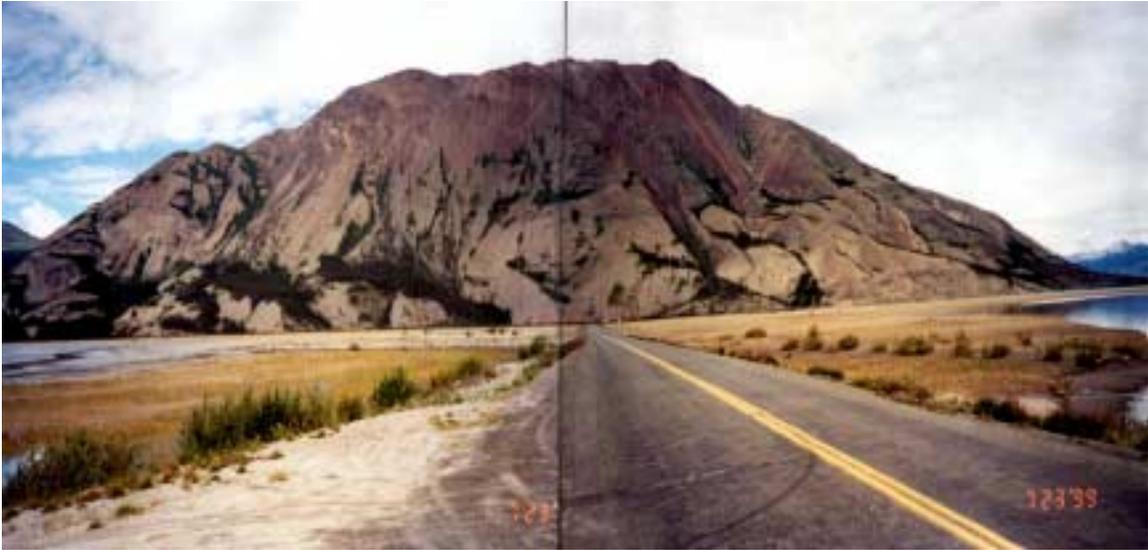
Sheep Mountain looking west from Slims River bridge. Upstream training groynes on left. Note debris chute and colluvial fan deposit right of causeway, unstable slope right-centre, and landslide deposit far right along existing highway on north shore.

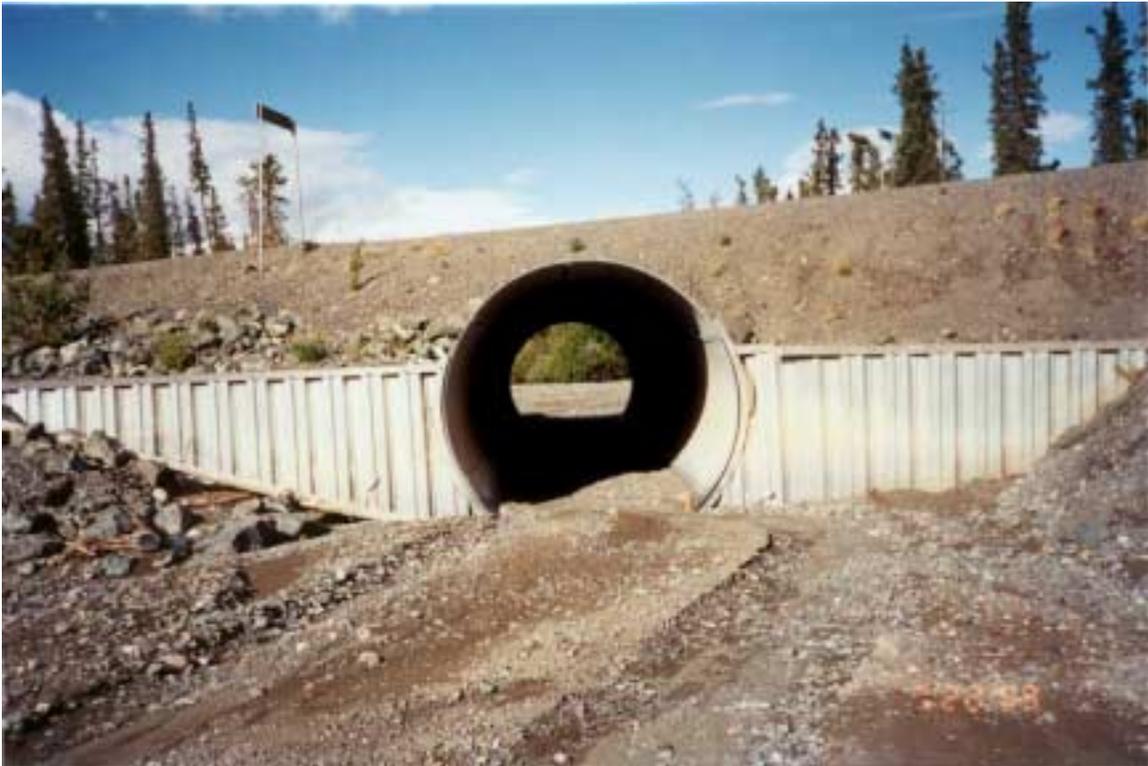
Congdon Creek culvert inlet. Note minor bedload deposition, sand with gravel.

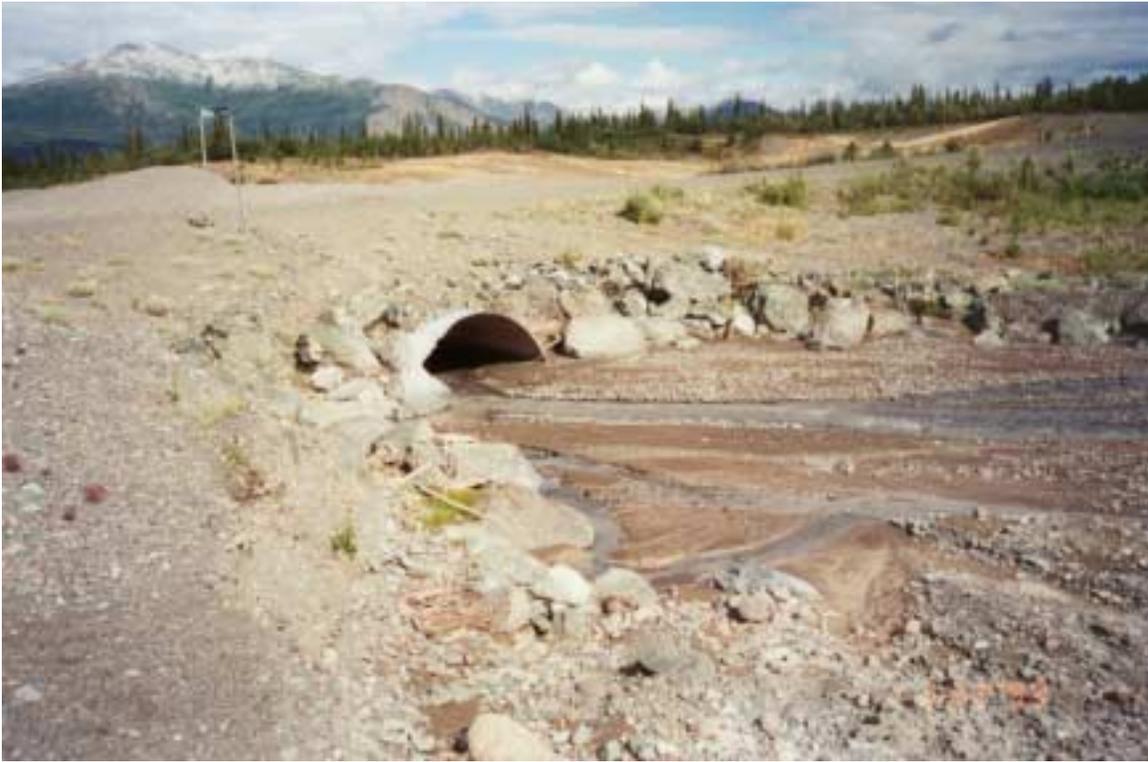
Mines Creek culvert inlet with severe sediment aggradation. Culvert could be 4300mm to 4600mm diameter circular or pipe arch with 4370 to 4570mm span and 2870 to 3070mm rise

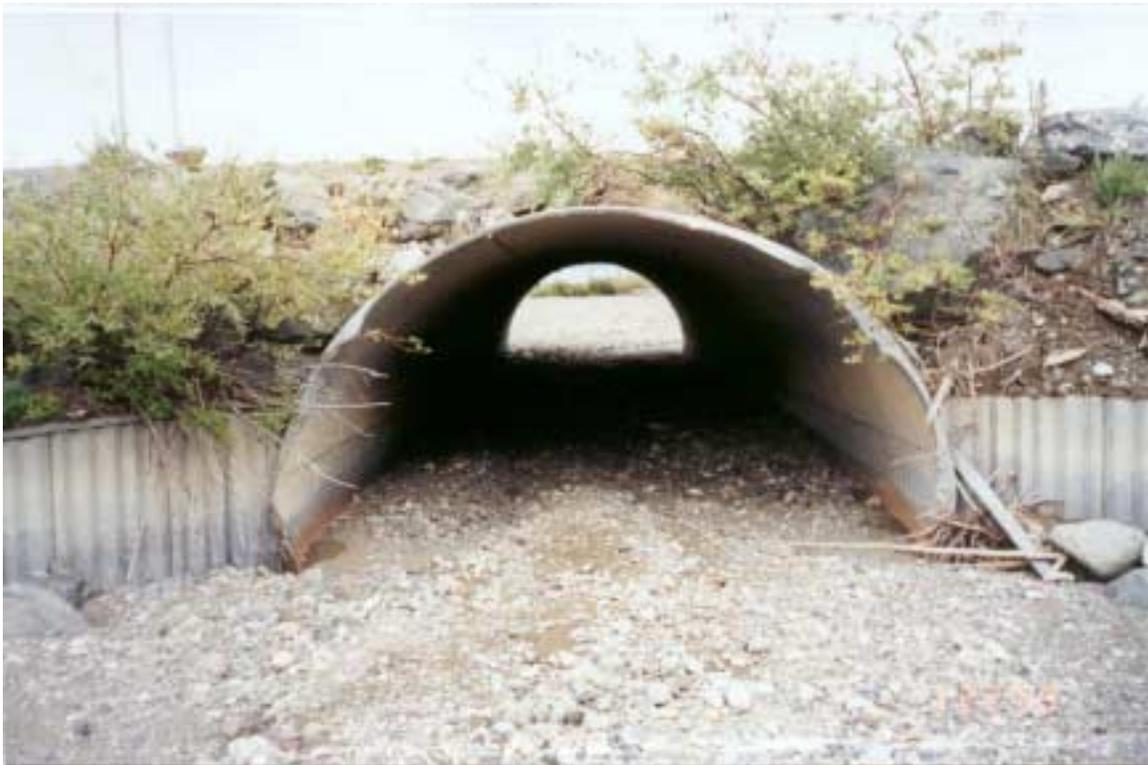
Bock's Brook looking downstream through culvert. Note extensive sediment deposition.

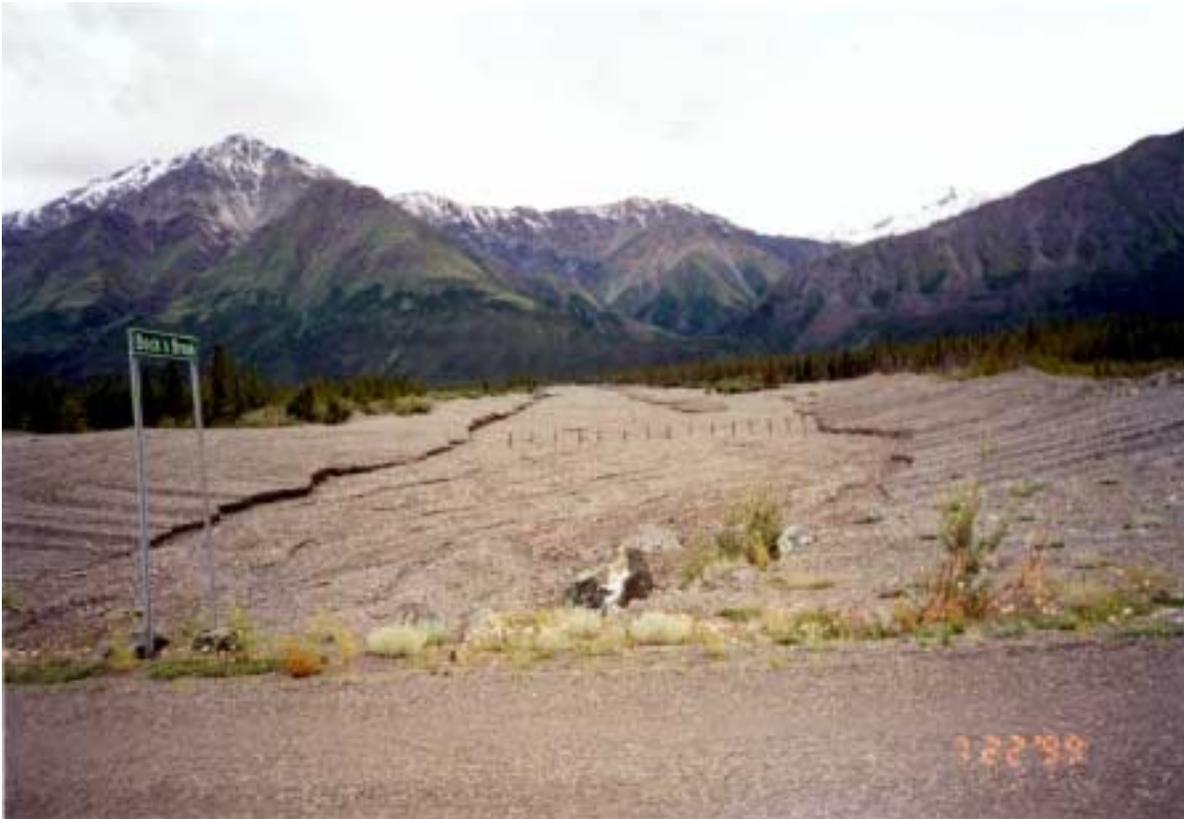
Bock's Brook looking upstream from highway. Note push-up dykes both sides, log-catcher angle irons across channel.

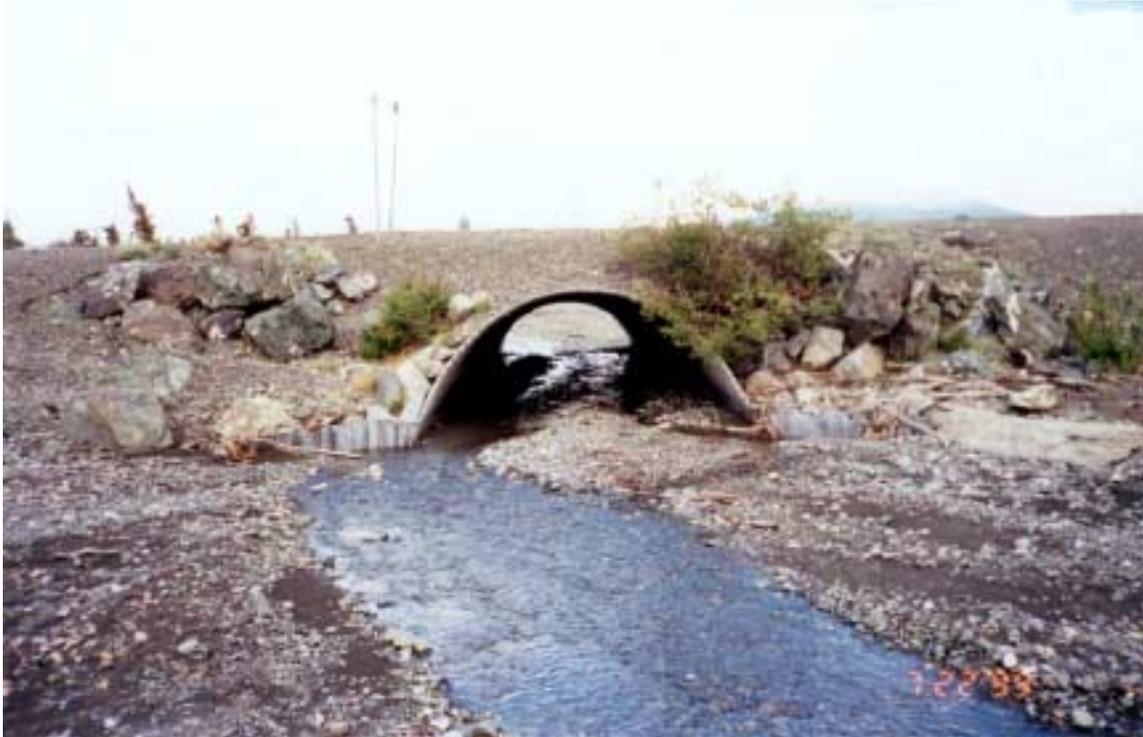
Lewis Creek looking downstream to multi-plate culvert inlet. Note severe bed aggradation. Culvert may be 4720mm span x 3070mm rise pipe arch or 4610mm diameter circular pipe.

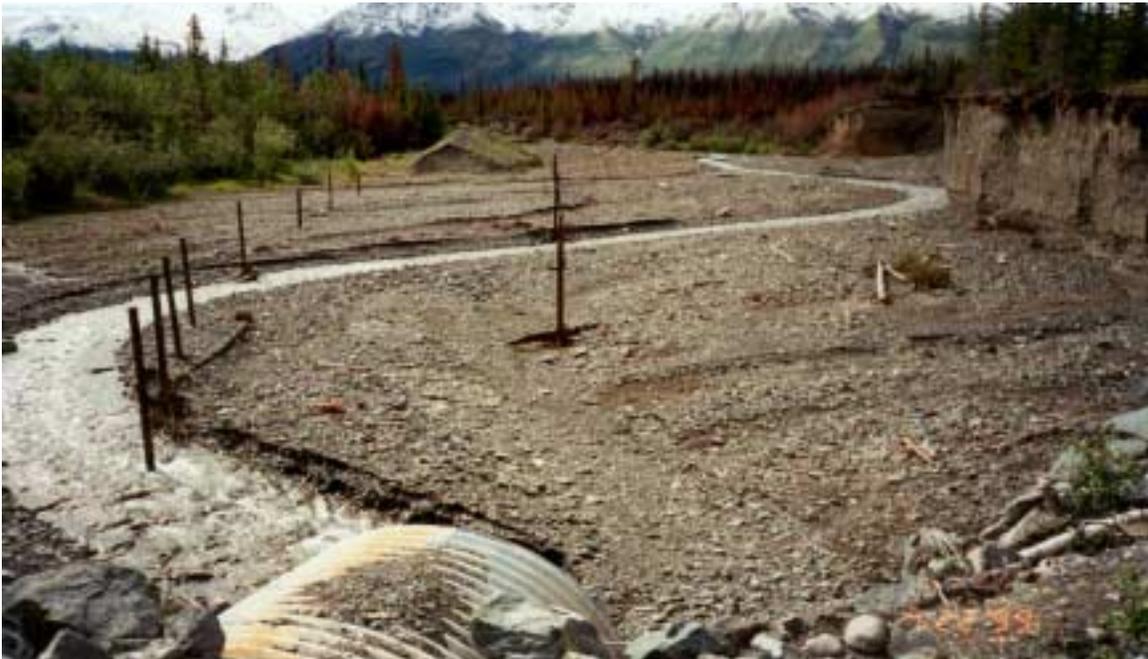
Copper Joe Creek looking upstream. Note angle-iron log deflectors and eroding left bank on right of photo.

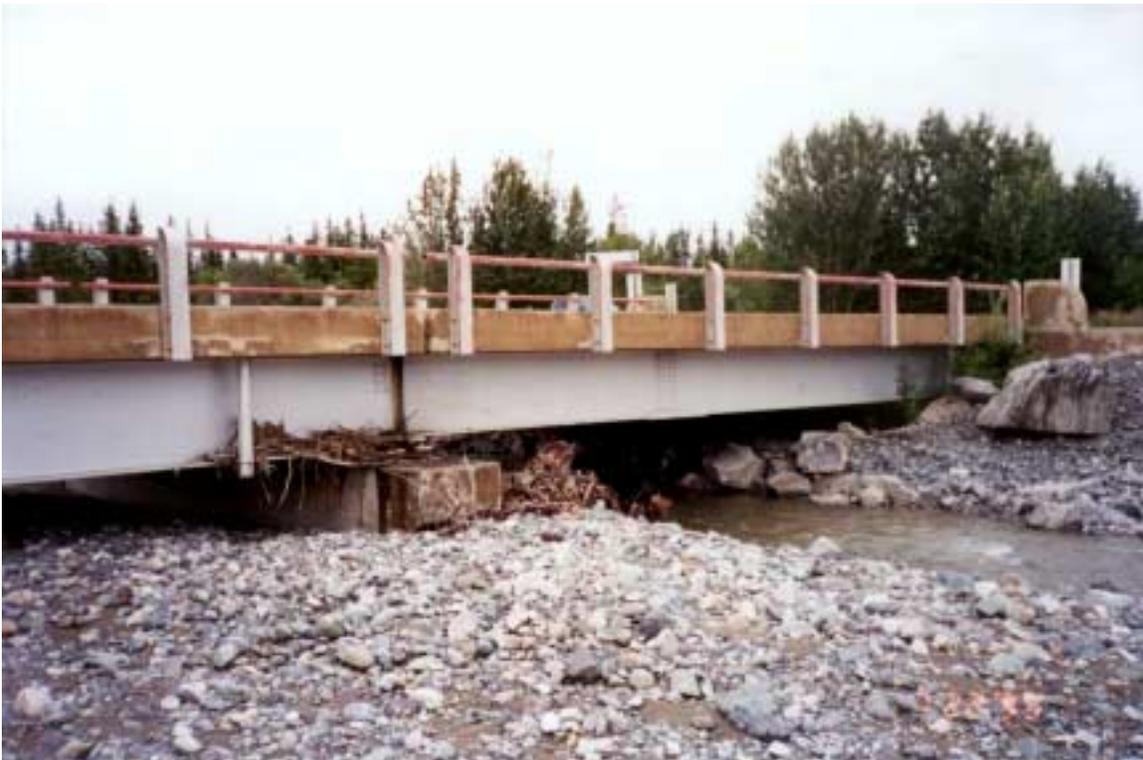
Burwash Creek bridge looking downstream at right abutment and right mid-channel pier. Note severe bed aggradation around pier.

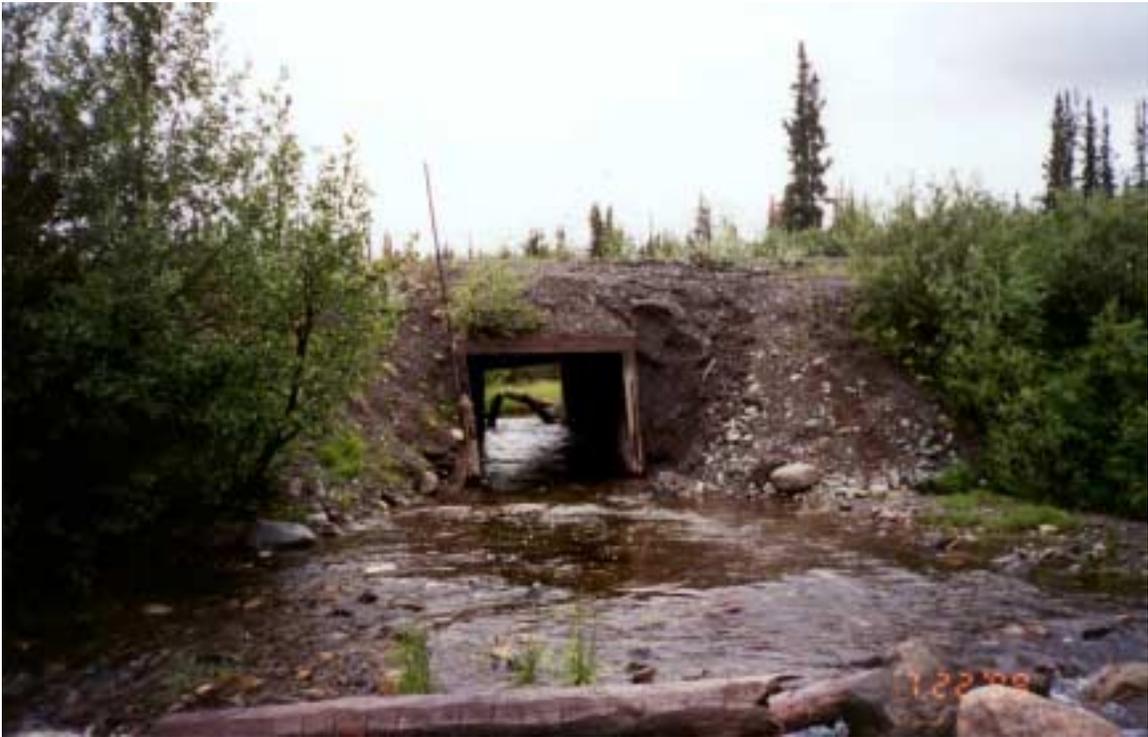
Sakiw Creek culvert looking upstream at outlet. Note fill slumping and sag in culvert crown.

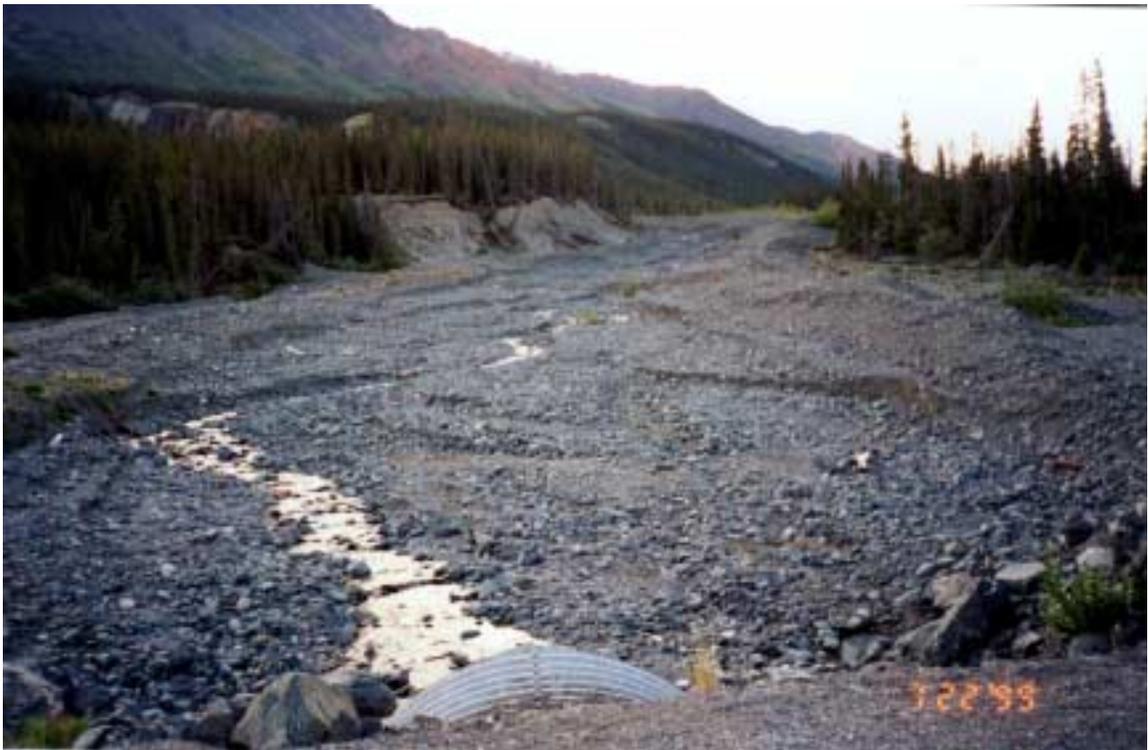
Williscroft Creek looking upstream at culvert. Note sharp bend in approach channel at upper centre/right of photo, bank erosion, large size of channel paving material.

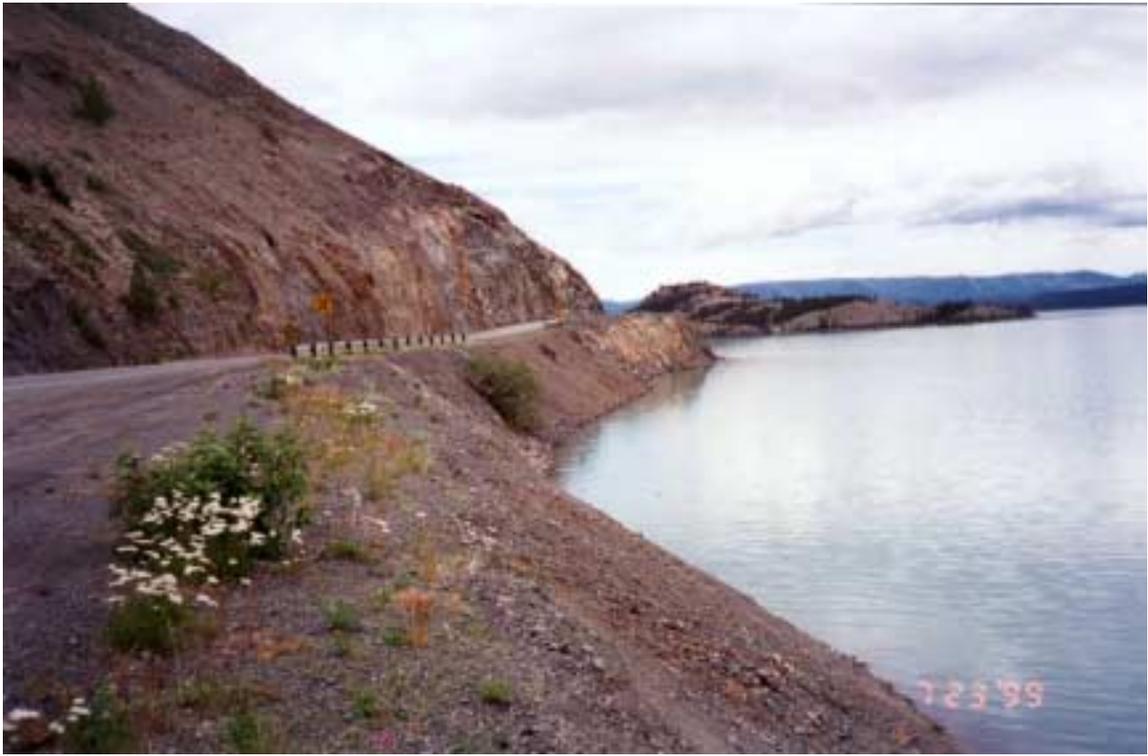
Kluane Lake shoreline looking northeast towards start of Alignment "B1". Note the lack of vegetation along the shore and potential for rockfalls from above the highway.
