October 2, 2009

Document No. 07-1413-0077 Doc. No. 124

ANNUAL INSPECTION – AUGUST 13, 2009 CARMACKS COPPER PROJECT CARMACKS, YUKON

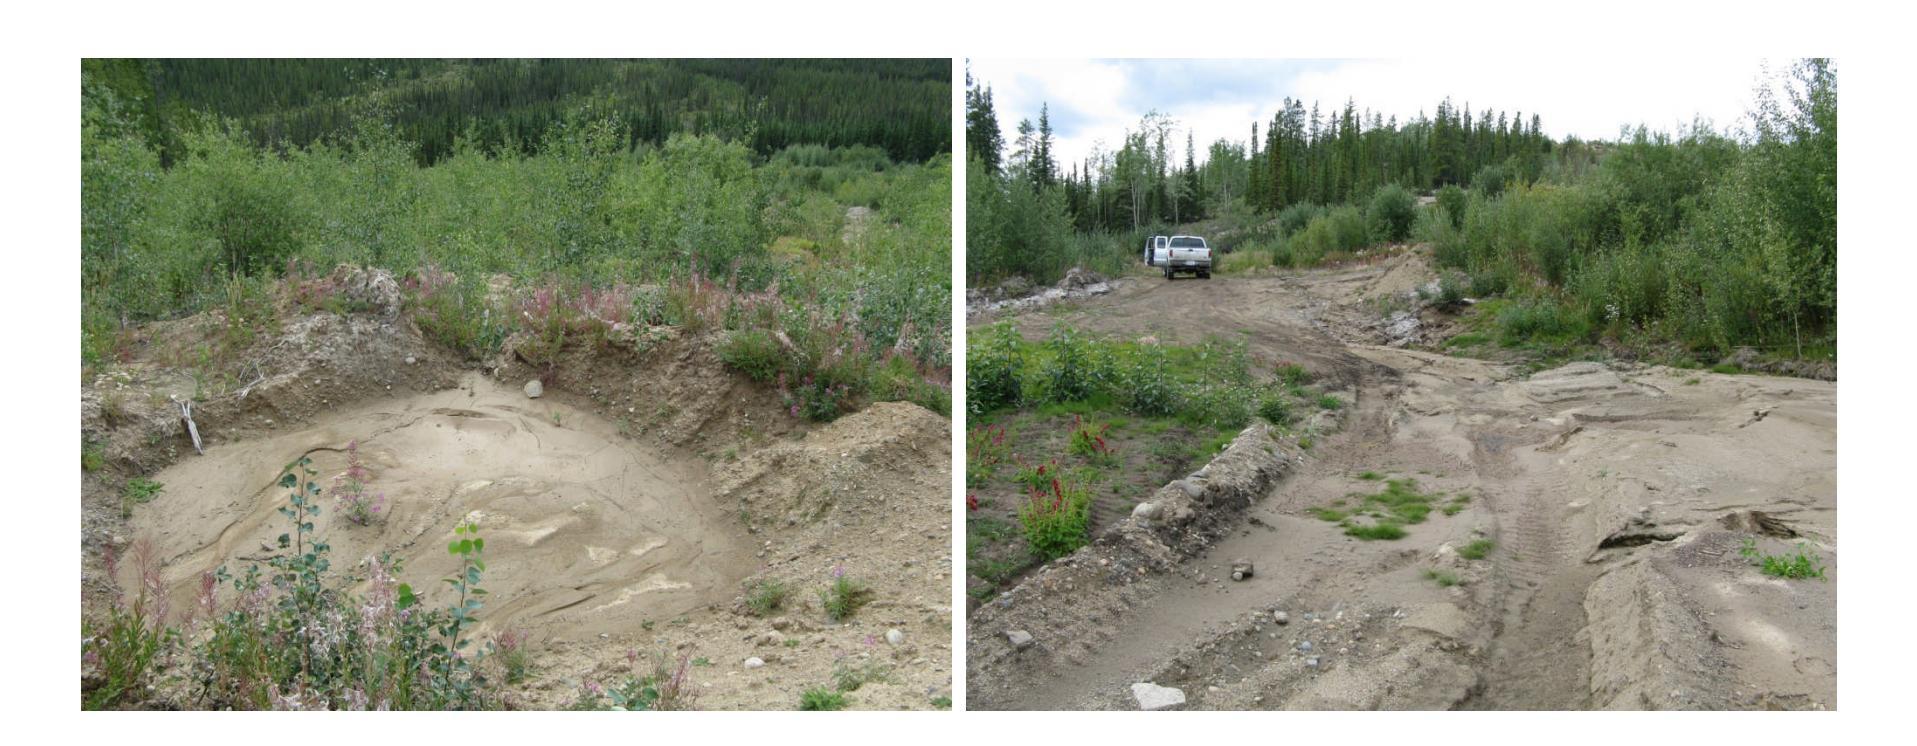
Description: Sediment basins full of sediments, near the proposed HLF sediment pond and Events Pond

The general site development has not started yet so there are no permanent water diversion structures in place. There are however, water management diversion structures (i.e. ditches and sediment catch basins) in place that are appropriate for the exploration stage of the operation Minor erosion was observed along some of the site access roads and in the cleared area of the future events pond. Mitigation of these areas was completed in September 2009 and is considered adequate at this time.

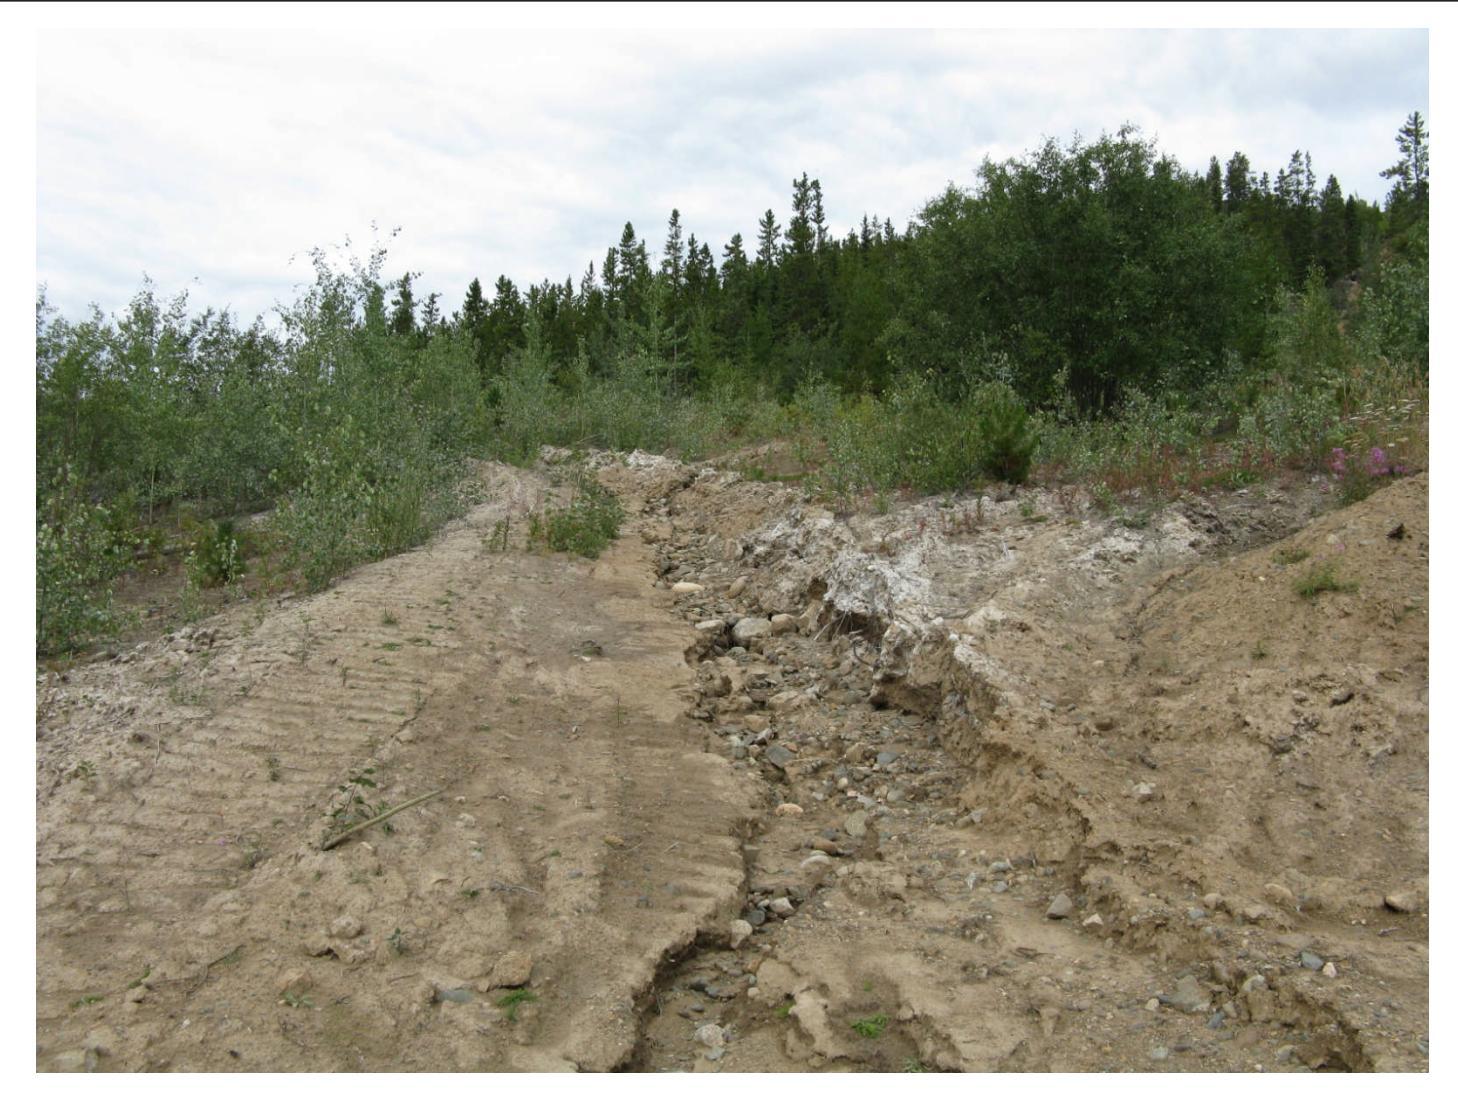
Golder		CARMACKS COPPER PROJECT SITE INSPECTION		
Drawn: JU	App'd:	Date: August 13, 2009	Figure: 2

Description: Erosion on road in proposed Events Pond area Date of Photograph: August 13, 2009

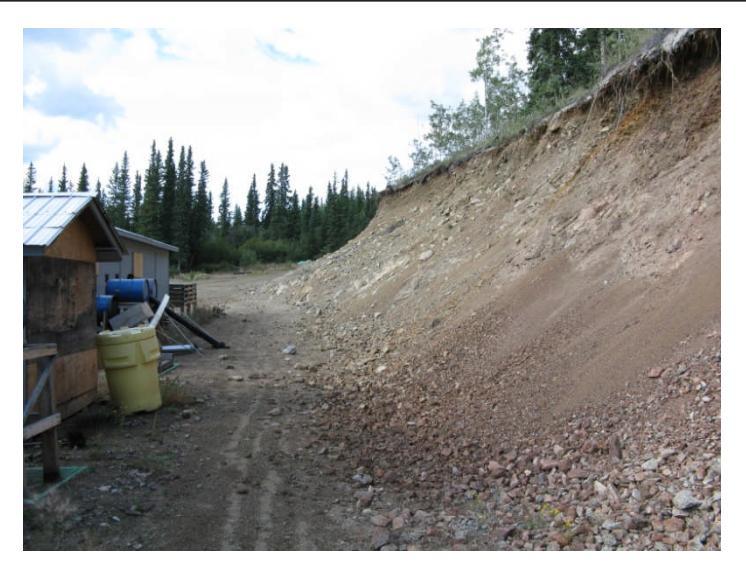
The inspection of the camp area indicated the camp is well maintained and there is no erosion of sediments from the pad area into the surrounding natural area. The slope behind or west of the camp is stable and is not impacting or causing any safety issues with the camp structures or operations. There is minor slumping of small sections of the slope, but these are not impacting camp safety nor would they represent an issue to workers on the project.

Slope Behind Camp Area

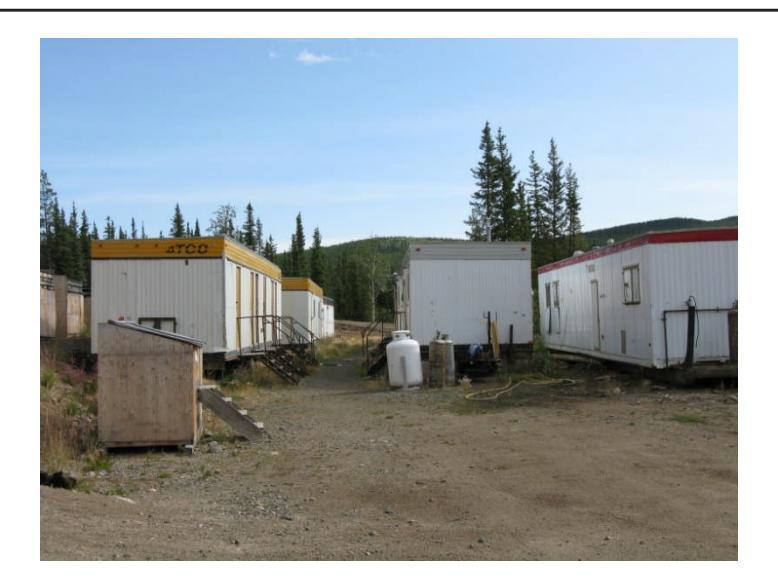
Exploration Camp Infrastructure

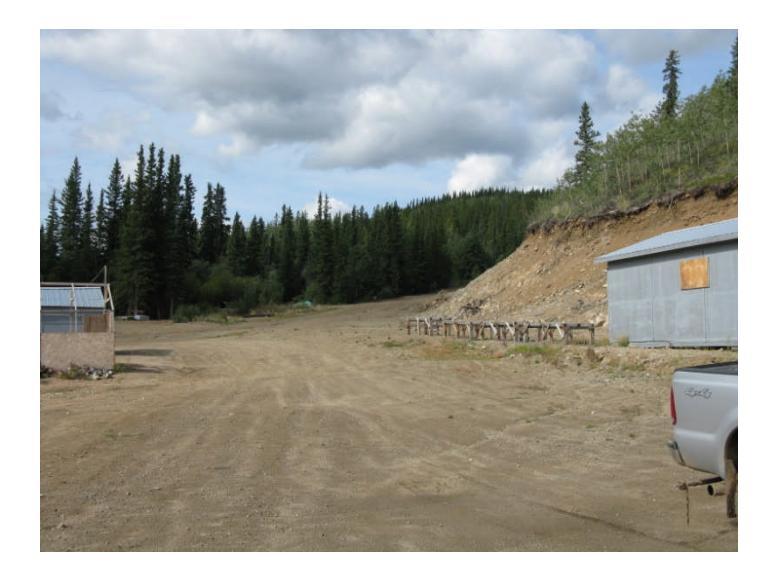
Camp Area

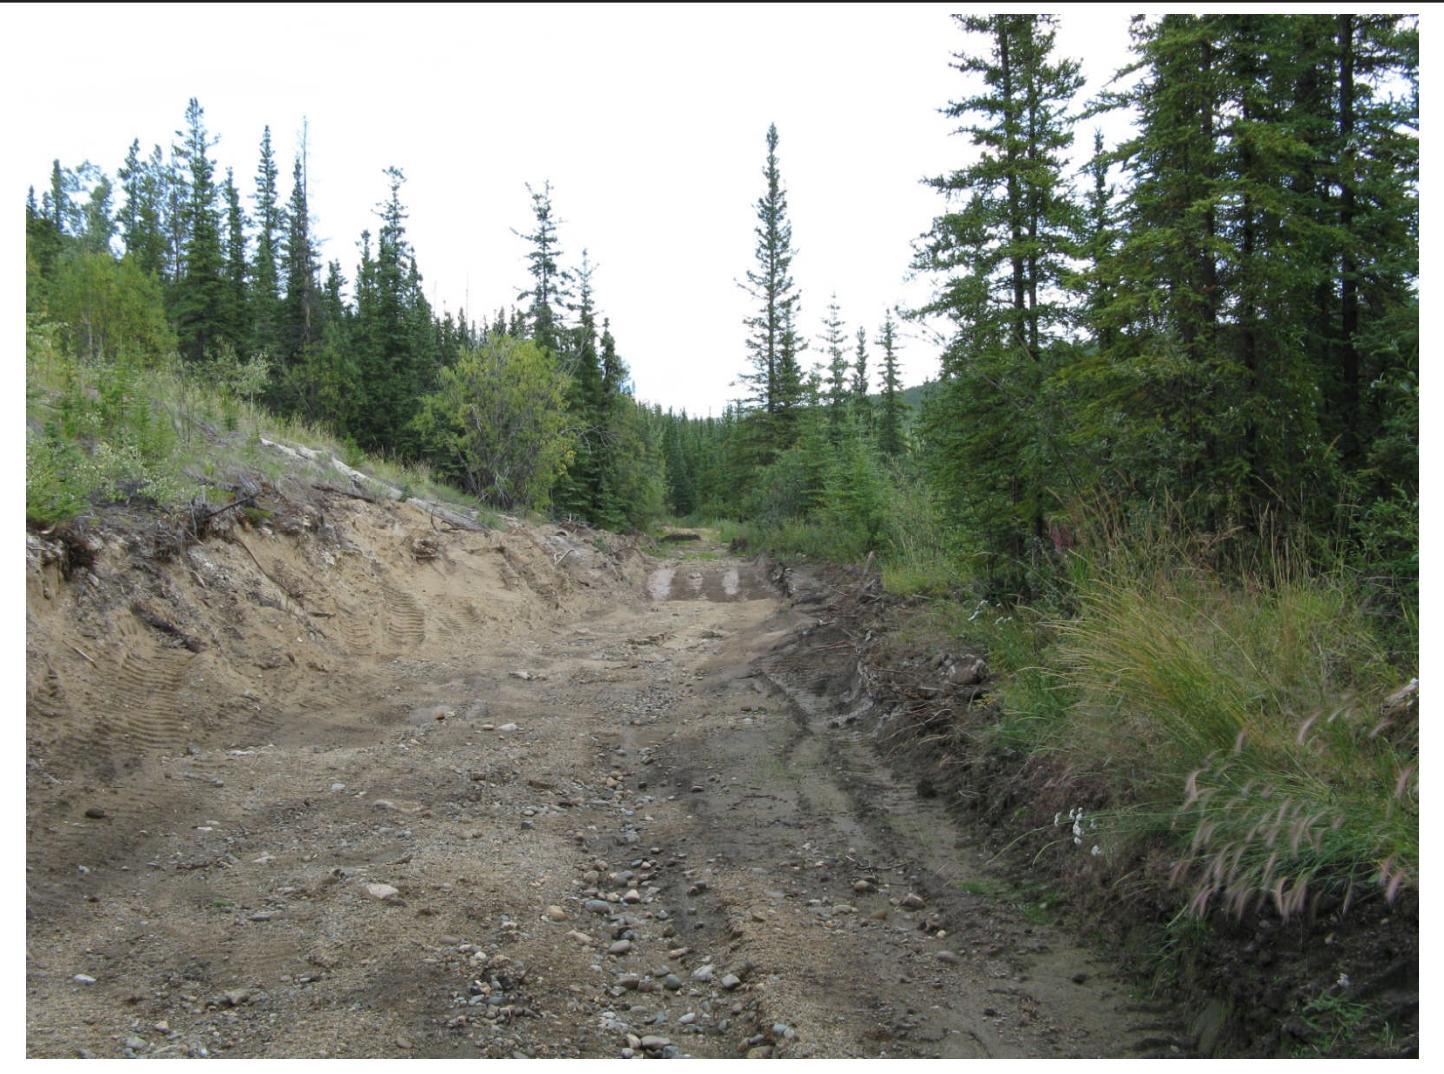
Description: Internal Road Date of Photograph: August 13, 2009

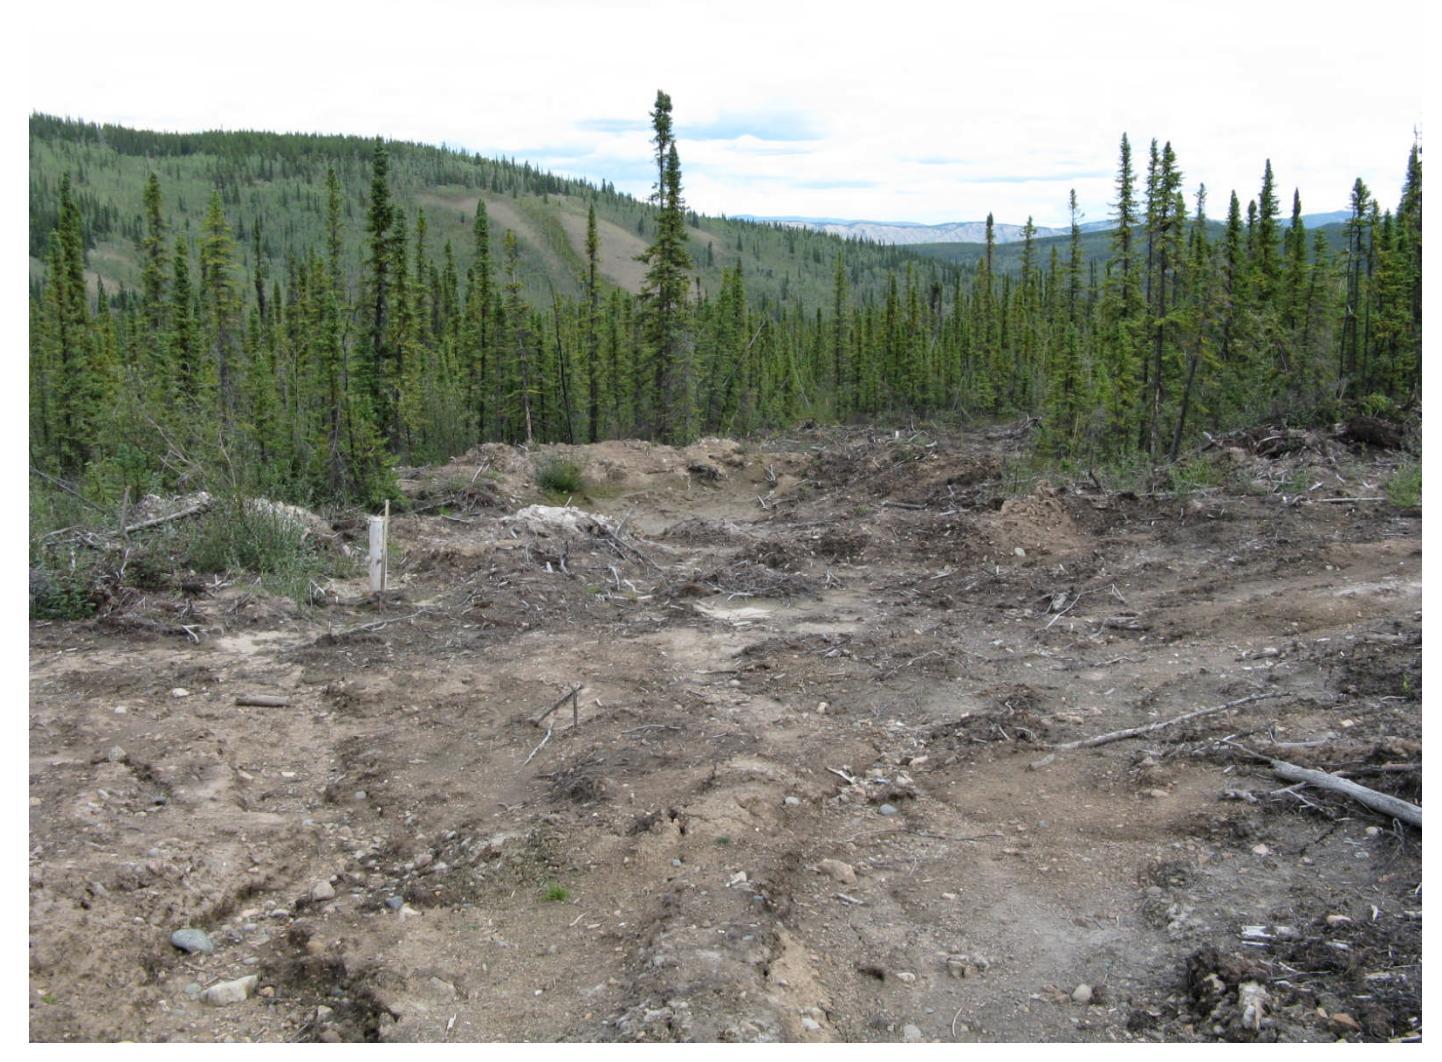
The area of the proposed waste rock storage area and the present access road crossing at North Williams Creek were inspected. The waste rock storage area is still tree covered and the drill pads in the area of the proposed waste storage area did not have any signs of sediment movement into the surrounding area. The small sediment catch basins at the drill pads still have capacity to manage more sediment, if required.

Description: Waste Rock Storage Area Date of Photograph: August 13, 2009
