CASINO MINING CORPORATION CASINO COPPER-GOLD PROJECT

TERRAIN HAZARDS ASSESSMENT FOR PROPOSED MINE SITE

VA101-325/8-3
Rev 0
April 13, 2012

TERRAIN HAZARDS ASSESSMENT FOR PROPOSED MINE SITE (REF. NO. VA101-325/8-3)

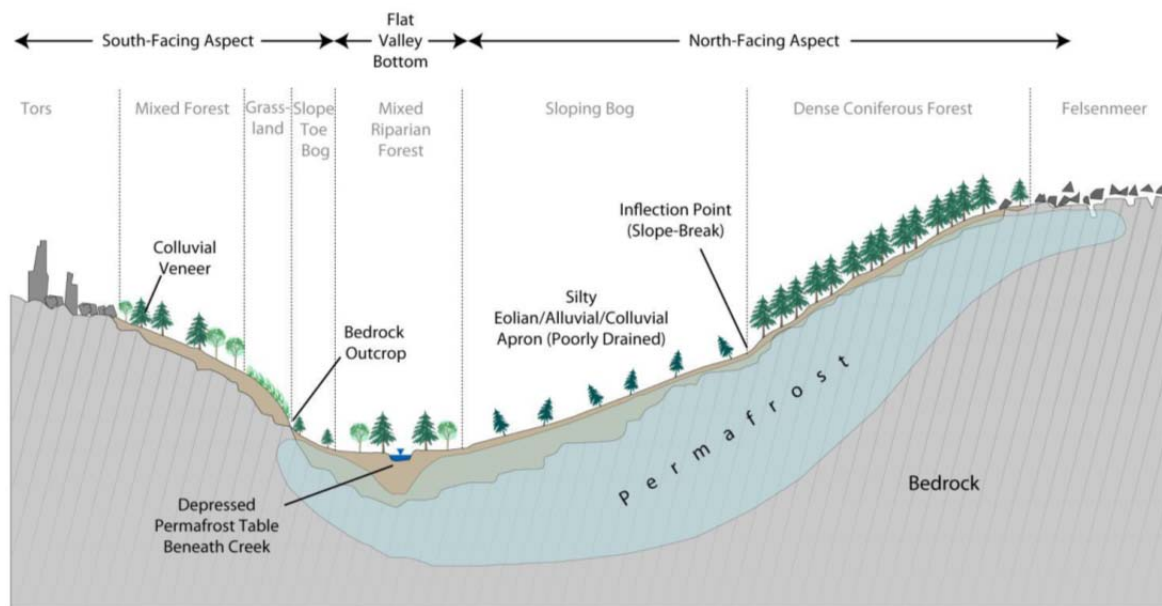
The key features of the model are:

- The 'sheltered' north-facing slopes have a shallow permafrost table. Sheetwash and solifluction occur during seasonal melting within the active layer in these slopes and result in colluvial soils

- The south-facing slopes have a deeper permafrost table or are free of permafrost. Permafrost-related processes are far less prevalent on these slopes and the surficial soils tend to be better drained.

- There is a depressed permafrost table associated with the main watercourse on the valley floor.
- The valley profile is distinctly asymmetric with shallower slope angles occurring on the north-facing slopes as a result of sheetwash and solifluction.

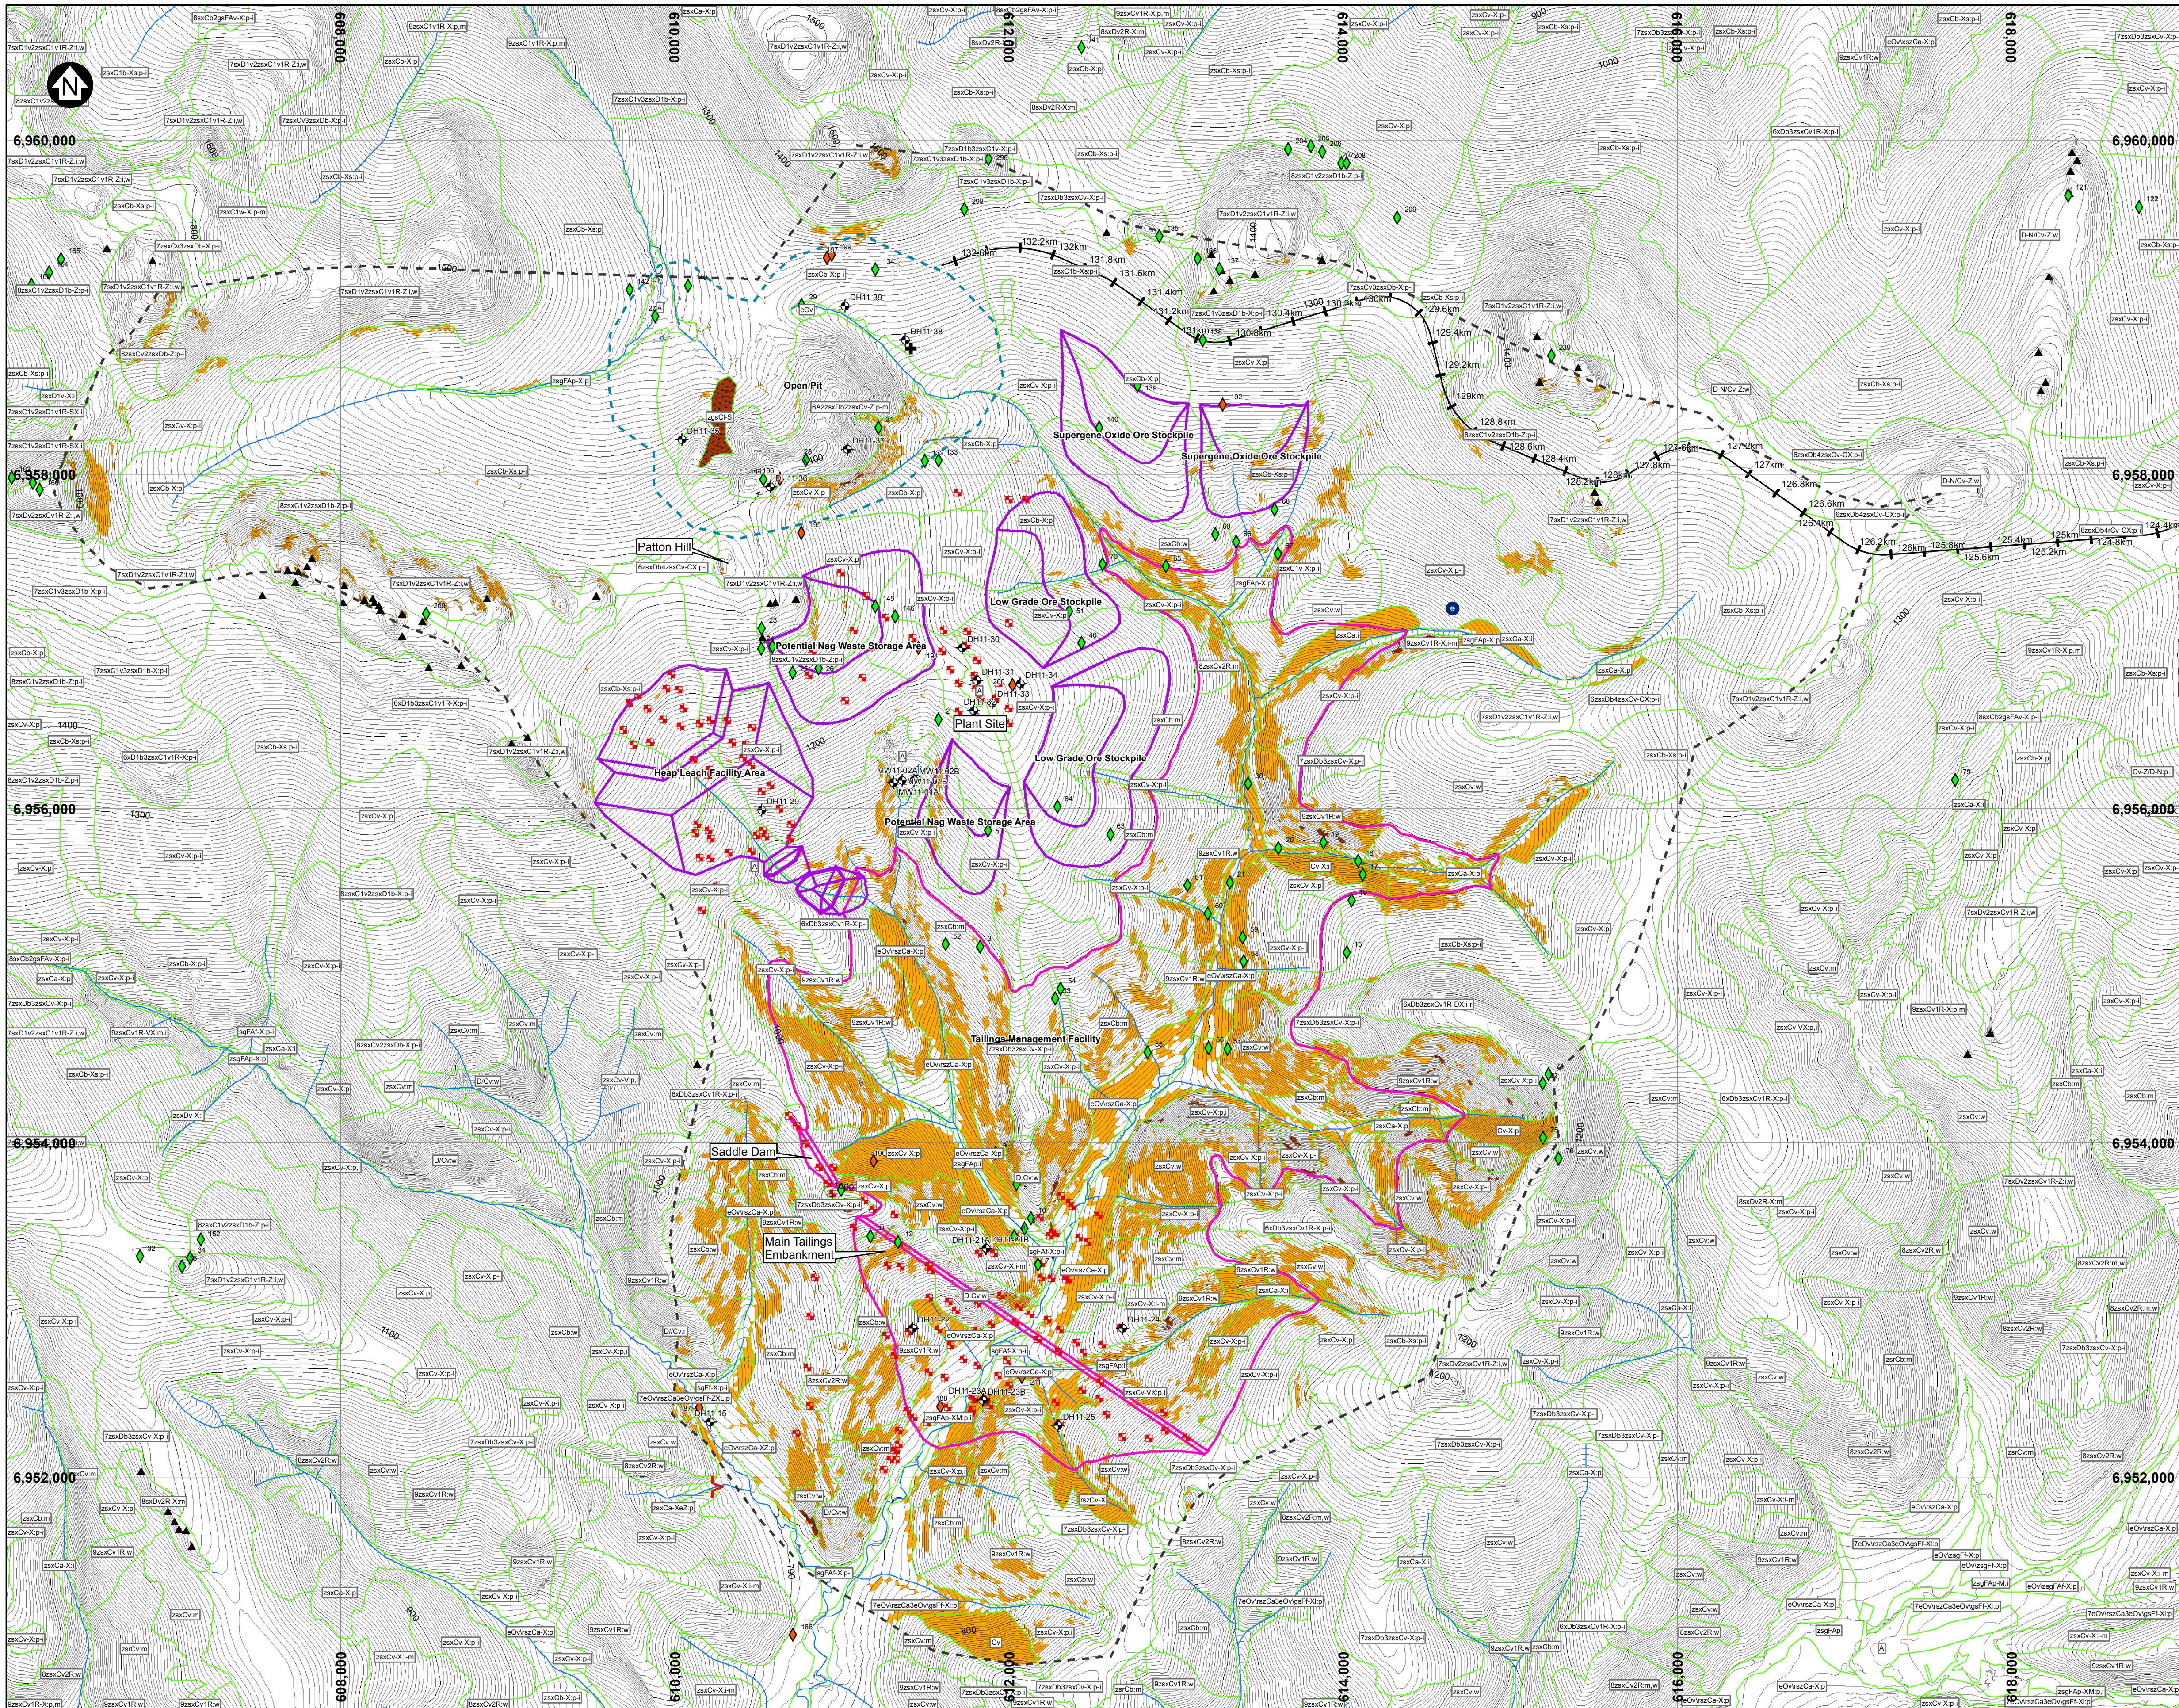
The findings of the mapping are presented in Figure 5. The preliminary geological/geomorphological model for the site, as described in Section 4, was developed further in the terrain hazards assessment. The key developments are highlighted below:

Permafrost is widespread but discontinuous in the northern Dawson Range (Bond and Lipovsky, 2011). The permafrost-related landforms identified in the Study Area are highlighted in Figure 5. It is interpreted that the permafrost table is generally close to ground level, within the Study Area. The main exceptions are expected to be the lower portions of the south-facing slopes and the areas in close proximity to the watercourses. In terms of the sites of the proposed facilities, the permafrost table was generally encountered at depths of approximately 0.5 to 2.5 m; the main exceptions were the colluvial slopes to the northwest of Casino Creek, where it was found, locally to be at a depth of greater than 4 m and the floor of the Casino Creek Valley, where the depth of the permafrost table was found to increase markedly in a southerly direction in the vicinity of the downstream toe area of the proposed embankment.

No 'recent' natural terrain landslides were identified within the Study Area. A possible solifluction lobe was identified in the footprint area of the proposed Open Pit, as shown on Figure 5. The solifluction lobe developed on a south-facing slope at an elevation of approximately 1400 m above sea level. The solifluction lobe was encountered in Trial Trenches 9053-C and 9076-D and was found to be approximately 0.35 m to 0.5 m-thick, comprising gravely sand with some silt.

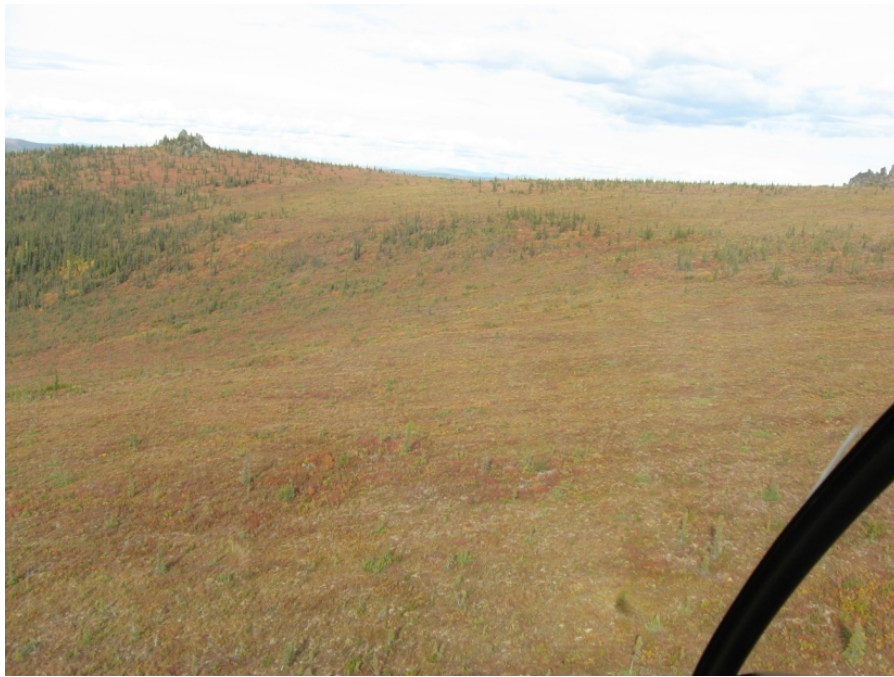
Tors occur locally in these settings, as shown in Photo 4. Tors are the remnants of frost-shattered bedrock. The tors are surrounded by blocky weathered bedrock, referred to as

PHOTO 4 – Hill top with Tors in the distance

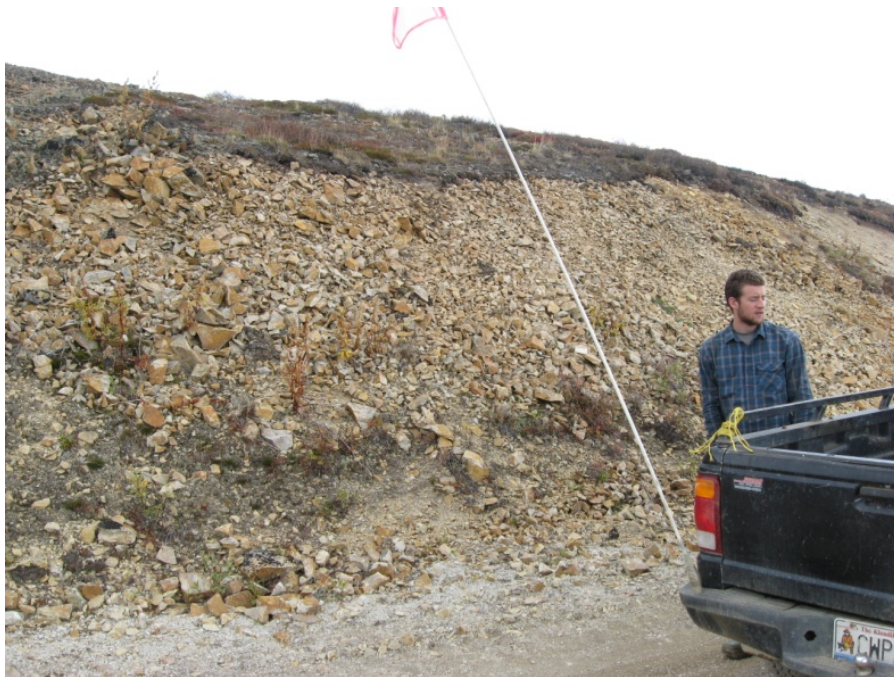
'felsenmeer'. The 'felsenmeer' was found to be several metres-thick at WP 196, located in a road cut at the site of the proposed Open Pit (Photo 5).

PHOTO 5 – ‘Felsenmeer’ at the site of the proposed Open Pit (WP 196)

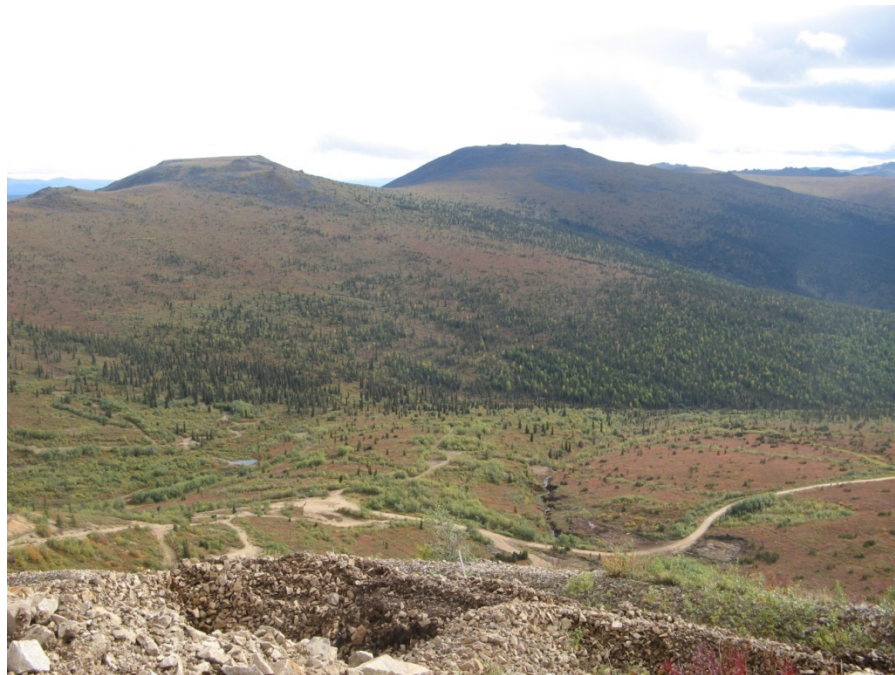
It is interpreted that extensive fine-grained loess deposits accumulated on some of the upland south-facing slopes in the north part of the Study Area, and were reworked over time, principally by sheetwash. The resulting colluvium in these areas tends to be silt-rich as it was derived principally from loess and is consequently susceptible to a shallow permafrost table with the possibility of massive ground ice. Ice-rich soils were encountered in Trial Trench 9063-B and Test Pit TP 94-5, which were undertaken at the site of one of the proposed stockpiles. Ice-rich soils were also encountered in Drillhole DH11-39 and Trial Trench 9076-D, undertaken at the site of the proposed Open Pit.

PHOTO 6– Thick Blanket of Re-worked Loess in the North Part of the Footprint of the proposed Open Pit

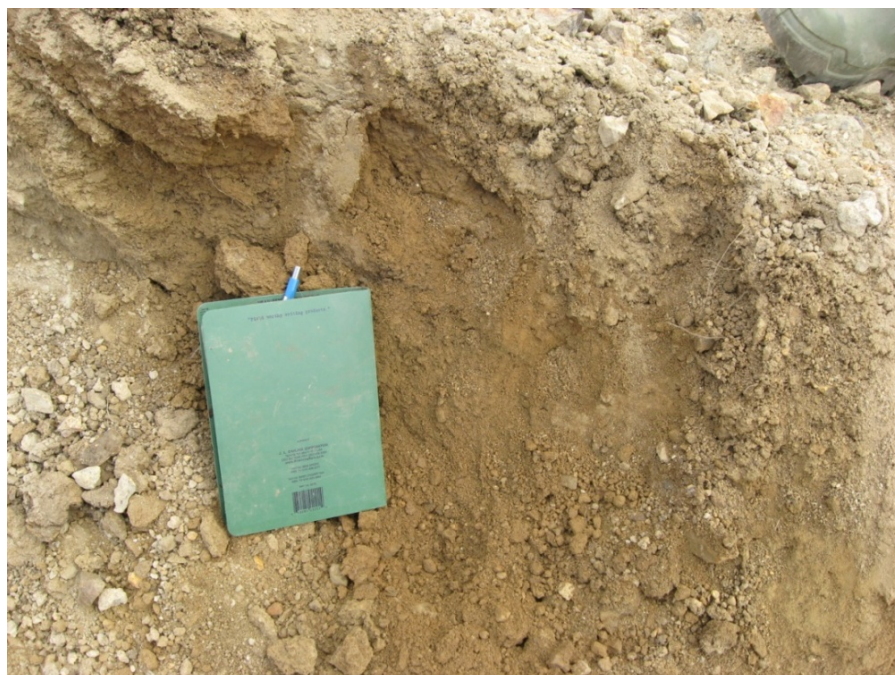
PHOTO 7– Loess Deposit (WP 199)

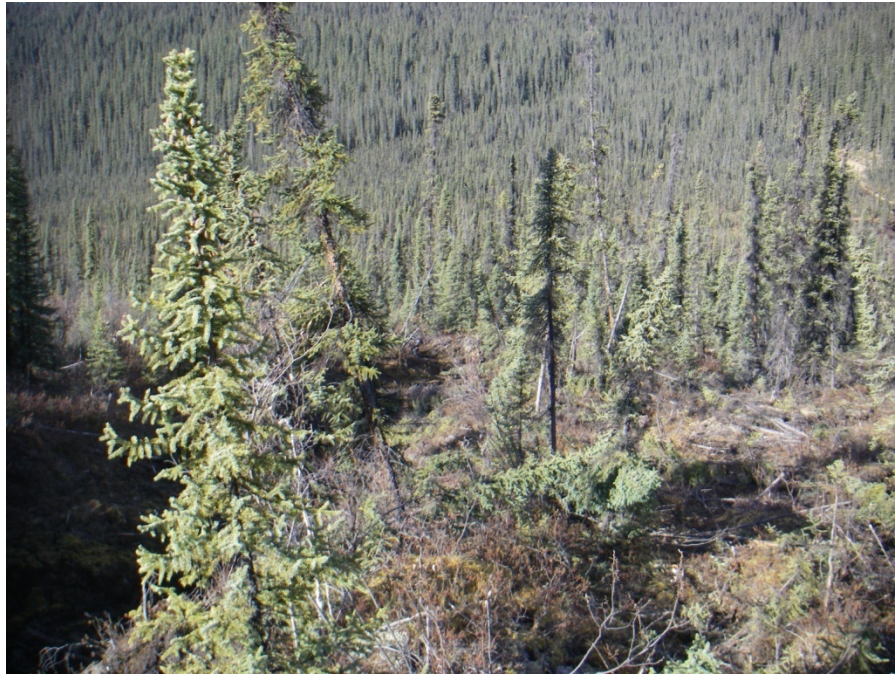
The presence of a thaw lake, adjacent to an access road at the site of the proposed Open Pit, provides possible local evidence of permafrost degradation due to anthropogenic processes. In addition, a thaw flow was observed on an access track where the vegetation had been stripped at the site of the proposed Tailings Embankment.

PHOTO 8 – Possible Thaw Flow at the Site of the Proposed Tailings Embankment

In all areas of known or suspected ice-rich soil, it will be important to develop design solutions and construction methodologies that mitigate possible permafrost degradation.
